Partial discharge patterns related to surface deterioration in voids in epoxy

PARTIAL DISCHARGE PATTERNS
RELATED TO SURFACE DETERIORATION IN VOIDS IN EPOXY.

J.T. Holbøll and M. Henriksen,
Electric Power Engineering Department, Technical University of Denmark
Building 325,
DK-2800 Lyngby, Denmark

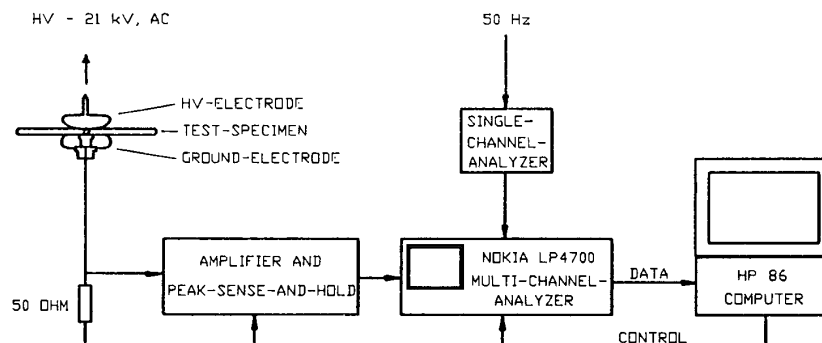
Fig.1: Test Set-Up

An HP86 Computer acted as the test set-up controller and data storage organiser, as shown in Fig. 1.

The specimens were placed in a test-chamber containing an SF6 atmosphere at 4 bar absolute when exposed to a 50 Hz test voltage of 21 kV (rms). A 50 Ohm resistor connecting the measuring electrode to ground was used as detection impedance. Via this resistor, the PD pulses used for the pulse height and pulse phase analysis were fed into the measuring system.

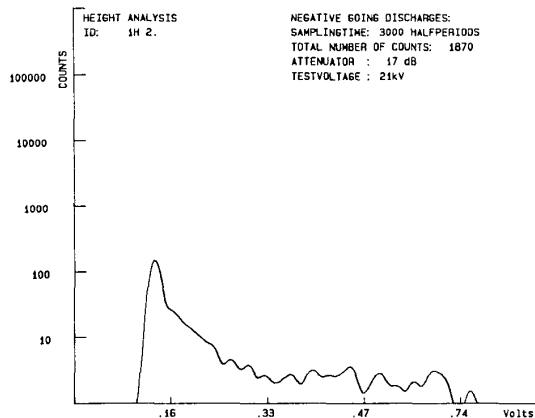
Fig.2: Height Analysis, Specimen 1, 2 hours.

The height analysis showed the following typical pattern for all the specimens:

Except for variations in the total number of pulses detected, this pattern was unchanged during the whole test period. The detected pulse height corresponds to max. "apparent charge" on the testelectrode of 89 pC(Specimen No. 1) and 191 pC(Specimen No. 5) and is independent of the polarity. Regarding Specimen No. 2, a very high PD activity was detected after 1518 hours into the test, and at the same time, a very pronounced difference in the total number of positive and negative pulses was observed, as shown in Fig. 3.a. and Fig. 3.b. respectively. As can be seen almost 10 times more positive pulses were detected than negative pulses.

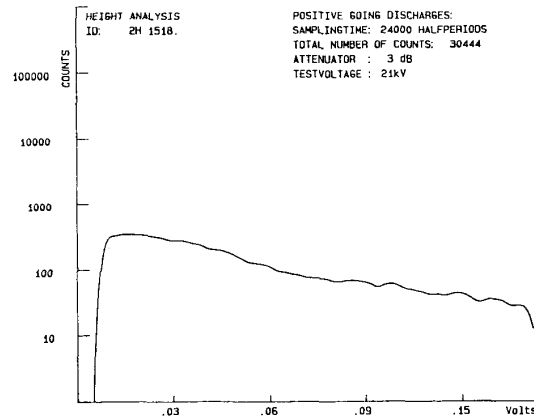
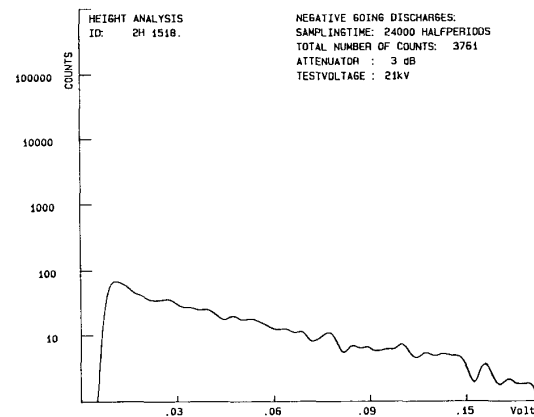
Fig.3.a.: Height Analysis, Spec. 2, 1518 Hours, Pos. Pulses.

Fig.3.b.: Height Analysis, Spec. 2, 1518 Hours, Neg. Pulses.

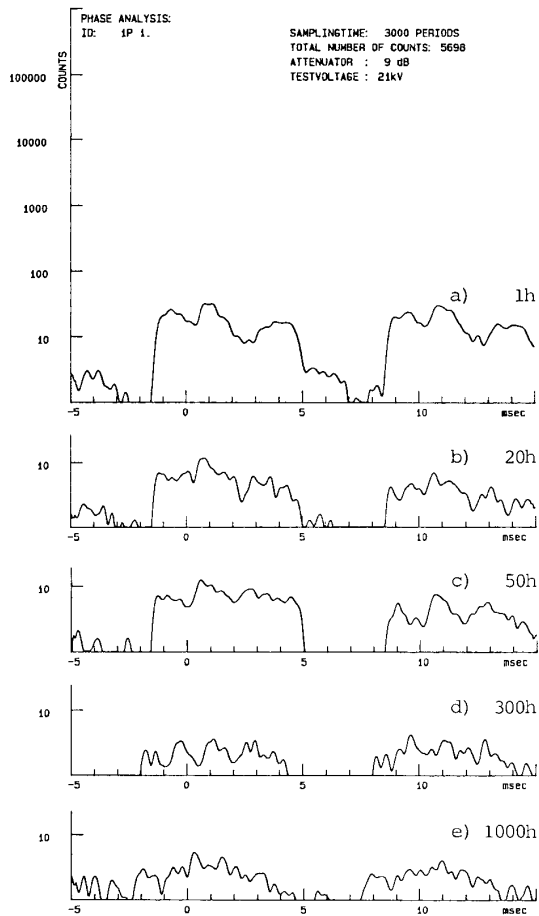
Fig.4.a-e.: Phaseanalysis, Specimen 1, 1 to 1000 Hours

For all the 5 test specimens the phase analysis also showed a general trend as a function of time, as shown in Figs.4.a to 4.e, recorded after 1, 20, 50, 300 and 1000 hours for test specimen No. 1.

As can be seen the activity decreases with time, but, at the same time, first three (5 Hours) and later five (300 Hours) maximums occur. This has been reported earlier [1], and could possibly indicate a decrease in the inception voltage. This is also somewhat indicated by the change in location of PD pulses in respect to the test voltage maximums. After one hour the PD inception does occur 1.5 ms before the test voltage zero passes, but after 50 hours this has moved to 2 ms and after 1000 hours to 2.5 ms. If it can be assumed that the remaining voltage is zero [2], it can be calculated that this corresponds to a decrease in inception voltage of 10% after 50 hours and 20% after 1000 hours in respect to the initial value.

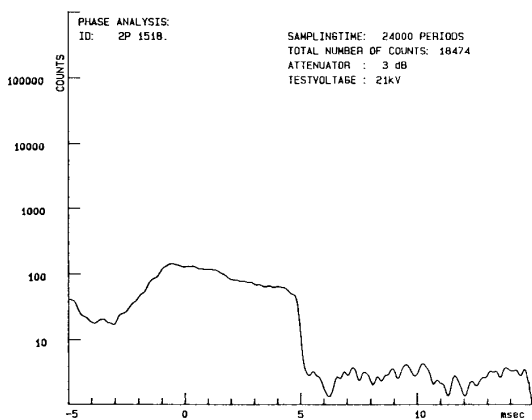
Fig.5: Phaseanalysis, Specimen 2, 1518 Hours.

Again, test specimen No. 2 deviates from this behaviour after 1518 hours, as shown in Fig.5 above. As can also be seen, the inception voltage can no longer be determined, but is much lower than the initial value recorded.

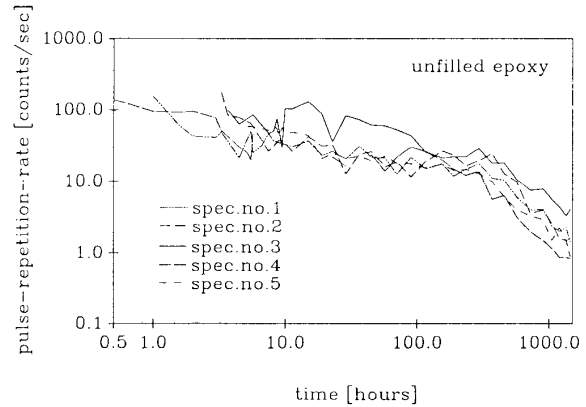
Fig.6: Pulse-Repetition-Rate, Specimen 1-5

The pulse-repetition-rate (the discharge activity) for the five test specimens behaved with time as shown in Fig.6 below.

The PRR decreases from an initial value of 100 counts/sec. to about 1 count/sec. after 1500 hours. Specimens 1,2,4 and 5 behave the same way, whereas specimen 3 shows, over long periods, a much higher activity (approximately 2.5 times higher). The time to inception of PD after voltage application (time lag) is also shown; it varies from 0.5 hours to 5 hours.

The decreasing PRR can be explained by either a void gas temperature increase or an increase in the void gas pressure caused by gasformation from decomposed surface material or a combination of both. This assumption is somewhat supported by the fact that an increase in PRR is detected when reapplying the test voltage after some time without voltage. Perhaps also a change in the pulse type is to be expected.

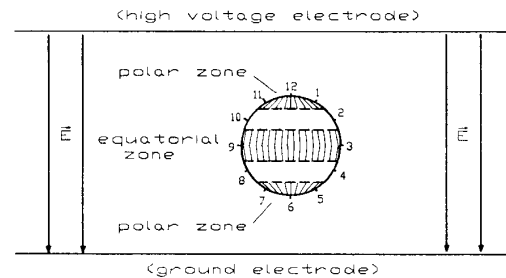
Fig.7:The Void Orientation in Respect to the Applied Electric Field.

The surface investigations here reported were performed using a light microscope (type Zeiss NU2) on the void surfaces of specimen 1, 2, 3 and 4 after the 1518 hours with voltage. The locations of the investigated areas are related to the applied electric field as indicated in Fig. 7.

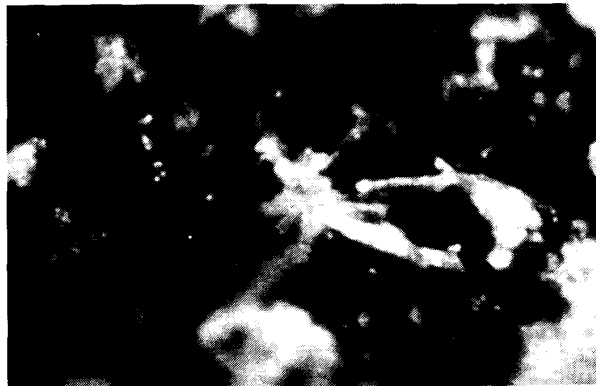
Fig.8: Specimen 1, Equatorial Zone, Crystal Length 33 um.

When looking from the outside at the void surface of specimen 1, about 10 "star-like" patterns were observed in the equator zone. The same patterns were also found after the void was opened, Fig. 8, and it is assumed that the patterns are formed by oxalic acid as reported in [3] and [4]. The same "star-like" patterns were also found in the equator zone of specimens 2 and 4.

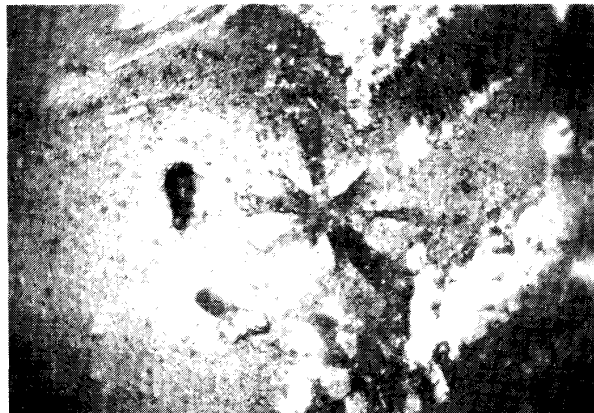
Fig.9.: Spec. 2, Polar Zone, Tree-like Crystal, Length 64um

Regarding specimen No. 2, a "tree-like" crystal was found in the polar zone at position 5, near the measuring electrode, and in the vicinity of the crystal, a severe surface deterioration had started, Fig.9.

The crystal in test specimen 2 could have been the reason for the very high PD activity observed for this specimen because the location of the crystal could have led to field enhancement, thereby leading to a much higher activity when positive than negative. Perhaps the crystal is the first stage of an electrical tree formation.

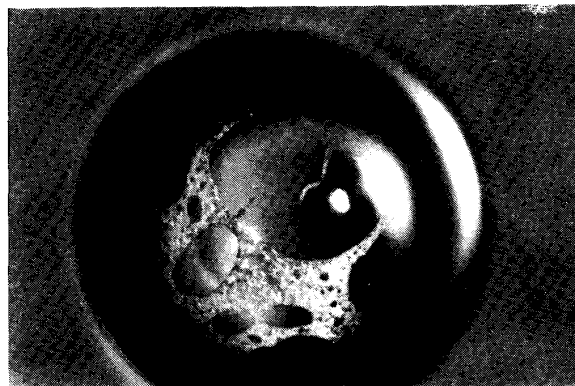
Fig.10: Specimen 3 before opening up the void, Polar Zone.

In Fig.10 is shown the polar zone of specimen 3 from position 10 to 2. It shows that only certain areas have been affected by the partial discharge activity, but on the other hand the affected areas have been greatly deteriorated. No form of crystal formation was found in the equator zone of this specimen.

Regarding test specimen no. 3: had high PRR, only part of the surface had deterioration and no crystal-like patterns found in the equator zone, which could indicate that the surface deterioration in this specimen has been different from that of the four other specimens, this being supported by the large variation in pulse height. All this makes the explanation of the nature of the surface deterioration caused by PD in spherical voids very difficult, when keeping in mind that the void diameters and the production parameter were kept the same. A very alarming result was that the PD signal from test specimen no. 4 did not give any indication at all of a channel growth.
