## Low-energy house in Sisimiut

Annual report of Low-energy house performance July 2008 to June 2009

Rapport SR 09-06  
BYG-DTU  
October 2009

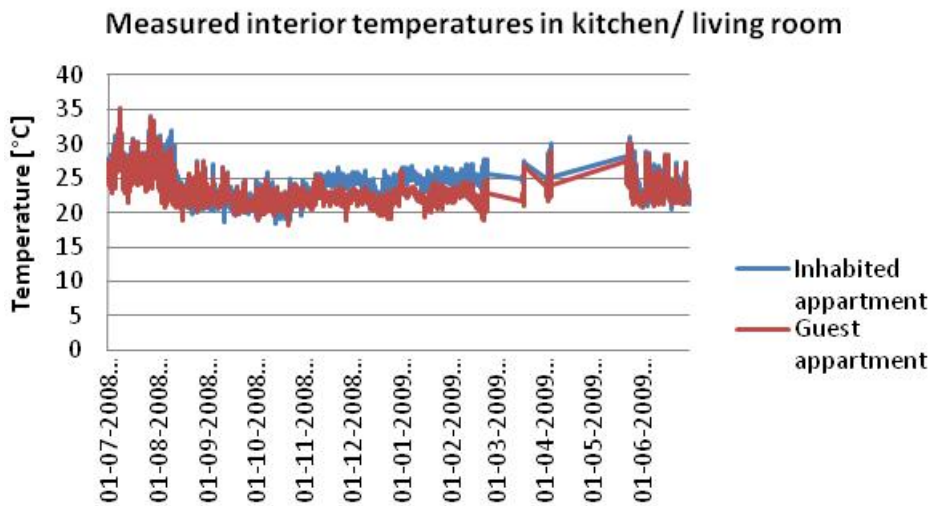
Figure 4 Measured air temperature in kitchen / living room from July 2008 to June 2009

The measured kitchen temperature in the right apartment from August 2008 and August 2009 shows rather high indoor temperature of 24 °C, the unoccupied apartment has measured indoor temperature of 22 °C. One explanation could be that the inhabitants often increase the set point of the temperature control. Other possible explanation could be the extra heat from the inhabitants, their electric equipment, cooking, etc.

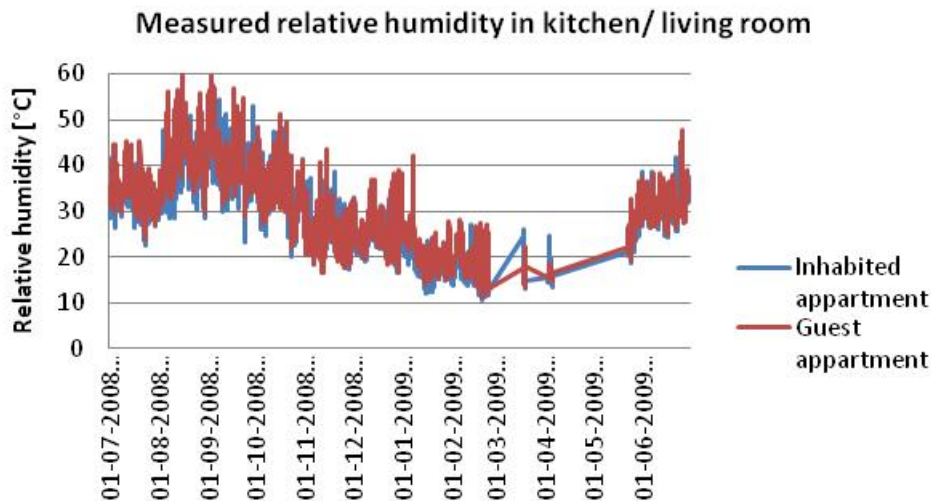
Figure 5 Measured relative humidity in kitchen / living room from July 2008 to June 2009

As expected, the relative humidity is seen to be lower than normal for Danish conditions.

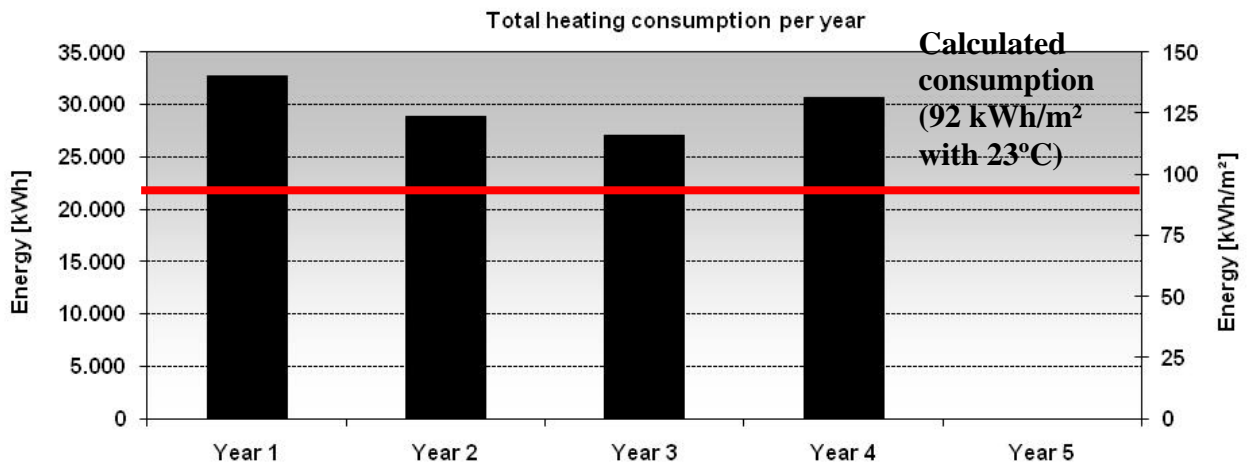
Figure 12 Comparison of heating consumption for each year

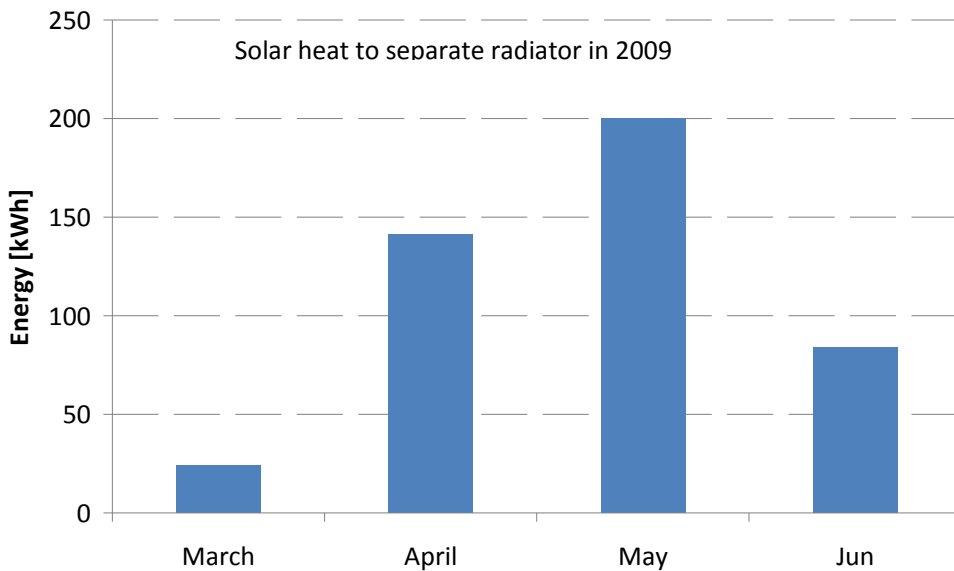
Besides the solar heat transferred from the solar collectors to the hot water tank, solar heat was from the spring 2009 also transferred to a separate radiator in the house. In sunny periods where the temperature in the hot water tank is high enough heat is transferred from the solar collectors to the radiator. The energy transferred from the solar collectors to the radiator is shown in Figure 19.

Figure 19 Energy transferred from solar collectors to separate radiator

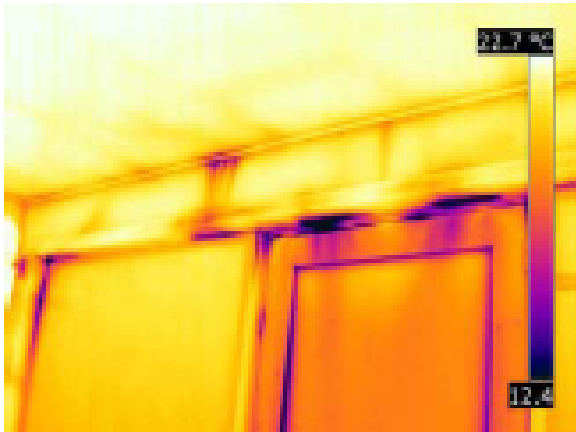
Entrance hall where there are leaking areas both inside of the windows, but also in the surrounding construction and seal in window panels.

Figure 26: Entrance door and leakage

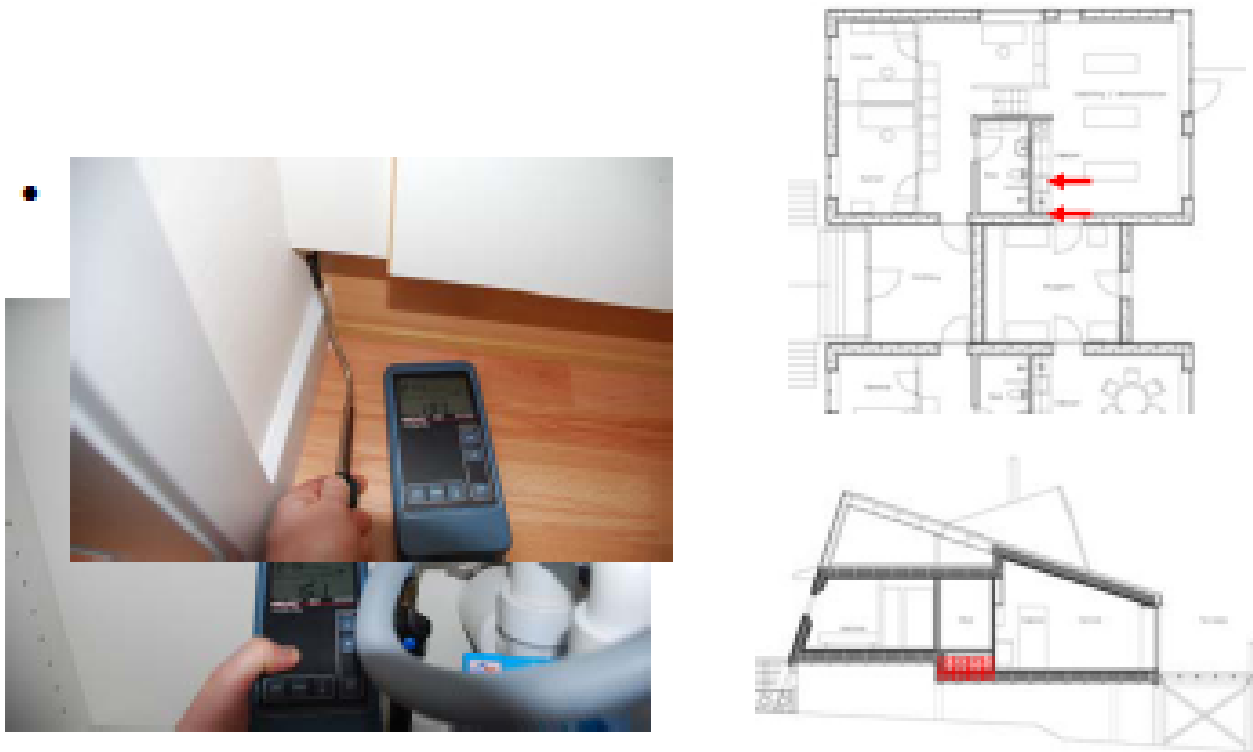
Large air flows from the crawl space beneath the kitchen cabinets and ventilation shaft.

Figure 28 Leakage between kitchen unit and crawl space (shaft)

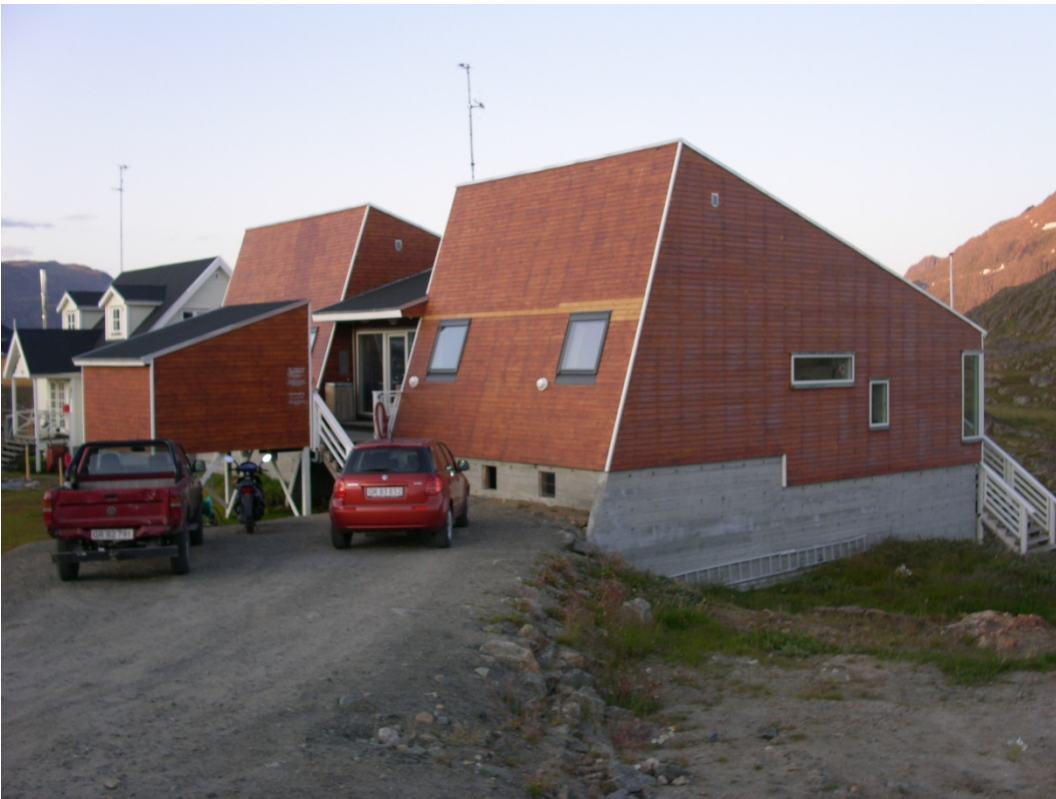
Figure 31 Low-energy house and fixing of windows in inclined wall

**Windows** are still in good condition, but certain fixing of leakage around the windows has been done after the blower-door and thermo graphic test. To fix the frosting between panels in terrace windows the holes have been drilled to avoid frost and condensation (executed in November 2006). See photos in Annex 1 - Pictures from the low-energy house 2008/2009.

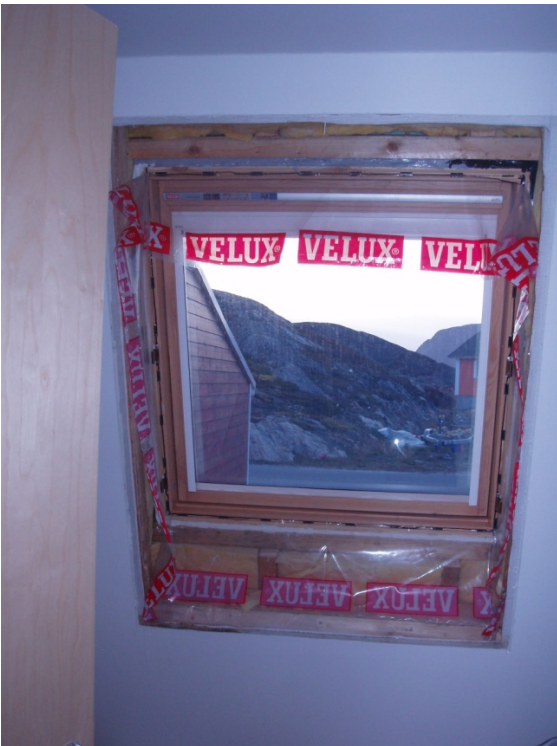
Figure 32 Fixing of skylight windows

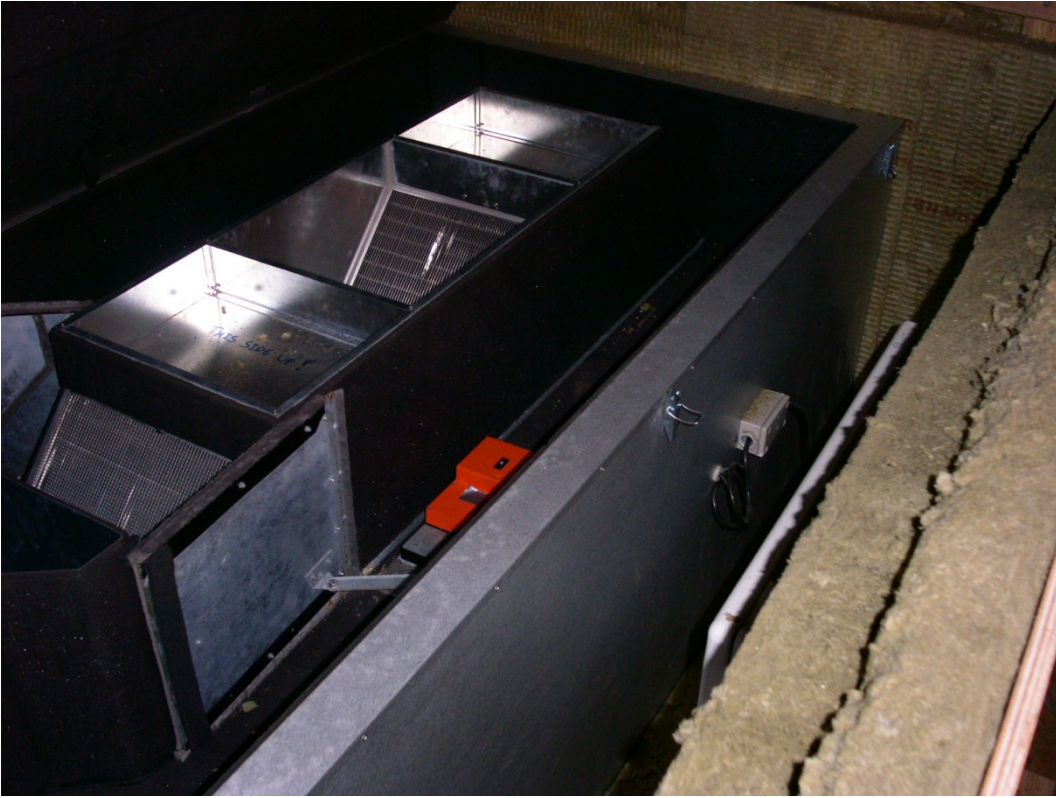
Figure 33 Heat exchanger in insulated box

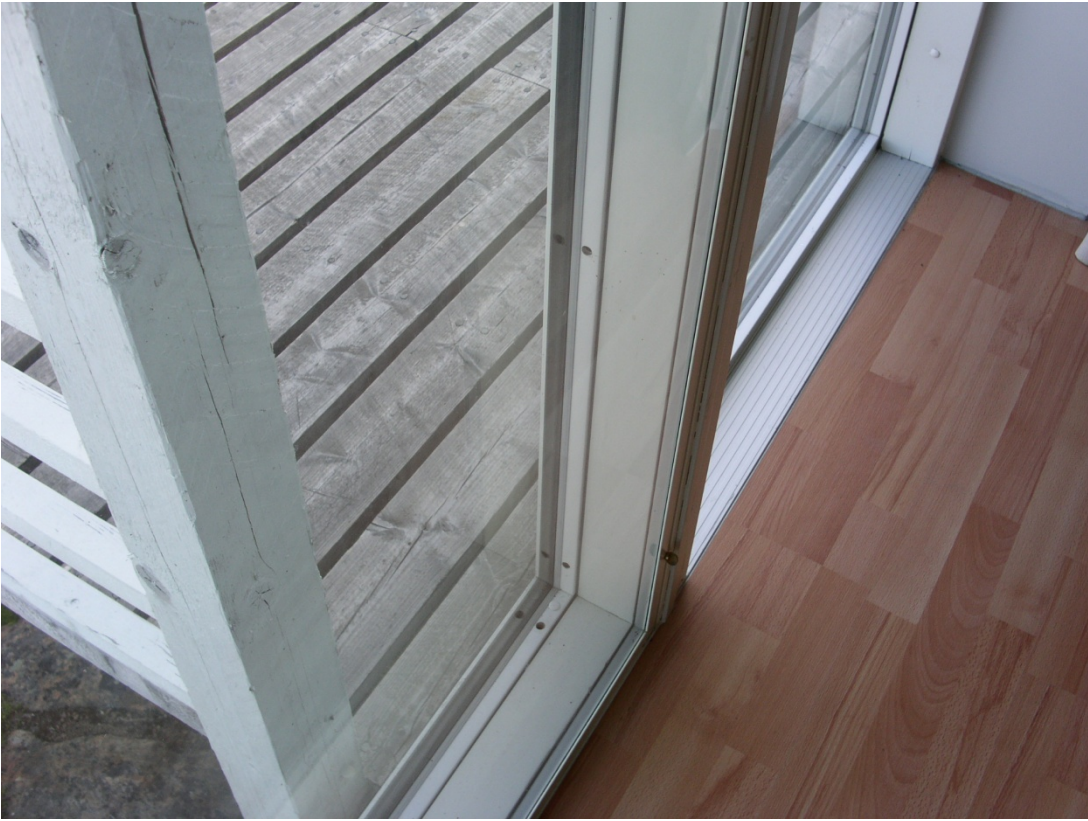
Figure 34 Holes in windows to prevent freezing in winter
