## Full Scale Test of a SSP 34m boxgirder 2

### Data report

## Full Scale Test of a SSP 34m box girder 2. Data report

This report presents the setup and result from three static full-scale tests of the reinforced glass fiber/epoxy box girder used in a 34m wind turbine blade. One test was without reinforcement one with cap reinforcement and the final test was with rib reinforcement. The cap reinforcement test was part of a proof of concept investigation for a patent.

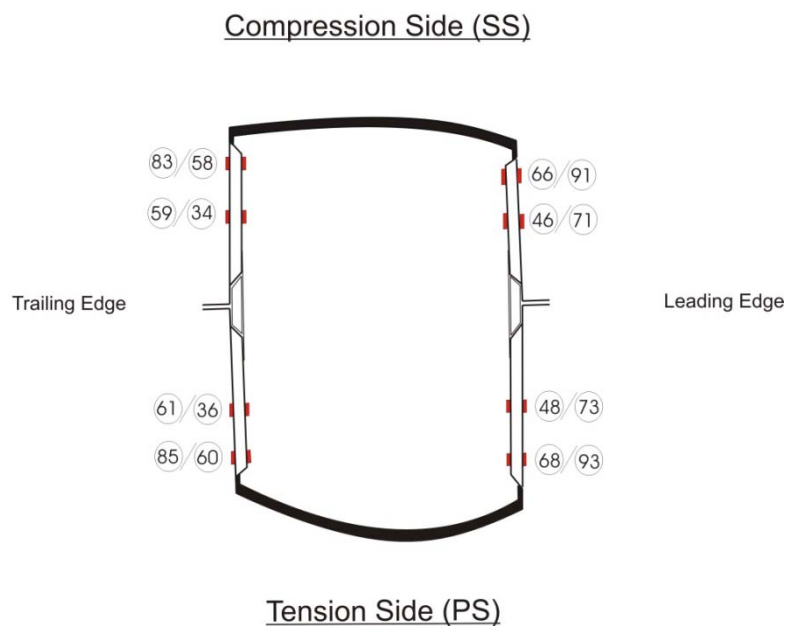
**Figure 2.** Strain gauge positions at section 11.5m from the root. The strain gauges were numbered with odd numbers on the outside, and even number on the inner side.

Strain gauges in the section 11.5m are presented in Figure 2. The box girder failed in this section, see chapter 4. Positions of strain gauges in other sections can be found in appendix B. Results from the strain gauge measurements can be found in appendices C to E.

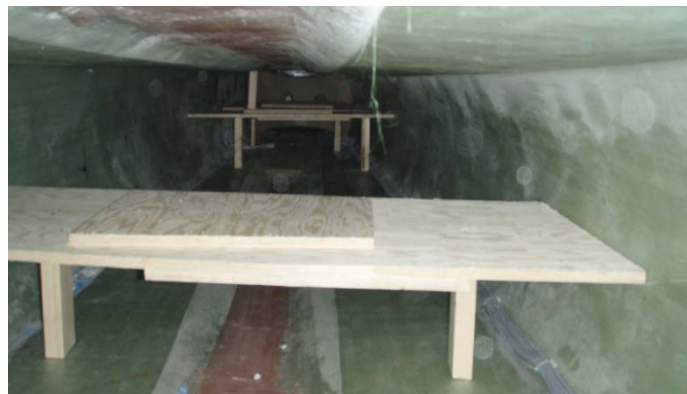
**Figure 19.** Additional longitudinal bulkheads, to prevent buckling failure at height load. The legs under the plates were used to secure the plate position.

The additional longitudinal bulkheads were made of wood plates which have shown to be satisfactory. The failure happened in the predicted region.

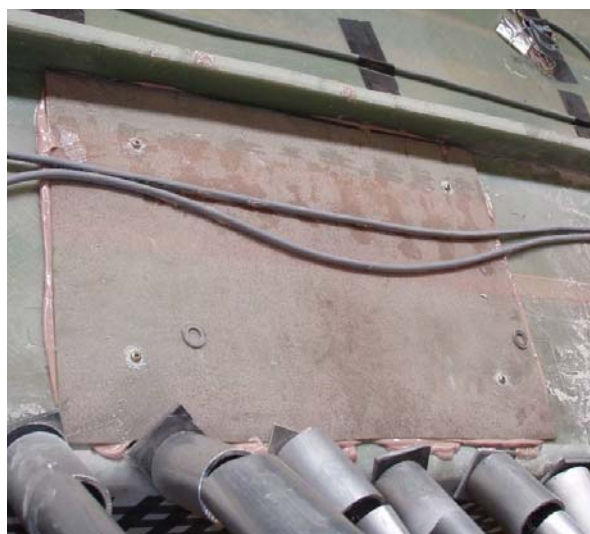
**Figure 23.** Repair damage on the shear web in the area 10.7m - 11.5m

The damage was repaired on site with a plate of same material as the original laminate. After preparing the surfaces, the plate was bounded to the web with epoxy adhesive, see Figure 23.

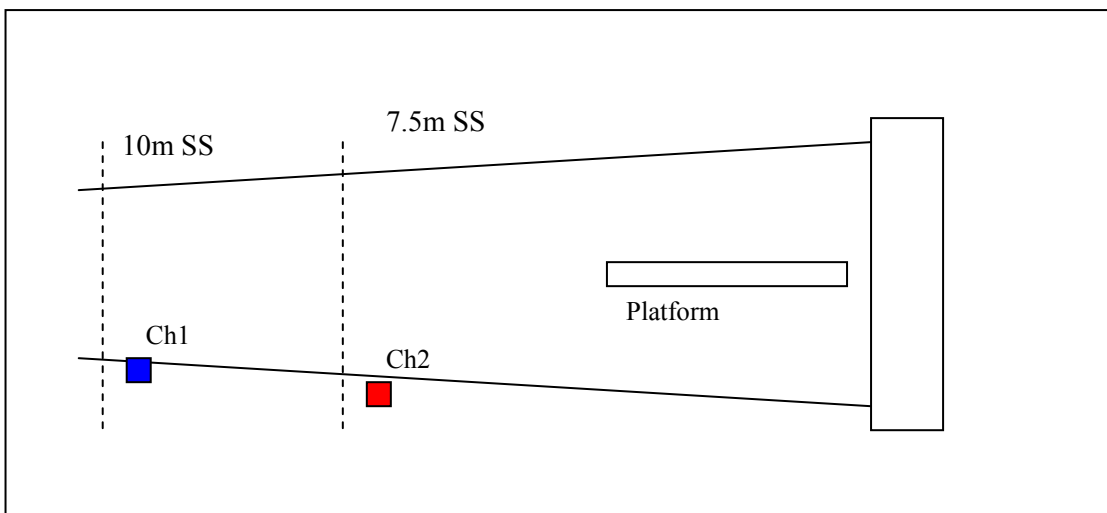
**Figure 25.** Scheme of the general position of the PAC sensors outside the spar

1300 It is decided to move the AE sensors from inside the spar to the outside, in order to minimise the likelihood of any hardware damage when the spar fails. Ch1 is again placed at roughly the same location; Suction side 10m. Ch2 is now placed at Suction side 7.5m. See the schematic below.

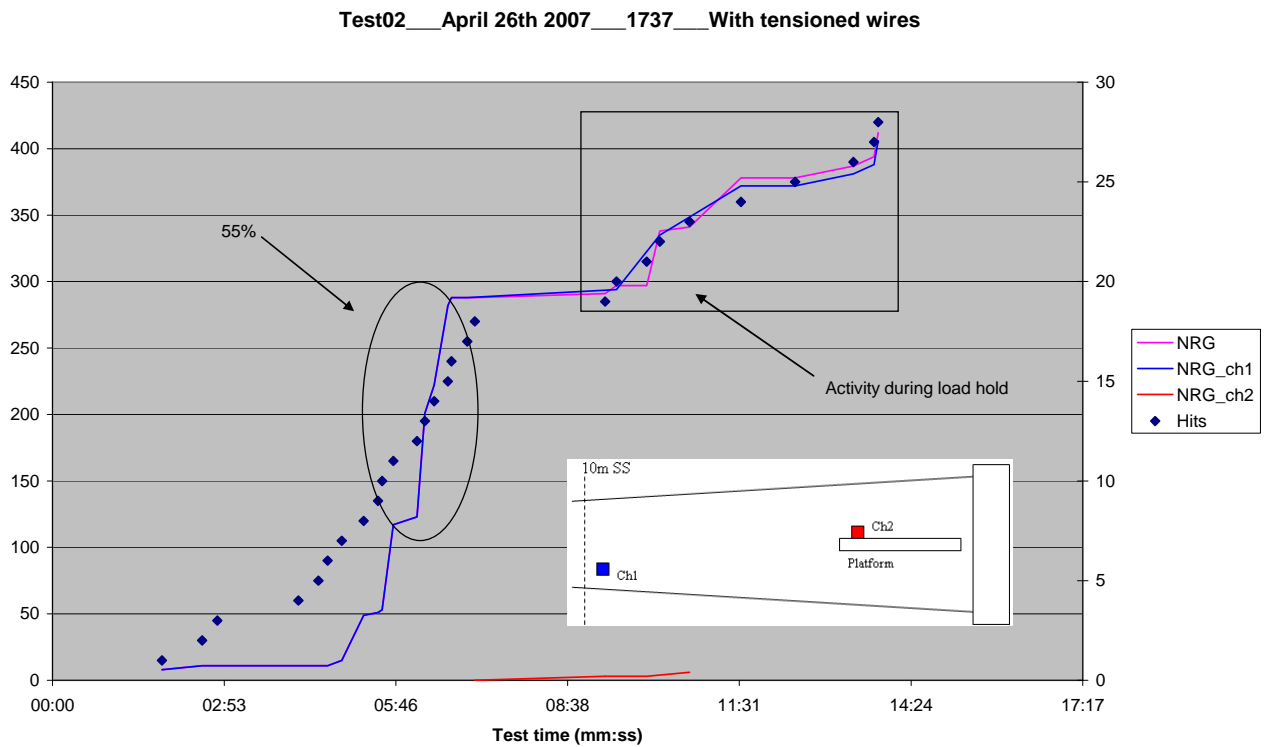
**Figure 28.** Activity trace for test 2, loading with tensioned wires.

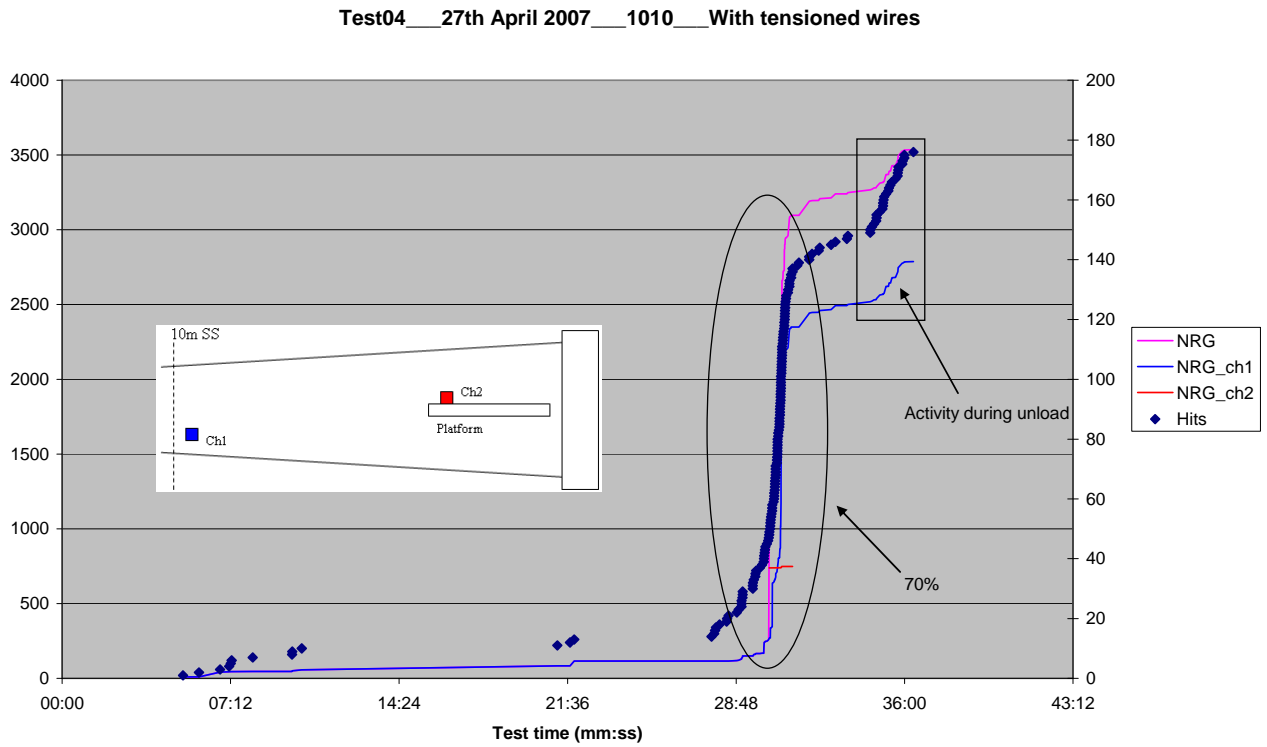
**Figure 30.** Activity trace for test 4, loading with tensioned wires.

In test04 the spar is loaded up to 70% (the highest loading at that point) while the wire reinforcements are in place. The sensor at 10m on the suction side (Ch1) returns a burst of activity with an “energy” rating of 2000. In test05 the spar is loaded in exactly the same way but Ch1 returns only a burst of 350, this drop in activity on subsequent loading is very typical and suggests that no significant damage is present here at this time.

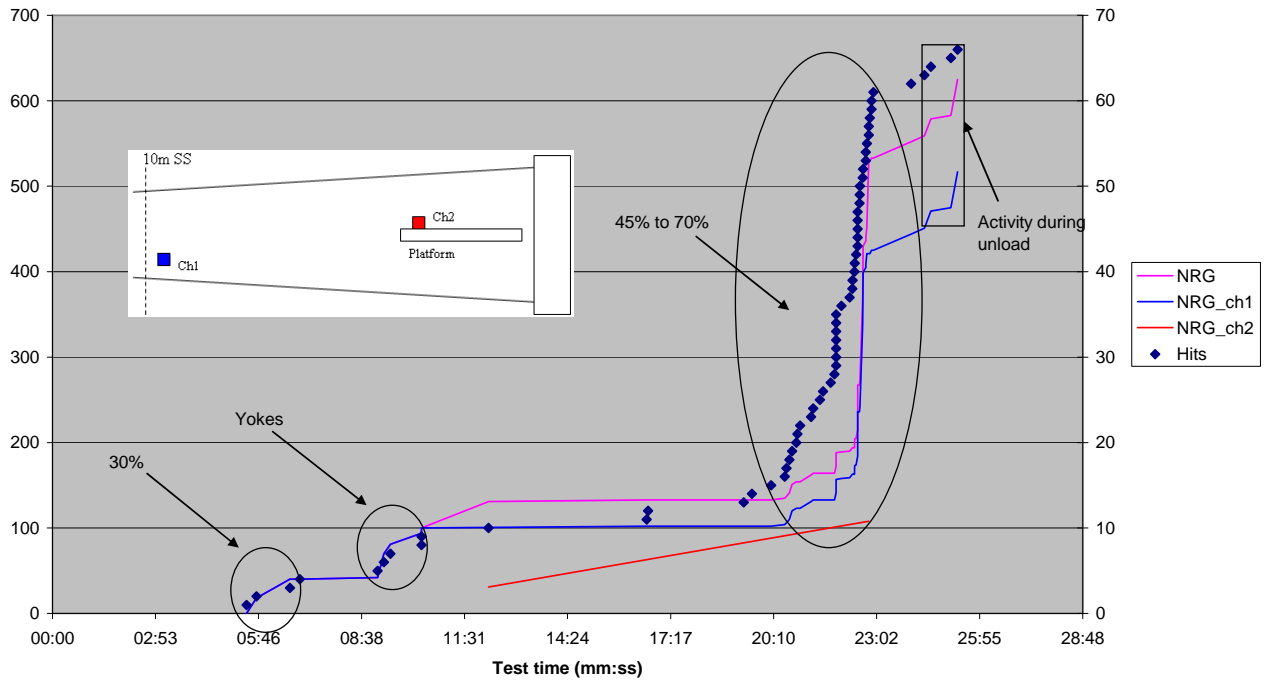
Test05\_\_27th April 2007\_\_1057\_\_With tensioned wires

Figure 31. Activity trace for test 5, loading with tensioned wires.

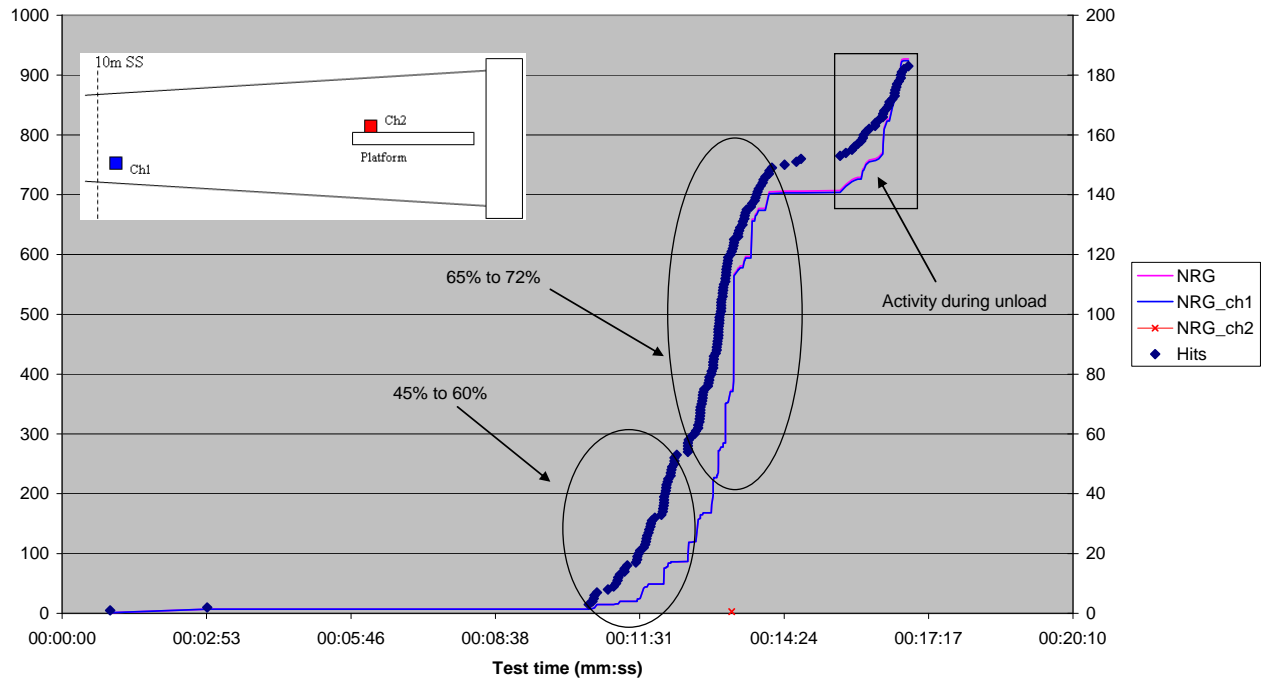
Test06\_\_27th April 2007\_\_1230\_\_Without tensioned wires

Figure 32. Activity trace for test 6, loading with tensioned wires.

Test06 is the first loading where the wire reinforcement of the spar is removed. Once again the spar is loaded up to 70%, but this time Ch1 is more active returning an “energy” rating of 700. This increase is most likely due to the redistribution of stress/strain into the spar material caused by the removal of the wire reinforcement.

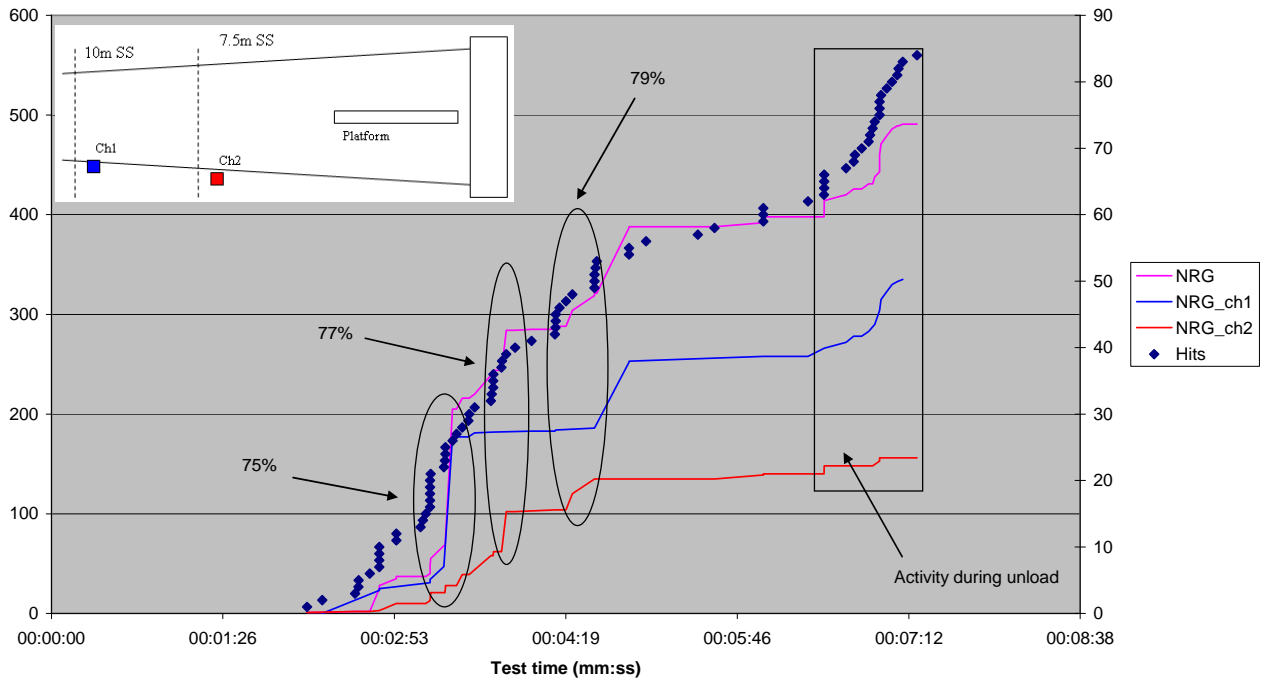
Test07 \_\_ 27th April 2007 \_\_ 1350 \_\_ Without tensioned wires

Figure 33. Activity trace for test 7, loading with tensioned wires.
