Proceedings of the 5th International Symposium on Building and Ductwork Air-tightness

Air tightness and energy performance of an Arctic Low-Energy House

Carsten Rode, Petra Vladykova and Martin Kotol

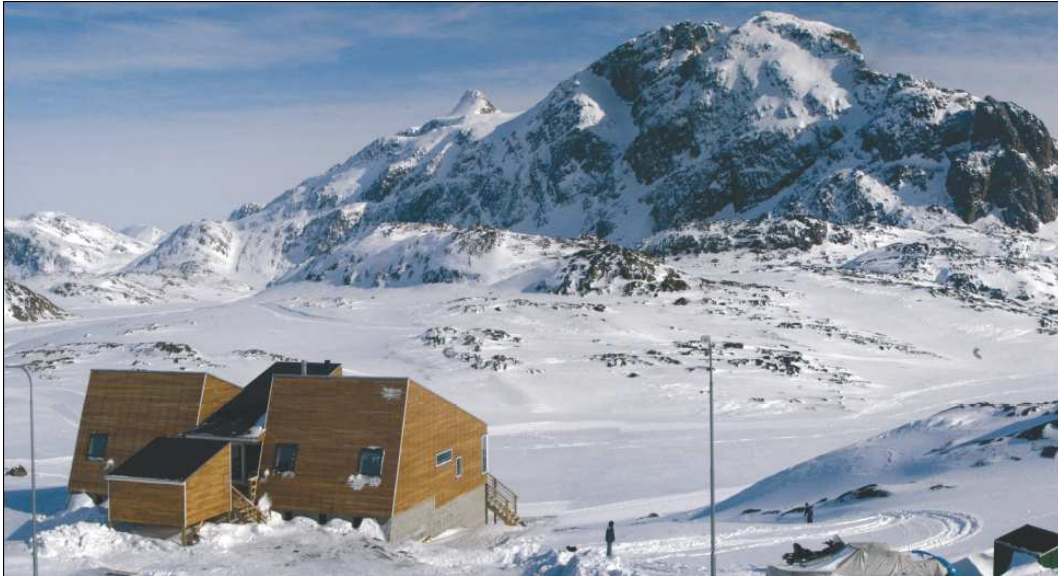
Figure 1: Picture of the low-energy house in Sisimiut.
