Low-energy house in Sisimiut

Annual report of Low-energy house performance July 2009 to June 2010

LOW-ENERGY HOUSE IN SISIMIUT

Annual report of Low-energy house performance
July 2009 to June 2010

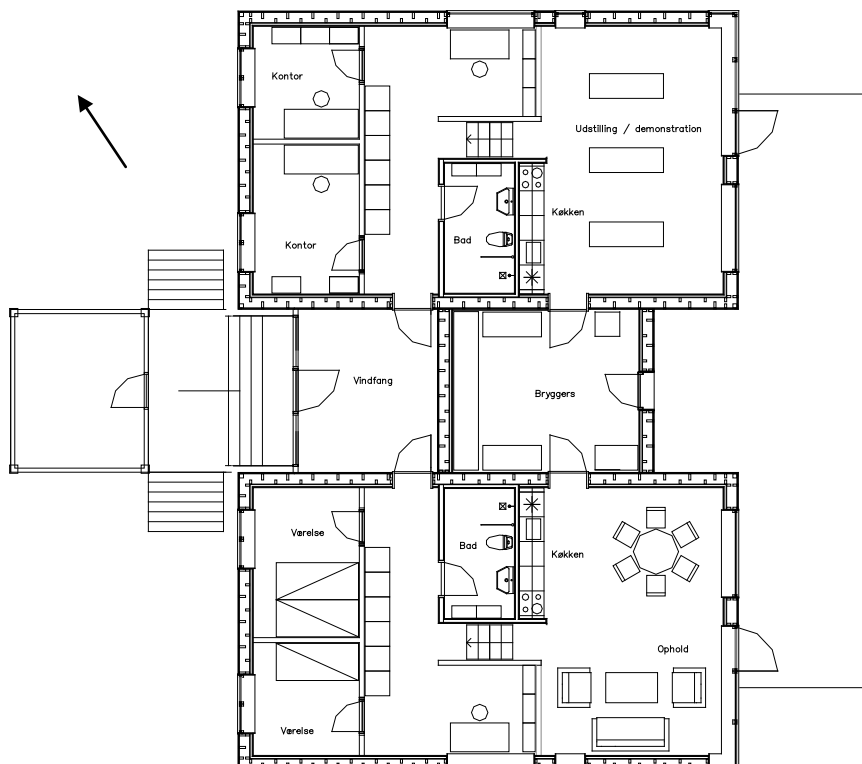
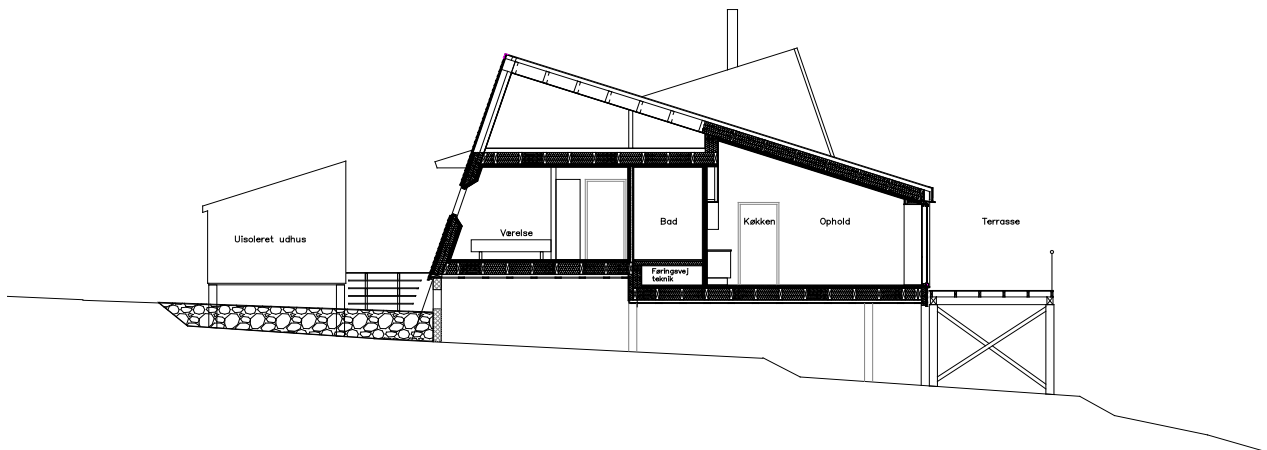
Figure 1 Low-energy house layout and cross section. The house is divided in two apartments, one serves as accommodation for a family and the other one as exhibition / guest house.

Figure 1 shows the floor plan of the low-energy house and a vertical cross section through one of the apartments.

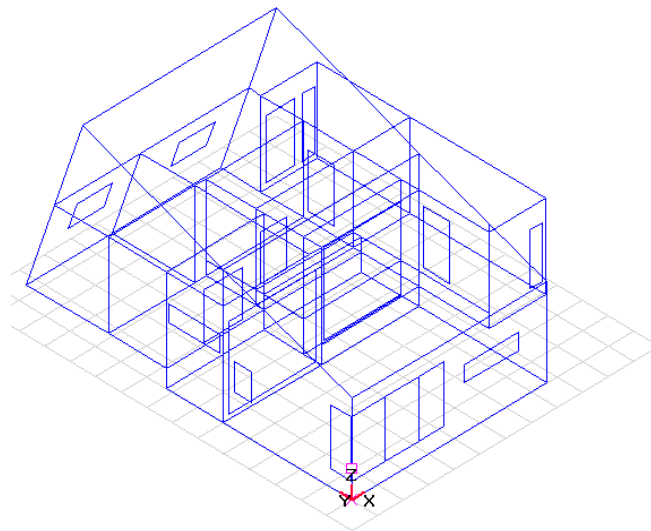
Figure 2 Simulated model from BSim

A simulation model of half of the low-energy house was created in the building energy analysis program BSim [5]. For the simulation of ambient temperature the annual weather data of Sisimiut (test reference year - TRY) was used. Figure 2 shows the simulation model BSim. The simulation model is described in detail in [6].

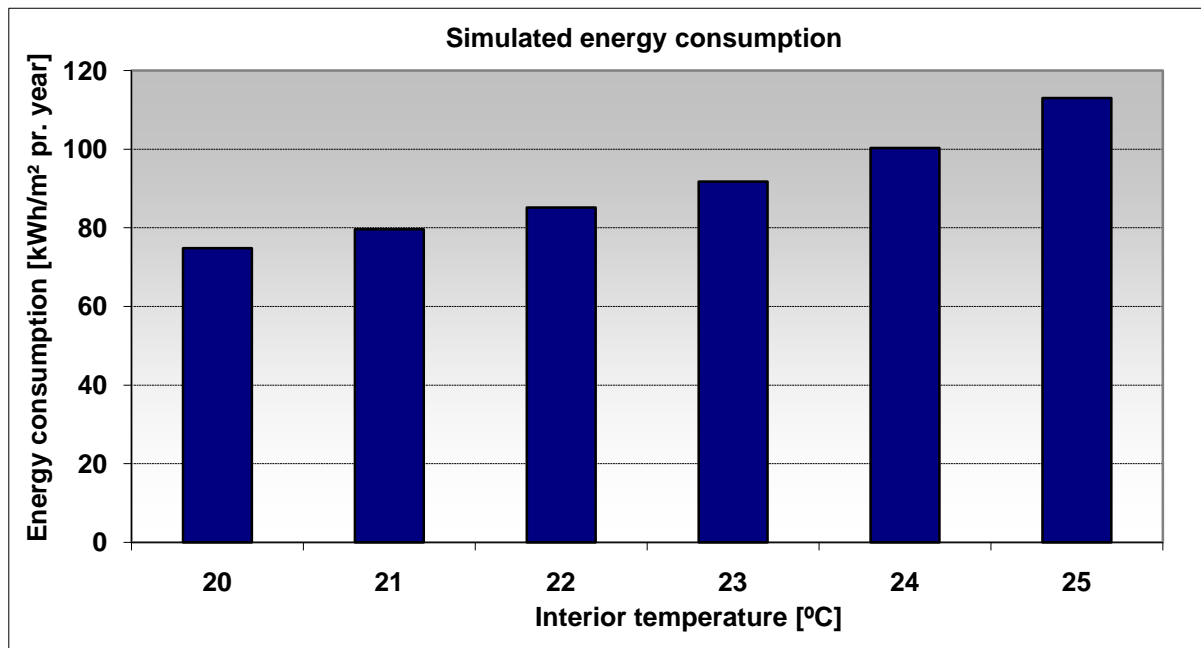
Figure 3 Simulated annual energy consumption (theoretical) for heating as a function of the interior temperature

Figure 3 shows simulated annual energy consumption for heating per square meter as a function of interior temperature.

It can be seen that the set point of interior temperature has a decisive influence on the energy consumption for heating. It is therefore necessary to know this when assessing whether the low-energy house lives up to the target in terms of energy consumption for heating.

As shown in Figure 3, the indoor temperature in the house has a large effect on the energy consumed for heating. Therefore it is interesting to see what temperature level has been inside the house through the year. Figure 4 shows the measured indoor temperatures in the kitchens. Figure 5 shows the measured relative humidity in the kitchens. The average temperatures in the kitchens were 23.9°C for the inhabited apartment (South-western apartment) and 22.7°C for the guest apartment (North-eastern apartment). The average relative humidity was 29.0% and 28.5 %. The devices were placed in the kitchens / living rooms of each apartment (Sensirion: T18, T20, RH18, RH20).

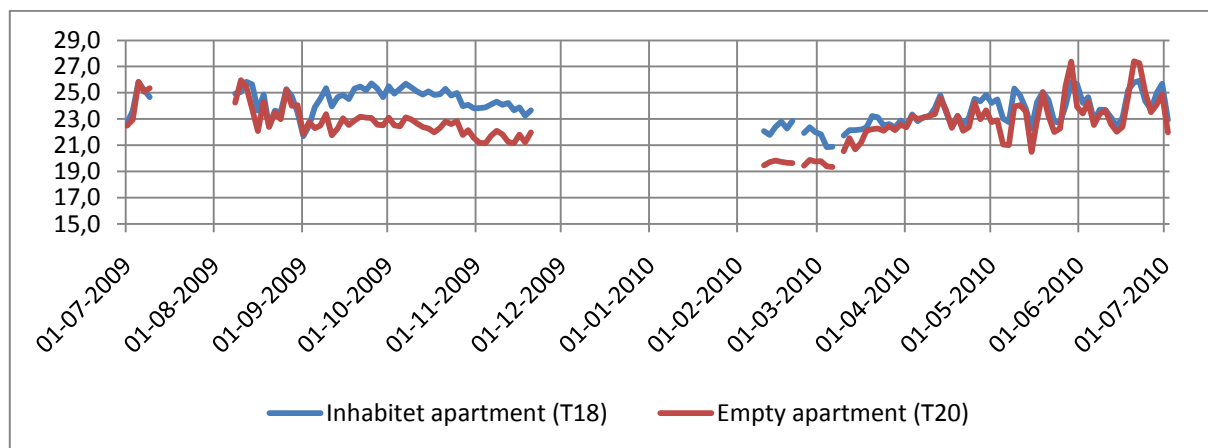
Figure 4 Measured air temperature in kitchens/living rooms from July 2009 to June 2010

The average temperature in the inhabited apartment has been rather high. Also the measurements from previous years showed the same phenomena. It is probably caused by the different demands of the people living in the arctic. However it might also be caused by the improper control of the heating and ventilation system where in case that the temperature in the space is above the set point, the after heater in the ventilation system should heat the air up to lower temperature.

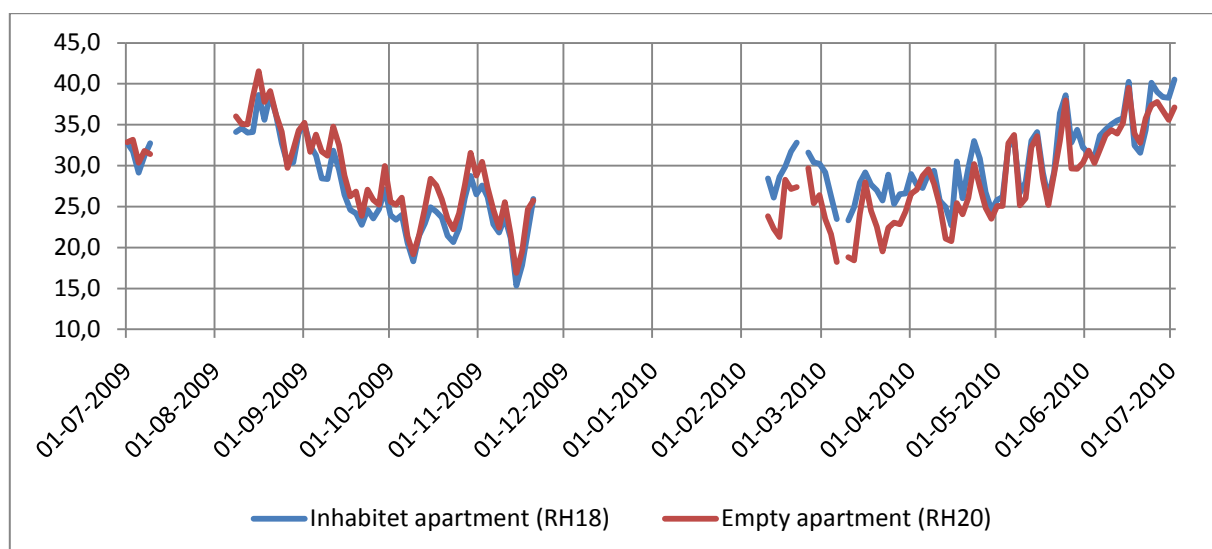
Figure 5 Measured relative humidity in kitchens/living rooms from July 2009 to June 2010

As expected, the relative humidity is seen to be lower than normal for Danish conditions.

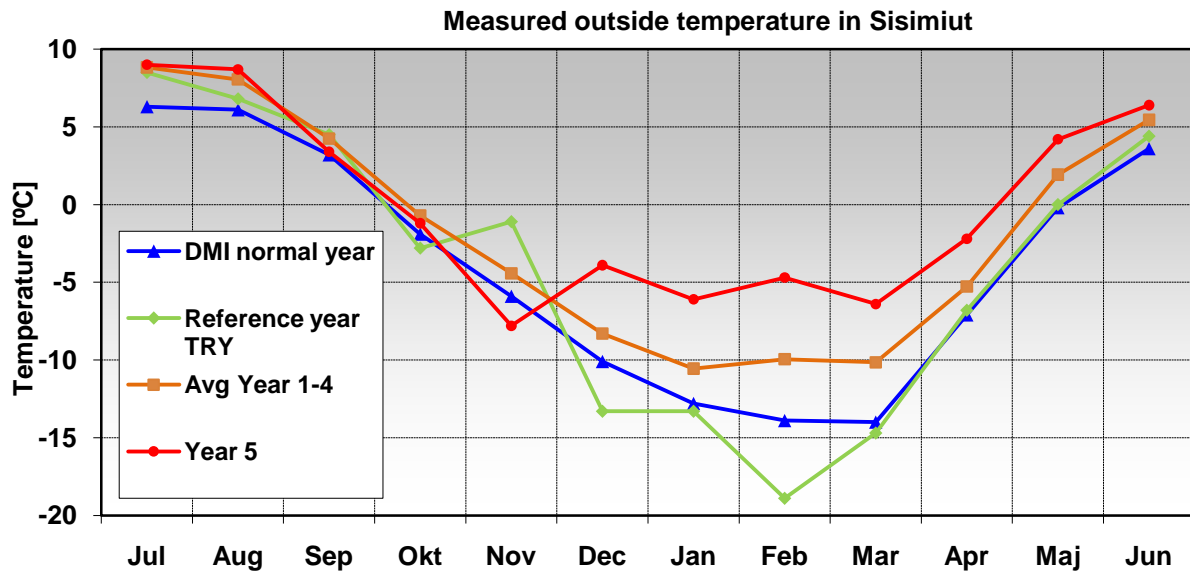
Figure 6 Measured outside temperature in Sisimiut. DMI normal year from www.dmi.dk. Data for reference year (TRY) from ASIAQ.

The temperatures of the TRY together with the real temperatures during last five years are presented in Figure 6.

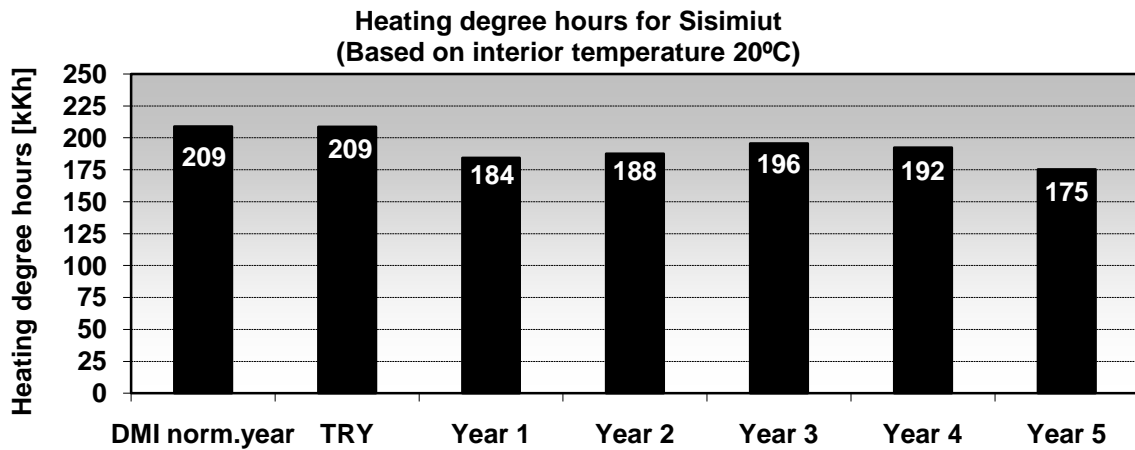
Figure 7 Calculated heating degree hours with interior temperature 20°C.

Figure 7 shows the estimated total annual number of degree hours. These values are compared with DMI's normal year and reference year (TRY).

Compared to the first four years of operation and to TRY data, the year 5 was milder. The number of heating degree hours in the year 5 was 10% lower than the coldest year 3 and 16% lower than the TRY.

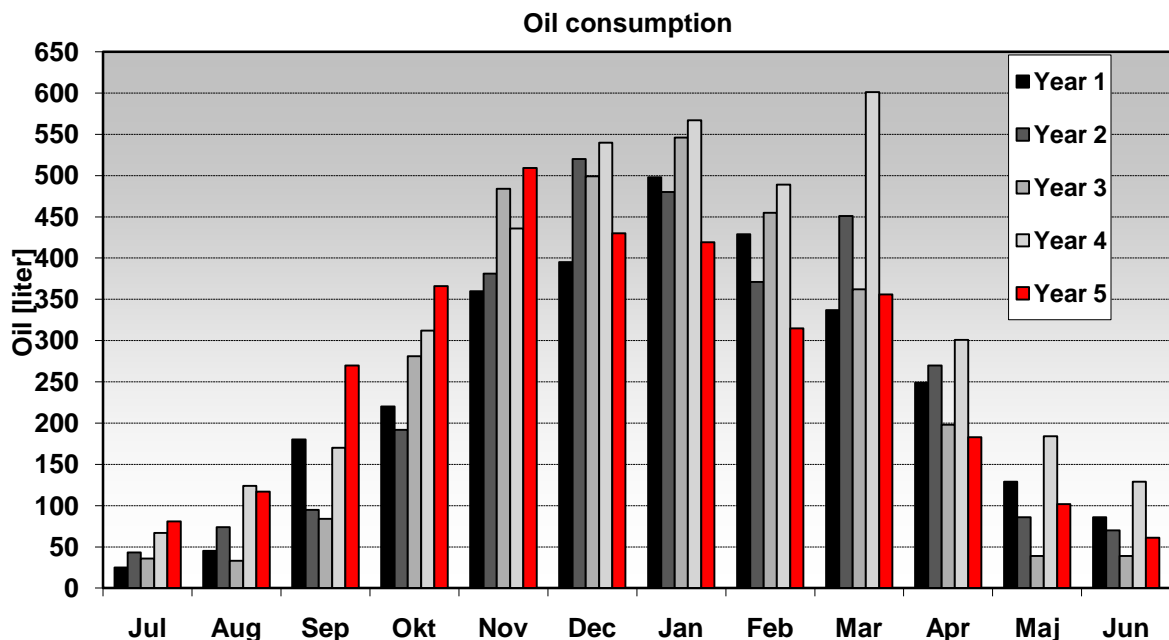
Figure 8 Oil consumption throughout the years

Figure 8 shows the measured oil consumption spread over the months of the year.

The oil consumption has decreased by 20% when compared to year 4. Part of this savings is caused by milder winter (app. 50%) and the rest is probably caused by fixing the broken damper in the heat exchanger in December 2009. After the damper has started working, the efficiency of the heat exchanger has increased¹.

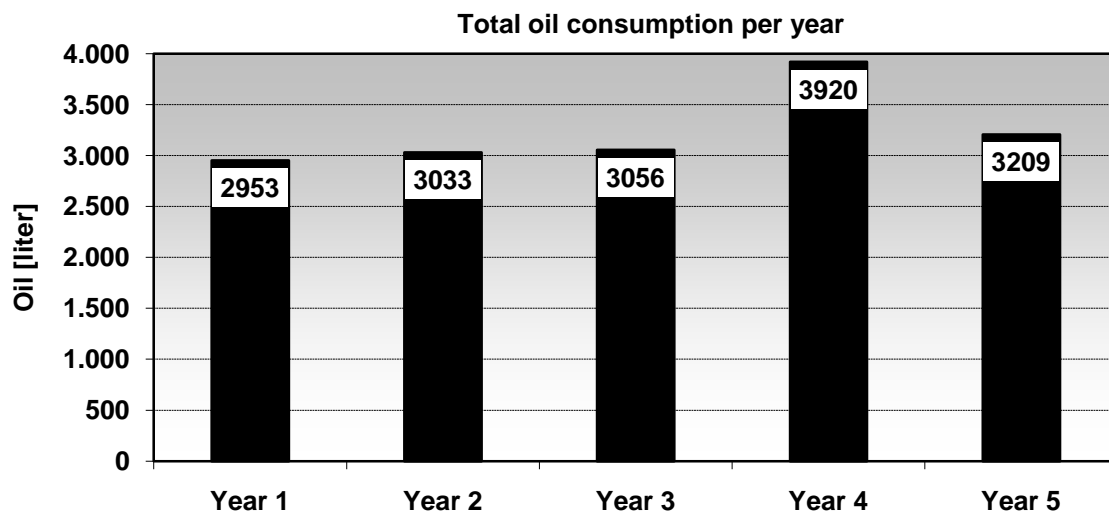
Figure 9 Annual oil consumption

Figure 9 shows the total annual oil consumption.

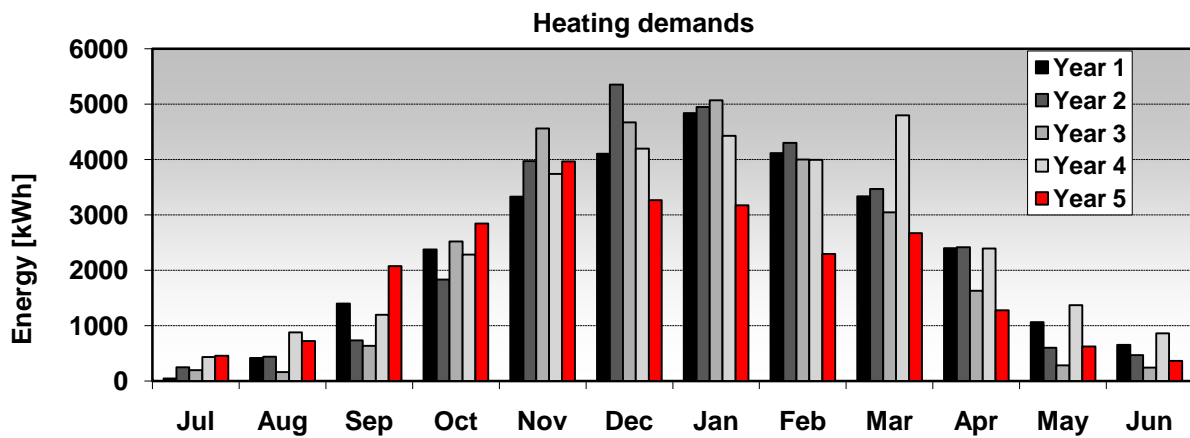
Figure 10 Heat distribution through the years

Figure 10 shows the measured heating demands spread over the months throughout measured years. Heating is excl. domestic hot water.

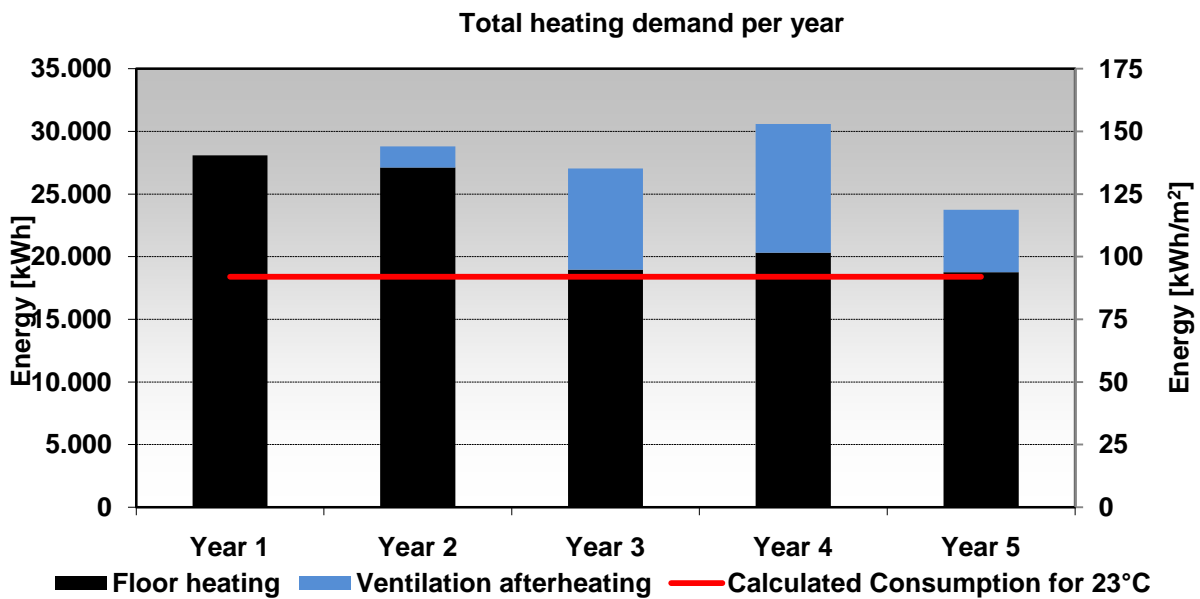
Figure 11 Comparison of heating consumption for each year

Figure 11 shows comparison of the annual heating consumption for each year and the targeted heating consumption.

As it could be seen from the Figure 11 the energy demand of the floor heating has been more or less identical for last three years. The only thing what has varied is the ventilation energy demand.

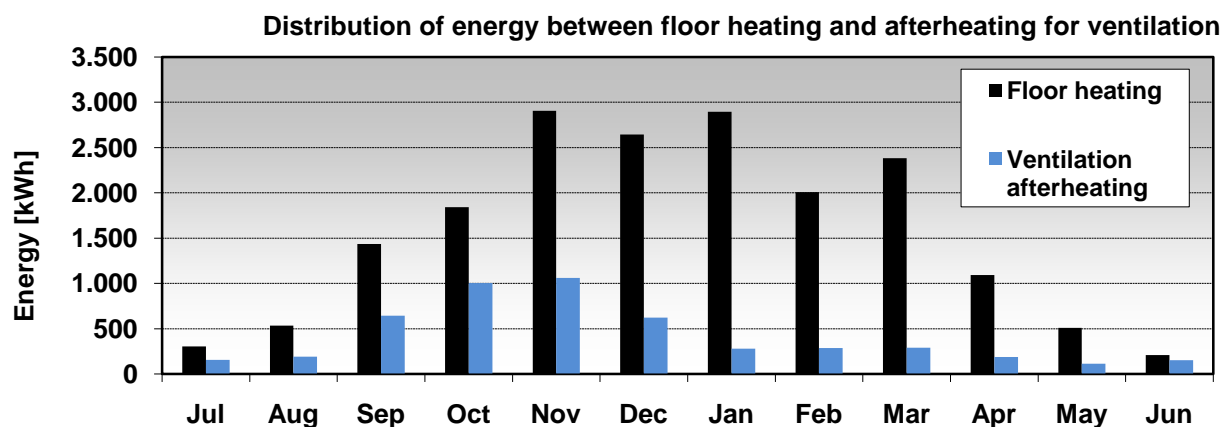
Figure 12 The distribution of heat between the after-heating for ventilation and floor heating

Figure 12 shows how the heat is distributed between the after heating of the ventilation air and floor heating.

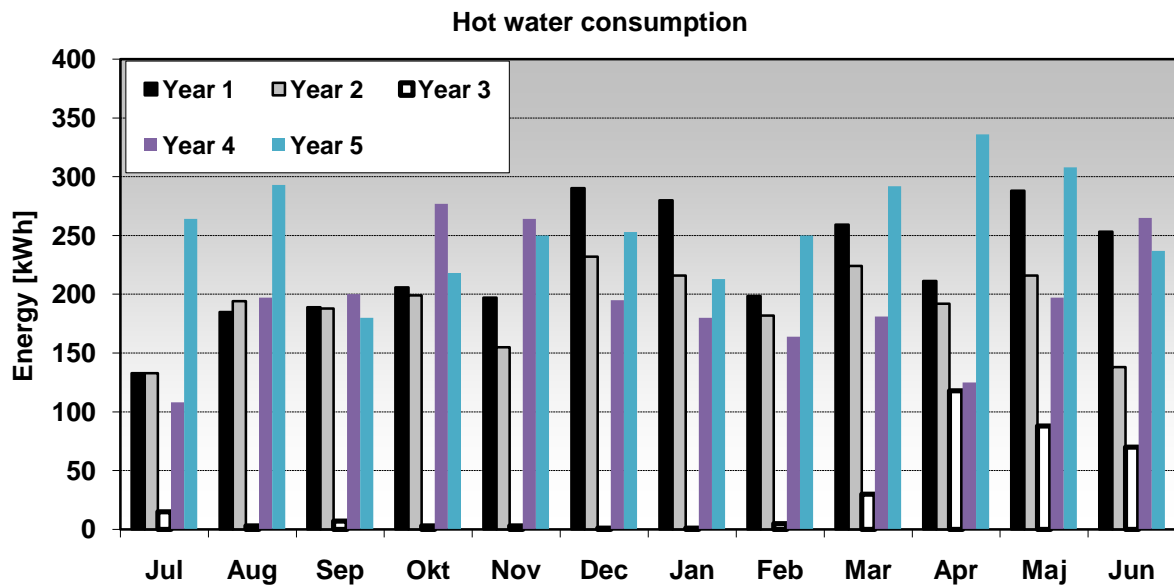
Figure 13 Measured energy consumption for hot water

Figure 13 shows the measured energy needed for domestic hot water.

Hot water consumption in year 5 is higher than during previous years which might be caused by higher occupancy of the guest apartment.

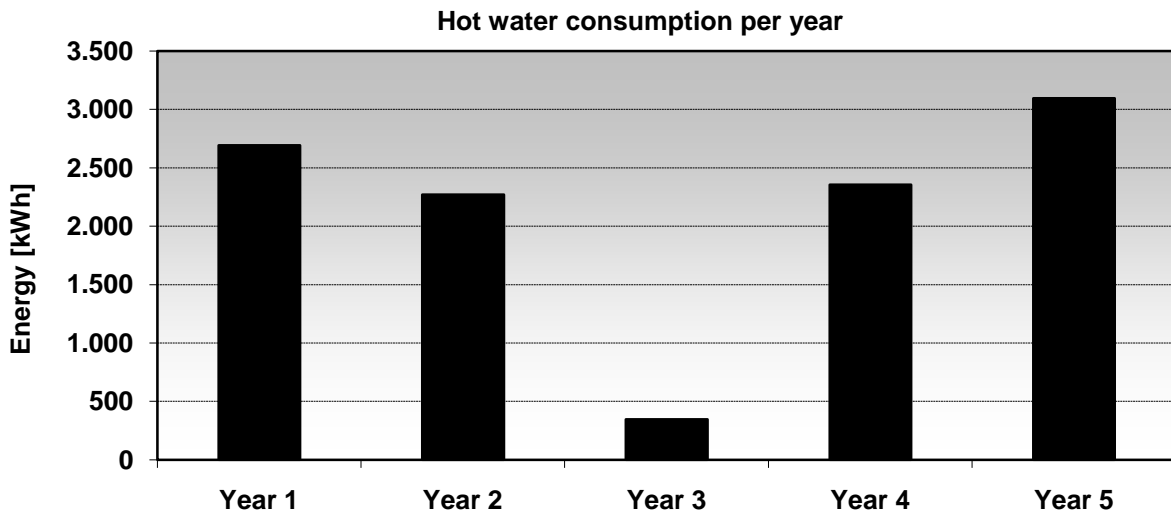
Figure 14 Annual collected energy for hot water

Figure 14 shows the annual energy consumption for hot water is obtained from the hot water tank.

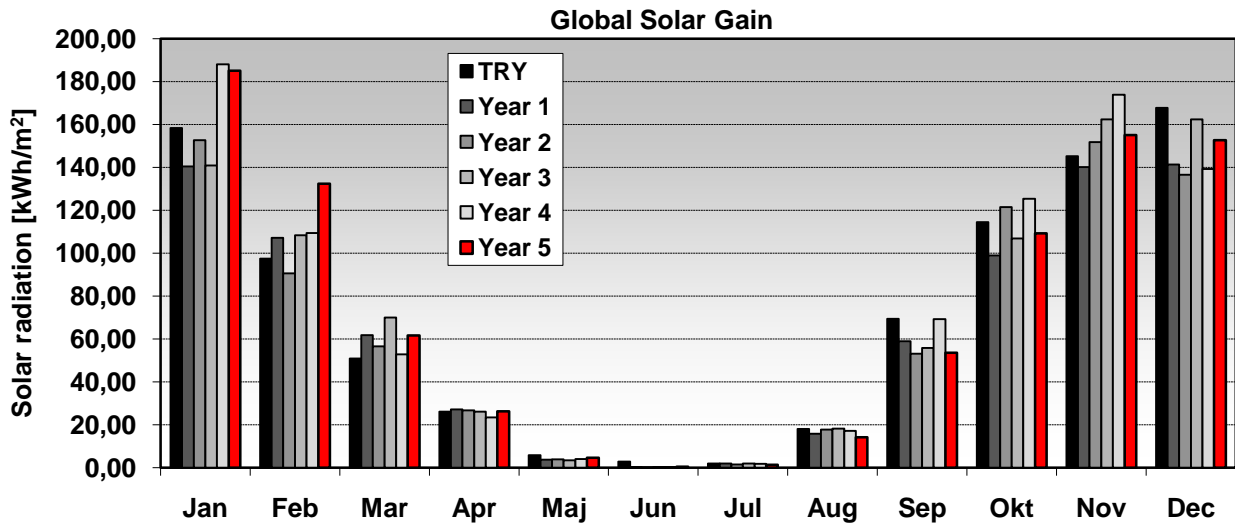
Figure 15 Comparison of reference year and measured global solar radiation

Solar radiation is important both for the solar gain collected by solar panels and for the solar gain received by windows. Figure 15 shows a comparison of monthly global radiation for reference year and for measurement (measured horizontally) made by ASIAQ [7].

Global solar radiation in year 4 and 5 is nearly the same (904 and 896 kWh/m²) which is about 4% higher than the reference year (860 kWh/m²). It can be seen that the solar gain through the windows (simulated and measured) is not quite the same, but nevertheless in an appropriate level. The reason for the difference between measured and simulated solar gain on vertical surface is partly due to the fact that solar radiation in the reference year has collection of different year variations.

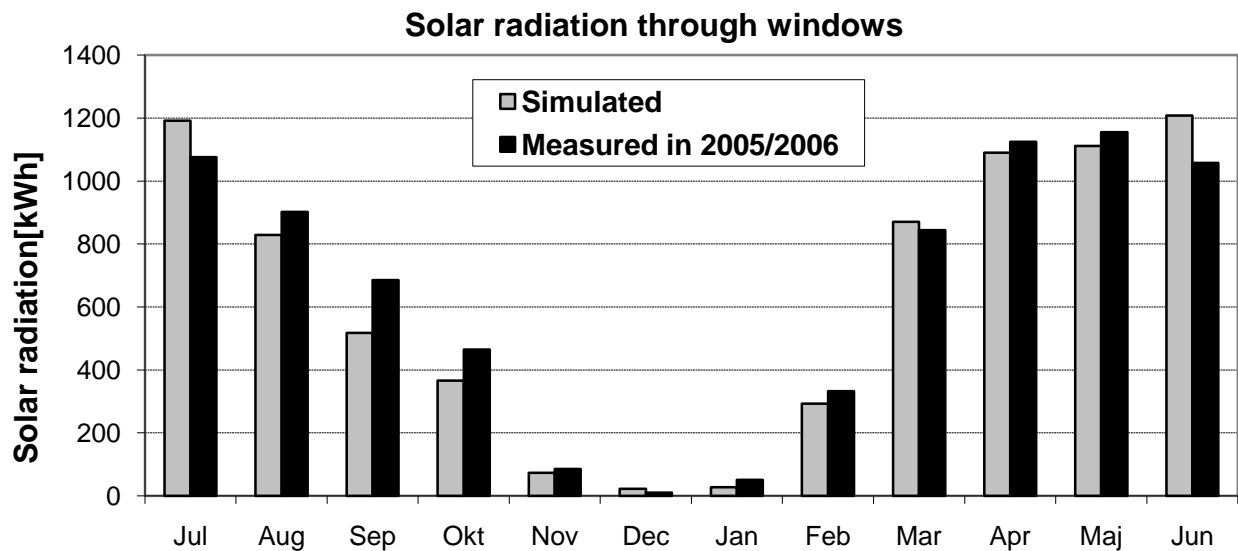
Figure 16 Solar radiation through the windows of the low-energy house

Figure 16 shows the monthly values of radiation on vertical surface for measured values in 2005/2006 and for simulated values (DRY).

The Solhat measurement on vertical surface is not working since the year 2007, therefore the solar radiation on vertical face cannot be calculated for current year (Figure 16).

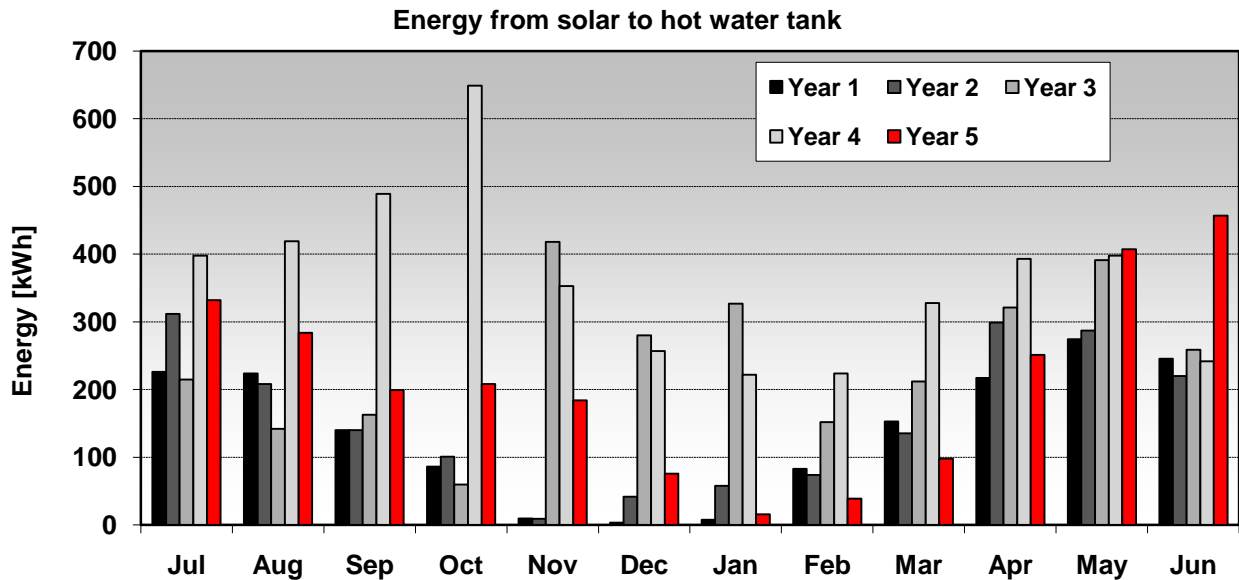
Figure 17 Energy supplied by solar panels for hot water tank

The annual projected thermal performance of the solar heating system is influenced by the hot water consumption. In [8] the net utilized solar energy for the solar heating system is calculated to be approx. 1700 kWh assuming a hot water consumption of 3000 kWh (corresponds to 150 l/day).

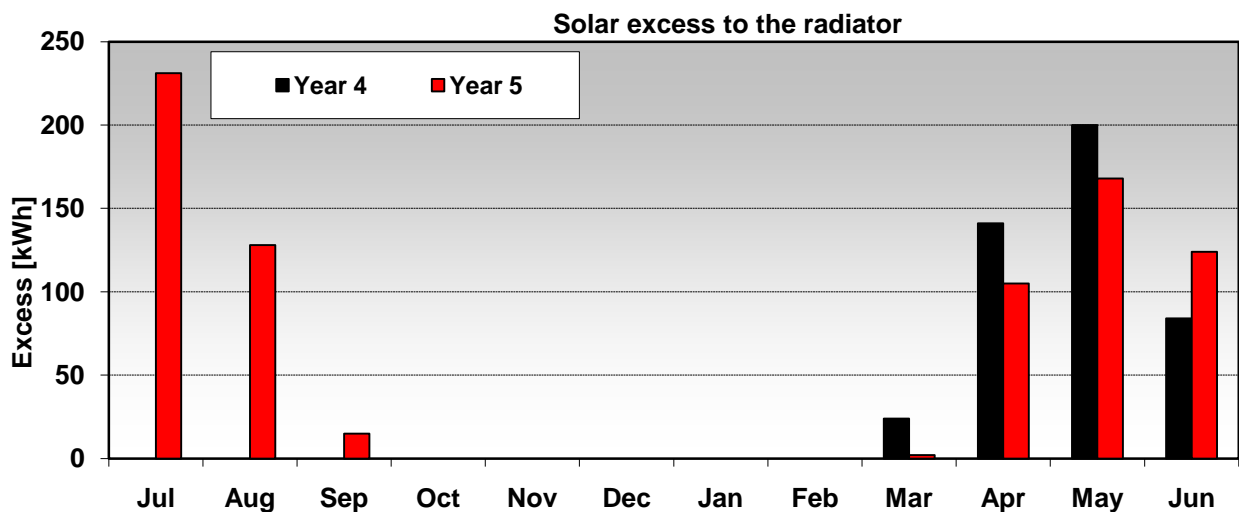
Figure 18 Energy transferred from solar collectors to separate radiator

Besides the solar heat transferred from the solar collectors to the hot water tank, the excess solar heat has been from the spring 2009 also transferred to a separate radiator in the house. In sunny periods where the temperature in the hot water tank is high enough heat is transferred from the solar collectors to the radiator. The energy transferred from the solar collectors to the radiator is shown in Figure 18.

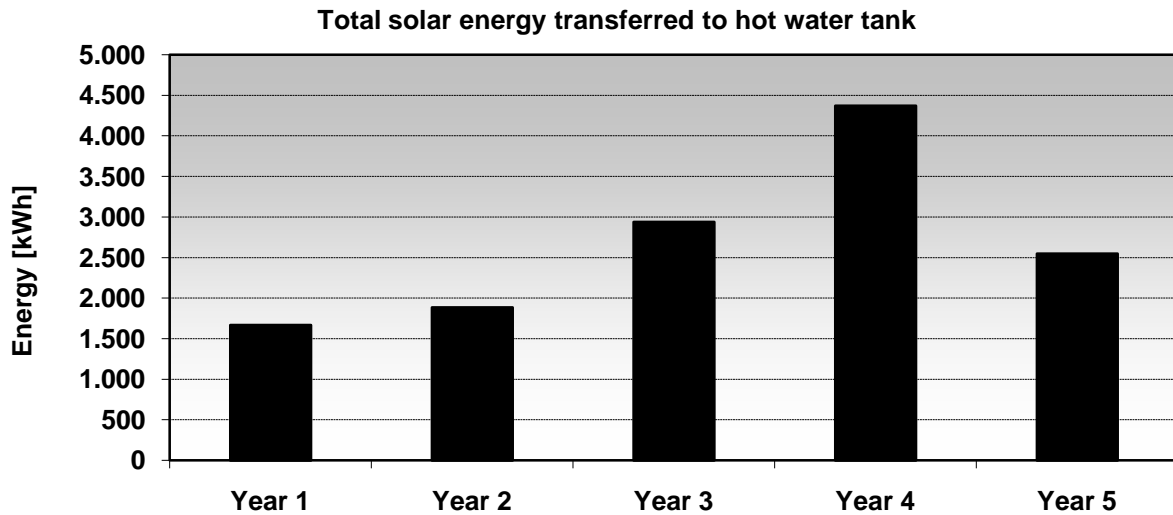
Figure 19 Total annual energy production transferred from the collector to hot water tank

Figure 19 shows the annual energy transferred from collectors to hot water tank.

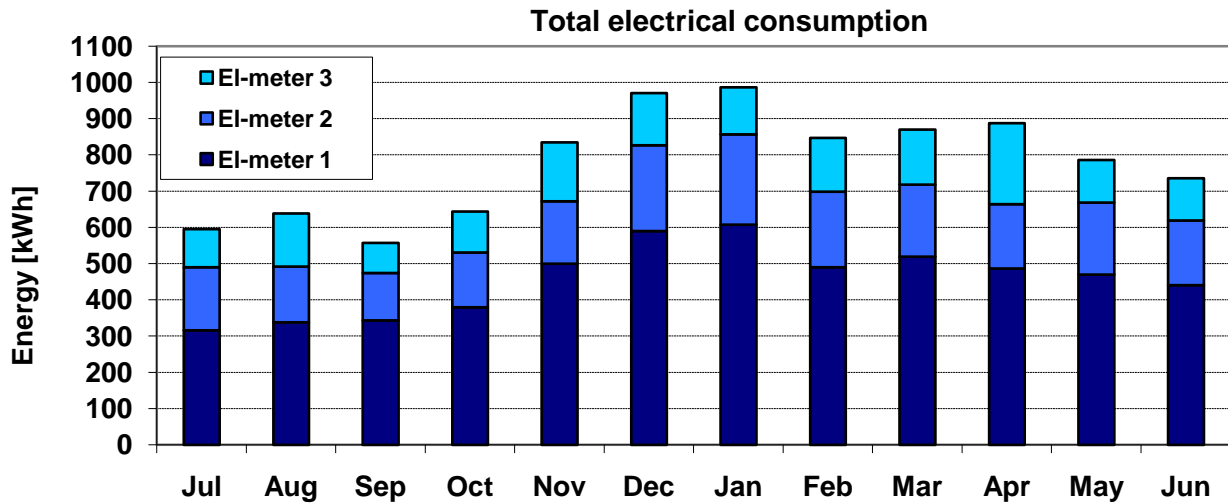
Figure 20 The distribution of electricity consumption throughout the year. El-meter 1 is for the common areas, el-meter 2 is for inhabited apartment and el-meter 3 is for guest part of the house

Figure 20 shows the monthly electricity consumption through the year. The low-energy house has two meters that log consumption in each unit of the house and one electric meter that log consumption in technical room and the other common electrical energy.

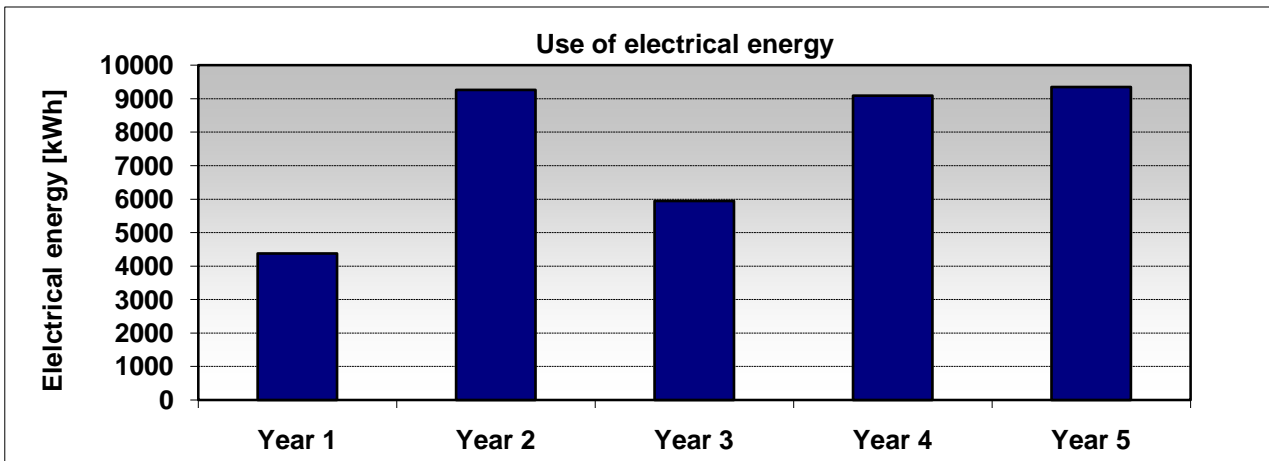
Figure 21 Total yearly electricity consumption

In Figure 21 the total electricity consumption is presented

The electricity consumption is almost the same as in the years 2 and 4 when the house was occupied and the frost protection of the sewer pipes was active during winters. It might be expected that the consumption will be decreased by adjusting the ventilation system to operate only when needed.

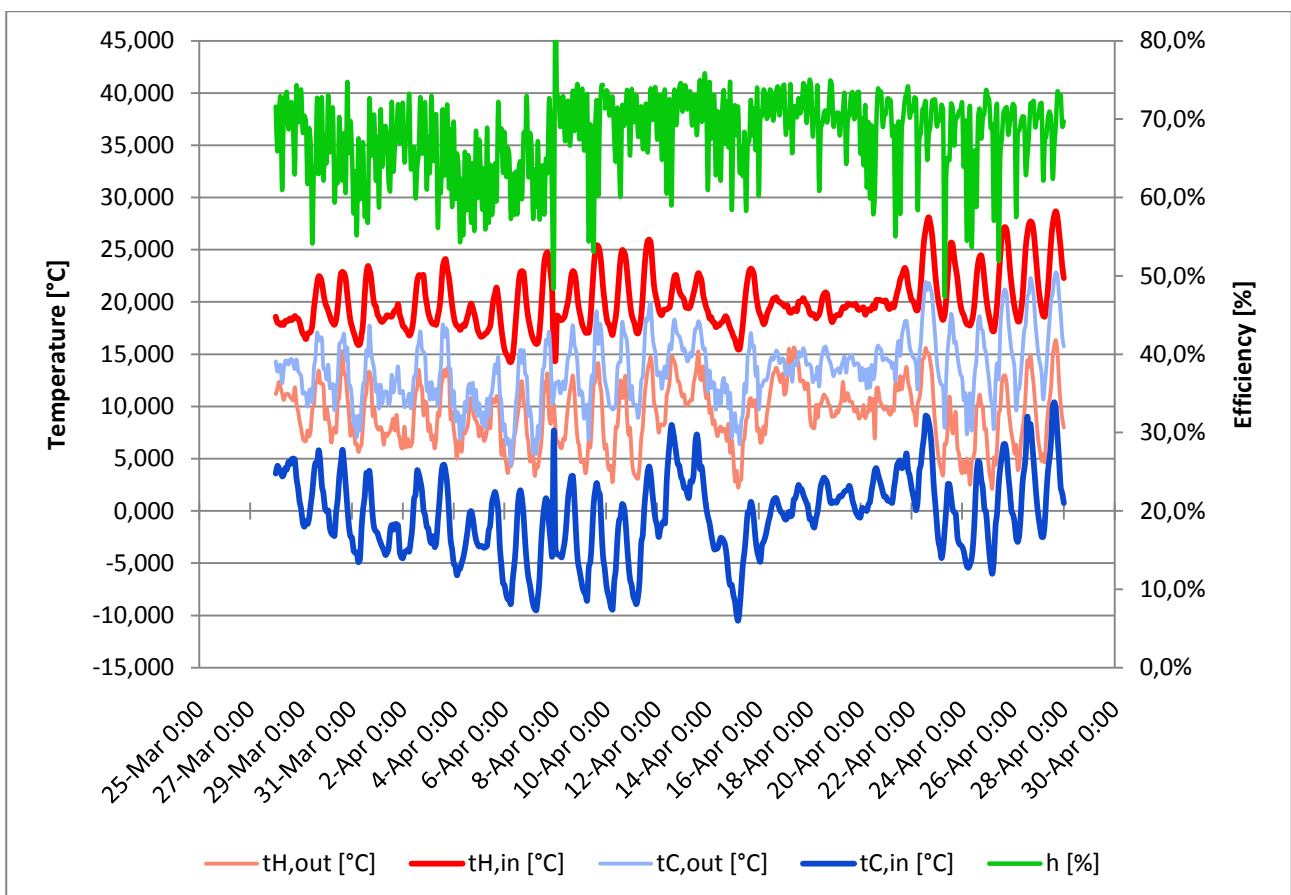
Figure 22 Temperatures and thermal efficiency of the HE

In December 2009 the revision of the HE was made. The revision discovered that the mechanical damper inside the HE was broken. Due to this failure the defrosting function didn't work and therefore there were so many freezing problems with the HE in the past. After fixing the problem the efficiency of the HE has increased. In Figure 22 the temperatures and thermal efficiency of the HE for the period from 28th March 2010 until 28th April 2010 is presented.

The efficiency of the HE is after fixing the broken damper significantly higher than in previous years but still lower than expected. It might be caused by untightness of the damper or by imbalanced flows as described in [9]. The fact that the air is supplied equally to both apartments even though that the one is almost all year long unoccupied and thus its ventilation is not needed is very surprising. Also the way of air distribution is untraditional, normally the air is supplied to the bed rooms and extracted from the corridors, bathrooms and kitchens but in case of LEH the fresh air is supplied to the corridor and living room and then extracted from bedrooms, bathroom and from kitchen by use of kitchen hood. This setup may cause that the polluted air from kitchen is being sucked through the bed rooms in case of kitchen hood being turned off.

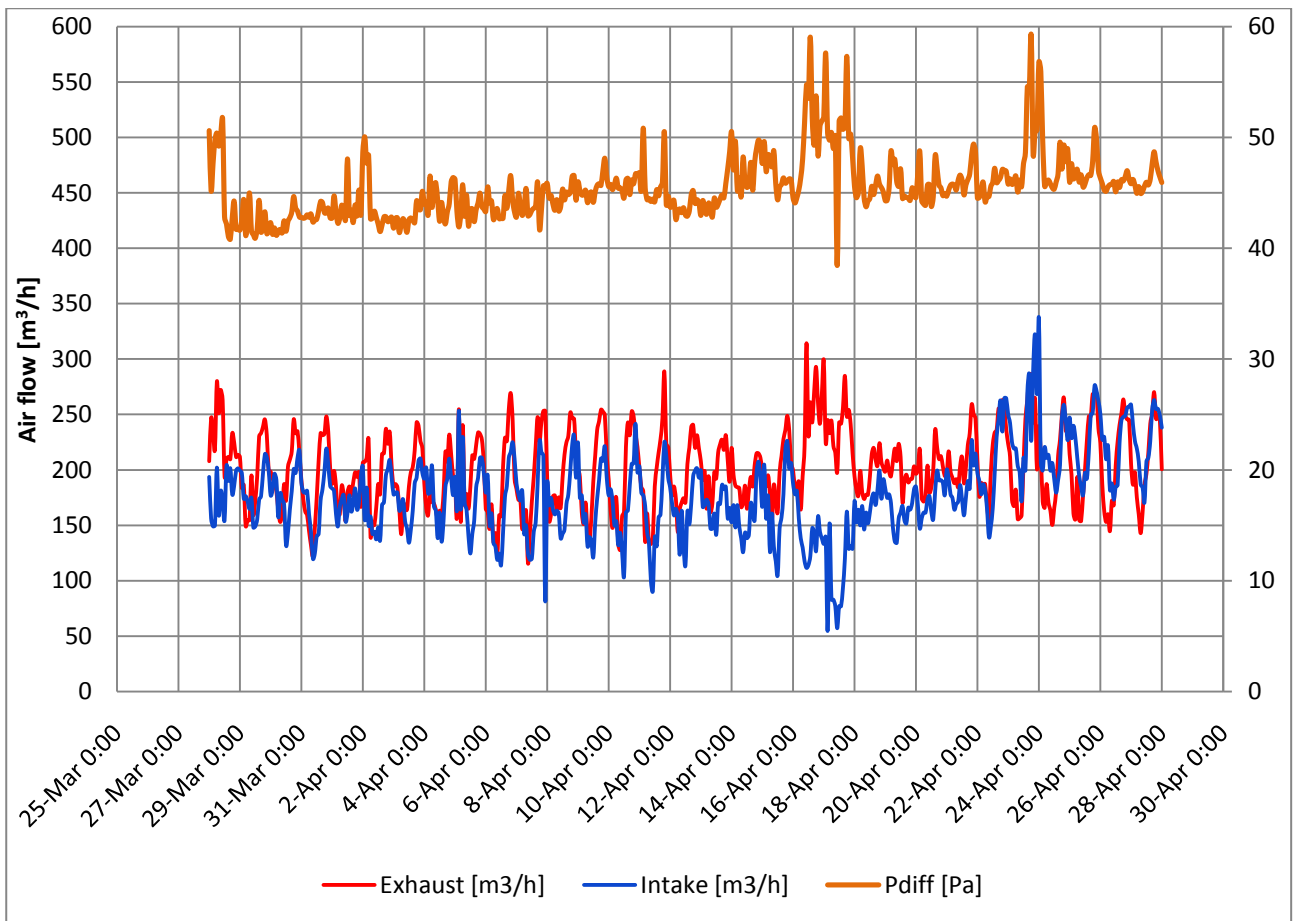
Figure 23 Air flows and pressure loss over the HE on the exhaust side

The air flows and pressure loss on the exhaust side of the HE are presented in Figure 23.

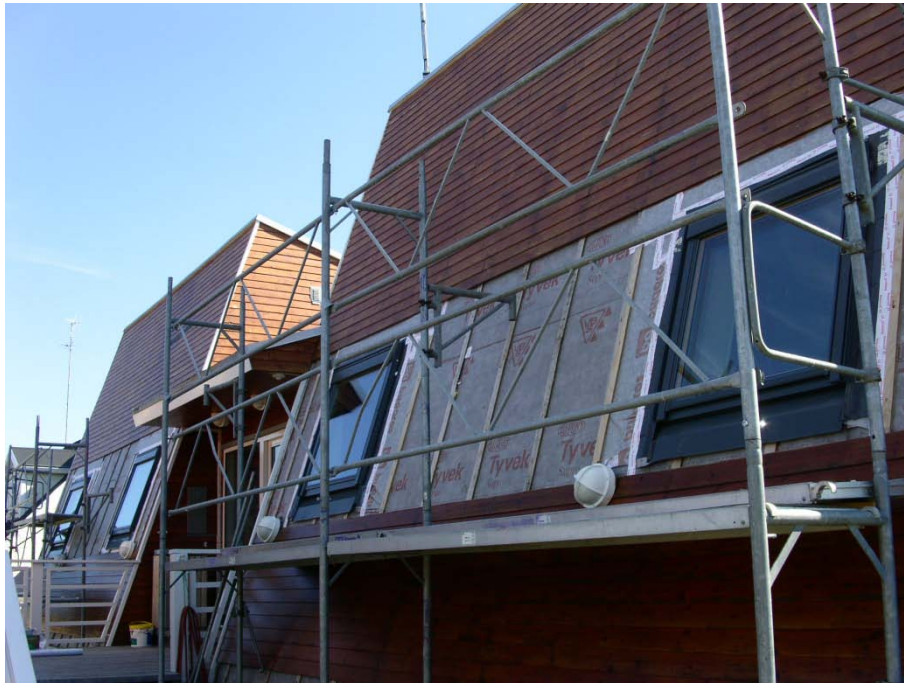
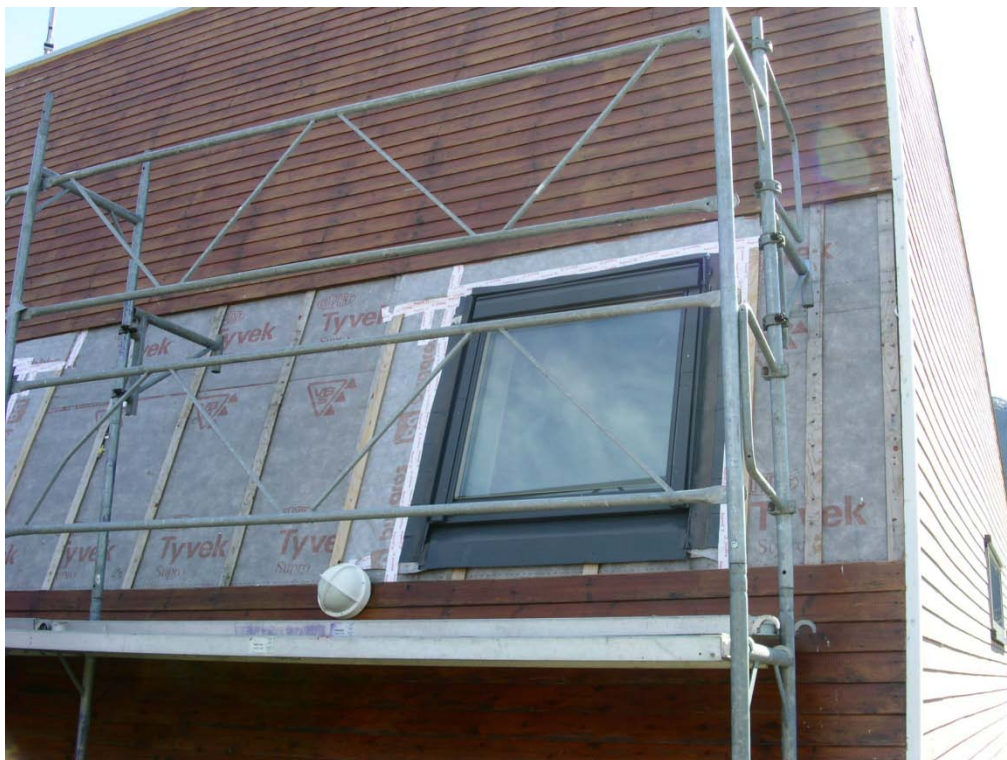
Improving the air tightness (summer 2010)

During the summer 2010 the wooden cladding on the façade was partly removed and the leakages of the wind barrier by the windows and corners were sealed after the cladding was back in place the new paint was applied on the entire outer surface. It is expected that the air tightness has been improved which will be tested by the blower-door test.

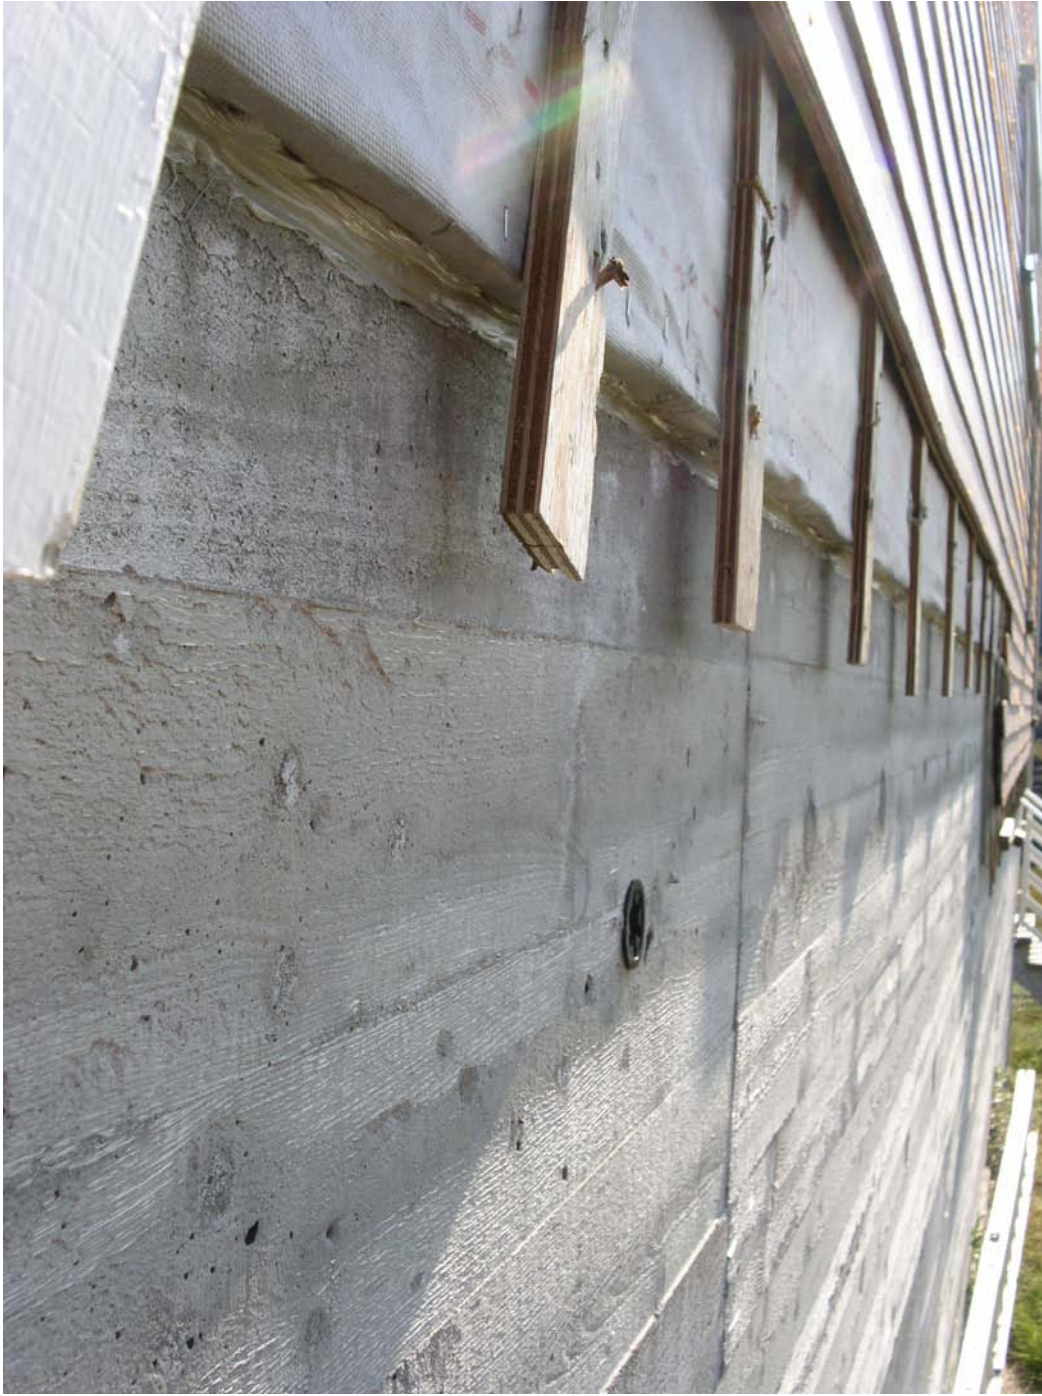
Improving the air tightness (summer 2010). The gap between wind barrier and wall has been sealed by silicon

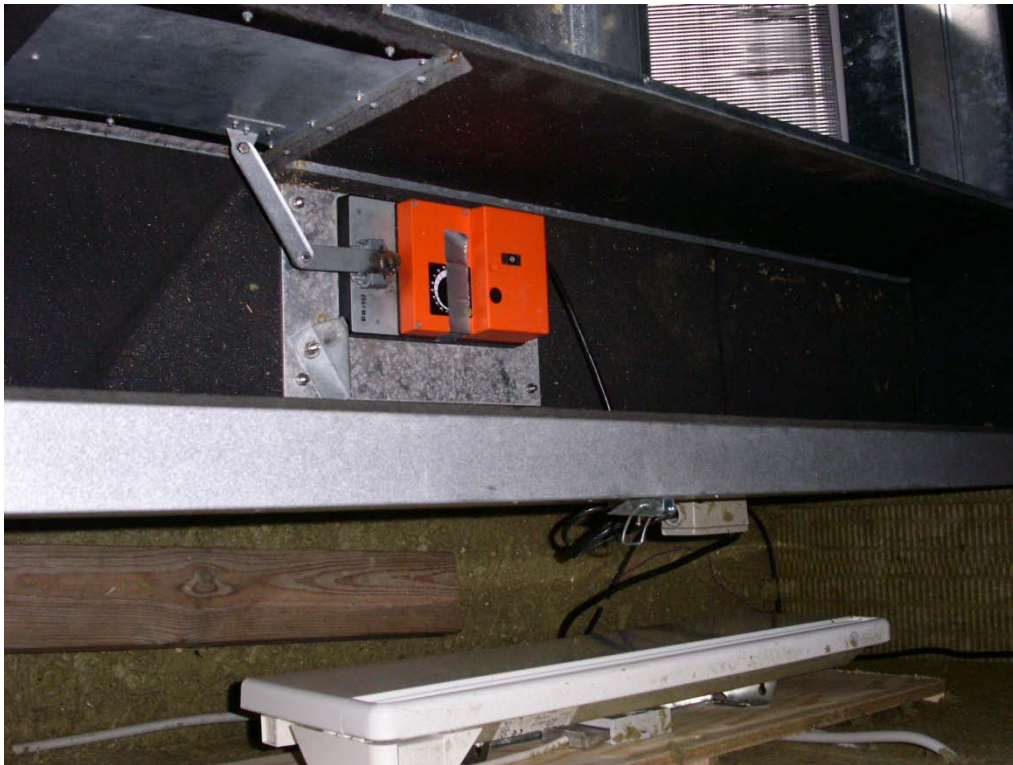
Mending the damper of the heat exchanger. The arm was welded to the servomotor.
