Low-energy house in Sisimiut

Annual report of Low-energy house performance July 2009 to June 2010

LOW-ENERGY HOUSE IN SISIMIUT

Annual report of Low-energy house performance
July 2009 to June 2010

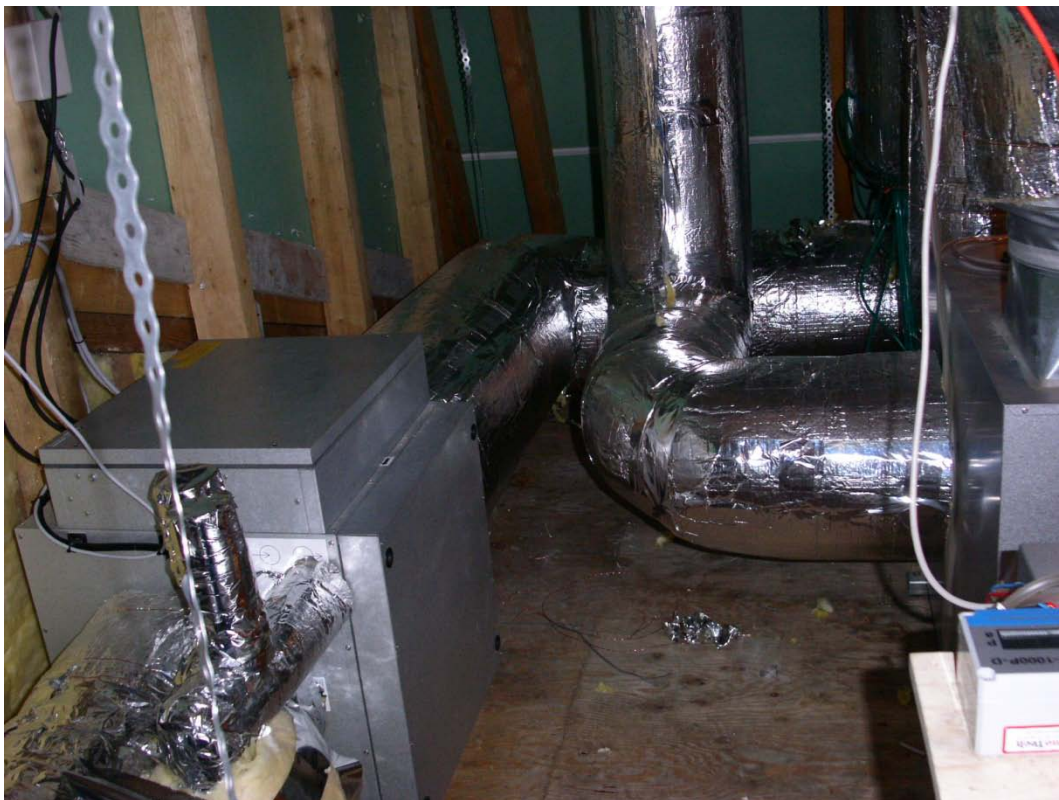
Insulated ducts and the additional heating coil.

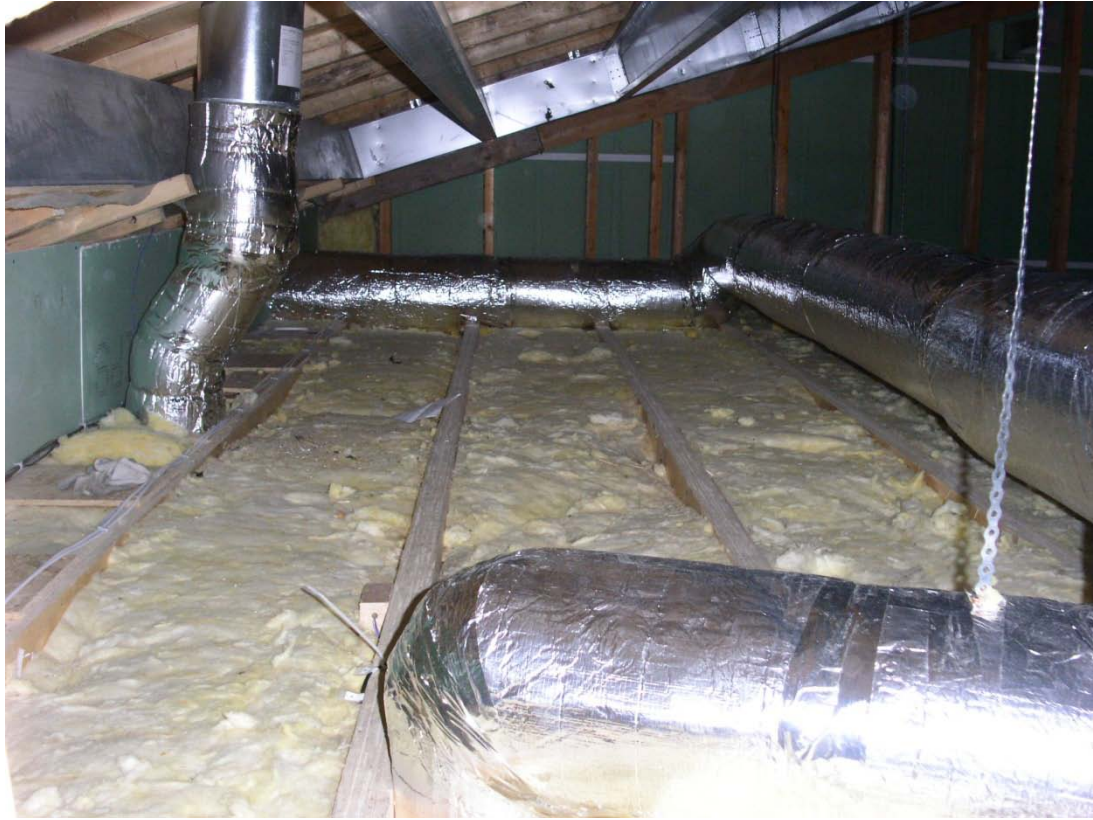
Insulated ducts in the cold attic.

During December 2009 the extra insulation was put on ventilation ducts

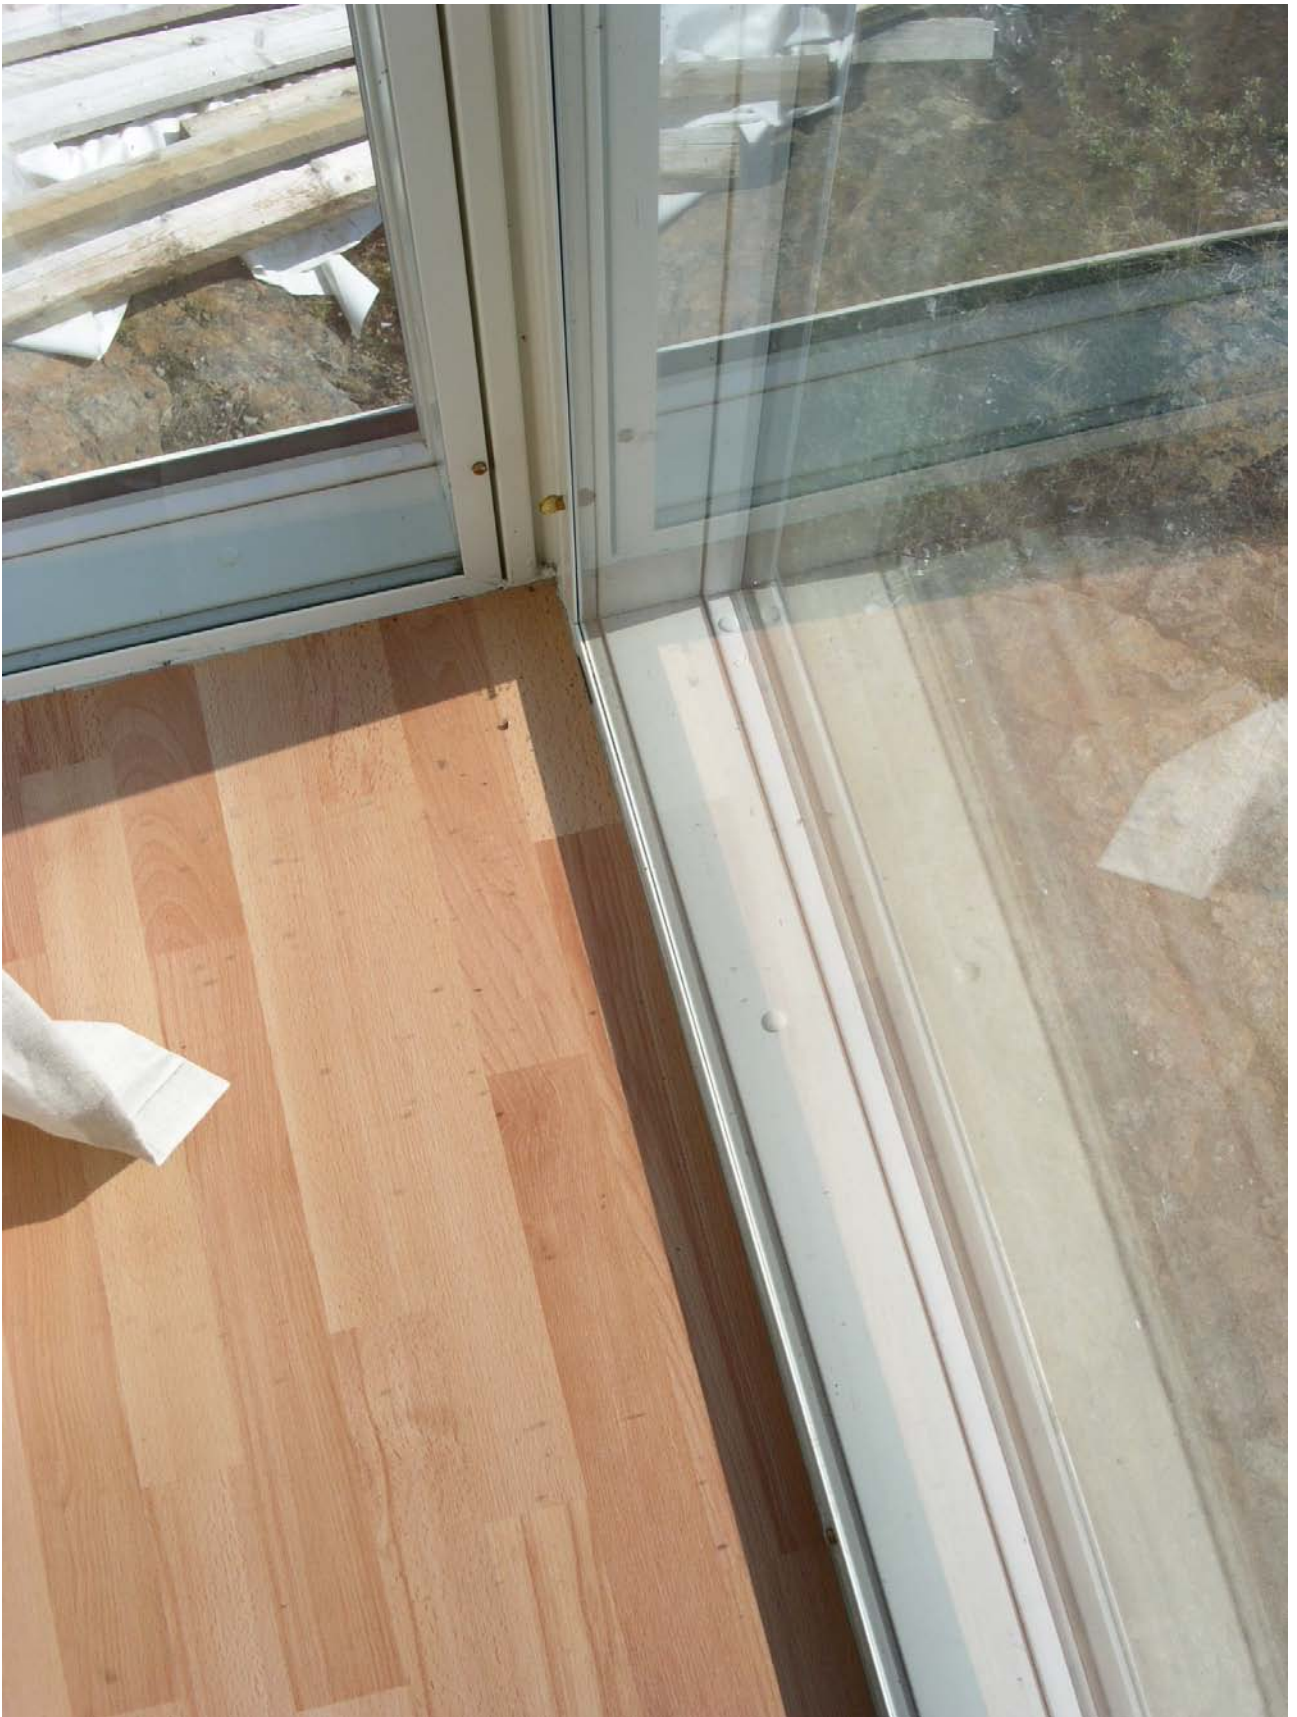
Sealed holes in the window frames.

July 2010	The cracks in the paving were sealed
July 2010	Large holes in the window frames which were drilled before in order to ventilate the windows were sealed now because the holes were found to be too large
