Full Scale Test SSP 34m blade, Combined load. Data report

Risø-R-Report

Risø-R-1749(EN)

This report is part of the research project entitled “Eksperimentel vingeforskning: Strukturelle mekanismer i nutidens og fremtidens store vinger under kombineret last” where a 34m wind turbine blade from SSP-Technology A/S was tested in combined flap and edgewise load. The applied load is 55% of an imaginary extreme event based on the certification load of the blade.

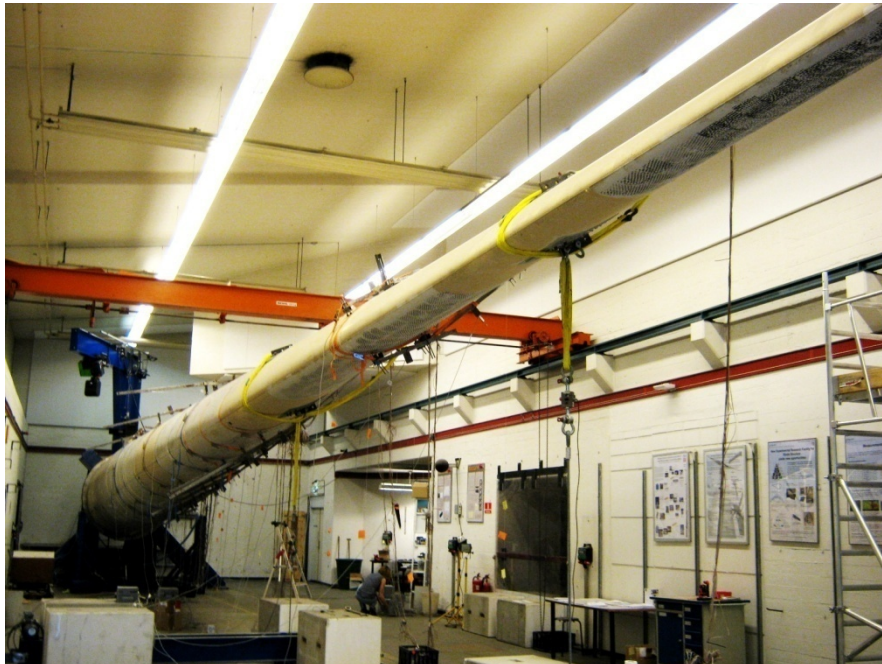
Figure 3.1. Photo of the blade bolted to the test rig. The tip has been cut off, so only 25m is tested. The blade is loaded at an angle of 30° to the flapwise direction, simulating a combined flap- and edgewise loads.

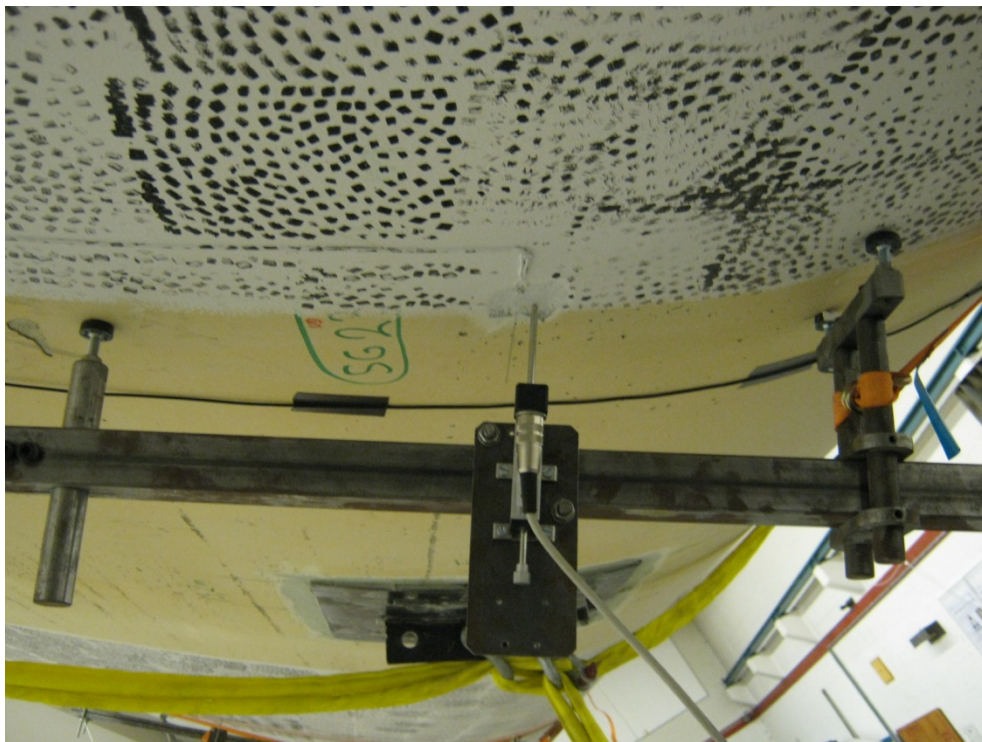
Figure 4.2. Photo presenting the method for placing the LT-NT frames

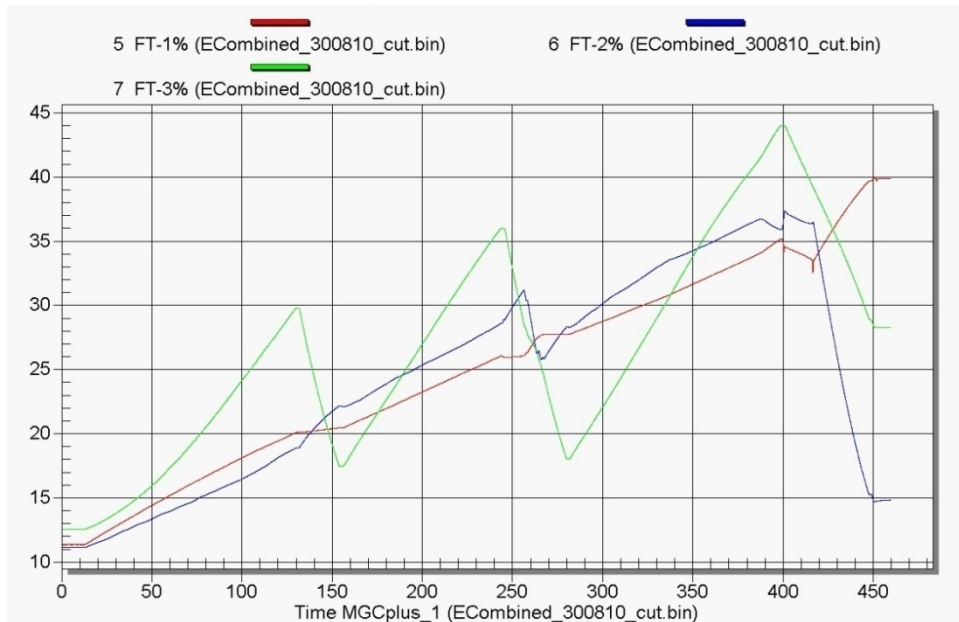
Figure 4.3. Loads in % of Risø load as a function of time for pull Ecombined_300810. FT-3% is the load application nearest to the root.

For the combined load case it is different because the blade is more flexible than in the LTT case. The frequency regulation controlling the speed of the wire loading *FT-3*, the load application nearest to the root, could not be reduced sufficiently, which caused the adjustment of the loads to be inaccurate. presents the load at the three load application in percentage of the Risø load during the test. It appears clearly that the load measured by *FT-3* (green) is increasing significantly faster than the other two. This is adjusted by reducing this load at *FT-3*.

Decreasing load *FT-3* increases load at *FT-2*, i.e. the middle load application point (at 18.61m).

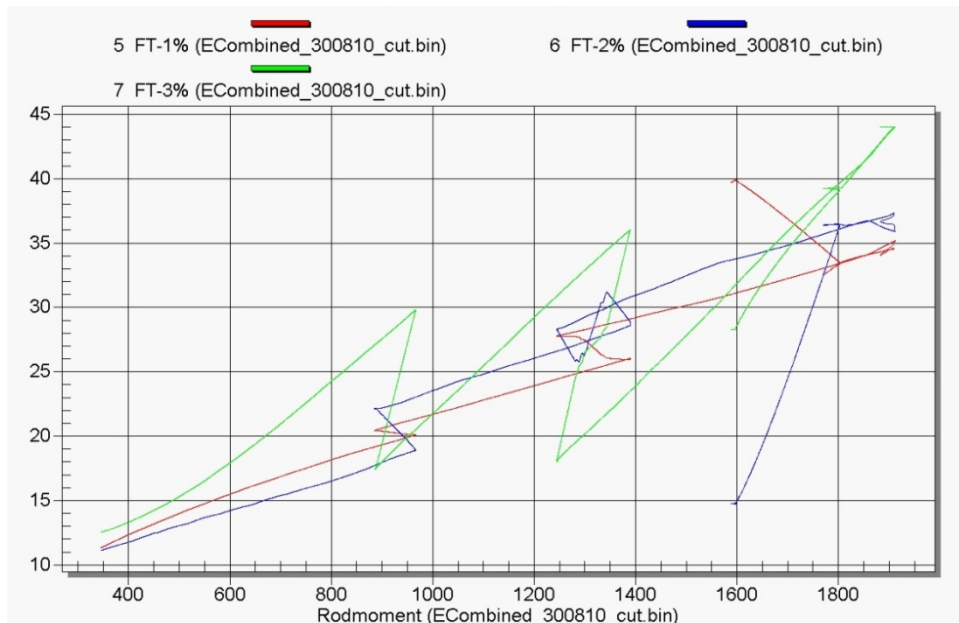
Figure 4.4. Loads in % of Risø load as a function of root moment for *Ecombined_300810* test.

The overall reduction of the load during adjusting the forces causes the root bending moment to decrease as well. illustrates this behaviour in the *Ecombined_300810* test. The graphs show the forces at three load application sections in % of Risø load as a function of the root bending moment.

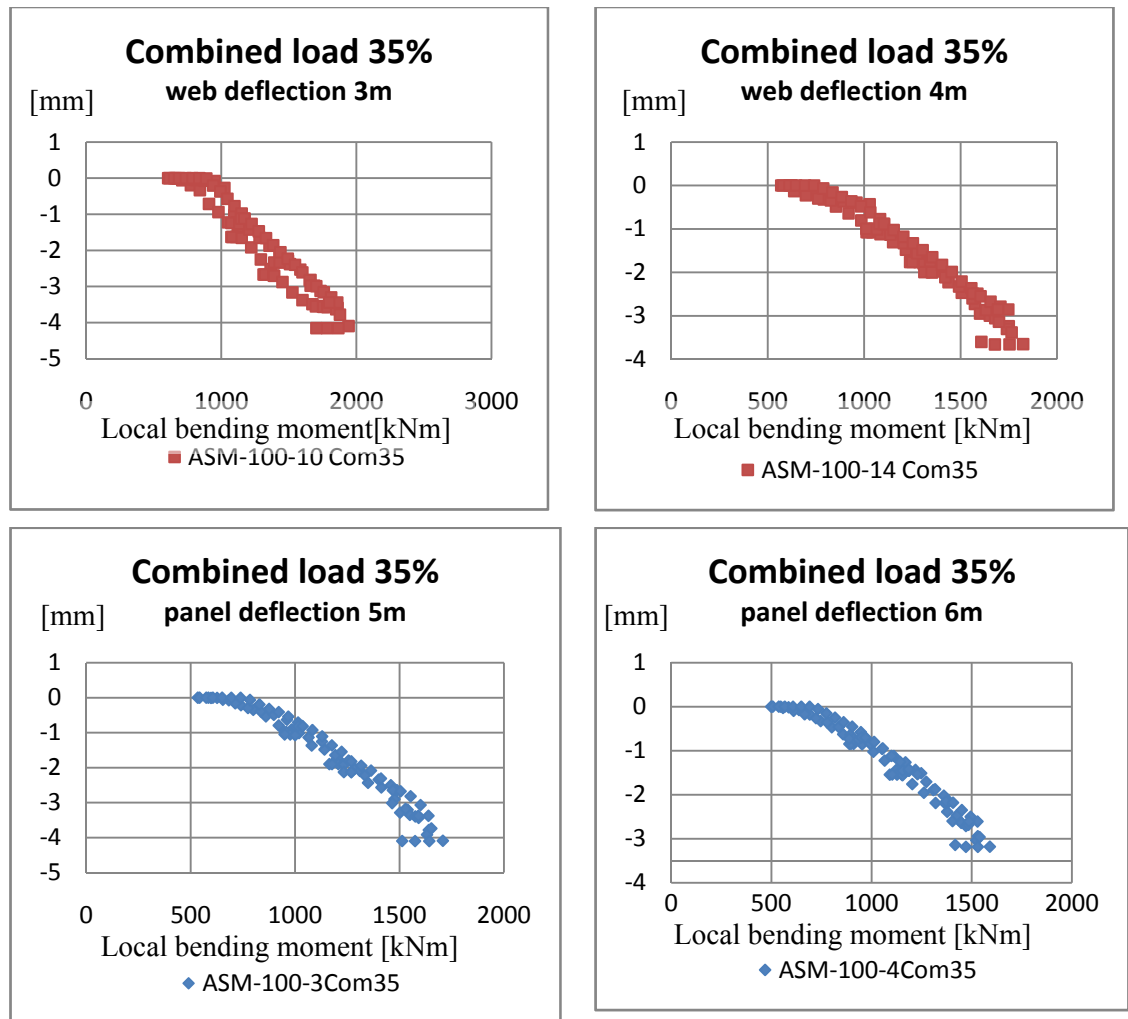
Figure 4.8 More measurements at 35% Risø load, showing deviation in repeated pulls, where one pull is differing itself from the others and can be parallel displaced into the measurements from the others.

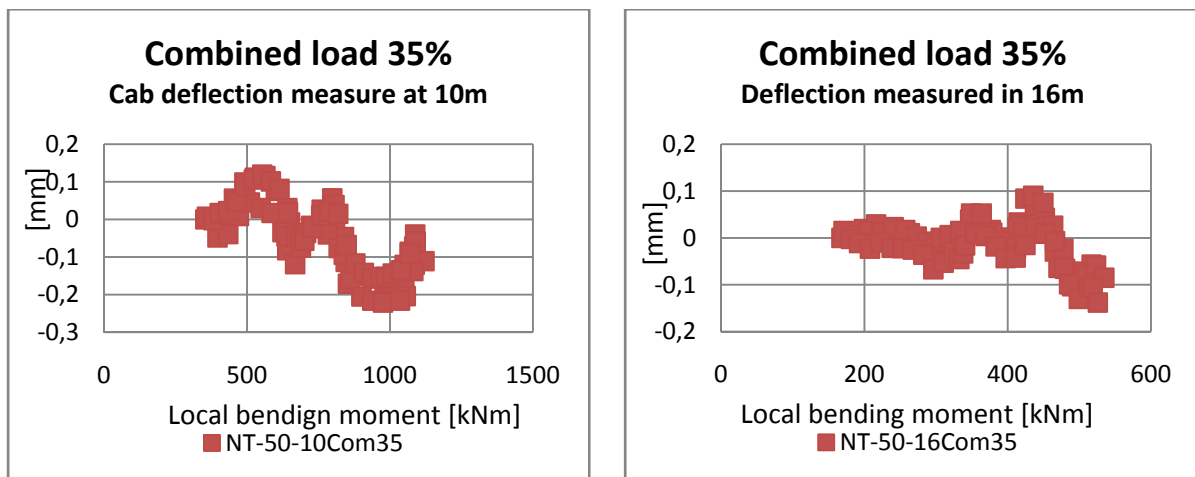
Figure 4.13. Pressure side cap deformation in 10 and 16m sections.

It is outstanding that the cap deformation behaves in the same way in all three pulls with very small variations in the measurements (at the level of 0.1, 0.2mm). Here, it cannot be undoubtedly concluded if this variation comes from the cap behaviour or the frames. As it is the same in all three performed pulls it suggests that it is the cap behaviour or some other behaviour induced by the blade.

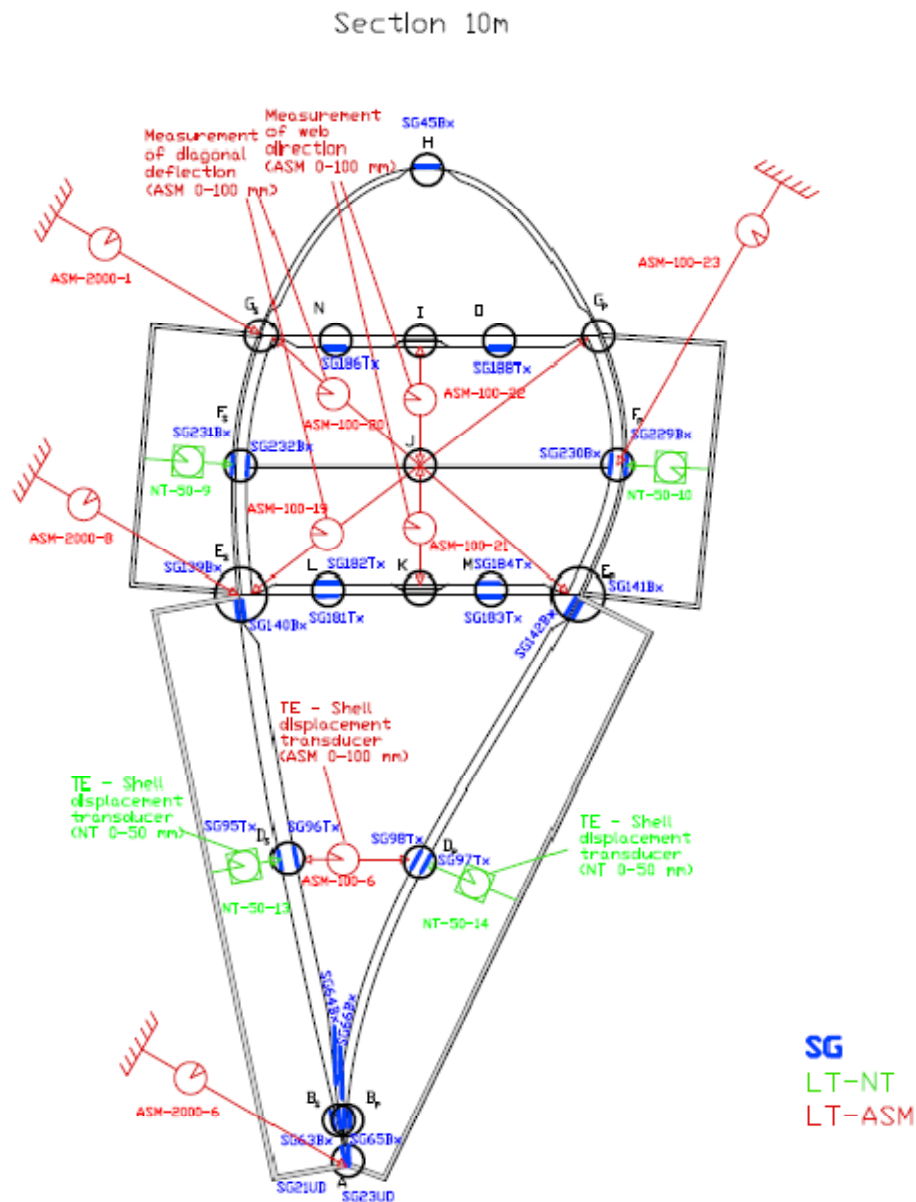
Figure 4.18. Scheme presenting the measurement equipment mounted at 10m section.
