BLUE HOUSE IN SISIMIUT, GREENLAND

Initial investigation of the Blue House

Report SR 10-07
BYG·DTU
August 2011

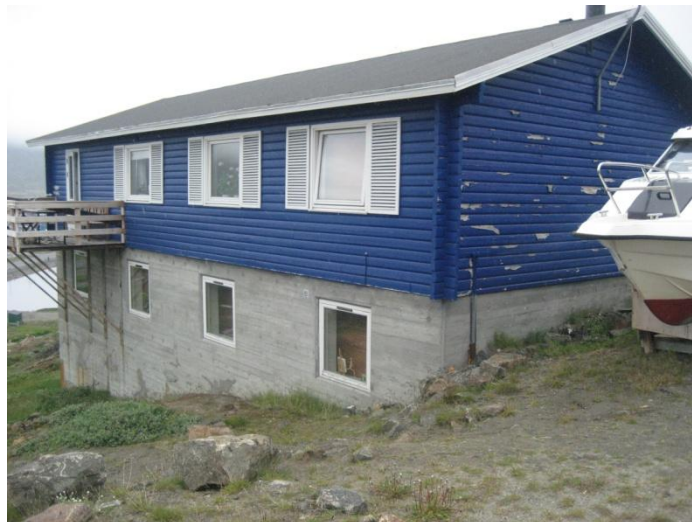
Fig. 1. The Blue House

The house has been built in 1985 as one of the typehouse produced by Panbo Huse A/S, Denmark (Panbo Huse, 2011) and it is made from a special construction from timber structure. There are only few of these typehouses located in Sisimiut. Former owner and purchaser of the house was Hans Martin Johansen, doctor. Today, the house is owned by the Municipality of Qeqqata and administrated by INI A/S (Fig. 1).

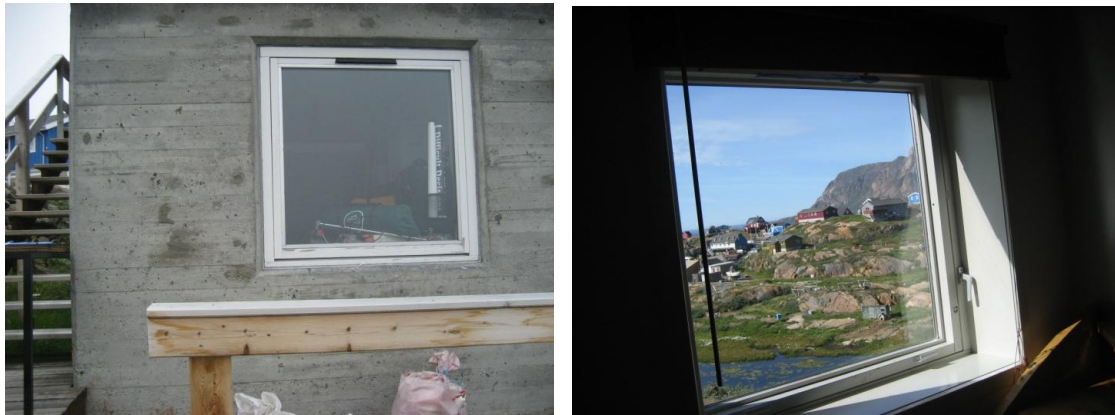
Fig. 13. Windows used in the Blue House

The windows have a frame from wood and double glazing. Windows in the basement have been installed when the house was built (85/11, PANALOOK 160~DS~10940 TF GAR). The windows in the first floor have been changed approximately 14 years ago (12/97, 190~DS~10940~1AT-class). All windows are a type

of awning window with top-hung or side-hung (Fig. 13). Most of the windows have a natural exhaust vent placed next to them. There are three main types of the windows which are listed in Table 3.

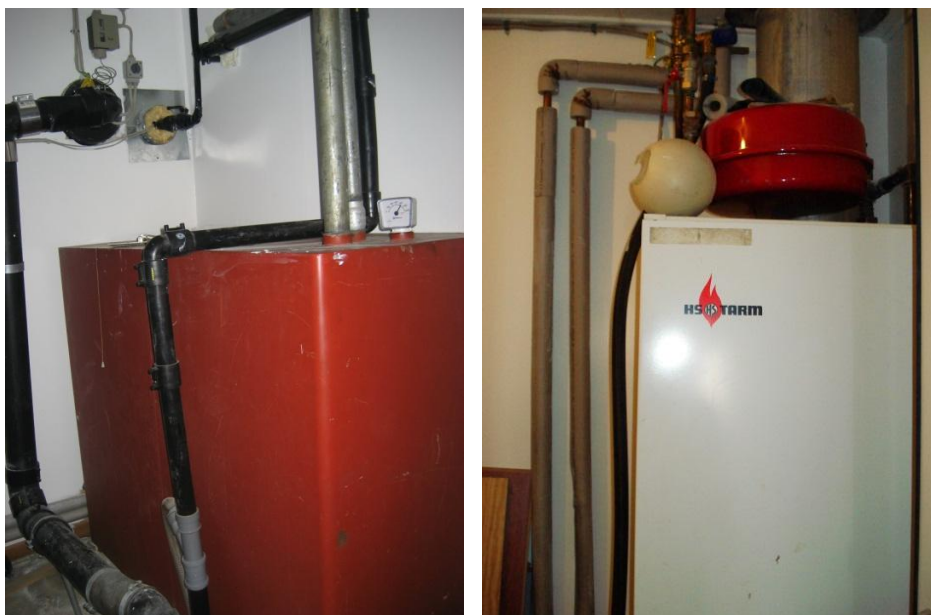
Fig. 14. Oil tank and oil-boiler in the technical room

The space heating is provided with a oil-boiler (type HS Hedler TARM) with an expansion vessel and a hot water storage tank. The conventional hydronic heating system is located in the house with 8 radiators with thermostatic valves in the first floor and 6 radiators with thermostatic valves in the basement floor. The oil-boiler also supplies hot water. The tank for the oil is located in the technical room in the basement floor (Fig. 14).

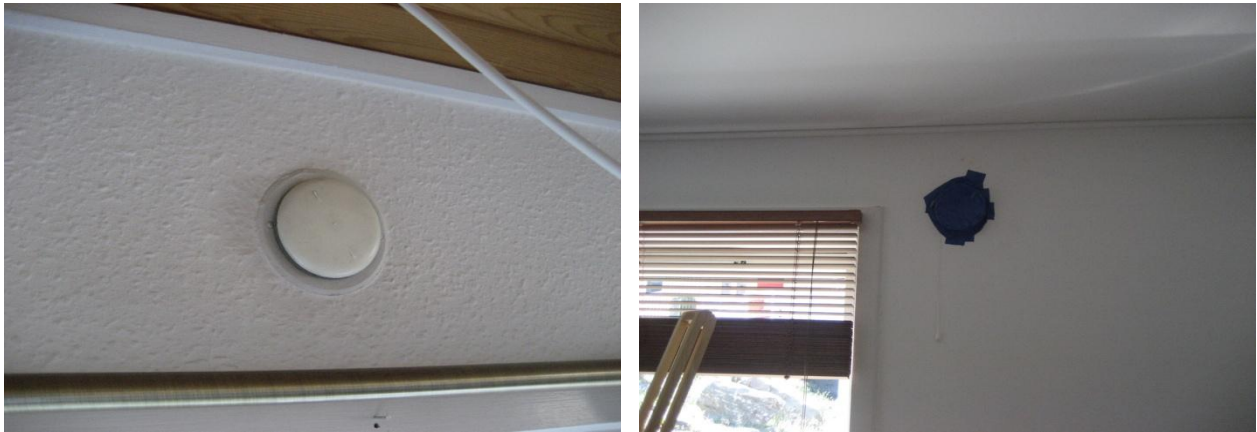
Fig. 15. Natural vents in the first and basement floor

The fresh air is provided through the natural ventilation with vents (6 opening vents in the first floor with diameter 120 mm and 5 opening vents in the basement floor with diameter 200 mm) and they are placed in each room close to the top of the window (Fig. 15). There is a mechanical exhaust in kitchen (kitchen exhaust hood) and in bathrooms (electrical exhaust vents along with natural ventilation vent). The mechanical exhaust vents in the bathrooms are based on a “switch on / off” together with light, meaning that there is no delay after switching the light off and, thus, the release of humidity. The cold attic is ventilated through the natural vents through facade (Fig. 16).

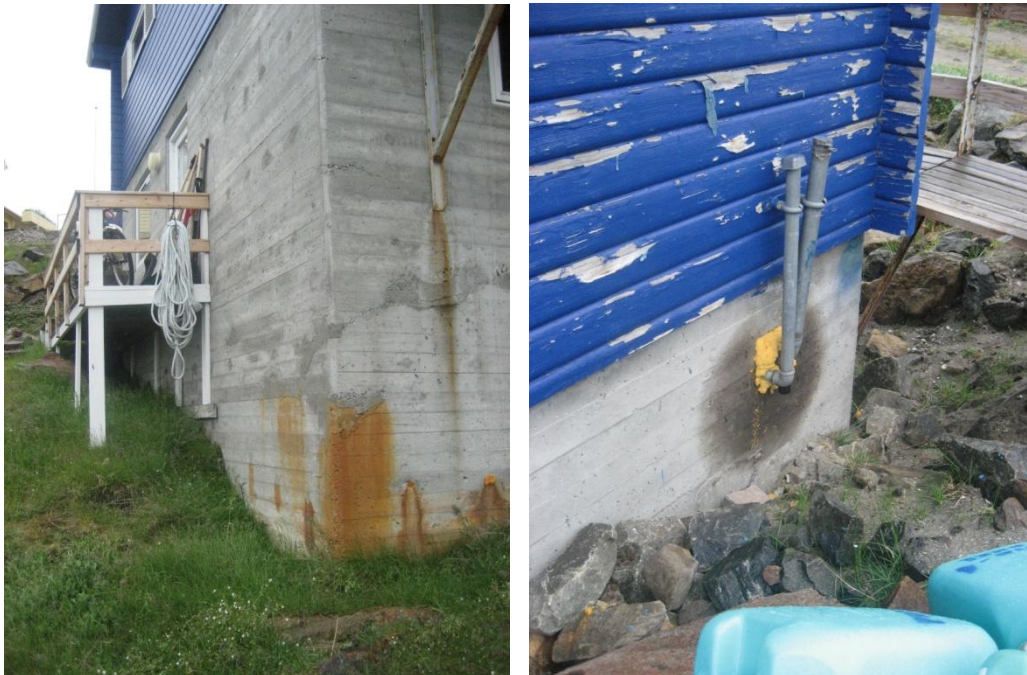
- There were found cracks in the basement walls and some traces of leaking water from beneath the house from the crawl space (Fig. 17).
- Problems with a squeaking sound from the building’s structure when there is a big windstorm.

- The exterior facade is stripping off and needs repainting. The stripping off is possibly caused by demanding weather conditions and possibly by a vapour transfer driven from interior to the exterior (Fig. 17).

Fig. 17. Cracks in the basement walls (on the left) with water leakages through the foundations and the exterior painting

- Recommendation to make static investigation because of strong winds and so the new facade is not blown off. The static stability of old structure should be secured by fixed and tight iron cross beams where the wooden and concrete parts of the house will be fixed together with steel bar profiles.

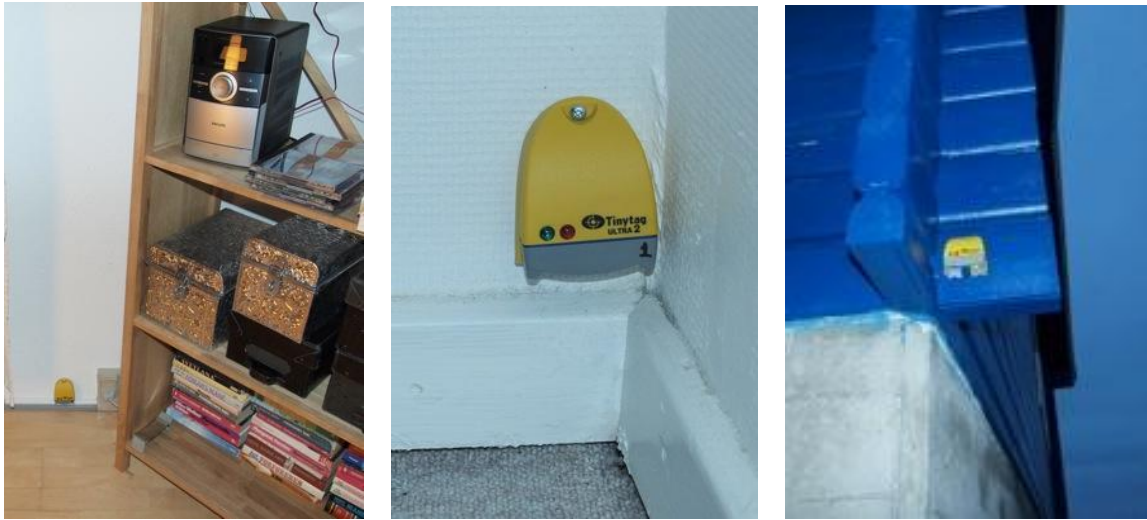
The indoor climate is measured continuously from December 7, 2010, onward (first readout from April 5, 2011; second readout from August 8, 2011). The Tiny Tags loggers were used to measure interior temperature and relative humidity. The logging time is every 20 minutes. For downloading the data the software Tinytag Explorer is used (6-week demo version, <http://www.geminidataloggers.com>). The locations of the sensors are as follows (Fig. 18, Fig. 19): bathroom (basement floor), bedroom (first floor), children's bedroom (basement floor), and living room (first floor) and exterior temperature (Fig. 20, Fig. 21).

Fig. 18. Location of Tiny Tags in living room (1) and bedroom (2) (first floor) and outside (3)

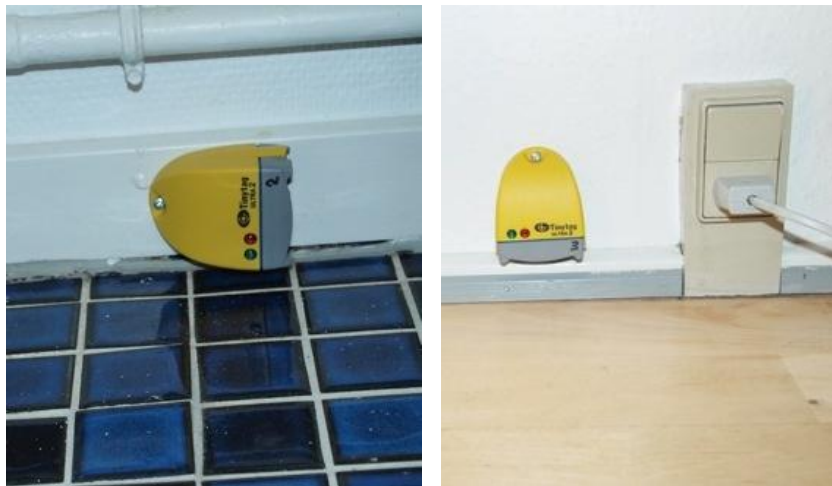
Fig. 19. Location of Tiny Tags in bathroom (4) and child's bedroom (5) (basement floor)

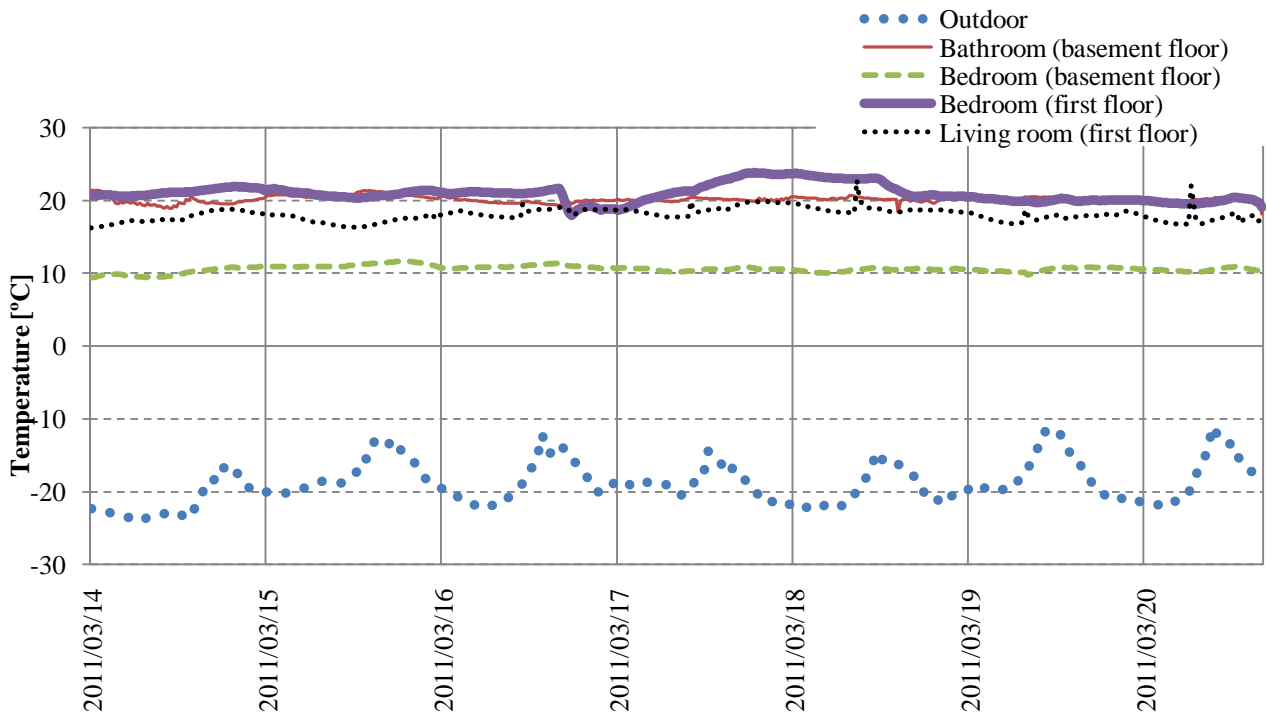
Fig. 22. Measured temperature in the coldest week of 2011 (based on a coldest hourly temperature measured outdoor, -23.8°C)

The two weeks have been chosen to see the monitored temperature and relative humidity in the Blue House in period from Dec 12, 2010, to Aug 8, 2011. As example were chosen: one week with the coldest hourly temperature and one week with the warmest hourly temperature. Also the average temperatures and relative humidity during the whole period are shown. The coldest week shows the usage of the house and the warmest week shows possible problems with overheating.

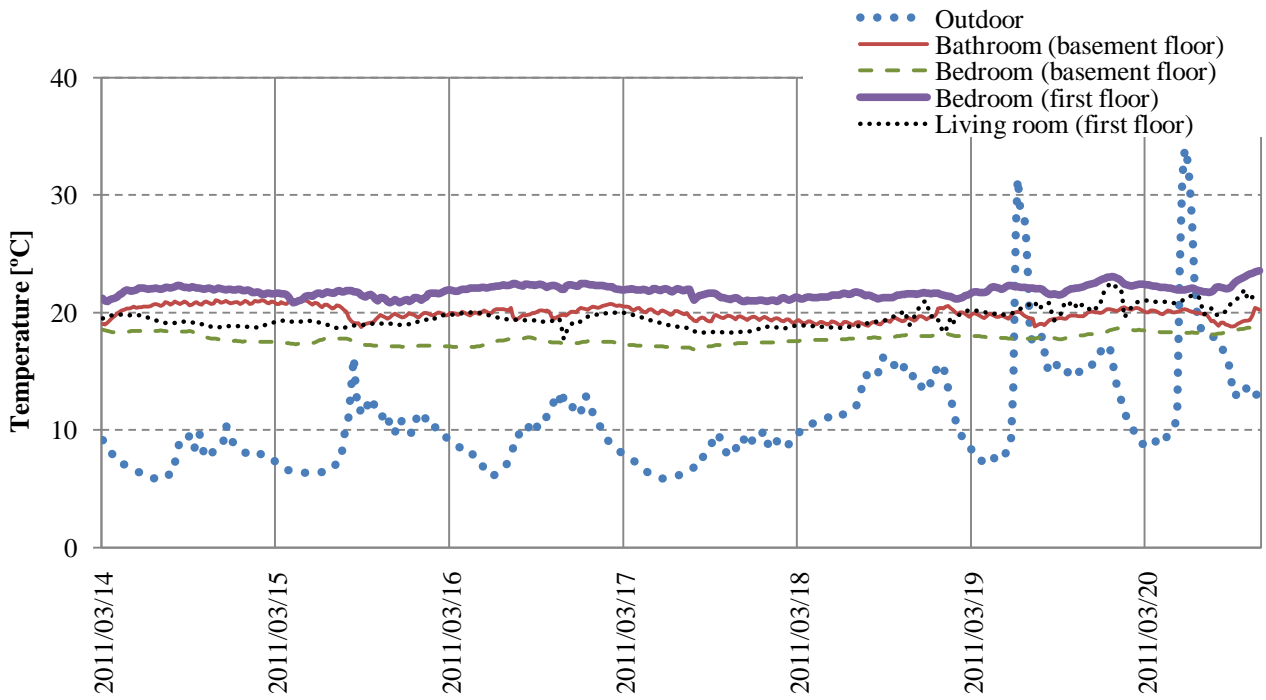
Fig. 24. Measured temperature in the warmest week of 2011 (based on a warmest hourly temperature measured outdoor, 33.9°C)

The results from the warmest week show the following. The relative humidity measured outside shows a probable malfunction of the sensor as the reading from the sensor shows 100% (Fig. 25). The humidity in the bathroom in the basement floor shows that the bathroom is used daily and that the temperature averages around 20°C. The average relative humidity in the bathroom is high even though the bathroom is not used, i.e. approximately between 65 - 75%. The temperature in the bedrooms differ approximately 4 - 5°C in the summer on the first and basement floor, i.e. varying from 18°C in the bedroom in the basement and around 22°C in the first floor (Fig. 24).

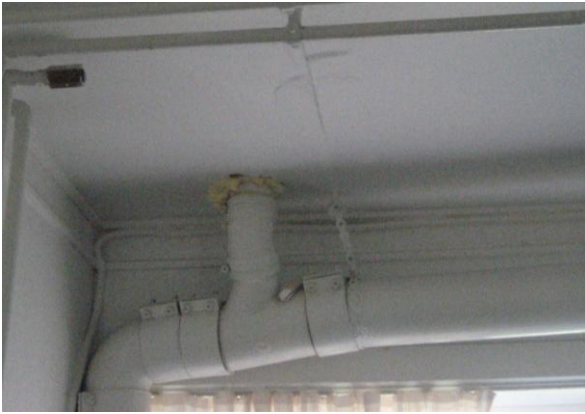
Fig. 30. Ceiling between two bathrooms, possibility of the humidity problems and cold floor

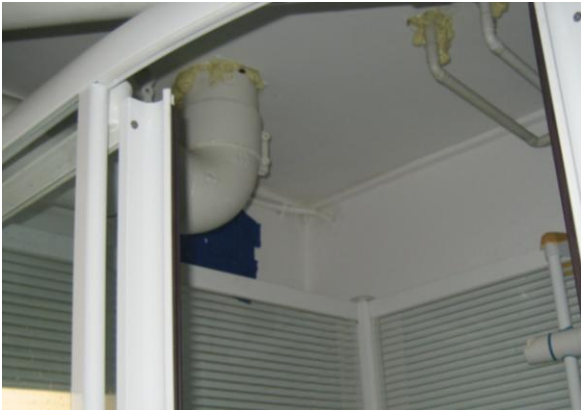
Fig. 31. Un tightness of the natural vent in the bathroom in the basement floor

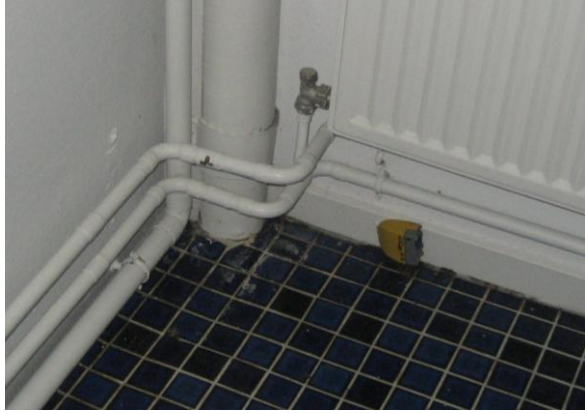
Fig. 32. Thermal bridge and cold floor along with corner in the bathroom in the basement floor

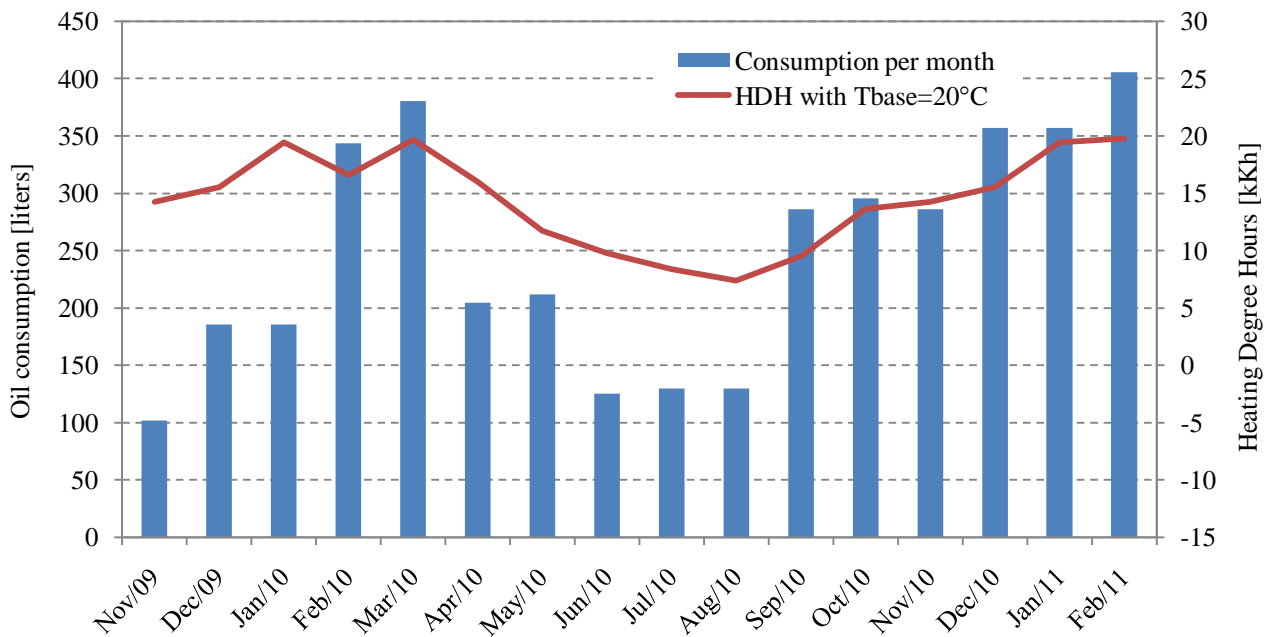
Fig. 39. Approximation of oil consumption based on oil delivered to the house

The approximation of oil consumption based on information obtained from the oil bills (Annex F) is showed in Fig. 39. The approximation is based on the calculation of daily oil consumption which is calculated from dates of between two deliveries, and amount of delivered oil is divided by the number of days between two deliveries. This daily oil consumption in a relevant month is multiplied by number of days in relevant month. The oil consumption includes the space heating and domestic hot water consumption.

The current price for the oil is 4.27 DKK/litre (obtained from the heating bills), there has been an increase in the prices for oil of 1,10 DKK/litre in summer of 2011. The electricity is 3.28 DKK/1 kW. Assuming that 1 litre of oil gives 10 kWh, the house needs approximately 29,350 kWh/a for space heating and domestic hot water in the warmer year, i.e. 140.4 kWh/(m²·a) respectively. The hot water consumption is not measured separately therefore it can be only estimated based on standard consumption in Danish's homes as 250 l/m² per household per year (Aggerholm and Grau, 2008), ΔT = 45°C, and it is on average to 2.7 kWh/(m²·a) respectively. Only the heating consumption amounts to approximately 137.7 kWh/(m²·a) which is comparable to the today's GBR requirement but it is still rather high consumption.
