Accelerated fatigue testing of LM 19.1 blades

Accelerated Fatigue Testing of LM 19.1 Blades

A series of 19.1 metre wind turbine blades manufactured by LM Glasfiber A/S of Lunderskov, Denmark were subjected to a series of flapwise fatigue tests. The object of these fatigue tests is to evaluate the impact of an increased load on the blade in a fatigue test and to give information if it is possible to increase the load in fatigue test to shorten test time.

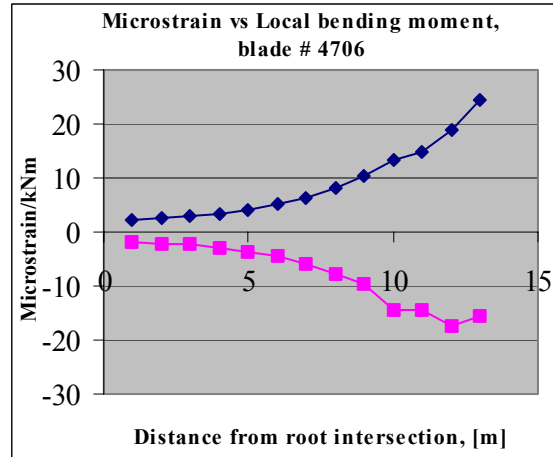
Figure 5. Normative strain distribution for blade # 4706

As the flapwise stiffness determination was carried out just prior to the fatigue test there was also made strain measurements during these tests. The strains measured on the blade are evaluated in correspondence with the applied load, i.e. microstrain vs. local bending moment. Figure 4, Figure 5 and Figure 6 show that blade no. # 4706 and # 4700 are very similar to each other in the sense of lengthwise strain distribution and blade no # 4703 differs a little from the two others.

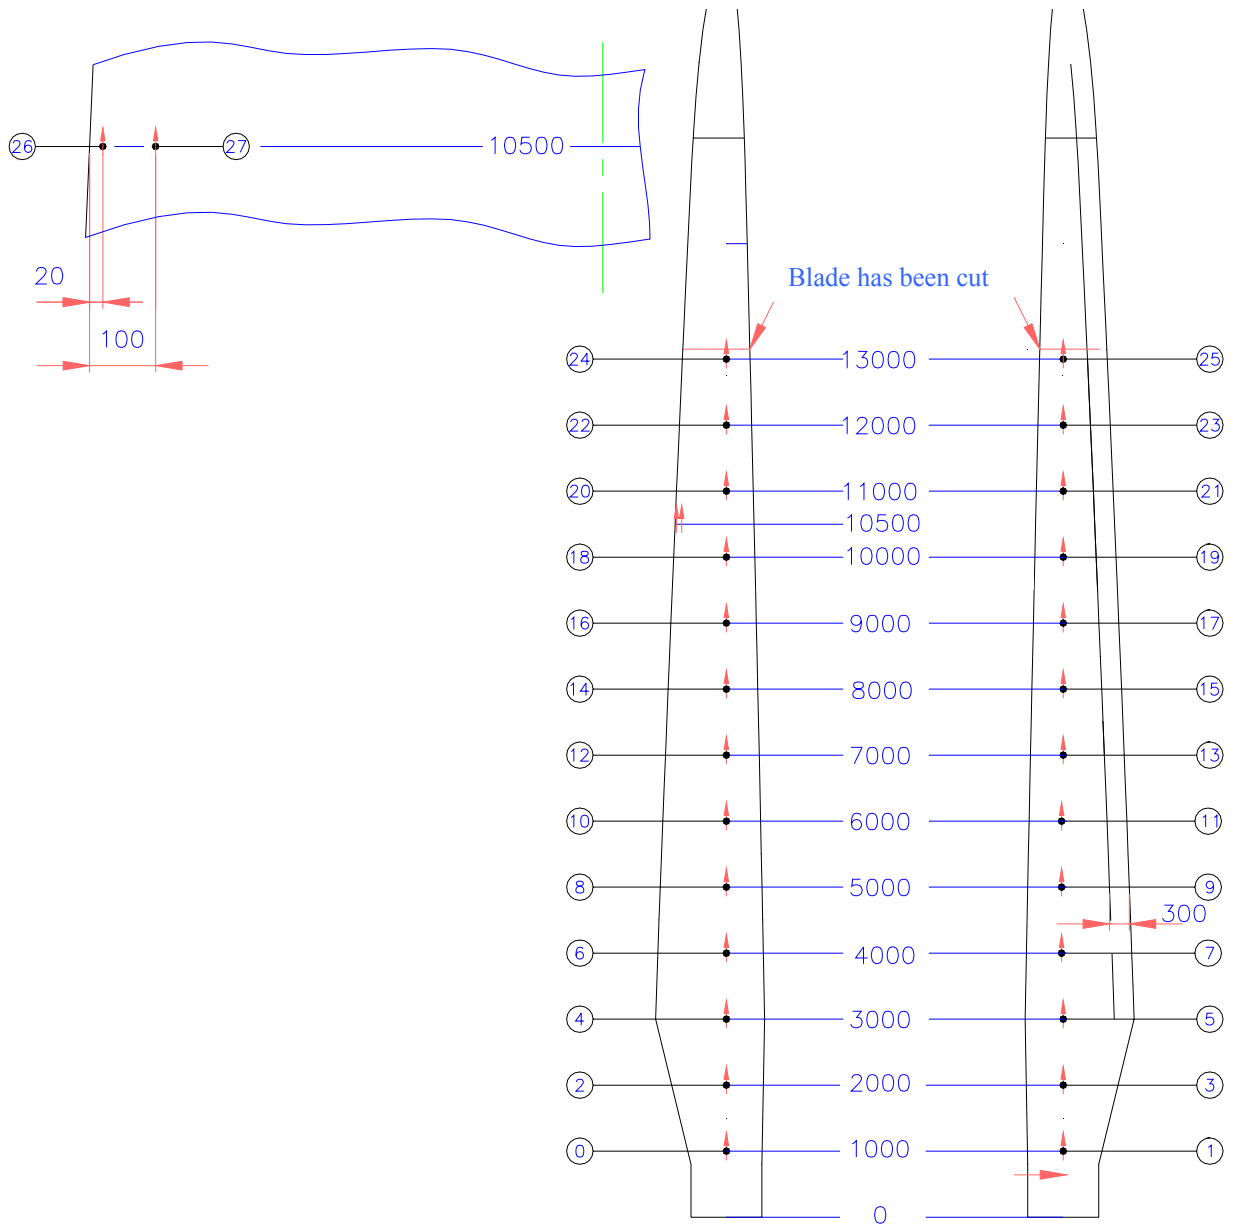
Figure 8. Strain gauge position and numbering, LM119.1 # 4706.

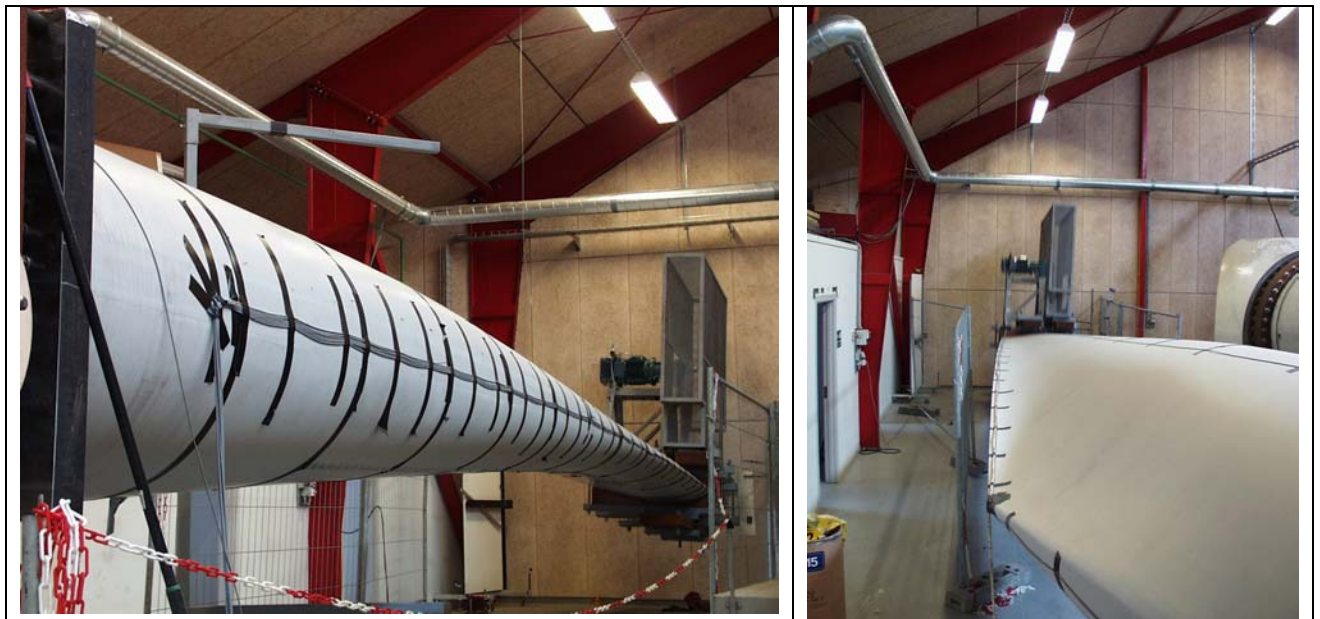
Figure 10. Test configuration at the flapwise fatigue test.

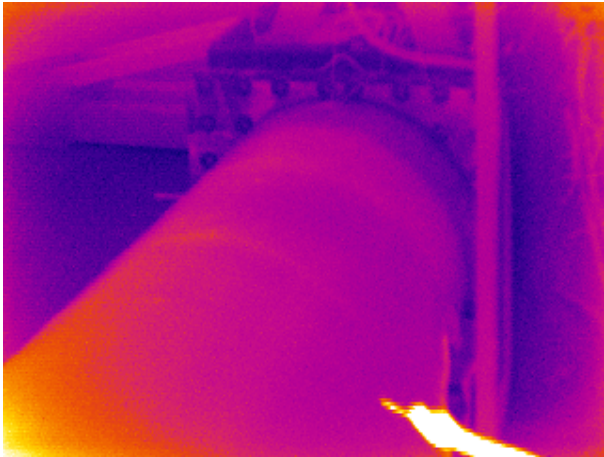
Figure 13. Thermal image of upwind side of root section

Figure 11 and Figure 13. During this second thermal surveillance, at this load level, there was also discovered a hot spot in the root section on the centre line on downwind side of the blade; see Figure 12 and Figure 14.

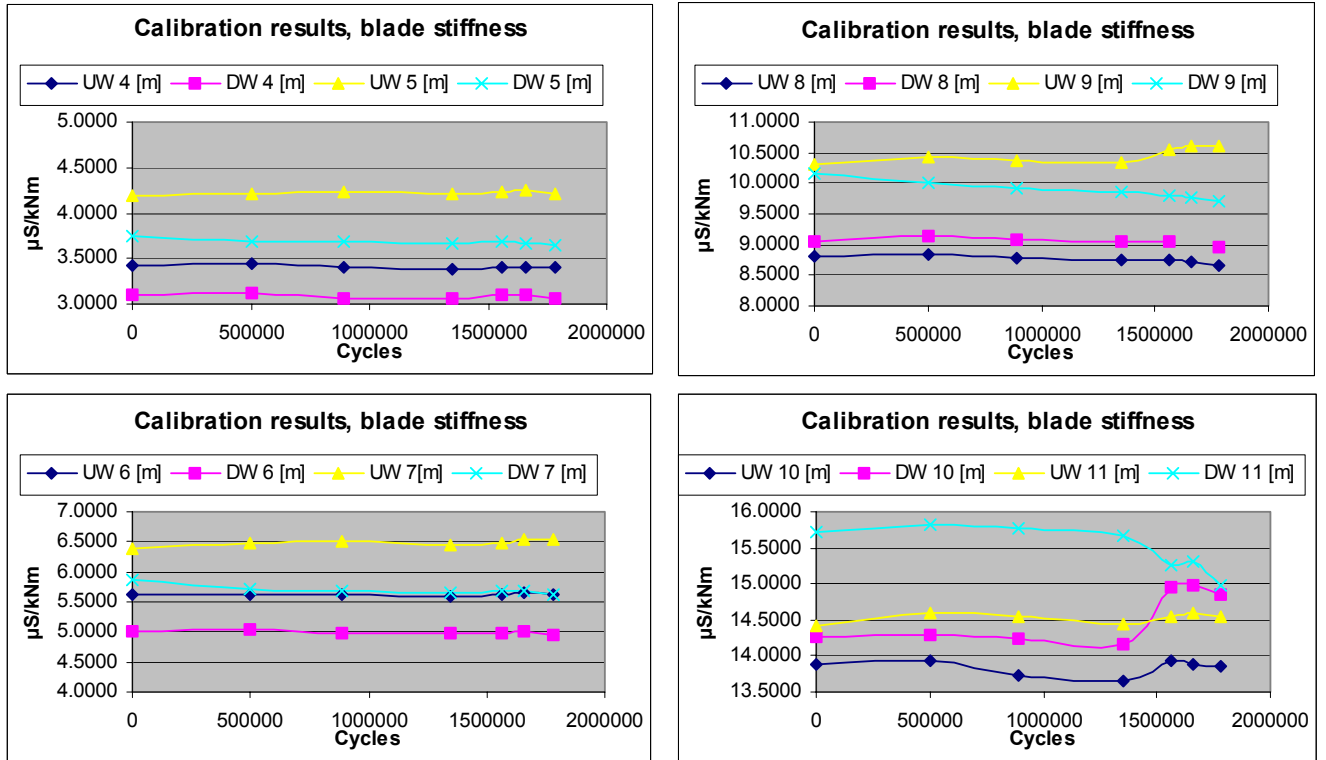
Figure 20. Discrete stiffness distribution for calibration tests of LM 19.1 # 4703, the x-axis is number of cycles applied to the blade

During the fatigue test several calibration tests were performed. The calibration tests were performed as static tests with load applied to make bending towards suction (down wind) side of blade. Figure 20 shows the normative stiffness of the blade for discrete sections of the blade. The measurements show the $\mu\text{S}/\text{kNm}$ local stiffness at maximum load for the calibration tests. The graphs are supposed to be linear i.e. no change in stiffness of the blade. The graphs show a change in stiffness for the sections from 9 [m] to 11 [m] as the test is carried out. The change is starting when the test has run for 1.3 million cycles, i.e. app. 500 000 cycles before visual damage was seen on the blade.

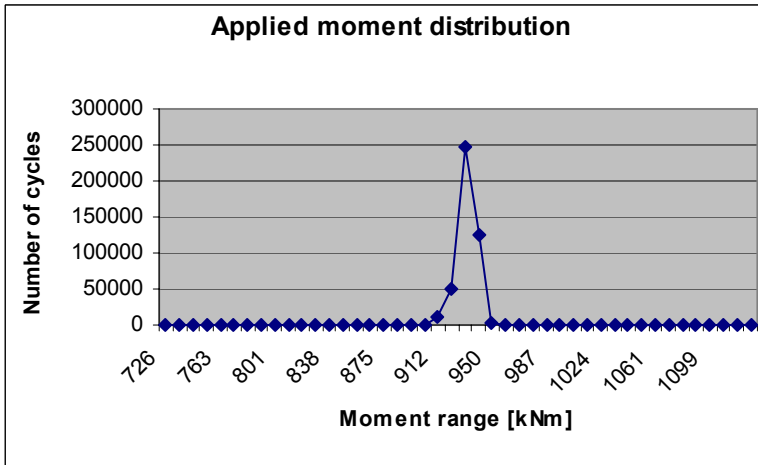
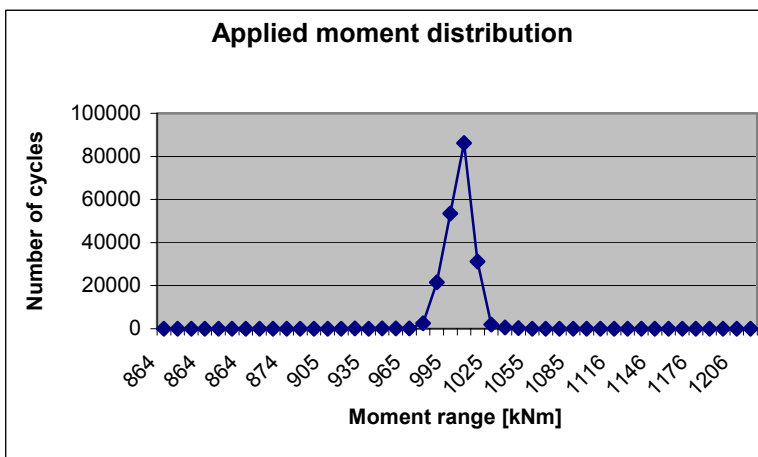
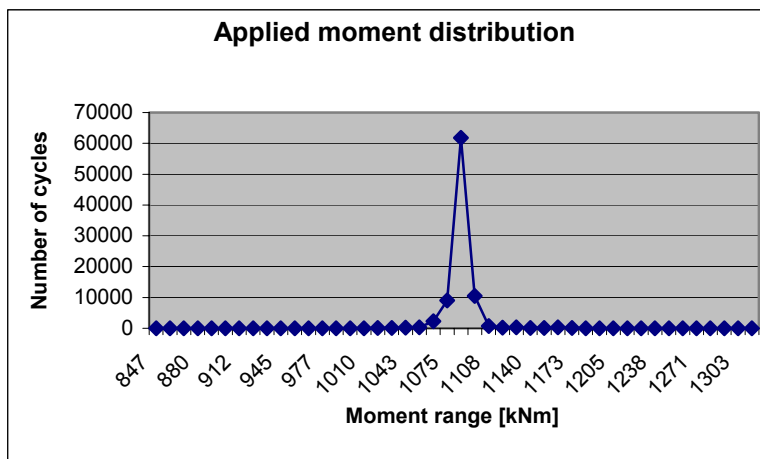
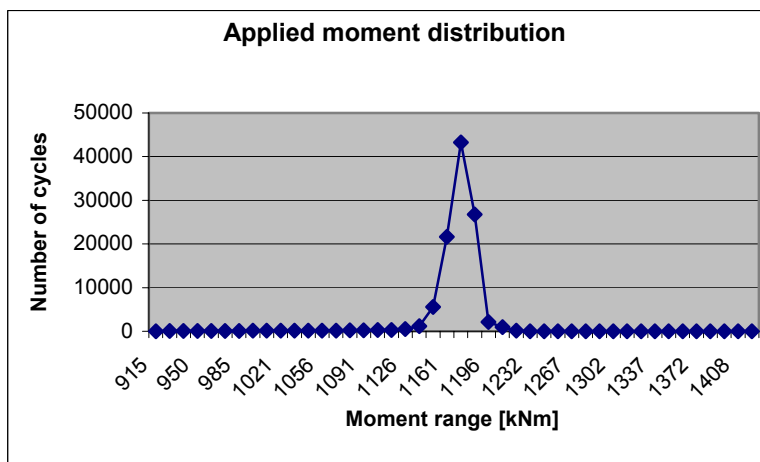
Figure 21. Moment distribution for blade # 4703 at load level 1

Figure 22. Moment distribution for blade # 4703 at load level 2

Figure 23. Moment distribution for blade # 4703 at load level 3

Figure 24. Moment distribution for blade # 4703 at load level 4

Figure 25. Moment distribution for blade # 4703 at load level 5

The number of cycles in Figure 21 - Figure 25 is determined from the data acquisition software.

These moment distributions are used to calculate the equivalent moment applied to the blade. For a more detailed view of the moment distribution see app D.

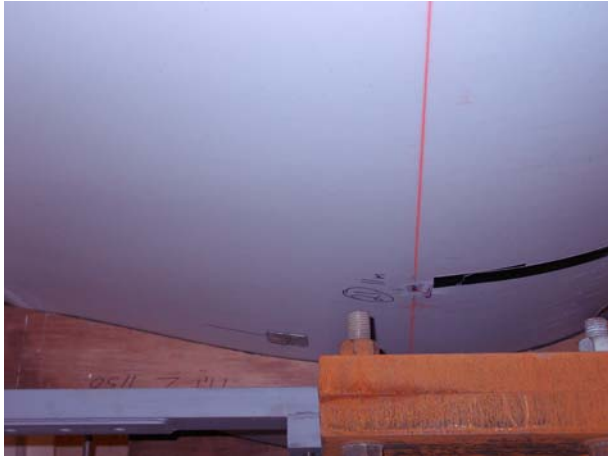
Figure 26. Suction side of blade with part of preload and exciter

side very similar to the picture from the pressure side, i.e. a hot area between the two webs, especially in the area of the web towards trailing edge, see Figure 26 and Figure 28. Hot spots observed in the root section on this blade, were similar to the spots on the first blade. Figure 27 and Figure 29 shows the root section, when the the thermal images were made the root bending moment was 1267 [kNm].

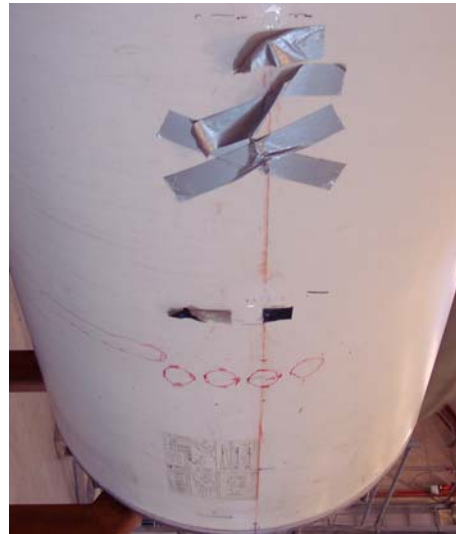
Figure 27. Downwind centre line, hot spot marked with red marker, diameter app. 3 [cm].

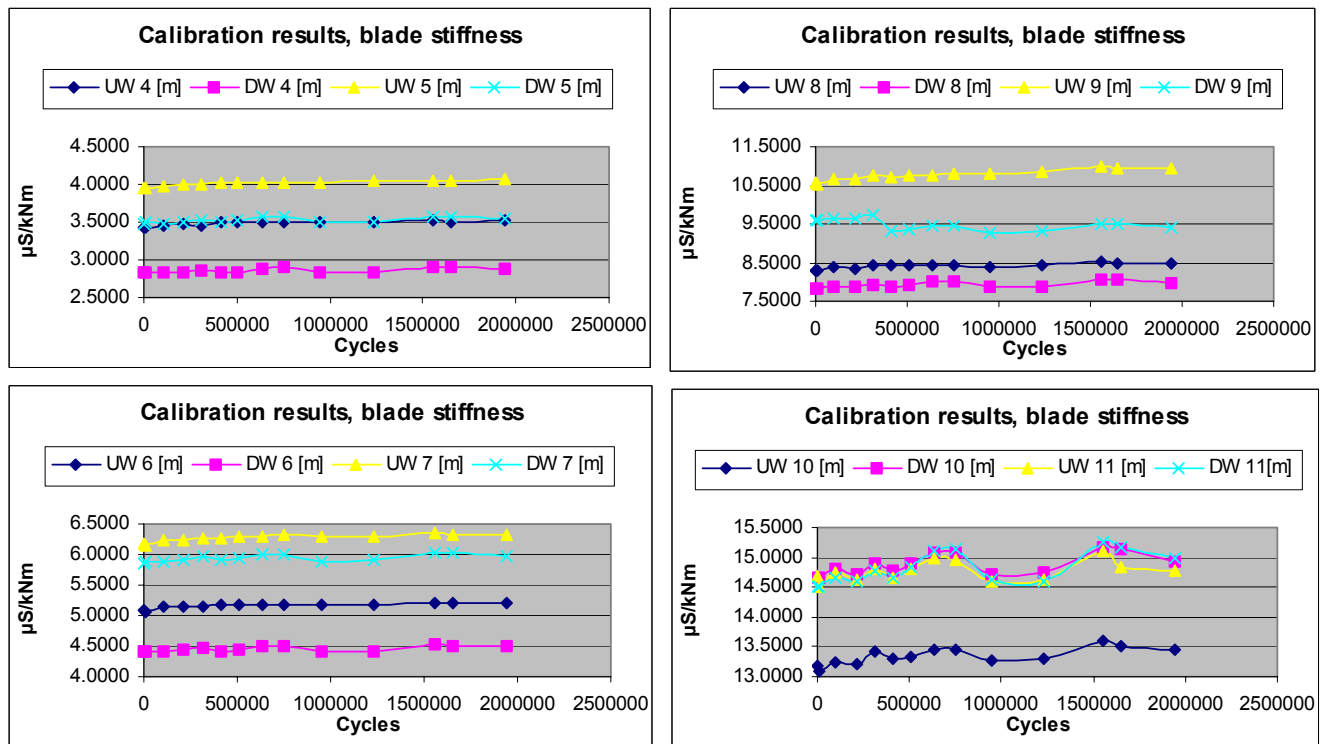
Figure 36. Discrete stiffness distribution for calibration tests of LM 19.1 # 4706, the x-axis is number of cycles applied to the blade

app. 1 500 000 cycles before visual damage was seen on the blade.

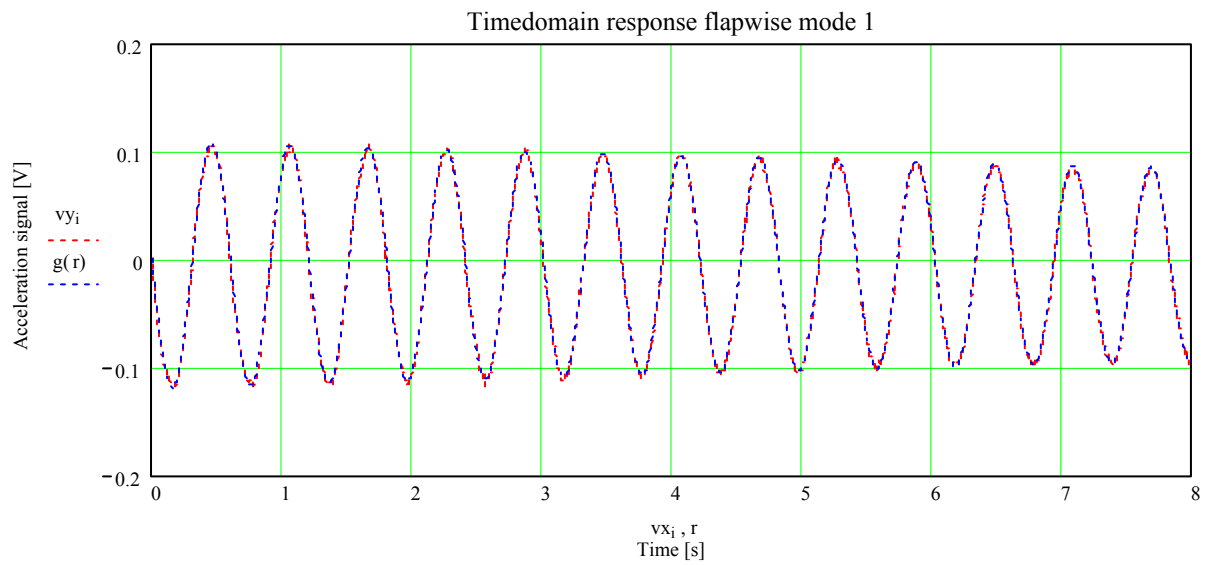
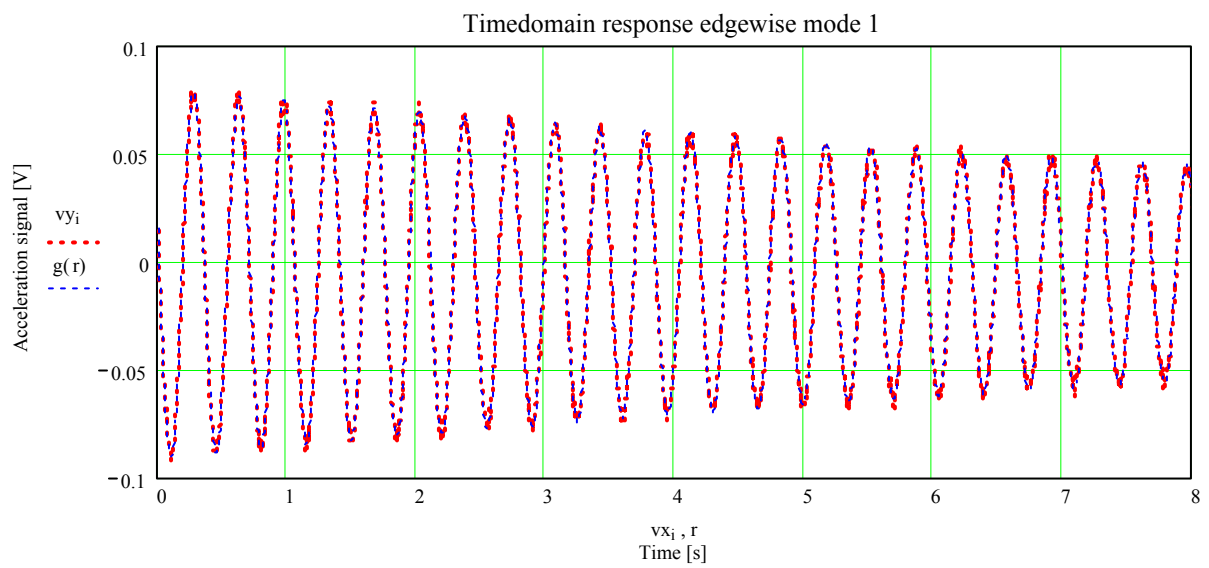
LM 19.1 # 4706 frequency graphs

Figure 55. Time domain response, flapwise 1. mode.

Figure 56. Time domain response, flapwise 2. mode.

Figure 57. Time domain response, edgewise 1. mode

Figure 58. Time domain response, torsional 1. Mode. The figure shows the torsional frequency replayed in a speed of 1/10 of the normal speed.

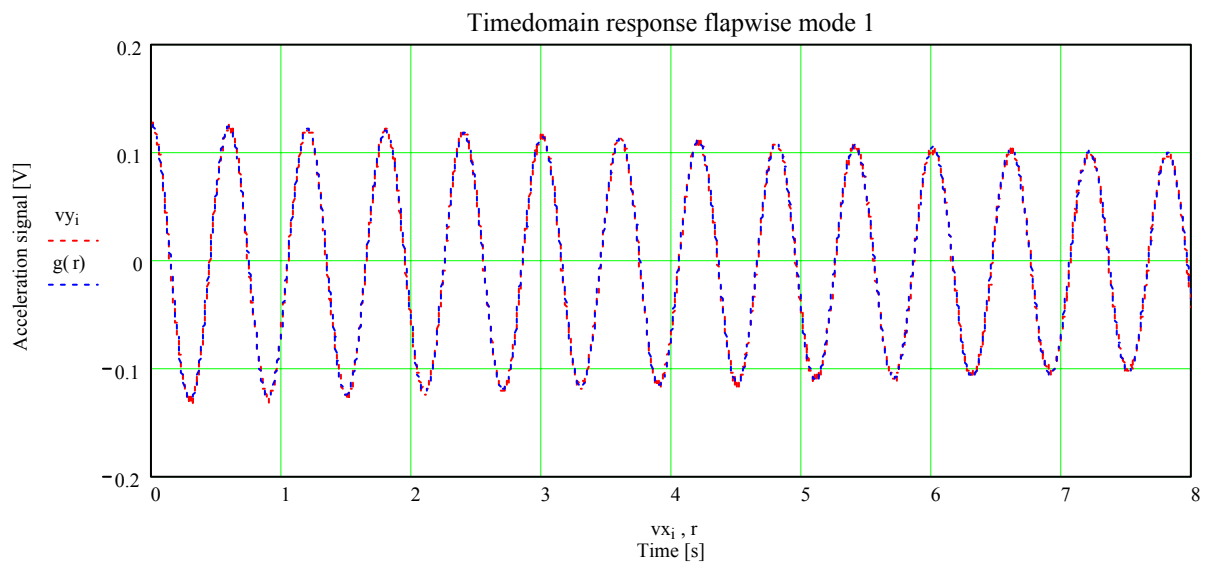
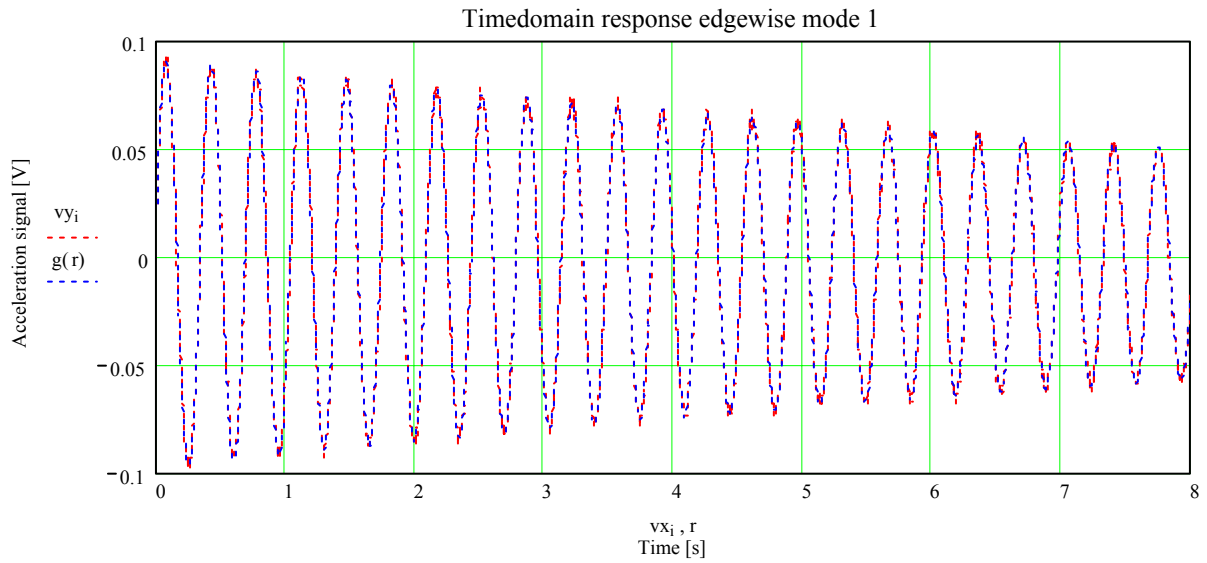
LM 19.1 # 4700 frequency graphs

Figure 59. Time domain response, flapwise 1. mode.

Figure 60. Time domain response, flapwise 2. mode.

Figure 61. Time domain response, edgewise 1. mode

Figure 62. Time domain response, torsional 1. Mode. The figure shows the torsional frequency replayed in a speed of 1/10 of the normal speed.
