Mechanical decontamination tests in areas affected by the Chernobyl accident

**Risø National Laboratory, Roskilde, Denmark
Federal Radiological Centre, St. Petersburg, Russia
August 1998**

Abstract Decontamination was carried out around three houses in Novo Bobovichi, Russia, in the summer of 1997. It was demonstrated that significant reductions in the dose rate both indoor (DRF = 0.27) and outdoor (DRF = 0.17) can be achieved when a careful cleaning is undertaken. This report describes the decontamination work carried out and the results obtained. The roof of one of the houses was replaced with a new roof. This reduced the Chernobyl related dose rate by 10 % at the ground floor and by 27 % at the first floor. The soil around the houses was removed by a bobcat, while carefully monitoring the ground for residual contamination with handheld dose meters. By monitoring the decline in the dose rate during the different stages of the work the dose reducing effect of each action has been estimated. This report also describes a test of a skim&burial plough developed especially for treatment of contaminated land. In the appendices of the report the measurement data is available for furthe

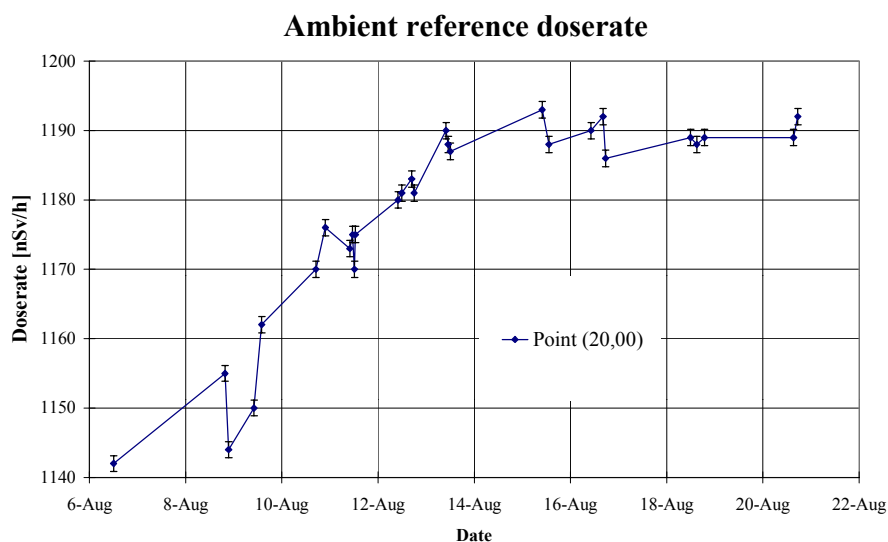
Figure 2.1. Total dose rate measured in Guta Muravinka at location (20, 00).

As much of the ^{137}Cs has penetrated several centimetres into the ground, the dose rate in air will depend on the attenuation of the photons in the ground. The attenuation will depend on the varying moisture content in the ground. In Figure 2.1 the dose rate measured at a reference point is presented. It can be seen that the dose rate increases by about 5 % from the start of the measurements in Guta Muravinka to the end. It rained the night before the work started, but the following weeks the weather was dry. Throughout the first week the topsoil dried out and the dose rate increased. After about one week with dry weather the dose rate remained stable.

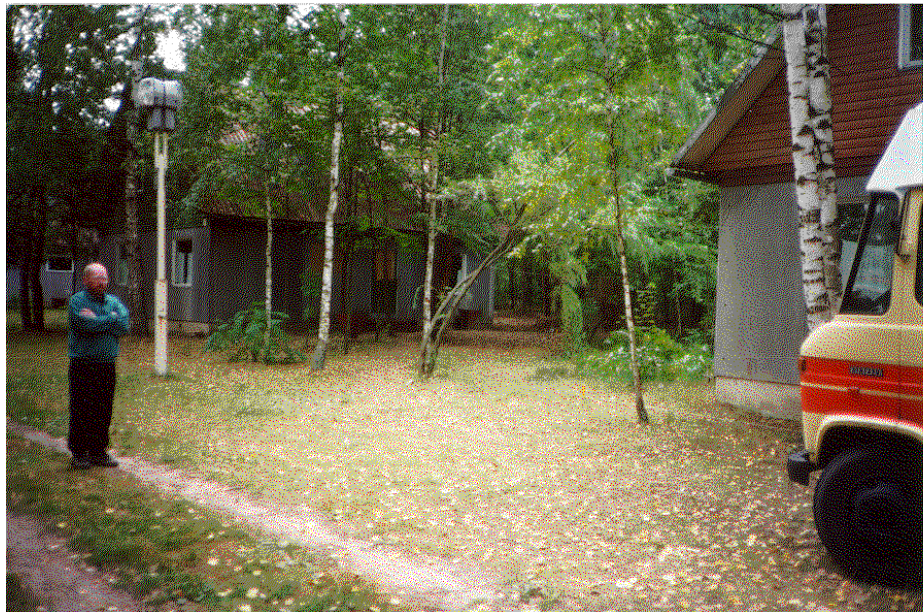
Plate 3.1. View of the houses before the decontamination. From the right to the left houses 1, 2 and 3 can be seen.

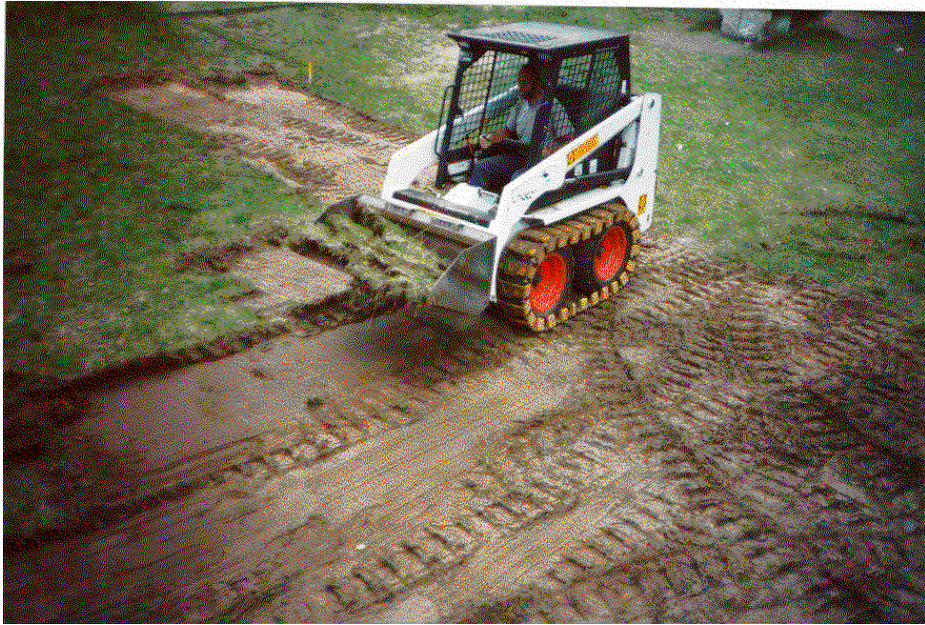
Plate 3.2. The first exercise with the Bobcat cleaning a grassed area close to the river bank.

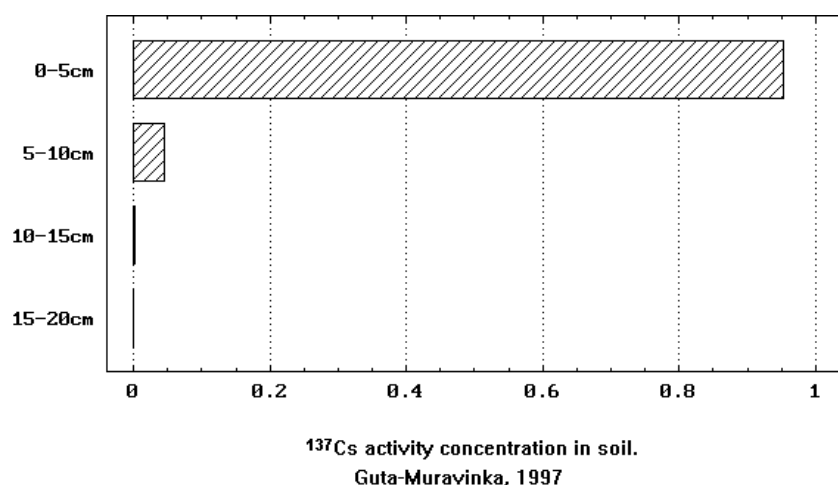
Figure 3.4. Average relative depth distribution of ¹³⁷Cs on the territory of the test site. Fractions of total activity, based on the analysis of 86 soil samples.

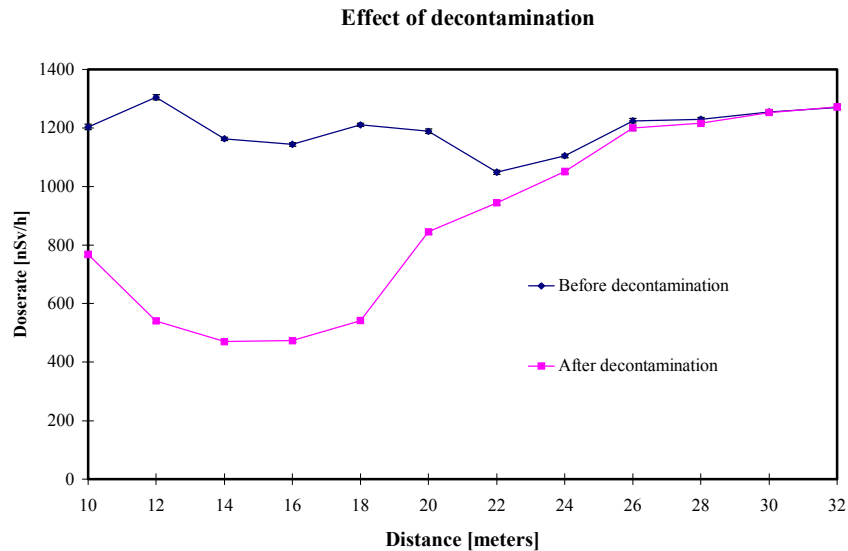
Figure 3.6. Dose rate profile over the green area at the ‘beach’. The ‘Distance’ is the x co-ordinate along the $y = 145$ metres line.

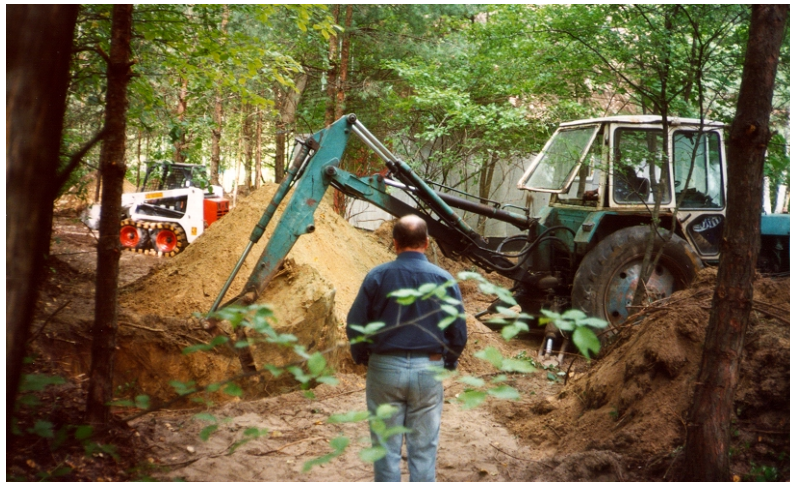
Plate 3.3. Excavator digging holes for waste burial in the forest. The sand is placed in a pile on the cleaned ground and the topsoil lies ready on the other side of the hole.

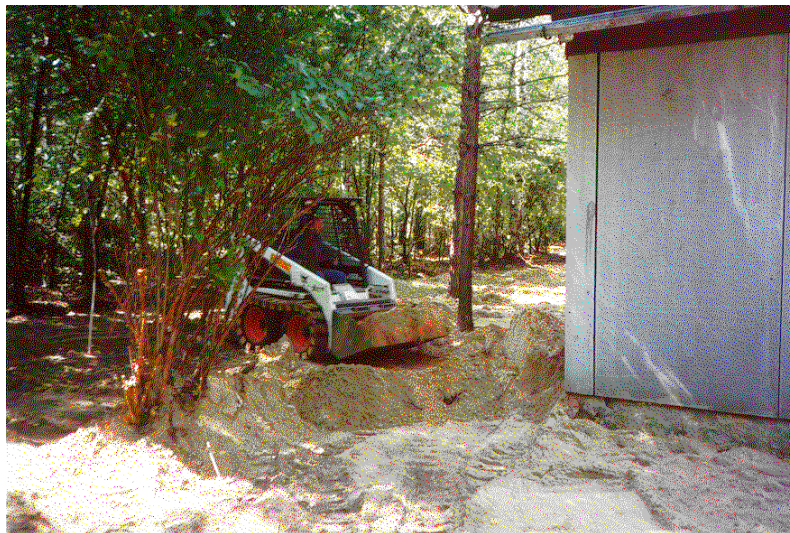
Plate 3.4. Application of clean sand at the corner of house number 1.

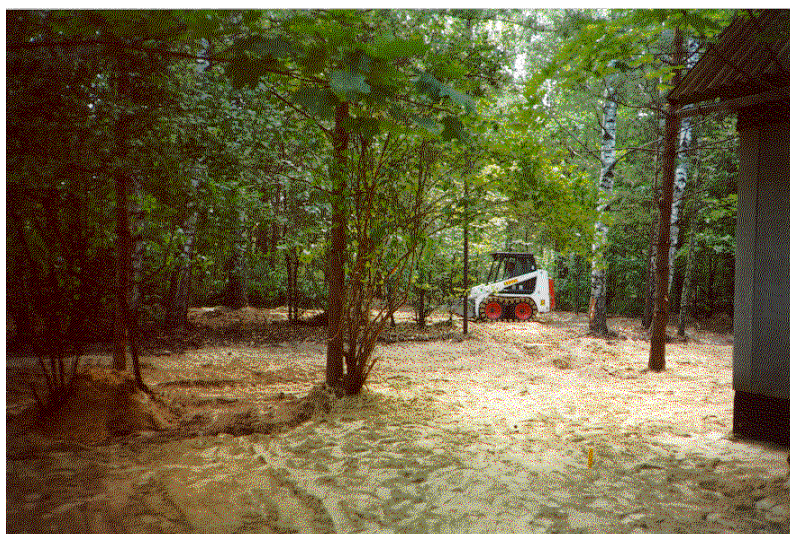
Plate 3.5 The Bobcat in the forest behind house 1. An area in the forest is cleaned to make room for an extra pit around (54, 32).

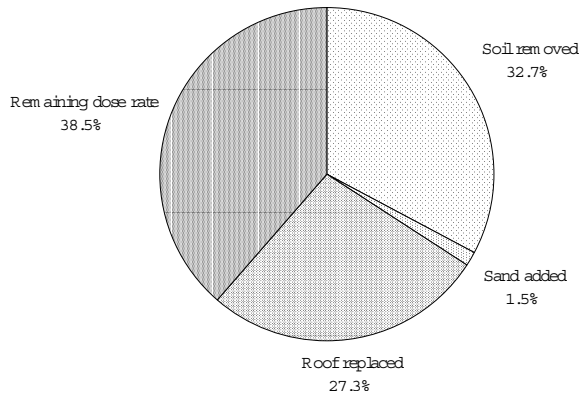
Figure 3.11. The effect on the Chernobyl-related dose rate of the various steps of the decontamination work on the first floor of house 1.

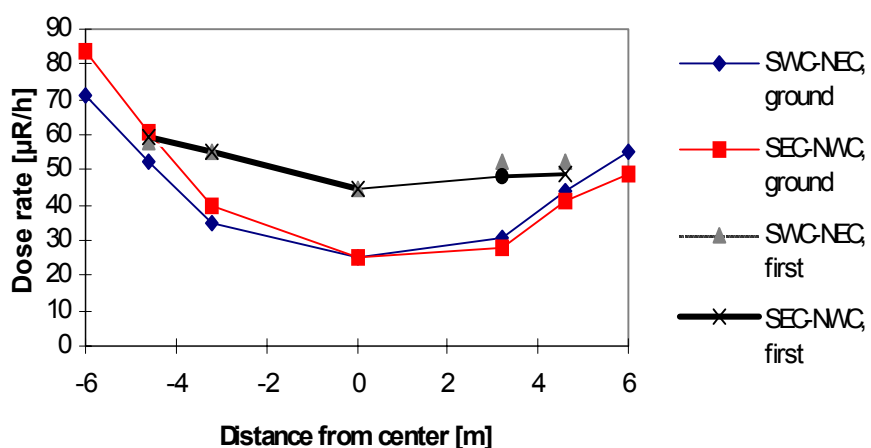
Figure 3.13. Dose rate profile at ground and first floor level inside house one measured with EL-1101.. South-west corner to north-east corner and south-east corner to north-west corner.

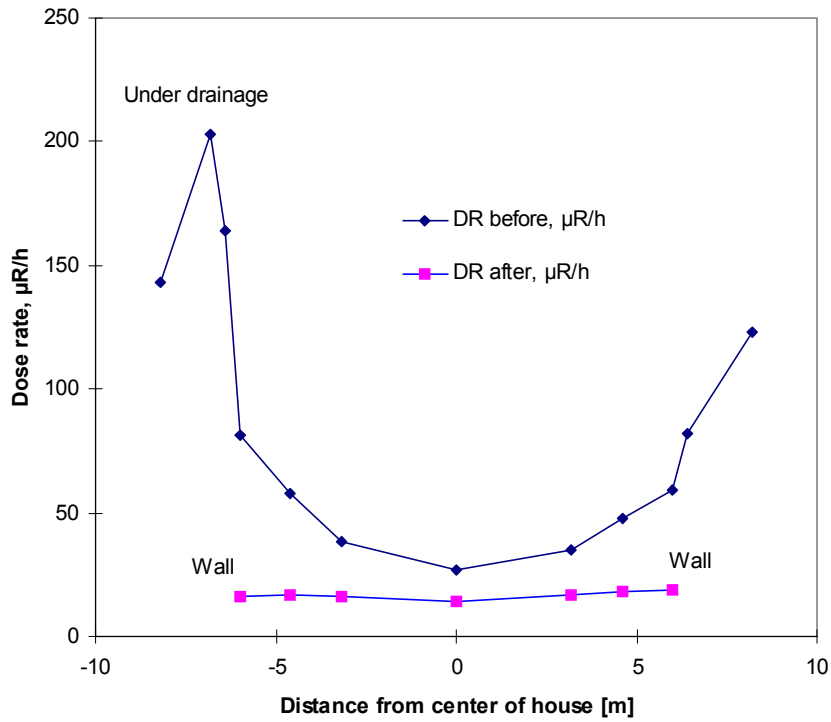
Figure 3.14. Chernobyl component of dose rate inside (ground floor) and outside House 2 before and after intervention, east-west corner direction measured with El-1101.

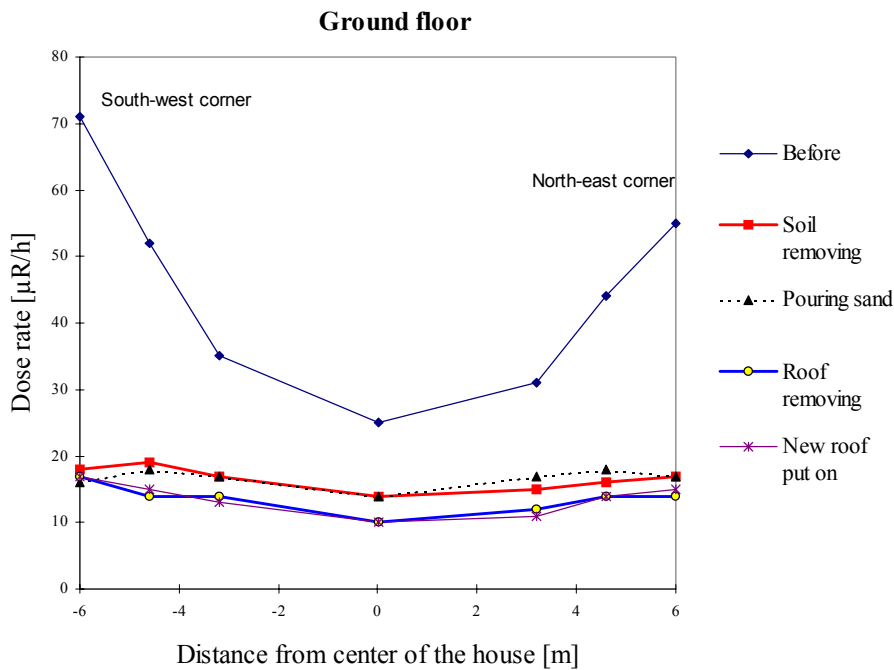
Figure 3.15. Dose rate at ground level in house 1 at different stages of intervention, Chernobyl component, measured with El-1101.

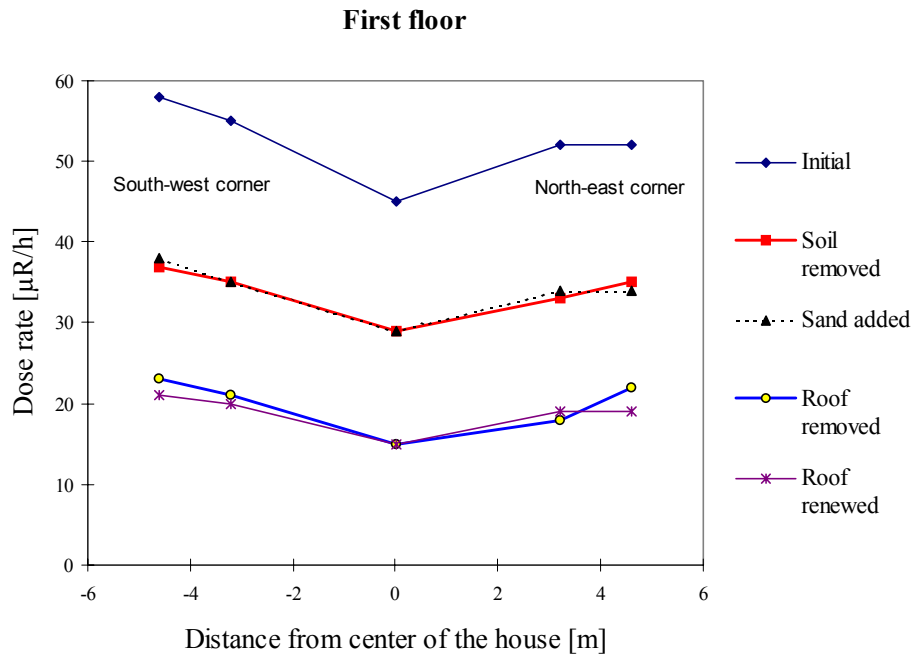
Figure 3.16. Dose rate in House 1 at different stages of intervention, Chernobyl component, first floor, measured with El-1101.

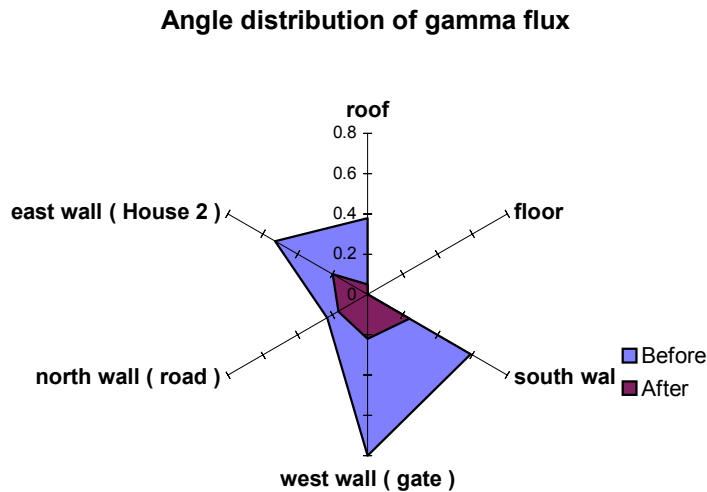
Figure 3.17. Unscattered gamma flux from different directions in house 1, ground floor, before and after dose reductive action.

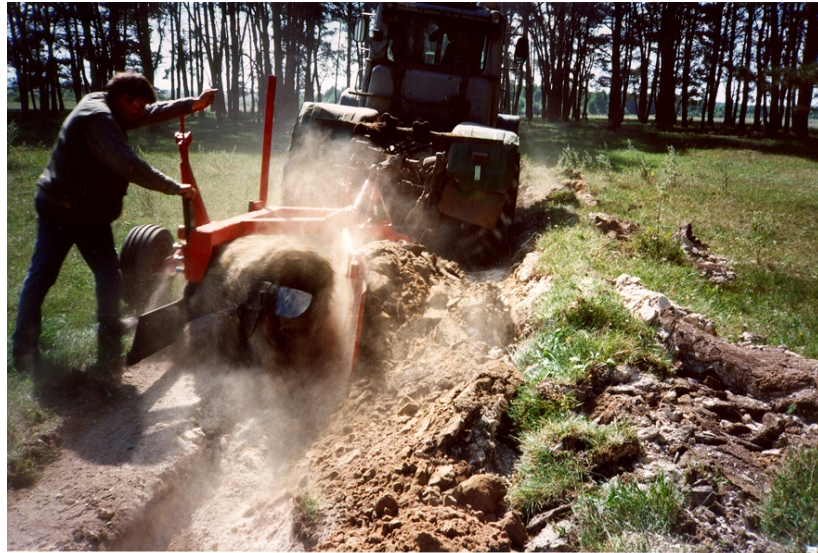
Plate 4.1. The plough in use in the Novo Bobovic area. The skim furrow is made on the left by the skim coultter while the main coultter simultaneously creates the deeper trench in which the top layer is buried. The plough is here going too deep and the person behind it is trying to adjust the ploughing depth.

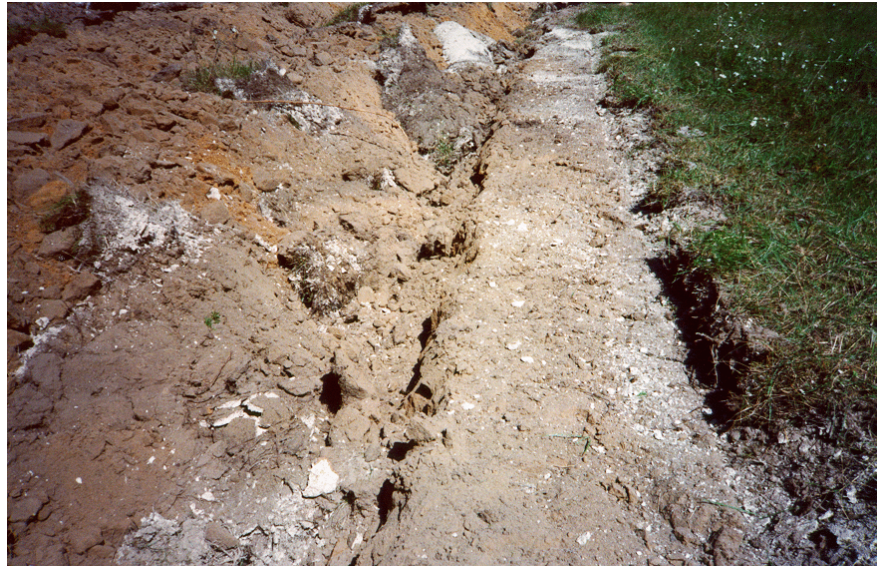
Plate 4.2. This picture shows the furrows after a ploughing. Traces of lime are clearly seen, both in the furrow produced by the skim coultter and in the treated land to the left, where soil from lower layers covers most of the area. Note that also bits of grass turf thrown to rather large dis-

tances are visible in the left part of the picture.

Plate 4.2 shows the furrows after a ploughing. The furrow produced by the skim coulter is seen to the right in the picture. It is seen that the furrow produced by the main coulter (immediately to the left of the skim coulter furrow) has to some extent collapsed. The reason for this was that the ploughing was carried out in the late summer, following a very warm and dry period. The soil therefore contained very little moisture and the subsoil crumbled and fell to the bottom of the trench. Consequently, the skimmed-off layer containing the contamination was not buried sufficiently deep. As the soil had not been cultivated in many years the thick top soil horizon was held together by the mature turf mat. Layers removed by the skim coulter and in some cases even layers under that contained so much organic material that they were held together and were in some cases stacked vertically because of the high velocity (sometimes broken at the middle) and only partially tilted. Therefore, several contamination peaks are in some cases seen at different depths in the vertical profiles after ploughing (see sample profiles NB25-28 in Appendix A). Bits of grass turf and chalk in the left part of the picture show that the skimmed-off top layer was, due to too high speed, in some cases slung far away from the furrow in which it should have been placed.

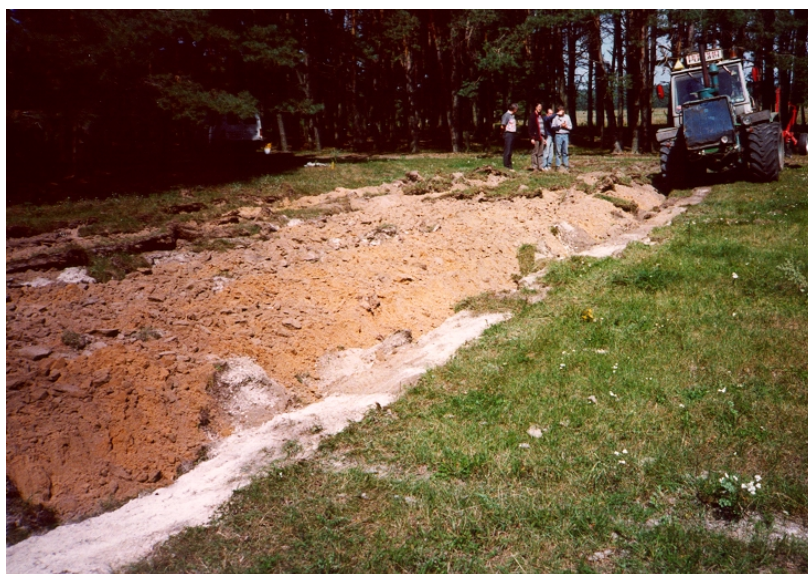
Plate 4.3. The tractor and plough are here about to start a new furrow. Note the white colour of lime in the skim furrow created by the previous run and that bits of turf have not been removed

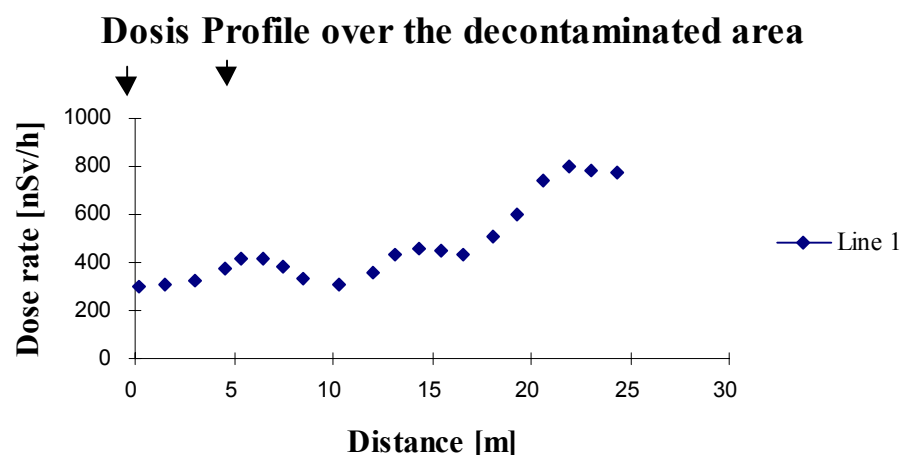
Figure 5.1. Dose profile across the decontaminated area in Novo Bobovich in 1995, as measured with the Reuter Stokes ion chamber. The arrows show the positions of the roads leading to the houses.

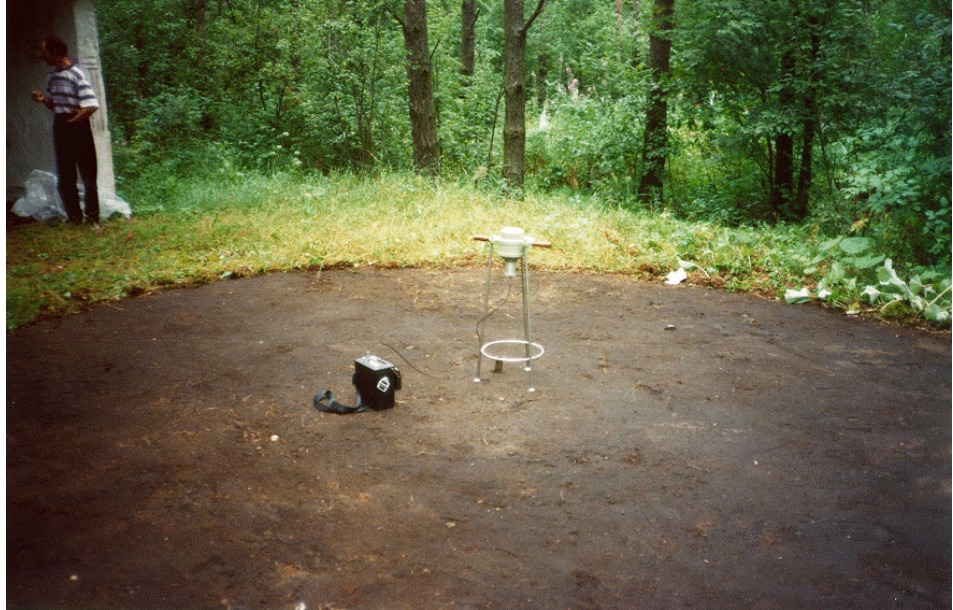
Plate 5.1. The CORAD device measuring the contamination of the asphalted area after removal of the organic cover. The picture shows that the photo-multiplier of the NaI crystal based system is facing down. This is the only opening in the lead collimator surrounding the crystal. The box with the electronics for data collection and treatment is seen to the left in the picture. The measurements are made at a height of 1 m above ground level.

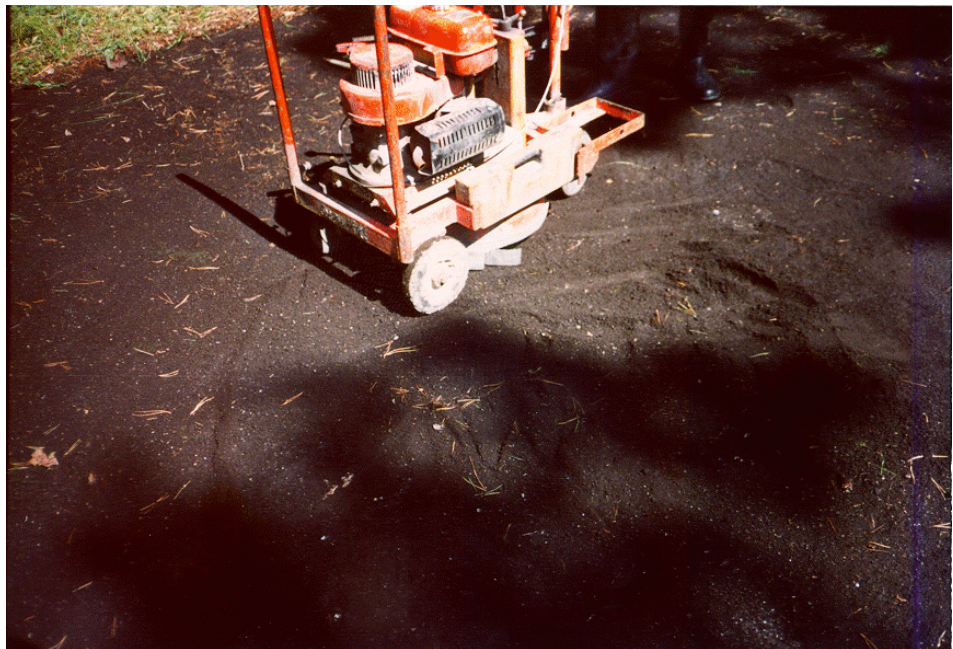
Plate 5.2. The asphalt scraper working on the contaminated pavement. As can be faintly seen from the picture, the road is covered with a powder of loosened asphalt particles after the operation.

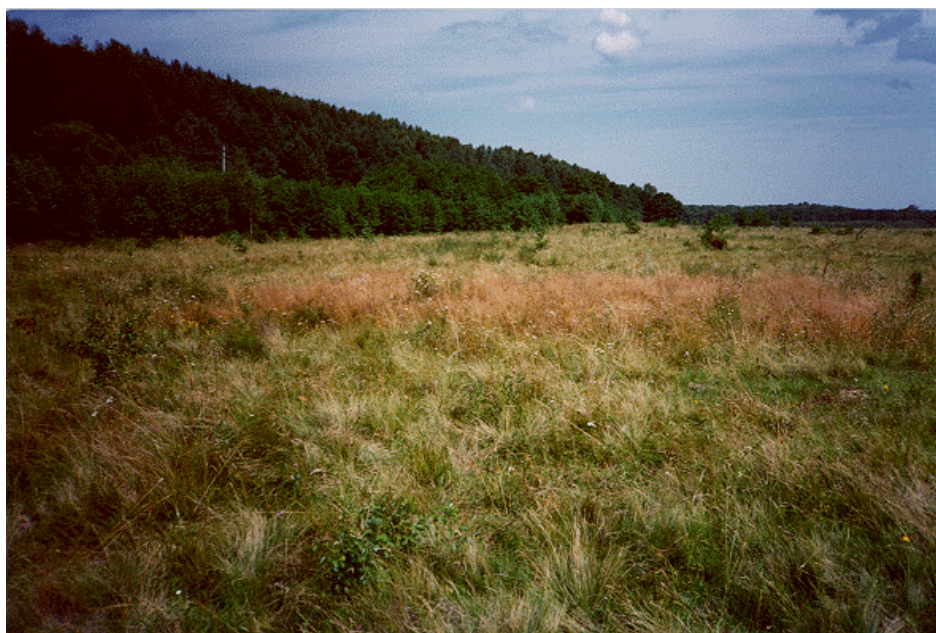
Plate 6.1. The 10 m by 10 m plot that was triple dug in September 1995, photographed in August 1997. The test area is shown in the centre of the picture. The colour difference indicates that a new type of vegetation (a fescue grass - *Festuca Rubra*) now dominates in the treated area.

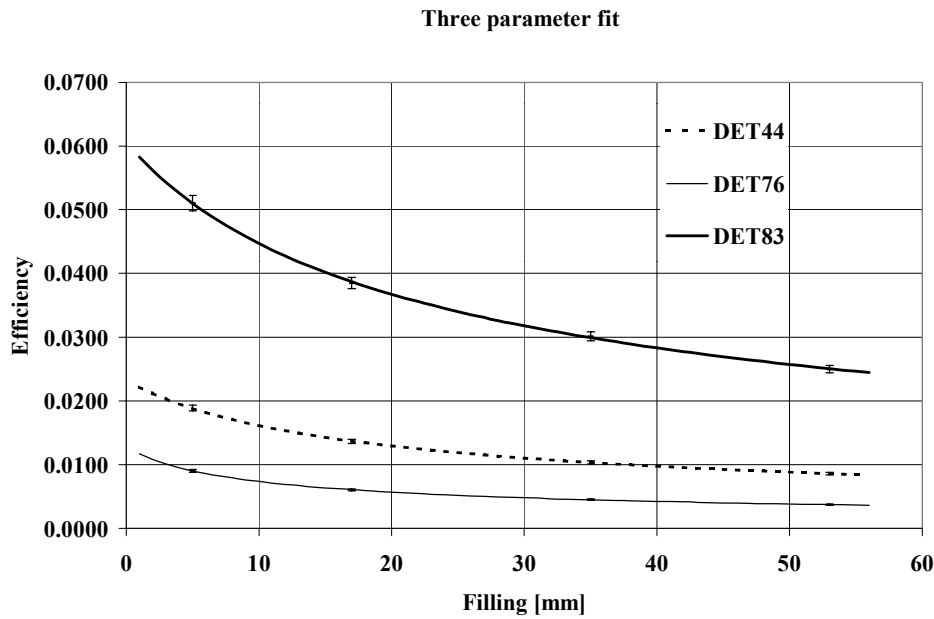
Figure 7.1. Efficiencies of the three detectors (DET44, DET76 and DET83) used for the analysis of the wood samples as a function of the filling of the sample container.
