The DR-2 project

The DR-2 Project

Abstract

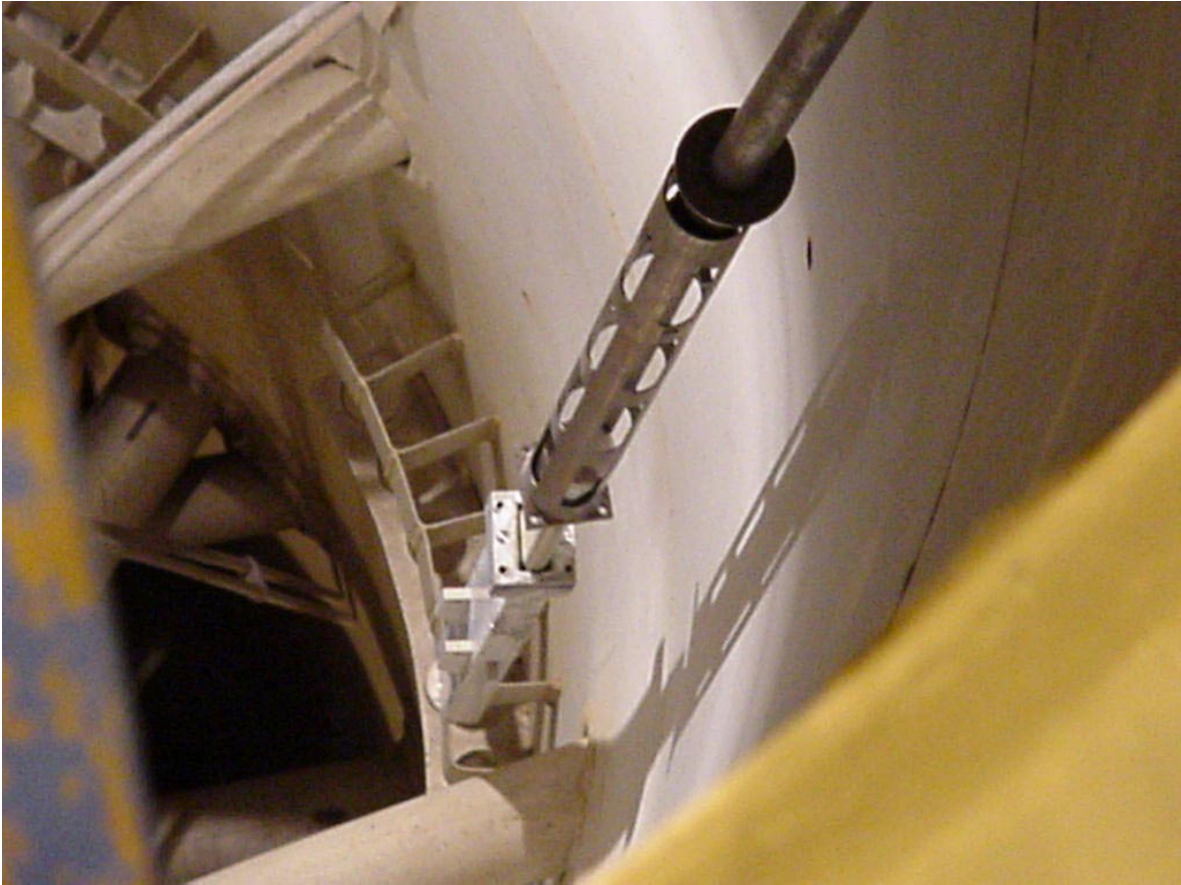
Figure A14. Calibration tool with stuck shim-safety rod and guide tube. Magnet rod on top.

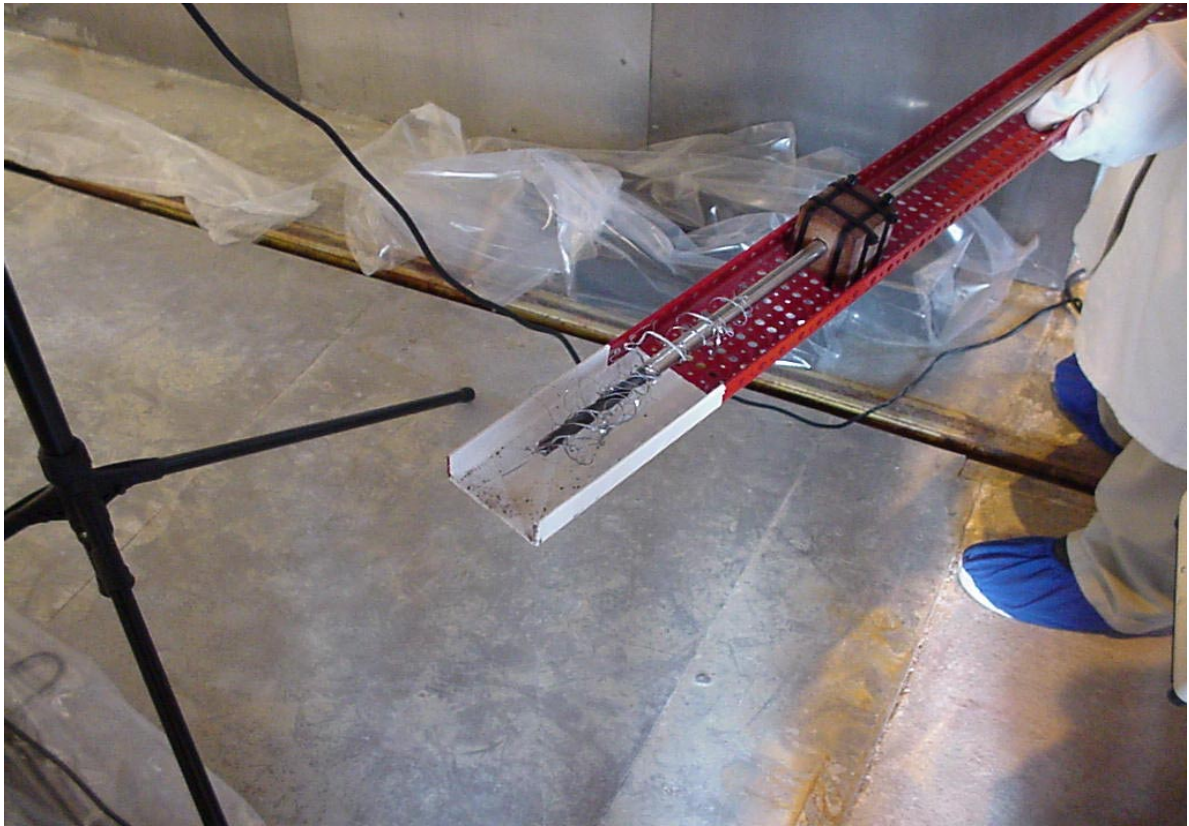
Figure A28. The drilling device for taking lead and aluminum samples at the wall at the inner end of the thermal column.
