Twin stability in highly nanotwinned Cu under compression, torsion and tension

Published in:
Scripta Materialia

Abstract:

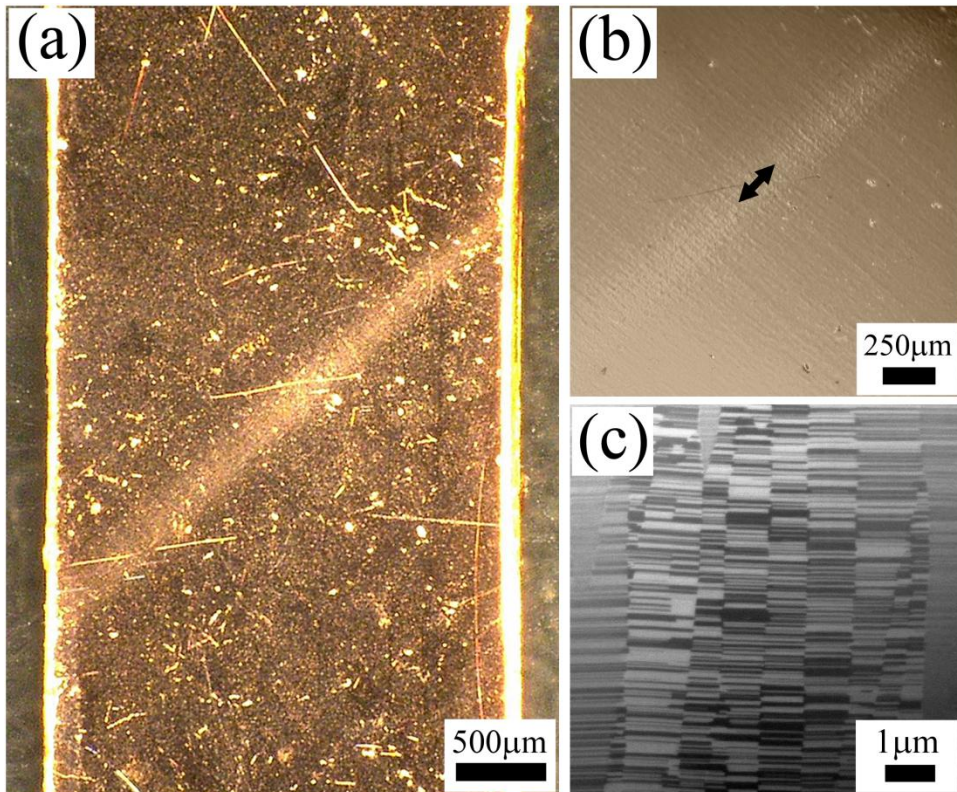
Figure 5

Figure 5. (a) Optical micrograph of the gage section of a representative tensile sample tested at 10^{-4} /s that was stopped immediately after the yield peak in the stress-strain curve. (b) A magnified optical micrograph of the shear band across the specimen width. (c) FIB cross-section micrograph of a section within the shear band region [location of FIB cut marked by double-headed arrow in (b)].

In order to further explore the microstructural stability of the nt samples and the role of nt's in the observed localized plastic deformation, a tensile test of the nt-Cu (strain rate of 10⁻⁴/s) was stopped immediately after the yield peak. **Figure 5a** shows an optical micrograph of the gage section after the test was stopped, in which a clear shear band is observed across the entire width. A slight difference in the surface roughness is observed in the magnified micrograph in **Figure 5b**. A representative cross-section FIB micrograph within the shear band region is shown in **Figure 5c**, in which there is little to no change in the microstructure compared to the as-prepared sample. It should be mentioned that FIB cross-section analysis of the microstructure was done in multiple locations within the shear band region and at various orientations relative to the shear band direction. In all cases, the microstructure was similar to that seen in **Fig. 5c**. This observation implies that the shear band was formed prior to any major change in microstructure, such as grain growth or detwinning. This result is in contrast to TEM observations by Hong et al [11], in which shear bands in a Cu-Al alloy processed by dynamic plastic deformation were seen to form as a result of bending, necking, and then detwinning of the original twin/matrix lamella.

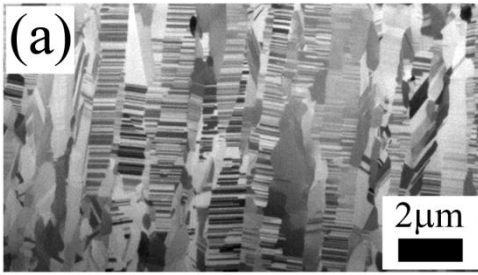
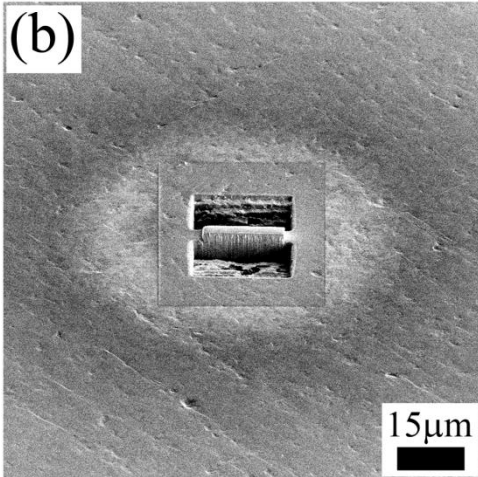
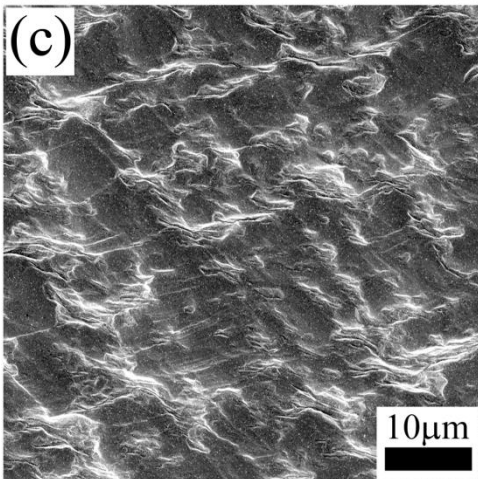
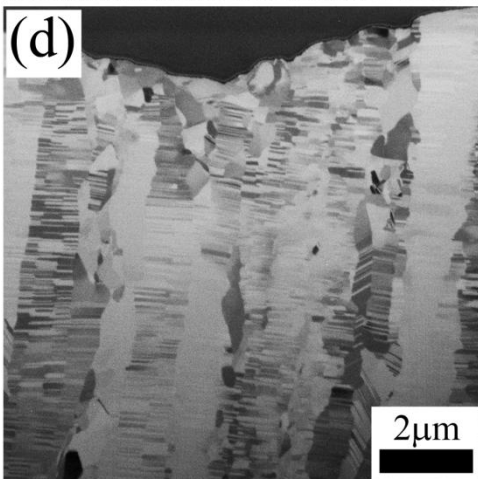
Figure 6

Figure 6. (a) Transverse cut of a nanotwinned Cu sample that has been fatigued to failure under a stress of 450 MPa. (Cut taken close to fracture site). (b) SEM image of surface of sample fatigued to failure at ~4000 cycles under a maximum stress of 550 MPa. Image is taken about 1 mm from the fracture site. Note the depression lines crossing the surface. (c) SEM of the surface of a sample fatigued to failure under a maximum stress of 405 MPa, showing apparent damage sites. Image is near the fracture site. (d) FIB image of a cut across a shear band in sample fatigued to failure under a maximum stress of 550 MPa, image taken near failure site. Note that the original nanotwinned structure has been lost in the region of the surface dip.

Deformation by tension-tension fatigue permits the study of accumulated strain on the nt microstructure. Stresses are applied in the same direction as in the case of the tension tests, but by cycling through several thousand cycles, the microstructure is subjected to a large accumulated strain, far greater than the fracture strain in a tension test. It is seen that fatiguing to failure in the low cycle regime produces a change in the nanotwinned microstructure (See refs [16, 17]). While most of the original twins remain, column boundaries are disturbed and within a number of columns, the original nanotwins have been replaced by other twins having different twin boundary spacing and orientation (**Fig. 6a**, see also Fig.3c in ref [16]). Damage originates at the surface, as is generally the case in fatigue failures. An SEM image (Fig. 6b) of the surface of a sample cycled between 550 and 55 MPa to failure at ~4000 cycles shows parallel depressions, crossing the surface at an angle of roughly 30° to the tensile stress direction. The image was taken about 1 mm away from the fracture site. These lines become more apparent as the fracture edge is approached. Closer to the fracture another set of parallel lines appears, slanted in the opposite direction (see Fig.7a in [17]). (This second set of lines might have been present but not apparent in Fig. 6b because of the tilt of the sample during imaging.) Surface cracks tend to appear at the intersection of two lines from the opposite sets (Fig 6c). A FIB image (Fig. 6d) of a cut made transverse to one of the lines near the fracture site in the sample fatigued between 550 and 55 MPa shows [some](#) loss of the original nanotwins near the surface, which has dipped below its original position. This loss of the original nanotwins at the surface
