Proceedings of the European Corrosion Congress 2012

# Effect of Ionic Contamination on Corrosion Reliability of Printed Circuit Board Assemblies

*Vadimas Verdingovas, Morten Stendahl Jellesen, and Rajan Ambat*  
*Materials and Surface Engineering, Department of Mechanical Engineering,*  
*Technical University of Denmark, DK-2800 Lyngby, Denmark*  
[vaver@mek.dtu.dk](mailto:vaver@mek.dtu.dk)

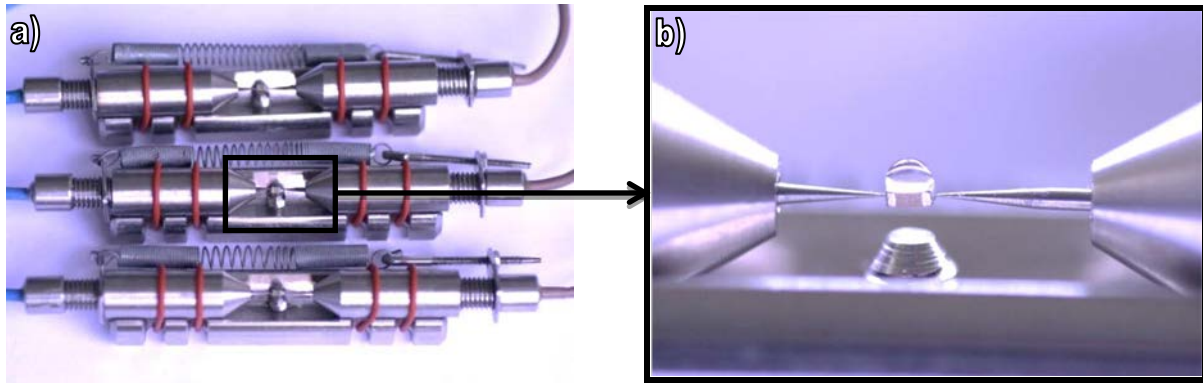
Single component electrochemical migration tests have been conducted using a special setup described by Minzari et al. [10,11]. The single component electrochemical migration (SCECM) setup consists of a sample holder having two small adjustable probes, which act as connectors to each end of the surface mount components (SMC) – in this case ceramic chip capacitors. The entire SCECM setup consists of three separate pairs of metal probes and enables the experiments to be conducted with three chip capacitors at a time, as shown in **Figure 1 (a)**.

**Figure 1:** Single component electrochemical migration setup

The ECM probability testing on the single components was done by placing a micro droplet of electrolyte at a desirable concentration on top of the surface mount components. The current was measured between the terminals of the components which are bridged via the droplet of electrolyte solution and biased at DC voltage in the range of 1 V – 25 V using an in-house built multi-channel multiplexer unit called “CELCORR test PCB set up”, described elsewhere [12]. The leak current followed by the current increase due to ECM (electric short due to dendrite formation) was measured with a 1  $\mu$ A resolution ammeter connected in the circuit via a two switch system. The sampling rate for the leakage current reading was set to 1 s. The experiments were carried out under ambient conditions: temperature 23.5°C – 24.5°C, relative humidity 30% – 40%.

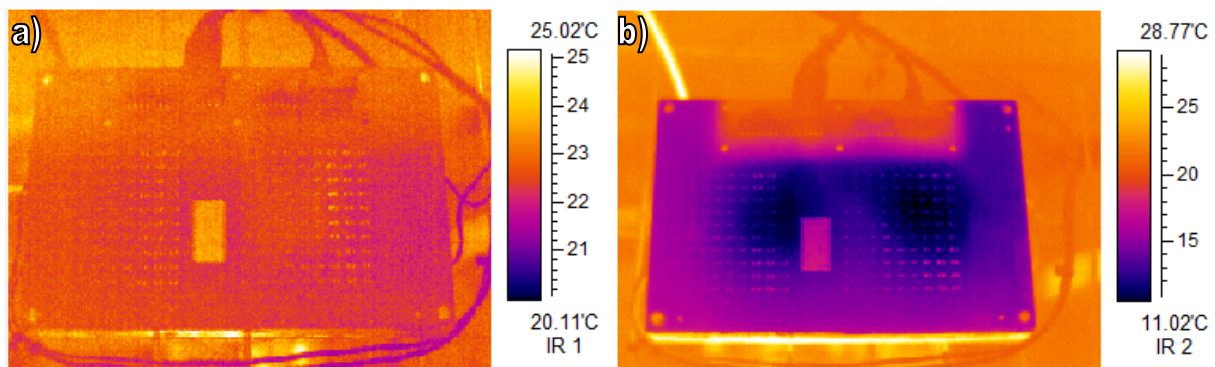
The temperature of the PCB was controlled by mounting the PCB on an aluminum block with embedded Peltier elements. The heat from the hot side of the Peltier elements was removed using a coolant passing through the hollow aluminum block. A DC power source (EA-PSI 6032-06 32V/6A) was used for applying potential to the Peltier elements. The surface temperature of the PCB mounted on the aluminum block was measured with two platinum Resistance Temperature Detectors (PT1000 class A) connected in a 2-wire circuit. DaqLink data logger “Fourier Systems DBSA720” was used to log the temperature/voltage readings on the surface of PCB throughout the duration of the experiment. The cooling effect on PCBs placed on the aluminum block is presented in **Figure 2**.

**Figure 2:** Temperature profiles of test PCB fixed on aluminum block with embedded Peltier elements taken at ambient temperature of 25°C: (a) – without cooling; (b) – 4V DC is applied on Peltier elements

The whole test was performed inside the climatic chamber under constant humidity (60% RH), while the temperature of the PCB was changed as described above. In-situ monitoring of the water layer formation and condensation was carried out using the video camera installed inside the climatic chamber. This allowed in-situ observation of water layer formation and corrosion failures on the PCB.

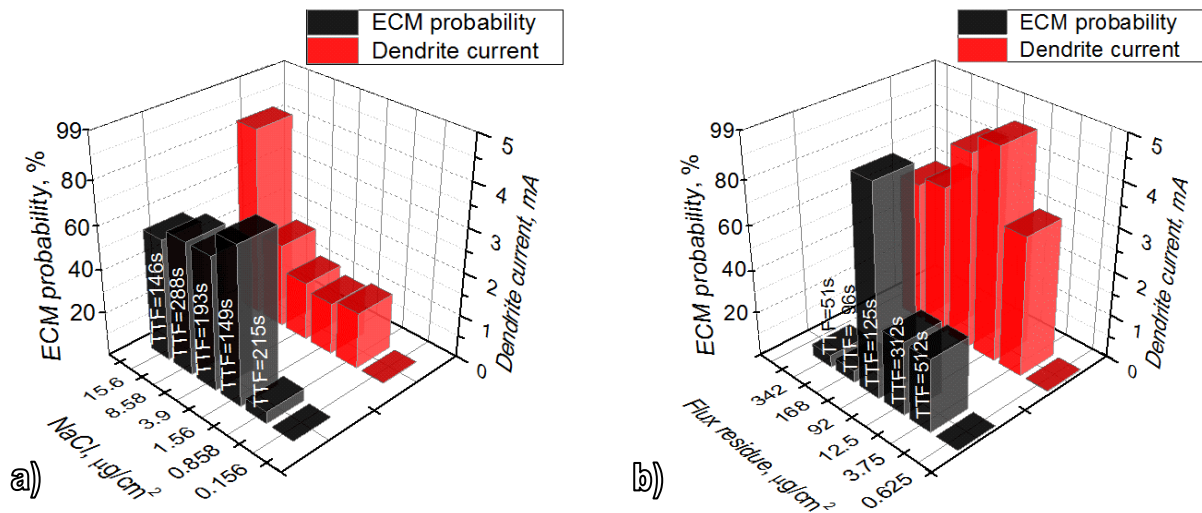
**Figure 3** shows the probability of migration (number of capacitors which showed ECM out of 18 experiments in each category expressed as a percentage) and the average dendrite current for NaCl and flux residue as a function of concentration. The average time to dendrite growth initiation marked as time to failure (TTF) corresponding to each set of experiments is shown on the bar.

**Figure 3:** ECM probability and dendrite current as a function of concentration: (a) NaCl and (b) flux residue

Further increase in flux residue concentrations caused only a low probability of migration (**Figure 3 (b)**), while the component shown in **Figure 5** shows heavy corrosion of the anode terminal, but no dendrites or precipitation of tin hydroxides as was seen in the case of NaCl. This appearance might indicate that the pH level of solution was moved towards the acidic area due to the high levels of weak organic acids in the flux residue and therefore the precipitation of tin hydroxides was

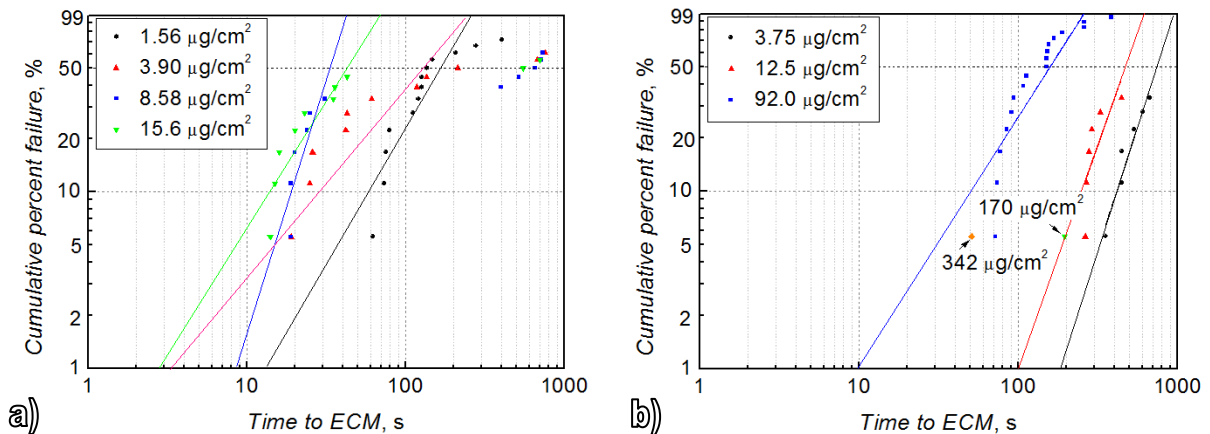
The level and the type of ionic contamination showed an influence on the probability of an ECM event and also the time of ECM initiation. The following effects are shown in the cumulative percent of ECM versus time graphs for NaCl and solder flux residues in **Figure 4**.

**Figure 4:** Cumulative failure dependence of time for (a) – NaCl and (b) – solder flux residue

As is seen from the graphs in **Figure 4**, increasing concentration shortens the time to an ECM event. This fact is also clear from the comparison of the time needed for 50 % of capacitors to show ECM as well as from the time to the first failure. In the case of NaCl, the increase of concentration from  $1.56 \mu\text{g}/\text{cm}^2$  to  $15.6 \mu\text{g}/\text{cm}^2$  reduces the time to first failure accordingly: 62s, 25s, 19s and 14s. The presence of flux residues reduces the time to the first ECM event from 354s to 72s with increase of concentration from  $3.75 \mu\text{g}/\text{cm}^2$  to  $92 \mu\text{g}/\text{cm}^2$ .

The results revealed contamination levels below which the probability of dendrite growth is very low. This empirically found limit for NaCl is in the range between  $1.56 \mu\text{g}/\text{cm}^2$  and  $0.858 \mu\text{g}/\text{cm}^2$ , whereas for “no-clean” solder flux residues investigated in this work, this limit is much more broad where it starts at  $3.75 \mu\text{g}/\text{cm}^2$  until it peaks around  $92 \mu\text{g}/\text{cm}^2$ . In general a decrease of TTF and to some extent an increase of cumulative percent failure was observed with increasing level of contamination (**Figure 4**). However a considerable reduction of ECM probability at very high

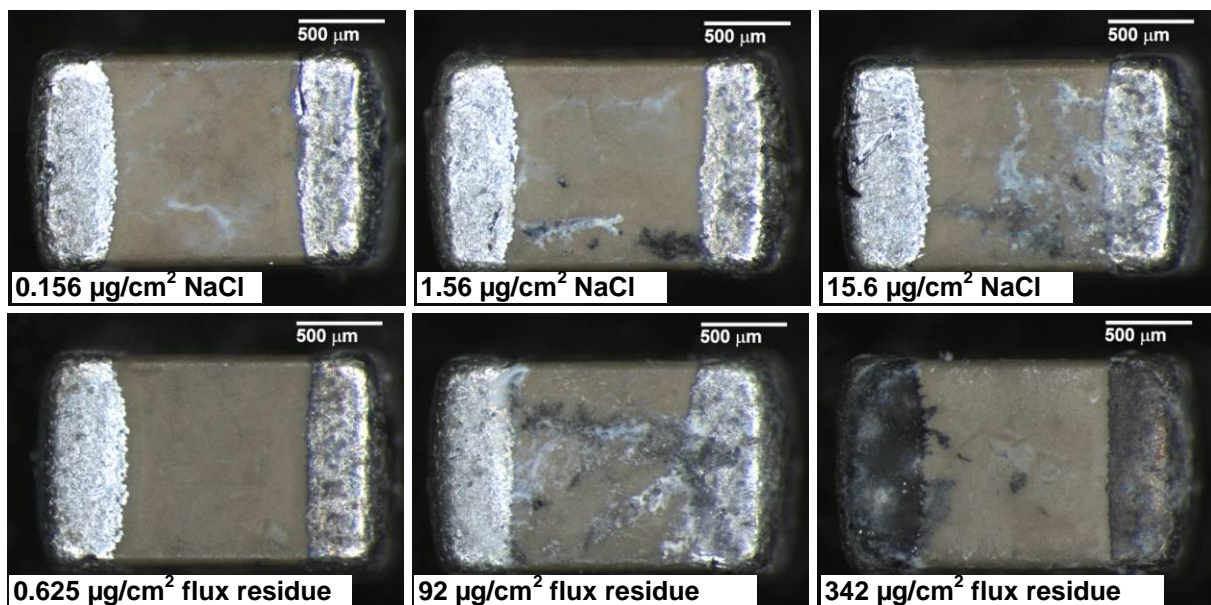
**Figure 5** shows the morphology of the dendrite after migration for NaCl and flux residue as a function of concentration. For NaCl, the probability of dendrite growth increases rapidly above a concentration of  $0.858 \mu\text{g}/\text{cm}^2$ . Below this level, the migration probability is low, probably due to the low dissolution of tin. Typical surface morphology of a component at  $0.156 \mu\text{g}/\text{cm}^2$  of NaCl shows very few corrosion products (appearing white in the image). However as the concentration of chloride increases, dendrites start appearing, and at very high concentration levels a mixture of dendrites and white precipitate species can be seen. At high chloride levels, the probability of ECM is also slightly reduced due to the large amounts of tin ions in the solution which leads to heavy precipitation, reducing the chance for dendrite growth as reported by Minzari et al. [13]. The precipitated species can be hydroxides of tin namely  $\text{Sn}(\text{OH})_4$  and/or  $\text{Sn}(\text{OH})_2$ , although intermediate hydroxyl chloride species are also possible [14].

**Figure 5:** Size 0805 capacitors after SCECM testing at 5 V DC; pictures corresponding to NaCl and solder flux residues are shown in the images. Anode terminal is on the right and cathode on the left side

Typical optical micrographs of the tested components with flux residue (**Figure 5**) shows that the level of corrosion is negligible at lower concentrations; however, at  $92 \mu\text{g}/\text{cm}^2$ , the surface of the component shows a clear dendrite mixed with some hydroxides. The appearance of ECM at flux residue concentrations  $3.75 \mu\text{g}/\text{cm}^2 - 92 \mu\text{g}/\text{cm}^2$  is similar to the appearance of ECM observed with NaCl. Light optical microscope images revealed the dendrites (dark grey color) bridging the terminals and the tin hydroxides (white color).

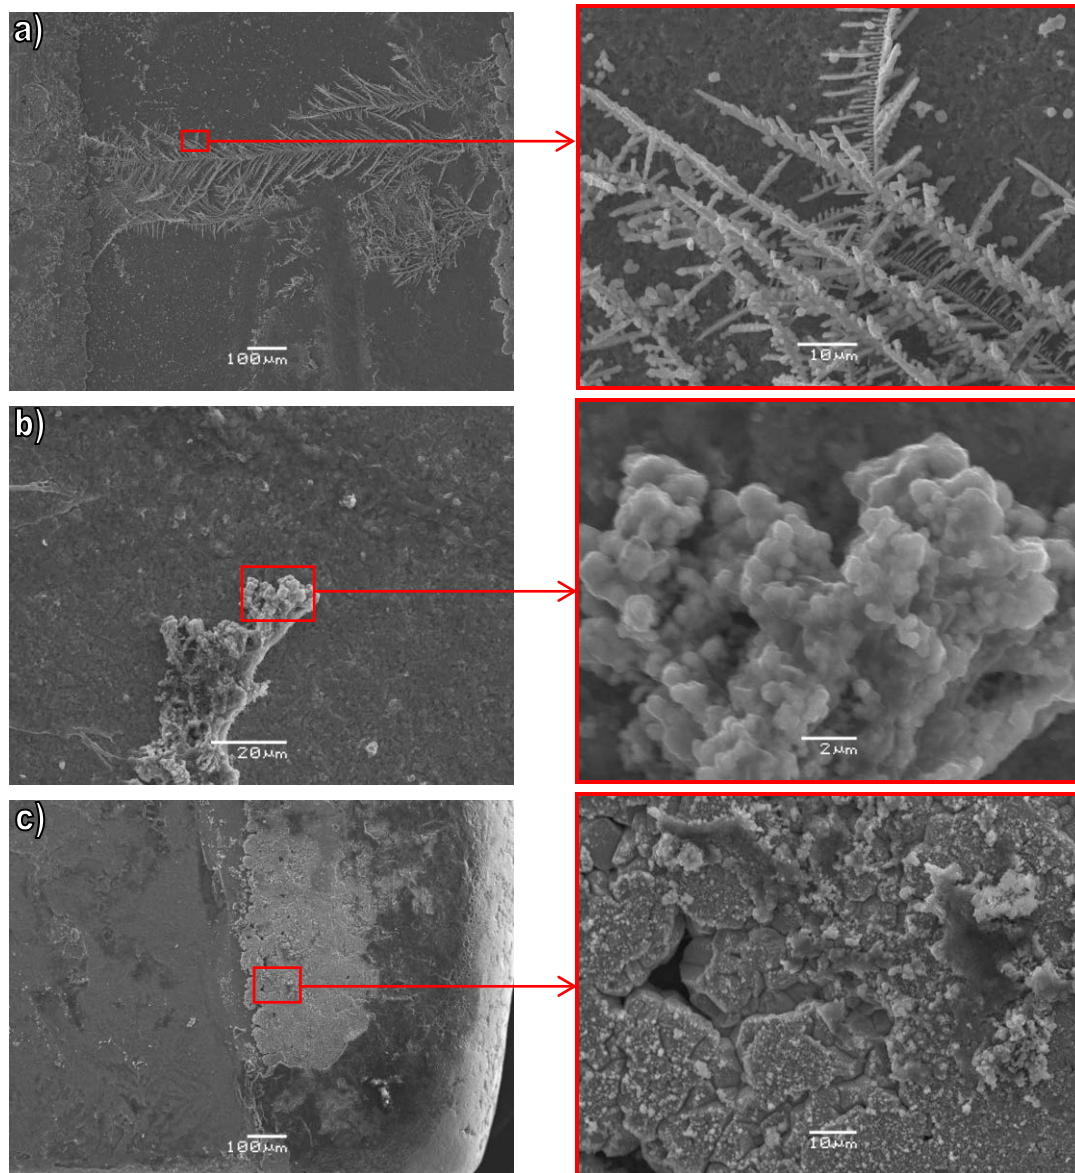
**Figure 6:** (a) – ECM on the size 0805 capacitors with  $92 \mu\text{g}/\text{cm}^2$  of flux residue; (b) – deposition of corrosion product (black deposits) nearby cathode terminal with  $342 \mu\text{g}/\text{cm}^2$  of flux residue and (c) – corrosion of anode terminal with  $342 \mu\text{g}/\text{cm}^2$  of flux residue

The EDS analysis of corrosion products on the anode terminal (**Figure 6 (c)**) indicated mainly tin (85 wt.%, however some amount of copper (10 wt.%) and small amount of chromium (less than 5 wt.%) were identified. Both elements are known to be used as termination materials for multilayer chip capacitors [17–19], and indicate a heavy dissolution of electroplated top layer of tin. The copper and chromium were mostly

identified on the very edges of the anode terminal, where the dissolution rate of metal is expected to be the highest.

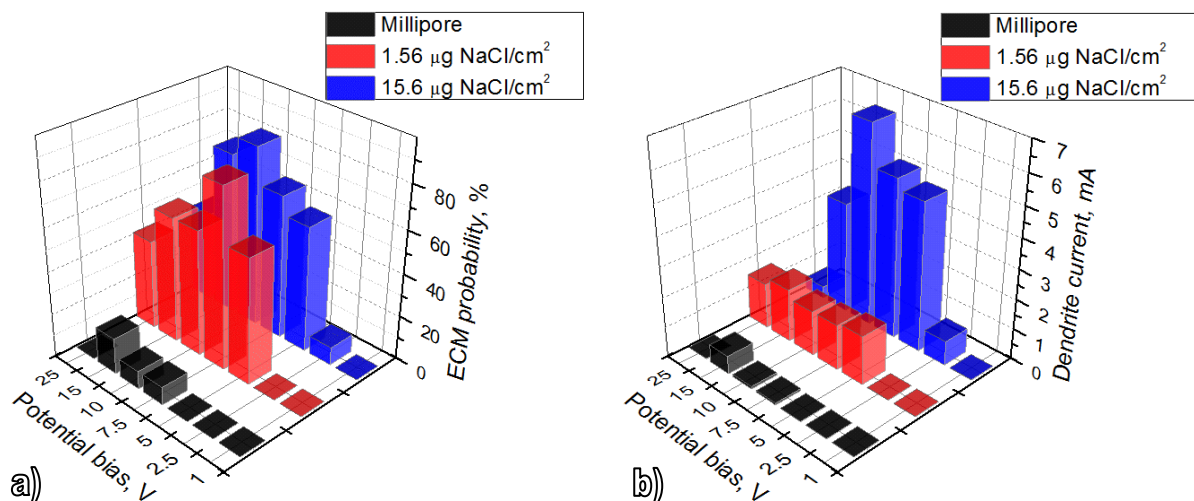
The effect of electric field in the range between  $1 \text{ mV}/\mu\text{m}$  and  $25 \text{ mV}/\mu\text{m}$  on ECM probability and dendrite current was investigated at contamination levels  $1.56 \mu\text{g}/\text{cm}^2$  and  $15.6 \mu\text{g}/\text{cm}^2$  concentrations of NaCl together with clean components. The graphs representing the results are shown in **Figure 7**. It is seen that the probability of migration initially increases with increasing electric field as the voltage applied on the terminals of capacitor until an intermediate voltage is reached, after which an increase in voltage causes a decrease in the probability of electrochemical migration. The electric field at which maximum probability of migration occurs is a function of NaCl concentration, however it was found to be in the neighborhood of  $10 \text{ mV}/\mu\text{m}$  –  $15 \text{ mV}/\mu\text{m}$  (respectively  $10 \text{ V}$  and  $15 \text{ V}$  potential bias). Also the probability of migration in general was low at lower potential bias values such as  $1 \text{ V}$  –  $2.5 \text{ V}$  above which the probability increases drastically in solutions containing NaCl, while the probability of migration in Millipore water remains low irrespective of the potential bias.

**Figure 7:** (a) – Comparison of the potential influence on ECM probability and (b) – dendrite current in terms of contamination

In general the probability of migration shows a bell curve with an increasing trend initially followed by a decreasing trend above the maximum, similar to the result found for increase in concentrations of contaminants. However, **Figure 7 (a)** shows

that the effect of contamination is more pronounced, especially from Millipore water to  $1.56 \mu\text{g}/\text{cm}^2$  chloride solutions. The dendrite current also shows a similar behavior except for a large increase of dendrite current at  $15.6 \mu\text{g}/\text{cm}^2$  conditions. This indicates the formation of thick dendrites, unlike in other cases. It shows that increased contamination increases the dissolution rate of the metal, which consequently forms thicker and more branched dendrites containing more metal and hydroxide precipitation. The high amount of metal content in the dendrites increases the current leaking through. However, as the potential increases, the probability of migration decreases, which also correlates with a decrease in the dendrite current. This is due to the fact that the rate of dissolution of tin increases with an increase in potential bias similar to increase in contamination. This leads to precipitation of the hydroxide species, while the heavy gas evolution at the anode and cathode also inhibit the formation of dendrites. Minzari et al. [11] have reported similar phenomenon with increase in potential bias or contamination level.

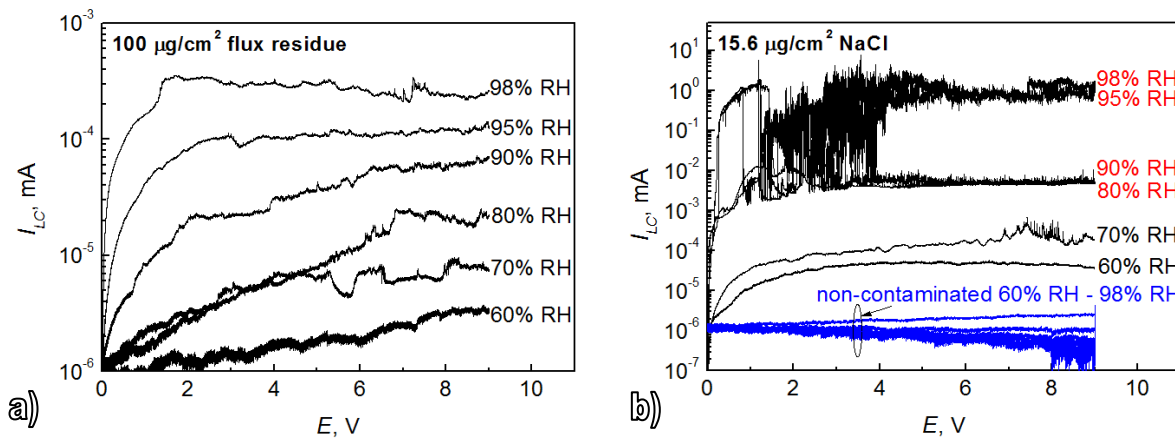
measured in the range from 0 V to 9 V with a sweep rate of 2 mV/s. The measured voltammetry curves as a function of RH are presented in **Figure 8**. The temperature during the experiment was kept constant at 25°C.

**Figure 8:** Leakage current as a function of applied potential and relative humidity: (a) – solder flux residue and (b) – NaCl and non-contaminated surface

The presence of flux residues (Cobar 390-RX-HT) is less effective in generating leakage current at all humidity levels compared to NaCl. With the increase of relative humidity from 60% to 98%, the leak current measured on the SIR comb pattern pre-contaminated with the flux residues has increased somewhat more than two orders of magnitude and no ECM initiation has been observed after the testing. Whereas in case on NaCl a more than four orders of magnitude increase in leak current has been observed when the relative humidity exceeded 80 % value. The observation of considerable increase of leak current is assumed to be an indication of NaCl dissolution and water layer formation on the SIR pattern. According to Kohler theory and Pöschl study on sodium chloride interaction with water vapour, the hygroscopic properties of NaCl enables adsorption of water molecules at RH around 75% [22]. The optical inspection of SIR comb pattern after the experiment revealed dendrite growth between the adjacent conductive lines. The increase of leakage current with increase of RH from 60% to 98%, measured on the non-contaminated SIR pattern was in scale of nA and negligible, indicating an importance of PCBA cleanliness for climatic reliability of electronics.

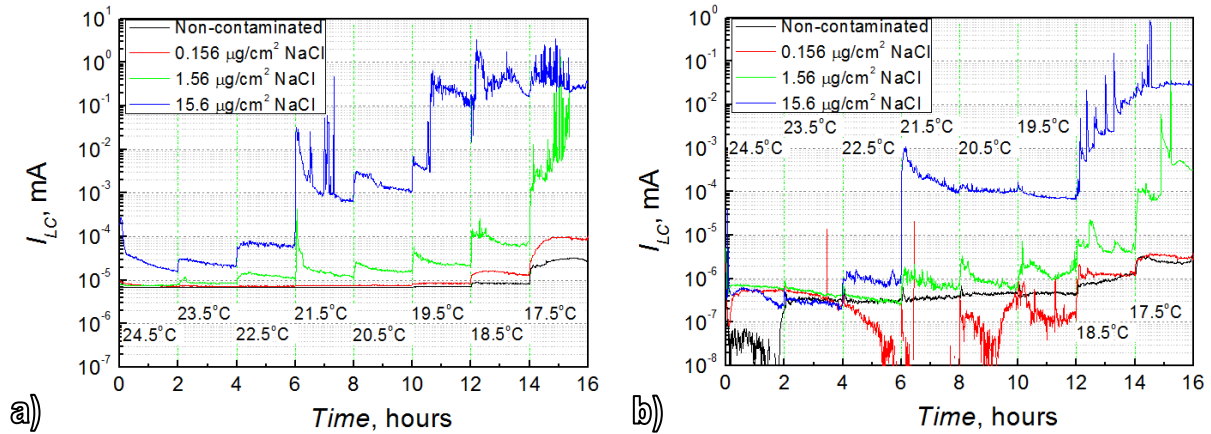
The effect of temperature difference between the PCB surface and surrounding air on the water condensation and leak current was studied on 10 surface mount ceramic chip capacitors connected in parallel and the SIR comb pattern biased at 5 V DC. The temperature of surrounding air has been kept constant at 25 °C. The leak current curves presented in **Figure 9** indicate the increase of current with increased difference in temperature of surrounding air and the surface of the PCB. The temperatures listed on the graphs are the average values of temperatures obtained with two RTD sensors places on the surface of the test PCB.

**Figure 9:** Leakage current measured on test PCB biased at 5 V DC (a) – SIR comb pattern and (b) – 10 ceramic chip capacitors size 0805 connected in parallel

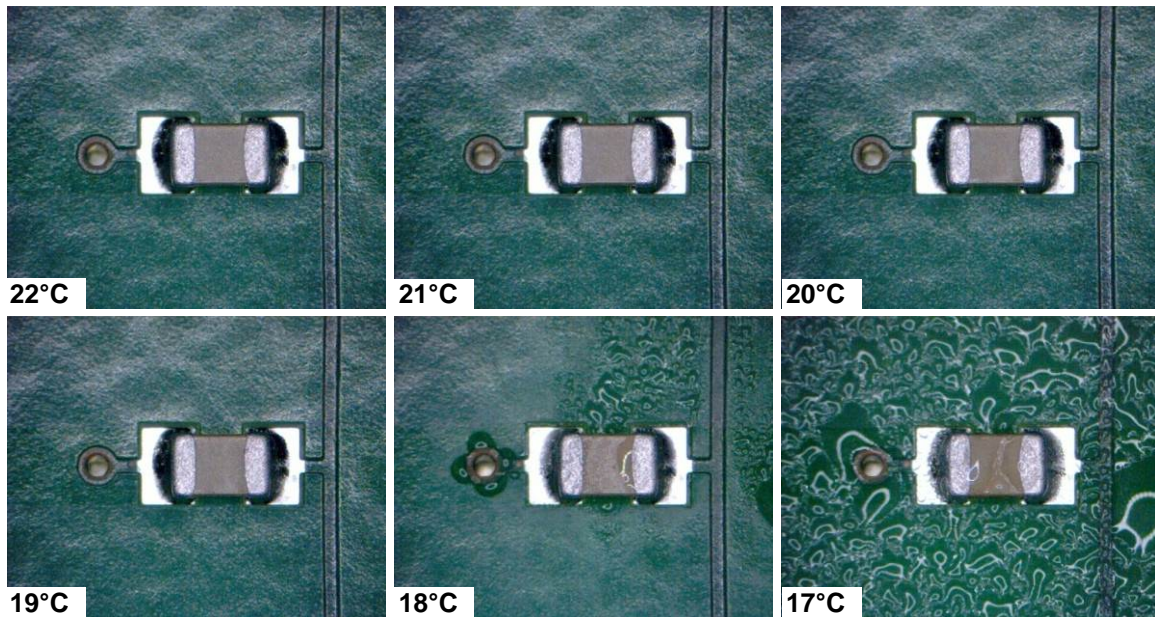
The effect of temperature difference on the condensation is presented in **Figure 10**. The expected error of temperature reading is 1°C. According to the leakage current measurements, the formation of thin water layer starts at 21.5°C, though it is not apparent from the captured images. A further decrease of temperature of the PCB increases the water build up on the surface, which is reflected in the leakage current versus time graphs. The condensation becomes clearly apparent when the temperature on the surface of PCB reaches 18°C.

**Figure 10:** Water condensation on size 0805 chip capacitors pre-contaminated with 15.6 µg/cm<sup>2</sup> of NaCl
