Design and test of box girder for a large wind turbine blade

Department of
Wind Energy
Report 2012

DTU Wind Energy E-0010 (EN); ISBN 978-87-92896-16-2

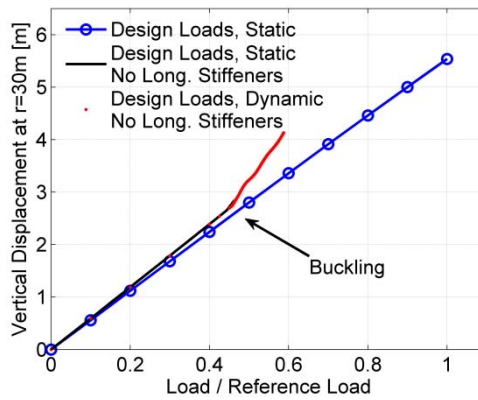
Figure 23 compares the standard model to a model configuration without longitudinal or transverse stiffeners (design load case). It can be observed that the suction side cap buckles at approximately 46% load – see also Figure 31. That is, the presence of the longitudinal stiffener increases the buckling load of the cap by more than a factor two.

Figure 23: Vertical displacement at $r=30m$; Design load case
Comparison to configuration without longitudinal or transverse stiffeners.

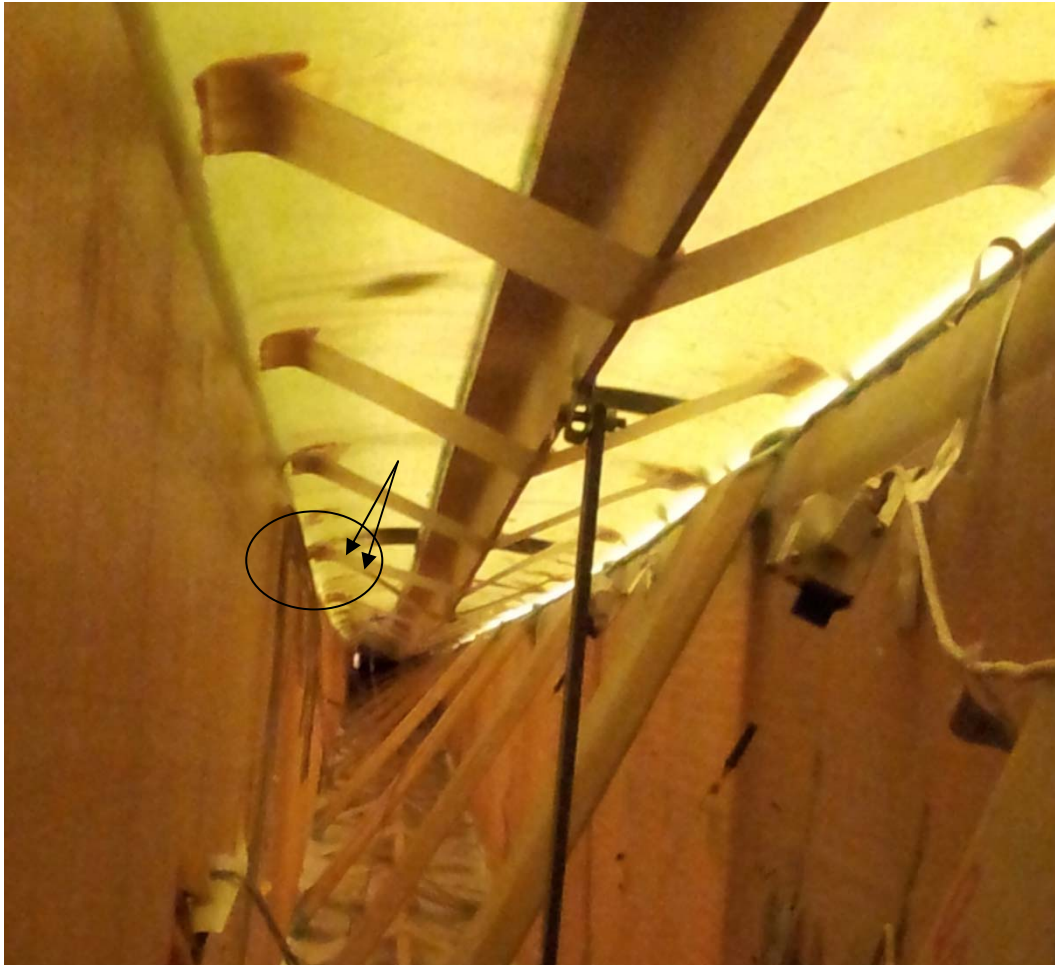
Figure 68 Photo inside the box after the test DMT_2012_05_31_A. the photo is taken inside the box, as it is difficult to get close to where the damage occurred. But examining it closely at the circle, one of the two transverse stiffener has debonded.

After the test the box was visual inspected inside, and it was revealed that at least one of the transverse stiffeners around 16,5m has debonded. The T-stiffener (Upper cap) has debonded in this area as well.

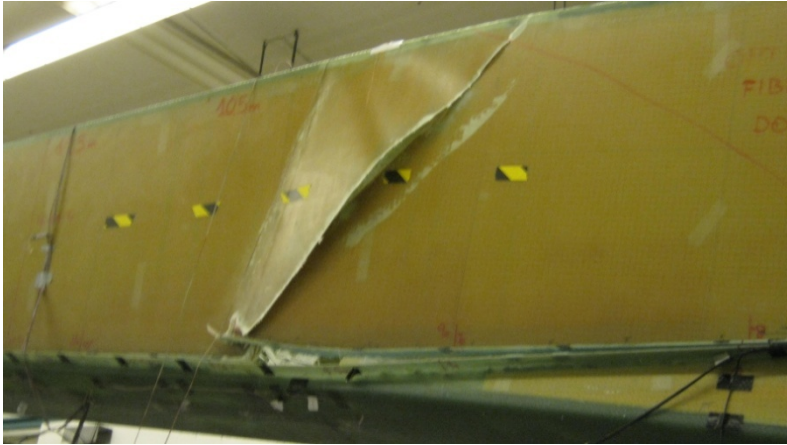
The webs were damaged at several places see Figure 82

Figure 82 Photos showing damage on the web at around 10m section

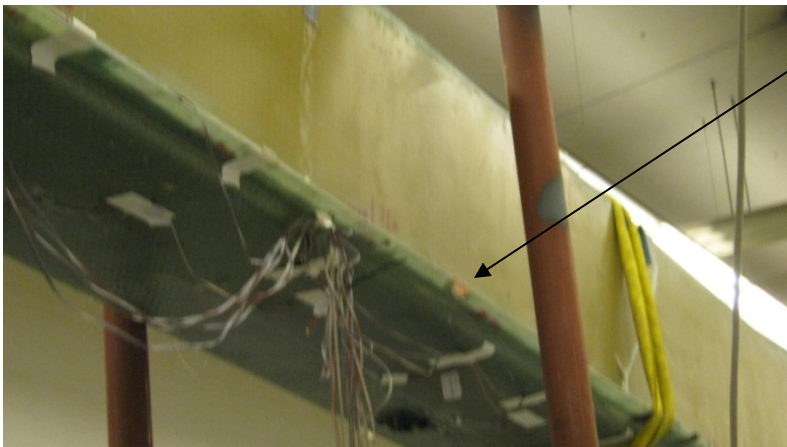
The steel support (read steel pipes) of the blade has been hit. Figure 83 shows how the steel pipe has damaged the connection between the cap and the web, and Figure 84 shows how the wooden construction placed between the blade and the pipes was been damaged.

Figure 83 Steel pipe supporting the blade. There is a damage in the connection between the web and the cap

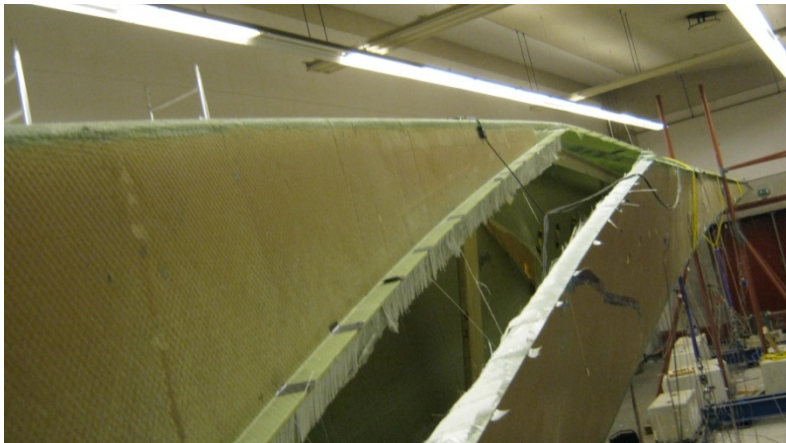
The adhesive joint on both side of the blade was damaged. Near the root, it was damaged towards the upper cap, and near the tip towards the lower cap, see Figure 85 and Figure 86

Figure 85 Damage of the adhesive bond near the root
