## **MECHANICAL EVOLUTION OF THE ROTATING BIOLOGICAL CONTACTOR INTO THE 21<sup>ST</sup> CENTURY**

**Abstract:-** This paper presents a review on the evolution of the mechanical design of Rotating Biological Contactors (RBC) within the United Kingdom. The findings documented have been taken from the biggest mechanical survey on RBCs ever undertaken worldwide and focuses on 300 operational units. The paper looks at the main components of the RBC and discusses the evolution of each member. Mechanical deficiencies associated with each design are briefly presented, giving an insight into reasons for improvements. This is the only known document that details changes in design philosophy employed over the last 30 years, with illustrative examples.

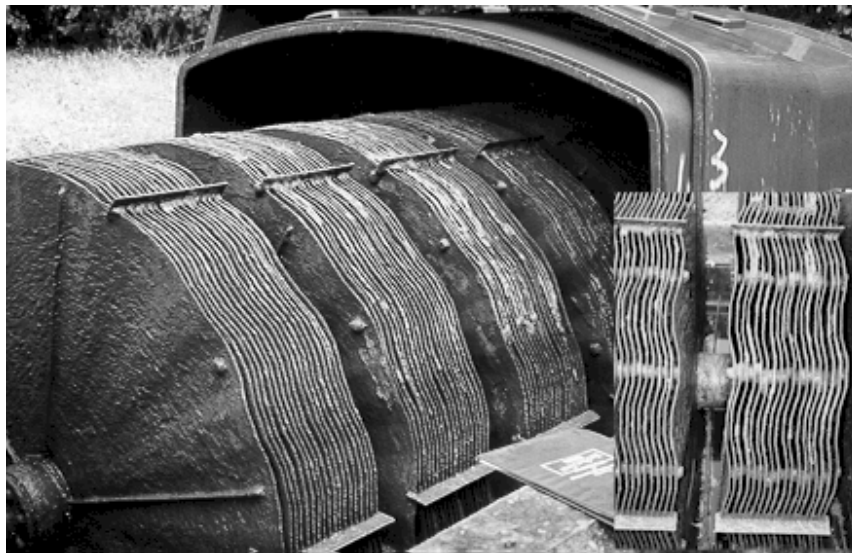
**Figure 3      Straight GRP media panels: Layout**

The earliest RBC units in the United Kingdom employed flat Glass Reinforced Polymer (GRP) circular disc panels, see figure 3. The design arrangement consisted of a GRP lay-up on the main shaft, thereby allowing the media panels to be cemented directly onto the shaft. Furthermore, adjacent panels were separated by plastic circular pieces placed on axial through-rods or stud, thereby fixing the distance between individual media panels, insert figure 3. The through rods run along the length of the media pack.

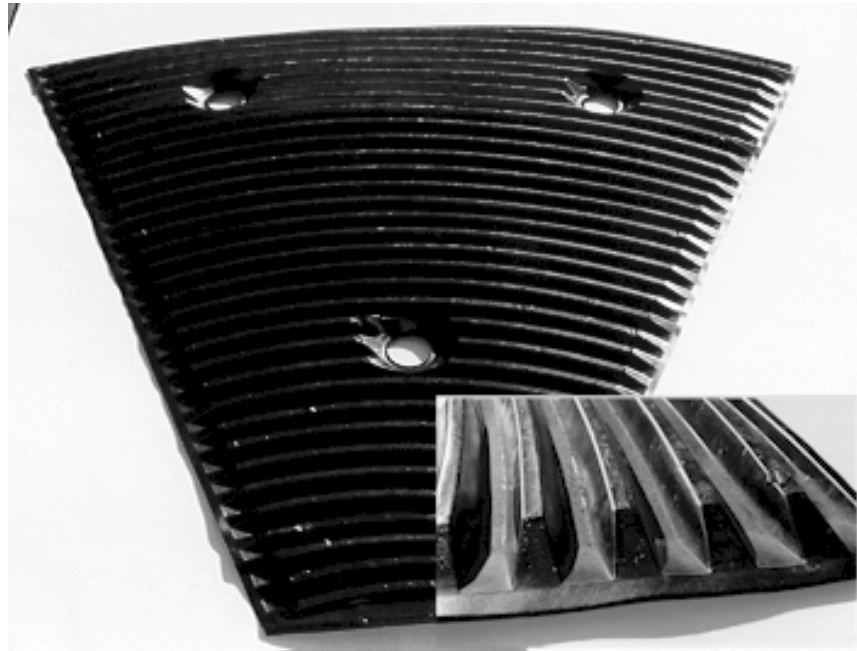
**Figure 19 Polymer media panel, type 3: Layout**

These new designs originated in the late 1970's and were of distinct segmented arrangement. This had the advantage of ensuring a faster and more economical manufacturing process. The drawback with polymer panels in respect to GRP panels is that they cannot be cemented directly onto the main shaft; consequently they require a supporting structure. Separation of adjacent panels is achieved by placing adjacent corrugations at 90 degrees to each other, see figure 20. Furthermore, the media panels were supported by through rods that ran along the length of the pack. These were passed through circular cutout sections in the media panels and generally three to four through rods are used to support each segment.

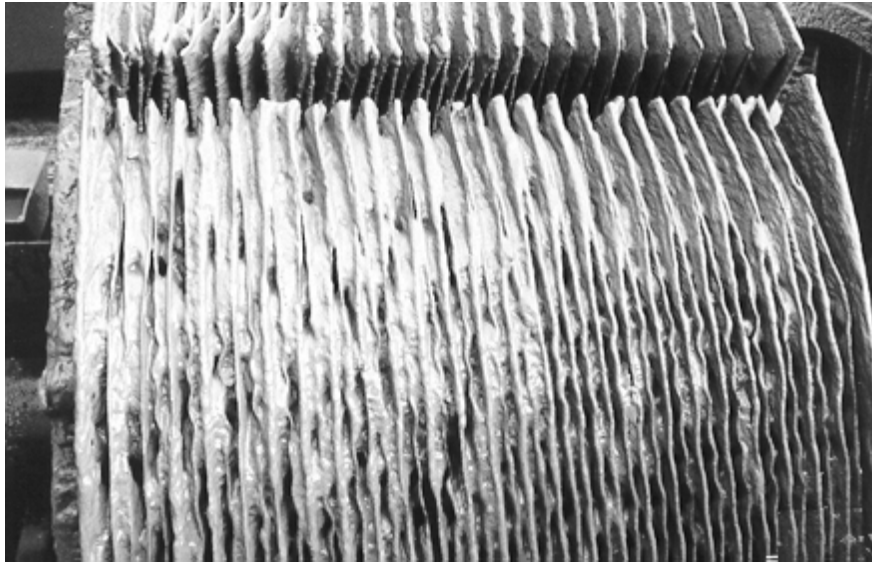
**Figure 27** Biomass bridging of High density polypropylene media panels

Similar to the GRP panels, bridging on polymer media panel is very evidently and the authors are unaware of any attempts to overcome this problem in the design of RBC's, see figures 27.

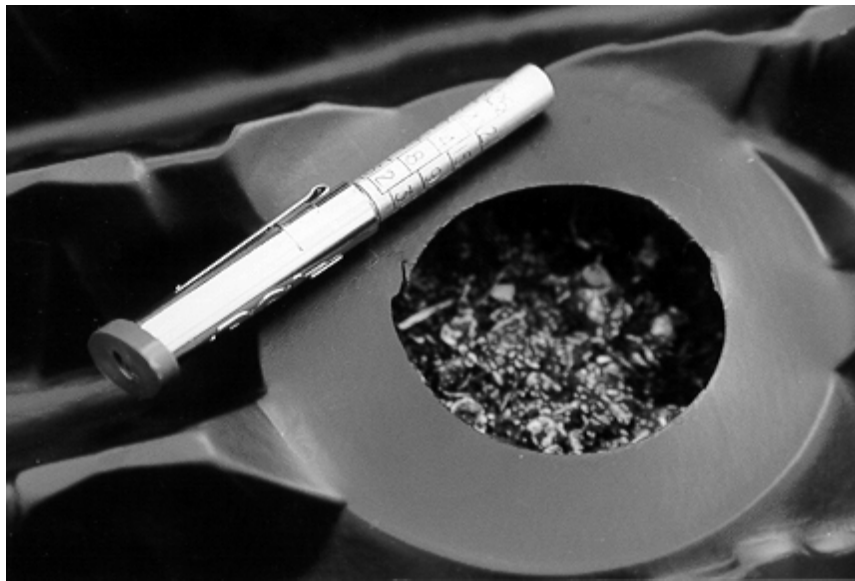
**Figure 28** Tearing of media panel in the vicinity of the through rod

The most common media designs employ high density polypropylene materials. The various design configurations employing this material have common mechanical deficiencies, particularly strength and rigidity. Tearing of panels generally occurs in the region through which the support rods pass, see figure 28. The reason is attributed to inadequate strength of the hole/ring circumference and poor quality finishes in cutting/manufacture these holes. The jagged edges give rise to stress concentrations, which eventually lead to crack growth and tearing in this vicinity. Current designs have improved the strength in this particular region and more stringent finishing requirements are in place, see figure 29.

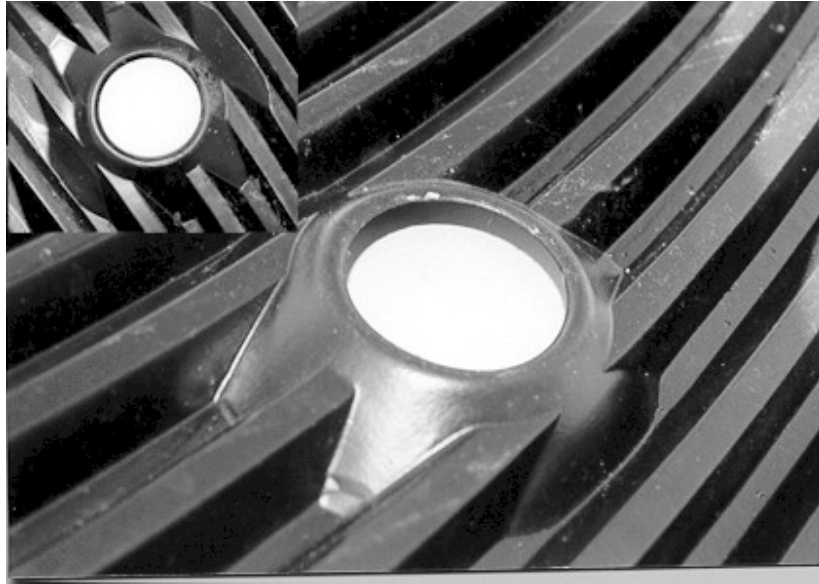
**Figure 29** Improved strength of hole in media panel

Following a mechanical design audit on RBC's [4] it was noted that the thickness of high-density polypropylene media panels employed (0.5mm) was insufficient to avoid tearing, improve operational life and to retain rigidity. Whilst an increased thickness is currently employed, 0.9mm, it has meant that capital costs have increased whilst whole life costs have reduced.

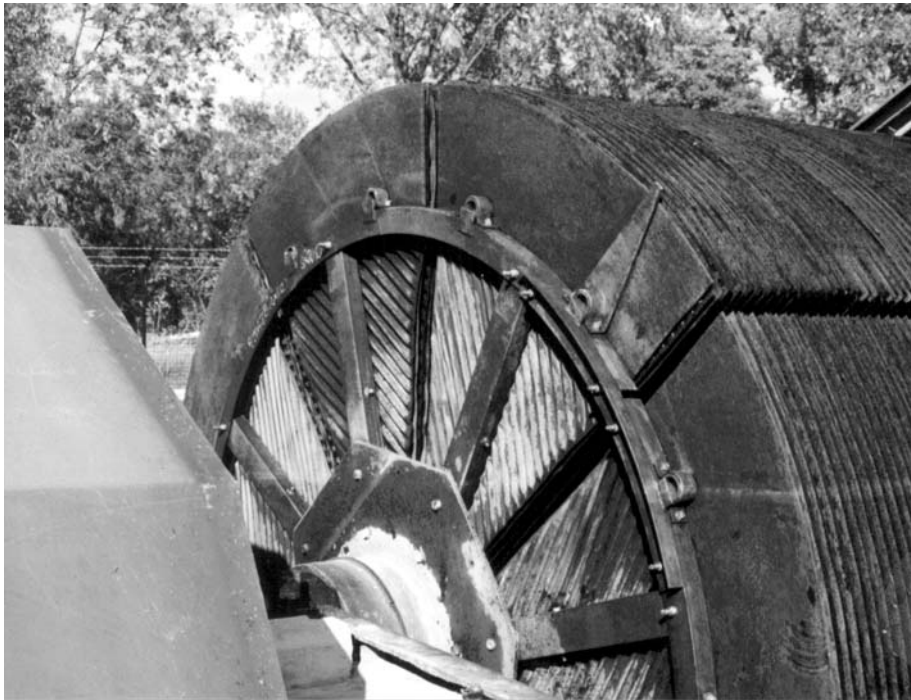
**Figure 30** Design to overcome loss of rigidity

The problem of rigidity, particularly on the end media panels was initially addressed by cementing the first five media panels together. Whilst this increased the rigidity, problems of this nature were still observed. More recently, particularly on the larger RBC units, supports have been designed to maintaining rigidity, see figure 30. Furthermore, to overcome crumbling of the end panels, a thick polypropylene panel, in the order of 5mm, has replaced the end media panel, see figure 31. In this particular instance, the design also overcomes loss of rigidity.

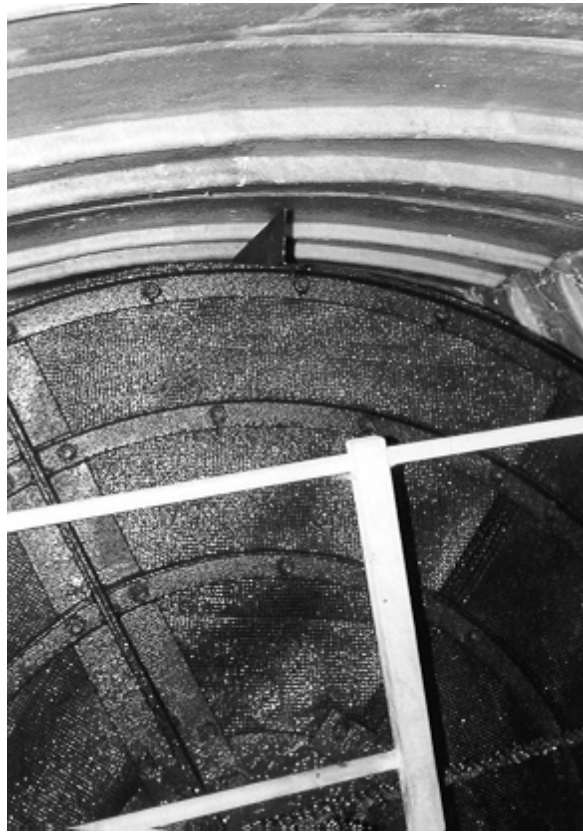
**Figure 34** Design arrangement of oldest known operational unit in the UK

Different RBC support structure designs have evolved over the last 30 years with the aim of producing a functional system at low capital cost. The earliest known RBC unit still operational to date is illustrated in figure 34. The media panels on this unit were of 'wire mesh configuration' (see figure 4) and held in position by longitudinal steel through rods which run along the length of the media pack. The through rods are in turn supported by a frame consisting of coated steel angles and plates. The steel angle sections are joined to form radial arms which are in turn bolted onto a plate that is welded to the shaft, see bottom left of figure 35. The through rod ends are bolted onto a circumferential angle rim, see bottom right of figure 35. Each media pack employed three circumferential rims. A steel angle ran along the length of the extreme outer diameter of each media pack and was held by opposite circumferential rims; this is illustrated in the top right corner of figure 35. The steel angle restricts media panel movement and provides extra structural support. To date this design is still operational with no reported faults, though it must be stated that assembly of such a unit will be laborious and expensive due to its intricate construction.

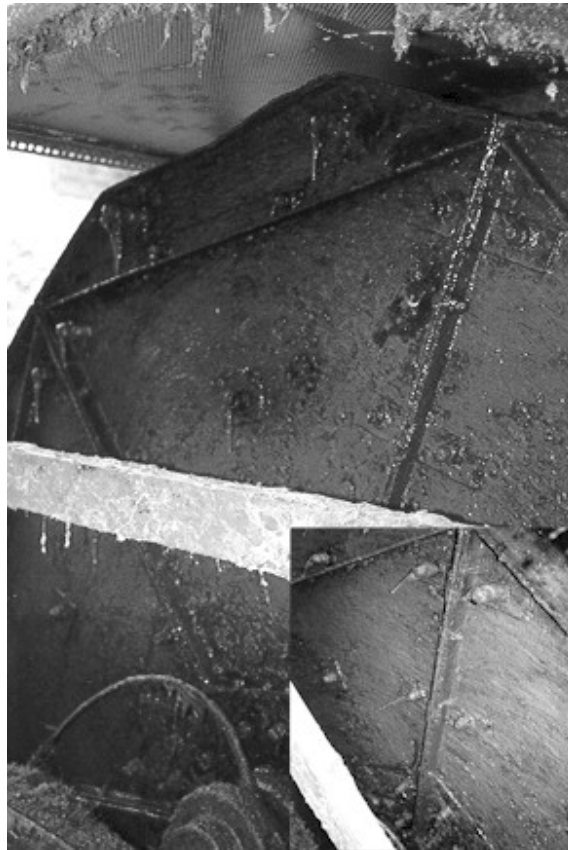
**Figure 36** RBC unit with segmented steel plate support frame design arrangement

Another design configuration employed for supporting ‘wire mesh type’ media panels is shown in figure 36. The support structure consisted of segmented steel plates bents at its extreme periphery. Adjacent segments were bolted together. The distal ends of the media supporting through rods were bolted to the steel frame. The through rods extend along the full length of each media pack and provided support for the media panels. A total of five through rods are employed per segment. The cost of manufacture of this design is considerably less than that detailed earlier. These are the only two designs known to the author employed for supporting the particular media configuration.

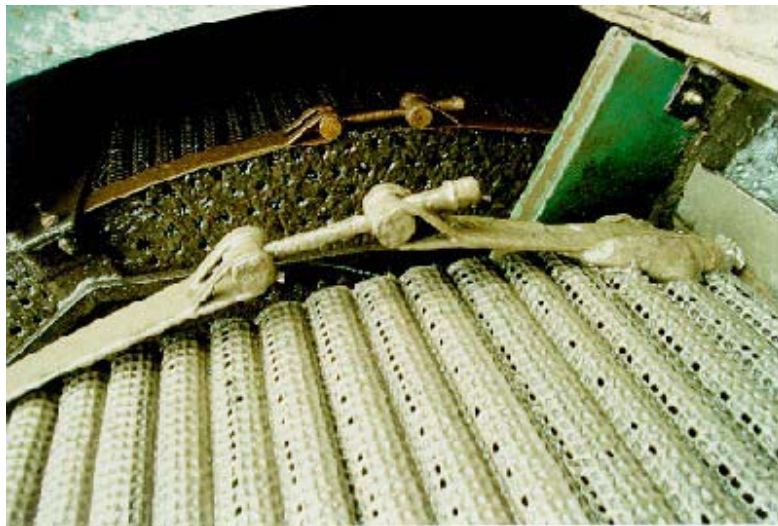
**Figure 38** Loose outer circumferential strap

A draw back with this particular design is that the circumferential straps, used to located the media coils can become loose, see figure 38. With the passage of time and under heavy biomass growth, creep of the circular coils results in compression of the media sections. Consequently, the entire media section loses its rigidity and initial size, and the circumferential straps become ineffective in positioning the media sections. The amount by which the media sections can creep is illustrated in figure 39. Furthermore, the flow of sewage liquor through the media sections affected by creep becomes impeded, consequently, the affected media pack carries excessive liquor during its rotation. A direct result of loose straps is media movement, which in turn results in additional impact forces on the support structure causing acceleration forces to be reacted back to the gear drive unit. These reactive forces have caused the foundation bolts, securing the drive unit to the foundation, to work loose. Figure 40 illustrates the consequence of such a mechanism.

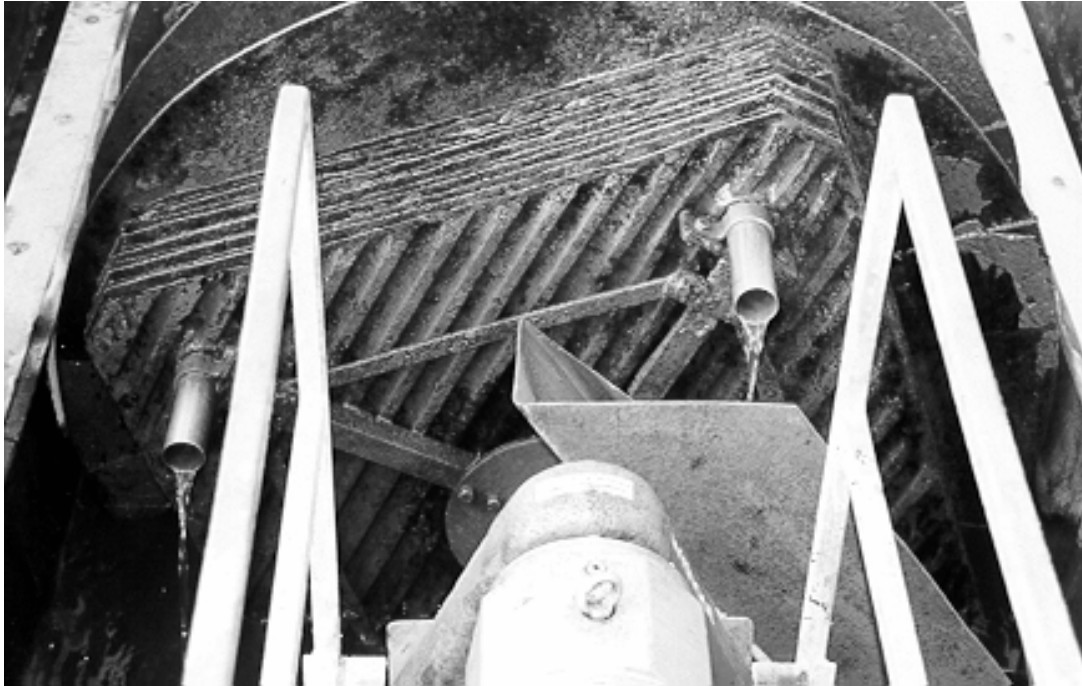
**Figure 43** Design arrangement of RBC unit

The unit illustrated in figure 43 is restricted to RBC sizes with diameters of less than 1.5meters. This design arrangement consisted of black high-density polypropylene media panels held in position by longitudinal through rods, which were in turn supported by a steel support frame.

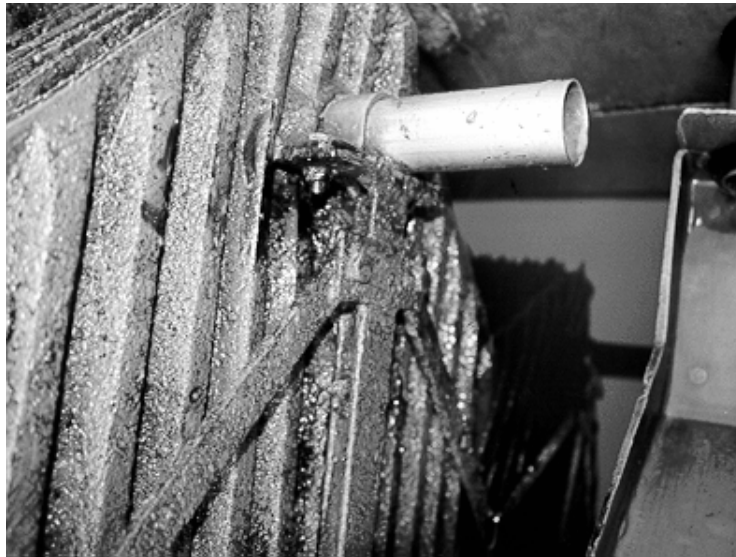
**Figure 44** 'U' shaped straps clamping the media support through rods to the support frame

In total, four longitudinal through rods supported each media pack. ‘U’ shaped straps clamped the longitudinal through rods onto a flat steel plate, which was in turn welded to an angle steel radial arm, see figure 44. Additional structural support was provided by a flat bar that was bolted to adjacent radial arms, illustrated in figures 43 and 44.

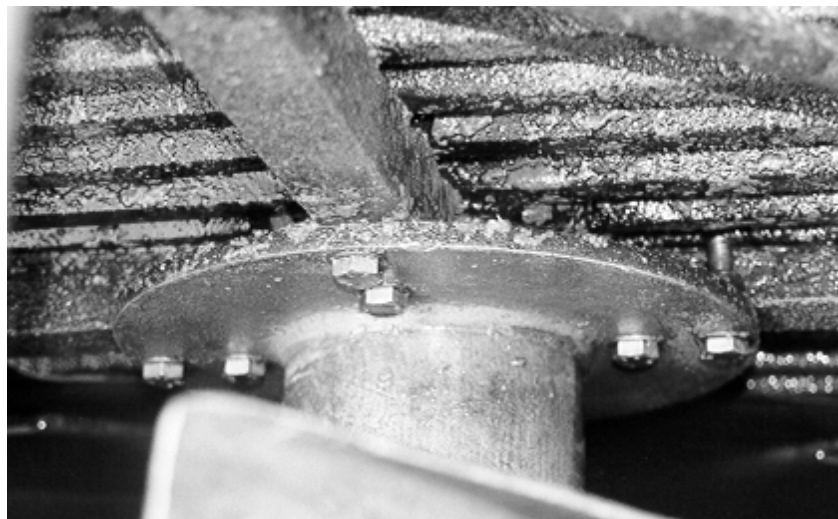
**Figure 45** Welded shaft plate

The radial angle structure was clamped to a shaft plate. Two designs of shaft plates were employed, the first was welded directly to the shaft, see figure 45, whilst the second was a clamp mechanism that was bolted into position, see figure 46.

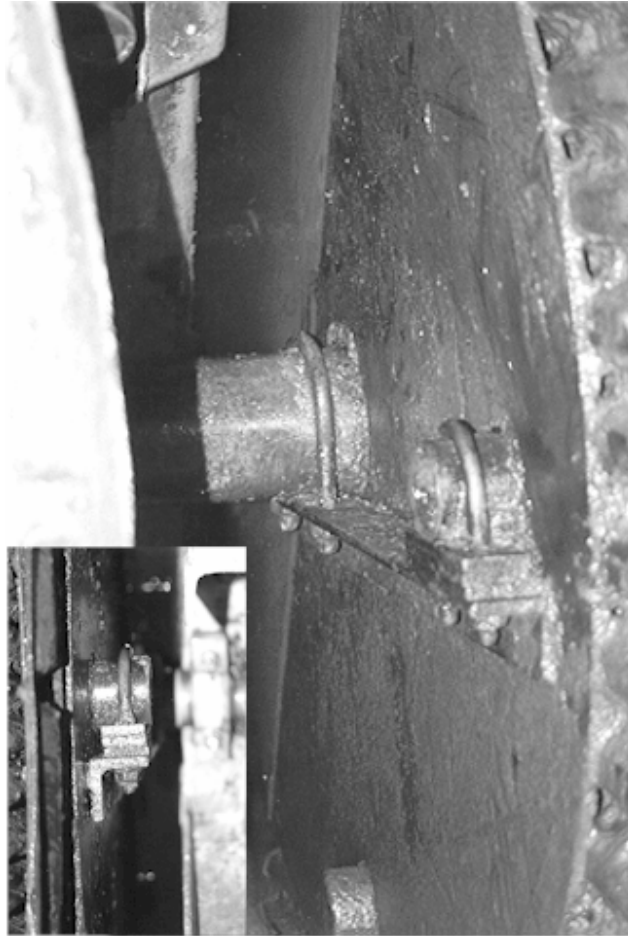
**Figure 49** Media pack support structure and clamping arrangement

Similar to the previous design each media pack was supported by a total of four longitudinal through rods. Two of the through rods were clamped onto an angle structure, which was in turned clamped to the main hollow shaft, see figure 49. The other rods were not supported and simply rested on the media panels.

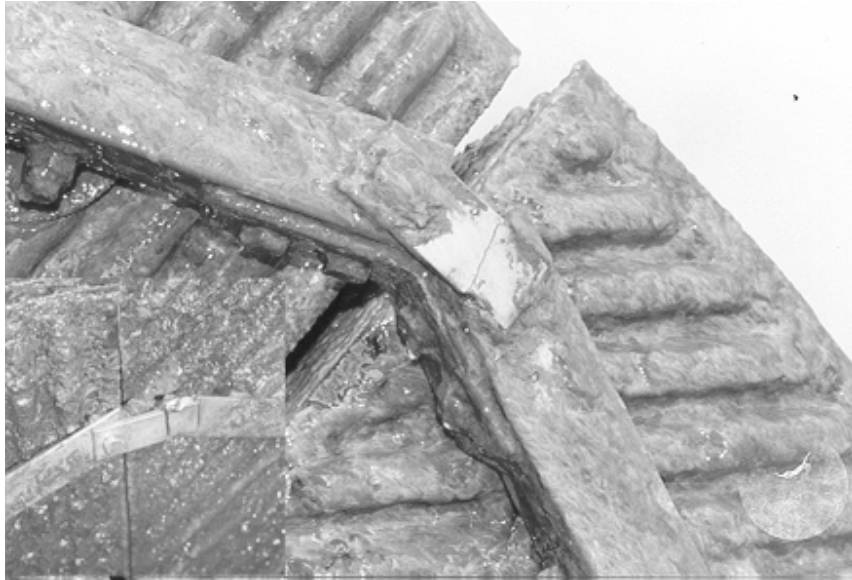
**Figure 58** Fracture support structure; Insert shows fracture at different rotational position.

Furthermore, a number of these RBC designs have suffered from support frame failure. It is perhaps interesting to note that this design employs structural steelwork having the lowest cross-sectional dimensions compared with other similar size RBC examined. Whilst it could be argued that this design offer low capital costs they hide the high whole life cost. In addition, due to the low fatigue limits of a lighter frame, fatigue fracture is common, see figures 58 and 59.

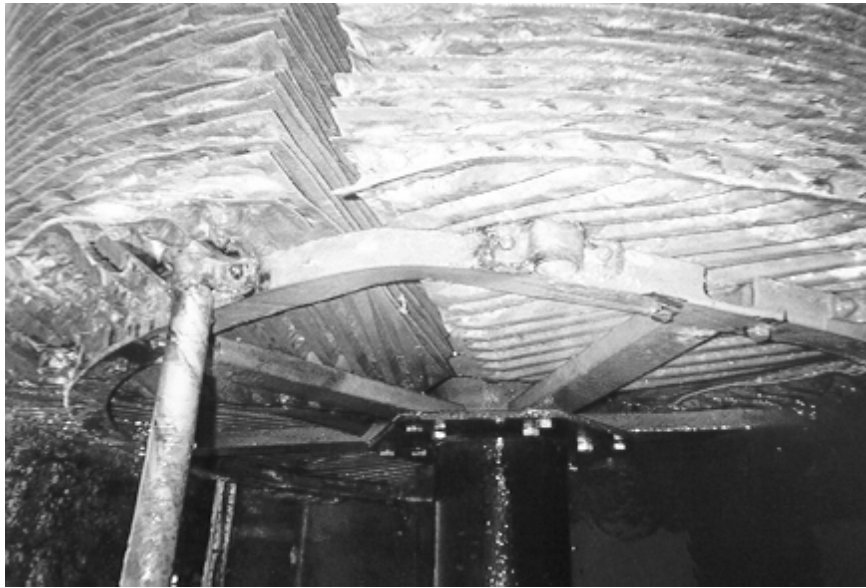
**Figure 67** Bend support structure

Whilst earlier designs did not restrict axial movement of the outer through rods, see figure 67, this has been overcome by welding end plates onto the circumferential angle rim, see figure 60, 61 and 68. Figure 67 shows axial movement of an outer through rod and bending of the circumferential rim. The latter is a direct consequence of the large bending moments the structure is subject to.

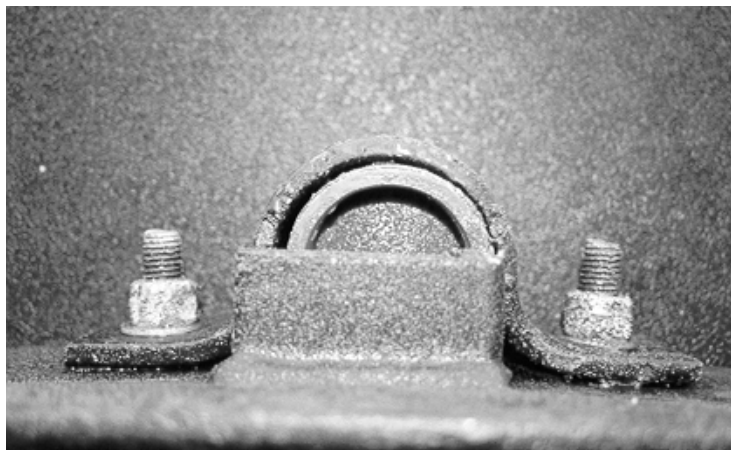
**Figure 68** Inadequate clamping of through rods plus axial end stop

In addition due to the inadequate clamping efficiency of the ‘U’ strap the outer through rod has been known to rotate within its strap and cut into the support structure, see figure 68 and 69.

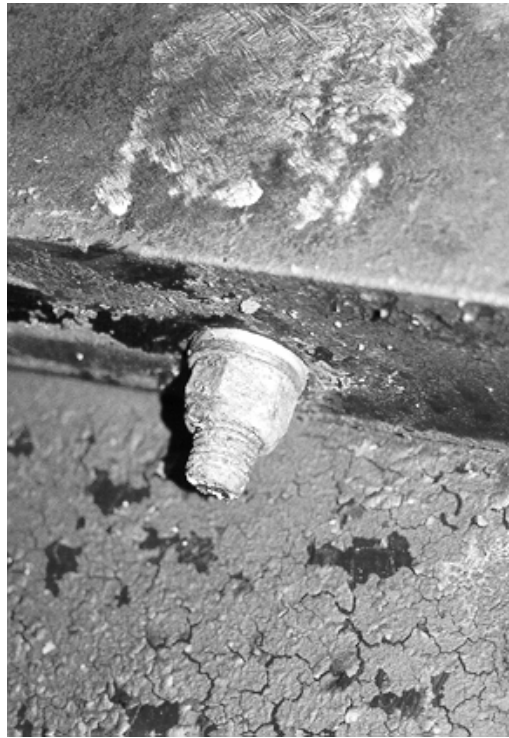
**Figure 70** Plastic washer

Of the designs already detailed it has been observed on numerous units that a mixture of materials were employed giving rise to galvanic corrosion. For instance whilst, the through rods employed were of stainless steel, the 'U' straps used to secure these through rods to the support structure were a mixture of stainless and galvanised steel. Furthermore, stainless steel bolts had been used to clamp components onto a steel structure. It must be noted that the main hollow shaft on RBC's detailed was always of mild steel. To assist in separation of stainless steel bolts from the steel structure plastic washers have been employed, see figure 70. Over the passage of time, these plastic washers will creep with the net result of loss of bolt tightening torque, see figure 71.

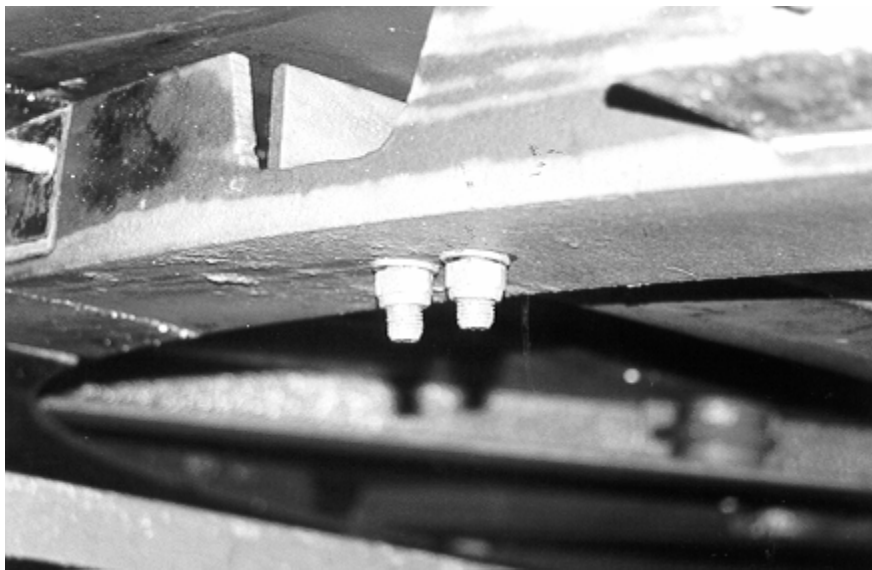
**Figure 71** Loss of bolt tightening torque due to plastic washer creep

This will result in movement of components creating additional impact forces on the structure.

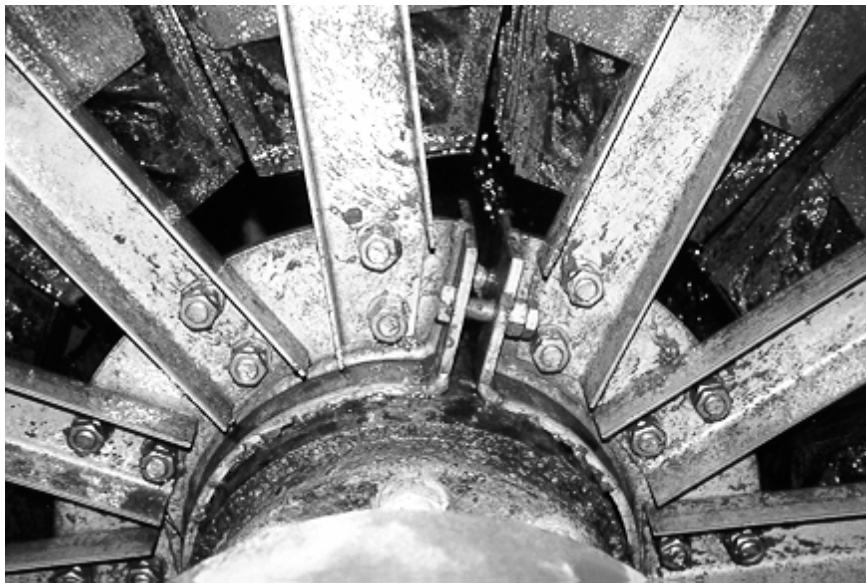
**Figure 75** Split hub arrangement

The spider is bolted to a shaft split hub and are mechanically locked by the use of lock nuts, see figure 75 for a typical arrangement. The types of positive locking employed include nylon lock nuts or double lock nuts, dependent on RBC unit, the latter can be seen in figure 76. The drawback with nylon lock nuts exposed to sewage liquor over a passage of time is that they have been known to work loose. Traditionally manufacturers employing double lock nuts (sometimes referred to as ‘Jam’ nuts) have placed the smaller nut on top of the bigger nut. Double lock nuts have the advantage of requiring minimum skill provided certain basic rules are applied. Historically the nuts are of different thickness, one standard nut and the other half the thickness of the standard nut. In assembly the thinner nut should be fastened first and the large nut fastened on top on the thinner nut [5].

The spider is bolted to a shaft split hub as with previous designs described earlier. Other features of this design are identical to those reported in figures 75, 76 and 77. The through rods are secured to the media pack support frame using a single bolt and locking is achieved by making use of a spring washer, however, on a number of RBC's this through rod securing bolt has become loose, see figure 81.

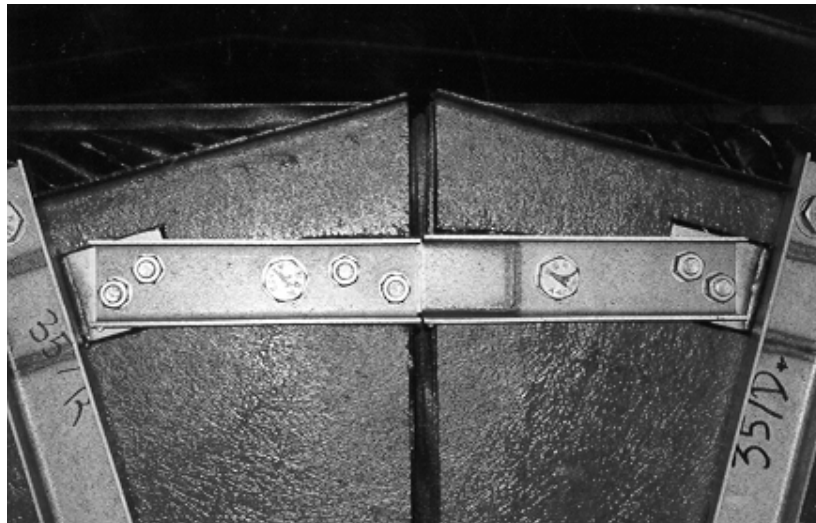
**Figure 77** Circumferential design arrangement

The distal end of the radial spider is secured to the outer circumferential rib via a weld cruciform plate onto which is bolted a further rolled channel using, figure 77 illustrates this technique.

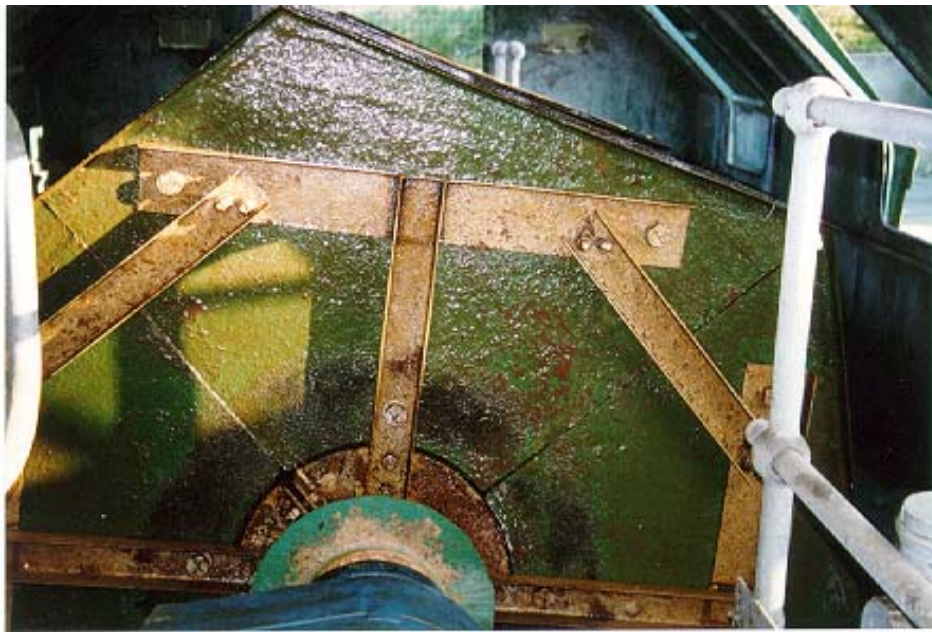
**Figure 78** Design arrangement of RBC

The design arrangement illustrated in figures 78 and 79 are restricted to RBC's with a diameter of 2.0m and employs four segments, each segment had a total of three through rods. Four radial steel channel spiders were employed which were welded at the distal end to steel angle sections. These were in turn bolted to steel channel sections acting as circumferential rims, see figure 79 (left). The spider is secured to a shaft split hub, as describer earlier (see figure 75) bolts which are mechanically locked by the use of lock nuts. The through rods are secured to the media pack support frame using a single bolt, locking is achieved by making use of a spring washer.

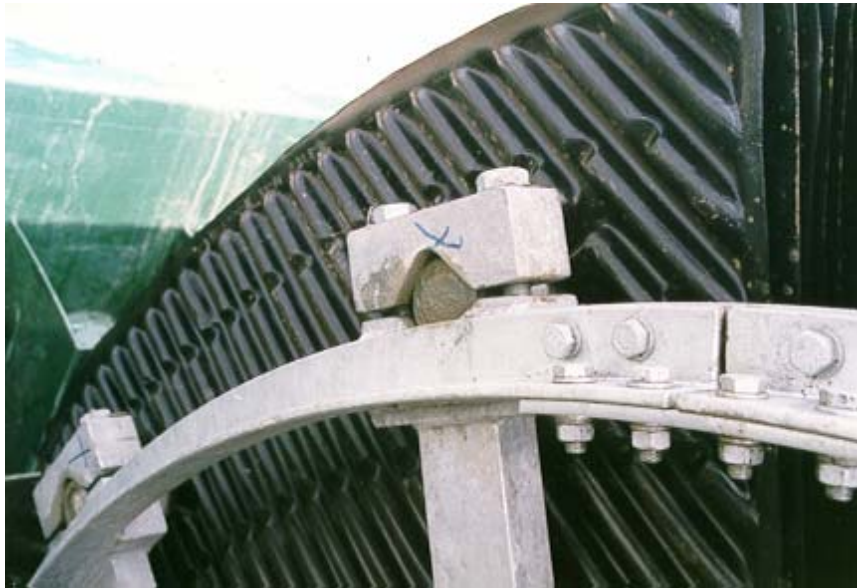
**Figure 82**                      **Four-point line contact ‘vee’ block**

A more palliative design solution is to allow small elastic distortions within the structure. Employing this design allows the through rods to be rigidly clamped to the structure, however flexing of the support structure results in lowering the reactional bending stresses thereby alleviating much of the stress intensity at the point of attachment. This strategy has resulted in a new method of clamping the through rods to the support structure as illustrated in figure 82.

This clamping arrangement is accomplished by bolting the top ‘V’ section onto the lower part. Specific tightening torques are calculated. This arrangement ensures contact between the clamp and the through rod.

Best practice relating to the design of through rod end clamps is governed by the design of the media pack support frame, moreover, most manufacturers acknowledge the loading pattern described above will give rise to bolt loosening. To combat loss of bolt tightening torque use is made of positive locking for both nuts and bolts, see figure 83. Initial difficulties of properly aligning tab washers have been overcome by pre-forming the washer on a jig thereby ensuring the “upturned” section always aligns with the flat of the nut or bolt. The design arrangement illustrated in figures 80 and 83 offers structural flexibility for this rigid method of securing the through rod to the supporting structure.

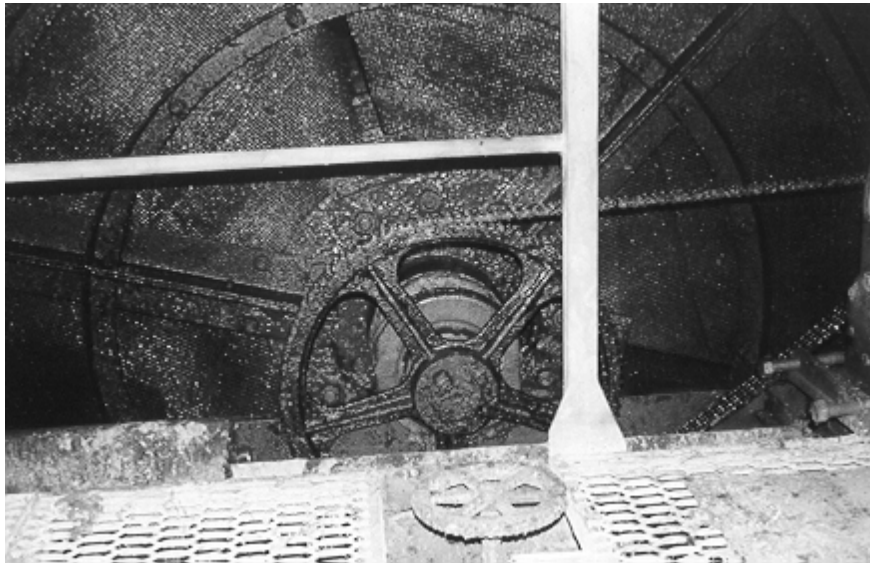
**Figure 85** Chain connection between motor and main RBC shaft

As RBC's operate at speeds of between 0.6 to 2 revolutions per minute, most power units require some form of speed reduction system. The earliest known RBC units employed chain connection for transmission of power to the RBC hollow shaft. Figure 85 illustrates this system on a unit of approximately 3 meters diameter, whilst figure 86 depicts the exact arrangement on a much smaller RBC (1.5meters diameter).

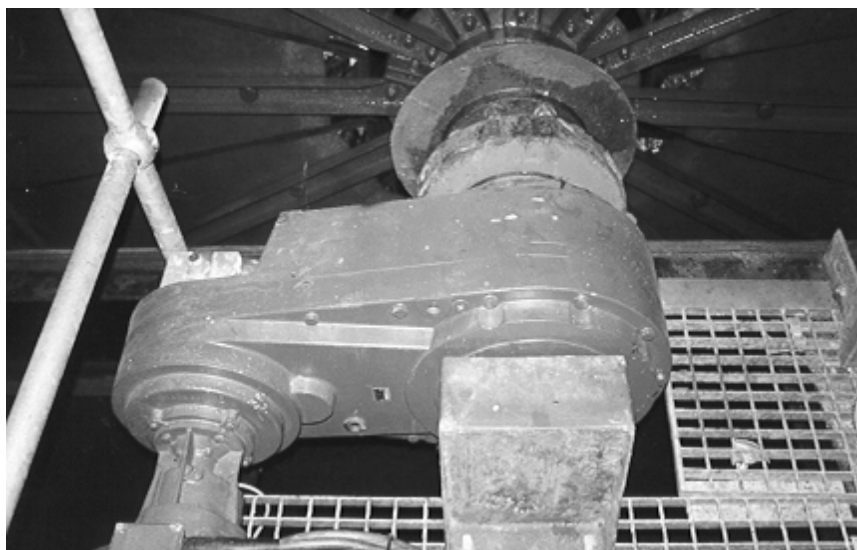
**Figure 93 Typical transmission unit employed on current RBC's**

The current designs today employ a much smoother power transmission systems, eliminating the problems of loose connections and wear on pinion/gear arrangements. Typical units employed today include power and speed reduction units supplied by ‘David Brown’, ‘Bauer’ (see figure 93) and ‘Brevini’, all of which are shaft mounted gear drives and produce successful transmission requirements.

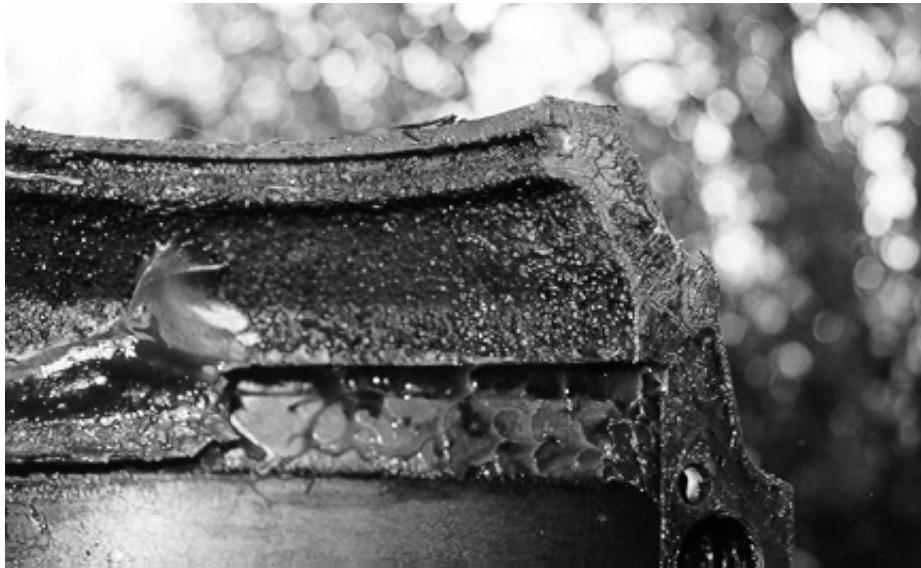
**Figure 97** Evidence of rust in a bearing housing

In addition, analysis of failed bearings has shown them to have adequate load carrying capabilities, but poor elastohydrodynamic film thickness. An adequate elastohydrodynamic film thickness is essential in maintaining an oil film between the components in the bearing. Furthermore, because of the slow rotational speed the centrifugal force generated within the bearing, to ensure circulation of the grease is greatly reduced in comparison to medium/high speed bearings. Therefore, even if grease was continually pumped into the bearing housing, there is no guarantee that the grease would reach the critical components, i.e., the raceway and rollers. This will inevitably lead to grease starvation of the most critical bearing components. The cause of premature bearing failure on the several RBC's is attributed to lack of lubrication, either as a result of an inadequate grade of grease, grease starvation or in some instances grease contamination. The latter has been observed on numerous RBC units, see figure 97.

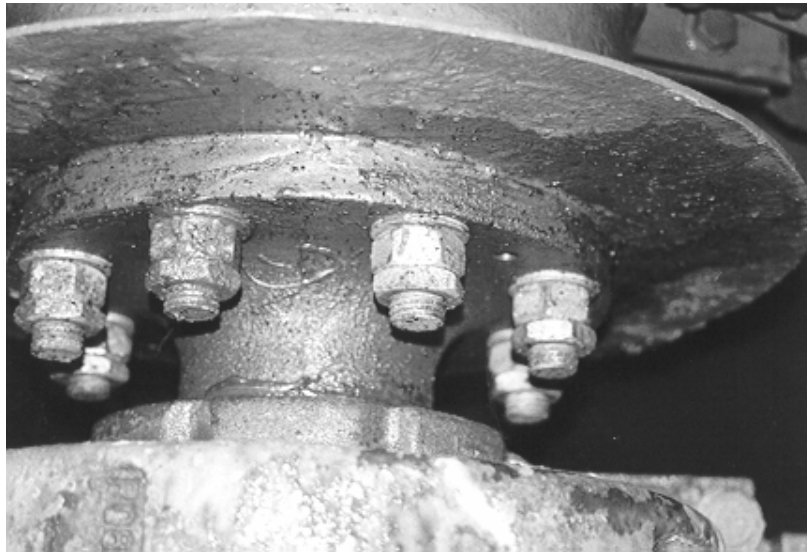
**Figure 100** Coupling bolts used to clamp stub shaft to the main hollow shaft

All RBC designs employ a stub shaft for locating the entire unit onto its bearings. In some design configurations, the stub shaft is bolted onto a plate which in turn is welded to the ends of the main hollow shaft, see figure 100. Without a thorough understanding of corrosion fatigue at low rotational speeds [4] these bolts have been known to fracture with devastating consequences, see figures 101 and 102. In some instances, apart from the complete loss of operation of the RBC unit, the GRP basin tank which contains the sewage liquor has been known to get damaged. Cognizance of the lowering effects on fatigue limits due to the combined effect of corrosion and low rotational speeds can overcome this mechanical deficiency.

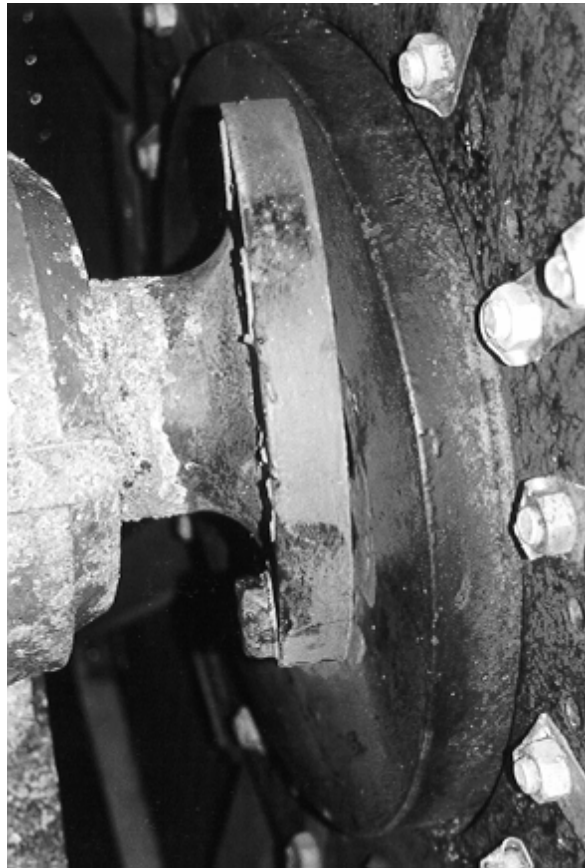
**Figure 102 Complete collapse of RBC unit due to fracture of stub shaft coupling bolts**

The effect of fractured coupling stub shaft bolts on other auxiliary systems, such as the gearbox and bearings is devastating. Even more damaging to the auxiliary systems, including the stub shaft, is complete fracture of the main hollow shaft, see figure 103. However, with a better understanding of the effects of corrosion fatigue at low rotational speeds, maximum stress levels for design of the main components of the RBC have been detailed [4].

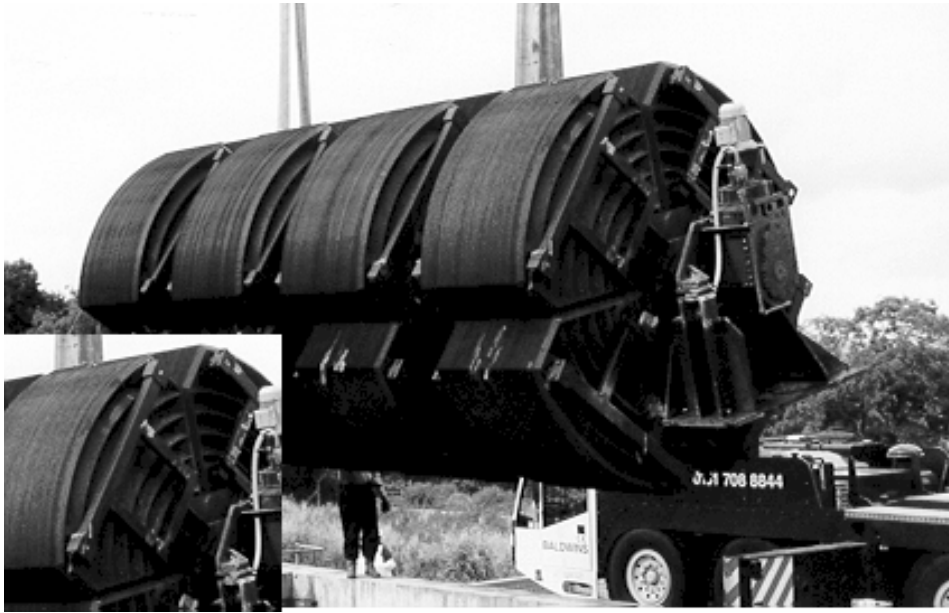
**Figure 104** New generation RBC

The majority of mechanical deficiencies on the support structure are attributed the effect of low frequency corrosion fatigued coupled with mixture of materials, inadequate clamping arrangement of all through-rods and the use of a polymer sheeting and washers to avoid direct contact of differing materials. The economic argument in relation to the current designs is really concerned with the conflict between balancing the initial capital cost of the equipment, with the cost of maintenance over the life of the RBC. However, good design should be focused on providing equipment requiring little maintenance, at a competitive cost, whilst maintaining stringent manufacturing standards.
