Safety Devices and Machinery Accident Prevention: An Enigmatic Conundrum

D.J. Edwards¹, E.A. Pärn² and Owusu-Manu, D³ and Sing, M.C.P.⁴

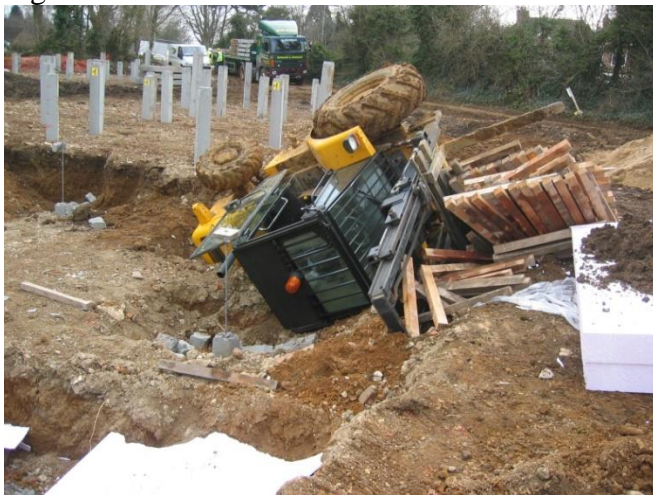
Figure 1 – Overturned masted forklift truck

A sub contracted transport driver delivering timber to site narrowly escaped serious injury when he decided to use a ‘parked up’ rough terrain masted forklift truck to unload the timber from his trailer (Figure 1). The driver was neither authorised nor trained to operate the machine and whilst attempting to unload the timber he drove too close to an open excavation which caused the excavation edge to collapse and the forklift to subsequently overturn. A review of this incident revealed that the driver was also not wearing the seatbelt (in accordance with manufacturer’s instructions) and that the incident occurred early in the morning when other operatives were not on site. This incident highlights several issues (e.g. the provision of adequate transportation routes, operator training and competence, site security and management and lone working).

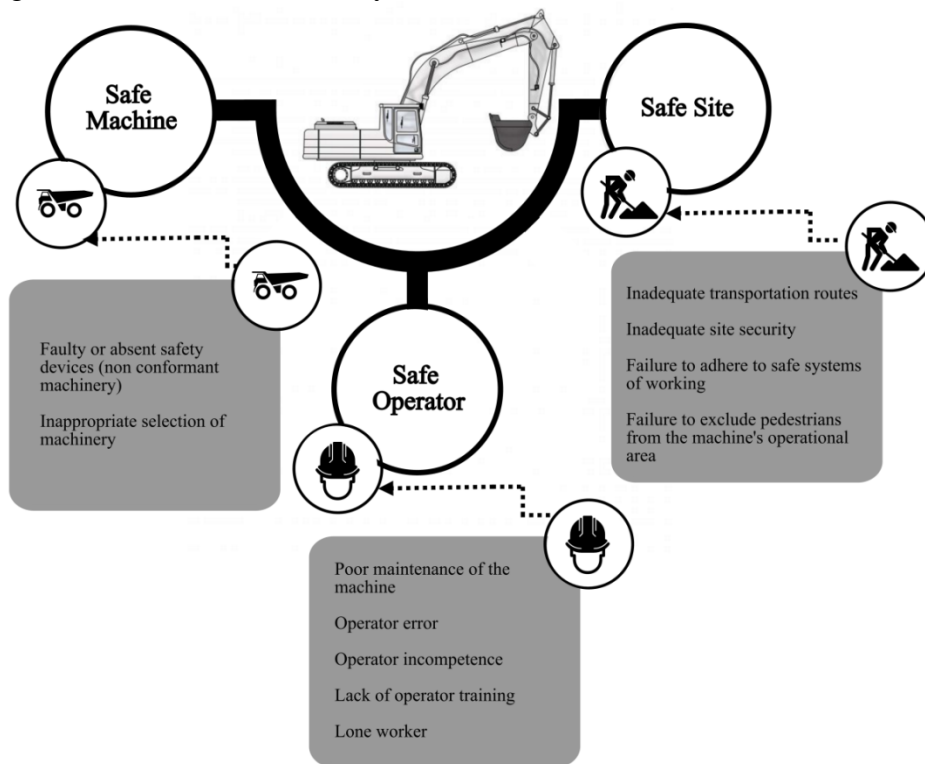
Figure 2 – Causes of case study fatalities/ near fatalities

These four case studies presented highlight that it is a multitude of interrelated factors coalesce to create conditions that lead to a fatal or near fatal incident. These factors include operator incompetence, inadequate site supervision, inadequate site security and poor maintenance of the machine (refer to Figure 2). It would be impossible to determine whether more accidents would have occurred within industry with or without additional safety devices being fitted to the machine. However two important findings are apparent.

First, the evidence suggests that human error, poor judgement, inexperience, unmitigated incompetence and a belligerent disregard for safe systems of working (on behalf of operators and site supervisors) were significant factors in all cases. Behavioural education and training may well mitigate these risk factors but not all because in some instances the operator and site management lacked basic knowledge of safe machine operation – such represents a fundamental building block

in operator competence development. Second, in two of the cases, safety devices had been tampered with and were inoperable. Although it would be difficult to assert that this was a sole causal factor, it would have certainly contributed to the accident and provides further evidence of a general disregard for personal safety and the safety of others working on site. Moreover, it illustrates how easy it is to deliberately vandalise safety devices or manipulate them so that they appear to be fully functional when in reality they are inoperable. It would seem that whilst advantaged technological and engineered-out solutions are becoming increasingly sophisticated, operators are becoming equally adept at disabling the device! These issues are further exacerbated by inexperienced and ill-informed site management who are often ill-prepared to manage a complex array of machinery – each with their own bespoke set of operation and maintenance requirements.
