Observations on the Desiccation and Cracking of Clay Layers

R.N. Tollenaar, L.A. van Paassen, C. Jommi

To appear in: *Engineering Geology*

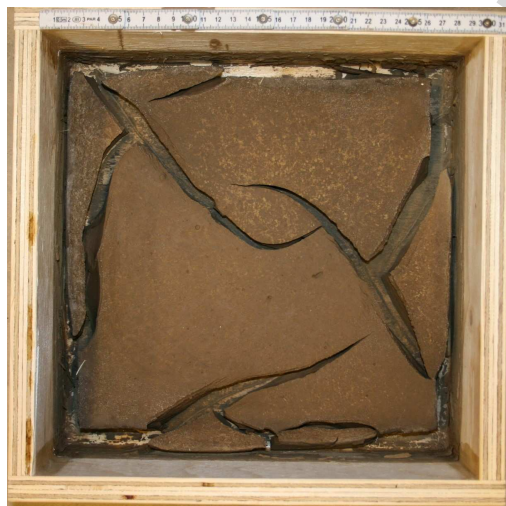
Figure 3: Cracking in 0.3 x 0.3 m board with 50 mm initial thickness and an initial water content of three times liquid limit approx. (170%).

amount of fractures was lower than in the boards with high initial water contents. Figure 3 and 4 compare the difference in cracking in 0.3 x 0.3 m boards with 50 mm initial thickness at similar stages of drying (i.e. water content).

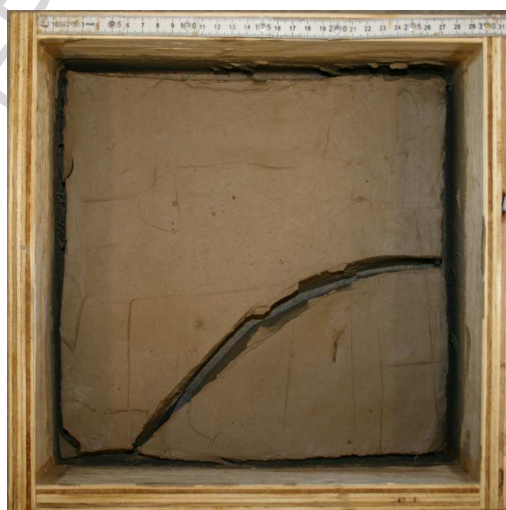
Figure 4: Cracking in 0.3 x 0.3 m board with 50 mm initial thickness and an initial water content of twice the liquid limit approx. (114%).

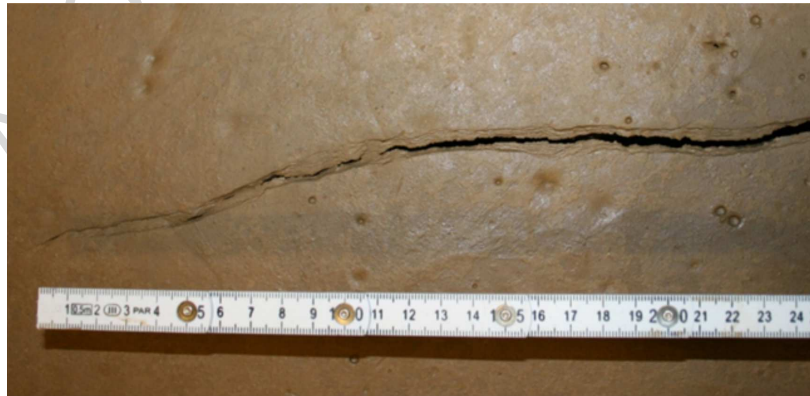
Figure 5: Surface depression on the clay surface ahead of a crack.

During the drying process, linear depressions were observed also on the surface of the clay. As the soil continued drying, these depressions developed into cracks and continued appearing ahead of the opening fracture (Figure 5). It was then evident that the depressions were the surface evidence of a fracture advancing horizontally and under the surface, before emerging at the surface.

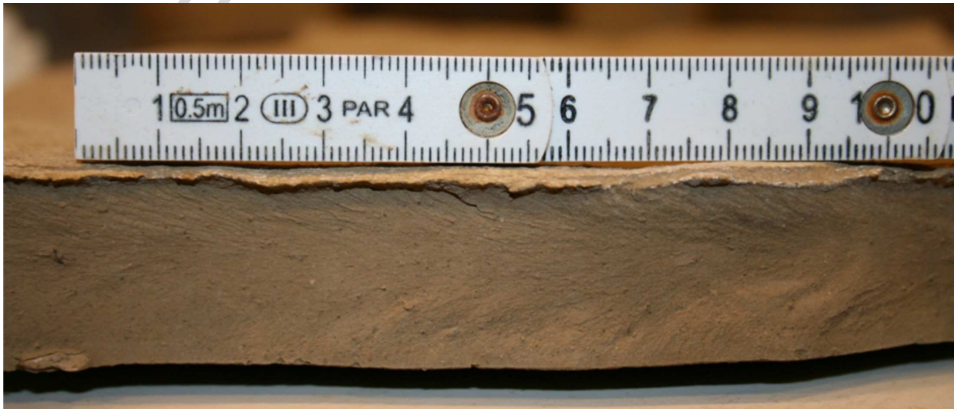
Figure 9: Plumose structures in fractures from container with a 50 mm initial clay thickness.

After the clay fully dried, the walls of the sections or cells formed by the fractures were inspected. Unlike Nahlawi and Kodikara (2002), Kodikara et al. (2004), Peron et al. (2009) and Zielinski et al. (2014), only slight curling of the clay cells in the experiments with 20 mm initial thickness was noticed. In that case, the curling can be attributed to the differential drying between the top and bottom of the sample, as explained by Scherer (1990) and Zielinski et al. (2014). A curvature of the clay surface close to the walls of the containers was detected in most of the tests, but this was a result of boundary effects (differential settlement) and not curling. Evidence of plumose structures was observed in the cracks from all the containers, no matter what size, tray material, thickness of soil, or initial water content in the tests (Figures 8, 9 and 10).

The experiments with initial thickness of 20 mm displayed quasi-symmetric plumose structures. However, in the tests where thicker layers were used (50 and 100 mm initial thickness), the structures started becoming asymmetric. The location of the plume axis and the crack front line, in addition to the surface depressions observed in front of the cracks, gave a strong indication that the overall propagation of the fractures happened under the surface.

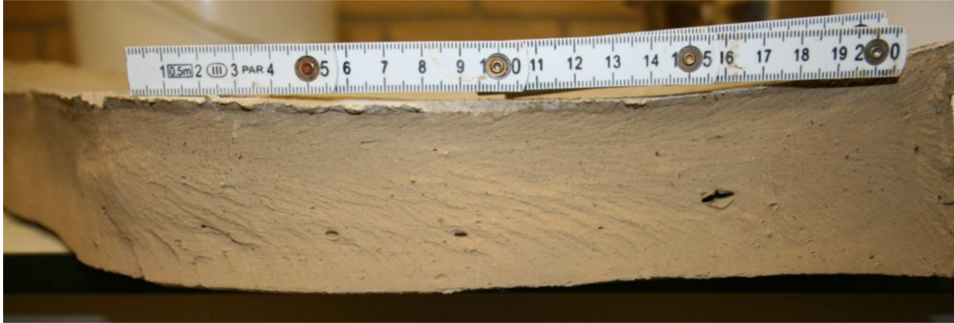
Figure 10: Plumose structures in fractures from container with a 100 mm initial clay thickness.

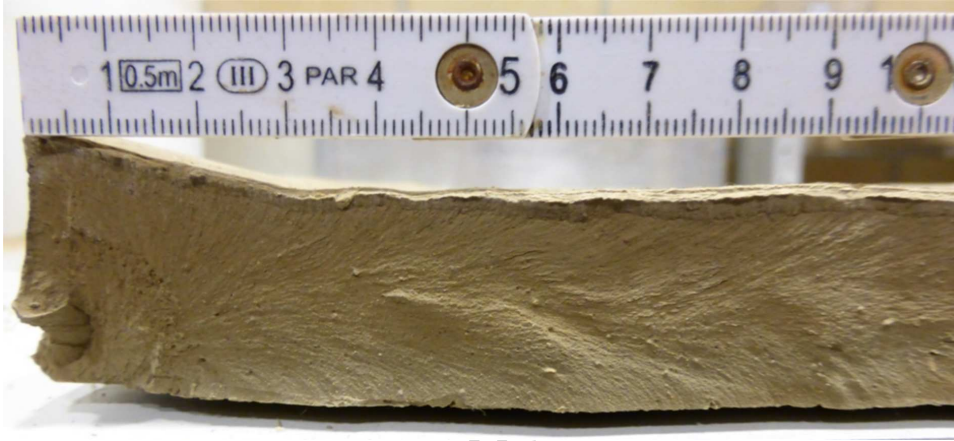
Figure 12: Example of a fracture starting at the bottom left corner of the layer and advancing under the surface towards the right.

What was observed during the experiments in this study is that the fractures might start anywhere along the depth of the layer (Figure 12). The exact location of initiation would be very difficult to establish, since it would require detailed knowledge of all the forces at every single point in the clay. Yet the general area where the fracture might originate can be deduced, and it is consistent with locations of local stress concentration (e.g. the edge of the clay board, or a surface disturbance). And unlike it was proposed by Corte and Higashi (1960), it was evident (in the case of these experiments) that the crack front line advanced under the surface.
