December 2017

A Field-based Study of Impacts of the 2015 Earthquake on Potentially Dangerous Glacial Lakes in Nepal

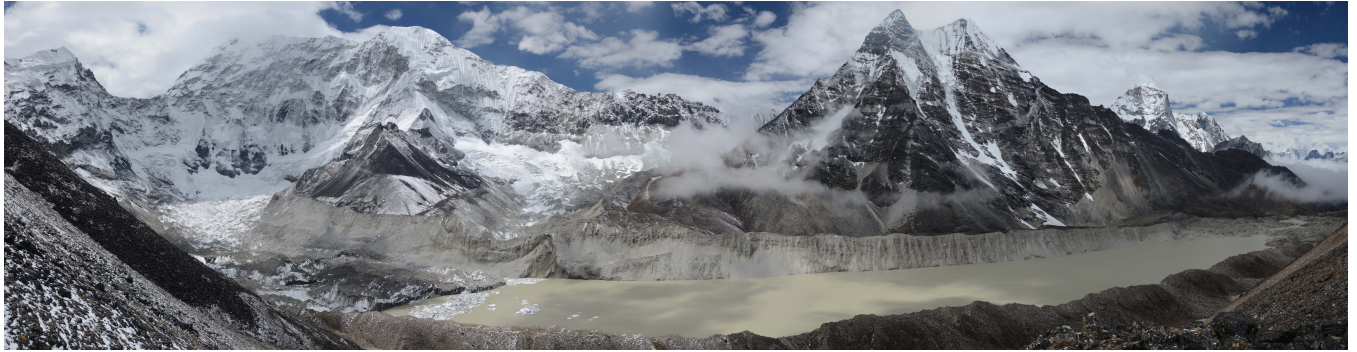
Figure 2. Imja Tsho in June 2015.

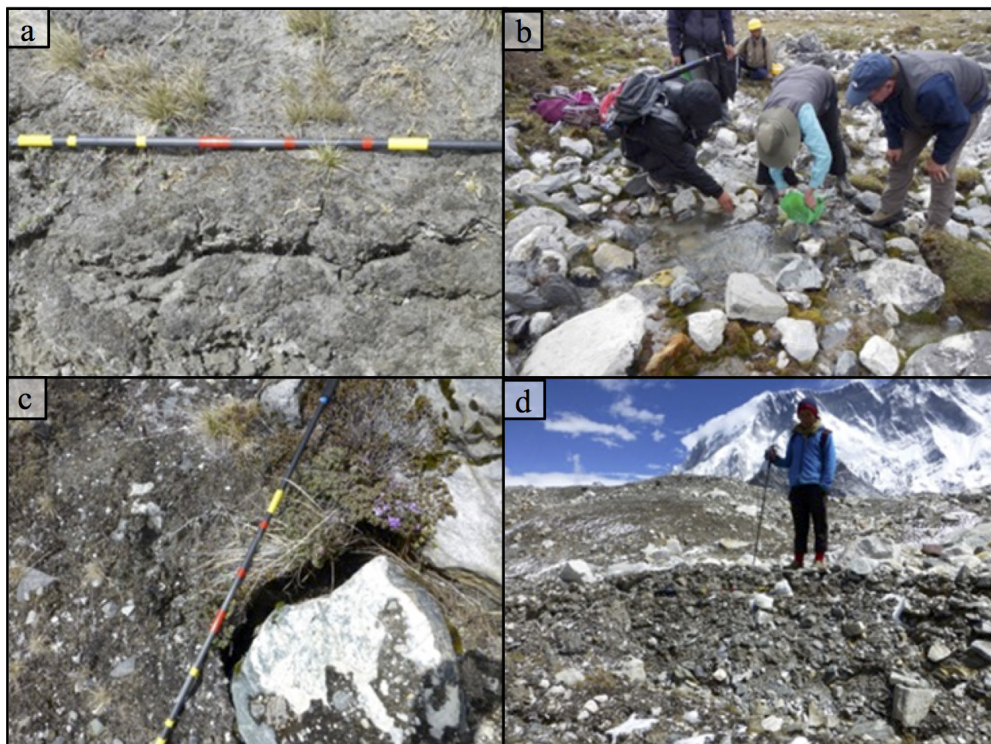
Figure 3. Observations at Imja Tsho: (a) abundant new cracks parallel to lake shore, (b) measuring seepage at the terminal moraine, (c) a boulder in the terminal moraine shifted by the earthquake, and (d) abundant 1 m high slumps parallel to the lake shore.

Impacts: Although not necessarily visible from helicopter flyovers or satellite imagery, a range of surficial and sub-surface impacts at Imja Tsho that may have been related to the earthquake were observed and measured within the area of its terminal and lateral moraines. They included the presence of abundant new cracks parallel to the lake shore (2-10 cm wide), the shifting of hundreds of boulders in the terminal moraine (average 10-20 cm gaps), slump benches at the entrance to the outlet (average 3 m deep), and apparently new landslide activity on sections of the inner lateral moraines (Figures 2 and 3). Discharge from Imja Tsho was measured as $2.8 \text{ m}^3 \text{ s}^{-1}$ on June 12, 2015.

Previous measurements of the outlet flow were $0.98 \text{ m}^3 \text{ s}^{-1}$ in May 2012 (HiMAP 2012) and $2.2 \text{ m}^3 \text{ s}^{-1}$ in September 2013 (Somos-Valenzuela et al. 2015). The seepage at the base of the terminal moraine that had been observed on previous expeditions (Somos-Valenzuela et al. 2015) had ceased. These observations indicate that after the earthquake there may have been internal changes in the terminal moraine structure that could have de-stabilized the already deteriorating moraine conditions that had been a concern of scientists for years (Benn et al. 2012; Watanabe et al. 2009).

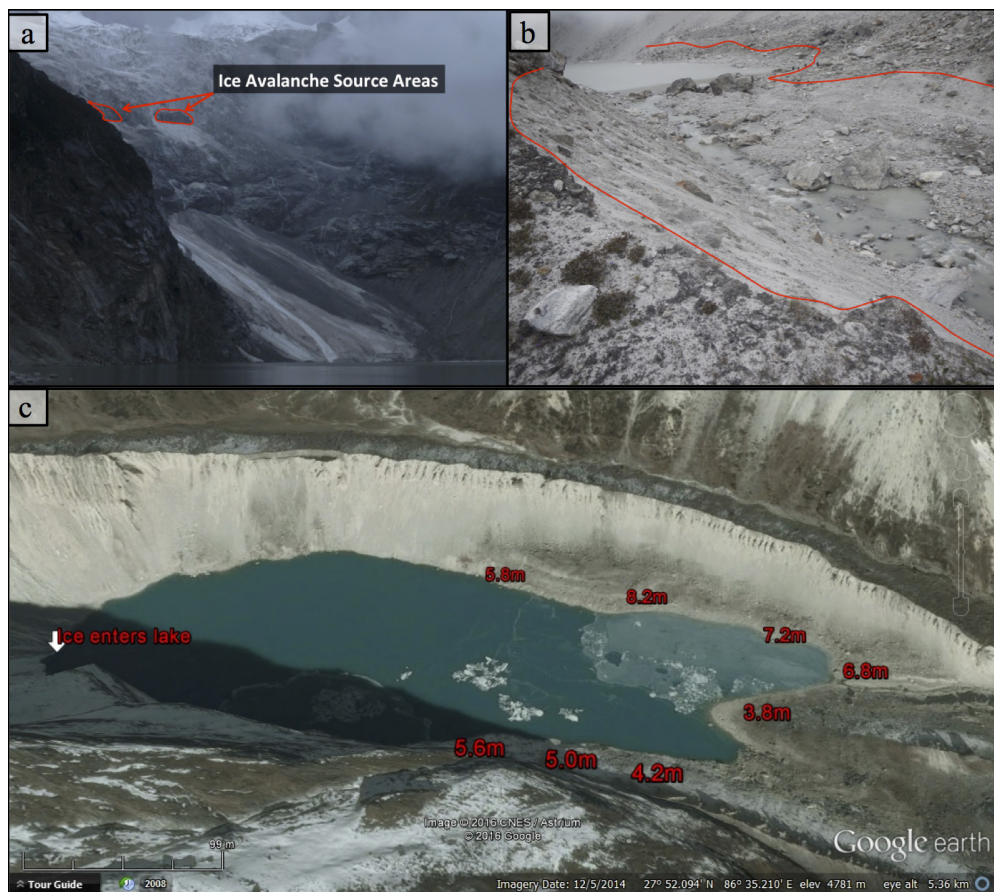
Figure 4. (a) Ice avalanche source areas above Dig Tsho, (b) lake outlet showing approximate path of the surge wave, and (c) measured heights of surge wave along shores of Dig Tsho. There was no significant lowering of the outlet and no subsequent change to future flood hazard.

to believe that Dig Tsho is no longer dangerous, the 2015 earthquake proved otherwise. On April 25, 2015, the day of the Gorkha earthquake, local villagers reported that an avalanche of ice and rock had dislodged from the Tengi Ragi Tau Mountain (6650 m) and cascaded into Dig Tsho, thus creating a 4.2-8.2 m high surge wave across the lake, as measured by high-water marks, fresh mud and sand deposits on vegetation, and uprooted vegetation (Figure 4). In informal interviews, eyewitnesses, and other informants claimed that, at the time of the flood, villagers in Langmoche, the first village downstream, were terrified, as a massive rock fall caused by the earthquake was taking place on the northern side of the village. The flood destroyed two small bridges downstream and damaged a third, larger bridge at Thametang, where the flood height peaked at about 1.5 m. Downstream, witnesses also reported that half of the Bhote Khosi River was white and half was black, the former being the normal silt-laden water of the Bhote Khosi River and the latter the debris- and mud-laden discharge from the GLOF. By the time of our visit on July 20, 2015, based on bio-indicators (e.g. the line of permanent woody vegetation along the lake shore) and the freshness of the water lines, we could determine the level of the lake had returned to its pre-earthquake level. This is the only known GLOF that was most likely a direct result of the earthquake. The event suggests that even if a glacial lake has already experienced an outburst flood, it can still be dangerous, subject to additional flooding activity in the future, and in need of regular monitoring.

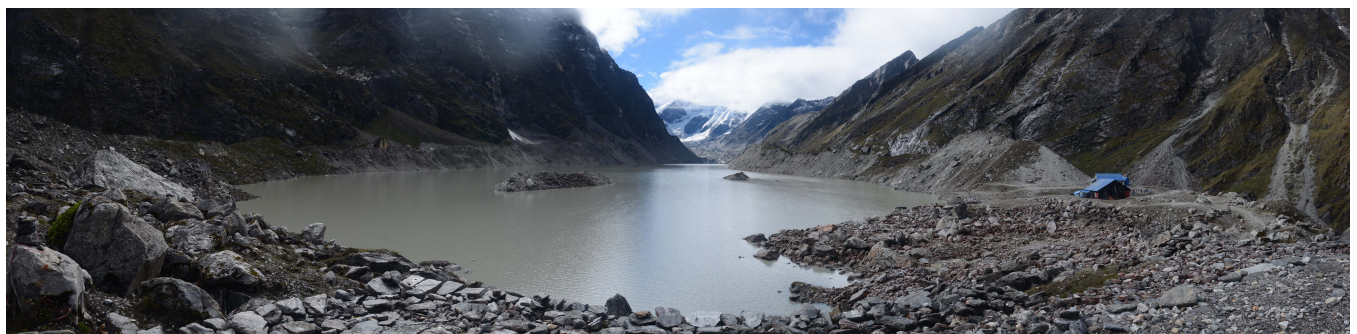
Tsho Rolpa: Tsho Rolpa is a glacial lake (Figure 5) located in central Nepal at an altitude of 4,546 m, forming the headwaters of the Rolwaling Khola River, which is a tributary of the Tama Kosi Lake in the Dolakha district. The lake is approximately 3.64 km in length, has an area of 1.54 km², a volume of 86 million m³, an average depth of 56.4 m, and a maximum depth of 133.5 m (ICIMOD 2011). Like nearly all of Nepal’s large glacial lakes, Tsho Rolpa began to form in the 1950s when small meltwater ponds at the glacier’s terminus began to coalesce, grow, and form a substantial glacial lake that has continued to grow in length by about 20 m yr⁻¹ for several decades (ICIMOD 2011); however, its growth has plateaued in recent years (Rounce et al. 2016).

Figure 5. Tsho Rolpa glacial lake from July 2015.

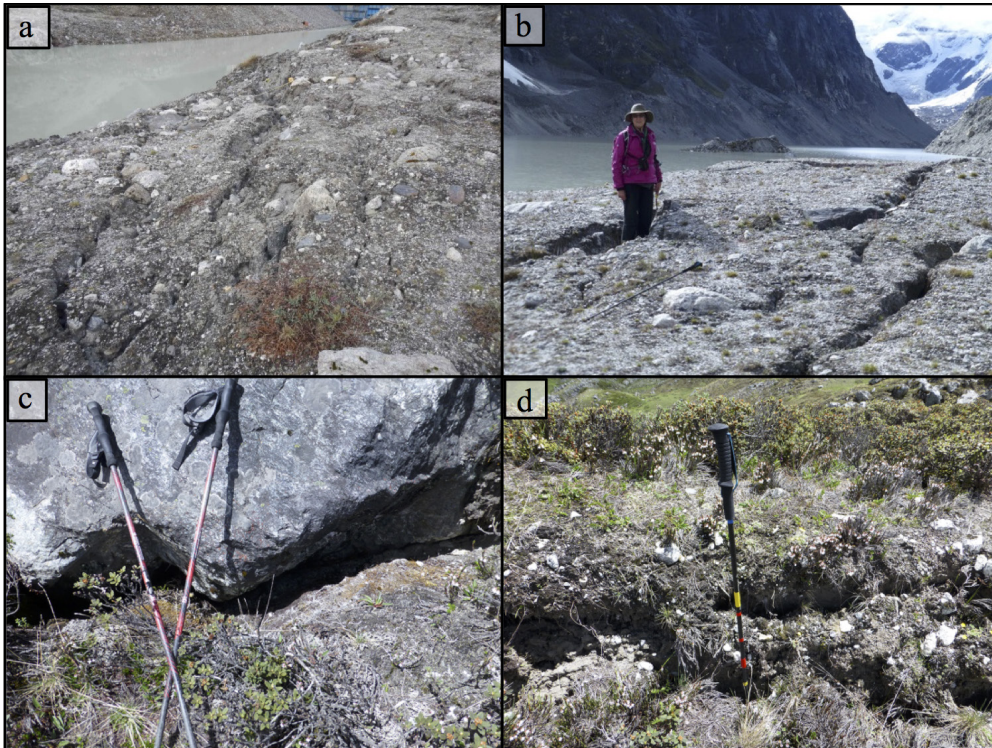
Figure 6. Slumping and cracking at the inlet canal entrance at Tsho Rolpa (a) on the right and (b) left sides of the canal, (c) a displaced boulder, and (d) a major crack at the crest of the terminal moraine.

Impacts: Tsho Rolpa showed considerable evidence of impacts from the earthquake. At the inlet of the canal structure we found distinct slumping and cracking of the

surface in the direction of the lake on both sides of the inlet (Figure 6a, b), damage that was most likely caused by the Gorkha earthquake and aftershock. The cracks measured between 10-15 m in length, 40-60 cm in width and 40-50 cm deep. Their repair is recommended in order to slow and/or stop the deterioration of the inlet to the canal.

Hundreds of boulders (50 cm to 1 m in diameter) in the terminal moraine at Tsho Rolpa were shifted during the earthquake or aftershock, which created gaps in which precipitation and other accumulation could occur that would potentially further destabilize the moraine. The shifting of a massive boulder perched directly on the knife-edged ridge of the right lateral moraine (Figure 6c), which appears to increase the possibility of collapsing into the lake and potentially generating a sizeable surge wave, was of further concern.

A 100 m long, 5-50 cm deep, and 3-40 cm wide crack was found along the ridge of the right lateral moraine with clear earthquake origins (Figure 6d). An older, parallel crack was noted a few feet away, indicating that this joint structure in the moraine has shifted more than once. Smaller cracks, formed through a combination of gravity, weathering, mass wasting, and the earthquake, were noted along the knife edge of the moraine; they may soon lead to the loss of more moraine material into the lake. Several square meters of silt deposits within one of the linear collapses, which appear to have been produced as a result of soil liquefaction, a phenomenon common to earthquakes

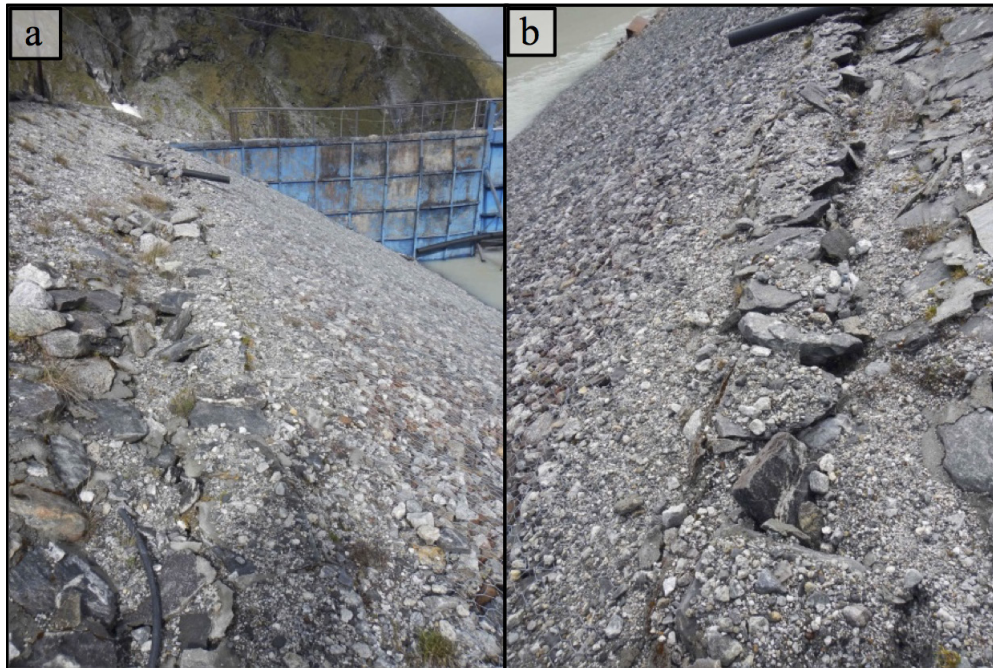
Figure 7. Separations in the sloping gabions on the left side of the inlet leading to the outlet structure: (a) looking west, and (b) looking east.

To lower the water level of Tsho Rolpa by approximately 3 m, a gated structure of 4.2 m wide by 3 m tall and a 70 m long canal were constructed across the end moraine in 2000 (Figure 7a) (Mool et al. 2001). From our observations over several days, it is clear that weathering and other processes have taken the normal toll on the structure, but that it has held up and performed well since it was built 16 years ago. We observed bulging of the wood facing the upstream (lake side) of the supporting gabions on both sides of the outlet structure gates, as was separation of the sloping gabions from the adjacent material on the left side of the inlet leading to the outlet structure (Figure 7b). We were unable to verify whether these features were new or the result of long-term deterioration of the structure. Regardless, repair we suggest it be repaired before further deterioration sets in.

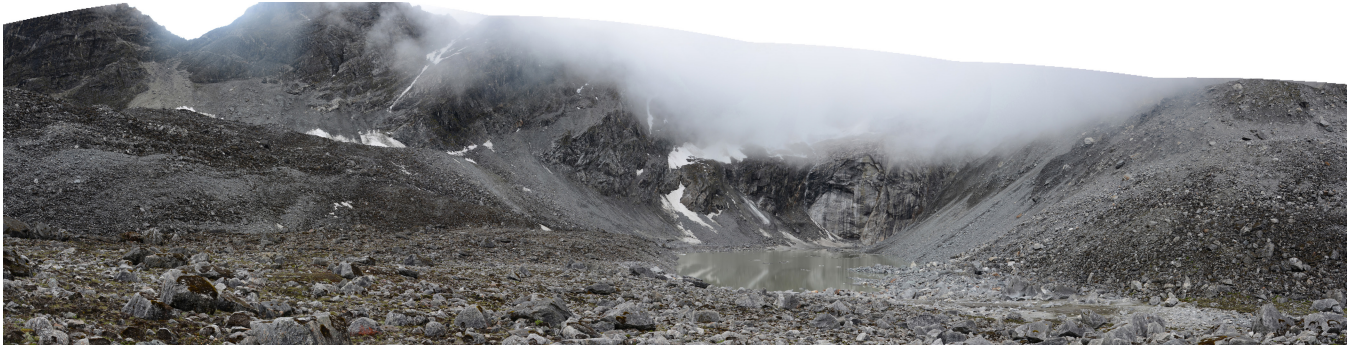
Panga Dinga Glacier, of which the lake is a part, occupies the largest valley on the southern slope adjacent to Tsho Rolpa. Its outlet stream debouches directly into Tsho Rolpa. At this time, the glacier has exposed ice but no

Figure 8. Panga Dinga glacial lake, above Tsho Rolpa.

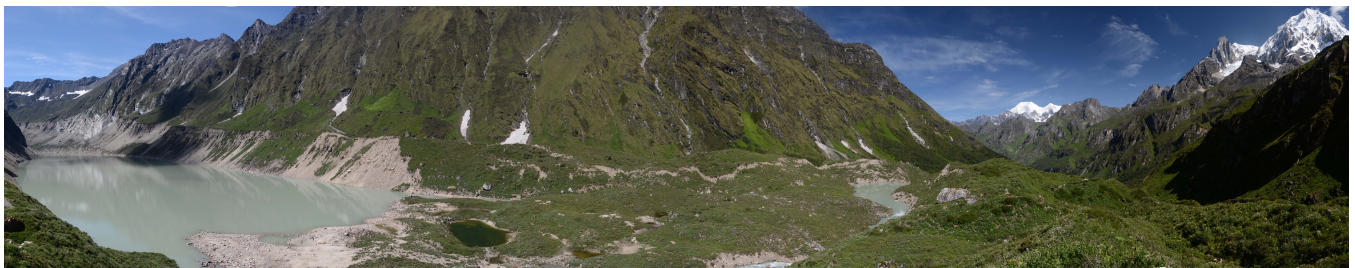
A second feature of Thulagi worth noting is the terminal complex currently acts as a buffer against possible surge waves and bears the brunt of the lake's hydrostatic pressure. Additionally, the steep right and left lateral moraines erode into the lake.

Figure 10. Thulagi glacial lake and its outlet complex in July 2015.

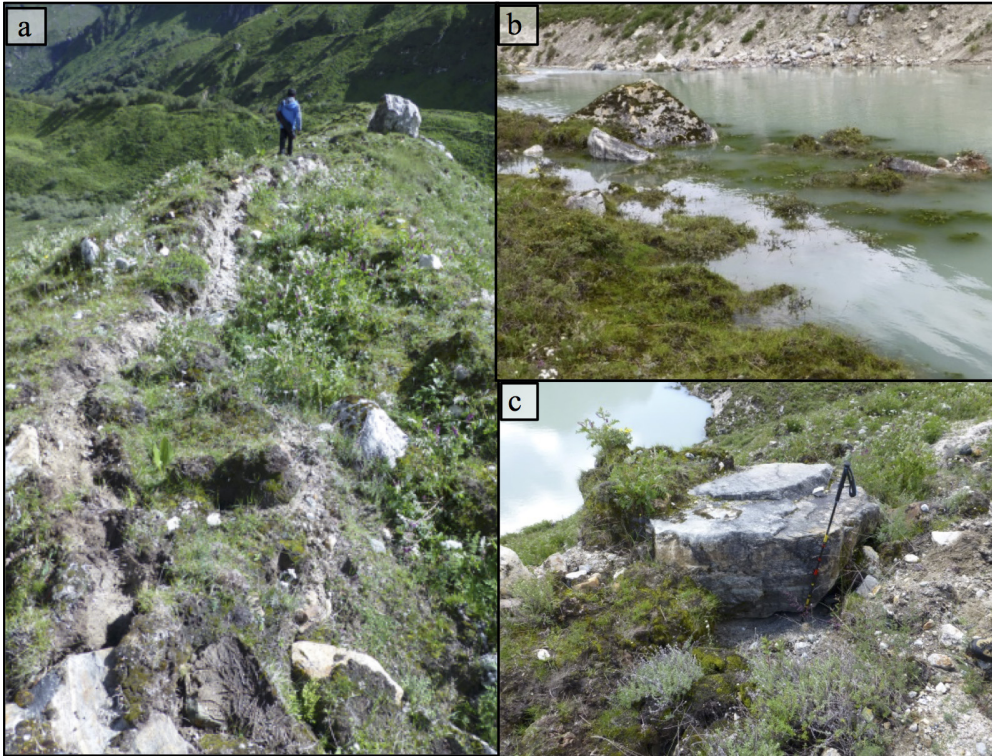
While the right and left lateral moraines were free of major earthquake-related cracks, the terminal moraine had extensive new cracks along the crest line (based on the observations of our informant, P. B. Gurung, a local yak herder), as well as slumping and mass wasting along the interior slopes (Figure 11a, b). We found that boulders throughout the terminal moraine and terminal complex had shifted considerably. For example, a boulder located near the crest of the terminal moraine, used as a benchmark by previous surveyors, had moved 15 cm toward the lake and 10 cm down the hillslope (Figure 11c). These changes to the terminal complex are of concern because the complex provides an important buffer against the potentially destructive impact of surge waves. As the terminal moraine complex changes and the outlet lakes grow, this buffer may be greatly diminished, which would increase the lake's susceptibility to a GLOF.

Figure 11. (a) Large crack and slump at the crest of the terminal moraine, (b) recent slumping of outlet channel sides as evidenced by submerged upland vegetation below slump scars, and (c) shifted benchmark boulder #2 located near the edge of the lake.

Observations from informant P. B. Gurung, as well as a range of bio-indicators, suggest recent changes in the shoreline and indicate that the outlet pond widened as a result of the slumping activity along the shoreline that was induced by the earthquake. The size of the lowest outlet pond had increased from 7,850 m² on November 26, 2013 to 9,230 m² on October 27, 2015, and its width has increased from 70 to 85 m, respectively. As the outlet pond continues to widen and deepen, and the terminal complex subsides and deteriorates, the hydrostatic pressure against the thinning terminal moraine will continue to increase, thereby making the moraine more susceptible to failure. We recommend that detailed studies be conducted to more thoroughly investigate the moraine stability.

In general, the terminal complex at Thulagi slopes from south to north and is pockmarked with thermokarst depressions and slope failures resulting from a melting ice core. These slumps occur toward and into the outlet pond and channel, which also contributes to the increasing the size of the outlet ponds. Other disturbances we found included an approximately 2 m wide, 20 m long swath of shoreline along the southern bank of the outlet pond that had slumped into the lake as a result of the earthquake (P. B. Gurung, 2016, personal communication, July 28). The slumps were covered by large masses of fresh vegetation and are now located within the outlet pond and channel.
