Effect of real time aging and cyclic fatigue on fused and cemented machined veneers to Y-TZP zirconia

BOSTON UNIVERSITY
HENRY M. GOLDMAN SCHOOL OF DENTAL MEDICINE
DISSERTATION

ABDULRAHMAN JAFAR M. ALHADDAD

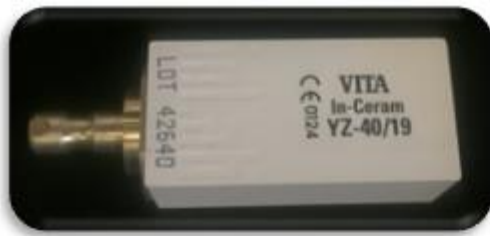
Figure 1: Vita In-Ceram YZ block

Figures	Material	Brand Name	Composition wt. %																		
Figure 1	Zirconia Framework	Vita In-Ceram YZ (Vita Zahnfabrik, Germany)	Pre-sintered yttria-stabilized zirconium oxide ZrO ₂ >90%, Y ₂ O ₃ 5%, HfO ₂ < 3%, Al ₂ O ₃ , SiO ₂ < 1%																		
Figure 2	Milled Ceramics	VITABLOCSS® TriLuxe Forte (Vita Zahnfabrik, Bad Sackingen, Germany)	Mixture of feldspathic crystalline particles embedded in glassy matrix SiO ₂ : 56-64, Al ₂ O ₃ : 20-23, Na ₂ O: 6-9, K ₂ O: 6-8, CaO: 0,3-0,6 TiO ₂ : 0,0-0,1																		
Figure 3	Milled Ceramics	IPS e. max CAD (Ivoclar Vivadent, Liechtenstein).	Lithium disilicate glass-ceramic SiO ₂ 57.0 – 80.0%, Li ₂ O 11.0 – 19.0%, K ₂ O 0.0 – 13.0%, P ₂ O ₅ 0.0 – 11.0%, ZrO ₂ 0.0 – 8.0 %, ZnO 0.0 – 8.0%, Al ₂ O ₃ 0.0 – 5.0%, MgO 0.0 – 5.0%, Coloring oxides 0.0 –0.8%																		
Figure 4	Fusing Porcelains	Vita VM9	Feldspathic Porcelain																		
Figure 5	Fusing Porcelains	IPS e. max CAD Crystall./Connect (Ivoclar Vivadent, Liechtenstein).	Fusing glass-ceramic SiO ₂ 50.0 - 65.0%, Al ₂ O ₃ 8.0 - 22.0%, Na ₂ O 6.0 - 11.0%, K ₂ O 4.0 - 8.0%, ZnO 1.0 - 3.0%, Other oxides 5.0 - 17.5%. Pigments 0.1 - 3.0%																		
Figure 6	Luting Cement	Multilink Automix (Ivoclar Vivadent, Liechtenstein)	<p>Adhesive Luting Composite <u>Multilink Automix</u></p>

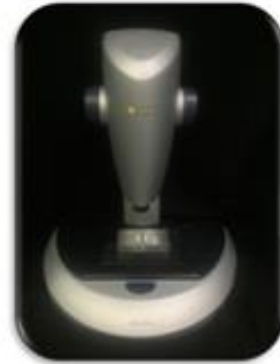
Figure 10: Sirona InEos Blue Scanner

Standard aluminum die (Figure 7) was placed on a metal holder (Figure 8) then sprayed with IPS contrast spray lab side (Ivoclar Vivadent, Liechtenstein) (Figure 9) and scanned using Sirona inEos Blue scanner (Sirona, Bensheim Germany) (Figure 10). The Zirconia substructure frameworks (Figure 11) were designed using the Sirona Multilayer technique for three unit fixed partial dentures by the Sirona InLab 3D software V3.80. Afterwards, milling was completed by Sirona's CEREC inLab MC XL milling machine (Sirona, Bensheim Germany) (Figures 12). Pre-sintered zirconia blocks were milled into 20-25% enlarged frameworks with 30 μm virtual cement space (Figures 13). Milled zirconia frameworks were thoroughly cleaned and dried, then sintered in Vita ZYrcomat T furnace (Vita Zahnfabrik, Germany) (Figure 14) following manufacturer's instructions (Table 3). The external surface of all zirconia frameworks were sandblasted with 50- μm alumina particles (Aluminum oxide 50 μm , Renfert GmbH industriegebiet, Hilzingen, Germany) using approximately 2.5 bar pressure. Then the frameworks were cleaned in an ultrasonic unit for approximately 5 minutes, rinsed thoroughly with water spray and dried with oil-free air.

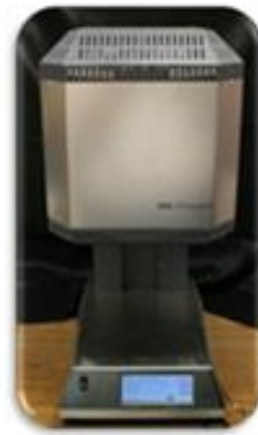
Figure 14: Vita ZYrcomat T Furnace

Sintering Steps	Rising time	Rising rate	End temperature	Holding time
Vita In-Ceram YZ	1.5 h	17°C/minute	1530°C	2 h

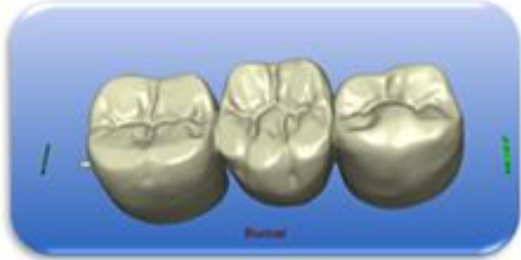
Figure 15: Veneer Design

IPS e.max CAD block (Ivoclar Vivadent, Liechtenstein) was milled based on the Sirona Multilayer technique of substructure via Sirona InLab 3D software V3.81 (Figure 15) using Sirona's CEREC inLab MC XL milling machine (Sirona, Bensheim Germany).

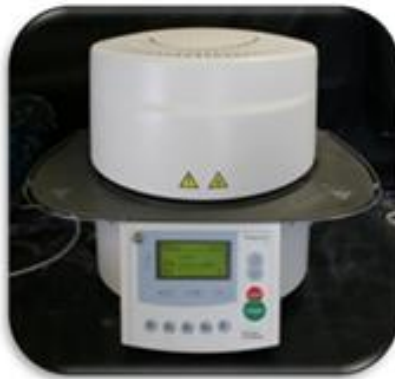
Figure 17: Programat CS Furnace

Stand-by temp. °C/°F	Closing Time min.	Heating rate °C/°F /min	Firing temp. °C/°F	Holding Time min.	Heating rate °C/°F /min	Firing temp. °C/°F	Holding time min.	Vacuum		Long term cooling °C/°F
								1 °C/°F 1 ₂ °C/°F	2 °C/°F 2 ₂ °C/°F	
403/757	6.00	60/108	820/1508	2:00	30/54	840/1544	7:00	550/820 1022/1508	820/840 1508/1540	700/1292

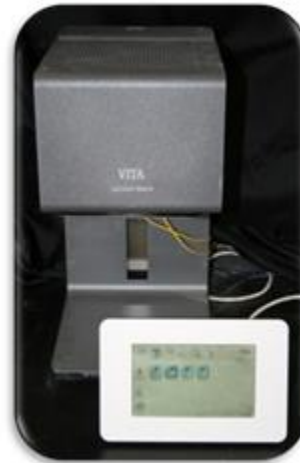
Figure 25: Vacumat 6000M

The veneers were glazed by Vita Akzent Glaze spray (Figure 24) and fired according to the manufacturer's recommendations for glaze firing chart (Table 6) using a Vacumat 6000M vacuum furnace (Vita-Zahnfabrick, Bad Sackingen, Germany) (Figure 25). Then the fitting surface of the veneer was etched using 5% hydrofluoric acid (IPS Ceramic etching gel, Ivoclar Vivadent, Liechtenstein) for 60 seconds then thoroughly rinsed with water spray, cleansed in ultrasonic cleaner for 5 minutes and dried with oil-free air. Monobond plus was applied to the pre-treated surface with a brush and allowed to react for 60 seconds. Next, it was spread with a strong stream of air. A thin layer of luting composite resin (Multilink Automix, Ivoclar Vivadent, Liechtenstein) was applied on the inner surface of the veneer and then seated on the zirconia framework with finger pressure. Excess cement was removed and each bridge was kept under a static load of 30 N (3kg) for 10 minutes in a loading apparatus. Two measurements were recorded (before and after applying the cement) on the FPD using a digital micrometer (Mitutoyo Corp. Japan) to make sure there was no significant height change during the cementation.

Firing Steps	Drying Temp. °C	Drying Time min.	Rising time min.	Rising rate °C/min	Final Tem. °C	Holding time min.	Cooling temp. °C	Vacuum min.
Glaze firing with Vita Akzent	500	4.00	5.15	80	920	1.00	-	-

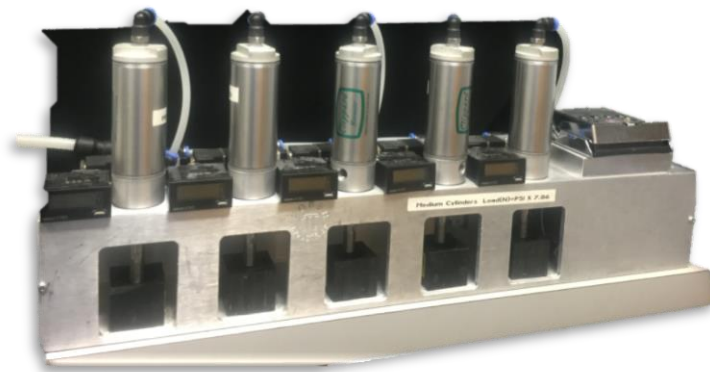
Figure 30: Cyclic loading apparatus, Pober Industries, Waban MA

This group was subjected to many cyclic test; 20K, 60K and 80K at a frequency rate of 1 Hz in a cyclic fatigue device (Pober Industries, Waban MA) (Figures 30) in a distilled water bath. The load applied on each specimen was 40% of the mean fracture load of each material. The load applied at the center of the pontic of FPD by a 4.7 mm steel ball. After cyclic loading was completed, each specimen was examined to detect any cracks or defects. The survived specimen was subjected to failure load test. The failure loads were measured in newtons and compared with statics groups. Failure modes, cohesive failure (total fracture extending through the veneer and coping), adhesive failure (veneer delamination) or veneer failure (veneer crack) observed and recorded after each test.

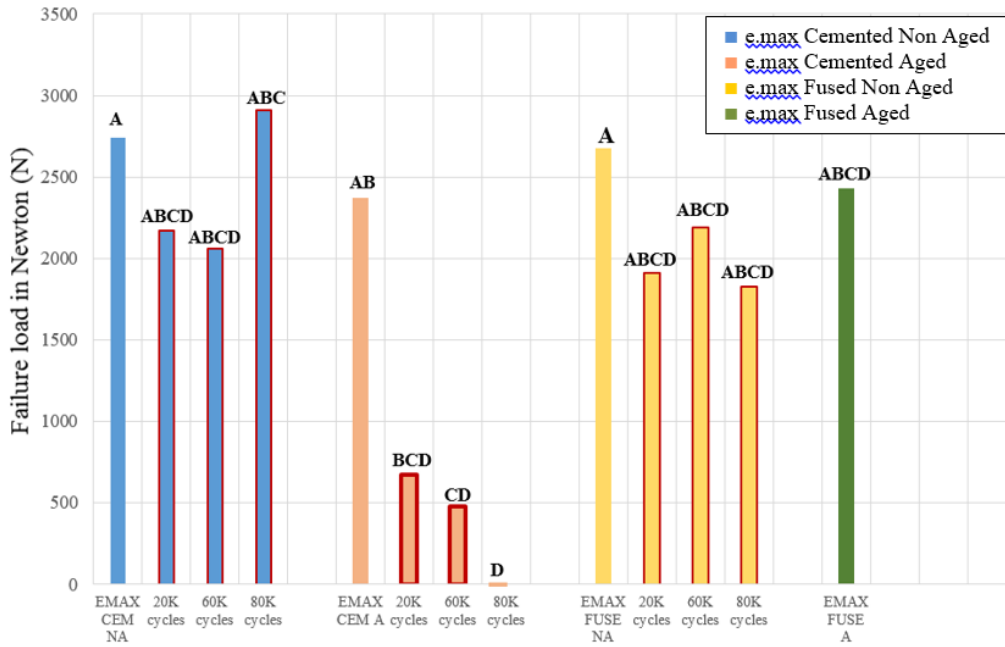
Graph 3: Effect of cyclic fatigue failure load on aged and non-aged e.max cemented and fused to YZ zirconia

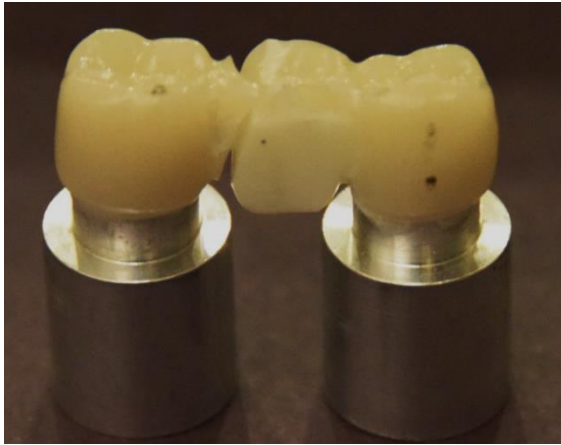
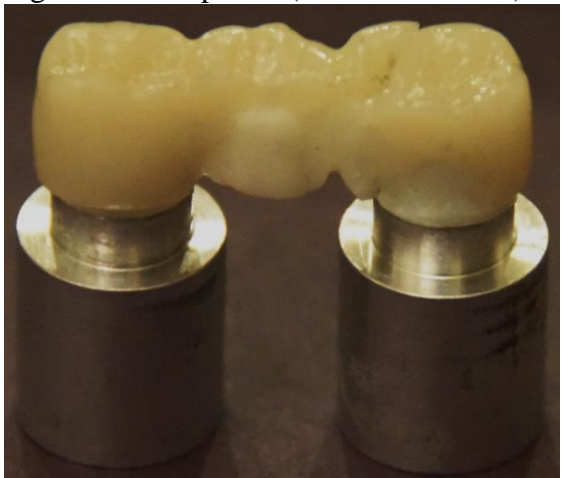
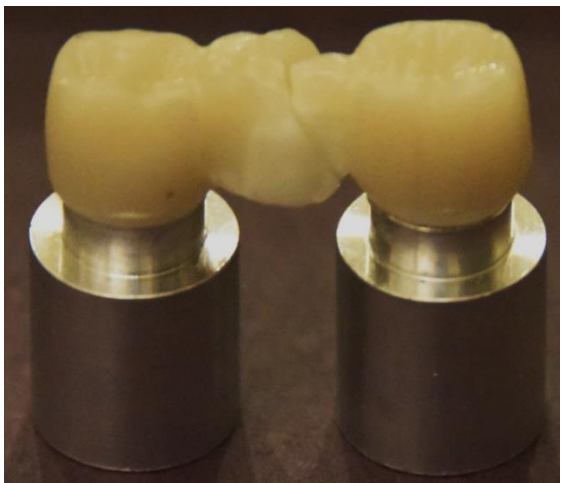
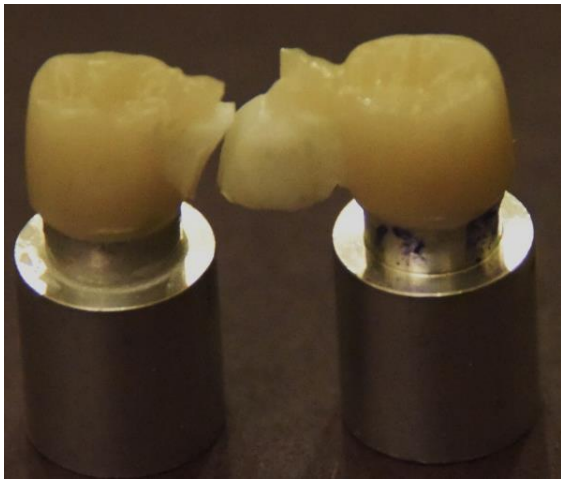
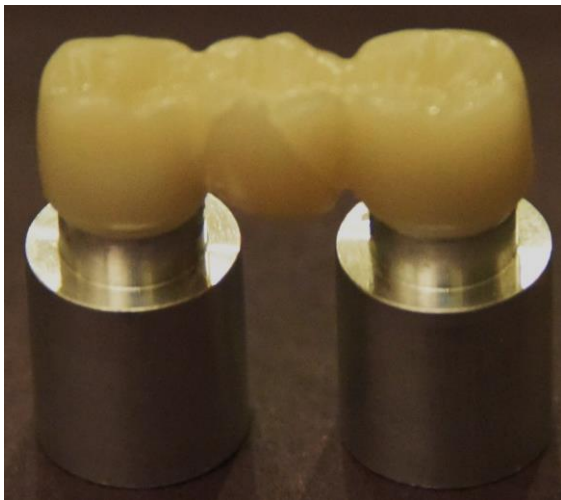
In YZ-e.max fused group, there were five incidences of adhesive failure at the pontic area and two incidences of cohesive failure at the pontic and connector area together. There was one incidence of cohesive at coping, connector and connector & coping area as well as one other incidence of veneer failure at the pontic area. (Figures 33-38)

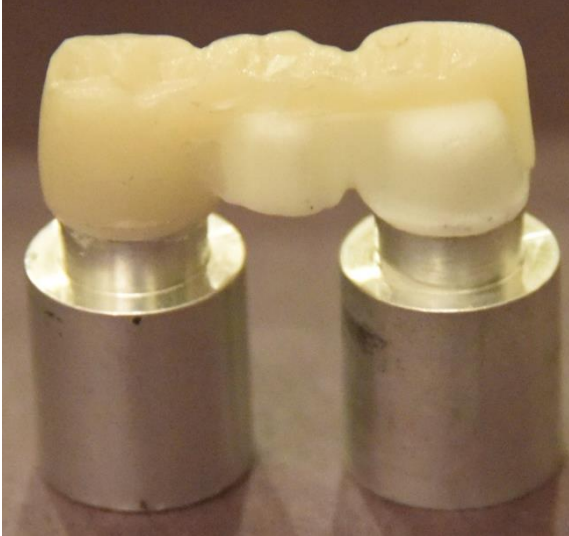
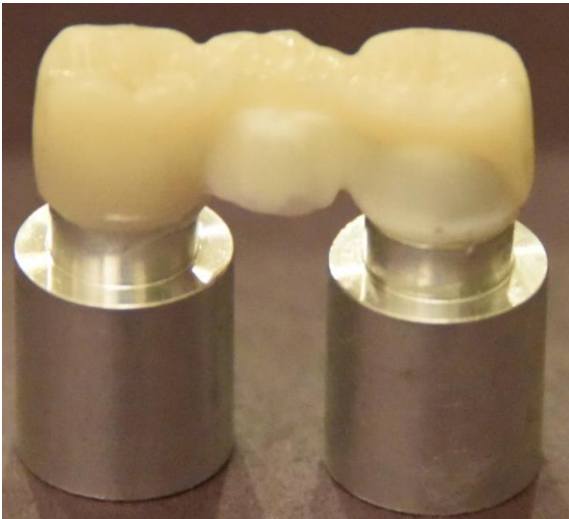
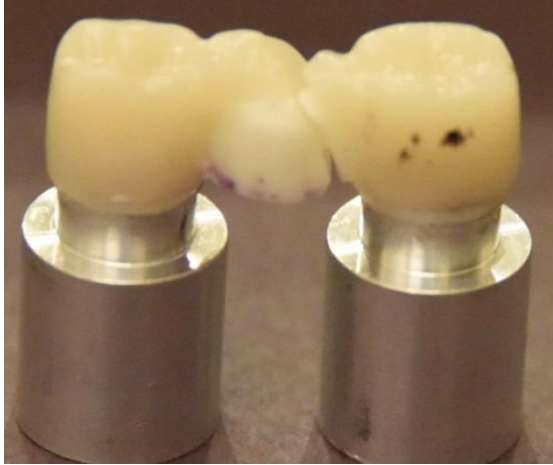
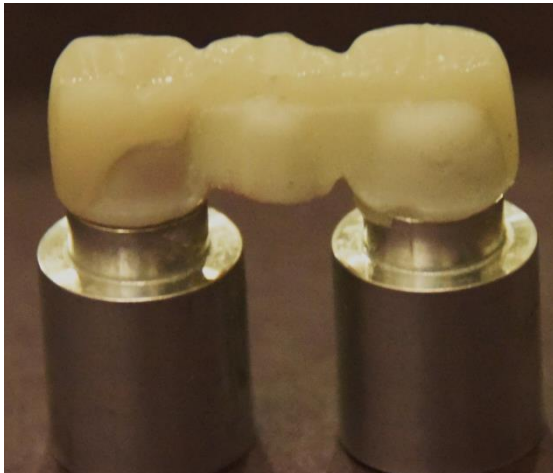
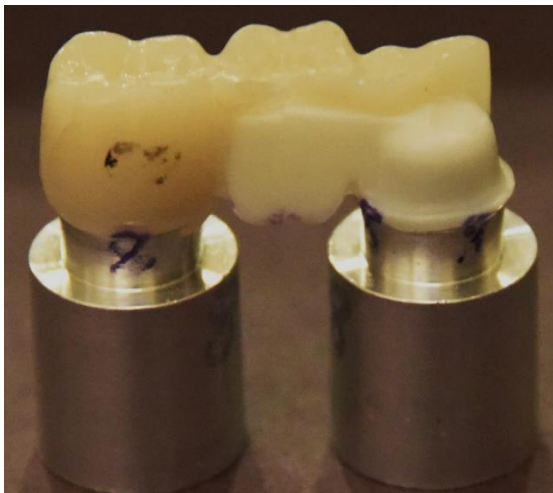
In the YZ-e.max cemented group there are four incidences of adhesive failure in the pontic, connector & coping area as well as an incidence of 1 specimen of adhesive and cohesive at the pontic area (Figures39-43)

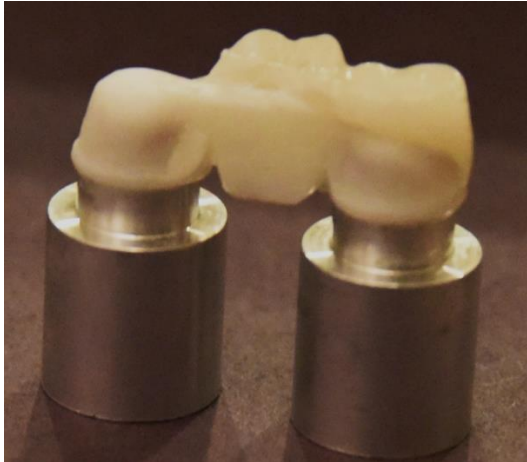
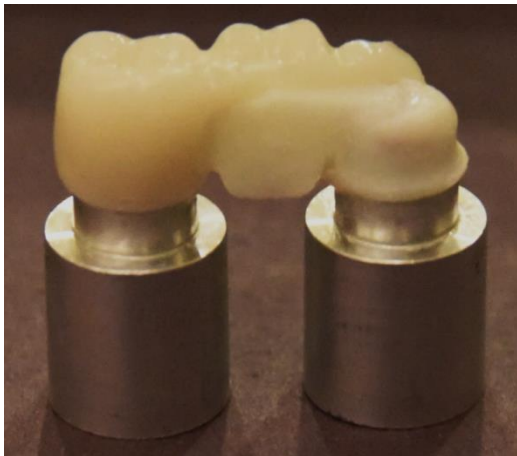
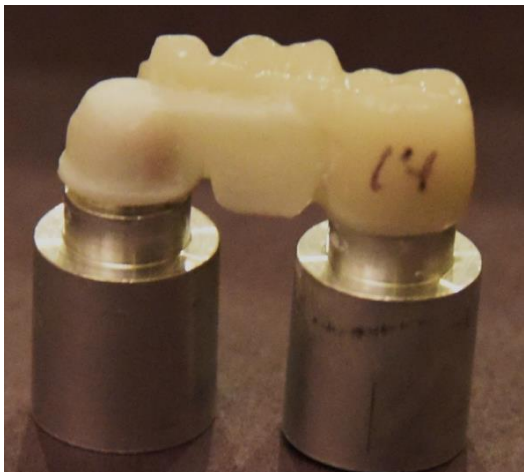
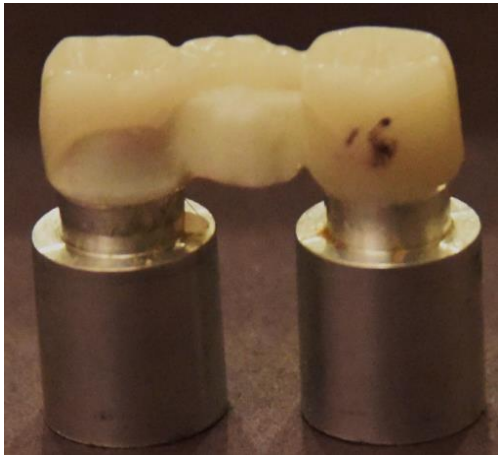
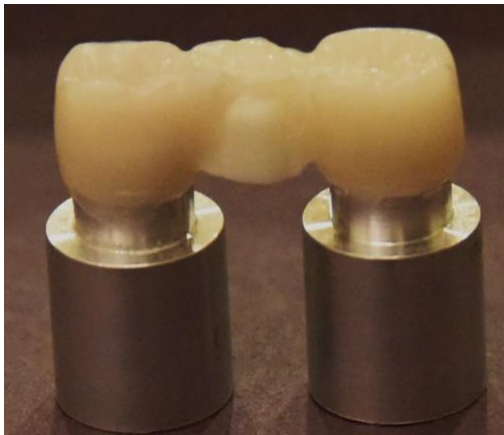
In YZ-Triluxe fused group there are four incidences of adhesive failure at the pontic, connector & coping area as there is one incidence of adhesive failure at the pontic area (Figures44-48)

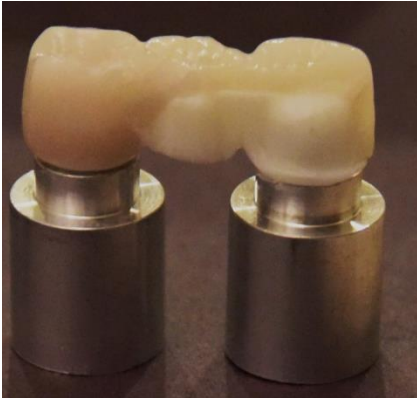
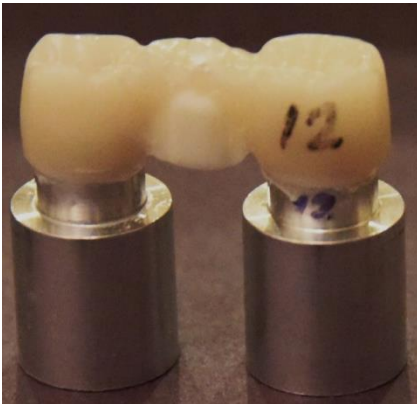
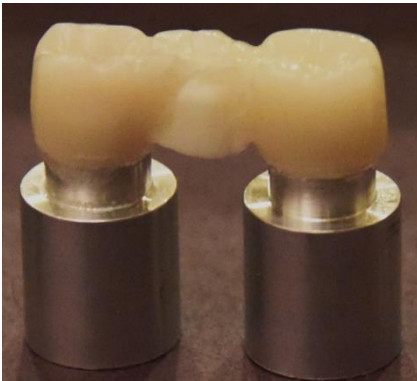
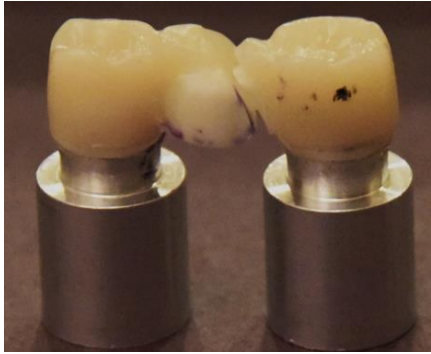
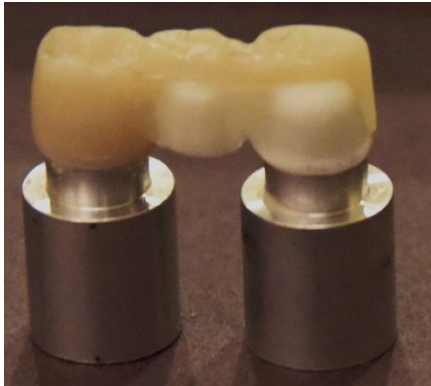
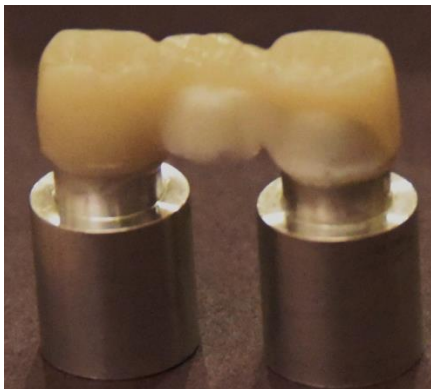
In YZ-Triluxe cemented group there are three incidences of adhesive failure at the pontic, connector & coping area as well as two incidences at pontic area, also we can see one incidence of cohesive and adhesive failure at pontic & connector area (Figures 49-54).

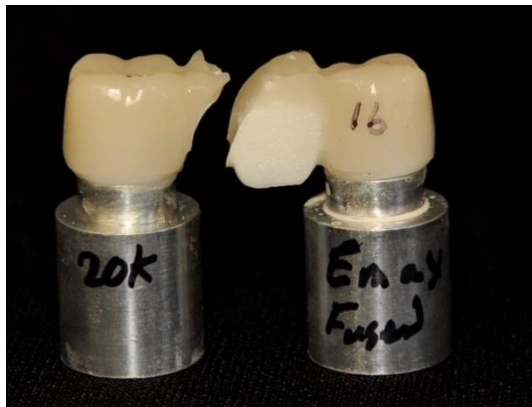
Figure 55: Sample# 16 (YZ-e.max fused 20K)

In YZ-e.max fused group that subjected to 20K cycles of the cycle fatigue showed adhesive failure at the pontic and cohesive failure at the pontic & connector area (Figure 55).

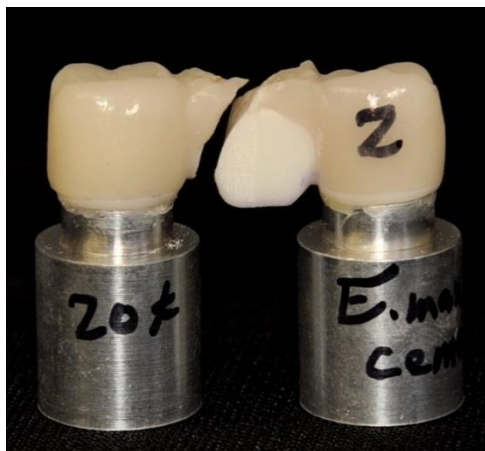
Figure 56: Sample# 2 (YZ-e.max cemented 20K)

In YZ-E.max cemented group that subjected to 20K cycles of the cycle fatigue showed adhesive failure at the pontic and cohesive failure at the pontic & connector area (Figure 56).

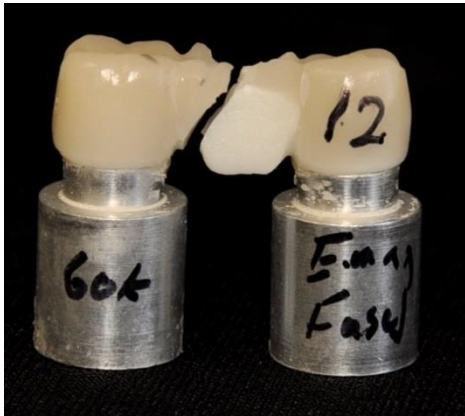
Figure 57: Sample# 12 (YZ-e.max fused 60K)

In YZ-e.max fused group that subjected to 60K cycles of the cycle fatigue showed adhesive failure at the pontic and cohesive failure at the pontic & connector area (Figure 57).

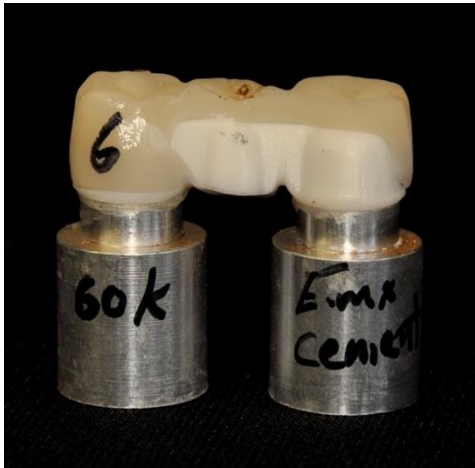
Figure 58: Sample# 6 (YZ-e.max cemented 60K)

In YZ-E.max cemented group that subjected to 60K cycles of the cycle fatigue showed adhesive failure at the pontic, connector & coping area (Figure 58).

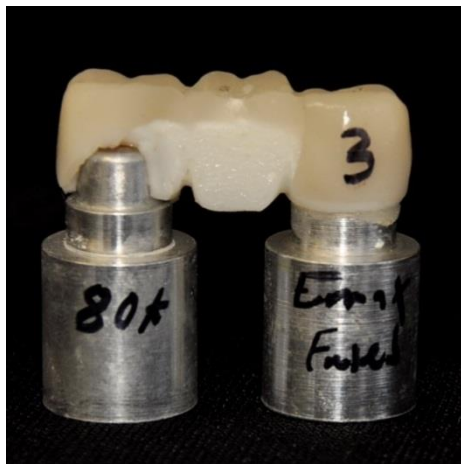
Figure 59: Sample# 3 (YZ-e.max fused 80K)

In YZ-e.max fused group that subjected to 80K cycles of the cycle fatigue showed adhesive failure at the pontic, connector & coping area (Figure 59).

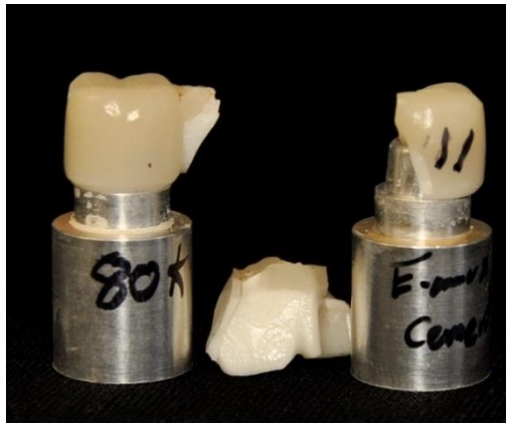
Figure 60: Sample# 11 (YZ-e.max cemented 80K)

In YZ-e.max cemented group that subjected to 80K cycles of the cycle fatigue showed a cohesive failure at the connector & coping area (Figure 60).

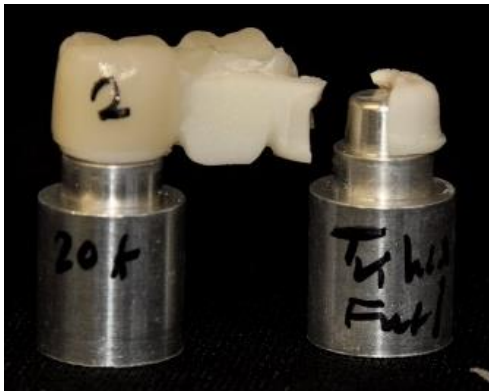
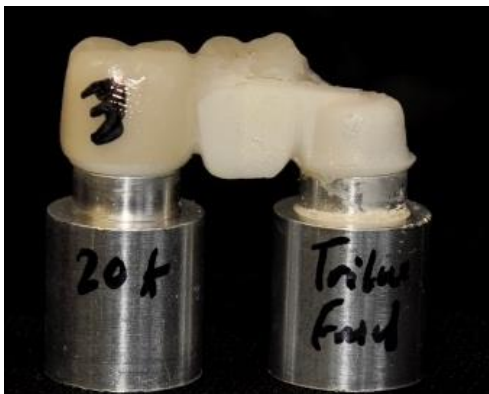
In YZ-Triluxe fused group that subjected to 20K cycles of the cycle fatigue showed one incidence of cohesive failure at coping area and two incidences of adhesive failure at the coping, connector & coping area (Figures 61-62).

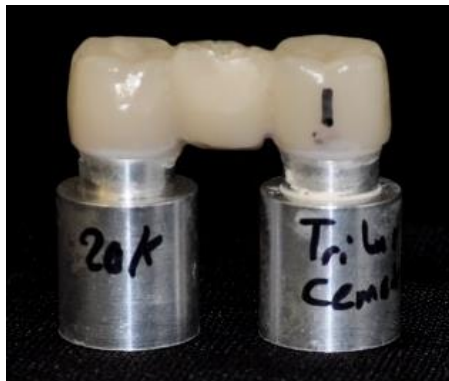
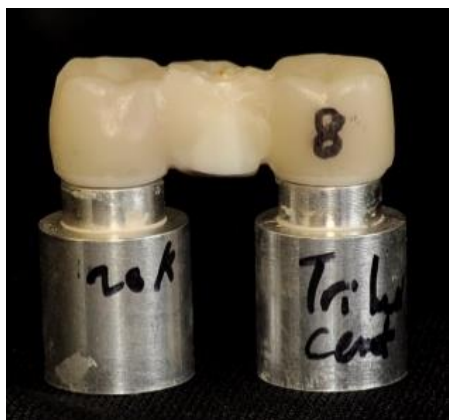
In YZ-Triluxe cemented group that subjected to 20K cycles of the cycle fatigue showed one incidence of cohesive and veneer failure at pontic (Figures 63-64).

Figure 63: Sample# 1 (YZ-Triluxe cemented 20K)

Figure 64: Sample# 8 (YZ-Triluxe cemented 20K)

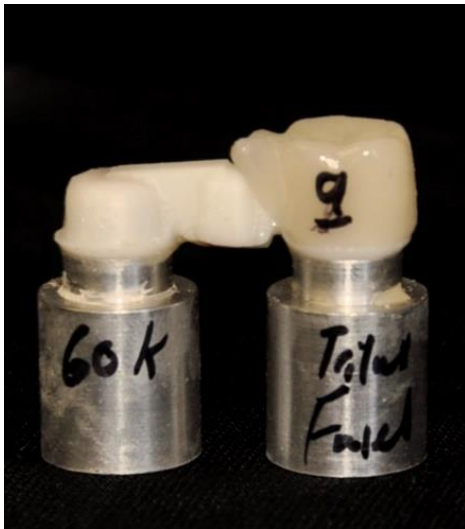
Figure 65: Sample# 9 (YZ-Triluxe fused 60K)

In YZ-Triluxe fused group that subjected to 60K cycles of the cycle fatigue showed one incidence of adhesive failure at pontic, connector & coping area (Figure 65).

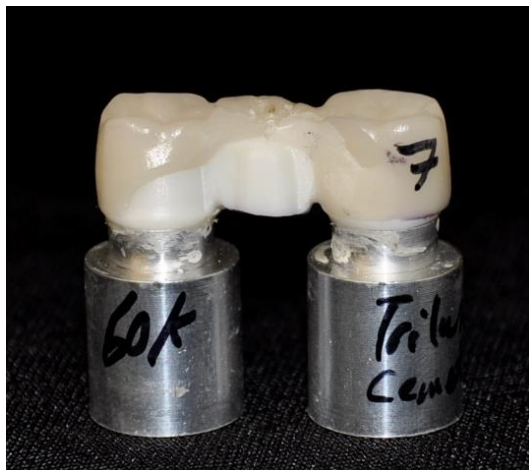
Figure 66: Sample# 7 (YZ-Triluxe cemented 60K)

In YZ-Triluxe cemented group that subjected to 60K cycles of the cycle fatigue showed an incidence of veneer failure at coping area and a cohesive failure at pontic, connector & coping area (Figure 66).

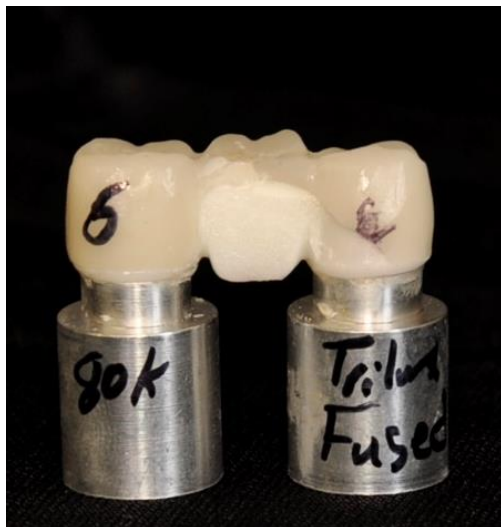
Figure 67: Sample# 6 (YZ-Triluxe fused 80K)

In YZ-Triluxe fused group that subjected to 80K cycles of the cycle fatigue showed one incidence of adhesive failure at pontic, connector & coping area (Figure 67).

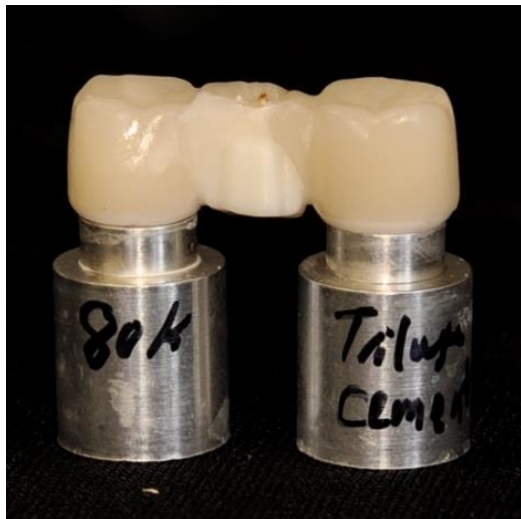
Figure 68: Sample# 4 (YZ-Triluxe cemented 80K)

In YZ-Triluxe cemented group that subjected to 80K cycles of the cycle fatigue showed one incidence of adhesive failure at pontic area (Figure 68).

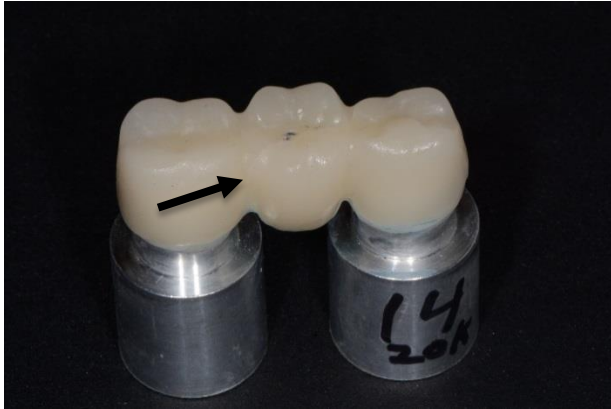
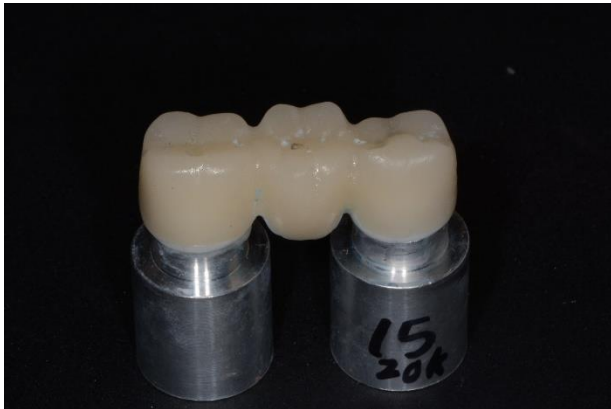
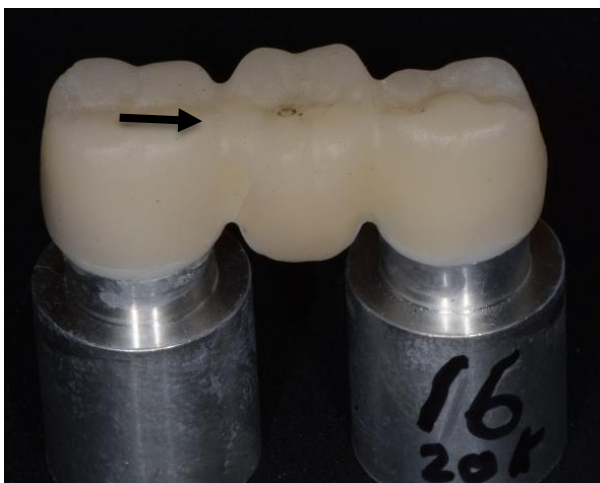
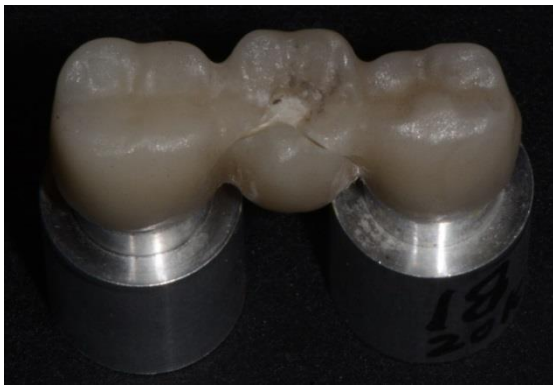
In YZ-e.max cemented aged group that subjected to 20K cycles in cyclic fatigue test; there are three incidences of veneer failure at the pontic & connector area and one at pontic, connector & coping area , as there is one incidence of adhesive failure at the pontic area (Figures 69-73).

Figure 69: Sample# 14 (YZ-e.max cemented aged 20K)

Figure 70: Sample# 15 (YZ-e.max cemented aged 20K)

Figure 71: Sample# 16 (YZ-e.max cemented aged 20K)

Figure 73: Sample# 18 (YZ-e.max cemented aged 20K)

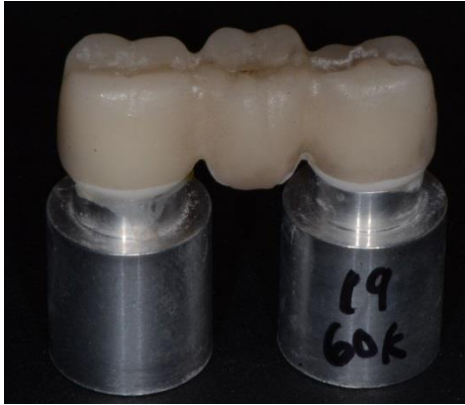
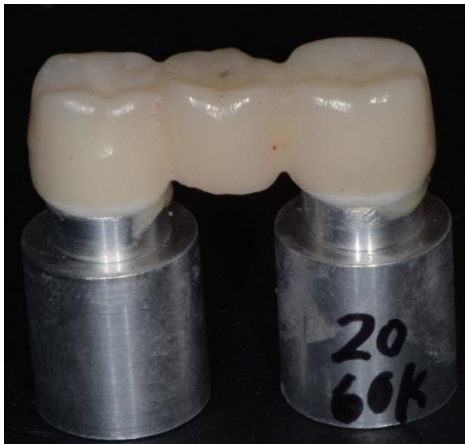
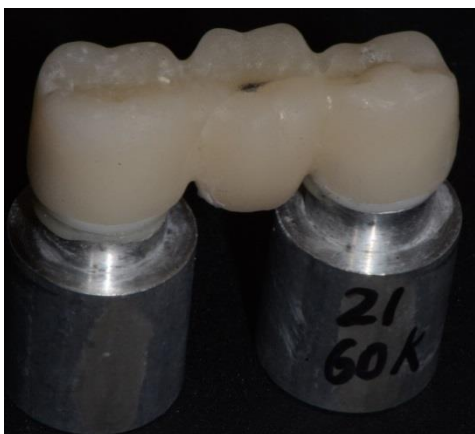
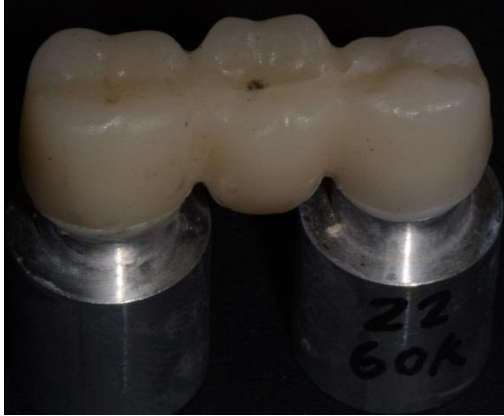
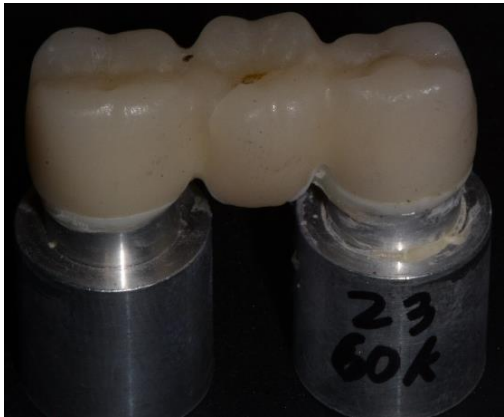
In YZ-e.max cemented aged group that subjected to 60K cycles in cyclic fatigue test; there are three incidences of veneer failure at the pontic & connector area (Figures 74-78).

Figure 74: Sample# 19 (YZ-e.max cemented aged 60K)

Figure 75: Sample# 20 (YZ-e.max cemented aged 60K)

Figure 76: Sample# 21 (YZ-e.max cemented aged 60K)

Figure 77: Sample# 22 (YZ-e.max cemented aged 60K)

Figure 78: Sample# 23 (YZ-e.max cemented aged 60K)

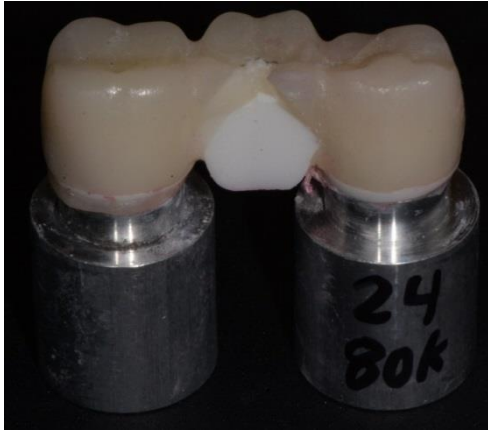
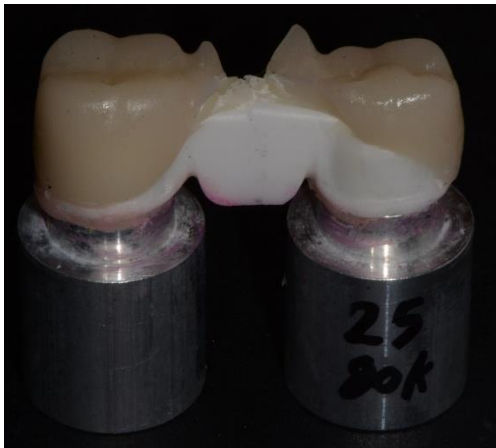
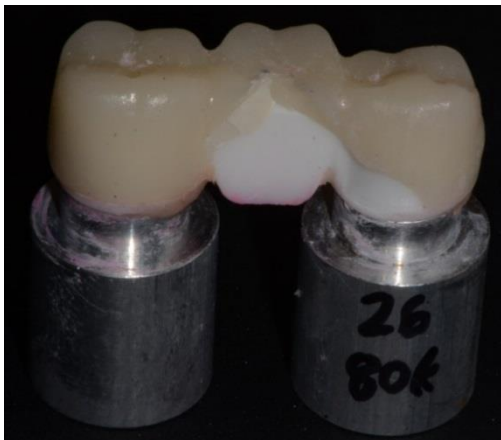
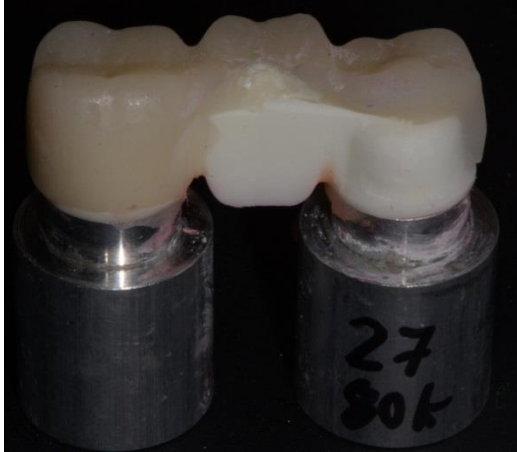
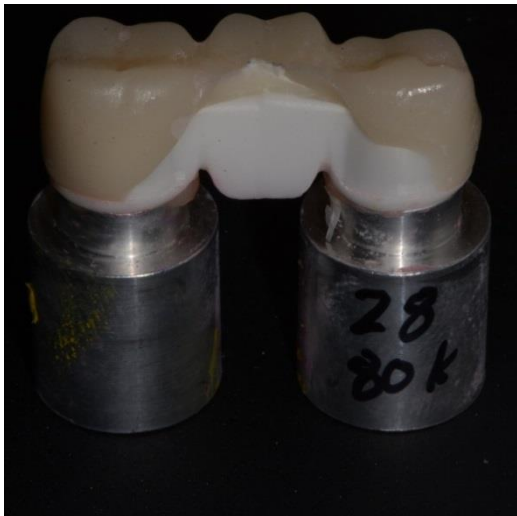
In YZ-E.max cemented aged group that subjected to 80K cycles in cyclic fatigue test; there are four incidences of adhesive failure at the pontic, connector & coping area as well as one incidence of adhesive failure at the pontic area (Figures 79-83).

Figure 79: Sample# 24 (YZ-e.max cemented aged 80K)

Figure 80: Sample# 25 (YZ-e.max cemented aged 80K)

Figure 81: Sample# 26 (YZ-e.max cemented aged 80K)

Figure 82: Sample# 27 (YZ-e.max cemented aged 80K)

Figure 83: Sample# 28 (YZ-e.max cemented aged 80K)

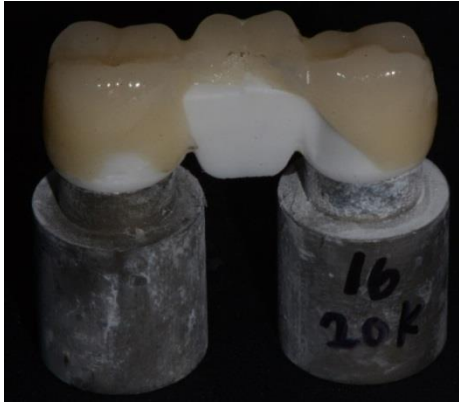
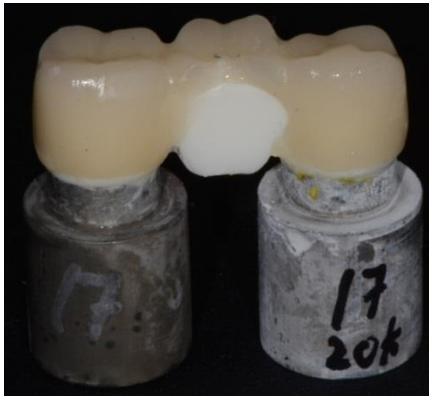
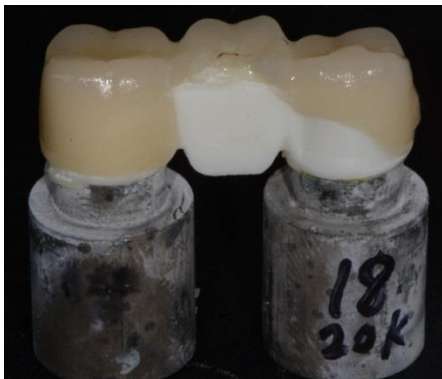
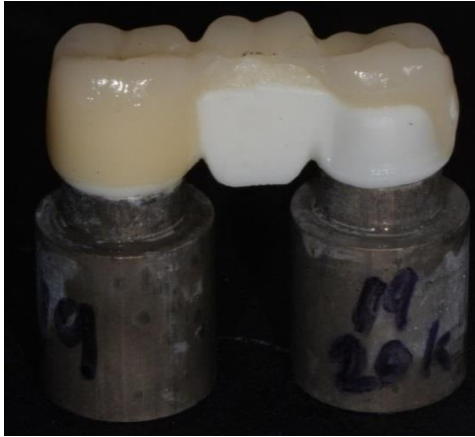
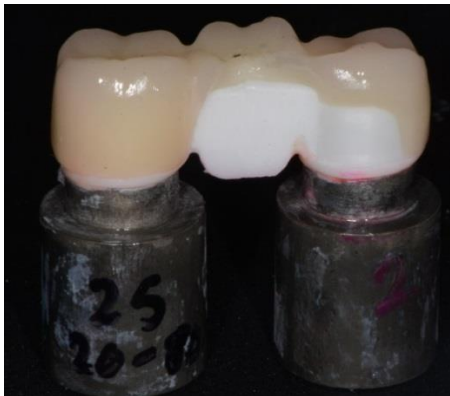
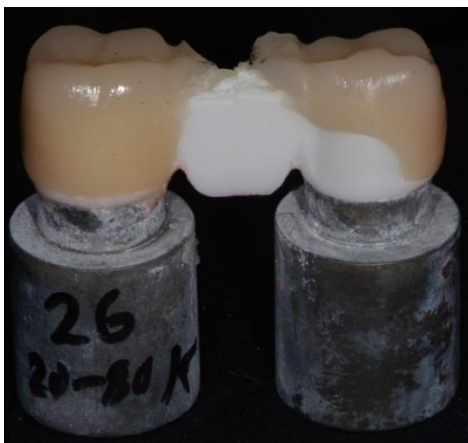
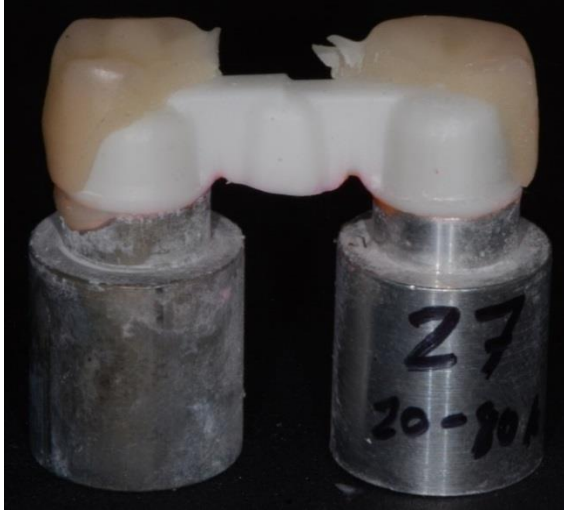
In YZ-Triluxe cemented aged group that subjected to 20K cycles in cyclic fatigue test; there are six incidences of adhesive failure at the pontic, connector & coping area and two adhesive failure at the pontic area only as well as one incidence of veneer failure at the pontic area (Figures 84-90).

Figure 84: Sample# 16 (YZ-Triluxe cemented aged 20K)

Figure 85: Sample# 17 (YZ-Triluxe cemented aged 20K)

Figure 86: Sample# 18 (YZ-Triluxe cemented aged 20K)

Figure 87: Sample# 19 (YZ-Triluxe cemented aged 20K)

Figure 88: Sample# 25 (YZ-Triluxe cemented aged 20K)

Figure 89: Sample# 26 (YZ-Triluxe cemented aged 20K)

Figure 90: Sample# 27 (YZ-Triluxe cemented aged 20K)

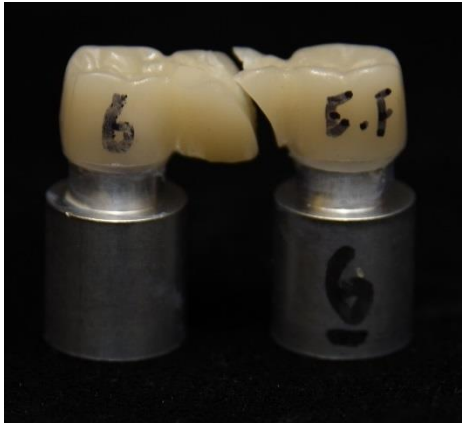
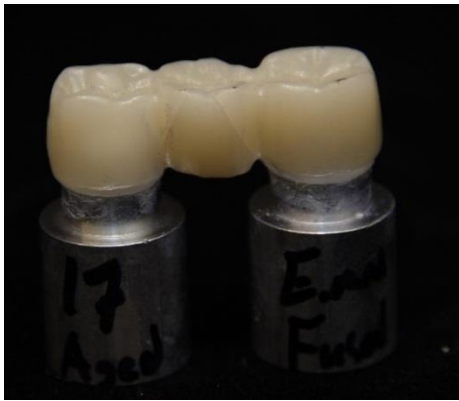
In YZ-e.max fused aged group there is one incidence of veneer failure at the pontic area and one incidence of cohesive failure at the pontic & connector area (Figures 91-92).

Figure 91: Sample# 6 (YZ-e.max fused aged)

Figure 92: Sample# 7 (YZ-e.max fused aged)

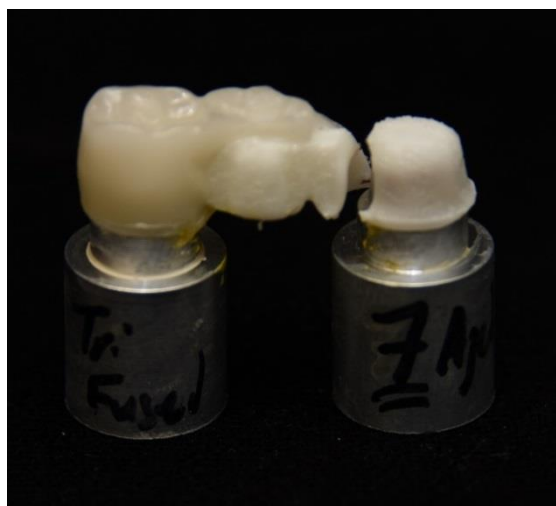
Figure 94: Sample# 7 (YZ-Triluxe fused aged)

In YZ-Triluxe fused aged group there is one incidence of cohesive failure at the coping area and two incidences of adhesive failure at the pontic, connector & coping area (Figures 93-94).

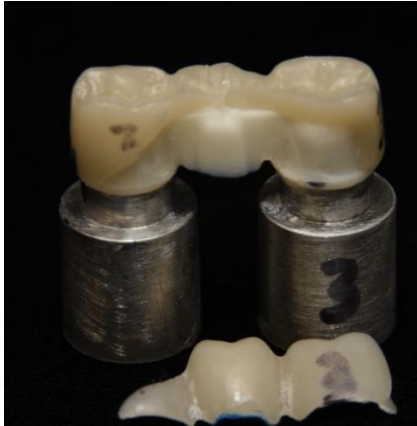
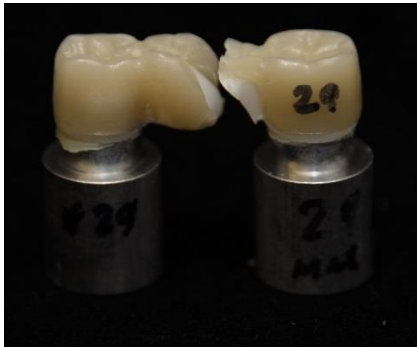
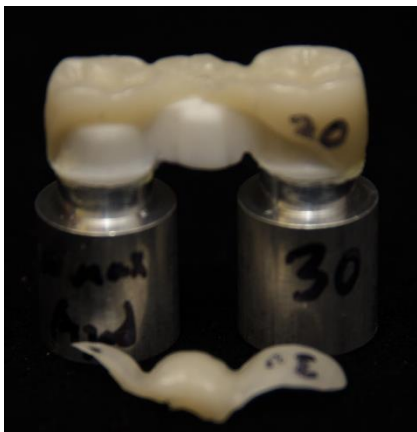
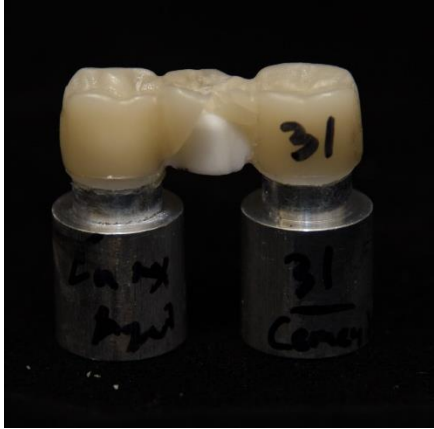
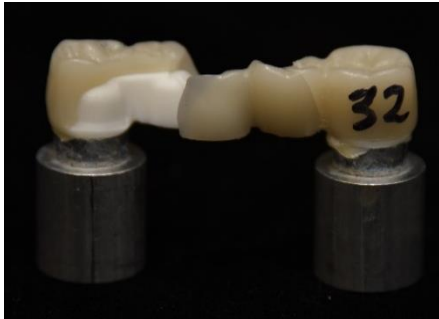
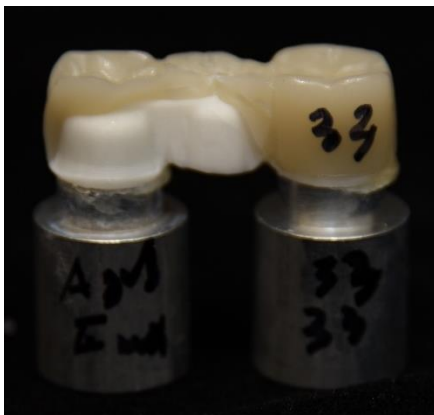
In YZ-e.max cemented aged group there is one incidence of adhesive failure at the pontic area and one incidence of cohesive failure at the connector as well as four incidences of adhesive failure at the pontic, connector & coping area (Figures 95-100).

Figure 95: Sample# 3 (YZ-e.max cemented aged)

Figure 96: Sample# 29 (YZ-e.max cemented aged)

Figure 97: Sample# 30 (YZ-e.max cemented aged)

Figure 98: Sample# 31 (YZ-e.max cemented aged)

Figure 99: Sample# 32 (YZ-e.max cemented aged)

Figure 100: Sample# 33 (YZ-e.max cemented aged)

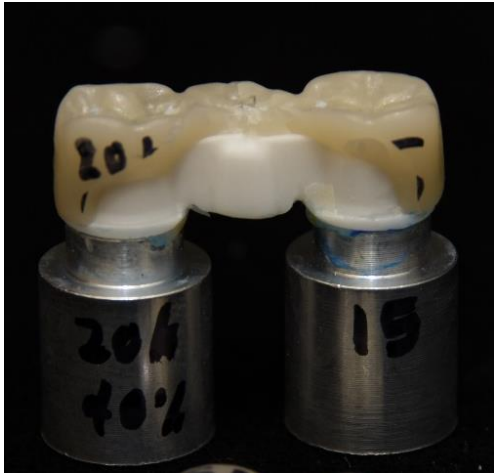
Figure 101: Sample# 15 (YZ-e.max cemented aged 20K 40%)

In YZ-e.max aged cemented 20K cycles group there is one sample survived with adhesive failure at the pontic, connector & coping area (Figure 101).

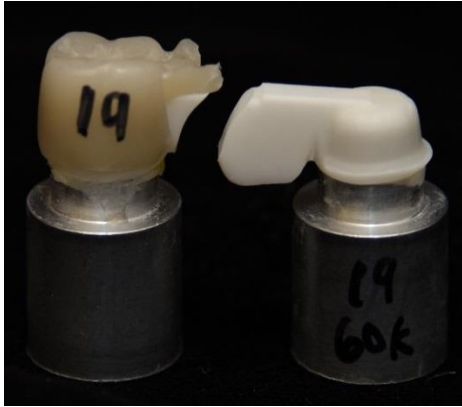
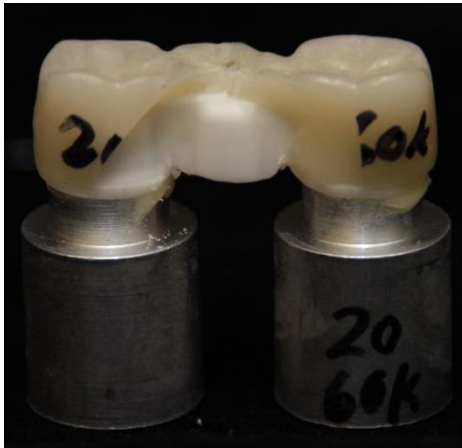
In YZ-e.max cemented aged 60K cycles group there are two samples survived and showed two incidences of adhesive failure at pontic, connector & coping area and one incidence of cohesive failure at connector area (Figures 102-103).

Figure 102: Sample# 19 (YZ-e.max cemented aged 60K 40%)

Figure 103: Sample# 20 (YZ-e.max cemented aged 60K 40%)

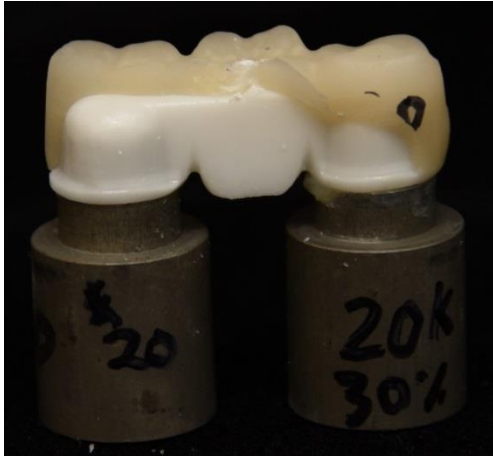
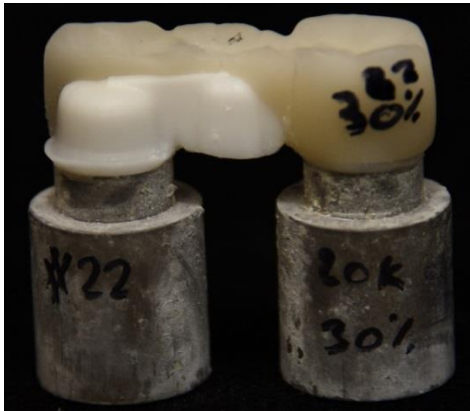
In YZ-Triluxe cemented aged 20K cycles 30% of load group two specimens survived and showed after load to failure test an adhesive failure at the pontic, connector & coping area (Figures 104-105).

Figure 104: Sample# 20 (YZ-Triluxe aged cemented 20K 30%)

Figure 105: Sample# 22 (YZ-Triluxe aged cemented 20K 30%)

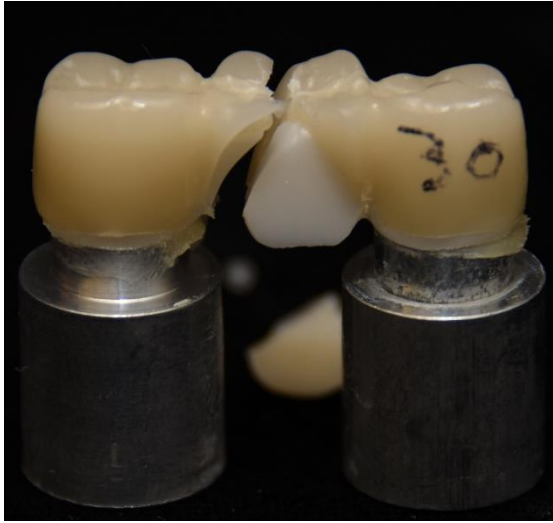
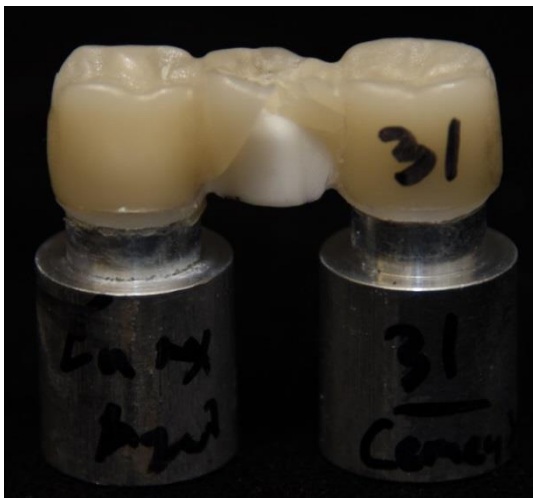
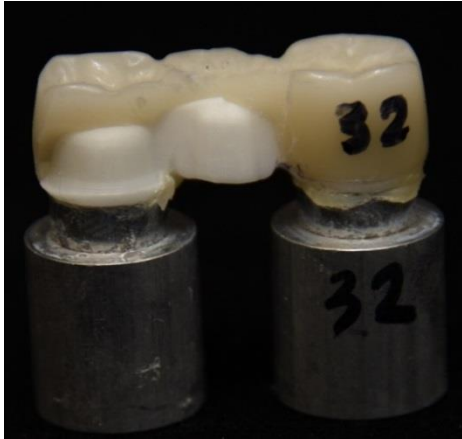
In YZ-Triluxe cemented aged group there are two incidence of cohesive failure at the pontic & connector area and one incidence of adhesive failure at the pontic area as well as four incidences of adhesive failure at the pontic connector & coping area (Figures 106-110).

Figure 106: Sample# 30 (YZ-Triluxe cemented aged)

Figure 107: Sample# 31 (YZ-Triluxe cemented aged)

Figure 108: Sample# 32 (YZ-Triluxe cemented aged)
