Stream Restoration and Meanders Position

Case Study of Černý potok, Ore Mountains, Czech Republic

Dissertação submetida para obtenção do grau de
MESTRE EM ENGENHARIA DO AMBIENTE – RAMO DE GESTÃO

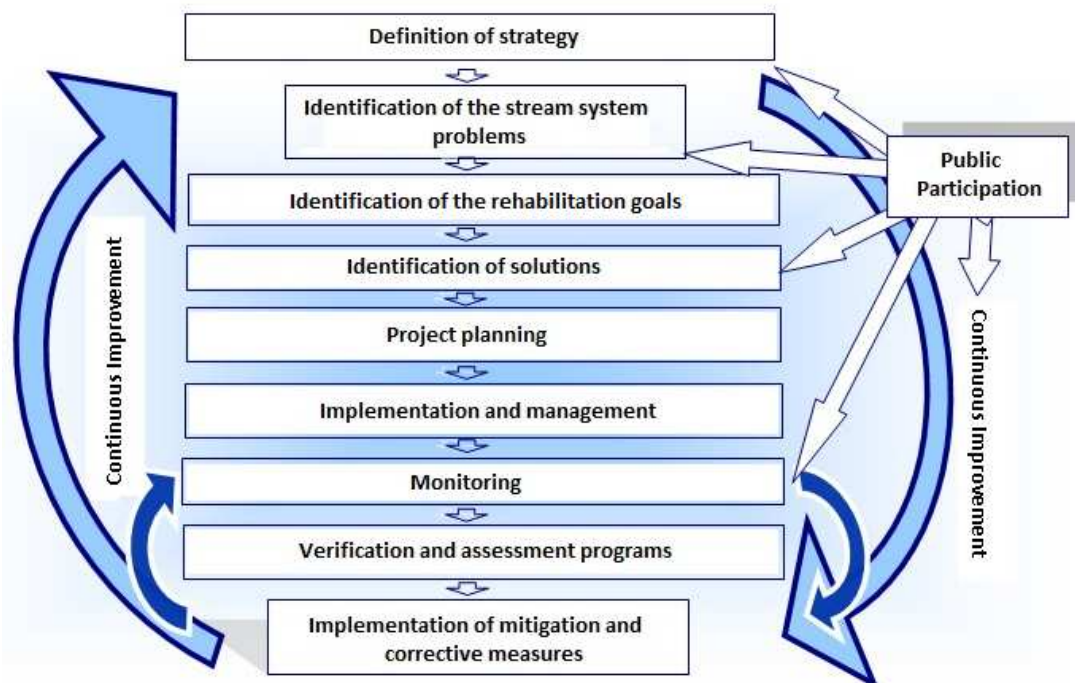
Fig.2: General scheme for the basic steps of stream rehabilitation (adapt. Teiga et al 2007)

Addressing to the *environmental management* issues, efforts have been made to compile information and systematize the conception of a restoration project, in order to avoid mistakes which can possibly lead to unsuccessful restoration or unpredicted/undesired results. There are some variants but the main idea has a common ground. In Figure 2 is presented the Teiga et al. approach to a methodology of river restoration. Focusing on the “continuous improvement” it is strongly reinforced the authors’ idea that assessment is an important step towards effective rehabilitation and should follow technical and scientific bases, providing comparable results, values which can also help evaluating the evolution of the measures implemented.

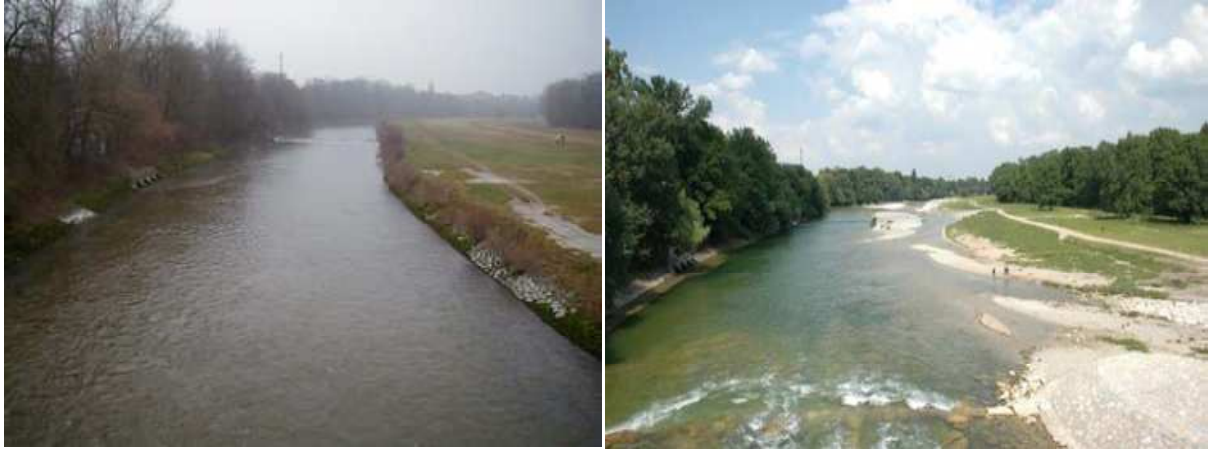
Fig.3 and 4: The Isar River before and after restoration (Arzet and Joven)

Perhaps, one of the most emblematic successful projects of restoration in Europe is the restoration of the Isar River, an urban river restoration project along 8 km, implemented in Munich, Germany. The “Isar Plan”, with estimated costs rounding 30 million Euros, started to be conceptualized in the 80’s, was launched in 1995 and the completion planned by 2011. The main channel was widened, the forelands were incorporated along the river and the floodplains and steep embankments secured with concrete and paving were replaced with flat and naturally developing banks. Also the artificially channelized river bed was transformed into a river bed of varying width with gravel banks and gravel stone islands in a system of dynamical evolution movements. It contemplates local flood protection, valorization of habitats for fauna and flora, the proving of a natural landscape within the city, creating the possibility of leisure and recreational use and, therefore, an overall investment in the future with a nature-oriented redesign of a river with an urban lifestyle of immeasurable value for the population (REURIS).

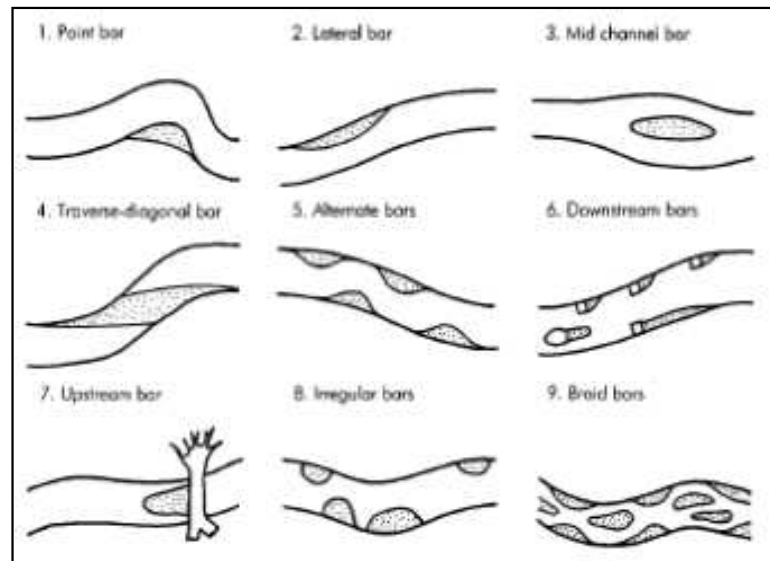
Fig. 7: Deposition of sediments in a stream

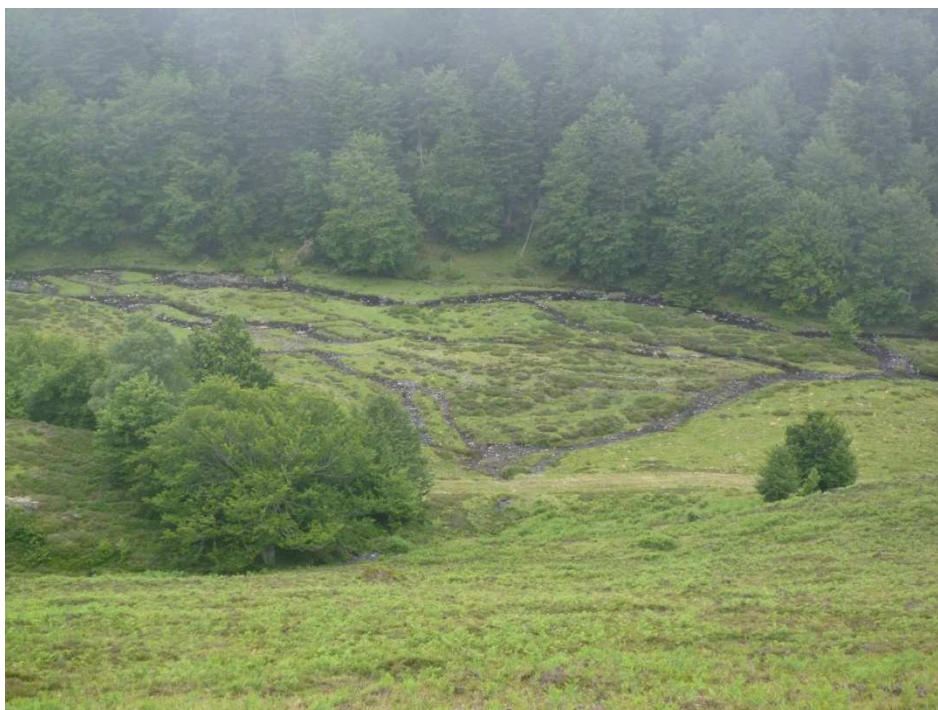
Fig. 9: Braided stream in the French Pyrenees (by Jan Říha)

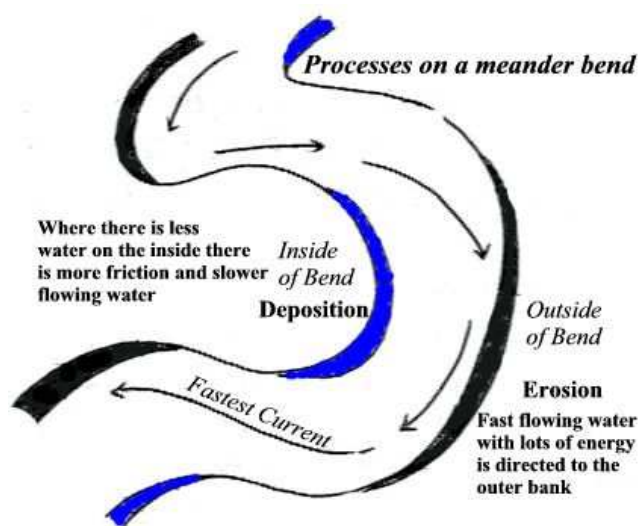
Fig.10 : Erosion and deposition on a meander (Dynamic Planet 2011/2012)

Studying meanders means studying the process of taking the eroded material from one river bank and making deposits of sediment on the opposite river bank (Neruda, 2010), according to the scheme of Fig. 10.

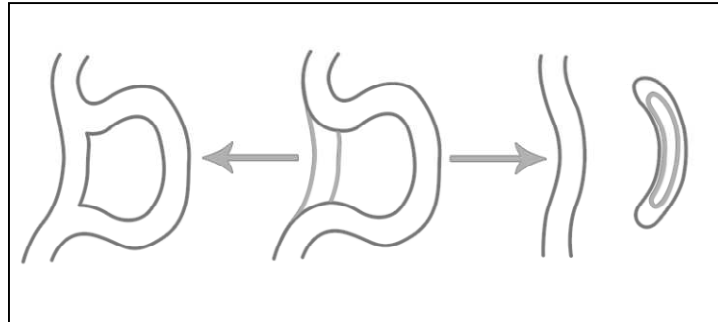
Fig.11 : Cutoff of a meander

These authors discovered that most rivers have a curvature radius to channel width ratio of 2-3 and are usually straight for less than 10 river widths. It should be the flow dynamics, particularly helical flow, and energy dissipation determining the meander shape. The curvature of a river decreases the sediment transport because of the dissipation of energy. They also observed that bank erosion occurs in a bend of a meander and an equal amount of deposition occurs on the opposite bank so that the channel moves across its floodplain. If a channel does not move in its floodplain, then the material eroded from the curve will be transported until a point bar on the same side of the channel downstream. It should be understood that these are energetic processes but, although meanders cause energy loss, they are the configurations found in curved channels which offer the smallest energy loss. In this context, it is interesting to observe the phenomenon of **cutoff** or headcutting. When cutoff happens, the stream abandons

one meander curve and opens a new shorter channel to the flow of water, as represented on the following picture.

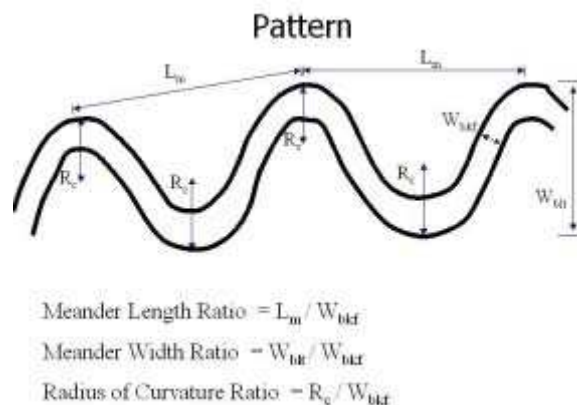
Fig. 13: Meander length, meander width and radius of curvature ratios (N.C. Department of Environment and Natural Resources)

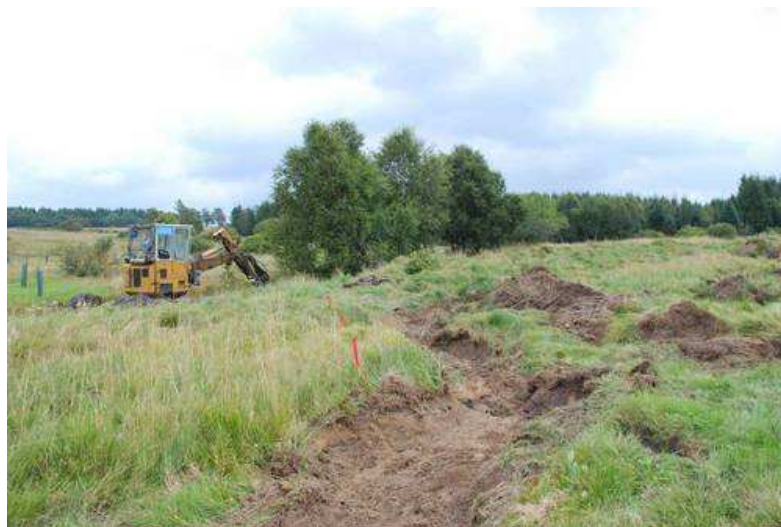
Fig. 21: Machinery opening meanders in the upper part of the stream (by ANCLP CR)

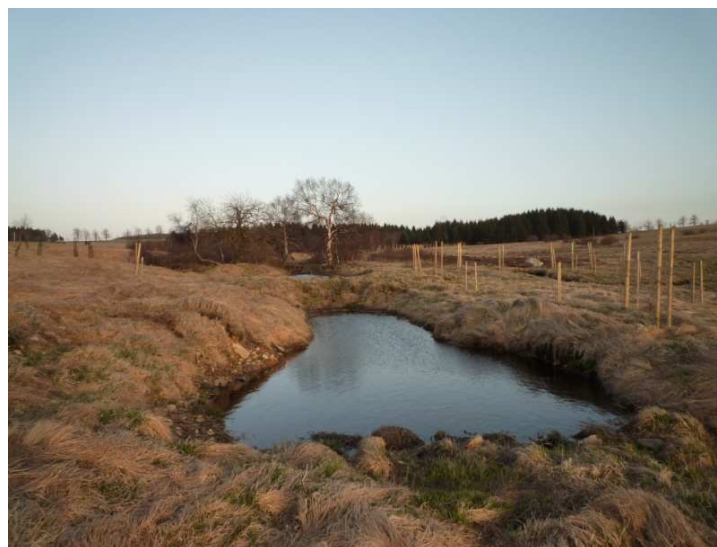
Fig 22: Pools created in the old channel and planted trees (by Jan Říha)

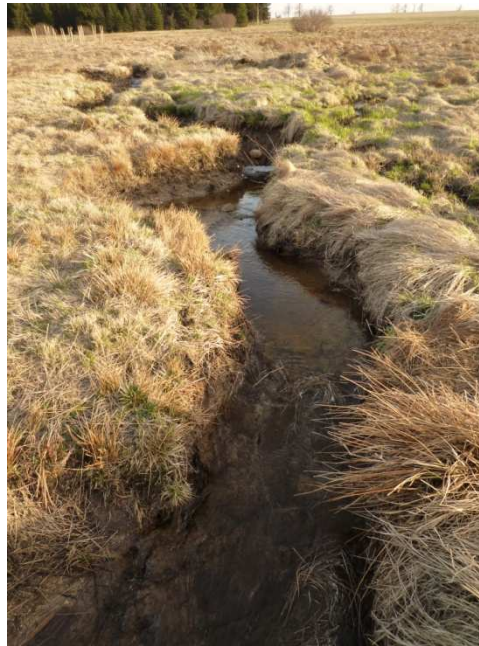
Fig.23 : New meanders (by Jan Říha)

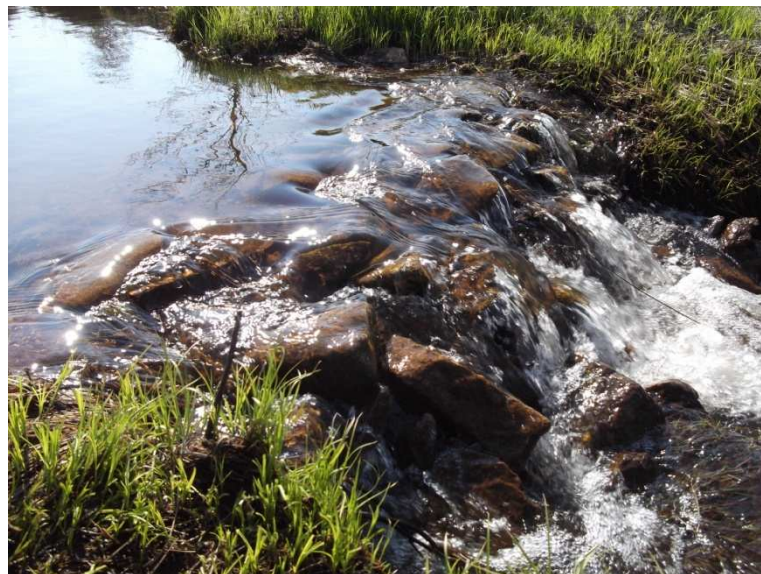
Fig.24 : Step built with rocks (by Jan Říha)

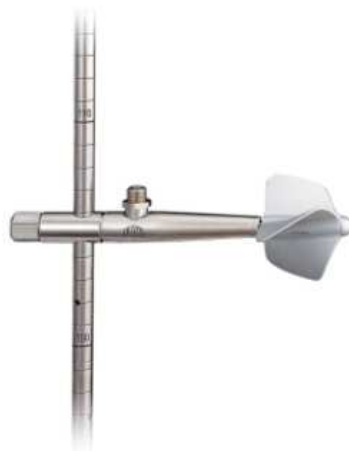
Fig. 26: OC TT2 current meter

The current meter was assembled and the survey location was the starting point of the meanders study section. It was introduced in the water in the thalweg zone of the cross section and during 40 seconds the device measured the number of turns given by the propeller on the middle of the thalweg and close to the water surface. The number of turns given (N) was then divided by 40 seconds, resulting the number of turns per second (n), and according to the calculated value, a specific calibration equation associated to the current meter was chosen to convert the value n into flow velocity (in m/s) and calculate the discharge of the stream in that cross section, (in l/s).

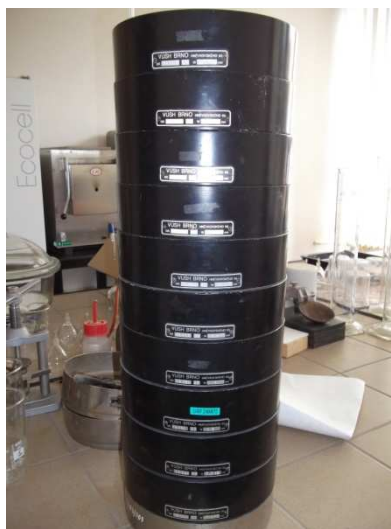
Fig. 27: Column of sieves used

Due to these inaccuracies in the application of the pebble count, a granulometry test was conducted in the laboratory to the collected samples of a sediments deposit, bank material and stream bead material from a pool. From every sample was collected 100g three times to conduct sieving tests. In the end, the particles diameter distribution was calculated.

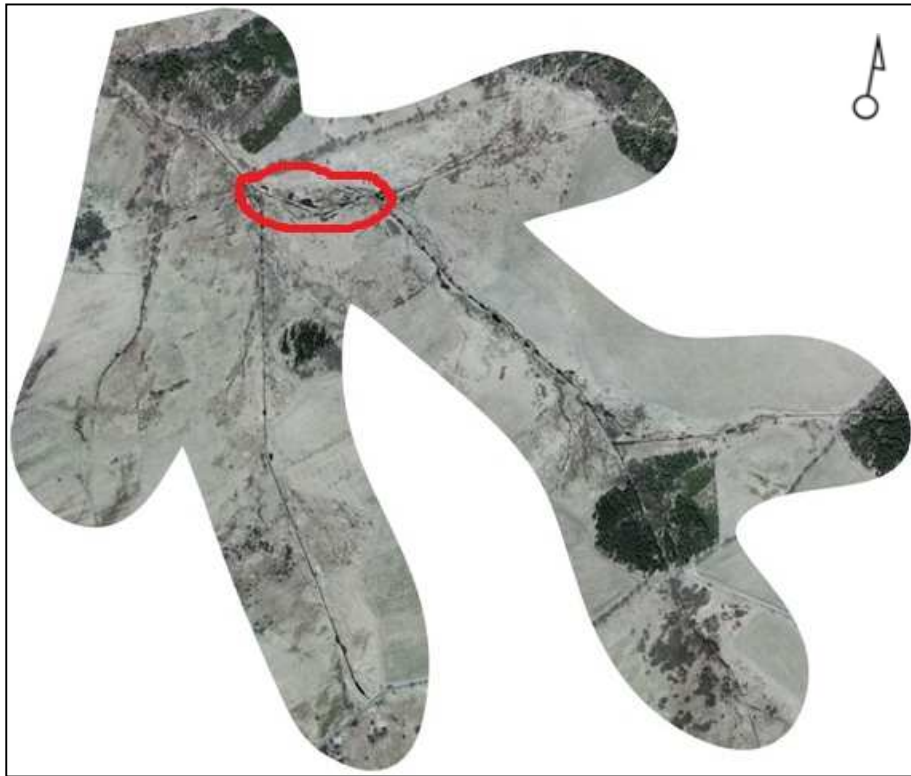
Fig. 29: Ortophoto (2010) of Černý potok and the chosen study site

To every measured point is associated a set of “x, y, z” coordinates. ArcGis is capable of reading those coordinates and associate them to the ortophoto data. The measured points can then be represent in the ortophoto to allow further measurements and calculations.

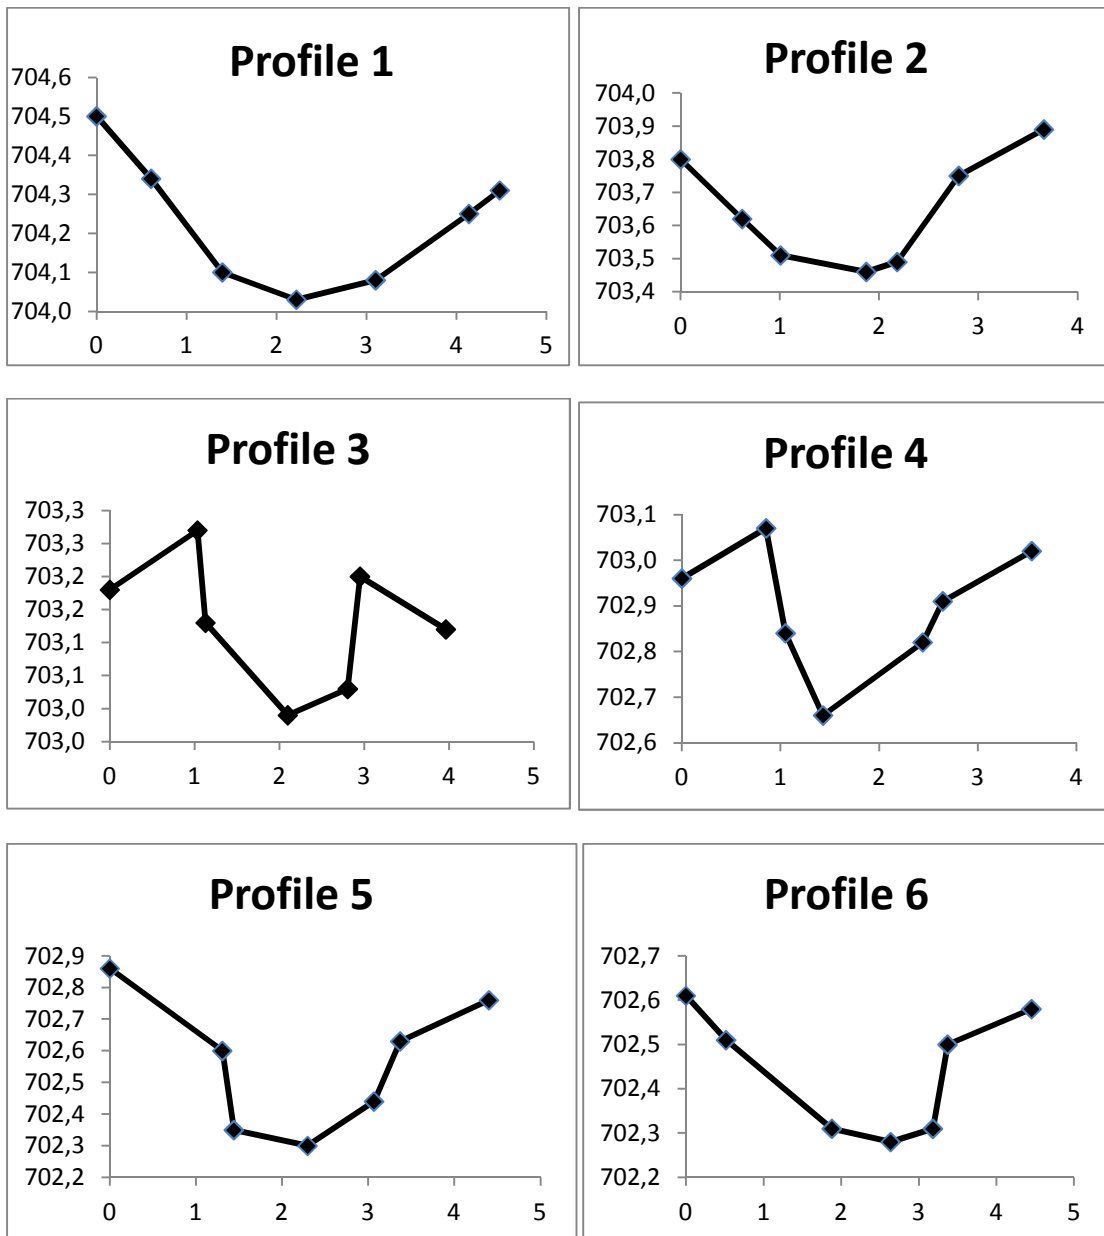
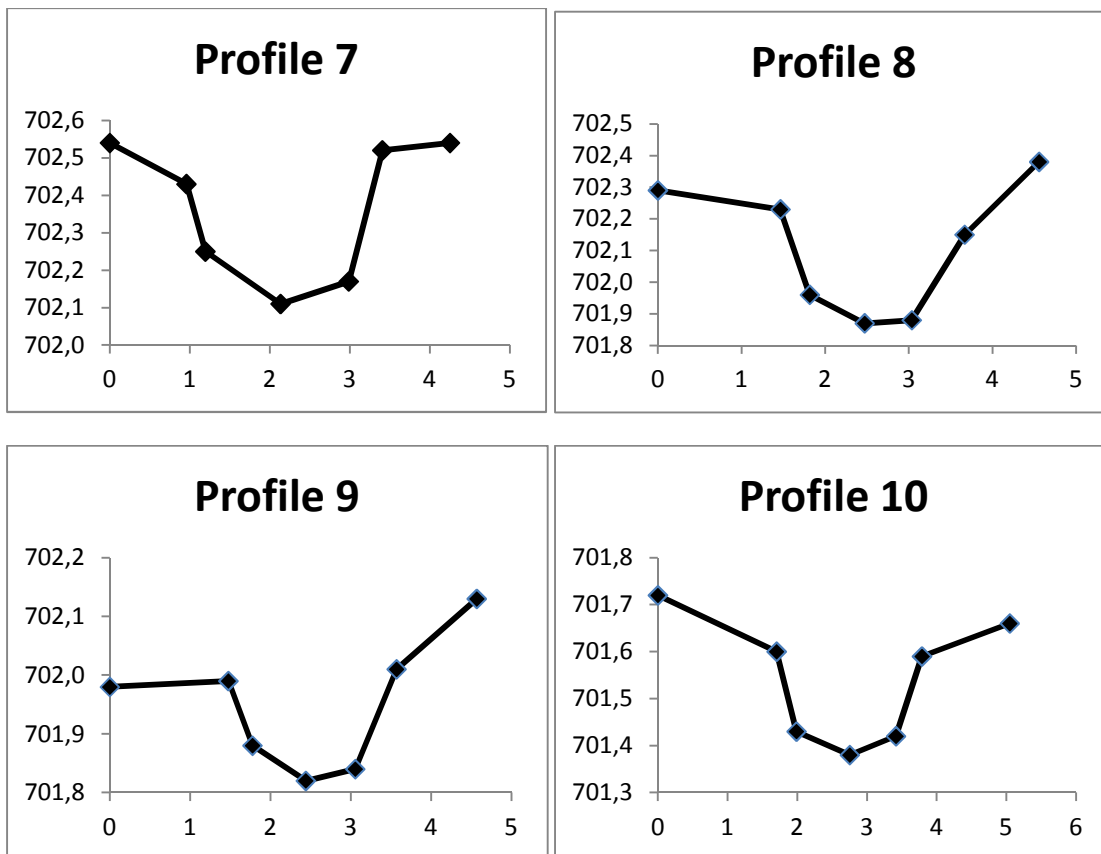
Fig. 31 (1 to 10): Graphic representation of the 10 cross section profile; in each graphic, from the left to the right, the represented points correspond to 7 measured points of the profiles (in meters)

The first calculations were made to represent the 10 cross section profiles. In the ArcGis, the data of the 7 measured points of every profile were plotted as XY coordinates and in Excel the representative graphics of the profiles were created. While reading the graphics, the scheme of the geodetic measured points in the cross sections (Table 2, page 44) should be taken into consideration, as well as the fact that the terrain is highly irregular.

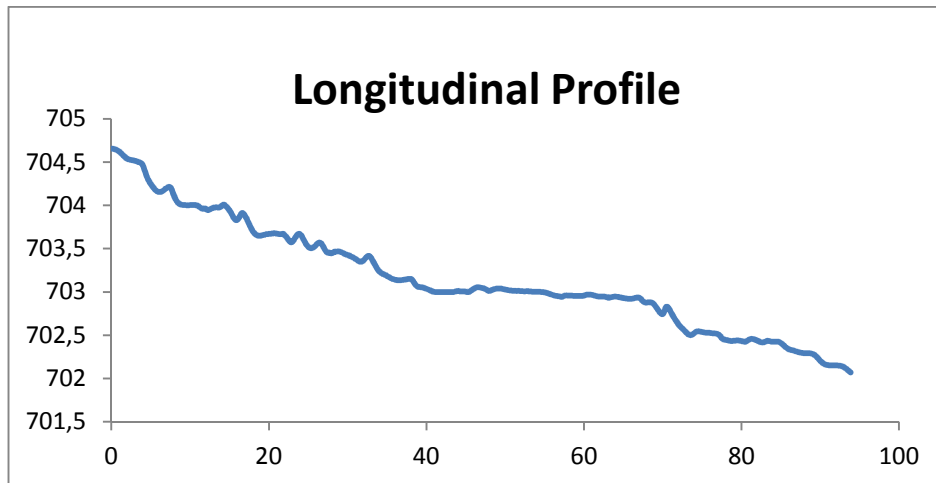
Fig. 32: Longitudinal profile of the stream from cross section 1 to 10 (the decrease of elevation on the flow direction, in meters)

between the surveyed sections of the stream. The slope between profile 1 and profile 10 was calculated with the ArcGis tool of editing, merging and planarization function. The plotting of the data was done on the same assumptions explained previously and graphic representation was made.

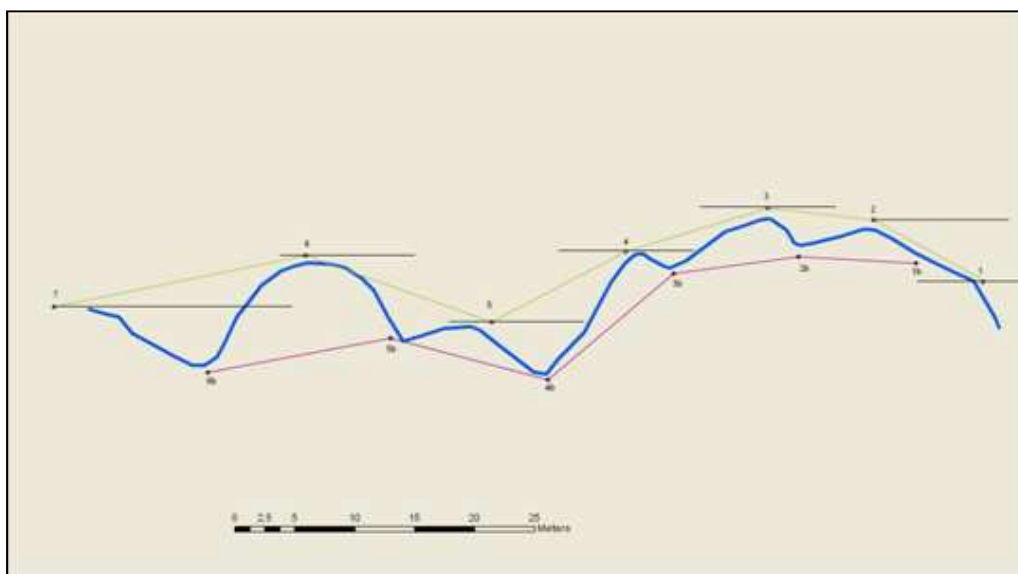
Fig. 34: Scheme of the first attempt to calculate the geometric characteristics of the meanders; the blue line corresponds to the central line of the stream created by drawing over the orthophoto of 2010; the yellow and purple limits were defined by joining the points which were marked on the orthophoto to represent the outer limits of the meander bend; those would be the references to calculate distances with the ArcGis measurement tools.

The second obstacle mentioned actually lead to the necessity of simplifying the first attempt to define the geometry of the meanders in study. It was tried to define the points which would represent the outer limits of the meander, in the adjacent bank, by reading the ortophoto, but the subjectivity and the uncertainty implied called for a different approach.
