Continuous dynamic monitoring of bridges: Different perspectives of application

Álvaro Cunha^{1,a}, Elsa Caetano^{1,b}, Carlos Moutinho^{1,c} and Filipe Magalhães^{1,d}

¹ViBest, Faculty of Engineering, University of Porto (FEUP), R.Dr. Roberto Frias, Porto, Portugal

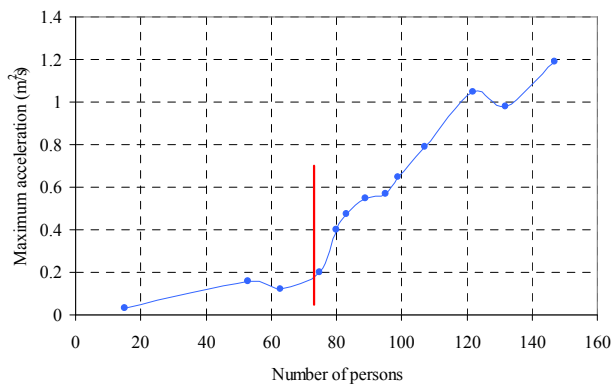
Figure 3: Variation of the amplitude of lateral accelerations at mid-span with the number of pedestrians

At last, with the purpose of analysing experimentally the lateral behaviour of the bridge, a test was conducted using the action of a continuous stream of pedestrians walking freely along the structure, with a gradually increased number of persons. As showed in Figure 3, the increase of acceleration with the number of pedestrians on the bridge is not linear, but instead exhibits a “jump” precisely for values of the number of pedestrians close to 70. This value is in perfect agreement with the formula developed in the context of the studies of the Millennium Bridge, in London, to estimate the critical number of pedestrians N_L above which significant lateral oscillations may occur, which led to an estimate of $N_L=73$ pedestrians. Extreme values of acceleration of $\pm 1.2 \text{ m/s}^2$ (about 12 times higher the limit value suggested in the recent SETRA [3] and HIVOSS [4] guidelines) were measured at the mid-span section, corresponding to a dynamic displacement of $\pm 4 \text{ cm}$, occurring when 145 pedestrians were walking on the bridge.

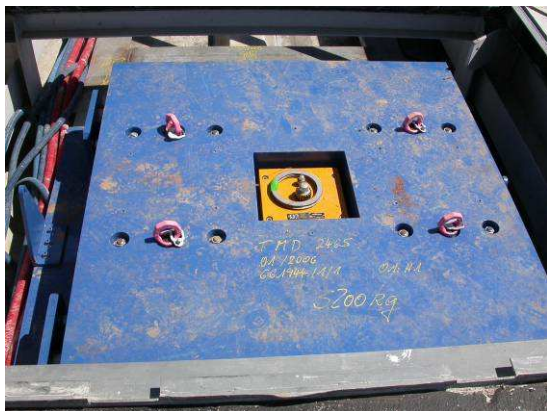
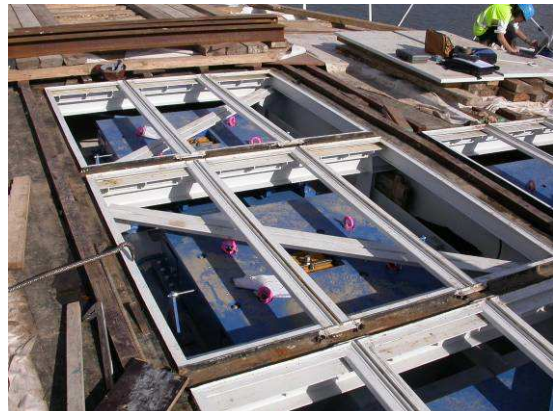
Figure 4: Horizontal TMD installed at the mid-span section

The lively behaviour of this footbridge was particularly critical for lateral vibrations associated to the fundamental lateral mode, which motivated a special concern with the design of the corresponding TMD [2]. In this case, assuming the validity of the formula developed by Dallard *et al*, it was possible to fix the number of pedestrians for which lock-in should not occur, which led to an estimate of damping that the control solution should introduce. Following that procedure and the studies of Bachmann *et al* [5], the value of 6% was adopted as the value of damping ratio to achieve after installation of a TMD tuned for this lateral mode of vibration. This implied the specification of a mass of 15000 Kg that was accommodated inside the bridge deck by means of 6 TMD units, each with a mass of 2500 Kg (see Figure 4).

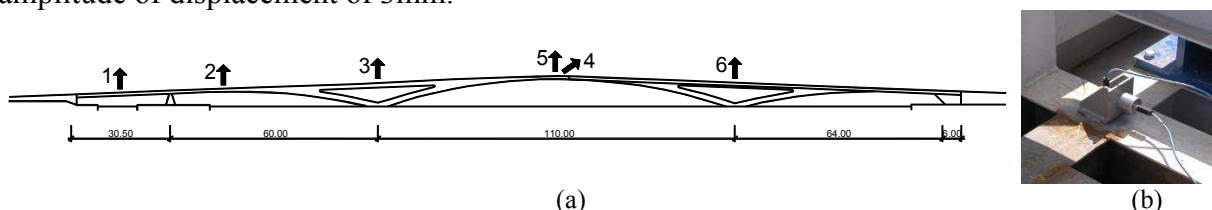
Figure 5: (a) Location of the accelerometers; (b) accelerometers used to measure accelerations at mid-span

The efficiency of this lateral vibration control device was checked, in a first instance, performing a forced vibration test applying a servo-hydraulic shaker at mid-span and measuring the lateral response of the bridge and of each of the TMD units. This test revealed that the activation of all TMD units was achieved for accelerations below the comfort limit of about 0.1m/s^2 , which is essential to avoid lock-in phenomena. However, due to different friction characteristics in the corresponding rods, inducing different damping properties, it was noticed that the equivalent damping introduced by the TMD is lower than the required at the corresponding design. Therefore, and taking into account the complex character of the bridge and the scarce experience with mechanical control devices, the Owner of the footbridge required the permanent observation of its structural behaviour during a period of 5 years after construction. In this context, the dynamic behaviour is being permanently monitored with remote control from the ViBest / FEUP, by recording vertical and lateral accelerations in 5 points along the deck. Four sections are instrumented with accelerometers positioned in the vertical direction and the mid-span section is equipped with two accelerometers positioned in both vertical and lateral directions, as shown in Figure 5.

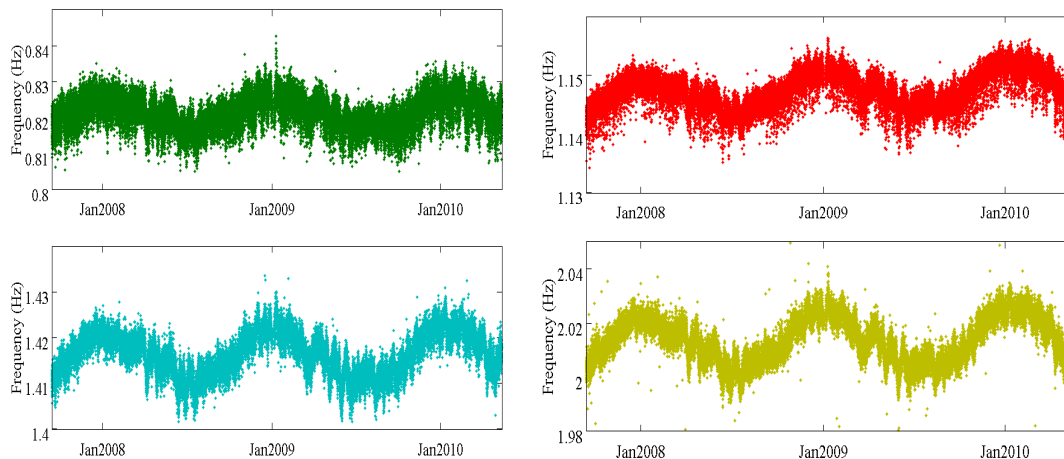
Figure 7: Evolution of the estimates of the first four vertical bending natural frequencies along three years, using the p-LSCF method.

A first inspection of the time evolution of the 12 first natural frequencies identified in the frequency range 0.5-4.5 Hz on the basis of the p LSCF method in the period 13/09/2007 to 12/09/2008 may suggest that these frequency estimates are very stable. However, a zoom of individual frequency plots evidences the occurrence of seasonal effects, as shown in Figure 7 for the first four natural frequencies during a period of observation of three years.

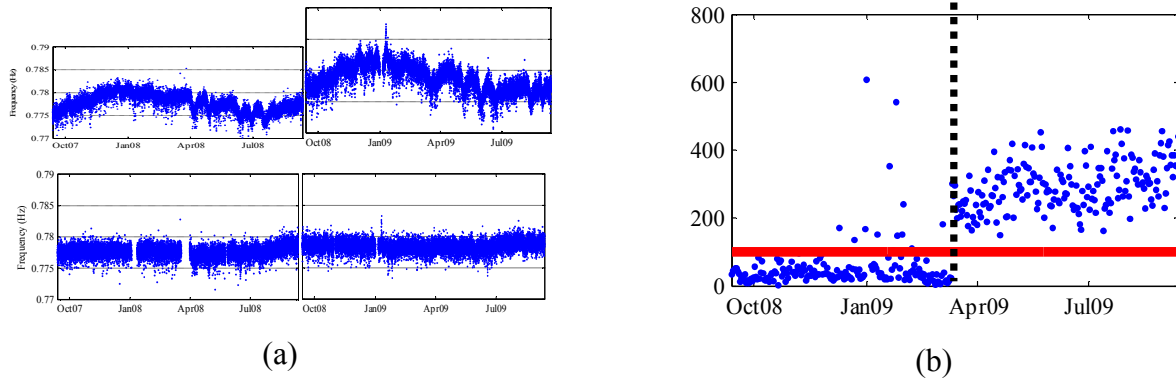
Figure 8: (a) Time evolution of the first natural frequency estimates before and after the removal of environmental / operational effects; (b) Control chart used for damage detection.

Frequency variations with time stem from environmental (e.g. temperature) and operational (e.g. traffic intensity) factors, and though they are relatively small, they can seriously disturb any attempt of damage detection based on natural frequency shifts. Therefore, it is important to mitigate the effect of these influences using appropriate statistical models and building suitable control charts using a novelty index that might flag the occurrence of slight structural damage [6, 8]. Figure 8(a) presents, for instance, the time evolution of the first natural frequency estimates before and after the removal of the environmental and operational effects. Inspection of this figure shows the efficiency of that correction, most of the estimates becoming then located inside a very narrow frequency range with an amplitude of about 0.005 Hz. This means that relatively small damage can be detected in the future, provided that the consequent frequency shifts are higher than that order of magnitude. This conclusion was confirmed analysing different slight damage scenarios idealized numerically and applying appropriate control charts, as indicated in Figure 8(b) [6].

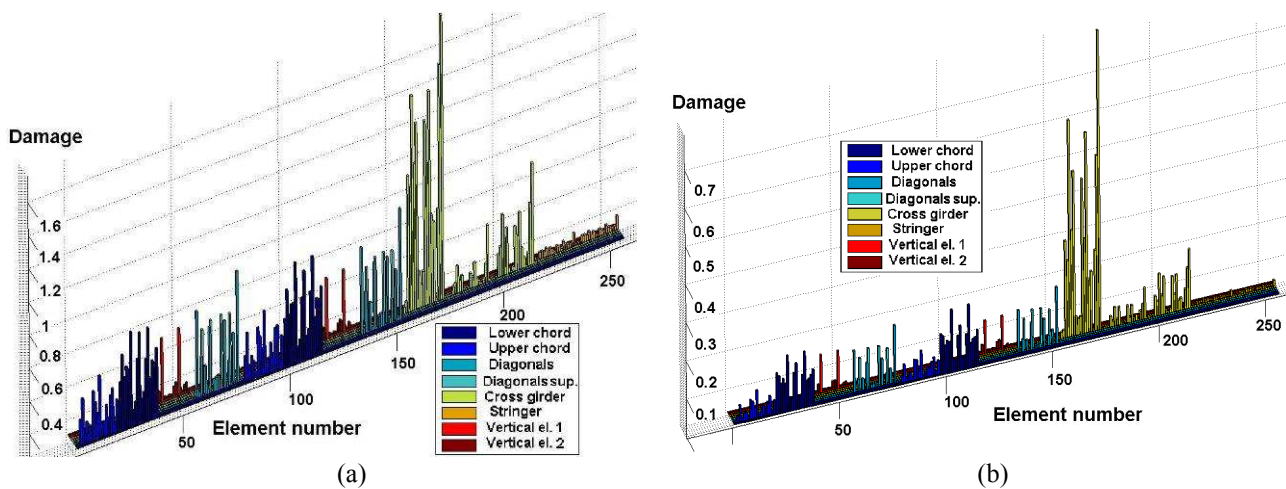
Figure 10: Fatigue damage indices for all structural elements: (a) using EN1991 Heavy Traffic scenario;
(b) using real traffic scenario.

The global fatigue assessment of the Trezói Bridge was carried out by using either code specifications or real traffic data [9]. In a first stage, based on the knowledge of the details Whöler class and using Miner's rule, it was possible to calculate the damage associated with the critical structural elements. A program developed with MATLAB allowed making the cycle counting in stress histories through the "Rainflow" method. In this case, the loading spectra for fatigue assessment defined in EN1991 [11] were used. A total of 256 structural elements were analysed in order to identify the most sensitive elements to fatigue loading. Figure 10a) summarises the damage indices obtained for all the elements considering the present age of the bridge and assuming the EN1991 Heavy Traffic scenario. It can be observed that there is a high number of elements with a damage index higher than 1.0, meaning that they would collapse under the conditions specified in this code. On the other hand, despite the upper and lower chords being the elements with the highest stresses, the highest damage values clearly occur at the cross girders. These elements have typically the highest damage values, since they suffer direct influence of each train axle, which leads to at least one stress cycle for each axle. For this reason, they are submitted to greater number of cycles than other principal structural elements.

The same calculations were made using real traffic data obtained from records of the Portuguese railway agencies CP and Refer for this specific bridge in the period of 2001 to 2006, assuming the traffic conditions in this period as conservative in terms of the bridge lifetime. The corresponding present damage indices are shown in Figure 10b) and clearly a difference in the magnitude of the damage is observed with regard to the one obtained based on the EN1991 Heavy traffic scenario. Damages are lower than the ones obtained from the calculations based on the Eurocodes, certainly due to the fact that the real traffic is significantly lower than the assumed in EN1991.

Inspection of the results of the global fatigue assessment clearly shows that there are some structural elements with much higher damage, which are the cross-girders at the extreme supports and above the structure columns. Beyond this global analysis, there is also concern about the local effects of vibrations in these elements, in the sense that it was verified that the first natural frequencies of these cross-girders fall in the range of the loading frequencies. Therefore, an additional study involving local effects of the vibrations was carried out [12].

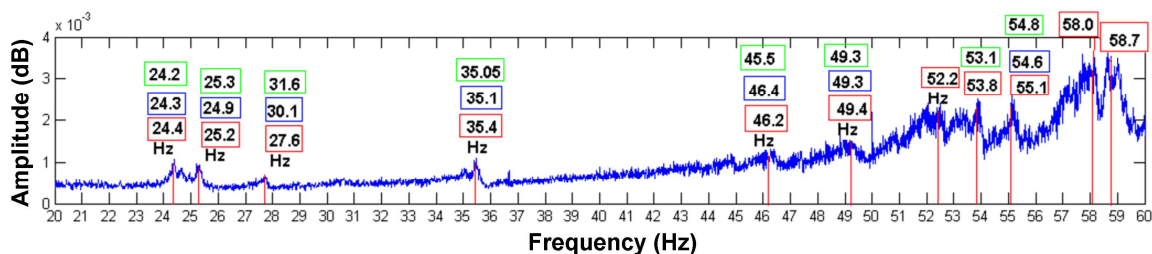
Figure 11: Comparison between calculated and measured frequencies (ANPSD for the vertical direction): red - frequencies from the accelerometers, blue – frequencies from the FEM and green – frequencies from ANPSD of measured strains

Figure 11 shows a comparison between calculated and identified frequencies using an ANPSD for the vertical direction obtained from the field test using accelerometers. The frequency values in red are associated to this field test, the ones in blue are obtained via numerical model, and the green ones were obtained with the ANPSD calculated from strains measured with the strain gauges. Generally a significant number of local modes with relevant dynamic contribution to the response can be observed, and a good agreement between numerical and experimental frequencies is found.

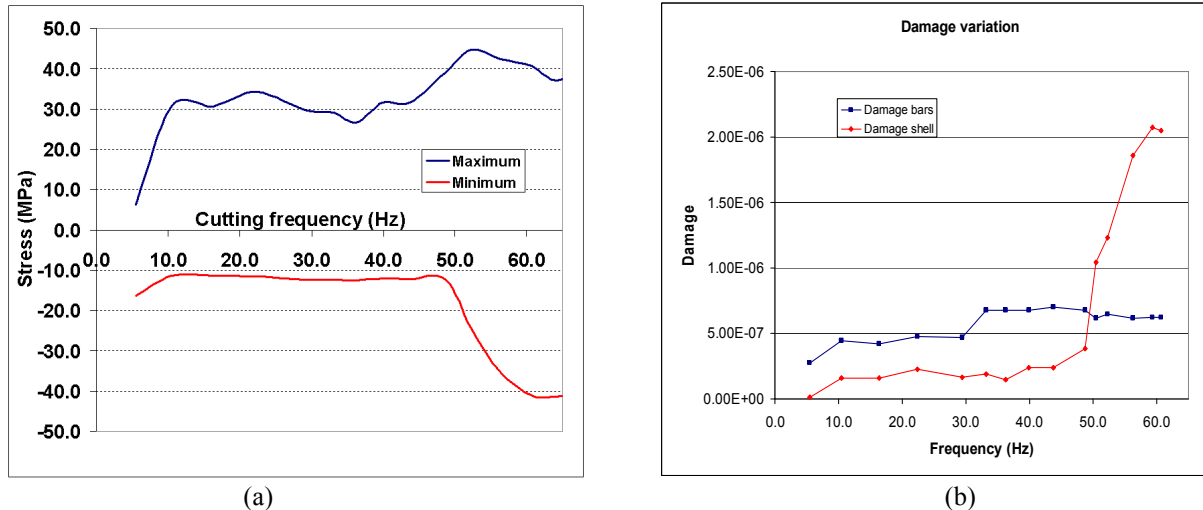
Figure 12: Influence of the local modes on the dynamic behaviour and on fatigue: (a) Peak stresses vs. Cutting frequency; (b) Damage vs. Cutting frequency

To better understand the influence of these vibration modes in the dynamic response of the bridge, an increasing number of modes were considered in the modal analysis. The lowest cutting frequency is 5 Hz, whereas the maximum value of the highest cutting frequency is 65 Hz, allowing the consideration of all the main global modes, as well as of the most relevant local modes of the cross-girders. Figure 12a) shows the effect of variation of the upper cutting frequency in the extreme values of stresses at the cross girder at the extreme support where a very high increase in the minimum and maximum values of the stresses is registered around 50 Hz. This is easy to understand because one of the local bending modes of this element has a frequency of 49.26 Hz. In Figure 12b) the influence of the local modes on fatigue is evidenced by showing the calculated damage of the cross girders using the simpler initial model with beam finite elements and comparing these results with the damage evaluated using the stress spectra obtained from the shell elements FEM for different cutting frequencies. It can be concluded that the fatigue damage has a small variation for almost all values of the upper cutting frequencies for the case of the bar model. However, for the case of the shell model, there is a very high increase of the fatigue damage at frequencies within the range of 49 Hz to 55 Hz, which are precisely frequencies corresponding to the main local modes of the cross girders. This means that the fatigue assessment based on a beam finite element model can clearly underestimate the fatigue damage in the cross-girder due to the importance of local vibration effects.
