Suggested Methodology for Rehabilitation of Ancient Masonry Castles and Forts on Rock Hills

A. Viana da Fonseca, L. Ribeiro e Sousa, A. Arêde, J. Guedes, E. Paupério,
K. Karam, A. Costa, J.E.Q. Menezes

Keywords: masonry forts, rehabilitation, rock mechanics, Guimarães Castle, Jalali Fort.

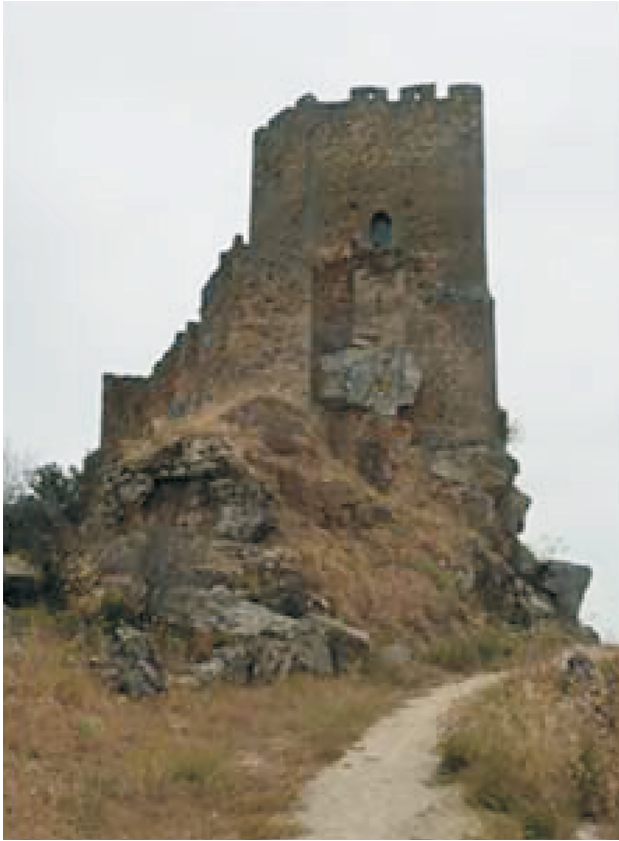
Figure 1 - Foundations of the medieval Algozo Fort.

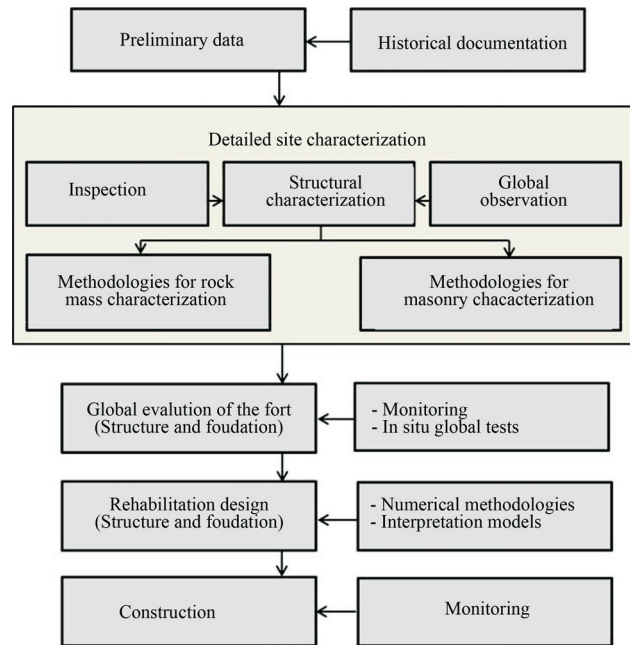
Figure 4 - Flowchart for rehabilitation of ancient masonry forts.

The flowchart of Fig. 4 summarizes the methodologies that should be followed for the rehabilitation of ancient masonry forts on rock hills indicating the need to assess to historical documentation and the existing information, and to have a detailed site characterization of the fort and its foundations.

Emphasis was made to the methodologies followed in studies and investigations on ancient forts and castles. A flowchart was presented that summarized the methodology that should be followed for the rehabilitation of ancient masonry forts on rock hills indicating the need to assess to historical documentation and the existing information, and to have a detailed site characterization of the fort and its foundations. Also the methodologies that should be implemented for rock mass characterization and masonry characterization were detailed. In situ and laboratory tests as well numerical modelling were discussed.

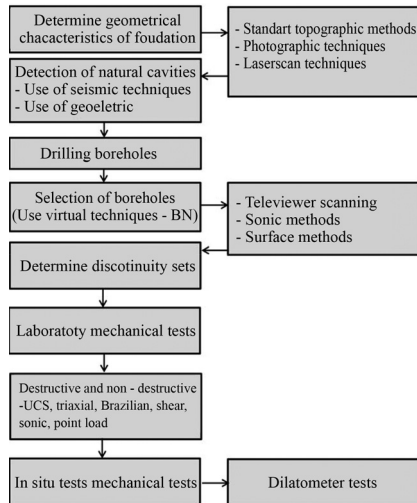
Figure 5 - Methodologies for rock mass characterization.

The characterization of structural materials and rock masses that form the foundations of such ancient structures through in situ experimentation is one of the fundamental steps in any rehabilitation process. The methodologies that should be implemented for rock mass and masonry characterization are summarized in Figs. 5 and 6, respectively.

Foundations of ancient forts, which are frequently in rock masses, are first characterized using standard rock mechanics procedures (Wyllie, 1992; Hudson & Harrison, 1997; Wyllie & Mah, 2004). Natural cavities are detected using seismic techniques such as high resolution seismic reflection, by boreholes in the areas where major cavities are expected. If necessary, P and S waves seismic cross-hole (CH) techniques, complemented with tomographic

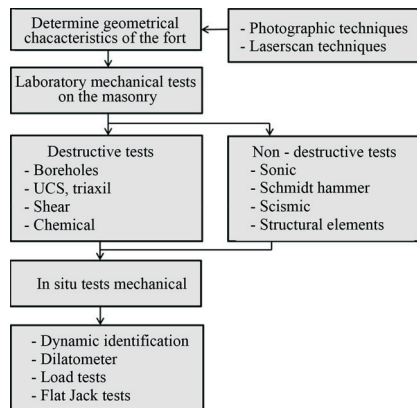
Figure 6 - Methodologies for masonry characterization.

The materials that make up forts masonry are normally rocky, with few cases existing in some countries where masonry is made of ceramic or earth materials. There are several tools, procedures and techniques that enable the qualitative and the quantitative characterization of these materials. Such techniques include the use of sonic wave propagation tests and flat jack tests at the location of the site, followed by broader characterization techniques, such as load tests and identification dynamics tests (Guedes *et al.*, 2010). In addition, classical rock mechanics tests can also be used to characterize the masonry.

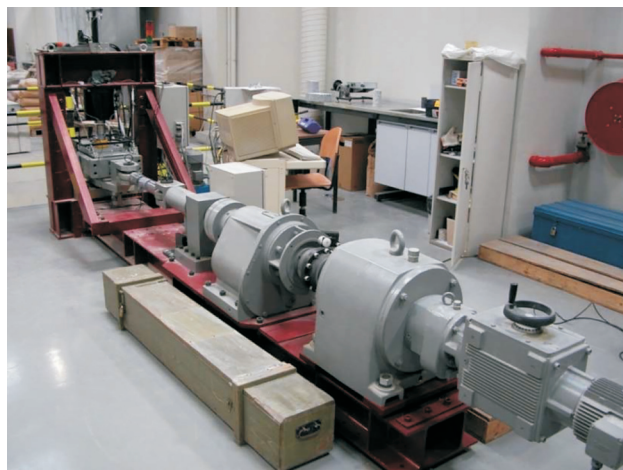
Figure 7 - Discontinuity shear tests.

A laboratory prototype for discontinuity shear behavior was developed at University of Porto to perform tests on stone masonry joints as illustrated at Fig. 7. The shear box is 200 x 200 x 150 mm³ with a capacity of 500 kN in normal and shear loads. Shear displacement is mechanically imposed up to a maximum 25 mm/hour rate. Normal displacements are measured for dilatancy characterization. The

equipment also allows cyclic testing of joints for residual shear strength determination. Masonry samples are specially cut to fit the shear box volume with the mean joint plane at 75 mm from base. When mortar is used in masonry

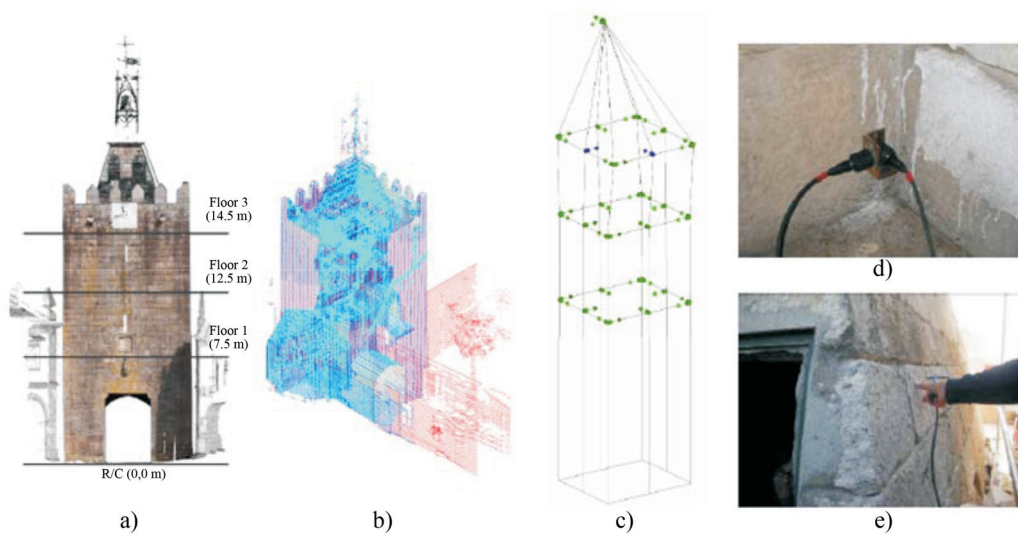
Figure 11 - Studies for the Caminha tower (Silva *et al.*, 2009). a) image of tower; b) laser scanning; c) points for vibration tests; d) colocation of accelerometers; e) hammer.

Century is what remains of a medieval castle, with three levels and a regular plan (Fig. 11a). The study involved a geometric, exterior and interior, survey using the laser scanner technique, and the mechanical characterization of the stone masonry using dynamic identification and sonic wave tests. Figure 11b shows the detail of a laser scan image, the control points and the positioning of the accelerometers for the vibration tests (Figs. 11c and d), and the hammer for the sonic tests (Fig. 11e). Details of the dynamic identification of the tower are analysed in Lopes *et al.* (2010).

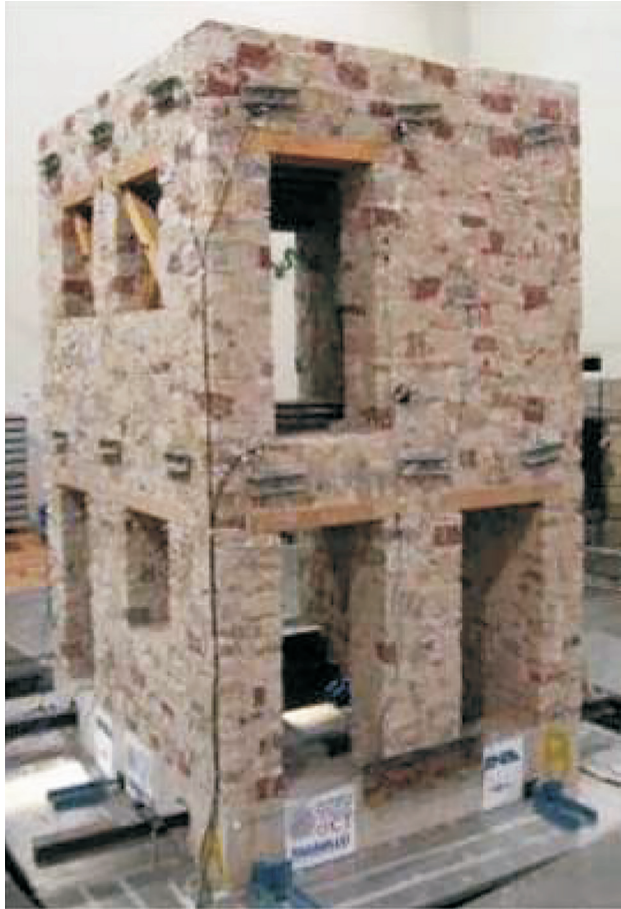
Figure 14 - Shaking table tests in a masonry model reinforced using injections (Modena *et al.*, 2010).

In seismically prone areas, it is important to study the response of ancient monuments during earthquakes, particularly during the process of rehabilitation. Figure 14 illustrates shaking table tests of a model simulating the fort that was severely damaged during the earthquake at Abruzzo, in 2009, after being strengthened (Miranda *et al.*, 2010).

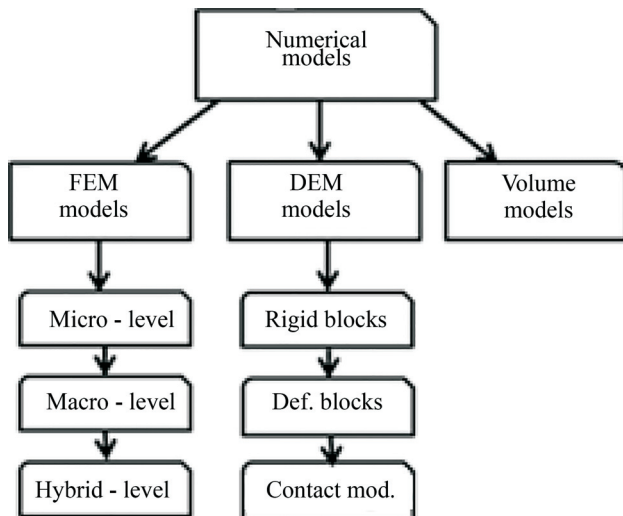
Figure 15 - Numerical models for masonry forts.

Other models can be formulated as presented by Silva *et al.* (2010). This is the case for volume models (Fig. 15), which allow one to reproduce in a more realistic way the areas of intersection of elements. When using volume models it is possible to evaluate the stresses in the thickness of a wall. However, the models must be used with more than one element to discretize the thickness, otherwise errors may be high.

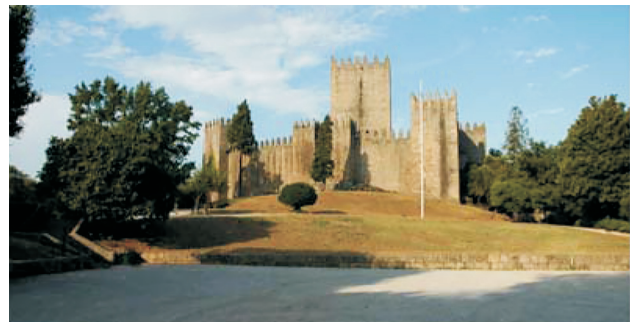
Figure 17 - A general view of the medieval Guimarães Castle.

The Guimarães Castle was founded in the 10th Century (Fig. 17). In the last gothic phase, the southwest corner of the fence was reviewed, advancing on the walls of the village. The castle was rebuilt between 1265 and 1318. In the last century, starting in 1936, several restoration works on the monument were made. The works consisted of consolidation of the walls, restoration of the main door, re-

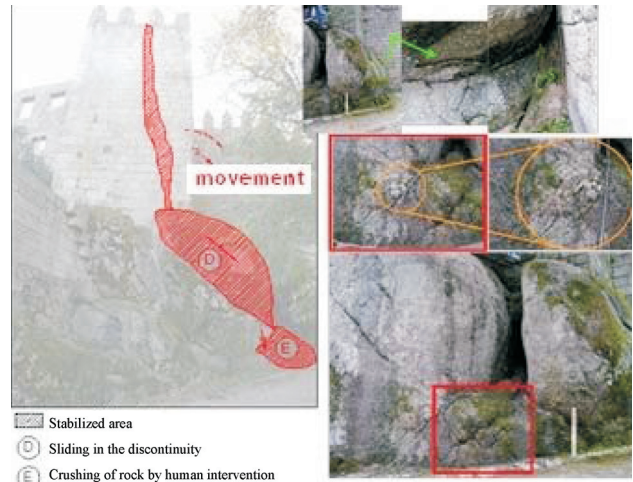
Figure 21 - Instability mechanism explaining the observed damage.

After the geological-geotechnical characterization, it became evident the need for adopting measures to stabilize the large block that supports the foundation of the tower, in particular the west corner, dominated by an inclined failure with an unfavorable tilt angle, and where, apparently, there had been a very recent movement that evolved to the foundation of that part of the structure which leaned partially. Figure 21 outlines the most likely mechanism of instability, and illustrates photos of areas of weakness.

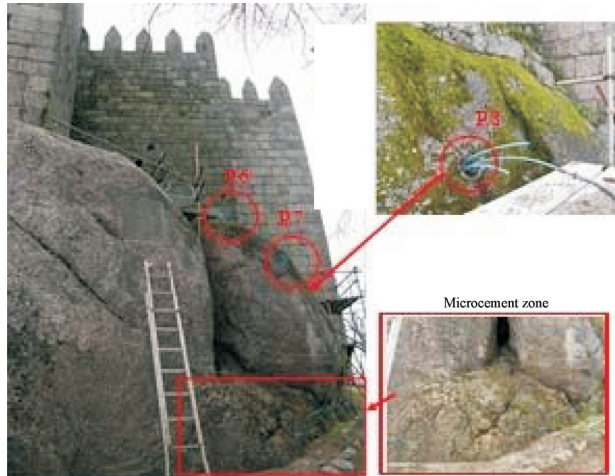
Figure 24 - Arrangement of nailings and consolidation zone with micro-cement.

The construction phases are illustrated in Fig. 24. The work should be started from injection upwards defining two injection steps: a first run by gravity purge tube up to the mouth; the second - performed immediately - by injection under pressure with the volume control (accompanied by a careful check upwelling). Two different types' injections should be considered: injections in rock masses of good quality and injections in rock masses very weathered and soils. The injections were performed with cement grout to achieve the pressures defined in paragraph below, which ensured the consolidation of land and good sealing of the armor. The first hole injection would be used to assess the type of solution to be used and method of implementation of the injections. In the treatment of mass for the foundations and in the presence of soils areas and highly weathered rock masses, selective and repetitive injections would be necessary in some specific sections.

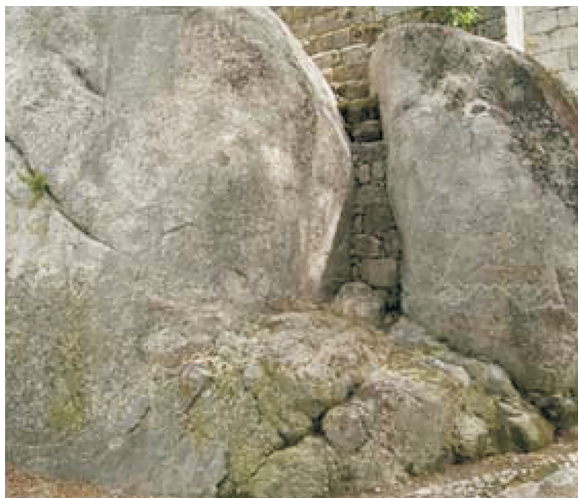
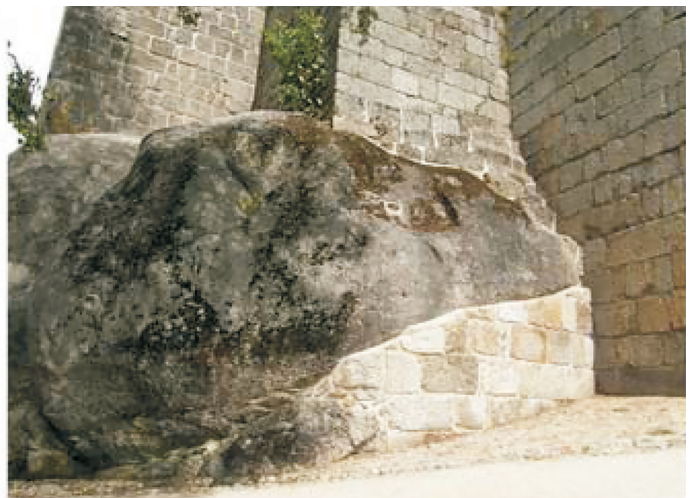
Figure 25 - Stabilized situation of the castle.

The space in between was filled with cemented large stone blocks and a dry stone masonry similar to the wall was built faceting that fill. At the base of the second block, where consolidation had been made with very fluid mortar and micro-cement it was proceeded similarly (Fig. 25).

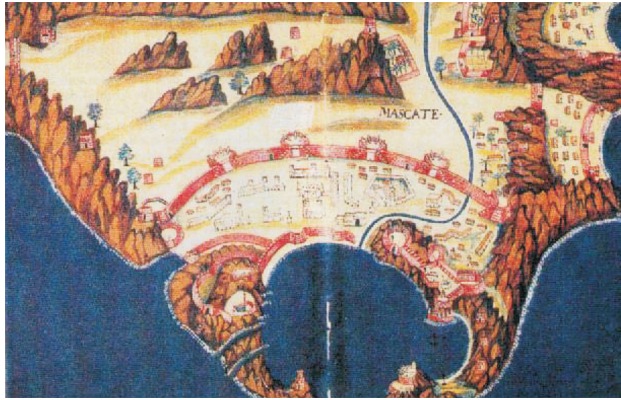
Figure 26 - Forts around Muscat (Garcia, 2009).

The fortifications in the region of Muscat with Portuguese legacy are very complex consisting of several forts and bastions arranged according to the nature of the mountainous terrain and were constructed to defend the bay. Figure 26 is a schematic of the fortification system from the 17th Century (Garcia, 2009). The Jalali and Mirani forts, which were built in the 16th Century, are the most famous forts and are located at the entrance of the Muscat Bay. The Jalali Fort in particular is the finest of Omans historical fortifications in the capital area and its environment (Fig. 27).

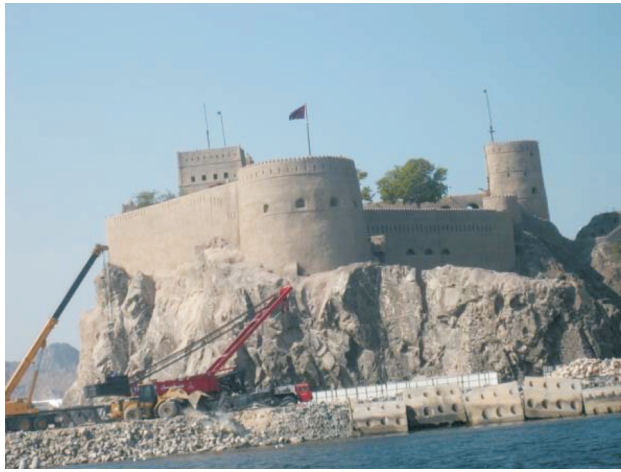
Figure 27 - Jalali Fort.

As part of a major rehabilitation and restoration program for forts around the Muscat area, the rocky slopes on which both the Jalali and Mirani forts are constructed were studied. For the Jalali Fort, a detailed geotechnical investigation was carried out including a topographic survey, plotting engineering geological data and collecting geotechnical information from the faces of the hill. Reference is made to the two watching towers protecting the entrance of the bay, as well as to the magnificent Mutrah Fort in a bay very near the Jalali and Mirani forts (Fig. 2). It is interesting to note that there is a small chapel located in one of the watching towers which is still preserved to this day. The Mutrah Fort lies on a rocky formation over the Sultan Qaboos harbour near the city of Muscat. The rocky slopes were studied in detail and a geological map was prepared. The topographic map was done by a total station where the geological structures were located. The cavities were also studied in detail and suitable measures were suggested for reducing their enlargement.

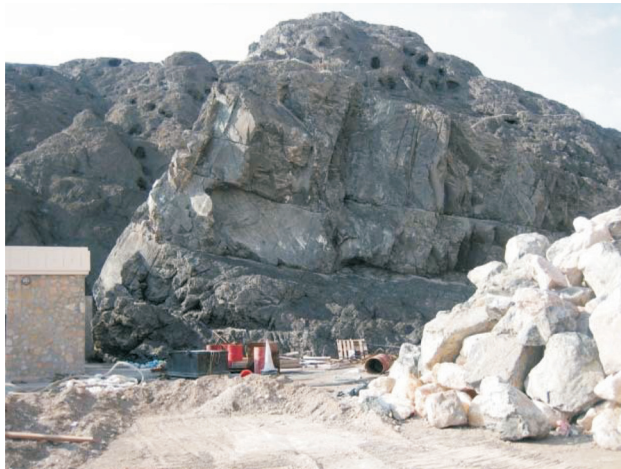
Figure 28 - Rock mass in the vicinity of Jalali Fort.

The geology of the old Muscat area is described in detail in a geotechnical report from Chaterjee (2007). The geology comprises mainly of dunite and peridotite (Hurzburgite). Therefore, the forts are founded on hard and tough ultra-basic rock stratum. The weathering effect of the rock masses, which is extensive, and the nature of the rocks have affected the strength of the rock masses, with the existence of significant discontinuities, sometimes with significant aperture, zones with marked heterogeneity, and the occurrence of natural cavities. Also relevant weak regions were identified which have important consequences on the stability of slopes upon which the forts are built. Figures 28 and 29 illustrate the occurrence of natural cavities, and dis-

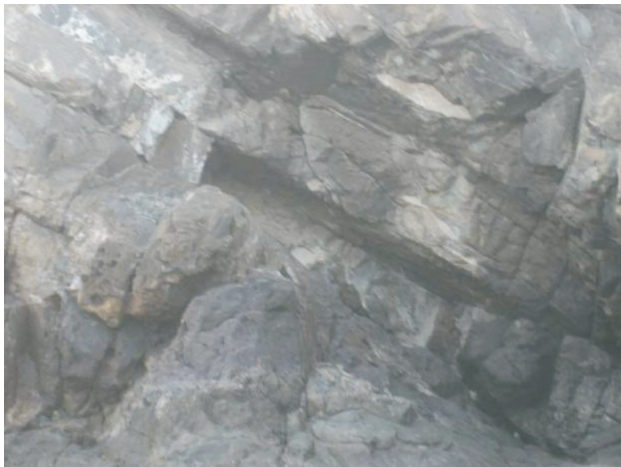
Figure 29 - Discontinuities in the rock mass.

continuities with significant aperture and major shear surfaces (Souza, 2009).

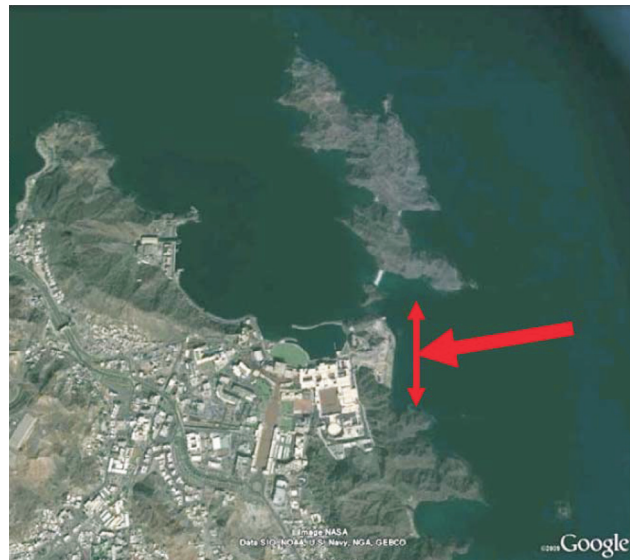
Figure 30 - Jalali Fort. Location of the new seawall.

In Muscat, Cyclone Gonu caused significant damage to the 300 m long seawall protecting the Jalali Fort (Fig. 30). The damage included destruction of 200 m of the Shed concrete armor units, collapse of numerous 160 ton concrete crest blocks and failure of the slope (Bentika *et al.*, 2010). It was therefore necessary to redesign the existing seawall for protection against the occurrence of cyclones as the first step in protecting these historically significant structures.

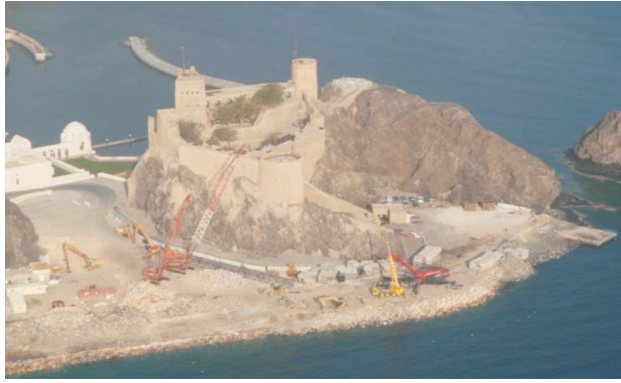
Figure 31 - Jalali Fort during construction of the seawall.

The seawall was originally constructed in 1980, and was about 265 m long. The armor was provided by Dolos units in two layers with total thickness of 2.6 m at a slope of 1:1.5 (V:H) laid on stone. The potential causes of failure included armor unit structural failure, toe failure and loss of underlayer leading to undermining of the units. Figure 31 shows a view of the fort during construction of the new seawall.

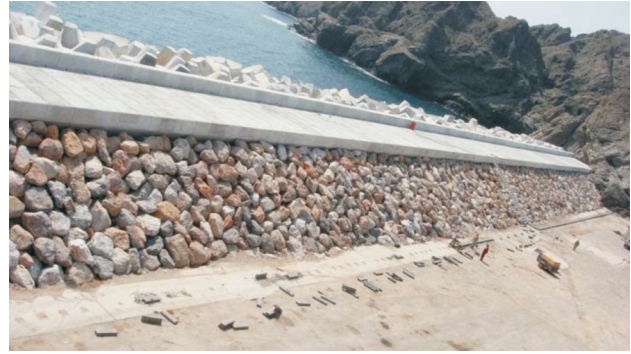
Figure 33 - View of the new protection of Jalali Fort.

The seawall was redesigned using appropriate hydraulic models for simulating the extreme conditions for the waves and scale tested in a random wave flumes to optimize the design. The new seawall is shown in Fig. 32, and the final configuration is shown in Fig. 33.
