**STRUCTURAL IDENTIFICATION OF OLD STEEL
BRIDGES: MONITORING AND REHABILITATION
ASSESSMENT**

A thesis submitted for the degree of Doctor of Philosophy in Civil Engineering
at the Faculty of Engineering of the University of Porto

Bruno José Afonso Costa

November 2012

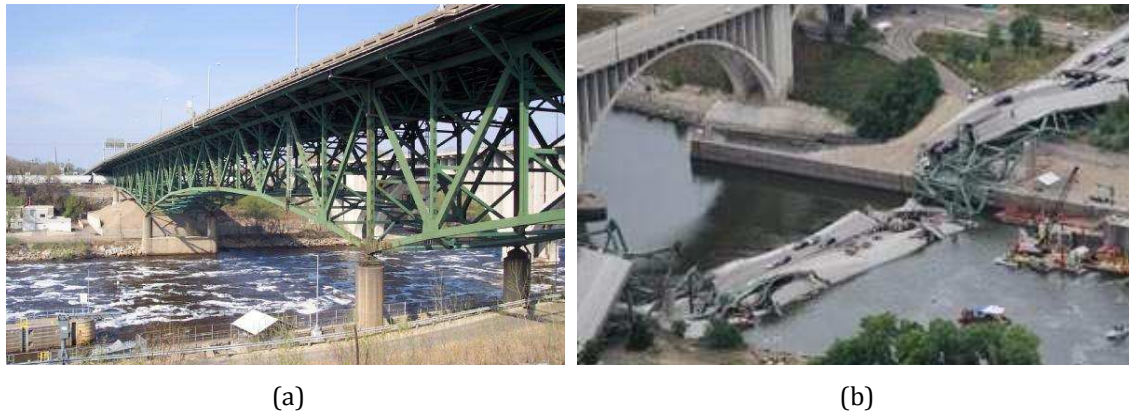
Figure 1.1 - I-35W Bridge: (a) Before the collapse; (b) After the collapse.

Since early ages, case studies of failures have constituted invaluable sources of insight and understanding for the design and construction of structures, particularly the ones with an innovative component (Petroski, 1995). However, during the second half of the 19th century the explicit discussion of the root causes of failures was not pursued, an attitude that is thought to be related with the embarrassment caused at the time by a great number of tragic collapses of railroad iron bridges. Only when a combination of a climate of overconfidence in the state of the art, lack of knowledge, and sum of a series of human errors led to the sudden collapse of the Quebec Bridge in 1907 during its construction, the technical community turn back to properly value once again the failure of real structures as lessons to learn in bridge engineering (Pearson and Delatte, 2006). Indeed, the structural behavior knowledge and the relatively today's high safety are the result of a continuous learning from the successive bridge collapses in history (Biezma and Schanack, 2007). Yet, in the present days advances in knowledge concerning the actual behavior of structures and their safety, in particular for metallic bridges, must not be pushed forward only after the occurrence of dramatic failures or in response to a sequence of smaller errors and/or defects. Collapses such as the one occurred in 2007 with the 40 years old I-35W steel deck truss bridge (see Figure 1.1) over the Mississippi River in Minneapolis are no more acceptable (Astaneh-Asl, 2008).

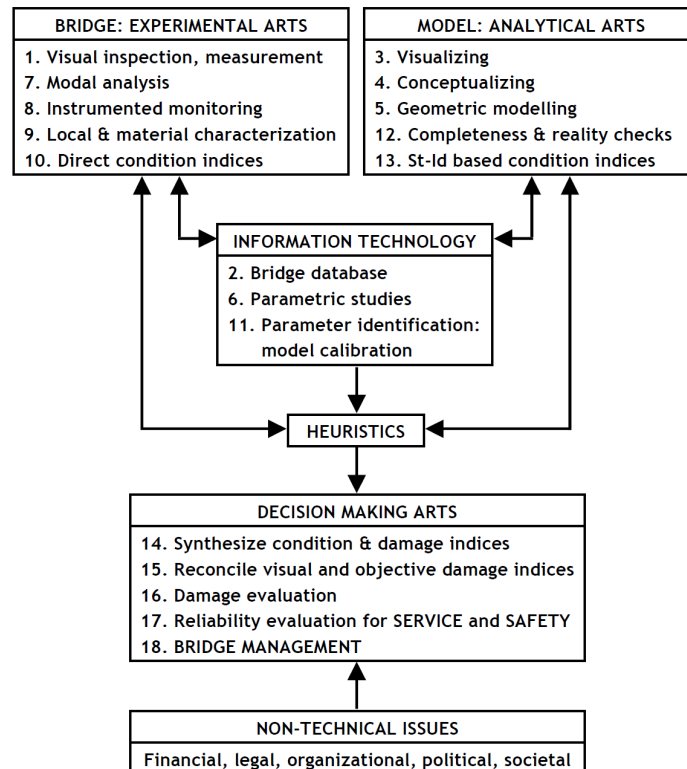
Figure 1.2 - Standard St-Id methodology (Aktan *et al.*, 1997).

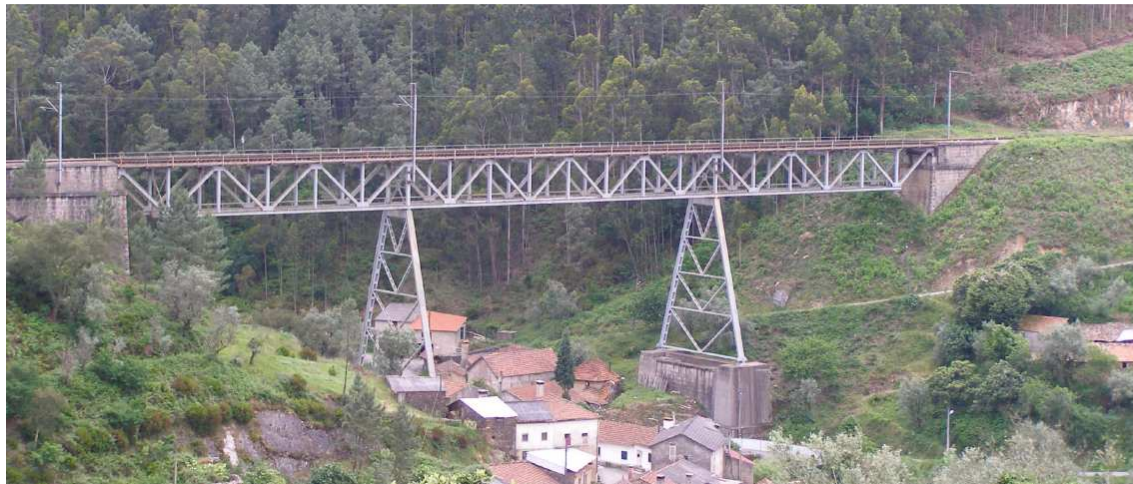
Figure 2.1 - General view of Trezói Bridge.

Two inverted Warren truss girders, 5.68 m high and 4.40 m apart between axes, constitute the steel deck of the bridge. Its total length is 126 m, comprising two extreme spans 39 m long and one central span 48 m long. The girders panels are 6.50 m wide in the central span and 6.00 m in the end spans. Two trapezoidal shape trusses acting as piers and two granite masonry abutments transmit the loads carried by the structure to the foundation (see Figure 2.1). All connections between the elements are riveted.

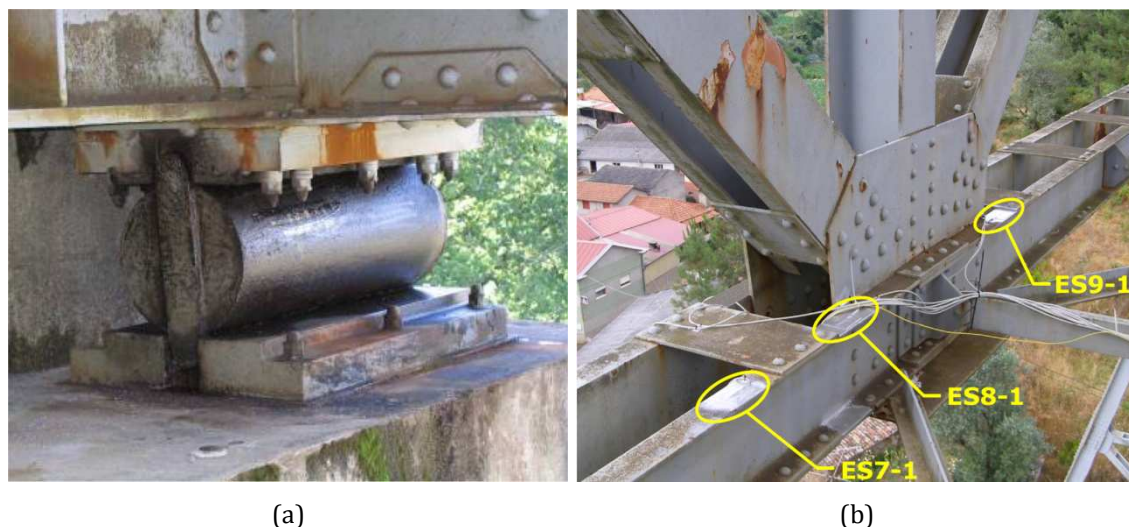
Figure 2.2 - Details of the bridge structure: (a) bearing placed at the west abutment; (b) lower joint of the truss girder instrumented with strain sensors in its vicinity.

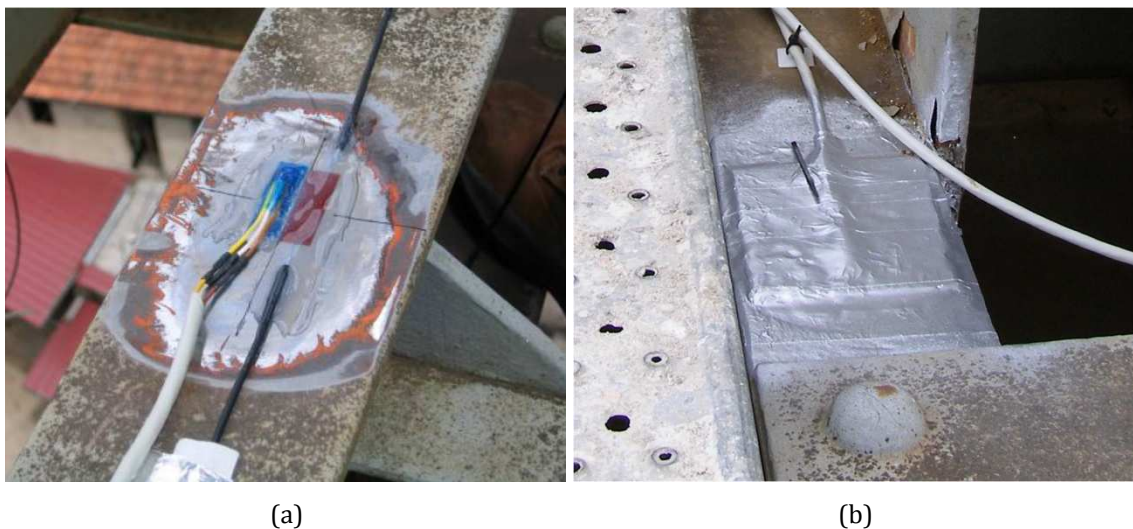
Figure 2.5 - Sensors installation: (a) strain sensors ES6-1 and OS6-1 in section S6 during the gluing process; (b) final aspect for sensor ES9-1 in section S9.

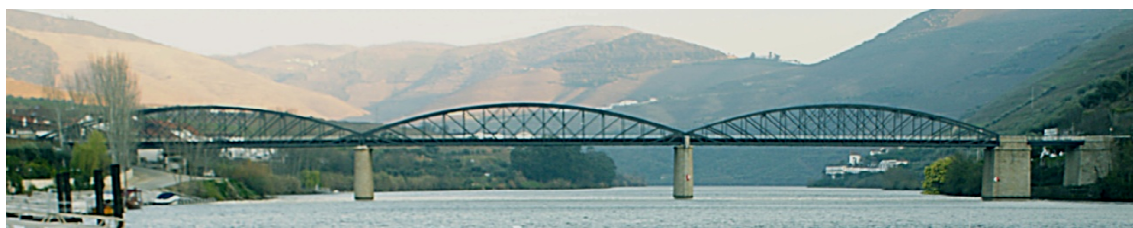
Figure 3.1 - Pinhão road bridge over the Douro river.

The bridge allows the crossing over the Douro river, linking the districts of Viseu and Vila Real near the village of Pinhão in the north of Portugal, and was opened to the traffic in 1906 (see Figure 3.1). After a thorough inspection to the structure in 2004, the Portuguese Institute of the Road Network (EP – Estradas de Portugal, E.P.E.) decided to post the bridge with speed and weight restrictions for the crossing vehicles. Then, a viability study for the bridge rehabilitation was conducted, which included an in-depth campaign for the complete characterization of its structural behavior. It led to the rehabilitation and strengthening of the bridge in 2006, making it suitable for the present traffic conditions established in the current design codes. In its new operation stage the bridge only comprises a single lane, hence not allowing the crossing of vehicles travelling in opposite directions.

The steel superstructure comprises three main through-truss spans, 68.60 m long between supports, and a highly skewed curved deck plate girder span, 10 m long, in the south entrance, resting on three piers and two abutments made of granite masonry. In its rehabilitated scheme, the floor system of the main spans presents a typical slab-on-girder concrete-steel cross-section, approximately 6.50 m wide and 1.00 m high, constituted by an orthotropic steel grid of crossbeams (17) and stringers (5), upon which the reinforced concrete slab (0.17 m thick) and the asphalt layer (0.07 m thick) lie on (see Figure 3.2(b)). The slab was made by pouring a 0.10 m thick layer of concrete over 0.07 m thick precast

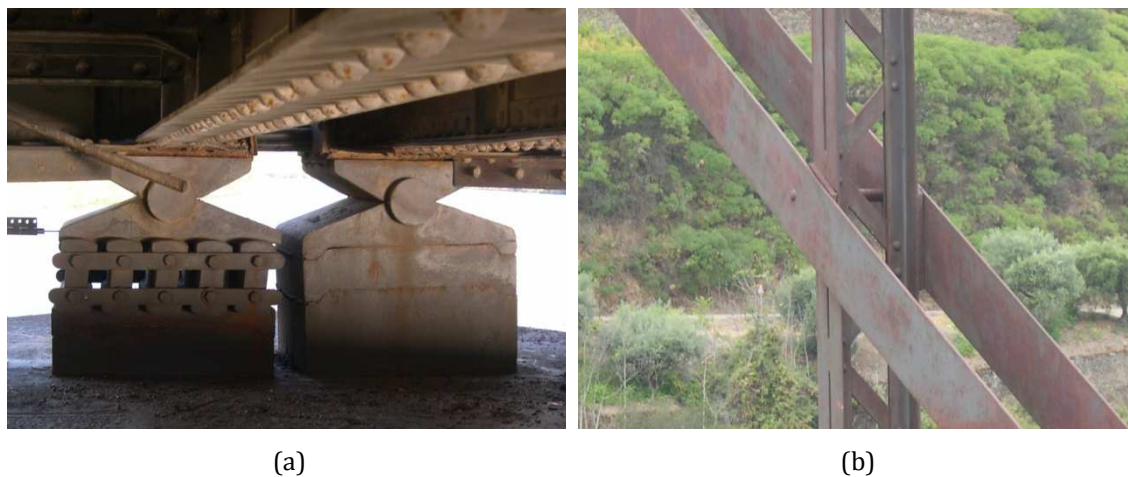
Figure 3.3 - Pinhão Bridge before the rehabilitation: (a) roller (left) and pin (right) bearings; (b) intersection node of a diagonal with a vertical.

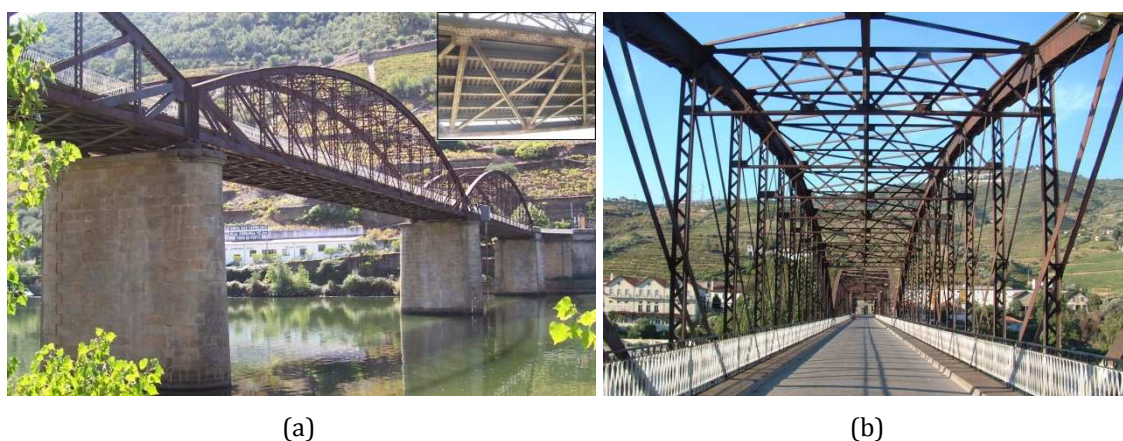
Figure 3.4 - Pinhão Bridge before the rehabilitation: (a) side and bottom views; (b) view from the road (inner view).

The elements pertaining to the original metallic structure are built-up members fabricated by assembling various plates and angles through riveted connections, a typical steel construction technique at the beginning of the twentieth century. The chords are U-type sections, while the crossbeams and stringers are I-sections. Pairs of double angles connected by lacings and pair of plates with no shear connection constituted the original verticals and diagonals, respectively (see Figure 3.3(b)).

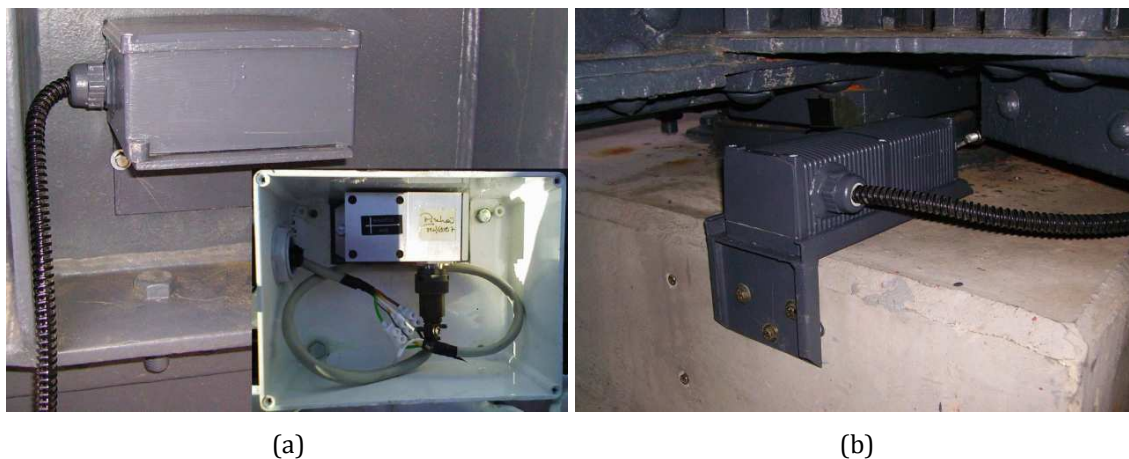
Figure 3.10 - Protection systems applied to sensors: (a) inclinometers; (b) displacement transducers.

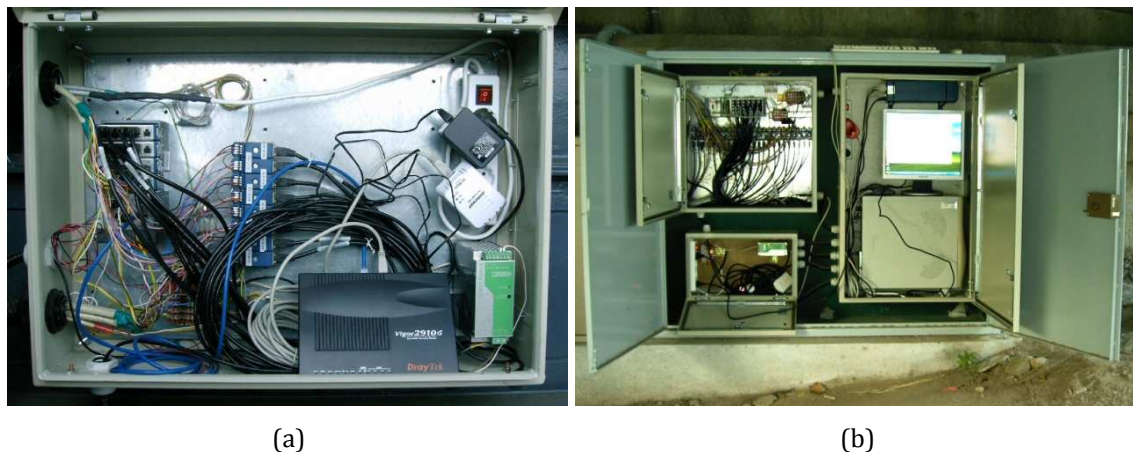
Figure 3.11 - Observation stations of the monitoring system: (a) Observation Station (OS); (b) Central Observation Station (COS).

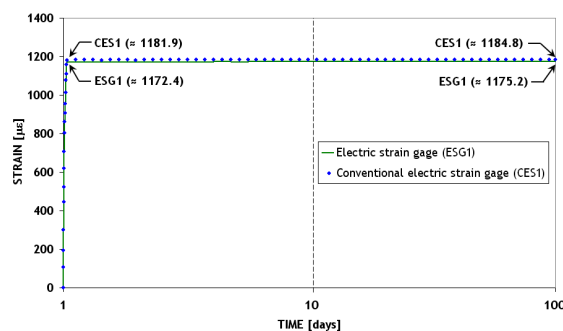
Figure 3.14 - Evolution of the strain readings under constant load during 100 days.

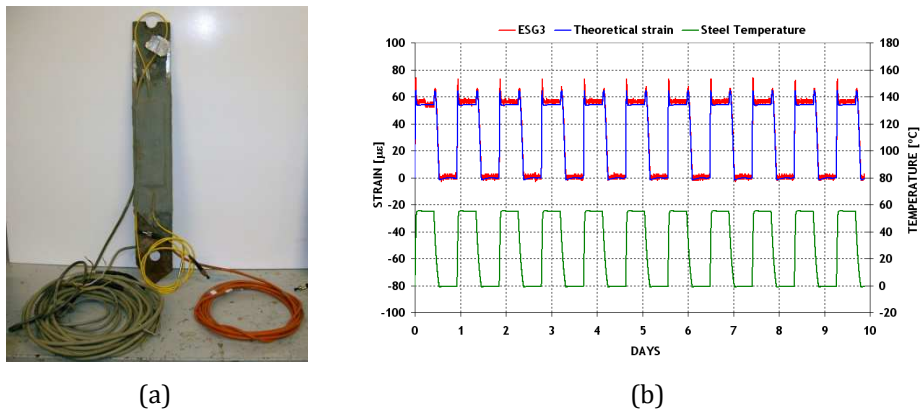
Figure 3.15 - Cyclic temperature test: (a) instrumented specimen; (b) evolution of the strain readings.

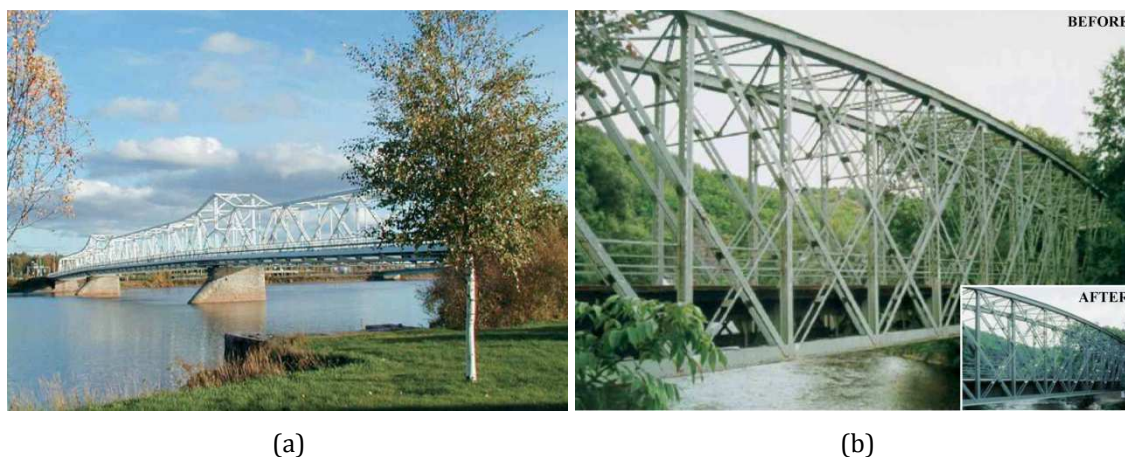
Figure 4.2 - Rehabilitation projects of steel bridges in Europe: (a) Tornionjoki steel Bridge (Kääriäinen and Pulkkinen, 2002); (b) side view of the old Kamp Bridge (Holzinger *et al.*, 2002).

Kääriäinen and Pulkkinen (2002) have presented the strengthening and rehabilitation of a riveted steel truss structure located in Northern Finland, whose main problem was the corrosion of the steel aggravated by the de-icing salts used on the road surface (see Figure 4.2(a)). The Kamp Bridge, in Lower Austria, is an example of a well successful

rehabilitation process performed on a wrought iron structure, whose design took into account the requirements of today's railway standards without producing visual changes in the structure, as depicted in Figure 4.2(b) (Holzinger *et al.*, 2002). Extensive construction works have been executed to upgrade a centenary double-deck steel arch bridge located in Northern Portugal, with the goal of providing the required capacity to safely withstand the new load conditions due to the integration of the upper deck in a light rail network (Lopes *et al.*, 2008).

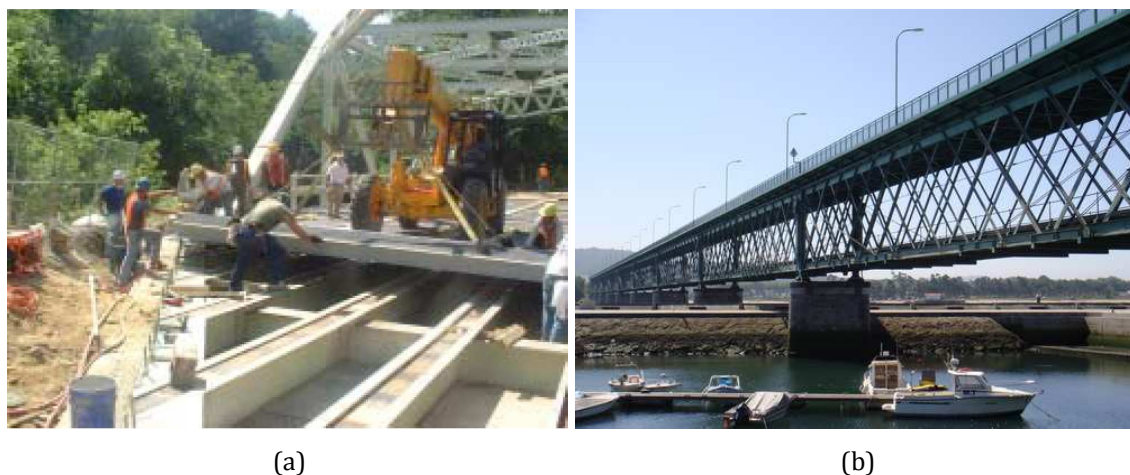
Figure 4.3 - (a) Placement of a new FRP composite deck on a truss bridge (Fu *et al.*, 2007); (b) double-deck steel truss bridge monitored by means of fiber Bragg grating sensors.

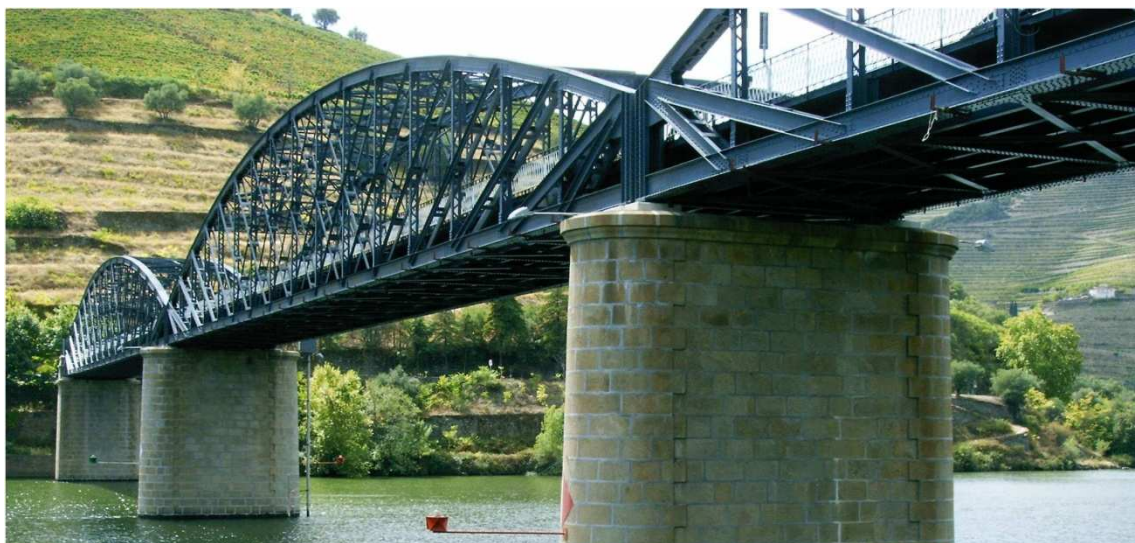
Figure 5.1 - Pinhão Bridge.

The Pinhão Bridge was commissioned in 1907 and since then it has been in continuous operation, still representing a vital link in the road infrastructure that serves the Douro vineyard region where the Porto wine is produced (see Figure 5.1). An in-depth rehabilitation of the bridge was undertaken following a viability study pushed forward by the tragic collapse in 2001 of an older bridge that crossed the same river (Wikispaces, 2011).

During the conducted surveys the most relevant problems were the widespread corrosion of steel due to lack of proper maintenance and the excessive vibration of some elements. Additionally, the safety level of the structure to carry the current loads and the evaluation of the need of a strengthening scheme to meet the contemporary standards were issues of concern. In this context, a first dynamic test was mandatory to support the rehabilitation project by enabling the bridge condition assessment and by supplying in-situ data for the validation of the numerical model to be used in the evaluation of alternative strengthening strategies.

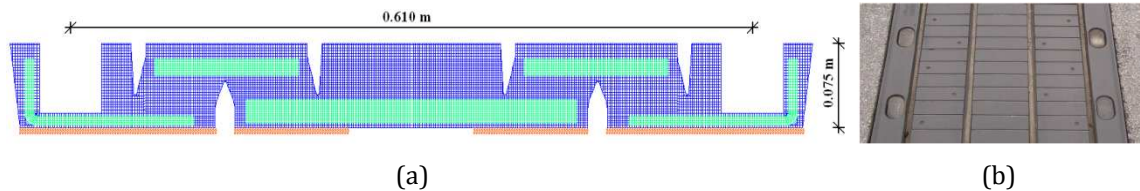
The total axial stiffness of the five bars that simulate the expansion joint was calculated through a planar linear elastic model of the reinforced elastomeric joint by means of shell elements, as shown in Figure 5.7. To this end, the geometric characteristics were retrieved from the technical sheet of the manufacturer and elastic properties were assumed with values common for the constituting materials:

- i. Neoprene, $E_n = 2.25 \text{ MPa}$ and $\nu_n = 0.25$;
- ii. Reinforcing steel, $E_{rs} = 210 \text{ GPa}$ and $\nu_{rs} = 0.30$.

The horizontal force applied to the expansion joint to achieve a unit relative displacement was taken as the total stiffness of the bars linking the slabs of two spans.

Figure 5.7 - Expansion joint: (a) detail of the model; (b) top view.

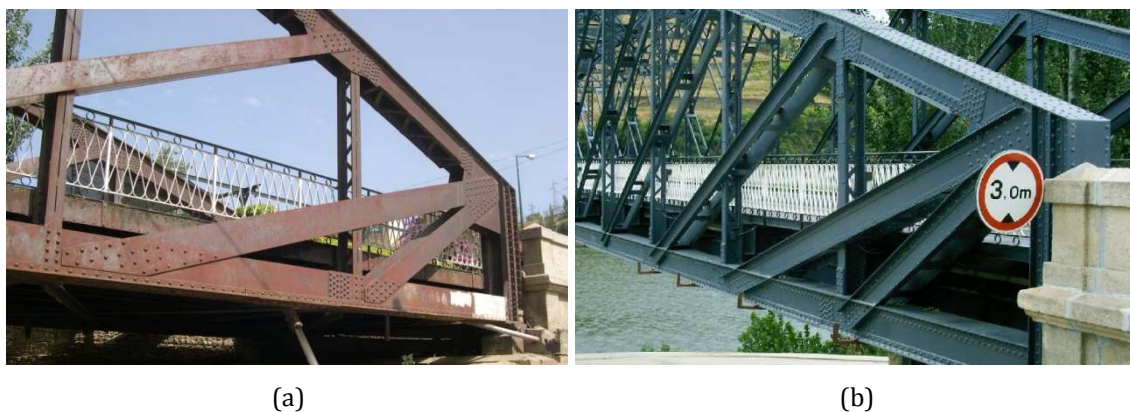
Figure 5.10 - Diagonals of the truss girders: (a) before the rehabilitation; (b) after the rehabilitation.

Figure 5.9 presents the acceleration time series recorded at sections where the peak values were found, before and after the rehabilitation. The plots reveal that the level of transverse vibration is considerable lower, not exceeding in general one sixth of the vertical accelerations. This difference in the vibration response of the structure has influenced the quality of the power spectral estimates provided by both tests, as shown in Figure 5.4. Furthermore, from these plots it is evident that spectra from the first test are noisier than the ones estimated after the rehabilitation since several small amplitude peaks are exhibited. Nevertheless, the natural frequencies estimates found for all three main spans in both tests presented a standard deviation less than 1.5% from the average values, thus permitting to conclude on the accuracy of the measurements. Besides making the identification of the natural frequencies related to the global mode shapes of the bridge more difficult, these small peaks primarily exposed the influence of the local vibration modes associated with the slender flat plates that constituted the diagonals, whose excessive vibration had been well noticed during the viability study (see Figure 5.10).

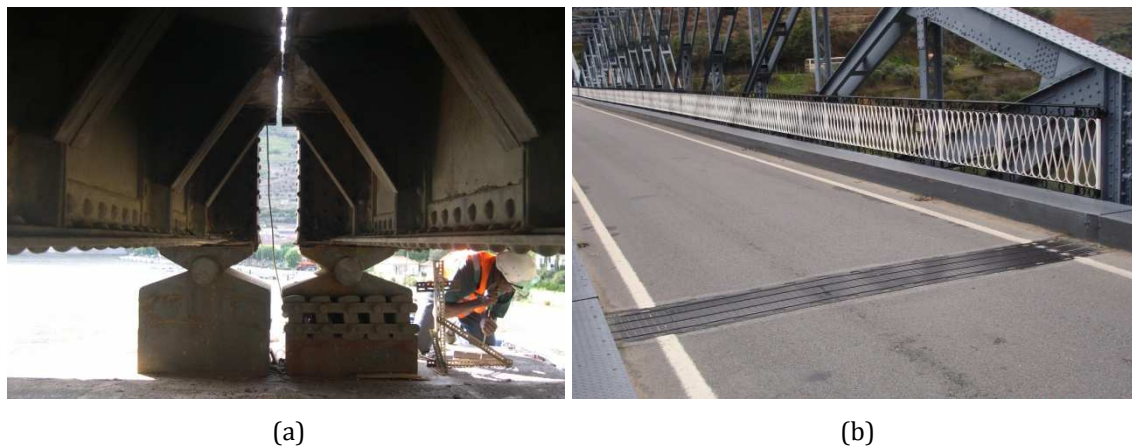
Figure 5.16 - Expansion joint: (a) bottom view before the rehabilitation; (b) top view after the rehabilitation.

expected independent/decoupled behavior. In a first stage, the only alteration made to the structure that could explain this significant change was the installation of reinforced elastomeric expansion joints connecting the slabs of adjacent spans and the slabs of the end spans to the masonry abutments. In fact, before the bridge rehabilitation this connection did not exist as the joint was materialized with no physical link. Figure 5.16 depicts the expansion joint before and after the rehabilitation.

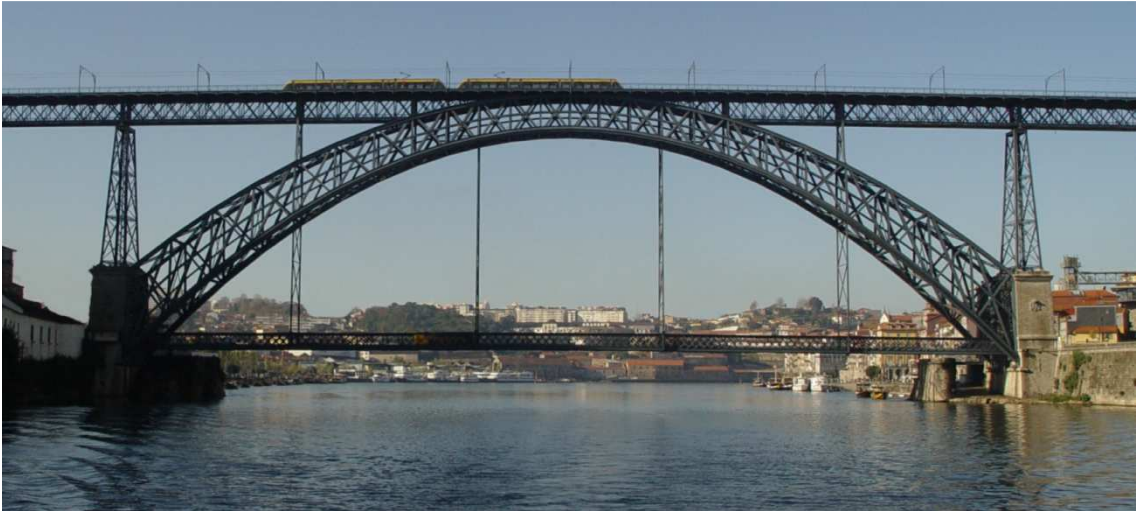
Figure 6.1 - Luiz I Bridge.

Luiz I Bridge constitutes a unique example of bridge engineering, worldwide known, which marked a time of the Portuguese industrial period (see Figure 6.1). Its distinctive feature is the existence of two decks at different levels supported by a single arch. This arch exhibits a parabolic geometry in elevation, spanning 172 m for a maximum rise of 45.1 m, with pinned supports at the lower chords end joints resting over the river banks. The 391.25 m long upper deck comprises 13 spans with lengths varying between 11.8 m and 50.7 m. Nine spans are formed by two 5 m high truss girders, spaced of 4.65 m between centerlines, other two have truss girders with variable height from 0.9 m to 5 m,

and in the remaining two, located over the arch crown, the trusses are substituted by 0.9 m high I-beams.

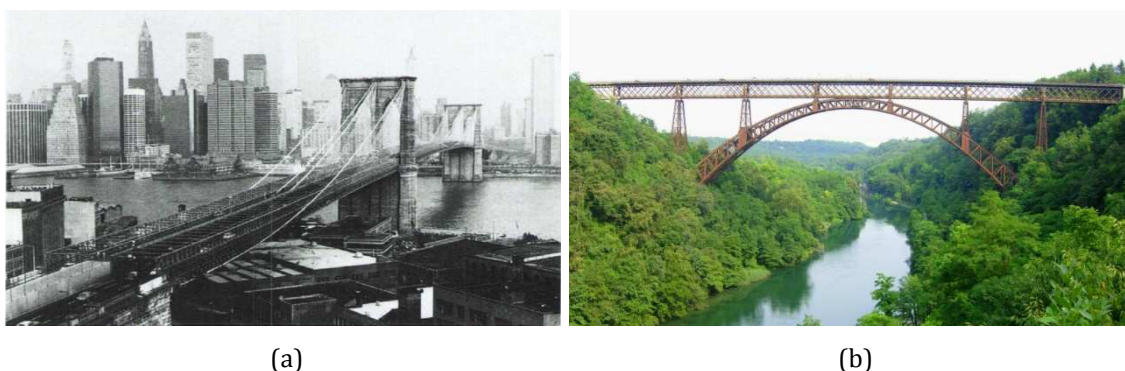
Figure 7.1 - Steel and iron bridges that underwent rehabilitation works (I): (a) Brooklyn Bridge in New York City, USA (Serzan, 1995); (b) Paderno Bridge in Italy (Nascé, 1993).

Some examples of rehabilitation and strengthening projects implemented on old metallic bridges are reported in technical literature. One of the most famous rehabilitation works was performed on the Brooklyn Bridge (Figure 7.1(a)), the oldest of New York City's East River bridges, opened to traffic in 1883 (Serzan, 1995). The work was completed in 1991, and essentially comprised the replacement of wire rope, solid rod suspenders, cable posts, stays and main cable wire wrapping, the adjustment of suspenders and the cleaning and repainting of the entire main bridge superstructure. In this project the critical aspects were the selection of the best suited rehabilitation strategy and the definition of the construction works to execute.

Nascé (1993) has presented the restoration study of an iron truss arch bridge built in 1889 over the Adda River, named as Paderno Bridge, whose trussed box girder supported over the arch carries both a road and a railway (Figure 7.1(b)). The main problems were related to its state of preservation and significant deficiencies in result of shortcomings of the original project. Several criteria were adopted for the restoration project, which led to the standardization of the residual bearing capacity of the elements at a level acceptable for service purposes. Firstly, given the bridge had been classified as a monument to be preserved, the appearance of the structure could not be altered through extensive strengthening, replacement of a large amount of its components or substitution of damaged rivets by bolts. Secondly, the restoration works would have to be compatible with short service interruptions, and should take into account the small budget available.

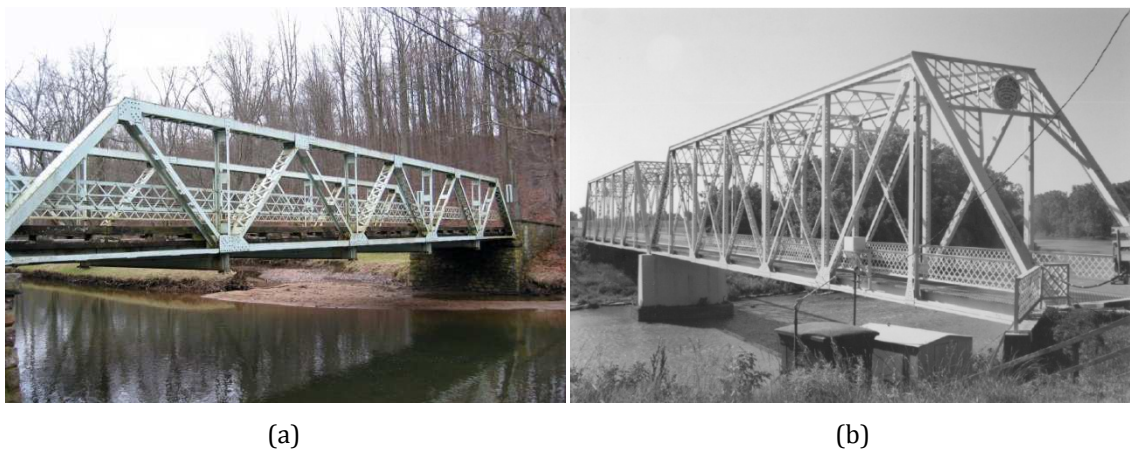
Figure 7.3 - Tested bridges (I): (a) Chester County Bridge 196, Pennsylvania, USA (Boothby and Craig, 1997); (b) Tindall Bridge in Freemont, Ohio, USA (Farhey *et al.*, 2000).

Boothby and Craig (1997) have conducted a field test on a historic truss bridge in the Chester County, Pennsylvania, with the purpose of obtaining an accurate load rating of the structure (Figure 7.3(a)). Bonded foil resistance strain gages were applied to the steel structure, as well as LVDTs for measuring the deflection. A double-axle dump truck, crawling at a pre-set speed along different paths, turned possible to record the influence lines for the monitored quantities. The results made clear that costly repairs were completely unnecessary and enabled to point out the weak points of the structure.

Farhey *et al.* (2000) have carried out a structural deterioration assessment of a steel truss bridge (Figure 7.3(b)), constructed in 1915, based on a methodology that integrated the microstructural analysis and diagnostic field testing with conventional procedures (measurement of strains and deflections under static or quasi-static loadings). The study stood as a demonstration of the use of emerging and conventional condition-assessment techniques for formulating effective and feasible rehabilitation.

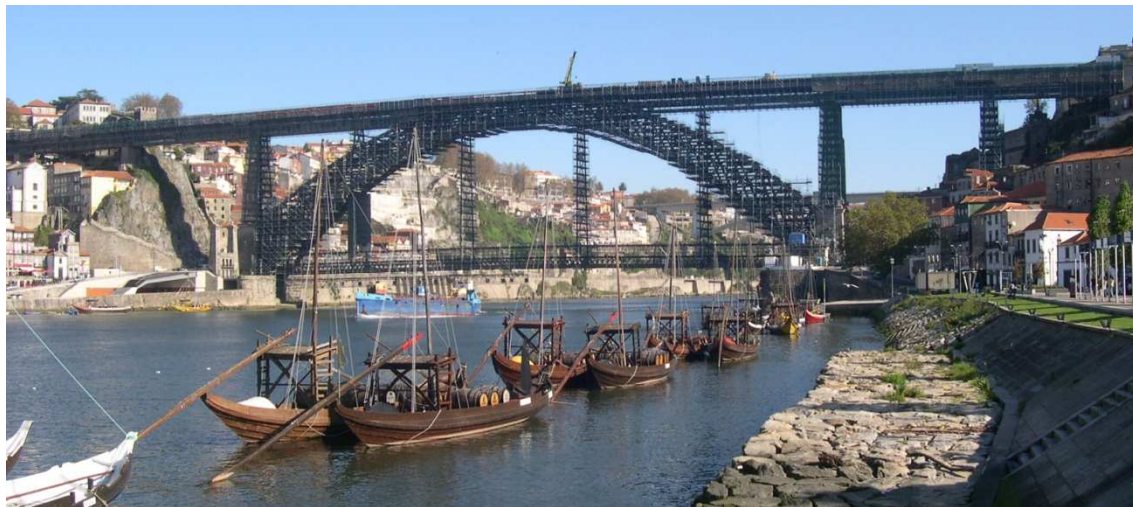
Figure 7.5 – View of Luiz I Bridge during the rehabilitation works.

The bridge was designed by the Belgium engineer Théophile Seyrig, a former partner of Gustave Eiffel in previous projects, after an international competition for a double-decked crossing over the Douro river to connect the cities of Porto and Vila Nova de Gaia (see Figure 7.5). Its construction was awarded to the *Société Anonyme de Constructions et des Ateliers de Willebroeck*, and took place between December 1881 and May 1886 (Azeredo and Azeredo, 2002; Seyrig, 1884).

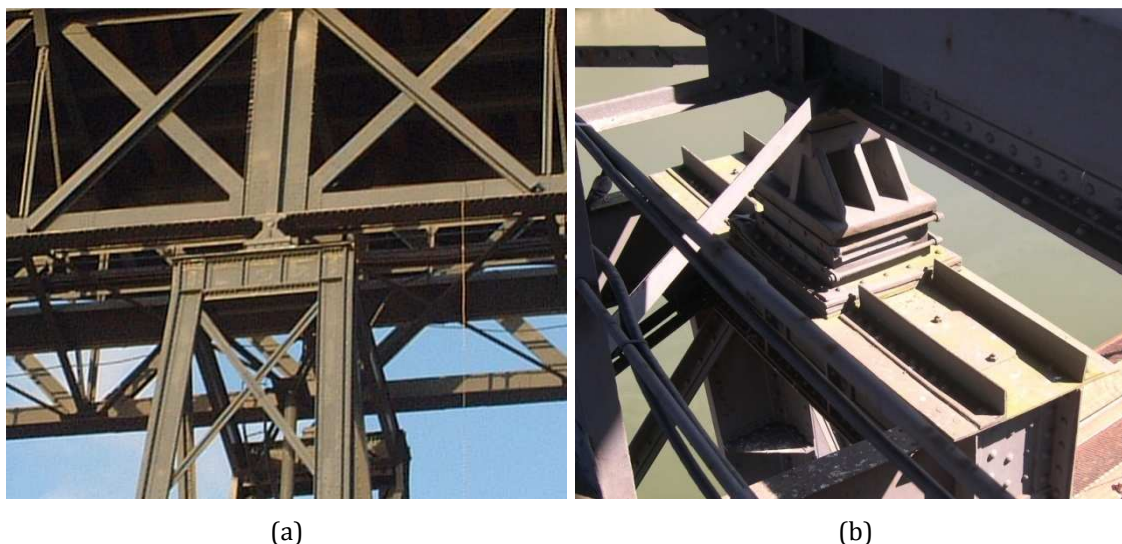
Figure 7.25 - Load transfer from the upper deck to piers P1, P2 and P3: (a) side view of the top of pier P2 after the rehabilitation process; (b) view of the upstream bearing located at the top of pier P1 (picture taken from the technical path of the upper deck).

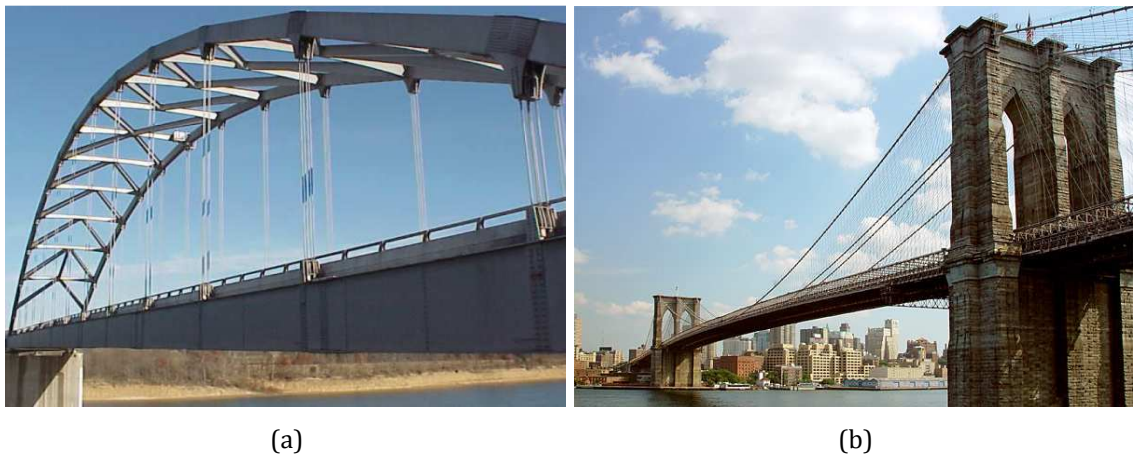
Figure 8.1 – Tested bridges (I): (a) I-24 Tennessee River Bridge, Kentucky, USA (Ren *et al.*, 2004b); (b) Brooklyn Bridge, USA (Ye *et al.*, 2005).

Ren *et al.* (2004b) have studied the dynamic properties of a steel-girder tied arch bridge by modal analysis and ambient vibration testing. Field data was collected for the construction of reliable 3D finite element models, which in turn were used to evaluate the concrete deck influence on the overall dynamic behavior of the structure. Ultimately, the study aimed at assisting the seismic evaluation of the bridge and its likely retrofit.

The dynamic properties of the Brooklyn Bridge have recently been investigated by Ye *et al.* (2005). Modal testing was accomplished by ambient vibration monitoring and forced vibration tests. The experimental mode shapes and natural frequencies compared well with the numerical results obtained by a detailed 3D finite element model, which will assist the seismic evaluation of the structure according to current standards and help to establish the rehabilitation and maintenance plans.

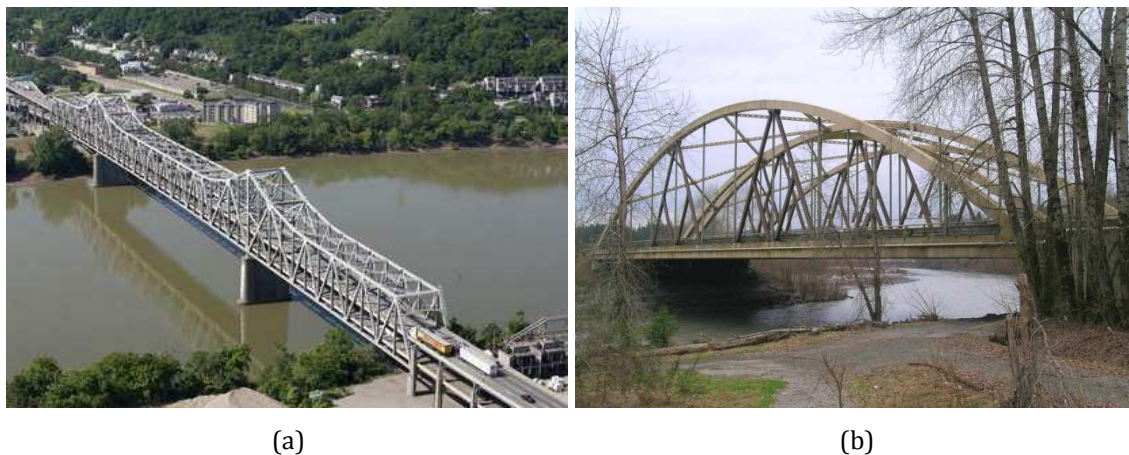
Figure 8.2 – Tested bridges (II): (a) Brent-Spence Bridge, USA (Harik *et al.*, 1997); (b) Toutle River Bridge, Washington, USA (Roeder *et al.*, 2000).

Harik *et al.* (1997) have carried out dynamic testing on a double-deck cantilever through-truss bridge to support a study for the assessment of its structural integrity under the action of seismic loads. The mode shapes and the associated natural frequencies of the structure were extracted from experimental data recorded during a four-hour ambient vibration test. These modal properties were subsequently used to calibrate a 3D finite element model which was then utilized for seismic response analysis enabling the identification of critical elements.

A steel tied-arch bridge was analyzed by Roeder *et al.* (2000). The Toutle River Bridge suffered from significant dynamic response and cracking, being representative of a set of similar bridges in the State of Washington, as well as of their main deficiencies. The experimental study encompassed the measurement of the free vibration response of the structure after the passage of trucks. The collected strains and accelerations have enabled the identification of natural periods of vibration and mode shapes, which in turn were compared with the predictions from finite element analysis. The validated 3D model was

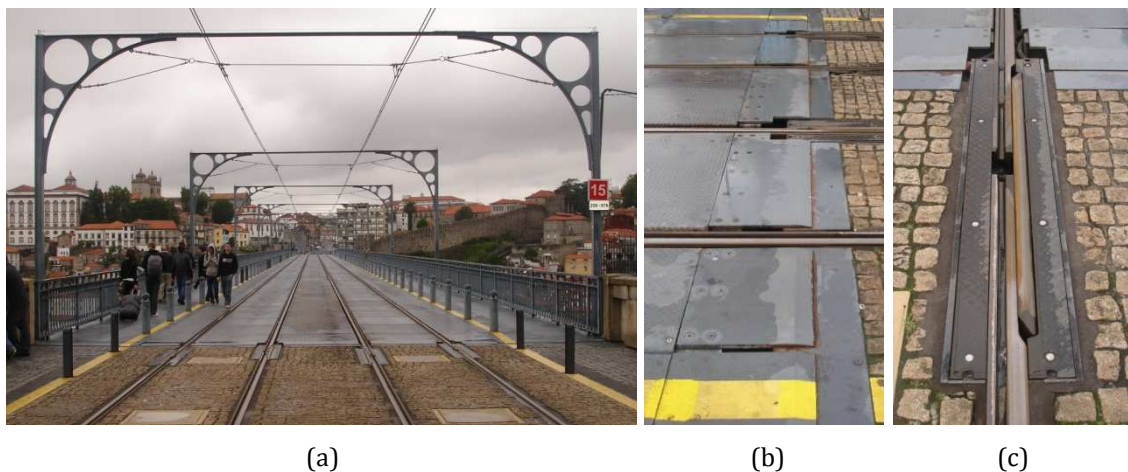
Figure 8.8 - South abutment of the upper deck in the new service phase: (a) general view; (b) cover plates of the expansion joint; (c) expansion device of a rail.
