Managing the conservation of 20th century cultural heritage

Esmeralda Paupério¹, Xavier Romão², Catarina Costa³, António Arêde⁴, Aníbal Costa⁵

3. Case study: the São João National Theatre

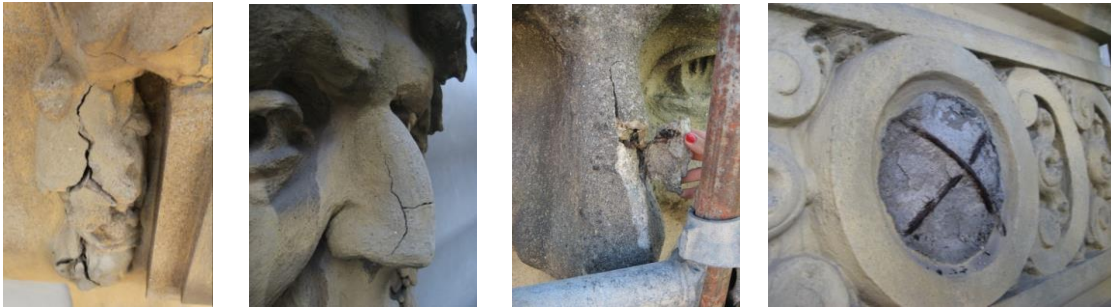
Figure 1 – Examples of reinforced concrete decorative elements and sculptures exhibiting some level of material degradation.

Reinforced concrete, which is made by cement and steel, forms a composite material with a reduced lifespan, when compared to natural and traditional construction materials such as stone or timber. Among other sources of decay, reinforced concrete deterioration is often caused by the corrosion of embedded steel. Since the origin of this deterioration usually starts from inside the concrete element, available repairing approaches are seen to be considerably intrusive. Therefore, this particular source of decay is especially difficult to address when dealing with the repair of reinforced concrete decorative elements or sculptures, where conservation operations could destroy their authenticity (Fig. 1).

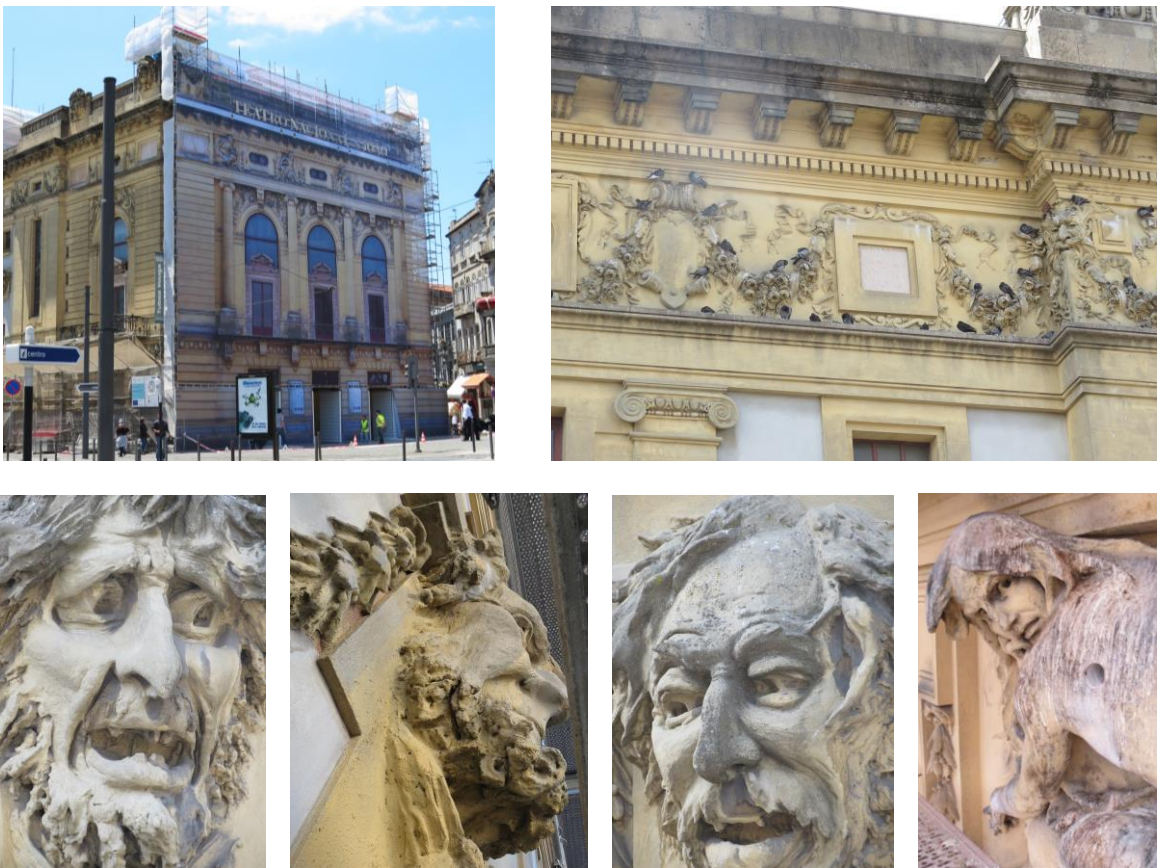
Figure 2 – Façades and reinforced concrete decorative elements of the São João National Theatre.

The Beaux-Arts architecture expresses a neoclassical architectural style that involved sculptural decoration along conservative modern lines and employed French and Italian Baroque and Rococo formulas combined with an impressionistic finish and realism. An abundance of balustrades, statues, columns, garlands, pilasters between doors and windows, and grand staircases is typical of this architectural style. In the case of the São João National Theatre, these decorative elements exist in all the façades (with a total area of approximately 4800m²) and are made of reinforced concrete (Fig. 2). Some of the decorative elements having vegetal and geometrical patterns are seen to be repeated throughout the façades.

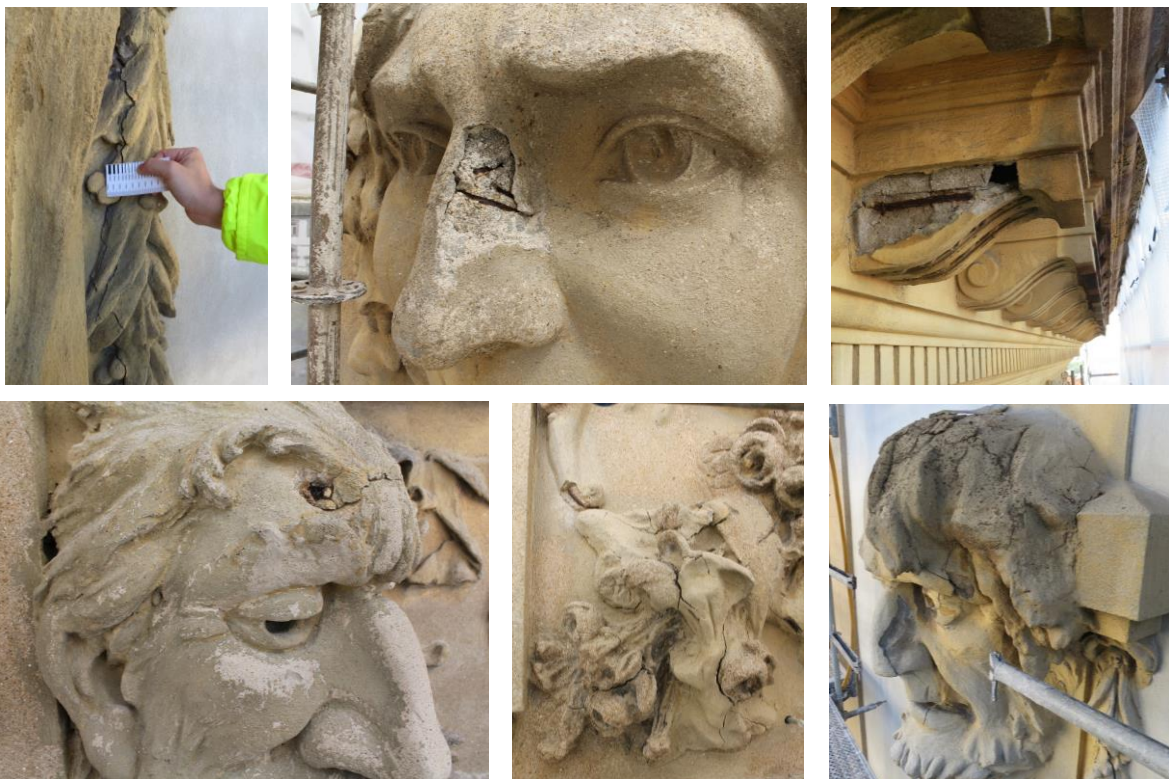
Figure 3 – Examples of damaged reinforced concrete decorative elements of the façades of the São João National Theatre.

Besides the severe cracking and spalling levels found in the concrete due to corrosion of the reinforcement, significant damages were also found to be related to bird dropping deposits and to the presence of black crusts. In order to illustrate the state of degradation of some of the reinforced concrete elements of the theatre façades, Fig. 3 presents some examples of damaged reinforced concrete decorative elements of the façades of the São João National Theatre.

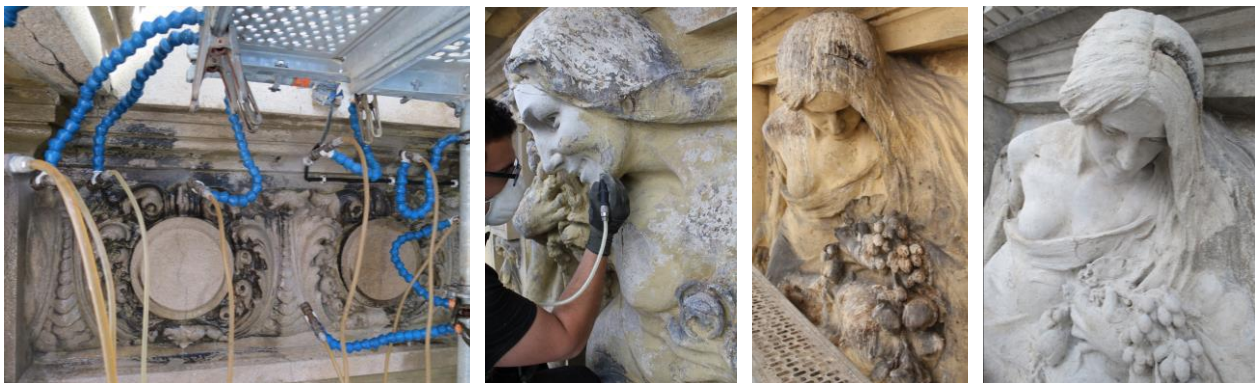
Figure 4 – Cleaning operation to remove limewash (left), cleaning operation by micro-abrasion (centre left), example of a decorative element before (centre right) and after (right) the cleaning operation.

To adequately plan and prepare these interventions, a survey of the damages and degradation levels found on the façades and their decorative elements and sculptures was needed. A first assessment of their state of degradation was carried out before the cleaning operations of the façades took place, which resulted in an incomplete characterization of the elements' condition. A reliable assessment was only possible after the cleaning operations (Fig. 4). In addition to the damage survey, several concrete samples were taken from the façades for laboratory analysis and testing in order to determine the components and mix proportions of the original concrete, thus enabling the development of a repair mix with properties compatible with the original concrete.
