THE USE OF INFRARED THERMOGRAPHY AND INTEGRATIVE TESTS FOR MEASURING RISING DAMP

ANA CLÁUDIA RIBEIRO FREITAS

MASTER IN CIVIL ENGINEERING - EXPERTISE IN CONSTRUCTION

The investigation realized in the matter of this thesis, aims to analyze the damages in the conference room of the Diocesan Museum of Mantua, diagnosing the source of the problem by combining non-destructive techniques as infrared thermography, with a destructive technique, the gravimetric test. The applicability of these methods, in addition with the microclimate monitoring, and the functioning of a device installed in the room to stop rising damp, are also objects of study in this paper.

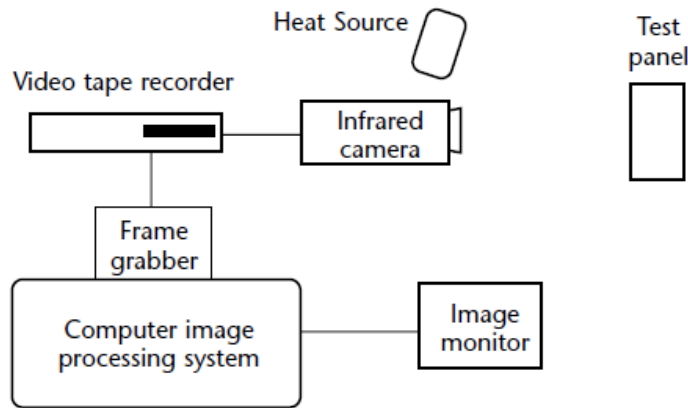
As it was previously said, the infrared method measures the temperatures of the surfaces by radiometers or infrared cameras. These devices consist in optics that collect and image, on a sensitive detector, the infrared radiation received. More specifically the collected data is transformed in an electrical signal that is processed by a microprocessor and presented, as a visual image, in the digital display (Figure 3.1).

Fig 3.1 – Diagram of a typical infrared inspection system^[15]

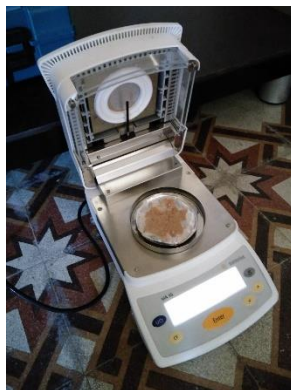
Fig 3.4 – Thermobalance used in diocesan museum;

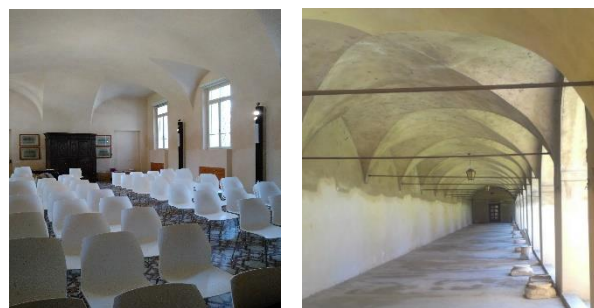
Fig 4.1 – Conference room at the present (left); Exterior wall of the conference room (right);

In 2013, refurbishment operations were made in the building, including the renewal of the air conditioning system in the conference room, the introduction of new window frames at the first floor and the renovation of the plaster in some interior and exterior walls at the ground level, as can be seen in figure 4.1. However, after a few months some stains and detachments appeared on the walls of the conference room. To discover the origin of the problem, the focus of the study transferred more specifically to this room instead of the entire museum.

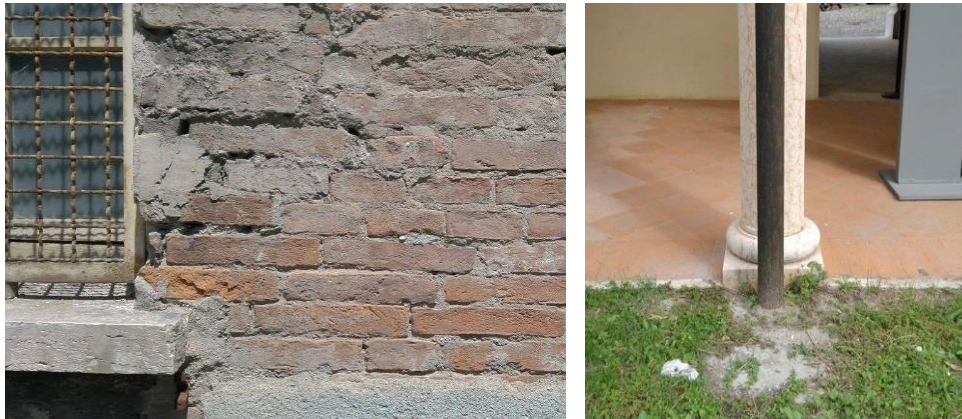
The masonry contained in the Diocesan Museum is known to be solid bricks bound together with mortar of lime and sand (figure 4.5). This type of masonry is a very common material in the historic buildings of the region, as they are composed by a ceramic porous paste, that derives from processing clayed soils, in which this area is rich. The walls in the building reach a thickness of 50 cm and the typical bricks used in the area are of variable size and that often present stretched courses. ^[45] Furthermore, their composition results from different materials having different porous and hygrometric characteristics.

Fig 4.5 – Exterior wall from Diocesan Museum (left); Downspouts in the cloister (right).

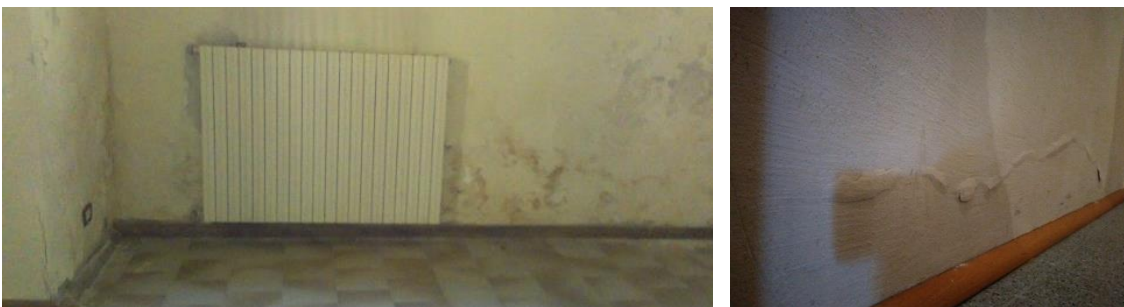
During the visual inspection to the entire museum it could be noticed that some of the rooms are not in good conditions, having some of them the appearance of abandonment. In addition, it can be noticed some plaster detachments in the lower part of the walls, as it is shown in figure 4.6.

Fig 4.6 – Plaster detachments on a wall from the ground floor (left); Lower part of wall from the conference room (right);

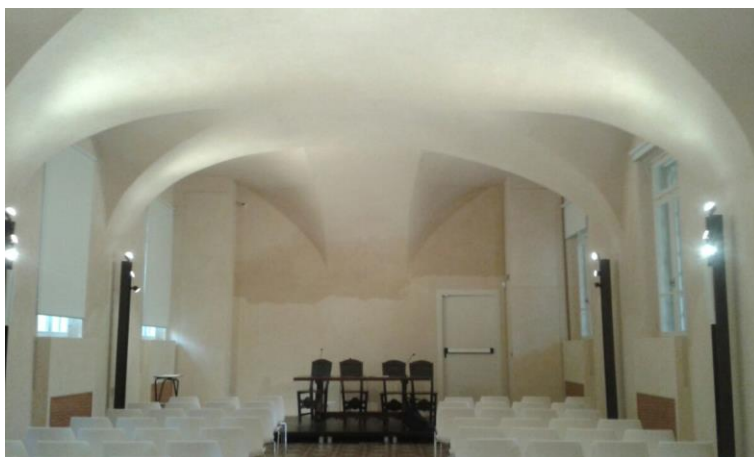
Fig 4.15 – Visual picture of the northeast wall, November 11th, 2015

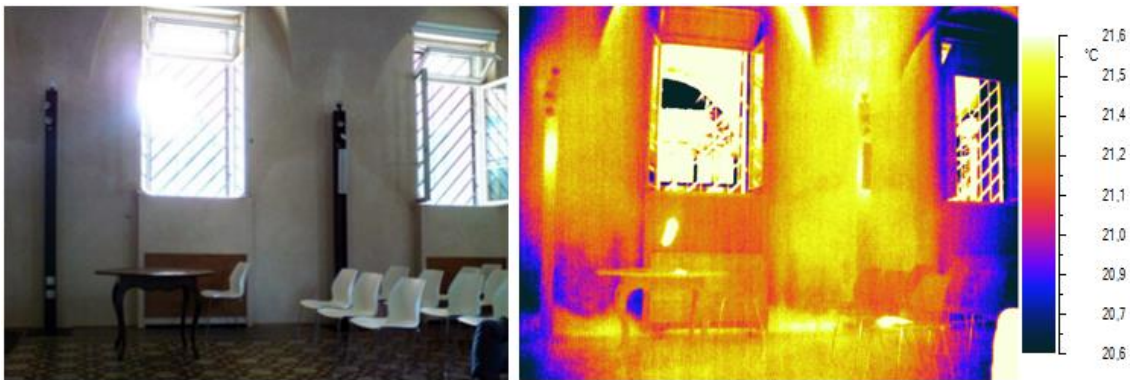
Fig 4.19 – Visual picture of the southeast wall, between 3rd and 4th window, (left) and correspondent thermogram from the survey of September 9th, 2015 (right)

Fig 4.20 – Southeast wall thermograms, from the surveys of November 11th,2015 (left) and March 24th, 2016 (right)

In figure 4.19 and 4.20, as in the rest of the walls, the scale acquires lower values from the first survey to the last and, as it was said before, it is easy to see the gradual change of temperature from the floor to the top of the wall, indicating the existence of water inside the masonry in the colder area. The high temperature of the floor is, possibly, due to the heating occurred before the test: on march the heat spread on all the interior surface of the room, whereas in June (figure 4.21, right) the floor has a lower temperature due to the contact with the soil, colder than the air.

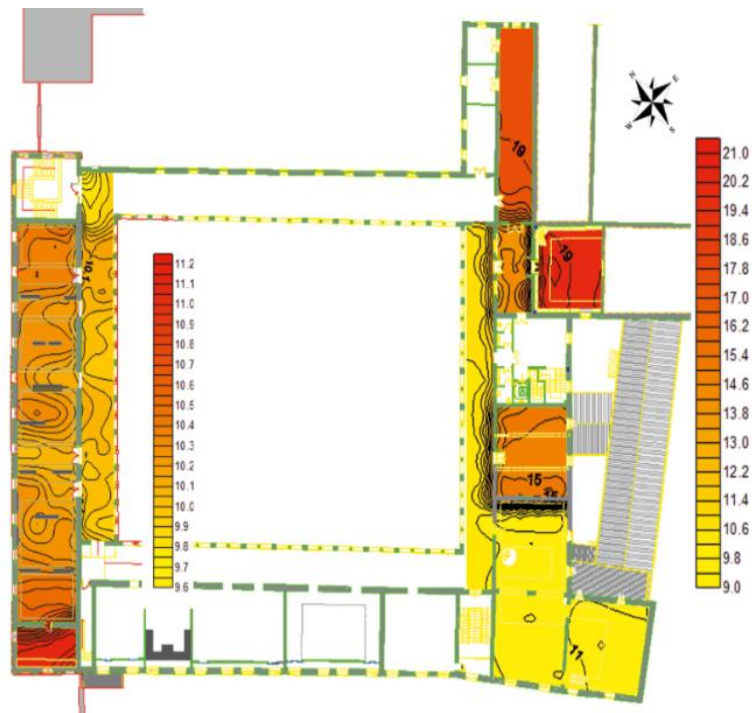
Fig 4.29 – First floor Temperature map from the 9.30h measure, from the February 4th, 2015, survey.

On the 1st floor the differences between the rooms where the heating is turned on and the others, like the corridors, are very accentuated. It is easy to notice, in figures 4.29 and 4.30, the heating flow through the walls in the rooms from the east side, where the isolines are much closer to each other, indicating a quick change of temperature. Between the heated room in the east and the corridor, there is a difference of approximately 10°C. However, on the west side the temperatures do not vary as much, being the average values of 10.5°C.

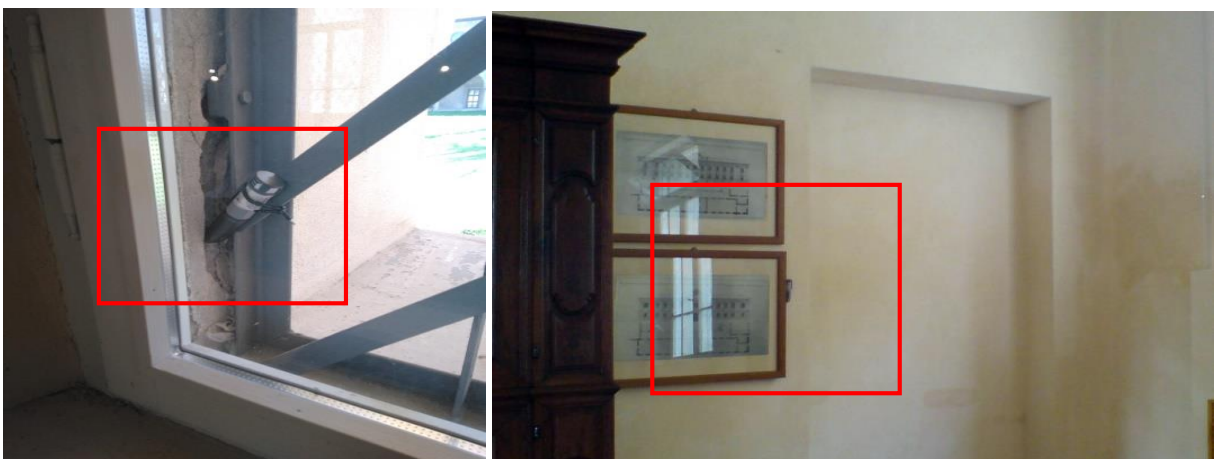
Fig.4.38 – Visual images of the location of the probes 6 (left) and 16 (right)

The probe collecting the data inside the conference room is the one represented in figures 4.37 and 4.38 right. To the interest of this project, another probe was installed on March 24, 2016, in the exterior of the conference room with the purpose of a more correct relation with the measurements did inside this room (figure 4.38 left).

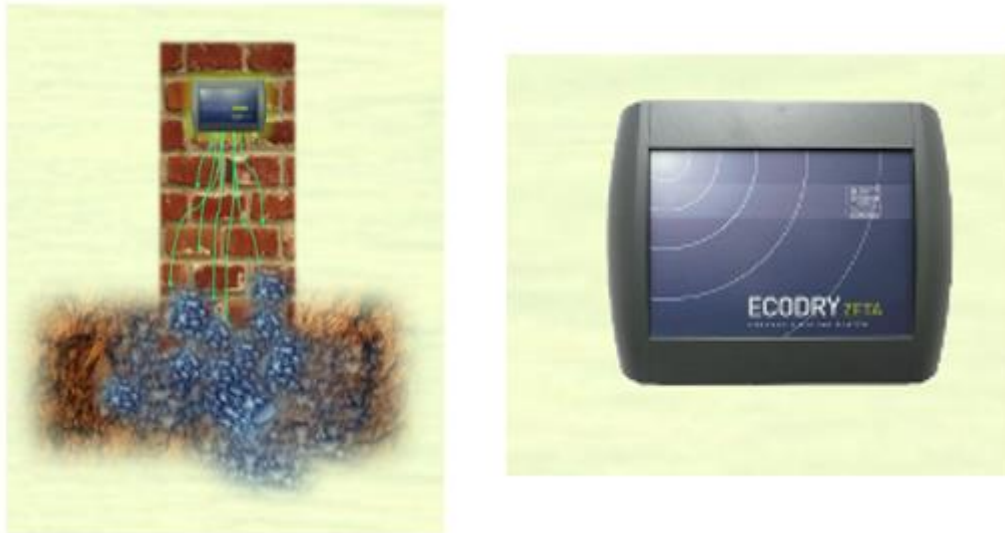
Fig 5.1 – Representation of the method of ECODRY (left); ECODRY device (right); ^[51]

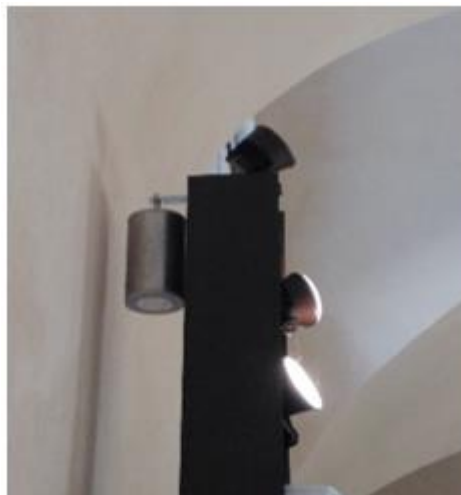
Fig 5.3 – Smeraldo device inside the conference room.

In addition, aiming to decrease the moisture content on the walls, the property manager of the museum installed in the conference room a dehumidification device, the SMERALDO⁸⁸, With the tests and measurements performed and the information given by the company, it is possible to conclude if the machine's functioning is reliable.
