STRUCTURAL CHARACTERIZATION AND MONITORING OF HERITAGE CONSTRUCTIONS

A Thesis presented to the Faculty of Engineering of University of Porto
for the Degree of Doctor in Civil Engineering.

JULY 2017

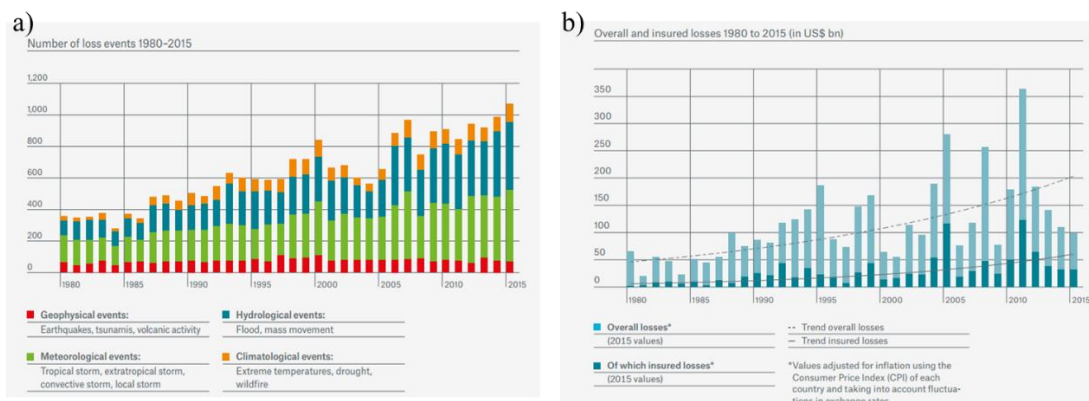
Figure 4. Natural hazards occurrence since 1980: a) number of events and b) monetary losses [30].

Annually the worldwide monetary losses related to the occurrence of natural hazards are in the order of billions of dollars (Figure 4.a), and are deeply linked with structural and infrastructural damages. A survey report presented by Munich RE about global economic losses caused by natural disasters occurred between years 2010 and 2015 relates that in this short time the losses were of US\$ 1 075 billions (Figure 4.b), and it is expected that until 2020 the losses will be the highest ever recorded in world history [30].

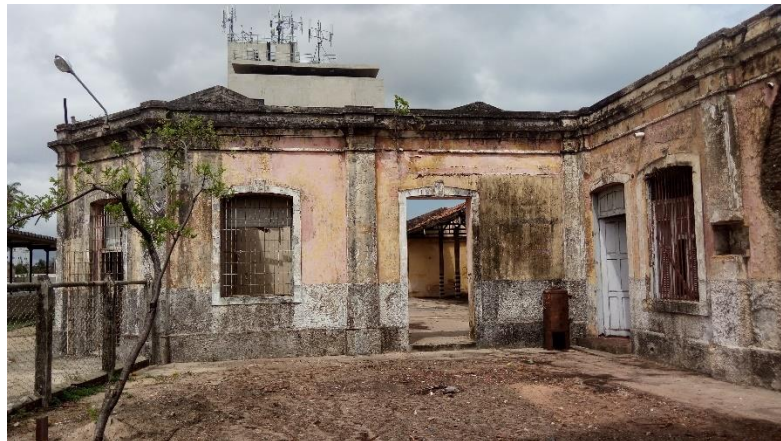
Figure 5. Material degradation by environmental action.

and alkali-silica reaction, which also have an influence on accelerating material degradation (Figure 5), and consequently decreasing their lifetime. From these, corrosion may possibly be the most evident phenomenon of material degradation in steel and reinforced concrete structures being accelerated essentially by the formation of chlorides or another inorganic salt. Hence, corrosion constitutes a global problem [33] that has mobilized the academic community to study its mechanisms of occurrence, catalytic agents, and methods of prevention (especially mixtures to concrete) and repair [34–37]. A survey performed by the Federal Highway Administration in the United States demonstrated that there are 134000 bridges requiring immediate repair measures and 226000 bridges presenting corrosion problems, resulting from environmental actions combined with a low frequency of repair proceedings [18]. Indeed, the structural assessment should not only include the structural parameters but also consider durability parameters, for a most effective evaluation with the purpose of offering data to a better structural characterization.

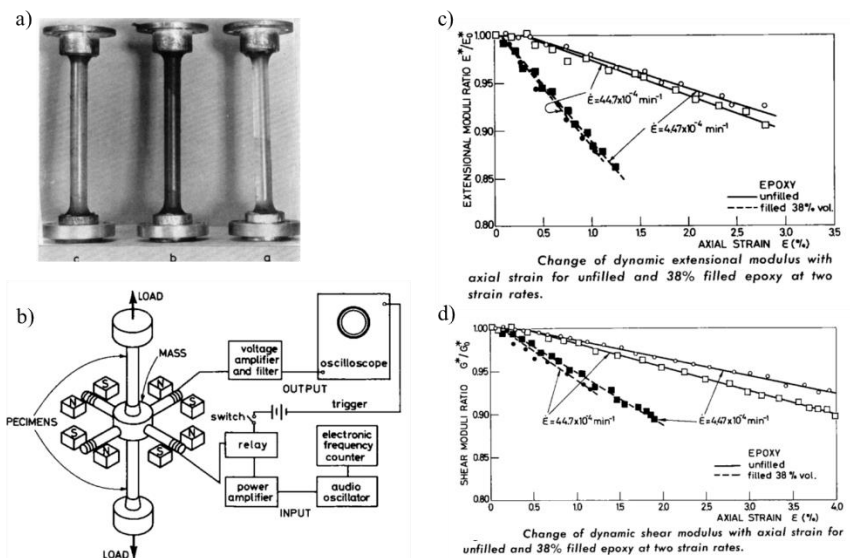
Figure 7. Summarized view of the Lifshitz & Rotem's work: a) samples (Polyester) used on the experimental (a' – unfilled, b' – 40% filled before reaching dewetting and c' – 40% filled after reaching dewetting), b) experimental setup and c) and d) the results of the dynamic changes detected by vibrational testing [47].

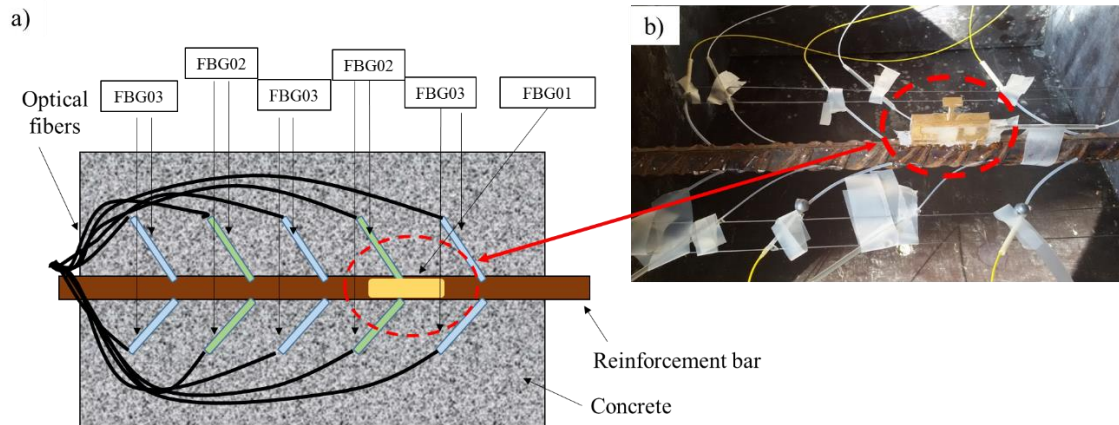
Figure 29. Disposition of the bond-slip FBG sensors inside the specimen.

positioning inside the RC specimen, and Figure 29.b show the detail of the sensors arrangement during the specimen preparation step.

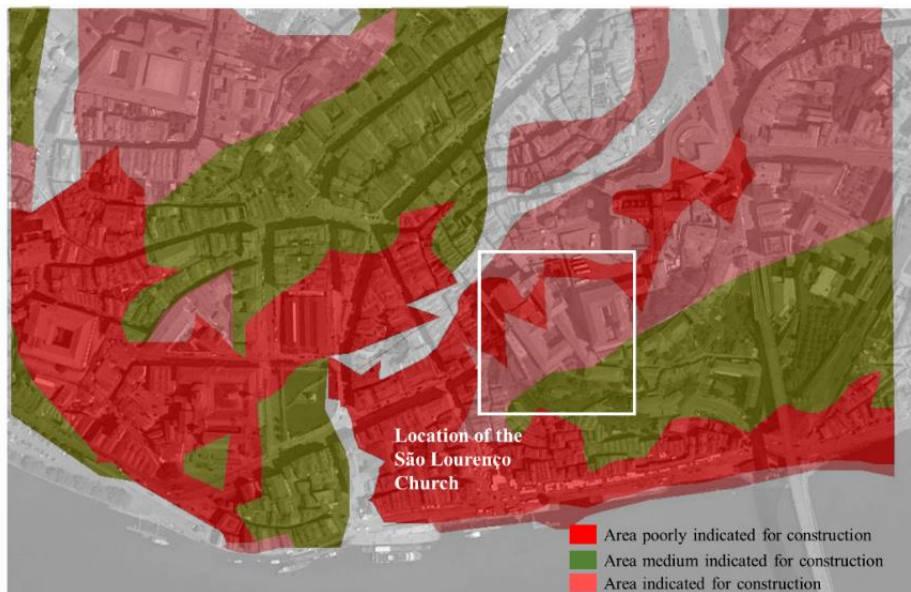
Figure 43. Mapping of soil classification for construction according with Porto Geotechnical Report and location of the São Lourenço Church.

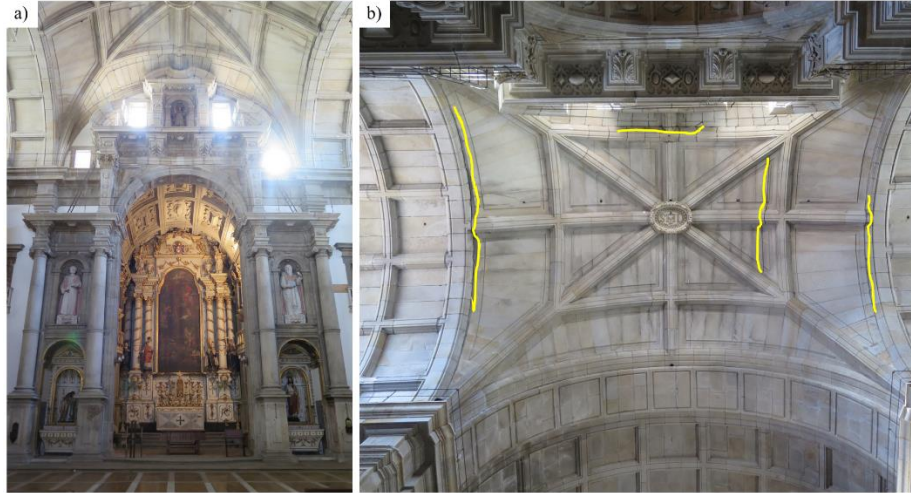
Figure 50. Altar-Mor of the São Lourenço Church: a) general view and b) main cracks occurrences.

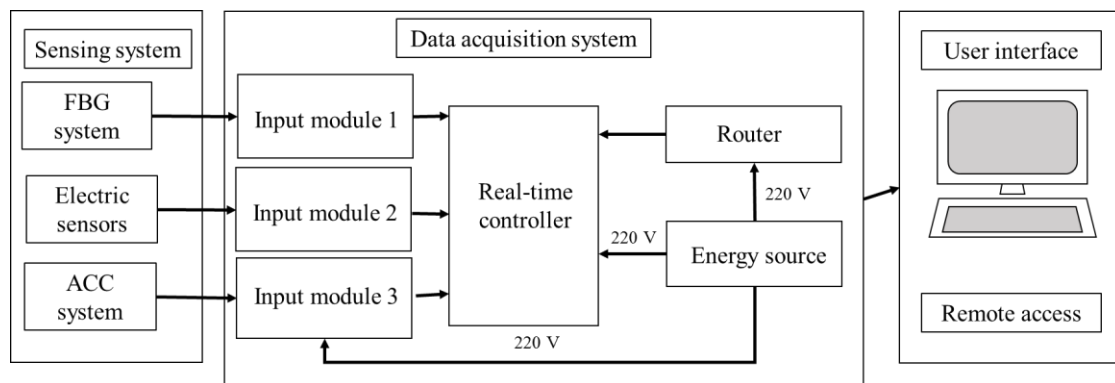
Figure 55. Detailing of the components of the SHM system for be implemented at São Lourenço Church.

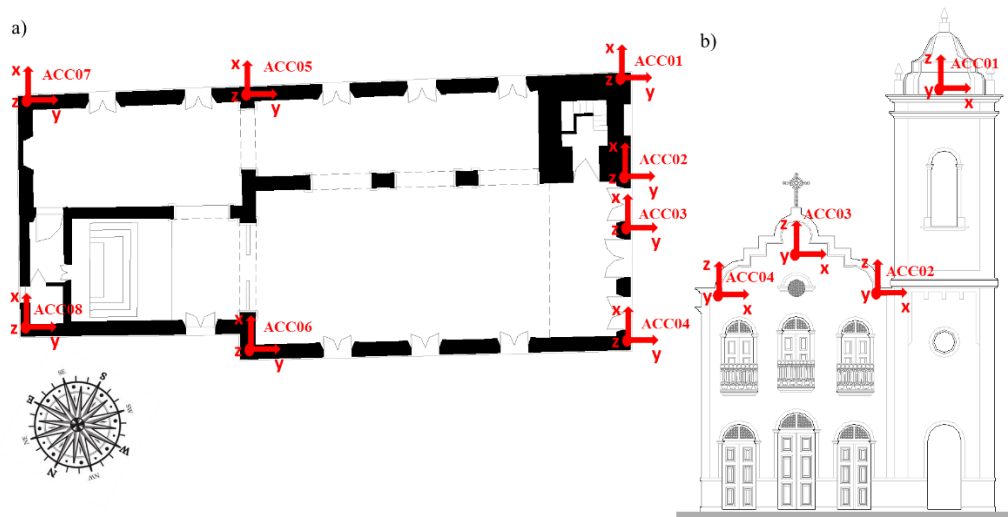
Figure 67. Scheme of accelerometers positioning.

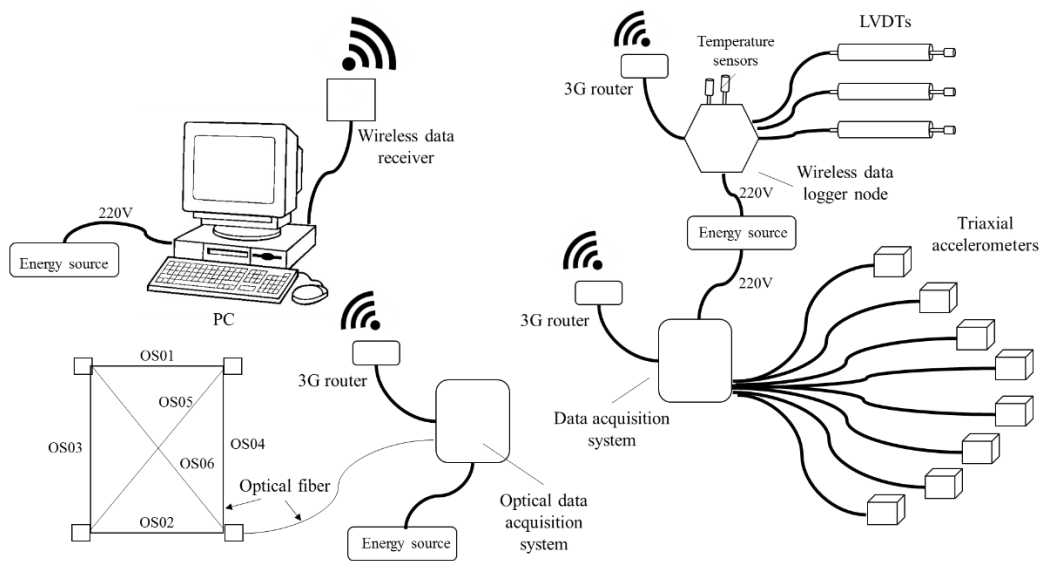
Figure 70. General scheme of the SHM proposal for Nossa Senhora das Dores Church.

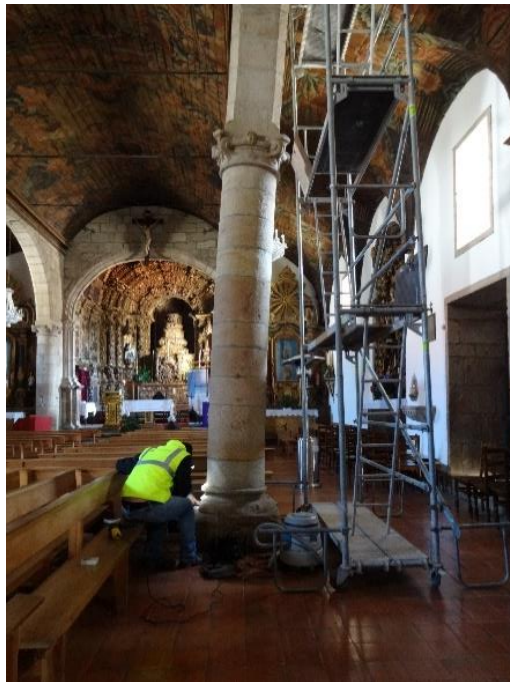
Figure 72. Photograph of column 2, evidencing its inclination.

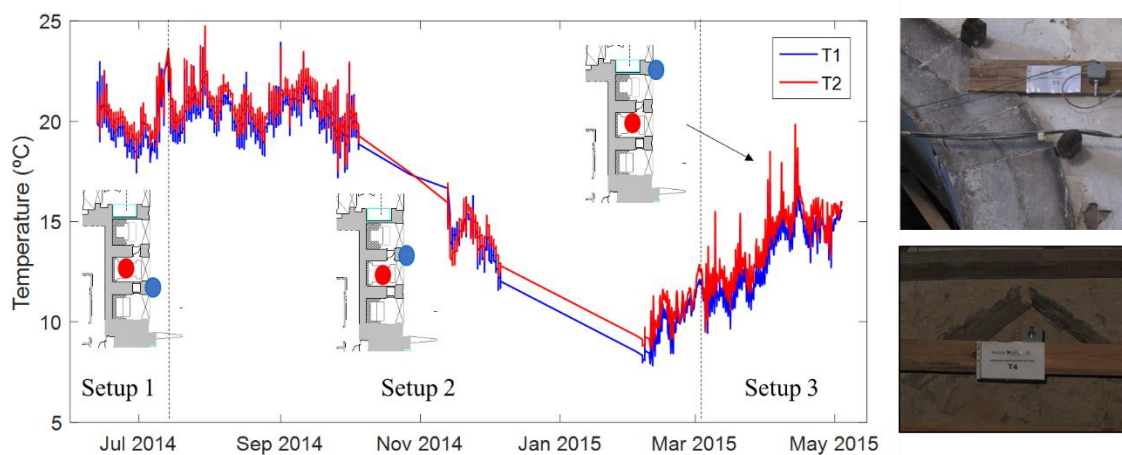
Figure 97. Time evolution of the temperatures collected by sensors T1 and T2.
