# Experimental assessment of the structural behavior of a masonry wall under horizontal cyclic loads

**ABSTRACT:** This paper presents a numerical and experimental study on the cyclic behavior of a masonry wall from a house that collapsed during the July 9, 1998, earthquake in the Archipelago of Azores. It is divided into three parts: the first one contains the description, analysis, and interpretation of the outcome of the laboratory tests; the second one describes the wall's numerical model adopted for the simulation of the tests and presents the comparison with the experimental results; the last part concerns tests made on the wall after being reinforced.

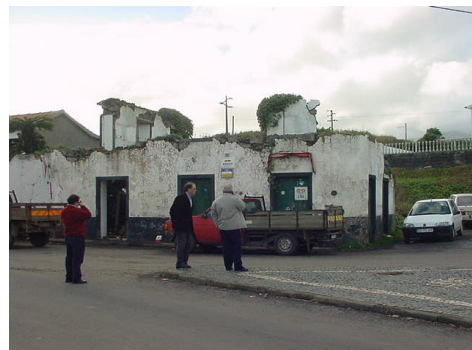
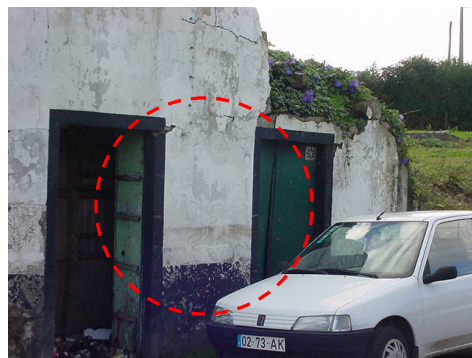
Fig. 1. Building from where the wall was removed.

This work presents the experimental and numerical behavior of a wall from a house located at the parish of Pedro Miguel, Horta council, Faial Island (Fig. 1) in the Archipelago of Azores.

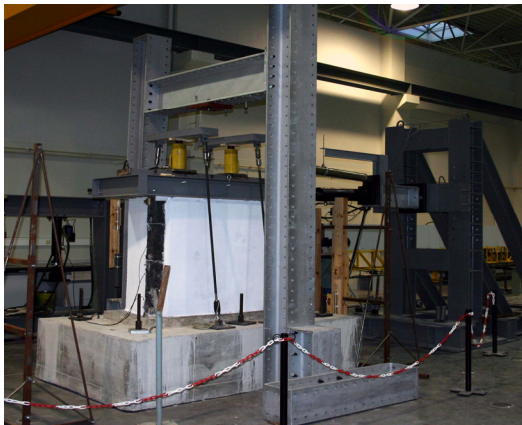
To reproduce the local conditions, two hydraulic jacks were set on the top of the wall against a reaction structure linked to the foundation through steel rods, to guarantee the existing vertical load. This system allowed a better distribution of the vertical load applied to the wall. The horizontal displacements were imposed using a hydraulic jack linked on one side to a reaction structure and, on the other, to the wall top through a hinged connection. The wall foundation was rigidly connected to the lab floor through high-strength prestressed rods (Fig. 2).

Fig. 2. Wall view and testing scheme.

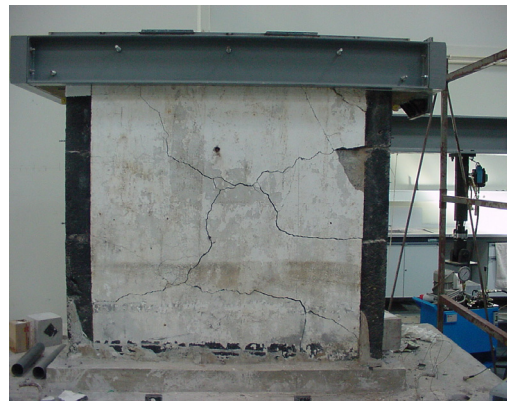
In fact, damage is concentrated on the joint immediately above the near the basement joints, i.e. spots 5 and 13. This situation is confirmed by the formation of an inclined strut from the top up to that spot, confirmed by an extensive crack towards this direction (Fig. 7). One can, therefore, conclude that the door column base is a more rigid area, meaning a lower damage concentration. This might be explained by the concrete foundation, which brought a further rigidity to this area.

Fig. 7. Wall after the experiment.

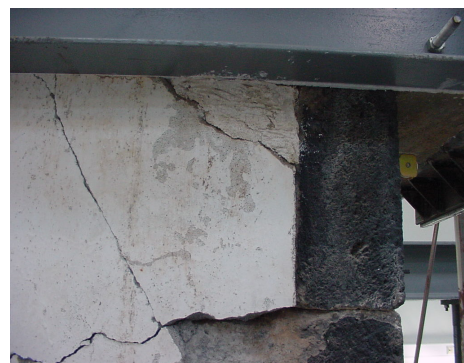
Fig. 10. Damaged area.

The LVDT 12 data was unusual. The behavior of this joint was opposite to what was expected. As the cyclical horizontal displacements were imposed, instead of opening (for displacements in the positive direction) and closing (for displacements in the negative direction), the joint displacement trend was always towards closure (almost 2.5mm), and in no occasion was there a displacement towards compression decrease and joint opening. The reason for this behavior lies in the fact that the wall before the test was accidentally damaged at the spot where the LVDT 12 was positioned (Fig. 10). Although the stones were reset into their original position, this measure was inefficient to reproduce the expected behavior of the wall on that area; the existing link between

As aforementioned, the damage inflicted to the high, right corner of the wall (12) before the test distorted the outcome and made impracticable a comparison between these two LVDTs results.

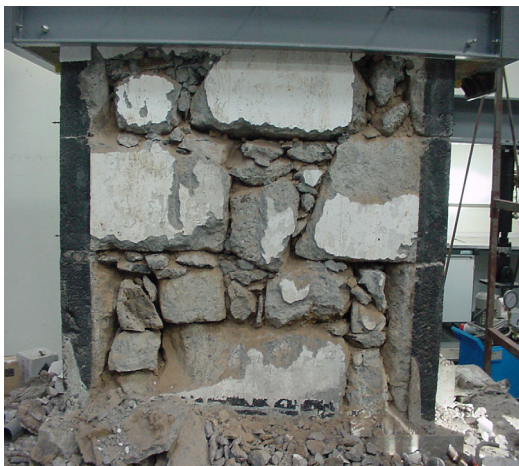
Fig. 13. The 3D image of the wall in SolidWorks and the actual picture of the wall.

The wall was then simulated using a finite-element method. To define the geometry underlying the numerical modeling it was necessary to make a geometric survey of the wall. The wall external outline was measured and the wall mortar was removed to get a clear view of the main stones geometry. This wall observation and survey was followed by the definition of the finite-elements mesh. This procedure involved the use in sequence of several auxiliary programs (AutoCad 2004, Solidworks 2004, GiD 7.5.0b, and a program called BLOCO). All these programs were necessary to convert the Autocad and Solidworks defined geometries into the language Gibiane of CAST3M finite-element program. Basically, CAST3M is a computer code for analyzing structures using finite-elements methodologies that was developed by the French Commission for Atomic Energy (CEA). The CAST3M is high-level tool for civil engineering investigation purposes and it integrates pre- and post-processing functions.

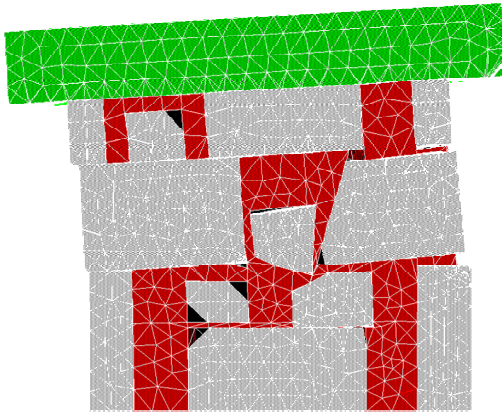
Fig. 16. Deformed shape at the +10mm displacement during cyclic loading.

Reviewing Figures 16 and 17, the wall shows a behavior with sliding at two levels, following the almost continuous horizontal joints surfaces quite evident in the two figures. Moreover, most of the displacements occur at these two sliding levels. For positive displacements (Fig. 16) the transverse bending of the wall is almost zero. However, there is a slight vertical rotation of the wall, meaning that

the rigidity center is not located on the line of the applied force.

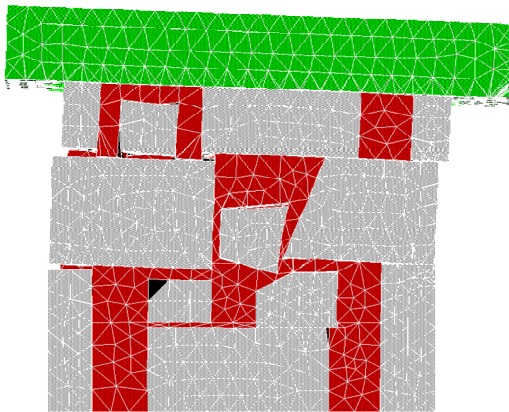
Fig. 17. Deformed shape at the -7.2mm displacement during cyclic loading.

As for negative displacements (Fig. 17), the wall bends in the transverse direction, weakening the links between the different front elements.

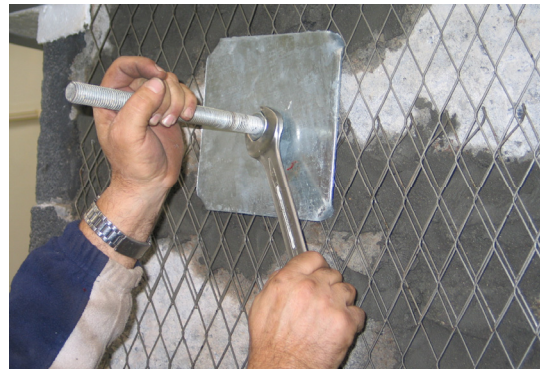
After the experimental test, the wall was reinforced using a process that is commonly used in the Archipelago of Azores. The process consists first of introducing steel rods (4 in this case) in the transverse direction of the wall in order to link both sides of the structure. Then, the joints between the

blocks are filled up with mortar. Afterwards, a metallic net is set around the whole wall and metallic plates ( $60 \times 40\text{cm}^2$ ) are set on the ties and tightened against the wall (Fig. 20), so that the steel rods and the metallic net act together with the wall, reinforcing it. Another metallic net is set on the metallic plates to enable bonding with the mortar. Then the metal structure is fixed to the wall on the sides through screws, and the ties are cut to prepare the wall to receive mortar (Fig. 21). Finally, the wall was covered with plastic to simulate the Azores concrete cure conditions, with a high air moisture percentage (Fig. 22).

Fig. 20. Reinforcing technique: metallic net and steel rods.

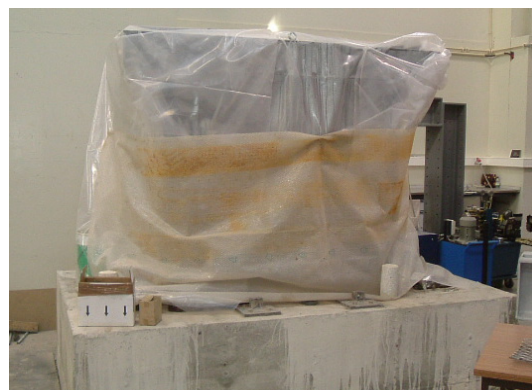
Fig. 22. Simulation of local air moisture conditions.

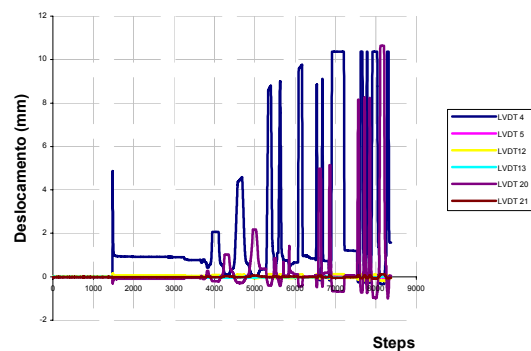
The results were quite different from those of the nonreinforced wall. The most relevant are presented. Figure 23 shows the horizontal top force versus top displacement curve, and Figure 24 the joints opening evolution. Unlike the behavior of the nonreinforced wall, the reinforced wall acted as a block; there was no sliding between successive levels. The wall acted as a block, with only a joint opening on the base, as can be observed in Figures 24 and 25. In Figure 23, one observes that for the same displacement level the reinforced wall showed greater resistance than the nonreinforced wall. The maximum resistance of the reinforced wall is  $\sim 100\text{kN}$ , almost three times higher than the nonreinforced wall ( $\sim 35\text{kN}$ ).

High and intermediate joints in both door columns show an almost null displacement. The joints at the basement (4, 20) showed a consistent behavior: when one of the joints opened, the other closed and

vice-versa. Both developed extensive opening displacements, which became quite visible during the test. In fact, all damage was concentrated on the bottom of the wall. This behavior was quite distinct from that obtained for the nonreinforced wall. Here there was joint movement and a more spread damage with extensive cracking of the wall facades.

Fig. 24. Evolution of the joints opening for the reinforced wall.
