**The 14<sup>th</sup> World Conference on Earthquake Engineering**  
**October 12-17, 2008, Beijing, China**

## **ASSESSMENT OF THE SEISMIC BEHAVIOUR OF GONDAR CHURCH USING A CONTINUUM DAMAGE MODEL**

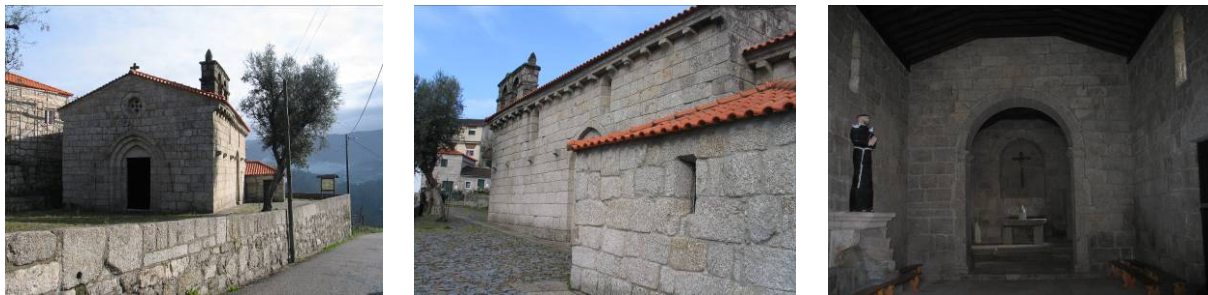
Figure 1 Gondar church

The Gondar church (Figure 1) is a beautiful but discrete example of religious, Romanic architecture, located on the Gondar village near Amarante on the north region of Portugal. This church, also known as Gondar monastery, is in fact what's left of a Benedict monastery founded on the XII century. After being abandoned and in ruins for many years, in 1978 the church was classified as property with public interest and it was registered on the General Directorate of Buildings and Monuments of the Northern part of Portugal (DGEMN). Architecture Heritage Inventory. At that time the church was bought by the town hall and later, during the 80's and 90's, the church underwent conservation and rehabilitation interventions by the DGEMN, which left it as it is presented nowadays.

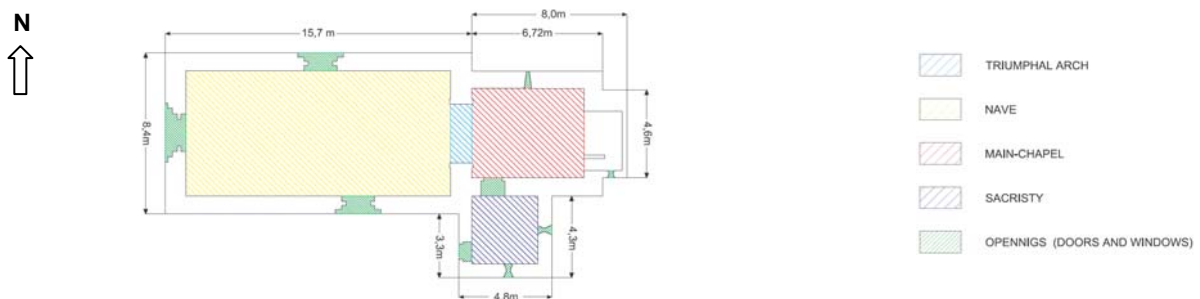
Figure 2 Church implantation and space description

The church presents a rectangular type plant. Figure 2 indicates the dimensions of the church according to the latest survey performed by DGEMN. The church is composed by a single nave, a main arch that makes the transition to the main-chapel and a sacristy with square plant positioned on the South side of the main-chapel. There is a small bell tower on top of the south wall, close to the main façade.

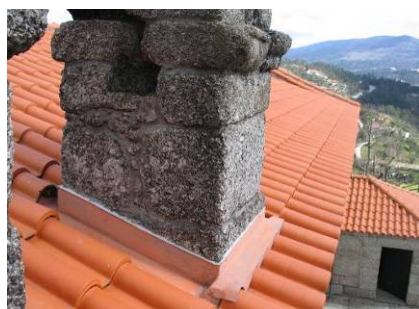
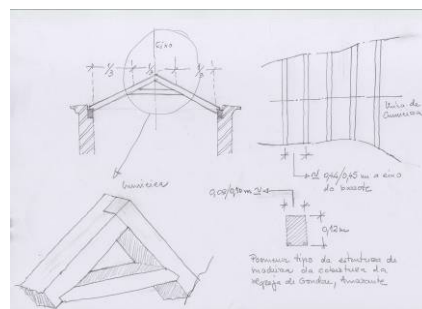
Figure 3 Church roof. (a) Outside view. (b) Schematic drawings by Augusto Costa, Director of DGEMN.

The church main supporting structure is composed by two leaf stone masonry walls with an infill middle layer, this walls are approximately 1.0m thick. The church roof (Figure 3) is covered by an oak wooden structure that supports to the outside tiles roof and it is composed by rectangular cross-section elements ( $0.10 \times 0.12 \text{m}^2$ ). The support structure is composed by wood trusses spaced of 0.45m. The trusses are connected on the inside by a wooden lining 2.0cm thick; on the outside they are connected by the framework that supports the tiles. This roof structure is not self-bearing, introducing horizontal forces to the supporting lateral walls.

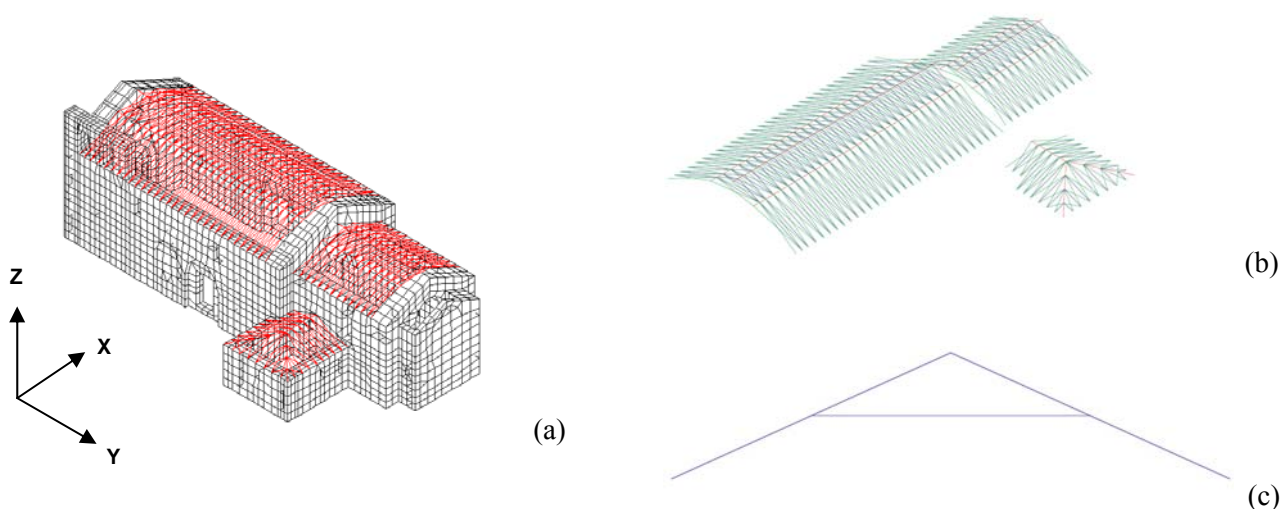
Figure 3 Numerical model of Gondar church. (a) Complete model. (b) Roof model. (c) Truss model.

The numerical model, presented in Figure 3, was created based on the geometrical survey performed during the technical inspections on the building and on the most recent topographic elements at DGEMN possession. This information was later treated through a set of steps that involved several auxiliary programs such as AutoCad (Autodesk, 2002), GiD (CIMNE, 2007) and other specially developed software, until it was ready to be introduced in the finite elements program Cast3M (CEA, 1990) used in the study.

The masonry structure was simulated using 8 nodes volumetric elements (CUB8), while the already existing roof wooden structure was simulated using a 2 nodes bar elements (BARR). As boundary conditions, the church was considered fixed on the base. Although the foundation and the soil conditions may be relevant for the church behaviour, they weren't considered in this study.

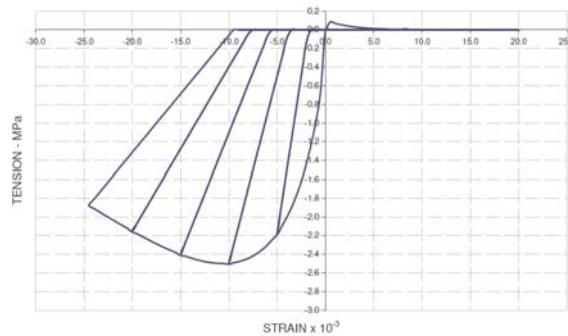
Figure 4 Numerical material behaviour curve for stone masonry.

The continuum damage model applied to the non linear mechanical behaviour of the masonry walls resulted on the axial curve presented in Figure 4. This behaviour was numerically reproduced through an extensive calibration process (Silva, 2008) based on the experimental tests (Vasconcelos, 2005).

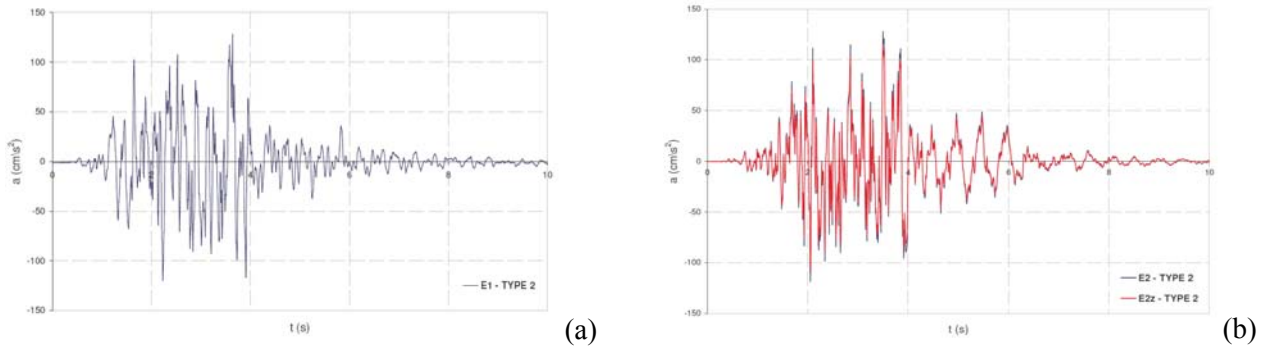
Figure 5 Artificial accelerograms. (a) E<sub>1</sub>. (b) E<sub>2</sub> and E<sub>2z</sub>.

The seismic analysis was performed using type 2 artificial accelerograms ( $E_1$  and  $E_2$  – Figure 5) generated according to the EN 1998-1:2005 (CEN, 2005) response spectrum and to the zoning proposed on the Portuguese DNA. This particular structure is located in a level 5 zone and over a medium terrain (type C), which corresponds to a maximum reference acceleration of  $80\text{cm/s}^2$  for a type 2 seismic action.

The accelerograms were generated using the program SIMQKE (Vanmarckle, 1969) and treated using an excel spreadsheet developed by Campos Costa (Costa, 1993) that permits the visualization of the corresponding response spectrums and its comparison with the normalized spectrum. The accelerogram  $E_1$  was applied on both horizontal directions (XX and YY) and  $E_2$  on the vertical direction (ZZ), according to the following load combinations:

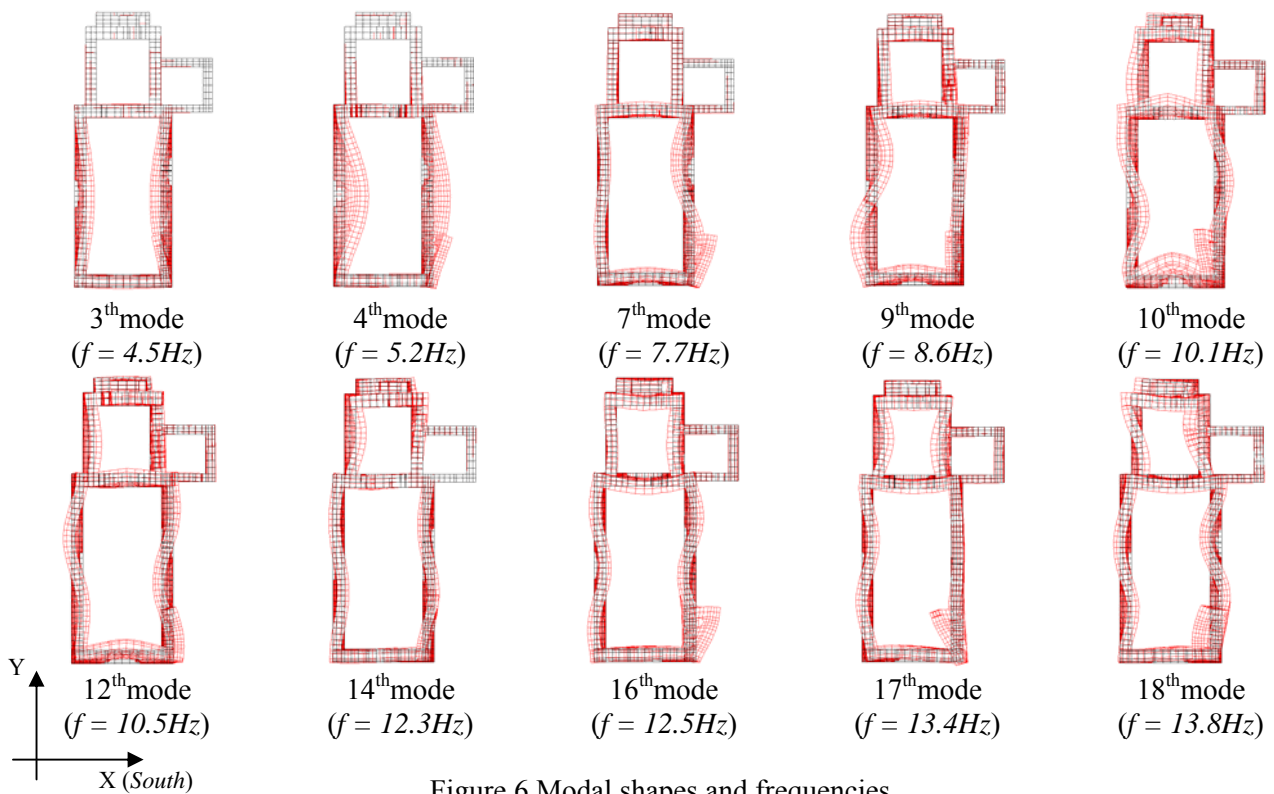
Figure 6 Modal shapes and frequencies.

In this phase, it was performed the modal analysis of the unreinforced church model. The knowledge attained from this type of analysis is of extreme importance: it provides knowledge on the structure dynamic characteristics and it helps understanding the structure response when submitted to seismic loads. Figure 7 presents the first 10 numerical vibration modes of the stone masonry structure (red color) using the unreinforced model MSV - UR, over the initial church plant (black color).

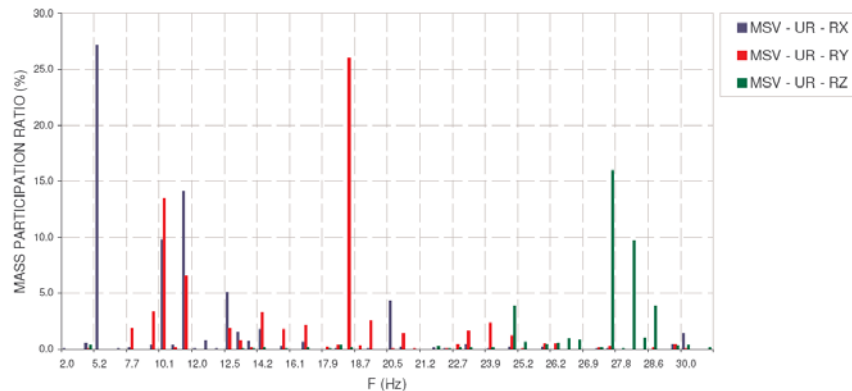
Figure 7 Mass participation ratios for each of the vibration modes and the main directions (XX, YY and ZZ).

The most participative modes in each of the main directions were: in the XX direction, the 4<sup>th</sup> mode ( $f=5.2Hz$ ) and the 12<sup>th</sup> mode ( $f=10.5Hz$ ), and in the YY longitudinal direction, the 10<sup>th</sup> mode ( $f=10.1Hz$ ) and the 27<sup>th</sup> mode ( $f=18.2Hz$ ), Figure 7. Besides the global vibration modes with higher effective mass percentage i.e., with higher mass participation ratios, there is the local vibration modes related to the church roof, like for example the 1<sup>st</sup>, 2<sup>nd</sup>, 5<sup>th</sup> and 6<sup>th</sup>. The deformed shape of the 4<sup>th</sup> mode illustrated in Figure 6 indicates that the church roof doesn't give enough stiffness at the roof level, allowing the independent movement of the nave lateral walls.

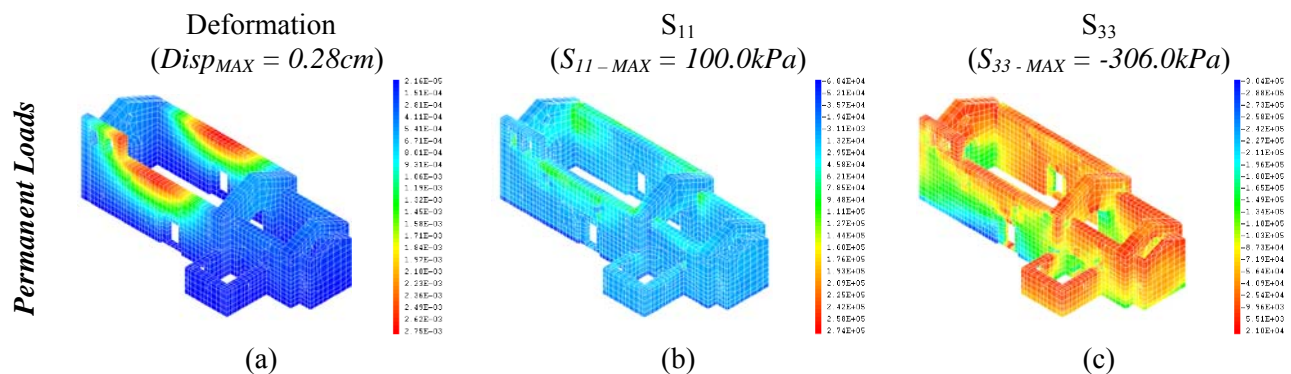
Figure 8 Absolute displacements and tensile ( $S_{11}$ ) and compression ( $S_{33}$ ) principal stresses maps for the model MSV - UR under permanent loads.

The seismic analysis was preceded by a static analysis that allowed representing the church initial stress and deformation state for the permanent loads. The results are illustrated in Figure 8 in terms of the principal stresses ( $S_{11}$  and  $S_{33}$ ) and absolute displacements.

The analysis of these results clearly indicates that the roof structure isn't self-bearing, introducing horizontal deformations on the lateral walls, especially at the nave, pushing them to the outside and increasing their relative distance, Figure 8a. These out-of-plane flexure movements of the walls introduced by the wooden roof are responsible by the main tensile ( $S_{11}$ ) and compression ( $S_{33}$ ) stress concentrations on the church, Figure 8b and Figure 8c. The main tensile stress concentration appears on the nave lateral walls outer face near the roof and on the inner face of the same elements on the intersection to the nave transversal walls, while the main compression stress appear on the outer face of the nave lateral walls near the base with values up to 306.0kPa.

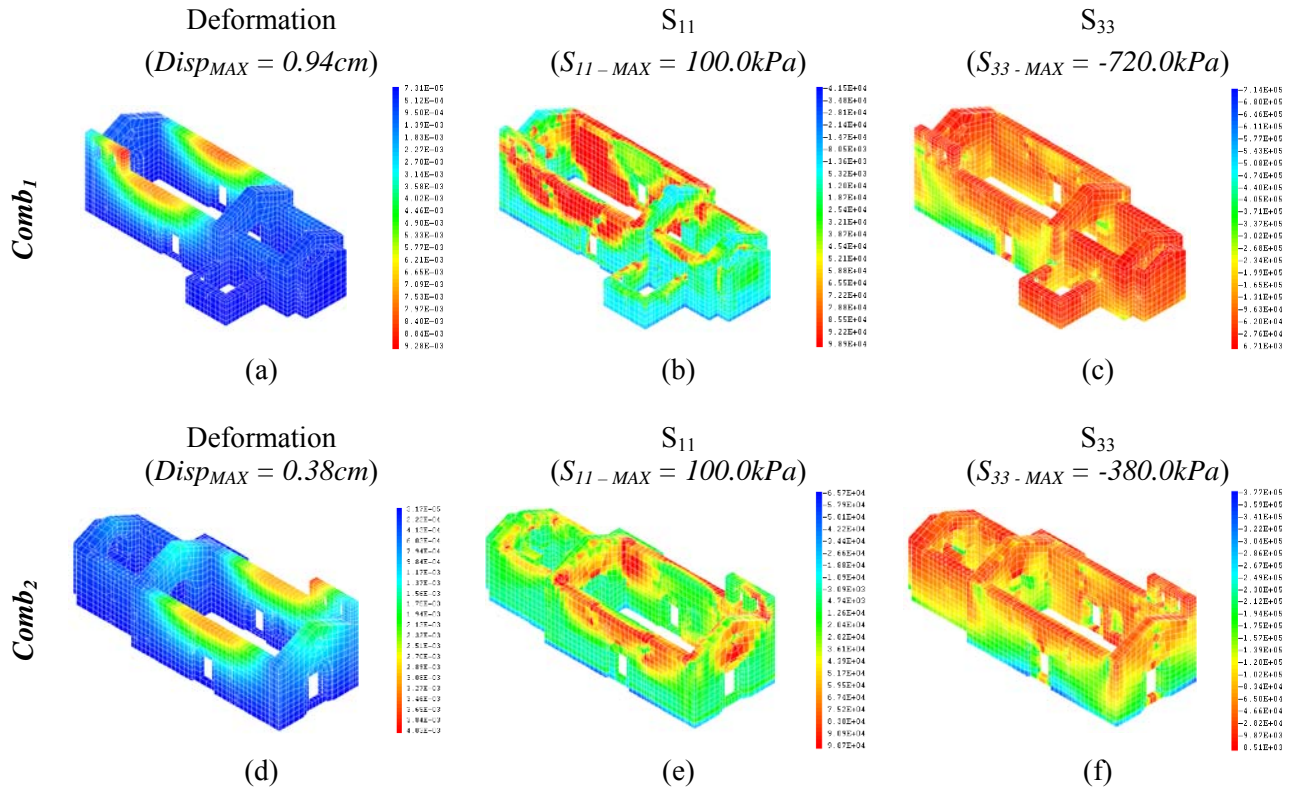
Figure 9 Maximum absolute displacements maps and tensile ( $S_{11}$ ) and compression ( $S_{33}$ ) principal stresses maps for the model MSV - UR under load combination Comb<sub>1</sub>.

The seismic analysis focused on the church global behaviour. The results are represented by the envelope of the maximum principal stresses ( $S_{11}$  and  $S_{33}$ ) and of the maximum absolute displacements, allowing the identification of the structures most critical zones, Figure 9.

essentially on same the zones already referred to the static analysis. This is mainly due to the roof influence, in this case added to the seismic load effect applied on the church XX direction, Figure 9 and Figure 10.

For Comb<sub>2</sub>, besides the expected deformation and damage concentration on the main façade, the maximum values continue to appear on the nave lateral walls with values similar to the ones attained when considering only permanent loads (Figure 9 and Figure 10), leading us to conclude: (1) that the church geometry “prevents” the seismic load  $E_{1Y}$  from having an important effect on the transversal direction; (2) the roof structure, not being self-bearing, has a major influence on the church behaviour.

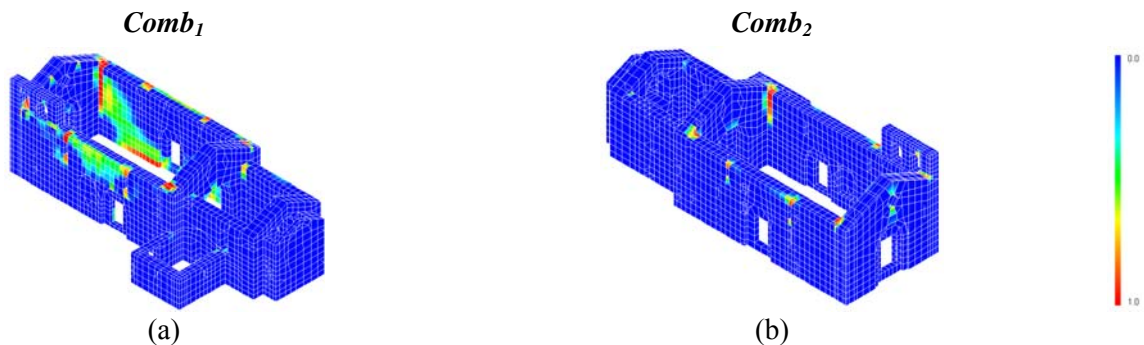
Figure 10 Tensile damage maps ( $d^+$ ) for the load combinations Comb<sub>1</sub> and Comb<sub>2</sub>.

Finally, it's compared the church tensile damage maps ( $d^+$ ) of the initial state for the load combinations Comb<sub>1</sub> and Comb<sub>2</sub>, Figure 9. This comparison allows a better understanding of the damage progression along the church walls.

In what concerns the load combination Comb<sub>1</sub>, the most important damage and deformations are concentrated
