The 14th World Conference on Earthquake Engineering
October 12-17, 2008, Beijing, China

SEISMIC RETROFIT OF RC HOLLOW-SECTION PIERS WITH SHEAR FAILURE

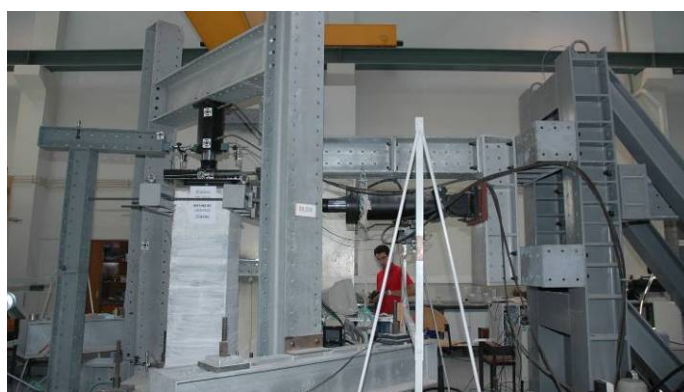
The test setup, shown in Figure 1, makes use of a 500 kN actuator to apply lateral loads and a 700 kN actuator to apply axial loads. The specimen and reaction frame are bolted to the strong floor with high strength prestressed rods. A constant axial load of 250 kN was applied during the tests, herein described, while the lateral loads were cycled, under displacement controlled conditions (Delgado (2007) and Delgado (2008)).

Figure 1 General view of the test setup at LESE laboratory

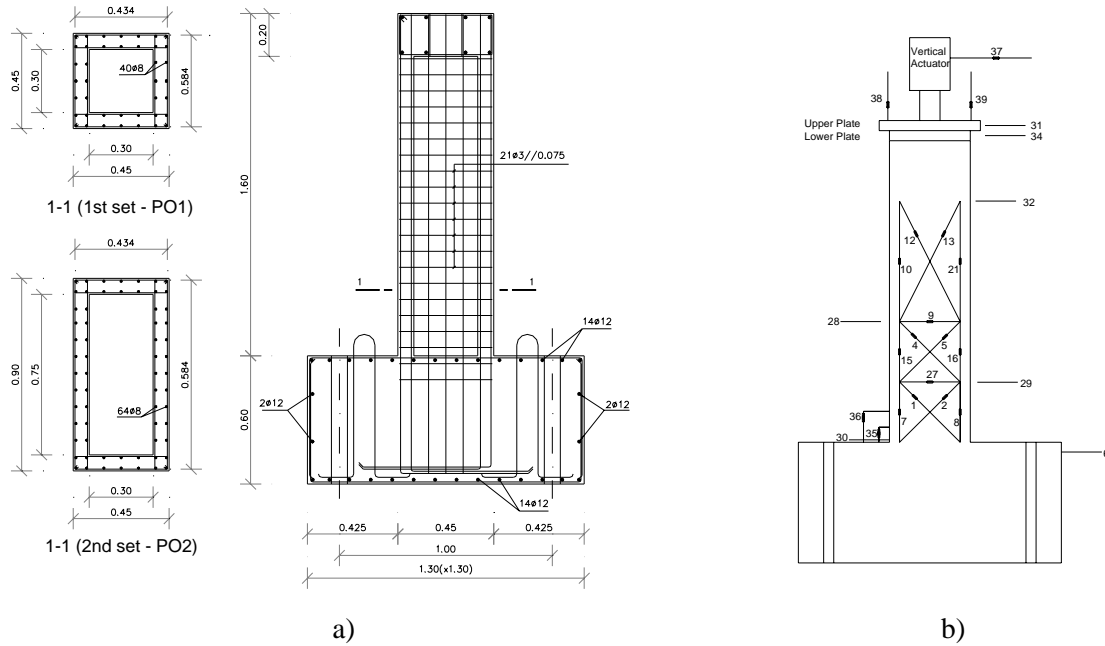
Pavese *et al.* (2004)), consisting on hollow section RC piers with 450mm x 450mm exterior dimensions and 75mm thick walls, and is being tested in order to understand the influence of the cross section geometry of rectangular hollow piers on the cyclic behavior, bearing in mind the purpose of assessing retrofitting solutions. The unconfined concrete compressive strength is 35 MPa and for both longitudinal and transversal reinforcement the yielding strength is 450 MPa. The model schemes shown in Figure 2a correspond to 1/4 scale representations of hollow section bridge piers, herein referred to as PO: PO1 for square section and PO2 for rectangular section. Instrumentation to measure curvature and shear deformations was included along the pier height, because important shear deformations were expected in these tests. The LVDT configuration used in both specimens is shown in Figure 2b.

Figure 2 Hollow RC piers: a) geometry of specimen and b) lateral LVDT layout.

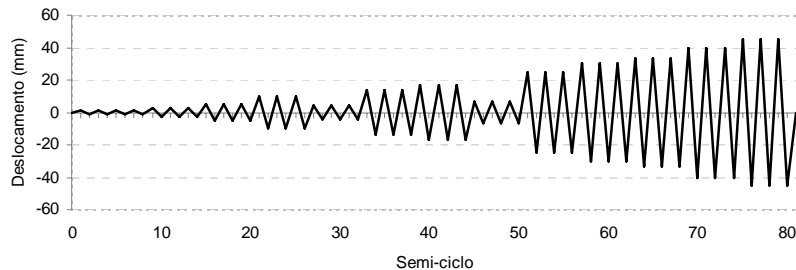
In order to characterize the cyclic behavior of piers, three cycles were applied for each of the peak displacements shown in Figure 3 and Table 1. These values were applied under a constant axial load of 250 kN that corresponds to a normalized axial force of 0.08, except for pier PO2-N3 that was tested for 440kN axial load (normalized axial force of 0.05), Delgado (2008).

Figure 3 Top-displacements during the tests

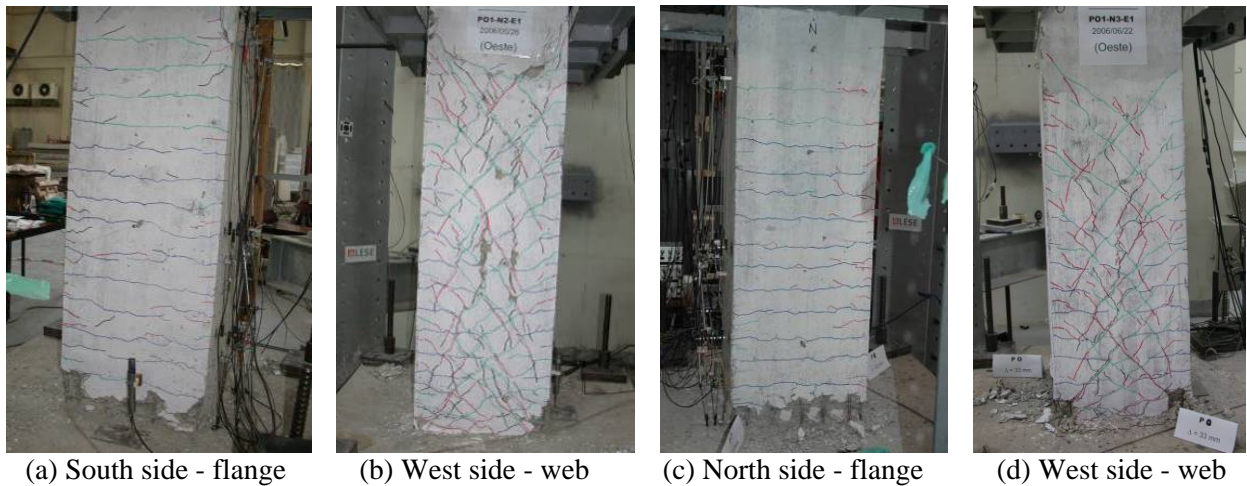
Concerning the results of the PO1-N2 original specimen test, the damage observed in the north and south sides was highly concentrated at the pier base with concrete crush and longitudinal reinforcement buckling, as shown in Figure 4a, and along the pier height well distributed cracks were visible. However, at the lateral sides, east and west (Figure 4b) strong damage was also found, where the concrete cover crushed within the entire pier height. At the final stage, shear and flexural damage was observed with significant concrete degradation due to the low efficiency of the transverse reinforcement. The damage of pier PO1-N3, illustrated in Figure 4c and 4d after the cyclic test, was quite similar to the previous square pier (PO1-N2), since both piers have identical geometry and materials. Therefore, these two piers also served to assess the reliability of the pier test setup.

Figure 4 Piers damage for 2.4% drift, PO1-N2 [a) and b)] and PO1-N3 [c) and d)]

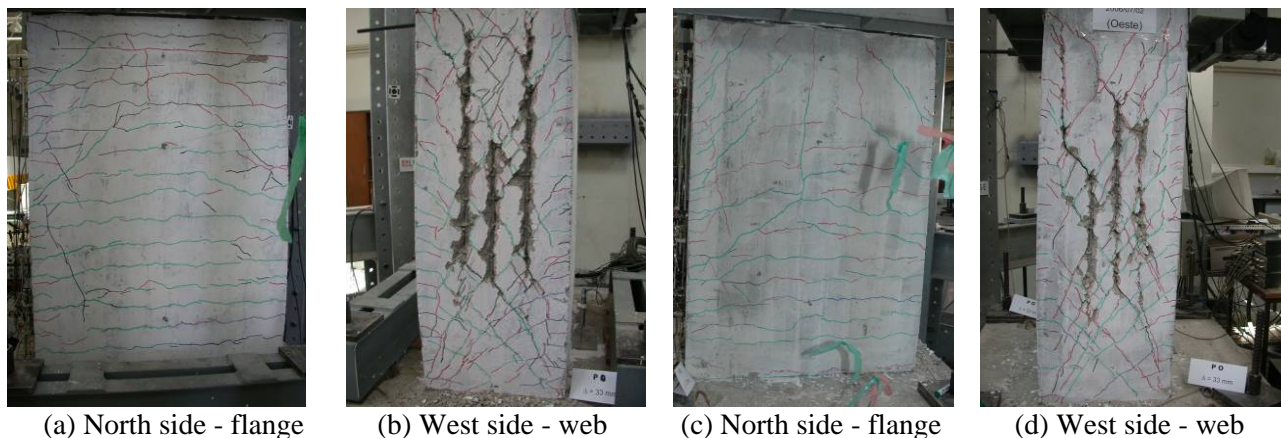
As for the test results of original specimens PO2-N2 and PO2-N3, the greatest amount of damage was mainly observed at the lateral sides, east and west, where the concrete cover crushed within the entire pier height (see Figure 5) and strong shear damage was achieved due to concrete degradation caused by lack of transverse reinforcement efficiency. Little damage was observed in the north and south sides, with well distributed cracks. However, the cracks observed in those sides are not only horizontal, as for the square piers tested before, but instead they show an angle that increases along the pier height, due the shear lag effect that occurs for this width/height ratio (2:1) and also found in other tests within this campaign, Delgado *et al.* (2006).

Figure 5 Piers damage for 2.4% drift, PO2-N2 [a) and b)] and PO2-N3 [c) and d)]

flexural capacity. Figure 6b shows the experimental responses of both piers PO2-N2 and PO2-N3 in terms of top force-displacement diagrams; as expected, these diagrams show larger initial stiffness and peak force for the pier with higher axial load (PO2-N3). However, failure of both piers was reached by the first cycles of 25mm amplitude (1.8% drift), with visible shear failure mode and the shear lag effect evidenced in the damage pattern shown in Figure 5.

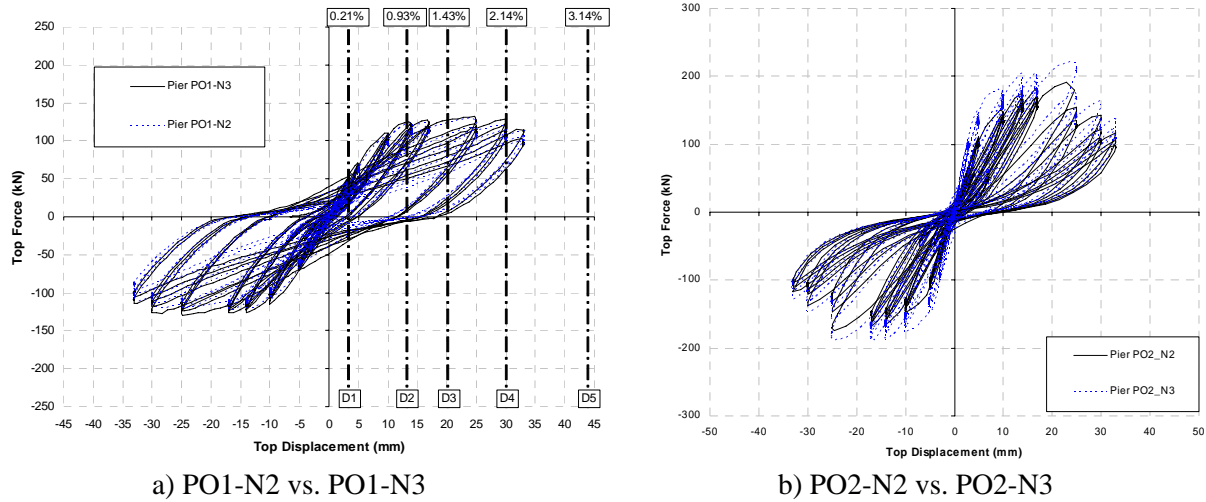
The cyclic response of piers PO1-N2 and PO1-N3 are shown in Figure 6a, where very similar behavior can be found in terms of stiffness and maximum top force achieved. A shear-flexure mechanism was observed on the pier response, since it seems to have a ductile behavior, but with an achieved horizontal force below its

Figure 6 Experimental results comparison

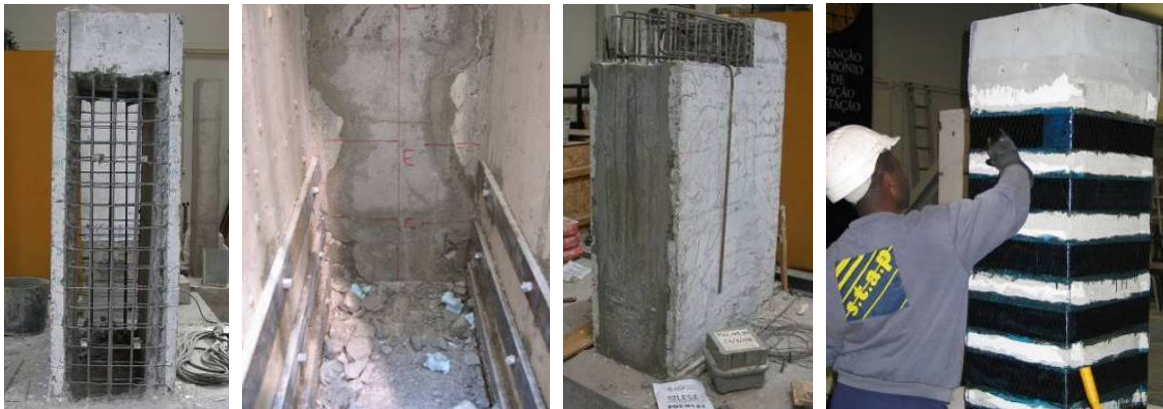
After the original specimen cyclic tests, piers were repaired and retrofitted by an external contractor (S.T.A.P.) according to the following steps: 1) delimitation of the repair area; 2) removal and cleaning of the damaged concrete; 3) inside retrofit with transversal steel bars; 4) application of formwork and new concrete (Microbeton, a pre-mixed micro concrete, modified with special additives to reduce shrinkage in the plastic and hydraulic phase); 5) outside retrofit with the CFRP sheets. In order to provide a general idea of the pier damage and of the retrofit process, the following pictures show the piers during repair and after retrofit with CFRP sheet jacketing (Figure 7). The inside retrofit with transversal steel bars (only for pier PO2-N3) was designed taking in account the feasibility for future real retrofits; such bars were concentrated at the bottom, in correspondence with the outer CFRP jackets, for improving the plastic hinge confinement. In order to design the outside shear retrofit with CFRP jackets, the methodology suggested by Priestley (1996) was adopted to evaluate the thickness of the rectangular hollow pier jacket for increasing the shear strength above the maximum flexural force while keeping the initial section conditions. According to this methodology the shear strength can be conveyed by Eqn. 4.1 [11]:

Figure 7 Hollow piers before and after the shear retrofitting with inside steel bars and outside CFRP sheet.

Therefore, using Eqn 4.1 in order to increase the shear capacity of specimens, the number of 0.117mm thick CFRP strip layers was estimated. This retrofit was doubled at the pier base for improving the concrete confinement and, therefore, the overall pier ductility.

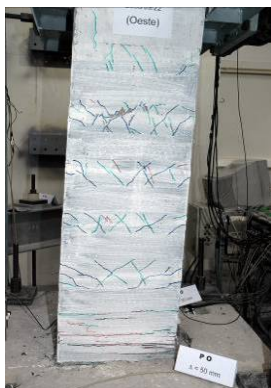
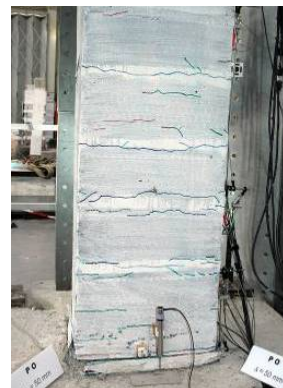
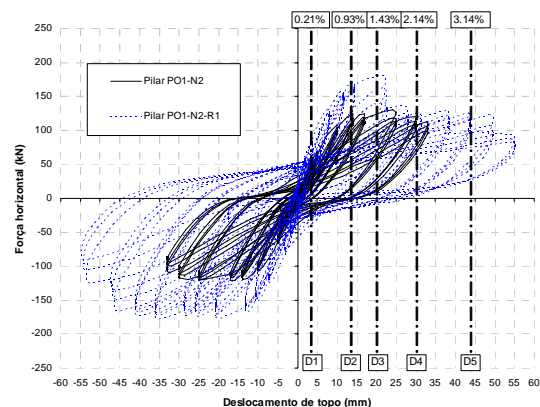
Figure 8 Experimental results of pier PO1-N2-R1.

For this specimen retrofitting two strip layers of CFRP sheet were adopted with 0.117mm thickness by 100mm width and spaced at 100mm along the pier height in order to increase the shear capacity. As above referred, this retrofit was doubled at the pier base, leading to a first strip layer 300mm wide. This CFRP retrofit design evidenced excellent benefits on the pier behavior (see Figure 8) since it avoided the shear collapse and allowed mobilizing a flexure mechanism with plastic hinge at the pier base (longitudinal reinforcement buckling). By comparing with the original ones, these retrofitted piers reached a significant improvement on the horizontal force capacity and maximum displacement achieved.

a) Final damage - west

b) Final damage – south

c) Comparison before and after retrofit

The CFRP retrofit design with two layers (PO1-N2-R1 e PO2-N2-R1) showed excellent benefits on both piers behavior since the shear collapse was avoided and a flexure mechanism with plastic hinge at the pier base was achieved. A significant improvement on the horizontal force capacity and maximum displacement was achieved for retrofitted piers.

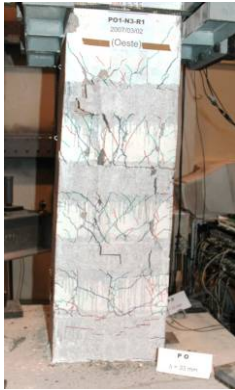
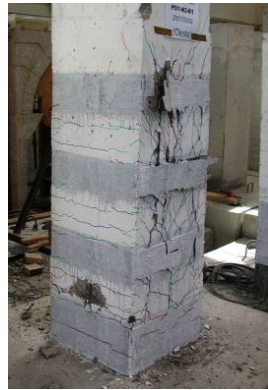
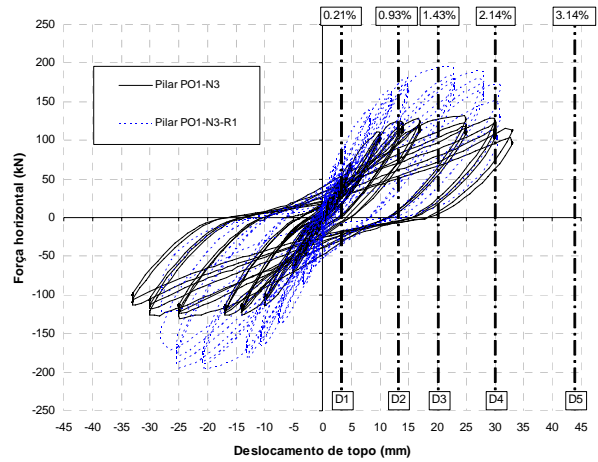
Figure 9 Experimental results of pier PO1-N3-R1.

For this specimen retrofitting only one strip layer of CFRP sheet was adopted with 0.117mm thickness by 100mm width and spaced at 200mm along the pier height in order to increase the shear capacity; as before, this retrofit was increased at the pier base, with a 200mm wide first strip layer. This retrofit aimed at an ideal shear design, with only 15% increase over the maximum flexural force, but it was insufficient as illustrated further on.

a) Final damage - west

b) Final damage – northwest

c) Comparison before and after retrofit

This retrofit exhibited earlier cracking between CFRP strips and the pier failure was achieved after the collapse of the first carbon strip (see Figure 9). By comparing with the original piers, at least 25% increase was obtained for the maximum force, but without significant increase on the maximum displacement.

Pursuing the objective of retrofitting for an ideal shear design, with only 15% increase over the maximum flexural force, tests have shown that such strategy is insufficient to allow a satisfactory ductility behavior, since cracks started developing earlier between CFRP strips and pier failure was achieved after the first strip collapse. Even so, the peak force increased to 25% over the flexural force.

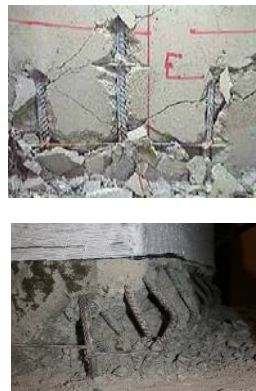
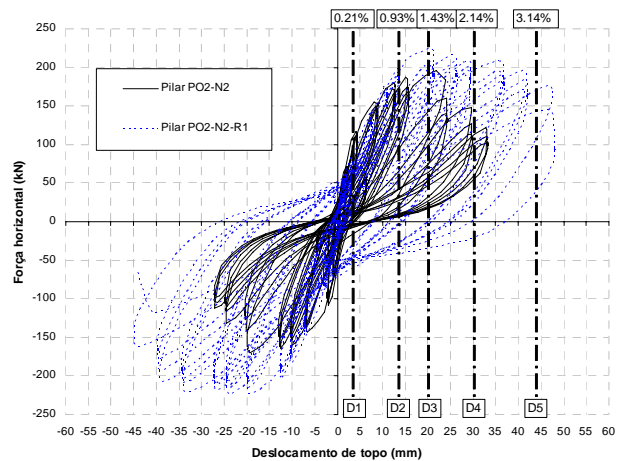
Figure 10 Experimental results of pier PO2-N2-R1.

As for the square pier with the same number (PO1-N2-R1), this specimen retrofit aimed essentially at preventing the shear failure observed on the original specimen. Thus, two strip layers of CFRP sheet with 0.117mm thickness by 100mm width and spaced at 100mm were adopted along the pier height, though with 300mm width on the first strip.

a) Final damage - west

b) Final damage – inside / base

c) Comparison before and after retrofit

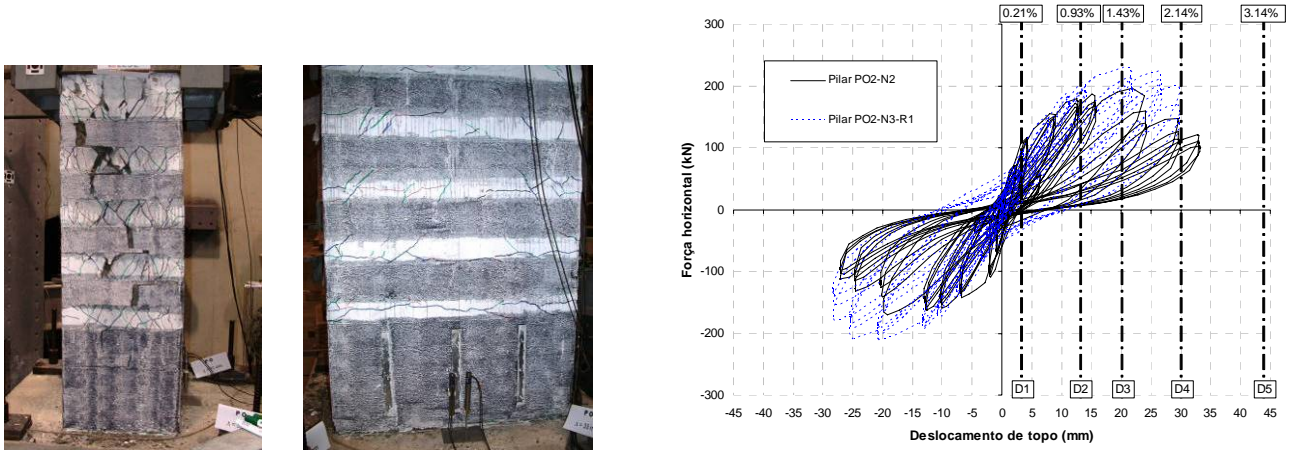
This specimen retrofit included only one strip layer of CFRP with 0.117mm thickness by 100mm width, except the first strip layer at the pier base with 400mm width, and spaced at 100mm along the pier height. Again, this retrofit objective was to obtain an ideal shear design, with only 15% increase over the maximum flexural force, but it was insufficient as shown below. An inside retrofit was adopted in this pier using three 10mm thick transversal steel bars, 40mm wide and spaced at 70mm, bearing in mind the feasibility for future real retrofits. Such bars were concentrated at the bottom (for improving the plastic hinge confinement) and pos-tensioned after the application of the outer CFRP jackets with screw bars crossing the pier flange wall thickness.

a) Final damage - west b) Final damage – south c) Comparison before and after retrofit
 Figure 11 Experimental results of pier PO2-N3-R1.

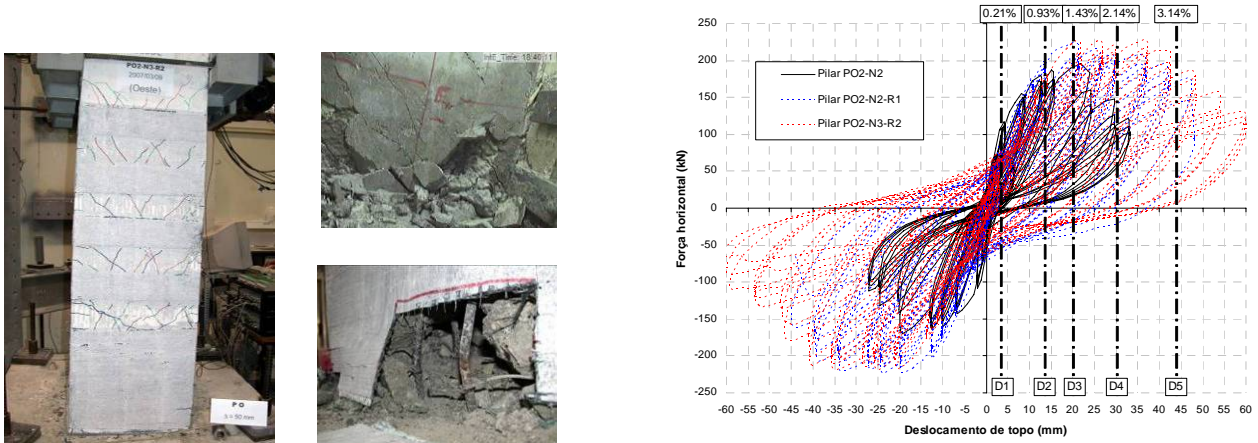
After the previous test that still exhibited shear failure due to the CFRP strip collapse, the same external retrofit was adopted but now with two strip layers of CFRP 0.117mm thick sheets, 100mm wide and the same 100mm spacing along the pier height. Again the first strip layer at the pier base was adopted with 400mm width (two layers also). And the internal retrofit was kept as before with three horizontal steel bars.

a) Final damage - west b) Final damage – inside / base c) Comparison before and after retrofit
 Figure 12 Experimental results of pier PO2-N3-R2.

Finally, by adopting a second retrofitting strategy, with two layers of CFRP and keeping internal retrofit, a good behavior and significant increase of maximum displacement was reached when compared with the previous retrofit option. Again, this shear retrofit design leads to an excellent response, since shear failure mechanism was avoided and the collapse was reached with a flexural mechanism. This occurred for a very large top displacement when the CFRP sheets lost the confinement capacity and allowed rebar buckling in the outer face of the pier wall; while the interior transversal steel bars were still effective in avoiding internal rebar buckling.
