SITE REMEDIATION IN NIGERIA: PROVEN AND INNOVATIVE TECHNOLOGIES (RECOVERY OF FREE HYDROCARBON FROM SOIL/GROUNDWATER)

Conference Paper · November 2014

Oluwapelumi O. Ojuri¹ Samuel A. Ola¹ Olaolu G. Fadugba¹ and Micheal A. Uduebor¹

¹Department of Civil and Environmental Engineering, Federal University of Technology, Akure, Nigeria

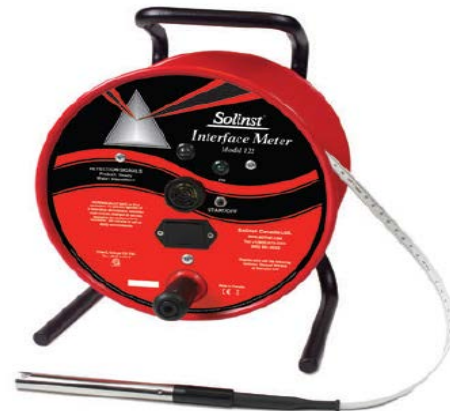
Fig. 2 Model 122 (CSA) Interface Meter, P8/LM3/60m (Solinst)

Oil/Water Interface meter (Figure 2) was used to measure the depth to ground water for earmarked wells and to measure thickness of free hydrocarbon on groundwater in water supply wells.

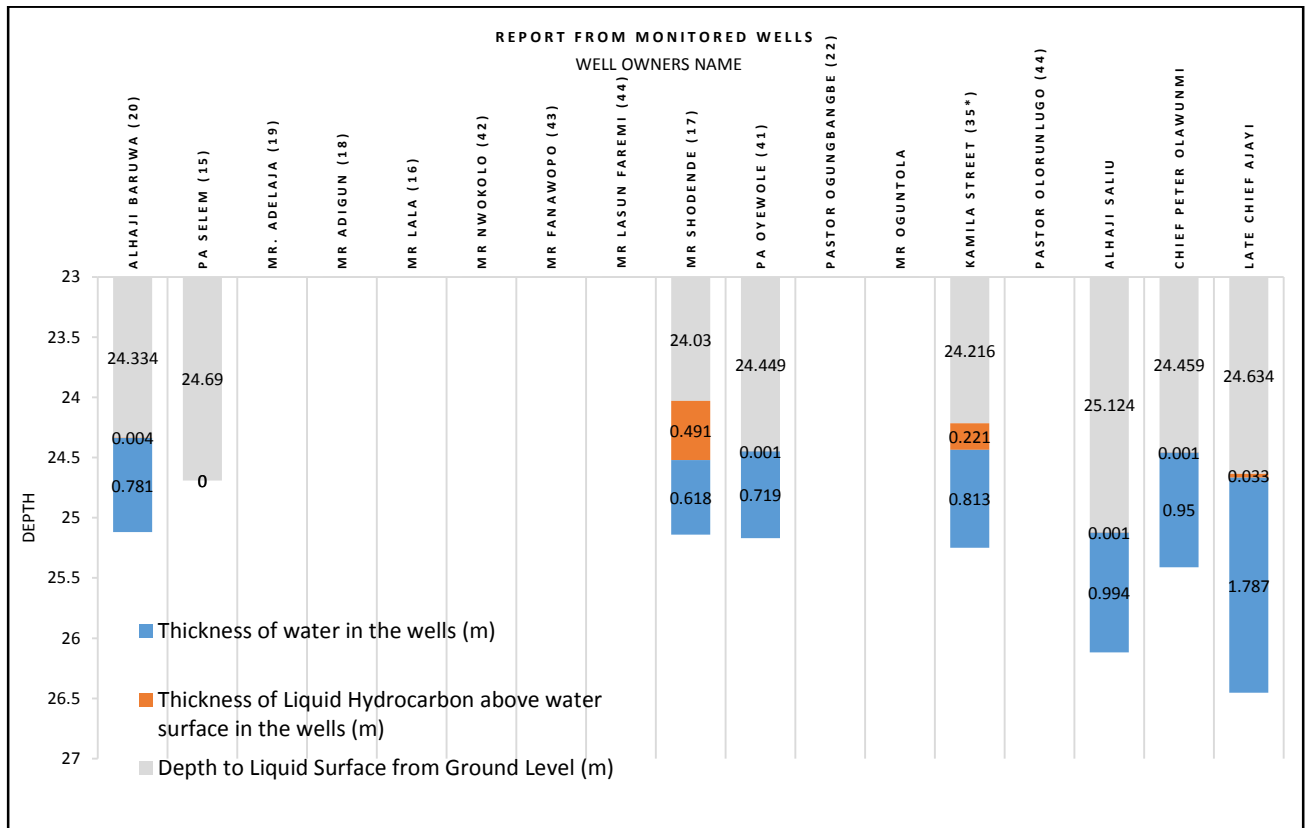
Fig 4 Reports of all wells monitored showing the various thicknesses of free hydrocarbon product and water

The present status of the examined wells within the pilot scheme area is indicated in Figure 3 and the monitoring test results presented in Table 2 and Figure 4.
