Destroying the Panthers: The Effect of Allied Combat Action on I./SS Panzer Regiment 12 in Normandy, 1944

Arthur Gullachsen

Abstract: This article is an examination of the operational record of the World War Two German Panther tank during the Normandy Campaign of summer 1944. Challenging its perception as mechanically unreliable, this article argues Allied combat action was responsible for a large percentage of Panthers that were out of action. Secondly, the inferior resources of the German tank replacement and repair program were no match for superior Canadian Army practices during 1944. To support these arguments the author examines Canadian and German wartime primary documents as well as multiple secondary sources.

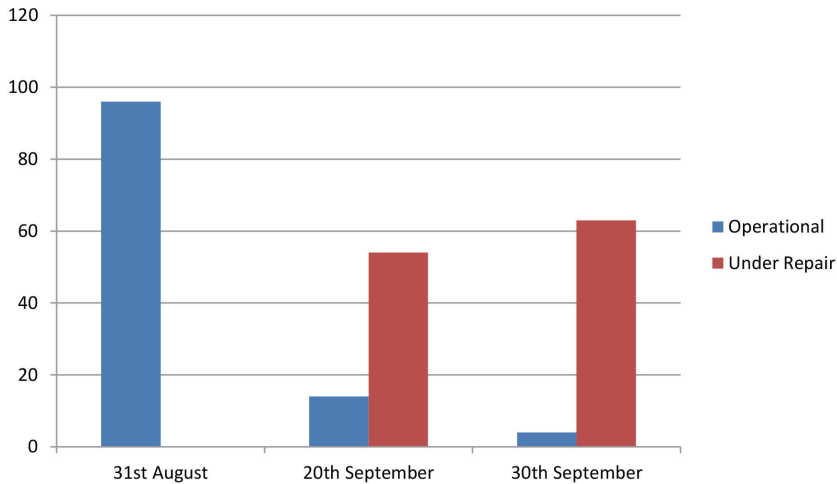
Chart 1: Number of operational Panthers versus those in repair for the 2nd battalion, 23rd Panzer Regiment in the Ukraine, August–September 1943. [Thomas Jentz, *Panzertruppen Volume 2*]

initially designed for a much lighter vehicle, and this increased weight led to the engine, transmission, and final drives being overstressed. Inadequate initial fuel pump and engine compartment design led to engine fires during the summer of 1943 which engulfed the tank. The first Maybach engine was also a weak link, with bearings and connecting rods that failed after a short period of time. A large number of tanks in the Panther battalions are recorded as sidelined due to these maintenance issues during the fall of 1943.¹¹ As illustrated in Chart 1, these figures are abysmal.¹²

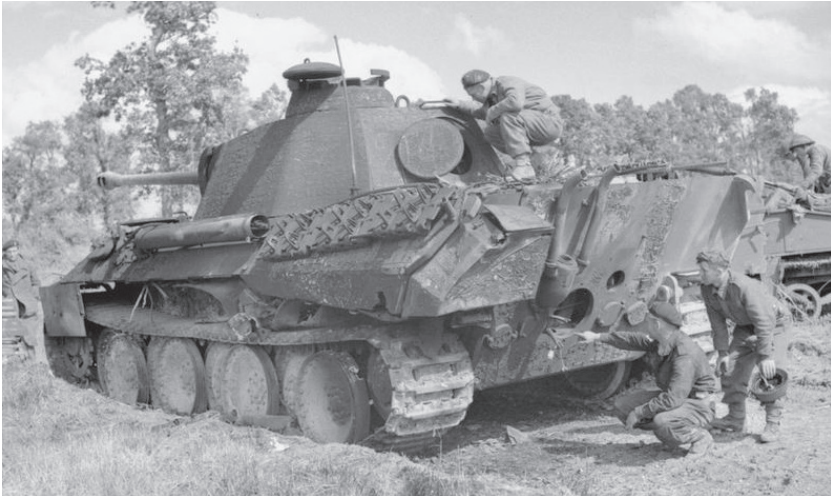
Destroyed 2nd Company SS Panzer Regiment 12 Panther Mark A being inspected by the Durham Light Infantry near Rauray, France, 27 June 1944. [© IWM (B 6046)]
