# Integration of LiDAR and Imagery to Delineate Water Bodies for Change Detection

Ashley Casselberry<sup>1</sup>, Haluk Cetin<sup>2</sup>

<sup>1</sup> Undergraduate Student, Department of Geosciences, Murray State University

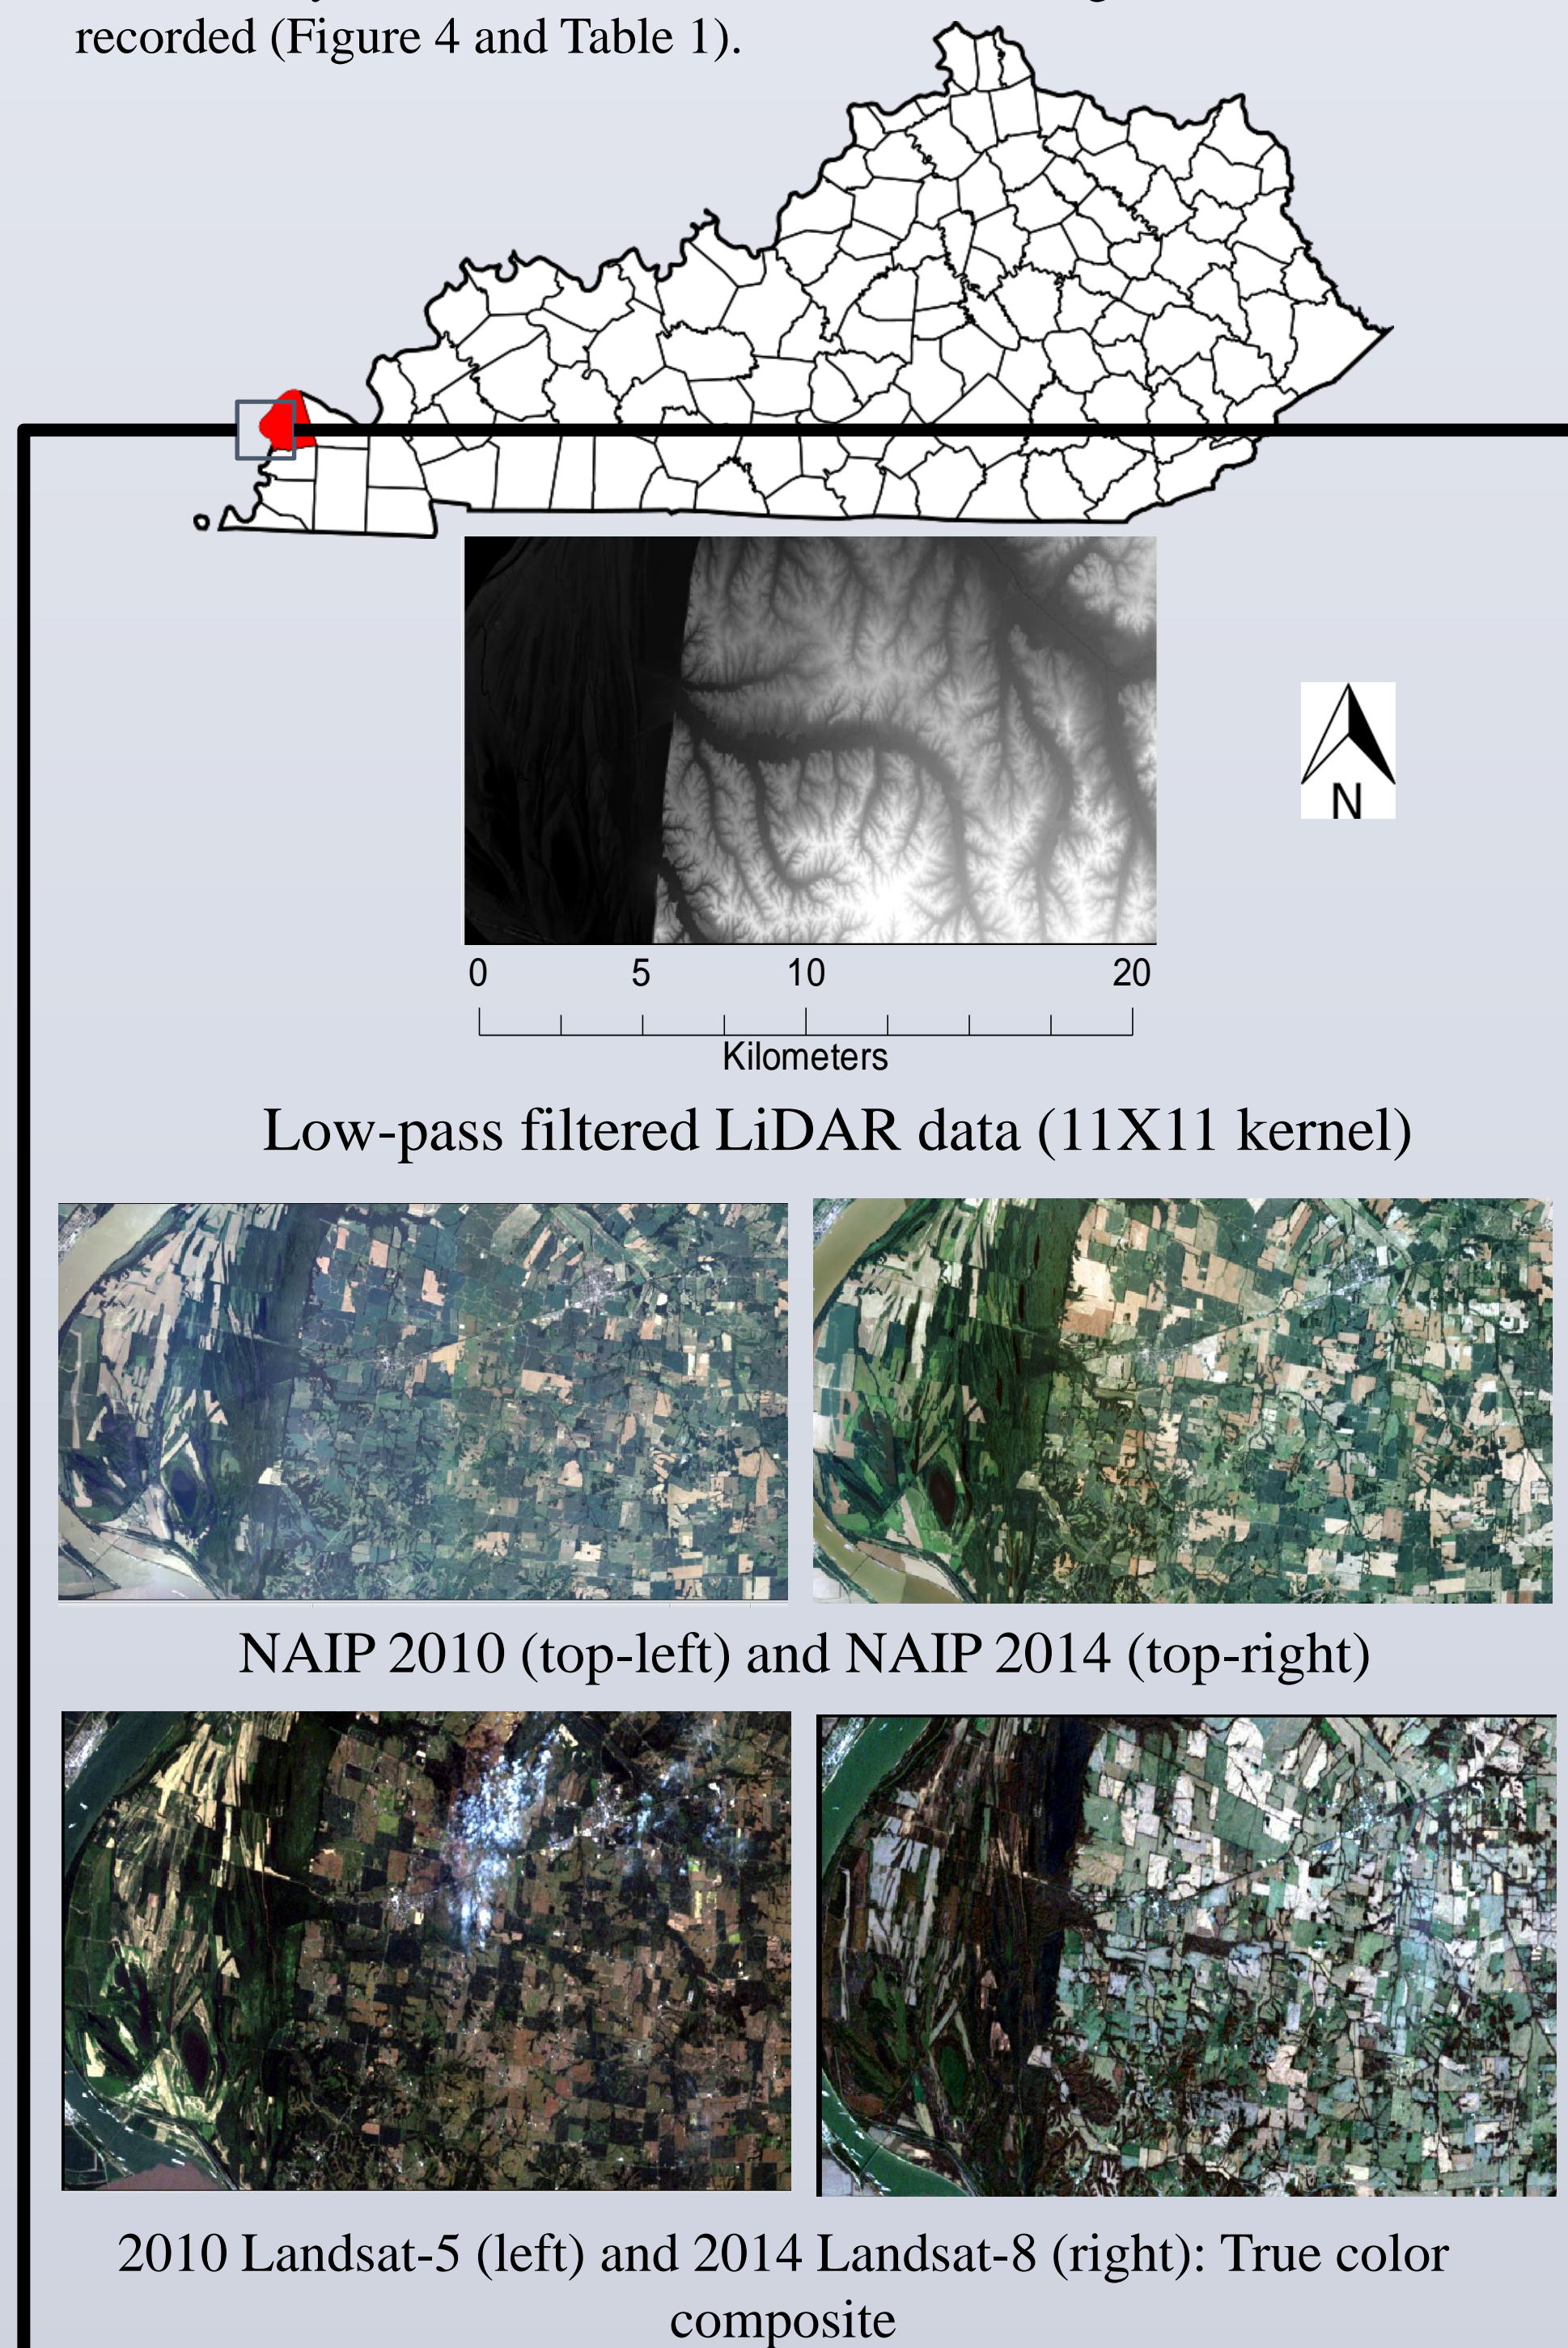
**Figure 1:** Landsat and NAIP images of the study area.

- All images, were subsetting (Figure 1).
  - Landsat-5, Landsat-8 (obtained from USGS)
  - NAIP 2010, NAIP 2014 (obtained from USDA)
  - LiDAR data were mosaicked together: A low-pass filter with 11X11 Kernel size was used. Then a slope map was created (Figure 3).
- 2010 Landsat/NAIP and 2014 Landsat/NAIP images were combined using Ehler's merge. All images underwent an unsupervised classification using 64 clusters to delineate the inland water bodies from the surrounding areas (Figure 2).
  - The classification results were coded as water and non-water
  - Water and non-water classes were created for simplicity
- An accuracy assessment was done for all six images and the results were recorded (Figure 4 and Table 1).

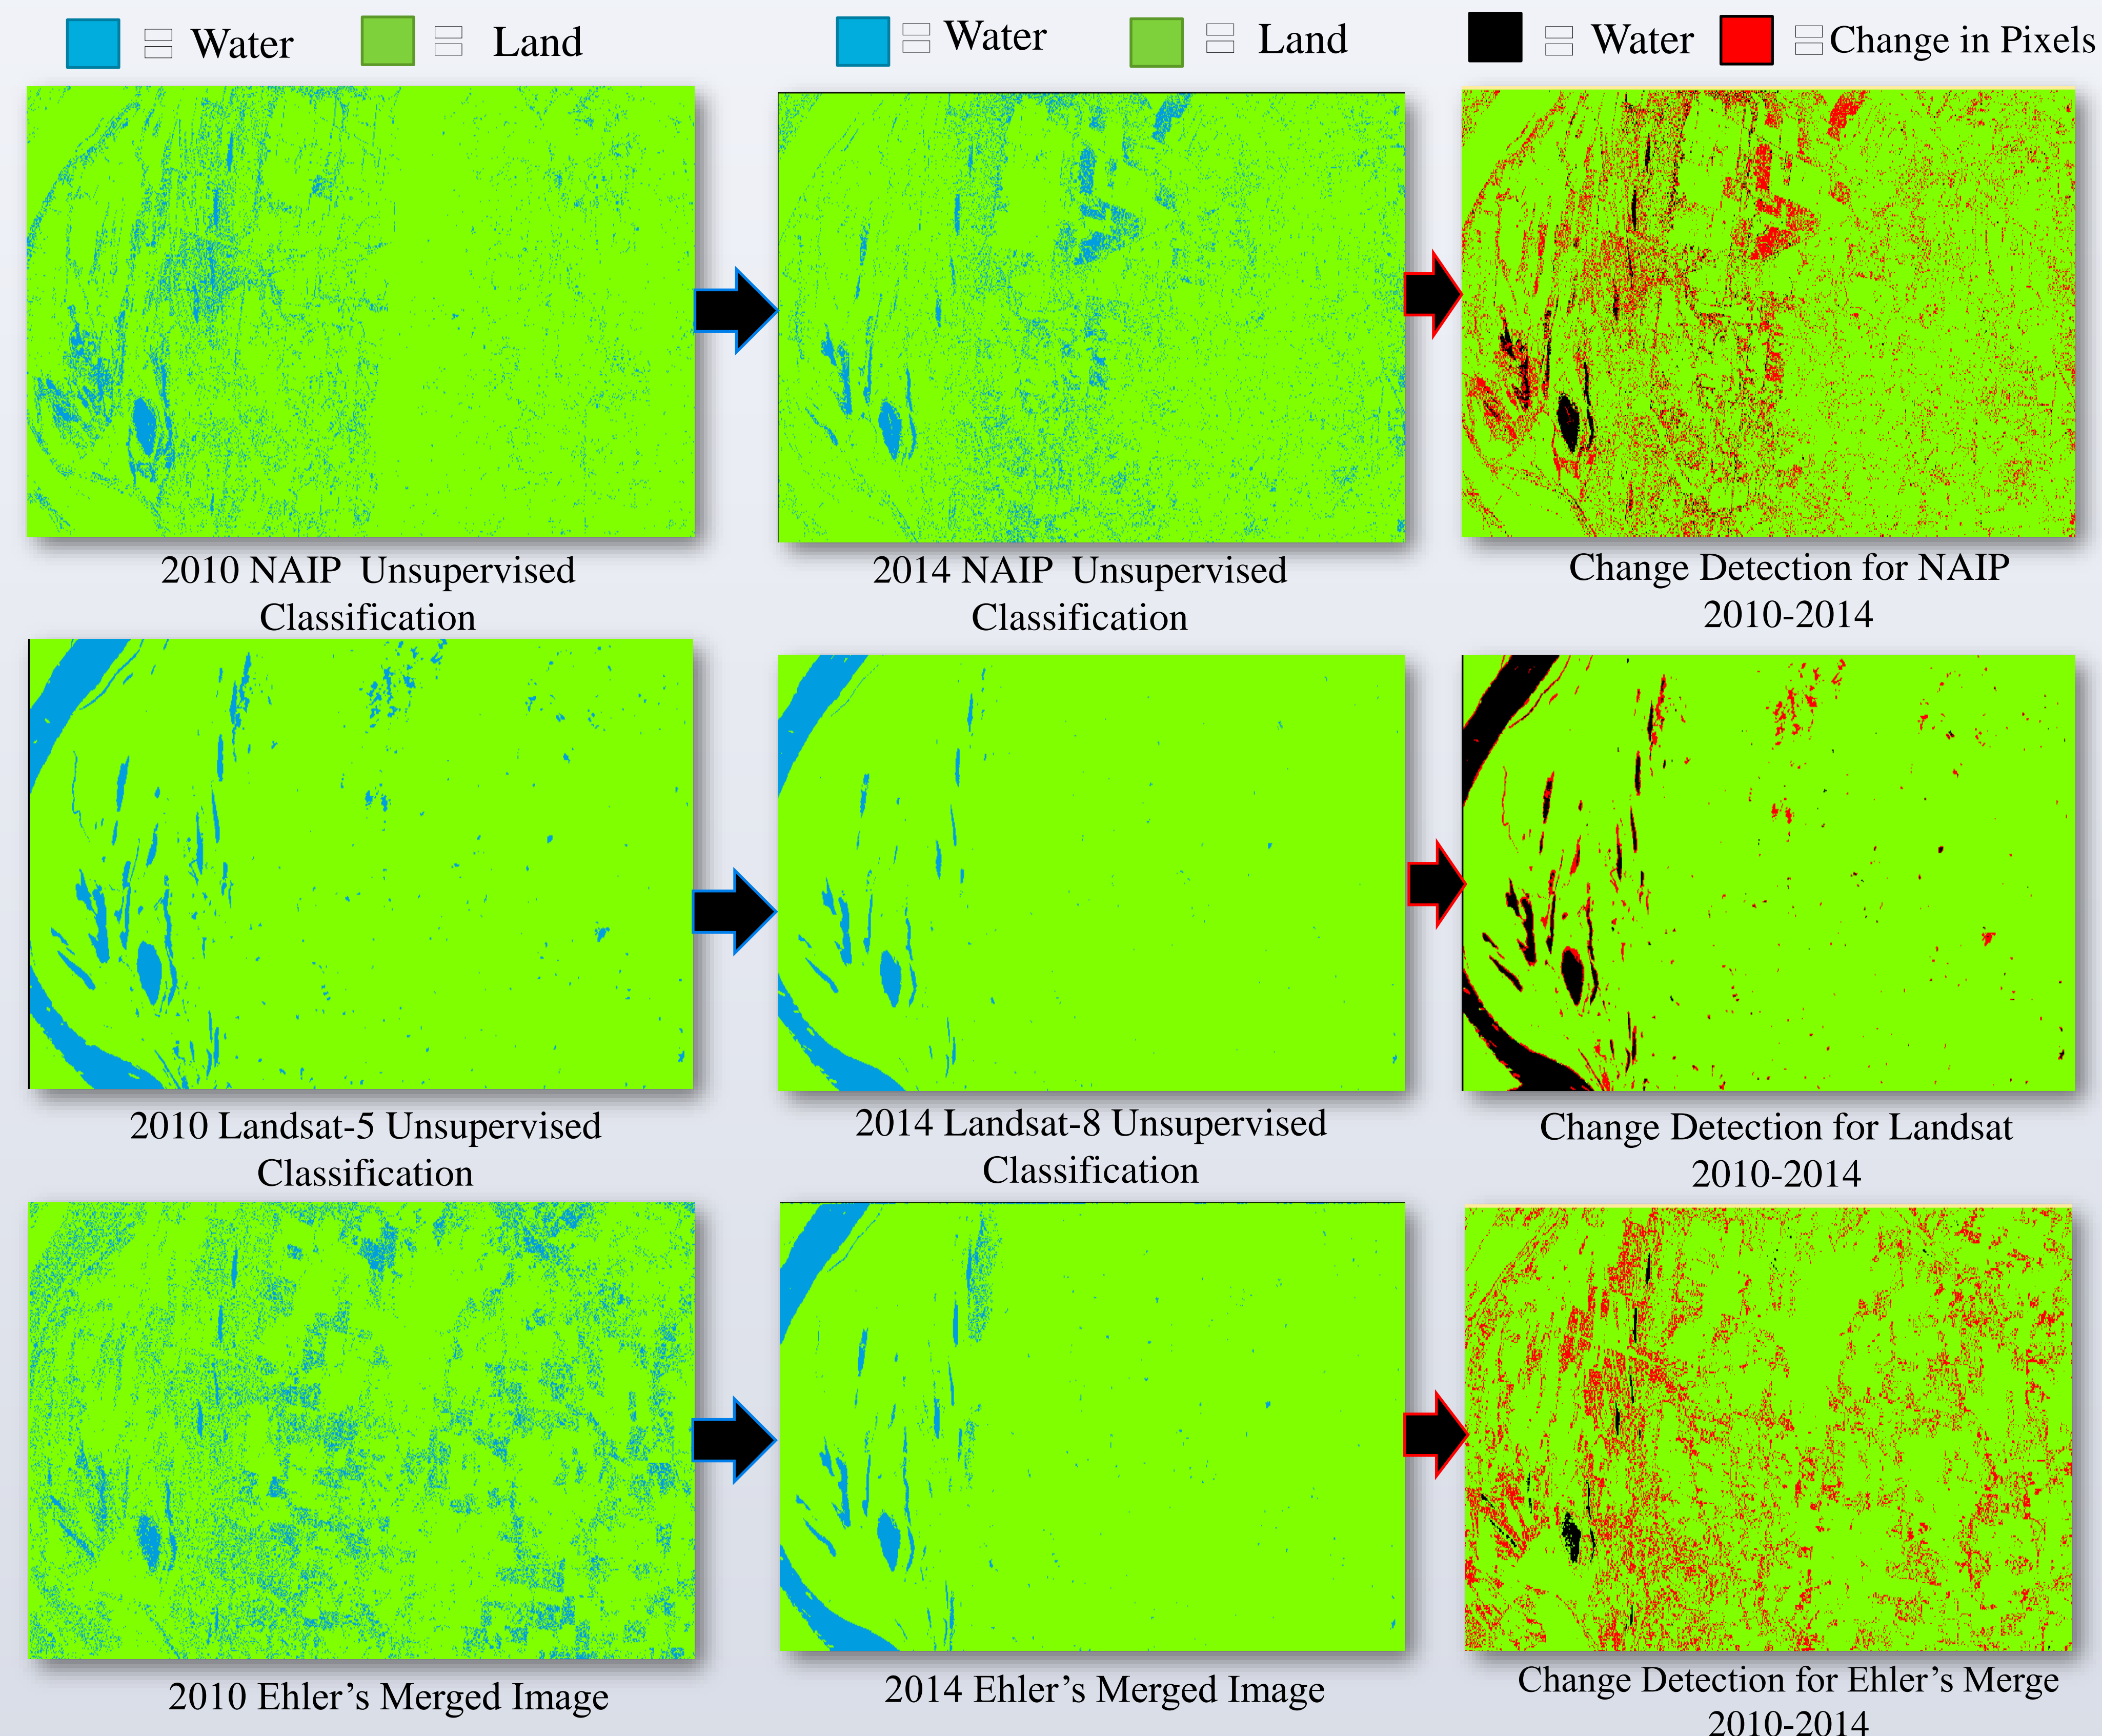
**Figure 2:** Classification of 2010 and 2014 NAIP/Landsat images and their corresponding change maps.

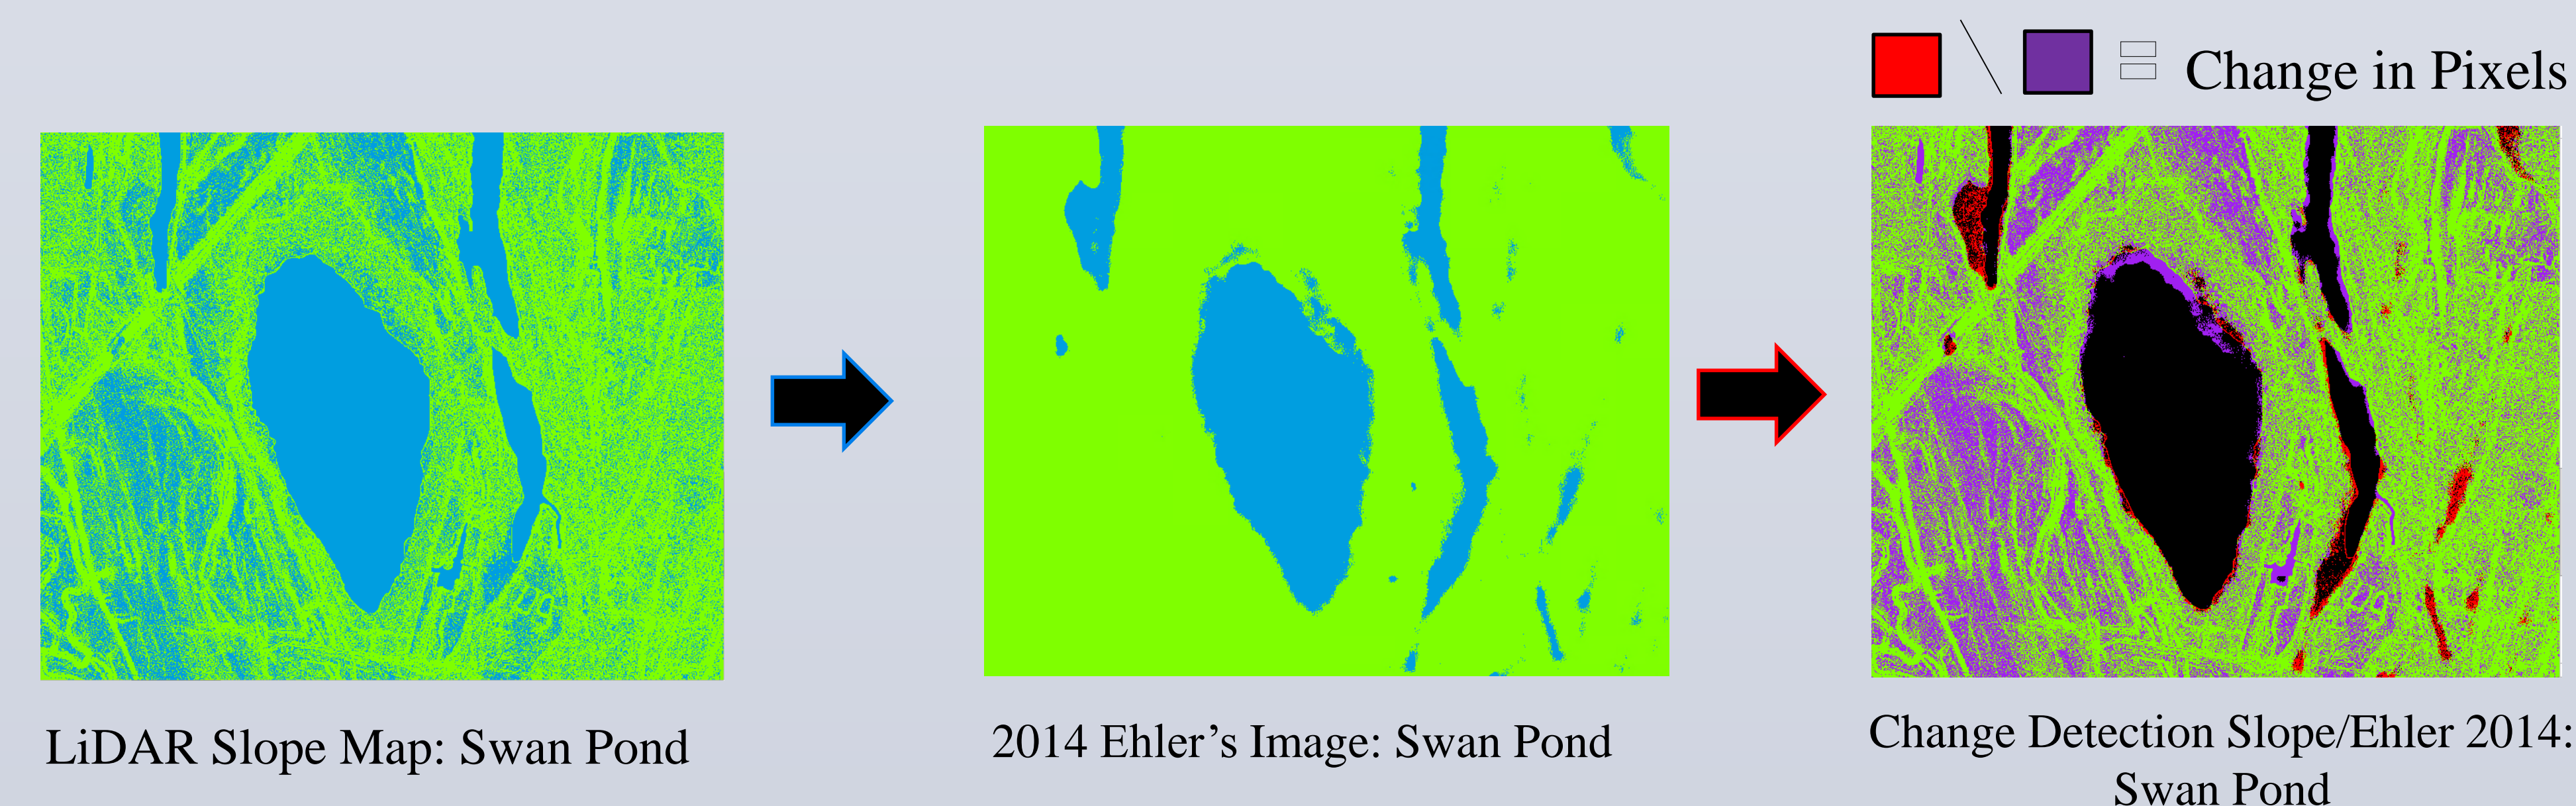
**Figure 3:** Visual comparison of Swan Pond with the 2014 Ehler's image and slope map, and their change detection map: Red pixels were actually shadows, which were incorrectly classified as water. Purple pixels were slope pixels, which were incorrectly classified as water due to their apparent surfaces, such as buildings.

- LiDAR data helped differentiate the water pixels from other flat areas, shadows, and previously misclassified pixels. The shadows and rooftops often were incorrectly labeled as water in the classifications.
- Overall, 2014 Ehler's merge and 2014 Landsat data were closely tied for accuracy. The 2014 Landsat image actually has the clearest distinction of the inland water bodies to the surrounding area even though it lacked the spatial resolution of NAIP images.
  - The NAIP unsupervised classifications were insufficient. There needed to be more than 64 clusters to differentiate the classes.
- The change in pixels (Table 2) more often indicated the amount of error, than the actual change in water concentrations because there were not enough classes to properly classify the images.

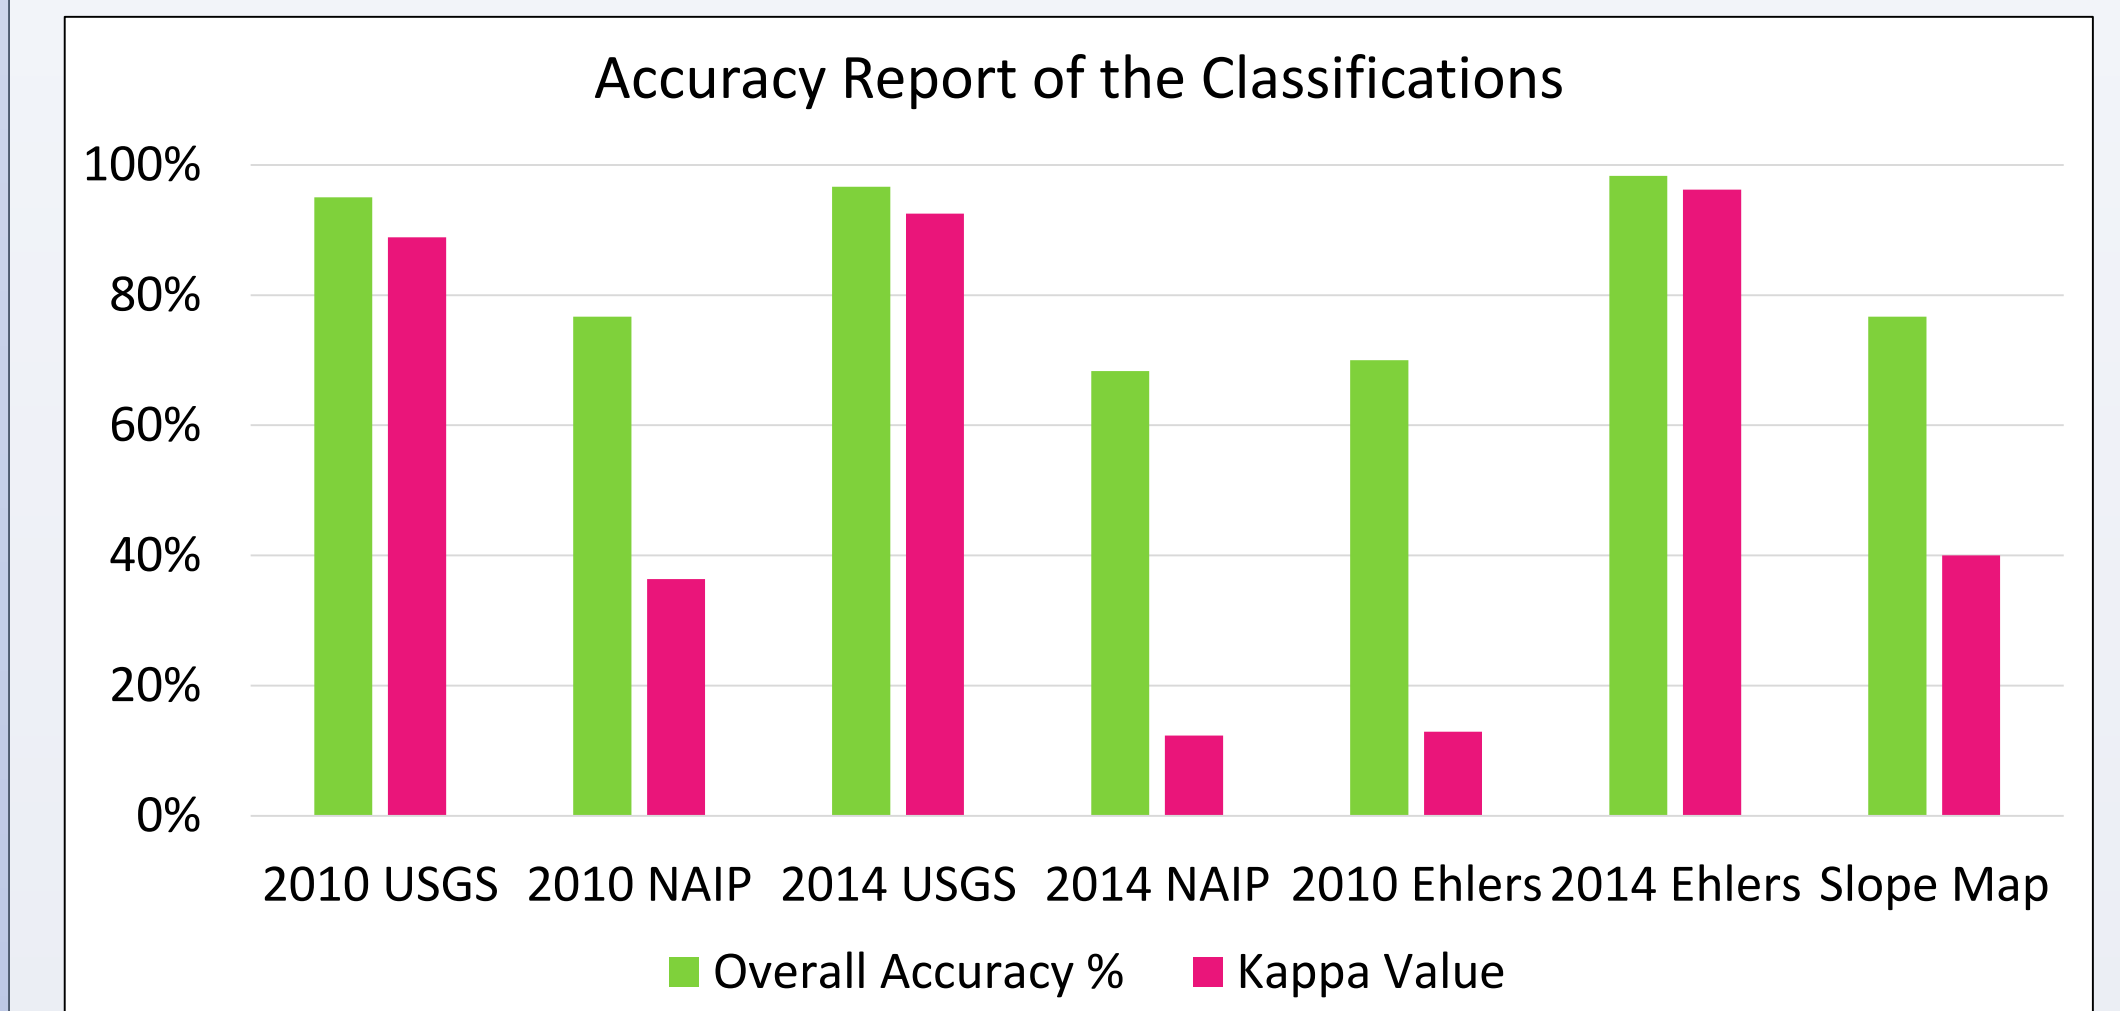
**Figure 4:** Accuracy assessment and Kappa values.

Classifications	Overall Accuracy %	Kappa Value
2010 USGS	95%	0.8889
2010 NAIP	76.67%	0.3636
2014 USGS	96.67%	0.925
2014 NAIP	68.33%	0.1231
2010 Ehlers	70%	0.129
2014 Ehlers	98.33%	0.962
Slope Map	76.67%	.4
