ERECTION OF A STAINLESS-STEEL TANK FOR STORING A PHOSPHORIC ACID

A storage tank for 93 % phosphoric acid was built in Luka Koper from 7 mm thick ground hot-rolled plates of 316L stainless steel. The capacity of the storage tank is of the 750 m³, diameter of 11 m and the height of 8,2 m. The shell plates were welded manually using the shielded metal-arc and gas-metal-arc processes. Before the erection, welding procedure tests according to EN 288-3 were carried out. During the construction several non-destructive examination methods were used, such as radiographic testing and visual and liquid penetrant examination. After the entire tank and roof structure were completed, a hydrostatic leak test was carried out. The surfaces of all the welds on the internal surface of the vessel were ground and the roughness was checked on site. The surfaces of the base material and the ground welds were passivated and tested for resistance to corrosion with electrochemical measurements.

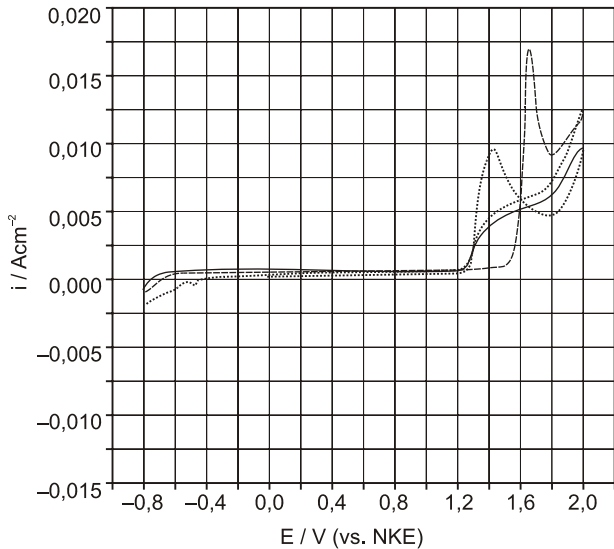
Figure 4. Polarisation curve, temperature 30 °C, quality of surface grinding R_a 1,5-2 (specimen 2)
Slika 4. Polarizacijska krivulja, temperatura 30 °C, kvalitet brušenja površine R_a 1,5-2 (uzorak 2)

the theoretical corrosion rate. The tests were carried out in the Tacussell cell with the tested steel as working electrode, a platinum measuring electrode and the saturated calomel electrode as reference. The dependences current intensity versus potential similar to those in Figures 3., 4. and 5.

were obtained and from the current intensity the theoretical corrosion rate shown in Table 4. was deduced.

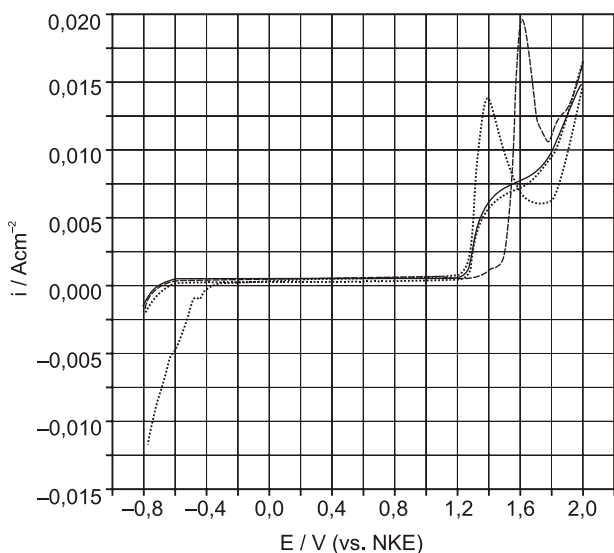
Figure 5. Polarisation curve, weld material, temperature 30 °C (specimen 3)
Slika 5. Polarizacijska krivulja, material zavora, temperatura 30 °C, (uzorak 3)
