D. KAKAŠ, L. KOVAČEVIĆ, P. TEREK, D. KRUMES, Z. KOLUMBIĆ

ISSN 0543-5846
METABK 48(3) 171-174 (2009)
UDC – UDK 621.746.019.77.026.34=111

USE OF SEM AND EDS ANALYSIS IN THE INVESTIGATION OF Al-Si-Cu PISTON ALLOY CAST POROSITY

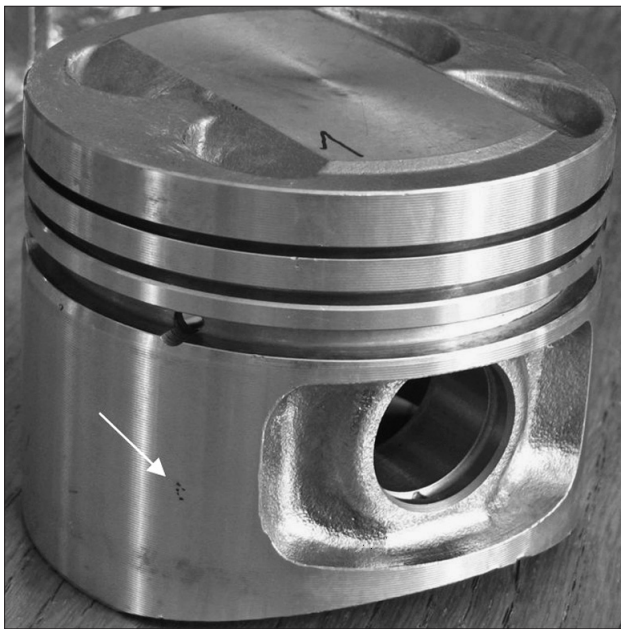
The pistons analyzed in this study are cast into two cavity steel mould. Appearance of the cast piston after machining process is shown in Figure 1. Material of the cast pistons is aluminum – silicon – copper alloy K AlSi12CuNiMg modified with phosphorous. Chemical composition of the alloy is given in Table 1.

Figure 1. Machined piston with found porosity – see arrow

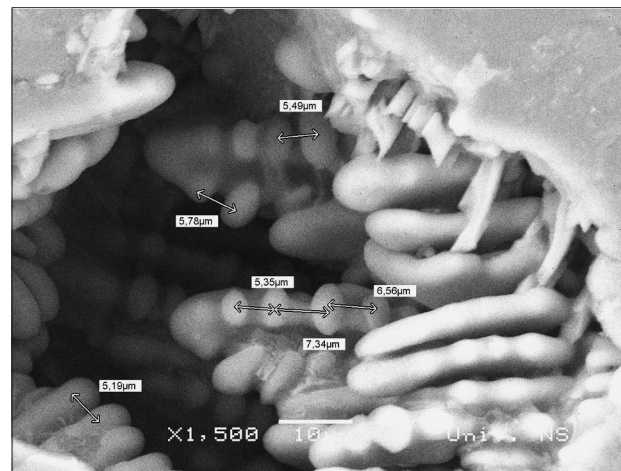
Secondary electron image of type B porosity is shown in Figure 7. Although found in proximity of A type porosity its morphology indicates different formation mechanism. Pores inner surface is clearly dendritic. Oxide bifilm is not visible and entrainment process is therefore not probable cause. The pore is most likely formed due to solidification shrinkage.

Figure 7. Secondary electron image of the type B porosity
