METABK 49(1) 9-12 (2010)

THERMAL FATIGUE CRACKING OF DIE-CASTING DIES

Original Scientific Paper – Izvorni znanstveni rad

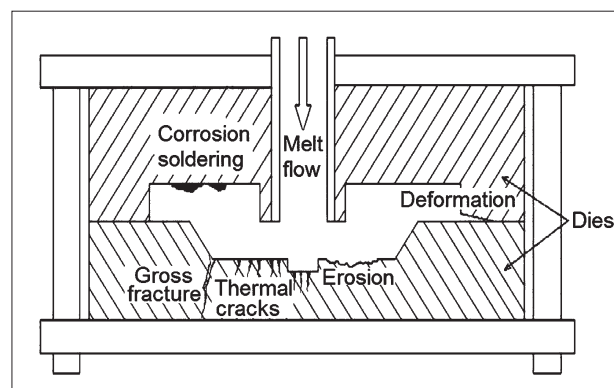
Figure 1. Schematic of defects occurrence on a die-casting die.

Die casting is the process of forcing molten under high pressure into mold cavities (which are machined into dies). The process of die casting is a cost-efficient method of making castings from aluminium, zinc, magnesium and copper-based alloys [1–3]. Dies are exposed to high mechanical, thermal and chemical loads which cause surface defects. These defects are thermal fatigue cracks, erosion of the melt flow, corrosion and soldering of aluminium to the die surface, deformation of contact surfaces of dies and gross fracture (Figure 1) [1-7].

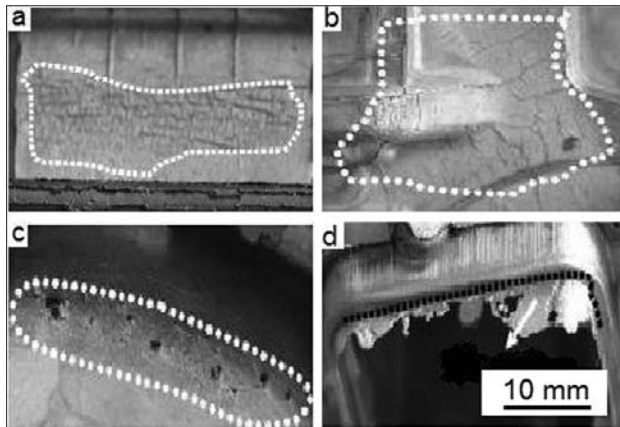
These defects are then reflected on castings. Figure 2 shows surface defects on aluminium castings. Figure 2a shows a worn-out surface, which is caused by the erosion of aluminium alloy melt flow. Figure 2b shows thermal fatigue cracks which occur due to thermal stresses during die casting. Figure 2c shows damage on an aluminium casting due to corrosion and soldering of aluminium to the die surface. The burr is caused by deformation of die parts (Figure 2d).

Figure 2. Surface defects of castings: a) erosion, b) thermal cracks, c) corrosion and soldering, d) deformation.

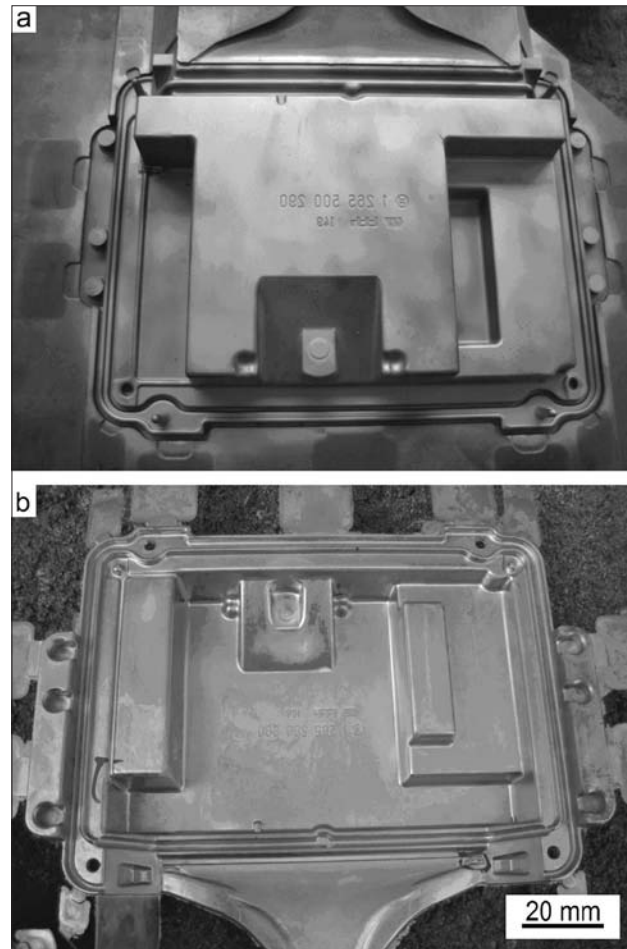
Figure 3. Die-casting die (a) and aluminium casting (b).

The material used in the investigation of thermal fatigue cracking was aluminium alloy AlSi9Cu3 (Table 1). (Figure 3). Experiments were made on an 8 MN cold chamber machine in actual production runs. The temperature of the aluminium melt was 680 °C and the total cycle time was 60 s during which the die was closed 25 s

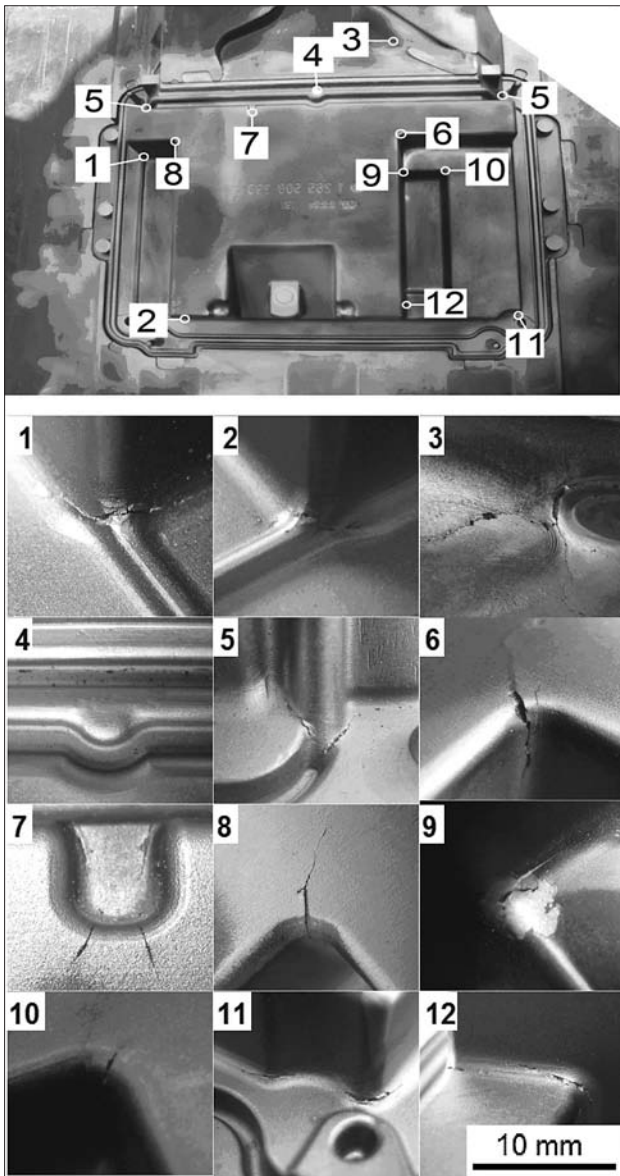
Figure 4 presents the locations of the surface defects on the dies and detailed photos of these defects. The identified local surface defects did not appear at the same time, i. e. at the same number of cycles.

They are numbered according to the time of occurrence; the first was observed at the edge at location 1 and the last defect was observed at location 12. The majority

of these surface defects generally occur on edges and corners. They tend to occur first at corners and edges with small radiuses. Locations closer to the gate were also subjected to higher temperature gradients and consequently higher stresses.

Figure 4. Locations of die surface defects and their detailed photos.

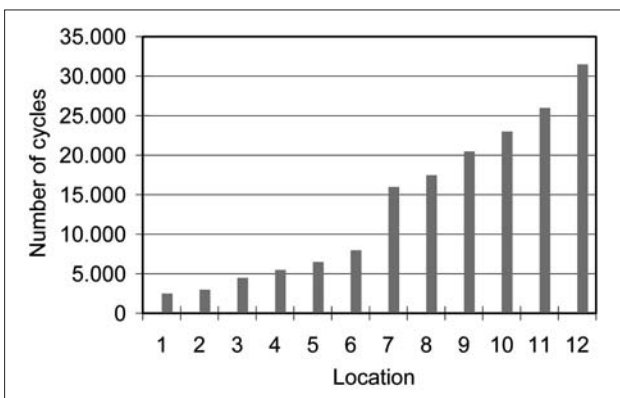
Figure 5 shows the locations and number of cycles at which the first thermal fatigue cracks occurred. At location 1 the first thermal crack occurred at around 2500 cycles, at location 2 at 3000 cycles and at locations 3 at 4000. Before 5000 cycles the cracks occurred at locations 1, 2, 3. The cracks at locations 4, 5, 6 were first detected after 6000, 7000 and 8000 cycles, respectively. The cracks at locations 7 and 8 were first observed at 16000 and 17000 cycles, at locations 9 and 10 at 21000 and 23000 cycles, and location 11 and 12 at 26000 and at 32000 cycles, respectively.

Figure 5. Die defect-crack occurrence (number of cycles).

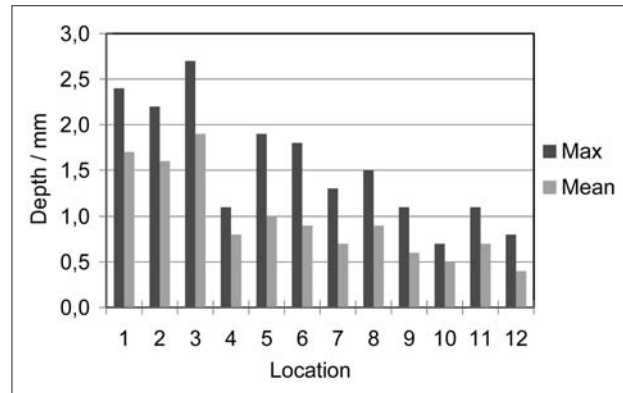
Figure 6 shows mean and maximum crack depth at different locations. Mean values of depth vary from 0,4 mm to 1,9 mm, and the maximum depths from 0,7 mm

Figure 6. Mean and maximum crack depth and their locations.

to 2,7 mm. The deepest cracks occurred at locations 3, 1, 6 and 2 with the maximal depths measured at 2,7 mm, 2,4 mm, 2,3 and 2,2 mm, respectively. The deepest cracks showed a tendency to occur near the die gate, where higher temperature gradients caused higher thermal stresses. The local stress concentrators (corners with small radiuses) additionally raised these stresses, which caused the local accumulation of plastic strain.

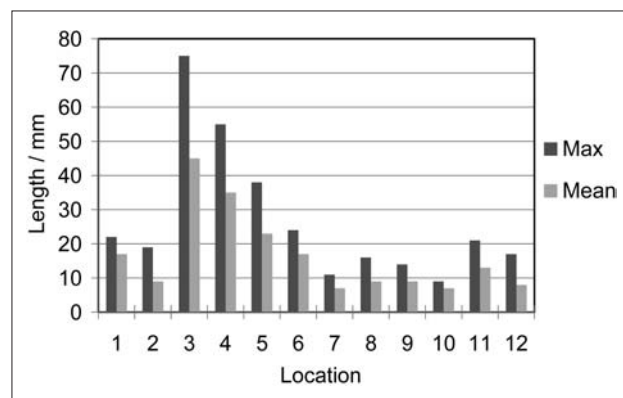
Figure 7. Mean and maximum surface crack length of and their locations.

Figure 7 shows mean and maximum length of cracks and their locations. Mean values vary from 7 mm to 45 mm and the maximum values from 9 mm to 75 mm. The longest cracks occurred at locations 3, 4, 5 and 6 with the maximal length measured at 75 mm, 55 mm, 38 and 23 mm, respectively.

The longest cracks also tend to occur near the die gate due to higher temperature gradients, which cause higher thermal stresses.

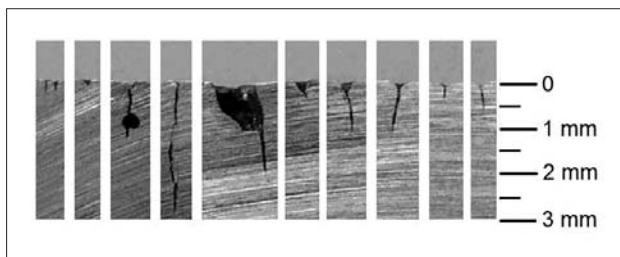
Figure 8 shows typical cross-sections of thermal fatigue cracks (found near the die gate at location 3). Depth of cracks amounts from a few tenths of a millimeter to a few millimeters. The deepest crack reaches the depth close to 3 mm. Width of cracks amounts approximately to 0,1 mm. The width is narrower at the tip of the crack (a few hundredths of a millimeter) and wider on the surface (a few tenths of a millimeter). The larger crack width on the surface is a consequence of melt erosion that causes constant loss of die material.

Figure 8. Cross-section of thermal fatigue cracks.

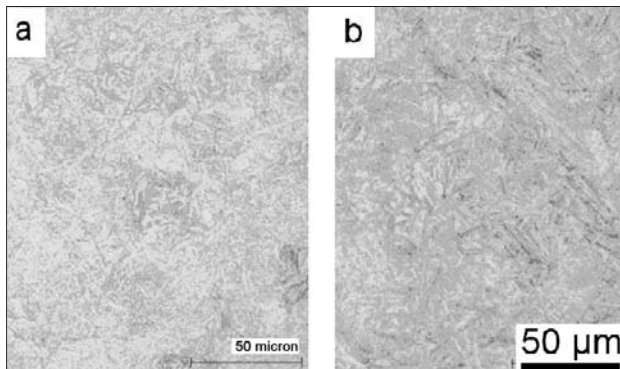
Figure 9. Microstructure of die material: a) near the surface and b) 3 mm below the surface.

Crack initiation is accelerated by gradual softening of die surface material during operation of the die [9, 11]. This is caused by tempering due to high temperature of aluminium alloy. Figure 9 shows microstructures of die material near the die surface (Figure 9a) and three millimeters below the die surface (Figure 9b).

The microstructure near the die surface (Figure 9a) has been changed due to high temperature that leads to tempering of the martensite. The tempering of the martensite caused a decrease in hardness by about 130 HV (Figure 10) on the die surface compared to hardness of the die material deeper in the core. Decrease in die material hardness consequently led to decreasing material resistance against thermal fatigue cracking.

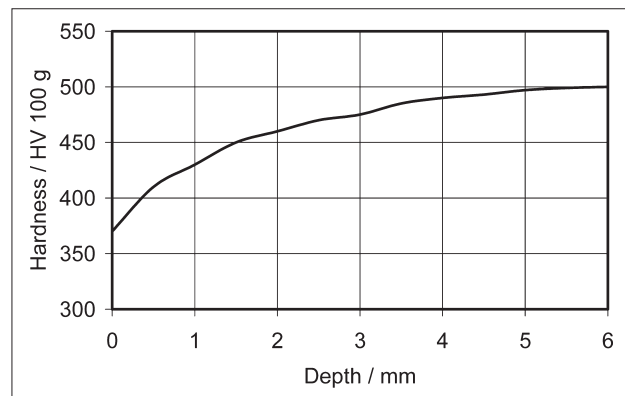
Figure 10. Die material hardness versus depth from surface.
