Salt crystallization tests: Focus on their objective

Charola, A. Elena; Rørig-Dalgaard, Inge; Chwast, Jacek; Elsen, Jan

Publication date:
2017

Charola, A. E., Rørig-Dalgaard, I., Chwast, J., & Elsen, J. (2017). Salt crystallization tests: Focus on their objective. Paper presented at 4th International Conference on Salt Weathering of Buildings and Stone Sculptures, Potsdam, Germany.

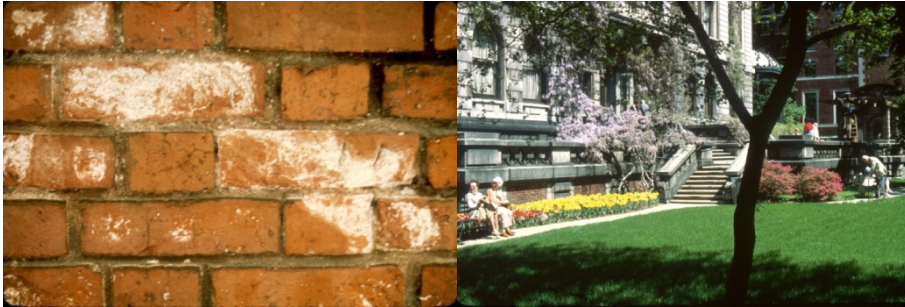
Figure 2: Detail of the brick wall showing the gypsum efflorescence formed on the parallel wall below grade to that seen in the garden at right.

A more prosaic of gypsum efflorescence was found on a brick retaining wall in the garden at the Cowper Hewitt Museum as shown in Figure 2. The gypsum, probably found in the soil of the garden on the other side of the wall, migrates solubilized in water (from watering plants and rain) through it and crystallizes out as a white efflorescence at about the top soil level on the garden side.
