Effect of Woodpecker Damage and Wood Decay on Wood Utility Pole Strength

A thesis
presented to the University of Waterloo
in fulfillment of the
thesis requirement for the degree of
Master of Applied Science
in
Civil Engineering

Waterloo, Ontario, Canada, 2011

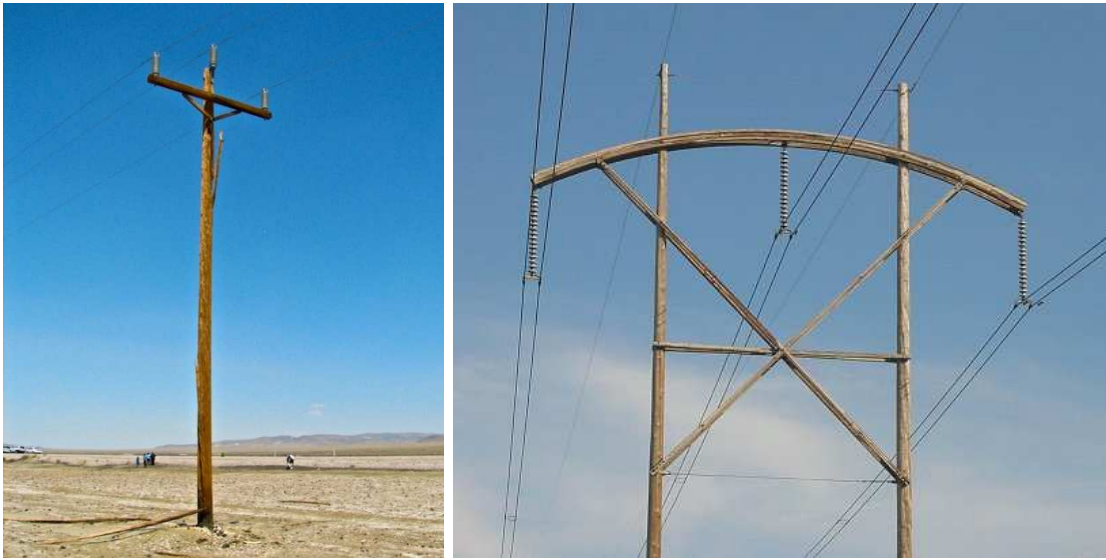
Figure 1. - Electrical distribution and transmission structures constructed of wood utility poles.

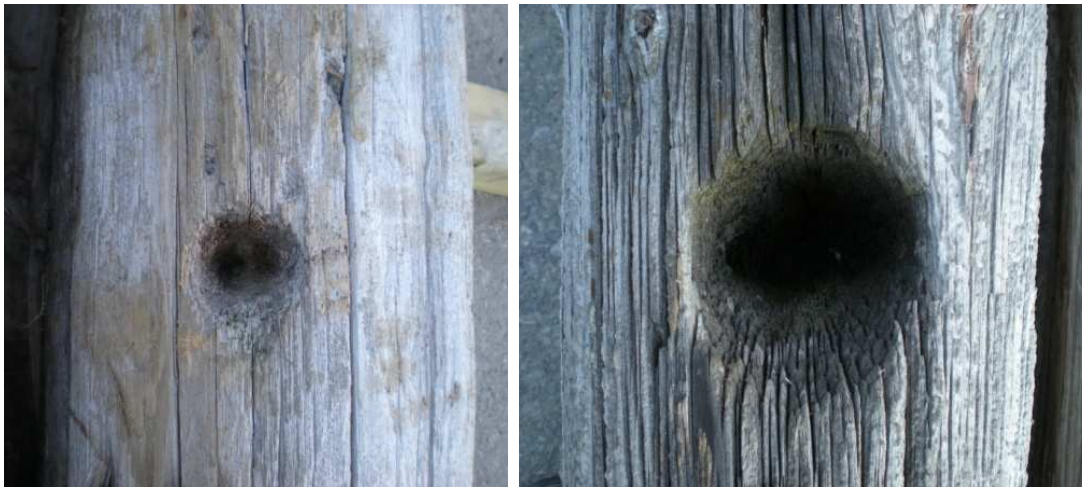
Figure 10. - In-service exploratory damage (left) and feeding damage (right).

Damage Level	Description
Exploratory	< 3" (75 mm) Ø opening and 3" (75 mm) deep
Feeding	< 3" (75 mm) x 7" (175 mm) opening and 6" (150 mm) deep
Nesting	3" (75 mm) Ø opening, 2' (600 mm) long with 1-3" (25-75 mm) shell thickness

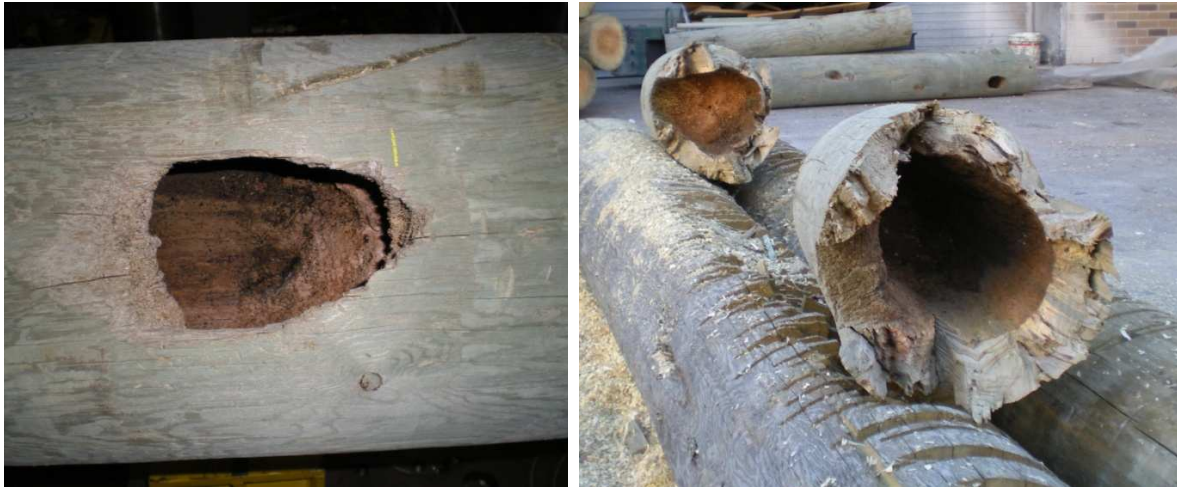
Figure 11. - In-service nesting damage and dissection of interior.

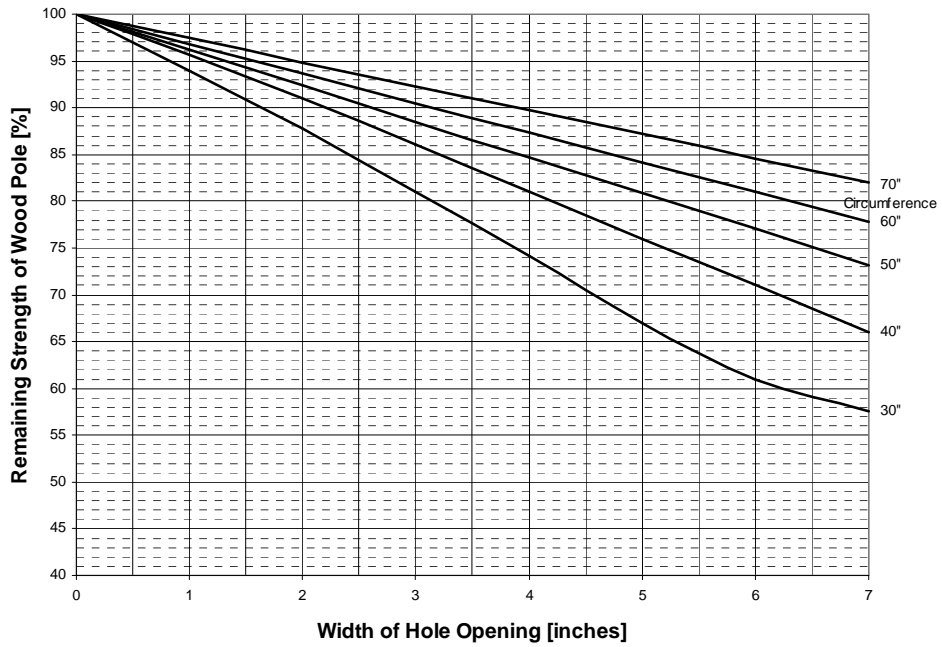
Figure 12. - Strength reduction caused by exploratory holes (HONI 2010).

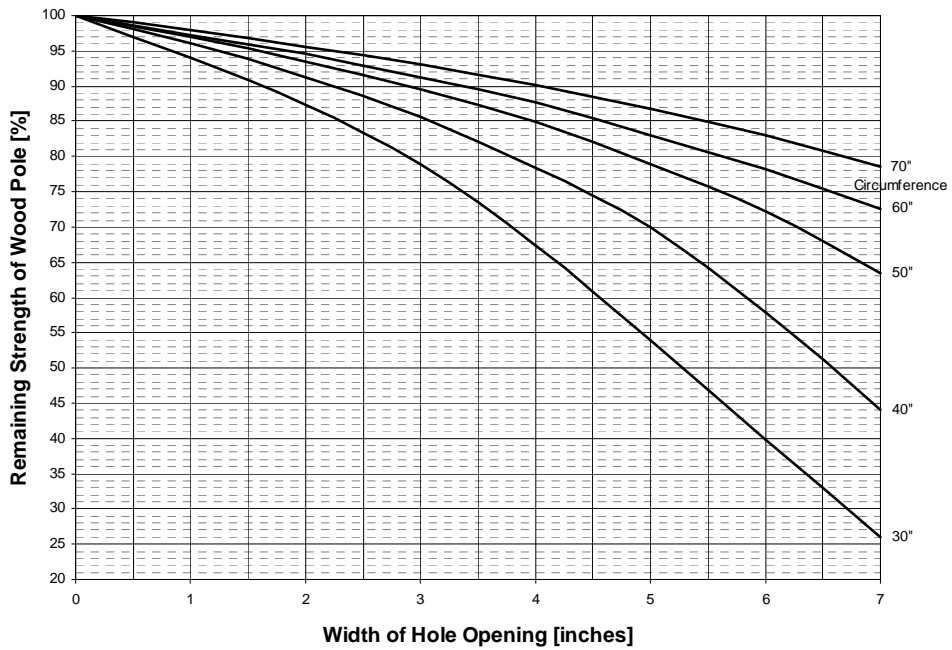
Figure 13. - Strength reduction caused by feeding holes (HONI 2010).

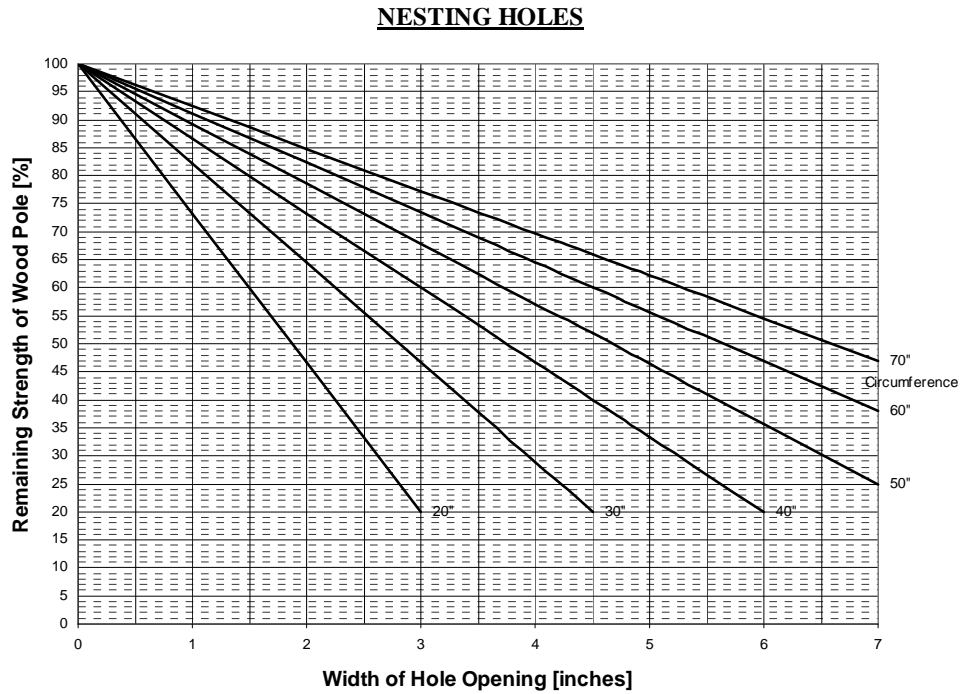
Figure 14. - Strength reduction caused by nesting holes (HONI 2010).

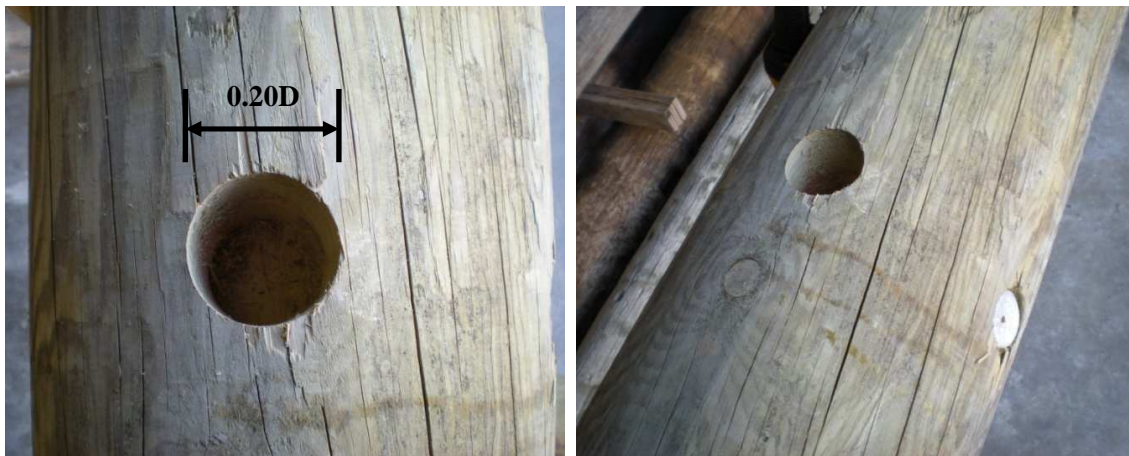
Figure 17. - New pole specimen idealized exploratory damage.

The idealized damage levels were used to categorize damage for the experimental portion of this research. As is discussed in Chapter 6, damage was mechanically introduced in some pole specimens. Figure 17, Figure 18, and Figure 19 show examples of idealized exploratory, feeding, and nesting holes introduced into test specimens using saw-tooth bits and an electric drill.

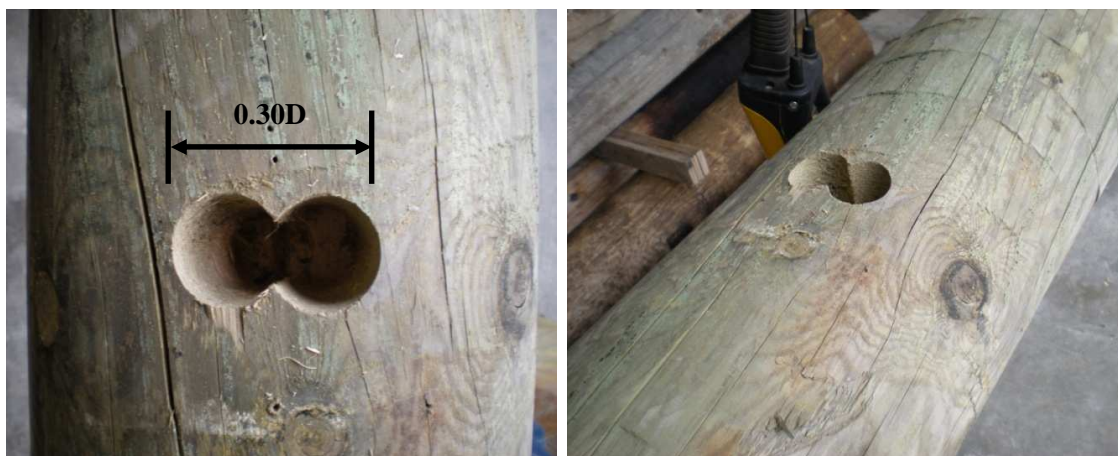
Figure 18. - New pole specimen idealized feeding damage.

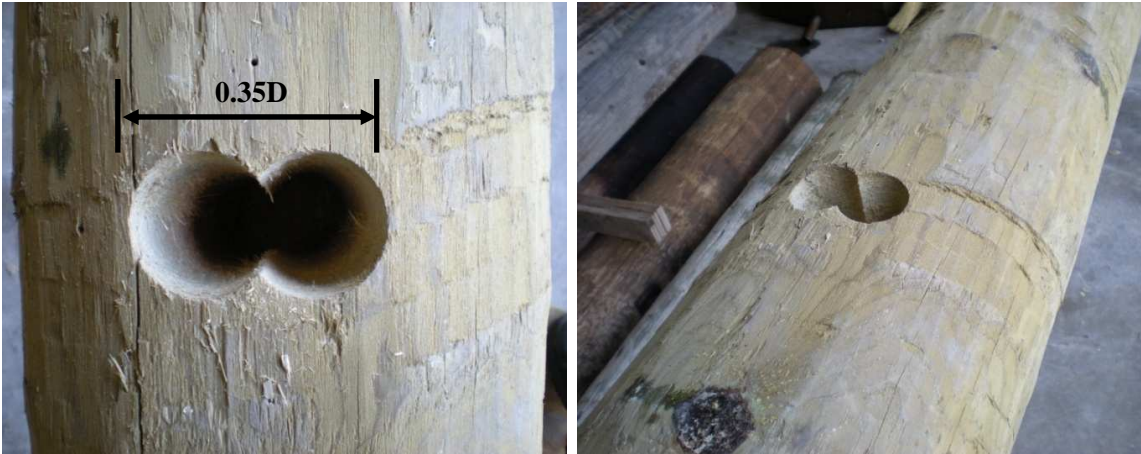
Figure 19. - New pole specimen idealized nesting damage.

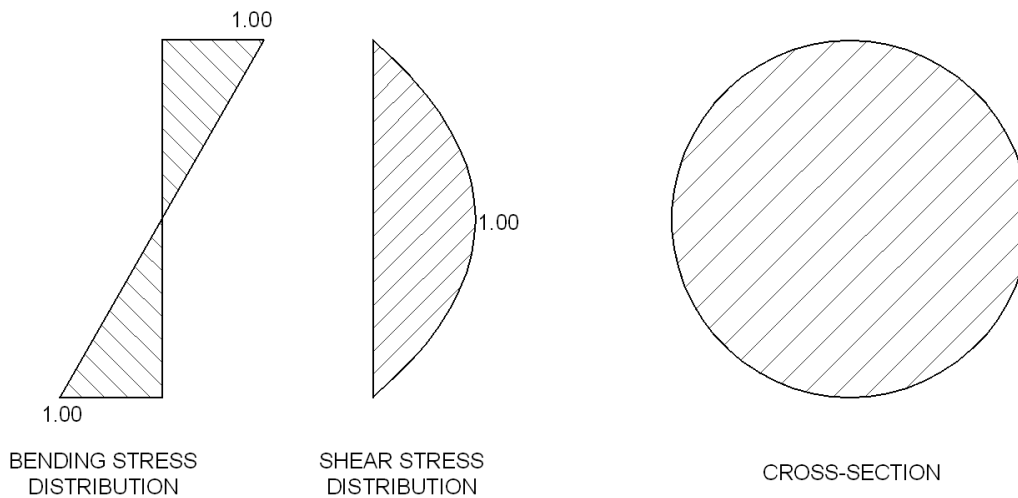
For comparison purposes, normalized shear and bending stress distributions for an undamaged circular cross-section are provided in Figure 21. Peak stress locations are indicated by a normalized stress of 1.00.

Figure 21. - Stress distributions of an undamaged cross-section.

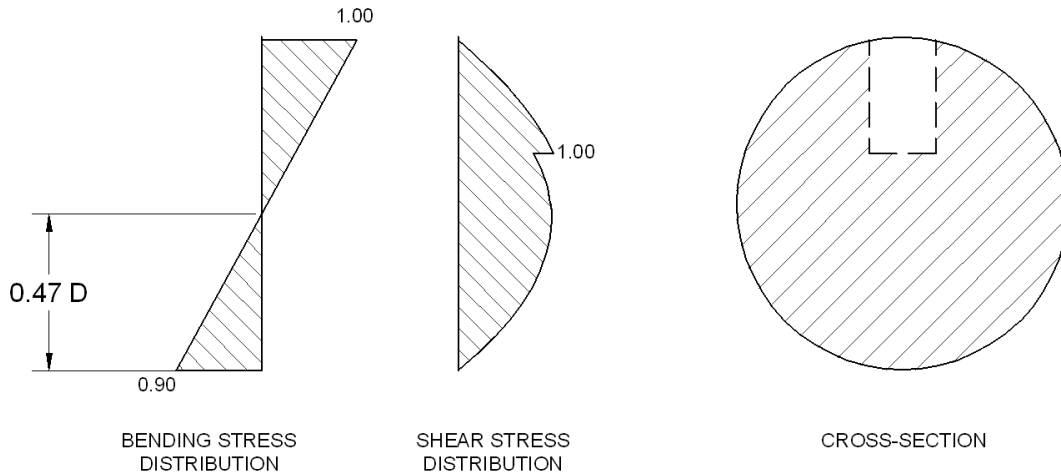
Vertically oriented damage caused a large decrease in section modulus due to the large areas of extreme fibres being removed. As a result, significant increases in bending stresses were observed. In addition, shear stress distributions formed local peaks on shear planes located at the base of damage locations due to reduced shear plane thicknesses. Normalized shear and bending stress distributions for cross-sections with different levels of vertically oriented damage are given in Figure 22, Figure 23, and Figure 24. Damage levels were defined previously in Figure 15.

Figure 22. - Stress distributions of a cross-section with vertical exploratory damage.

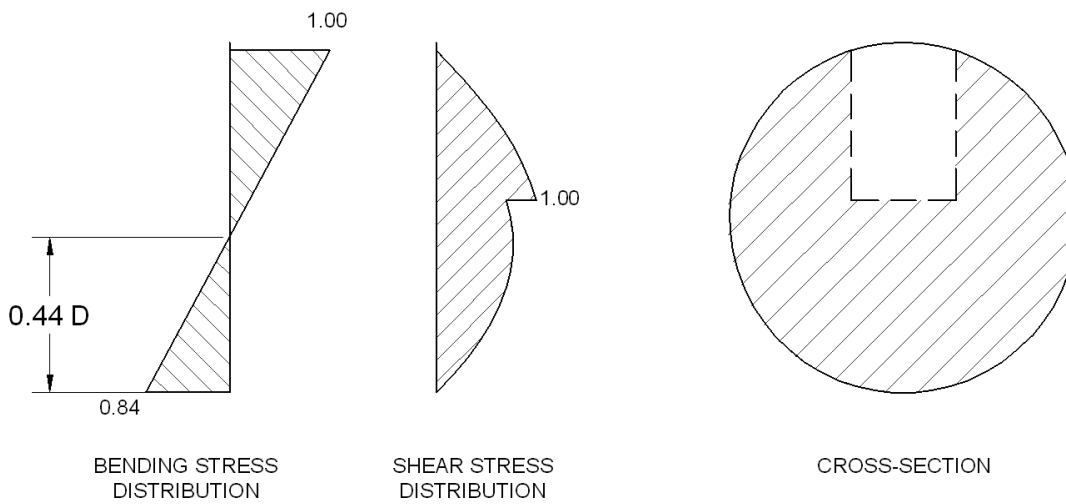
Figure 23. - Stress distributions of a cross-section with vertical feeding damage.

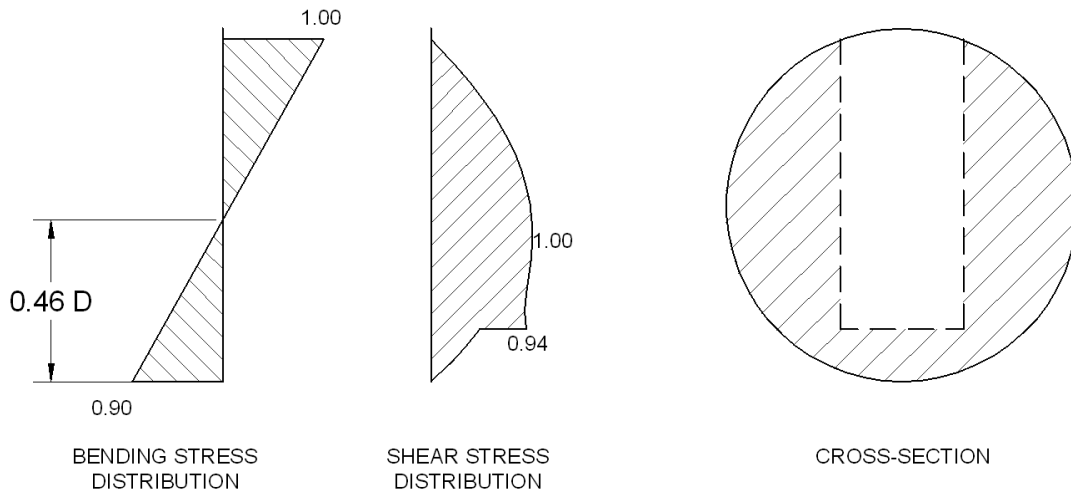
Figure 24. - Stress distributions of a cross-section with vertical nesting damage.

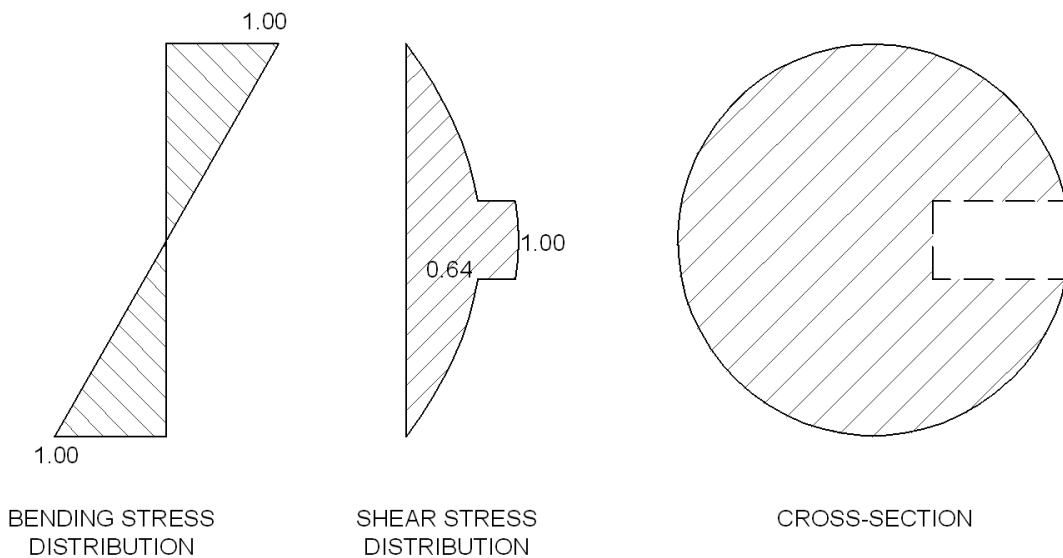
Horizontally oriented damage was observed to cause large shear stress increases due to a significant reduction in shear plane thicknesses at hole locations. Section moduli were minimally reduced since horizontal damage locations were located close to the neutral axis. As a result, bending stress increases were observed to be minimal. Normalized shear and bending stress distributions for cross-sections with different damage levels are given in Figure 25, Figure 26, and Figure 27.

Figure 25. - Stress distributions of a cross-section with horizontal exploratory damage.

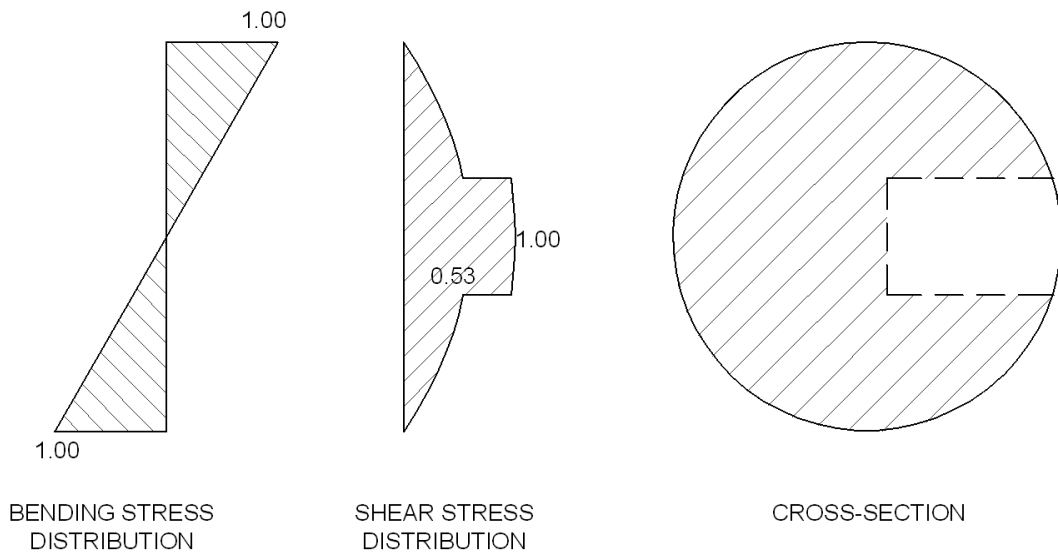
Figure 26. - Stress distributions of a cross-section with horizontal feeding damage.

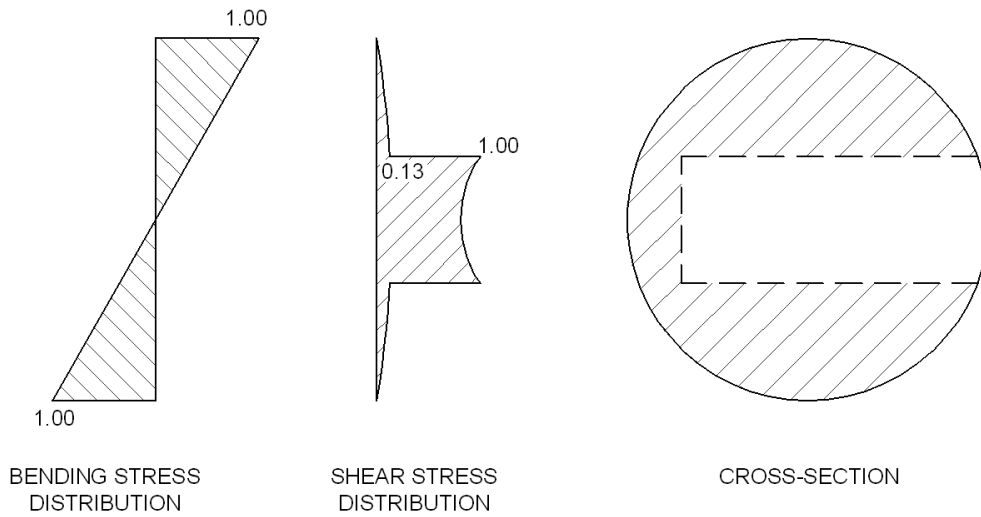
Figure 27. - Stress distributions of a cross-section with horizontal nesting damage.

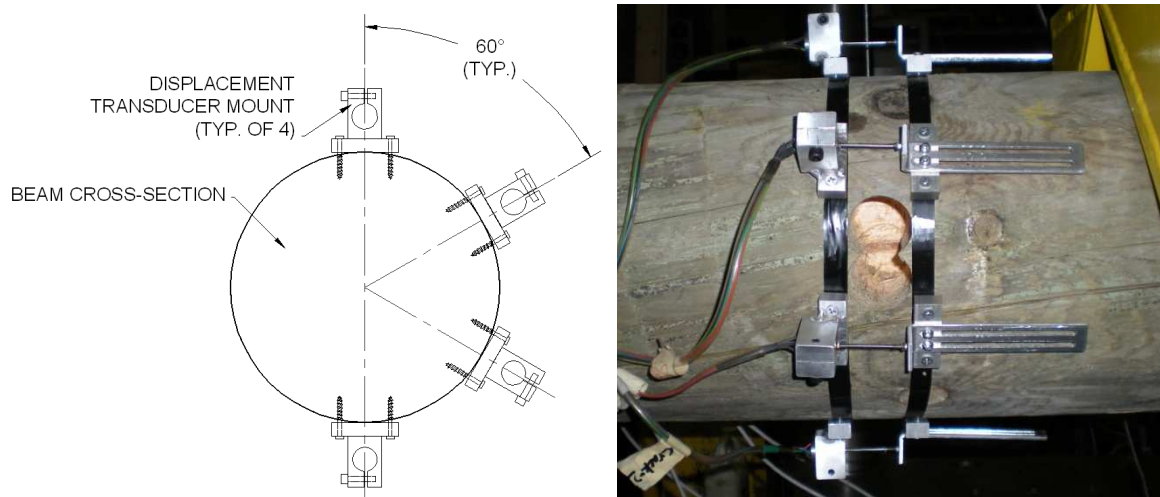
In order to better understand cross-sectional behaviour in flexure at the damaged locations, longitudinal strain was measured at the hole locations using displacement transducers (DCDTs). The DCDTs provided measurement of the average strain within gauge lengths varying from 50 to 100 mm. The DCDTs used had a range of ± 1.27 mm and a sensitivity of ± 0.001 mm. Strain was measured at four locations evenly spaced around the cross-section circumference as shown in Figure 33 so that the strain profile could be determined over the cross-section depth.

Figure 33. - New pole specimen DCDT configuration.

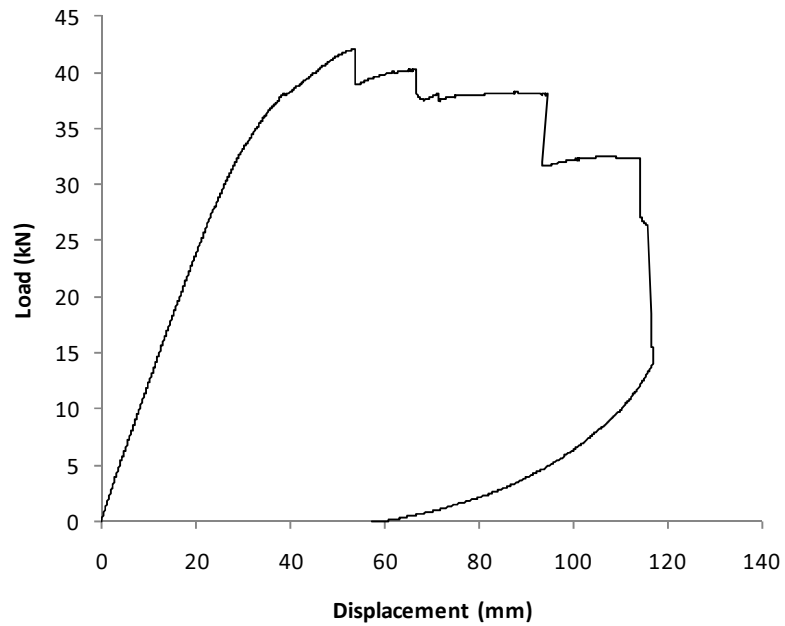
Typical load-deflection curves for new pole specimens are shown in Figure 34 and Figure 35 for bending and shear failure, respectively. Below the proportional limit, the load-deflection behaviour was linear. Beyond the proportional limit, the specimens behaved non-linearly with deflection increasing more rapidly. Specimens reached their ultimate load with only limited non-linear response. After specimens reached their ultimate load, further deformation resulted in decreased load capacity. The vast majority of control and woodpecker damaged specimens failed in bending and had a relatively gradual stepped decrease in load capacity as shown in Figure 34. Specimens with neutral axis nesting damage failed in shear and underwent a more sudden significant decrease in load capacity as shown in Figure 35.

Figure 34. - Typical load-deflection curve for new pole specimen failing in bending (60-2-1).

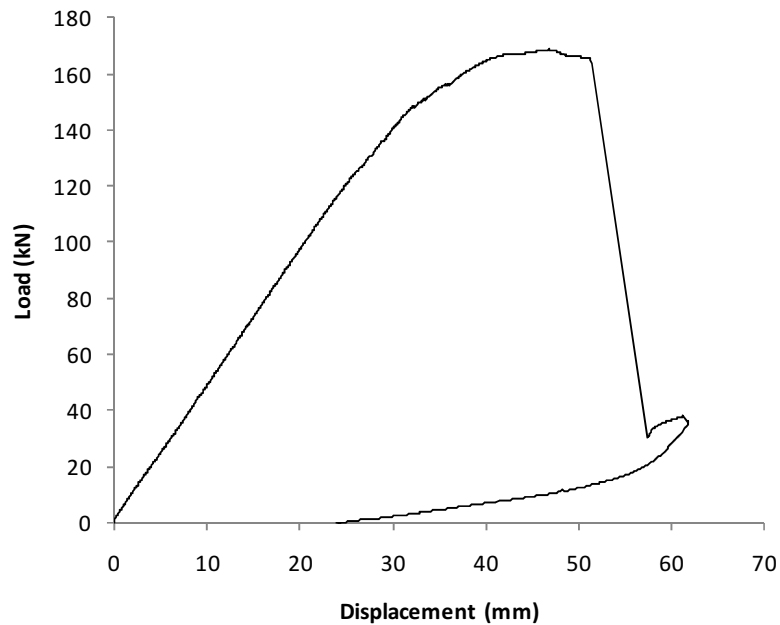
Figure 35. - Typical load-deflection curve for new pole specimen failing in shear (55-2-3).

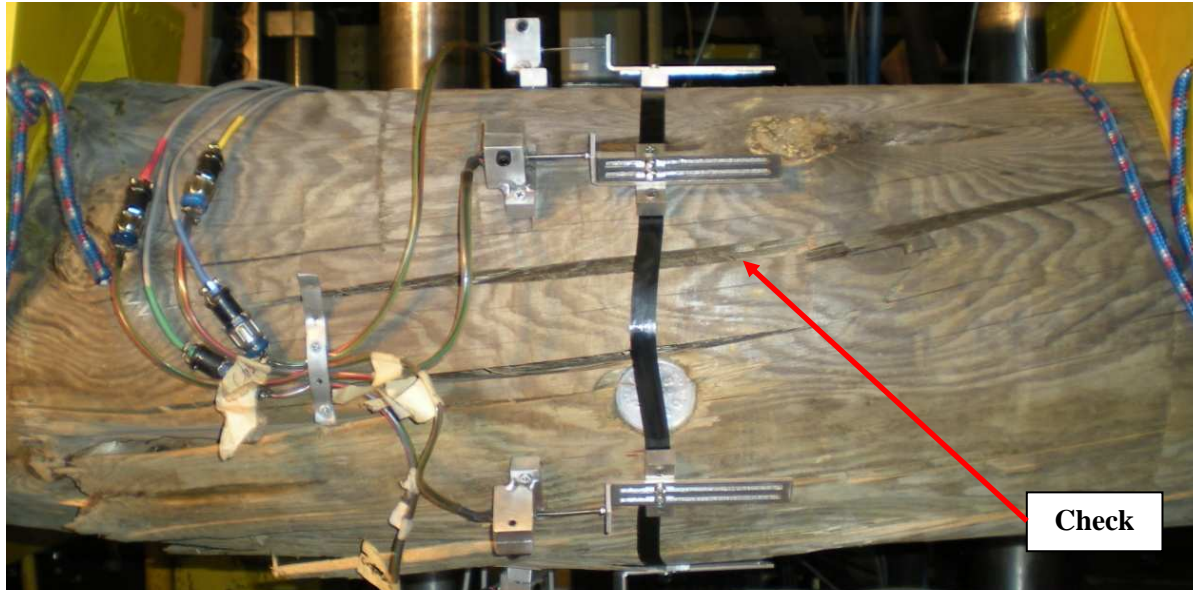
checking and large amounts of knots. Checks, as shown in Figure 36, were observed to have minimal impact on wood strength and did not influence failure locations. Red pine specimens typically had rings of knots located at close intervals along specimen lengths. Many failures occurred at cross-sections with knot rings, indicating they cause strength reduction in red pine specimens. Large knots, such as the one shown in Figure 37, were found to be more significant than knot rings, and caused severely reduced bending strength. It was observed that some specimens within red pine poles had unusually clear wood at failure locations. Typically the larger the diameter of the specimen the clearer the wood became and higher bending strengths were observed.

Figure 36. - New pole specimen with checking at midspan (45-1-3).

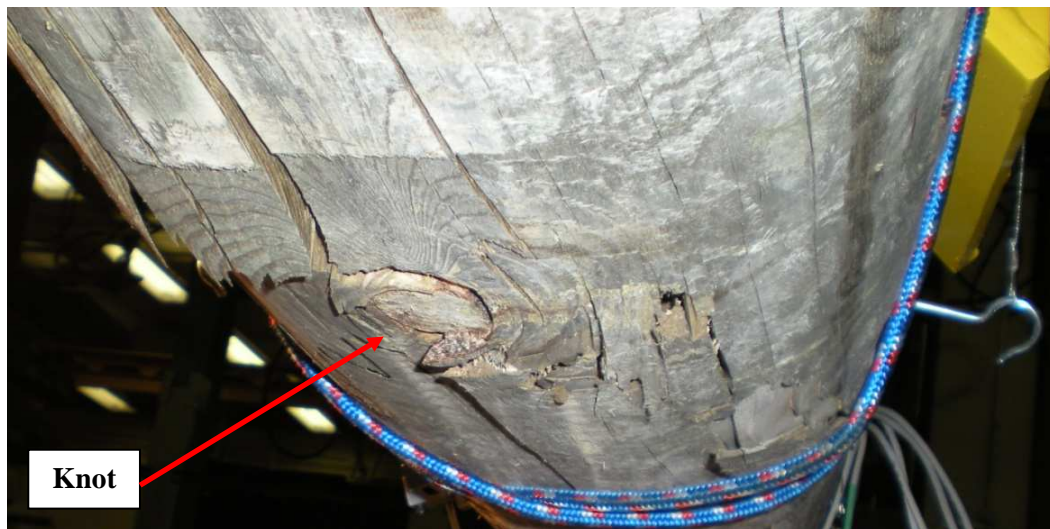
Figure 37. - New pole specimen with a large knot at failure location (45-1-2).

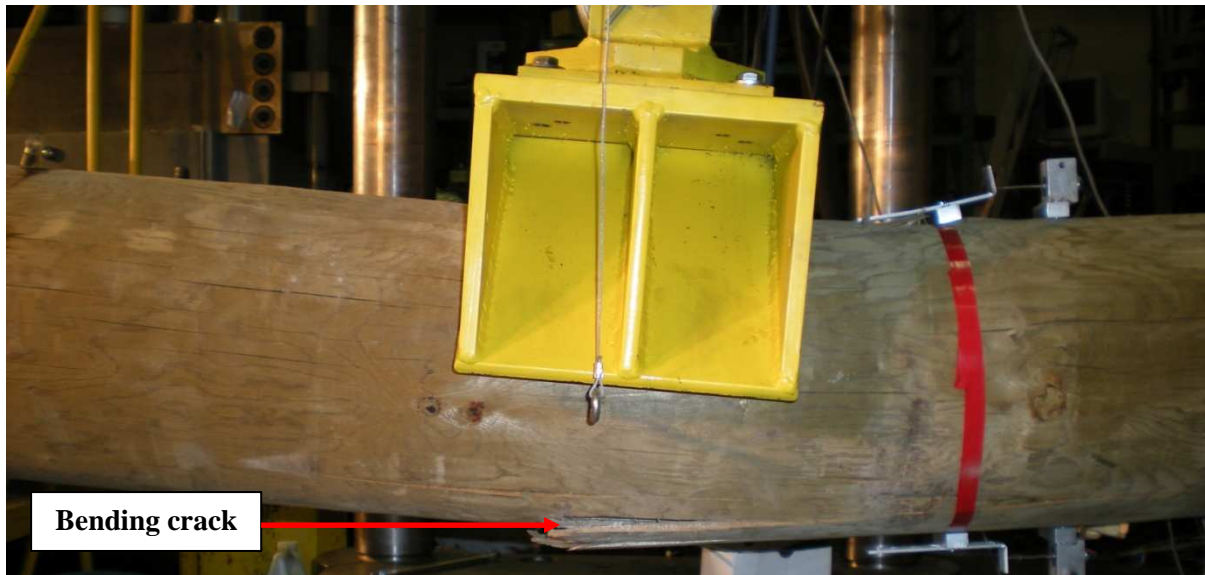
Control specimens were tested in three-point bending in order to obtain reference bending strengths for analysis of woodpecker damaged specimens. All control specimens failed in bending as shown in Figure 38. Several specimens had minor compression fibre crushing and ultimately all specimens failed due to tension fibre rupture. Control beam bending strengths were calculated using both the BF and SBIF analytical models. Shear strengths were assumed based on values from published literature for specific species and moisture content (USDA 1999f). Geometric section properties were determined using mechanics of materials principles (Mikhelson 2004).

Figure 38. - Typical new pole control specimen bending failure (60-2-2).

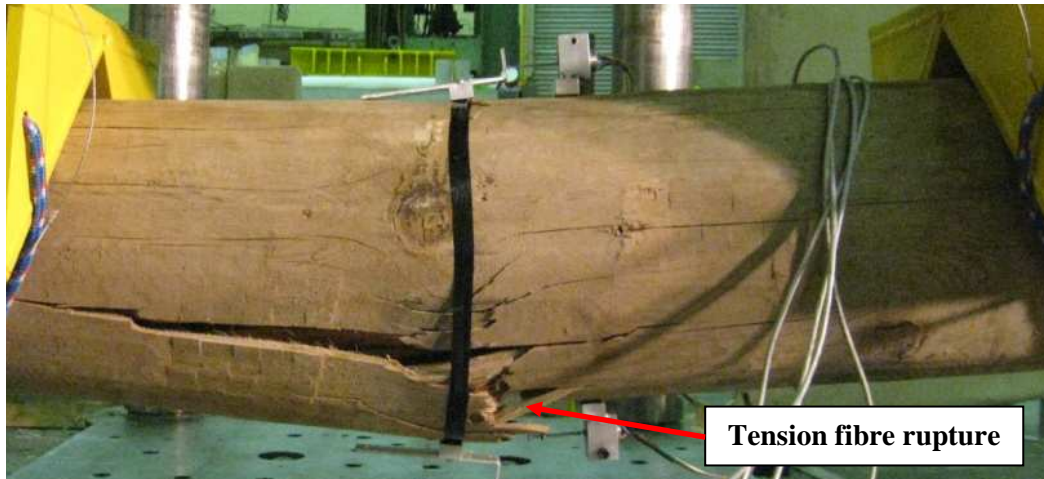
sudden and resulted in cross-section separation along the longitudinal axis of the beam at the failure plane. The moment of inertia of the specimens with woodpecker damage was calculated using the BF, SF, and SBIF analytical models. Shear strengths were assumed to follow values from published literature (USDA 1999f) while geometric section properties were determined using mechanics of materials (Mikhelson 2004). It was assumed that the damaged specimen bending strengths were equivalent to the control specimen bending strengths taken from the corresponding poles.

Figure 40. - Tension fibre rupture of new pole specimen with tension damage (60-2-1).

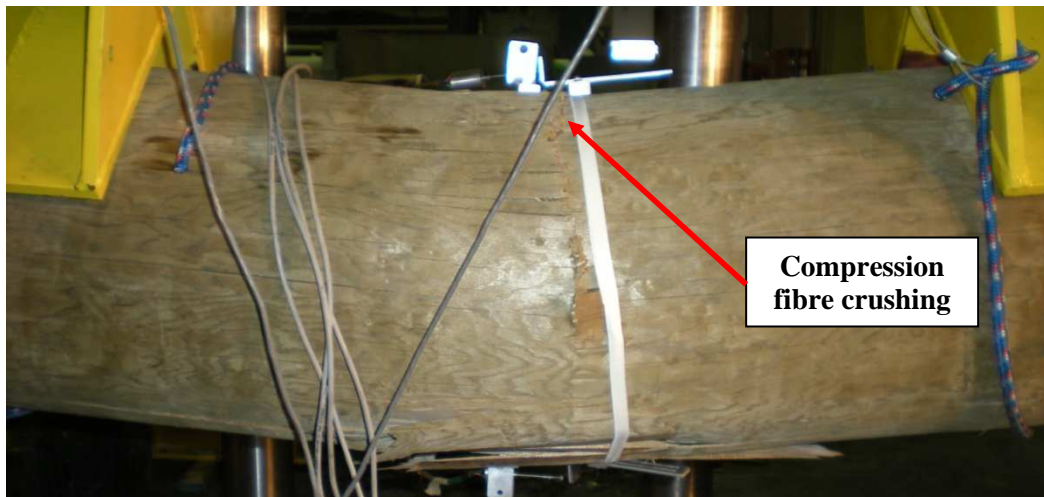
Figure 41. - Compression fibre crushing of new pole specimen with compression damage (60-2-4).

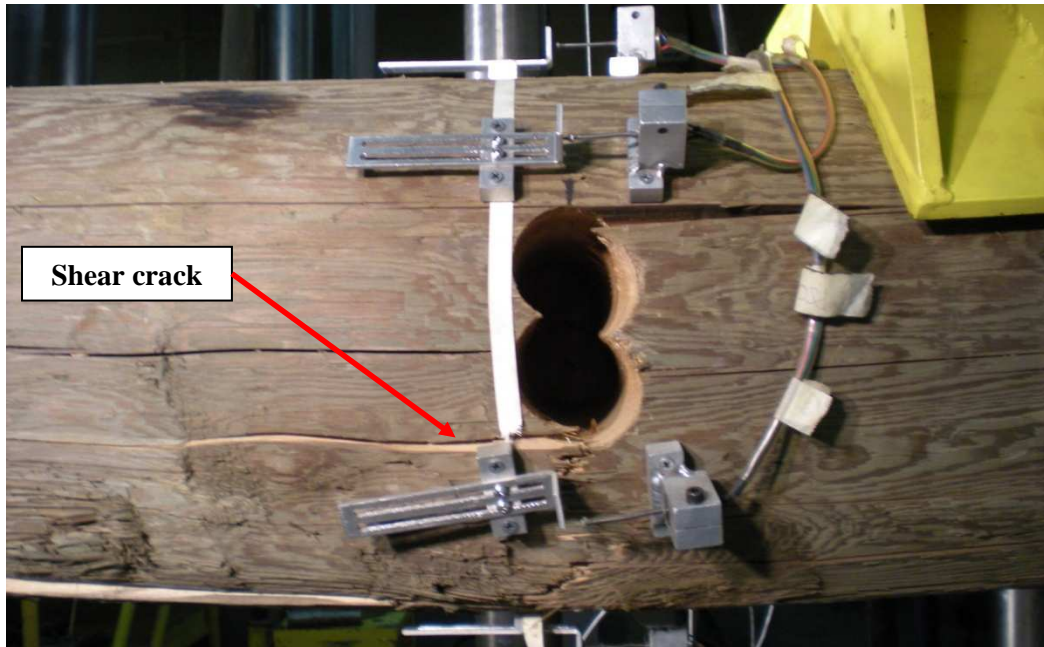
Figure 42. - Shear failure of new pole specimen with neutral axis nesting damage (55-2-3).

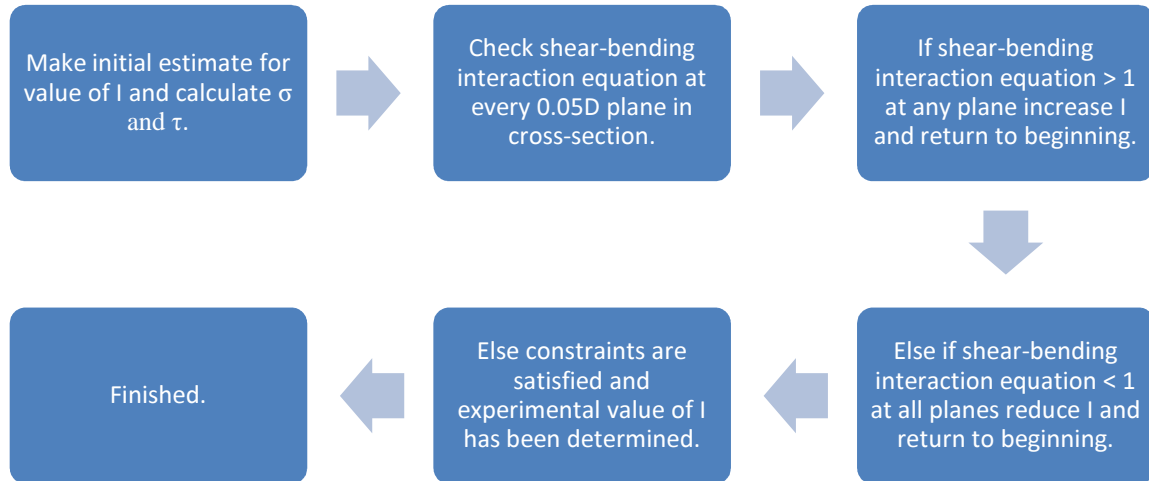
where f_b is bending strength from control specimens and f_v is shear strength from published data (USDA 1999f).

Figure 43. - SBIF equation iterative solver for new pole damaged specimens.

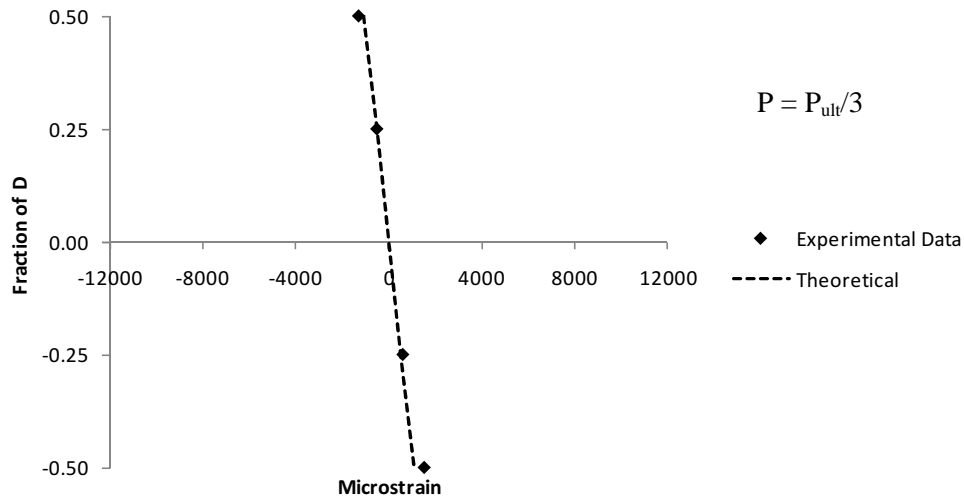
The control specimens exhibited a linear strain profile as shown in Figure 44. The predicted strain profile is also included for comparison. Minor differences were observed between the theoretical and experimental strain magnitudes, likely due the difference between the assumed and actual modulus of elasticity at the cross-section location. In addition, the slight non-linearity of the theoretical strain profile can be attributed to an imperfect circular cross-section and the non-homogenous nature of wood due to knots and local wood properties.

Figure 44. - New pole control specimen strain profile (45-1-2).

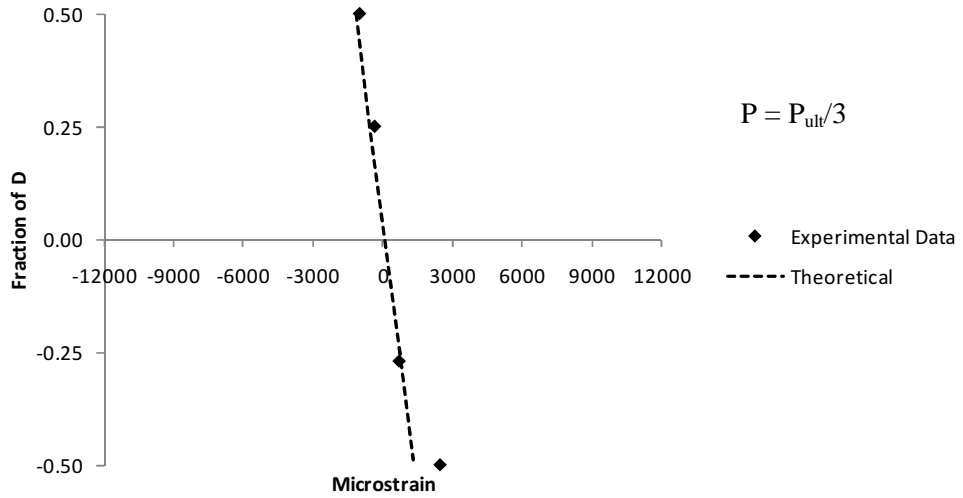
Specimens with woodpecker damage oriented in the tension and compression positions exhibited similar, but inverted, strain profiles (Figure 45 to Figure 50). Strain profiles were linear over the majority of the cross-section and rapidly increased near the surface where woodpecker damage is present. Theoretical analysis predicts a linear strain profile for specimens with tension and compression oriented damage (Figure 45 to Figure 50). The experimental profiles did not match theoretical strain profiles very well at the surface where woodpecker damage was present. Experimental strain magnitudes for tension and compression damage at surface locations ranged from 2 to 7 and 4 to 9 times higher, respectively than those predicted theoretically. The low ends of these ranges corresponded to low level damage while the upper end represents high level damage. Increased strain magnitudes at damage locations are attributed to stress concentrations that arise due to the discontinuity between damaged and undamaged cross-sections. At a localized area in the cross-section where damage is introduced, the presence of the hole caused an abrupt redistribution of the bending stress field, resulting in a local increase in stress around the hole or damage location. This increased stress was reflected in the increased measured strains at the damage locations.

Figure 45. - Strain profile of new pole specimen with tension exploratory damage (45-1-3).

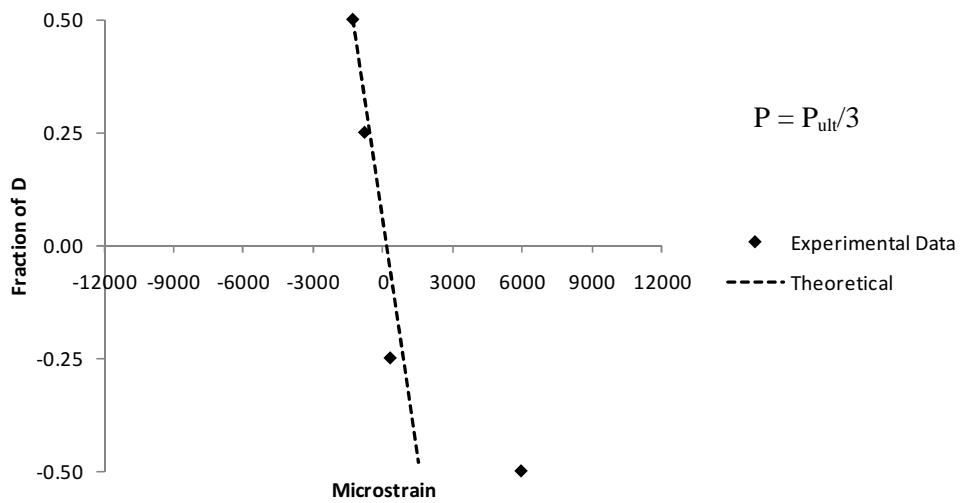
Figure 46. - Strain profile of new pole specimen with tension feeding damage (60-2-1).

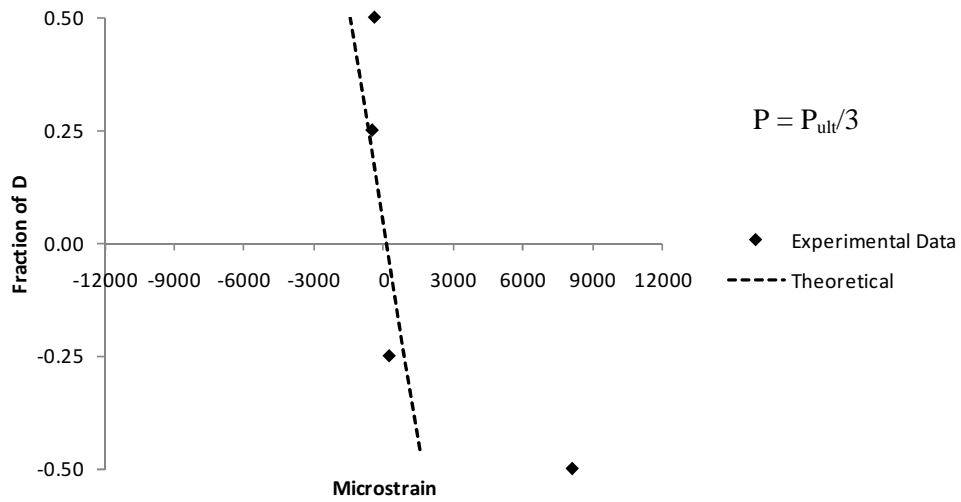
Figure 47. - Strain profile of new pole specimen with tension nesting damage (55-1-1).

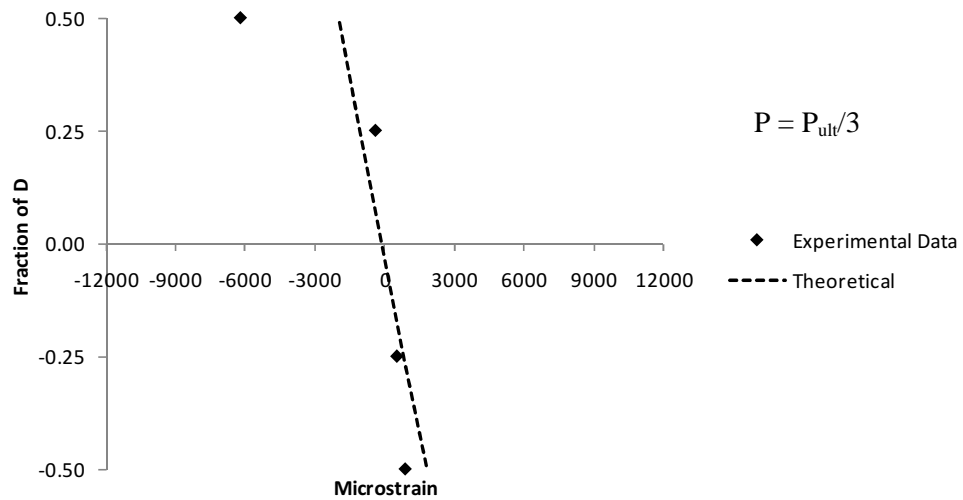
Figure 48. - Strain profile of new pole specimen with compression exploratory damage (60-1-4).

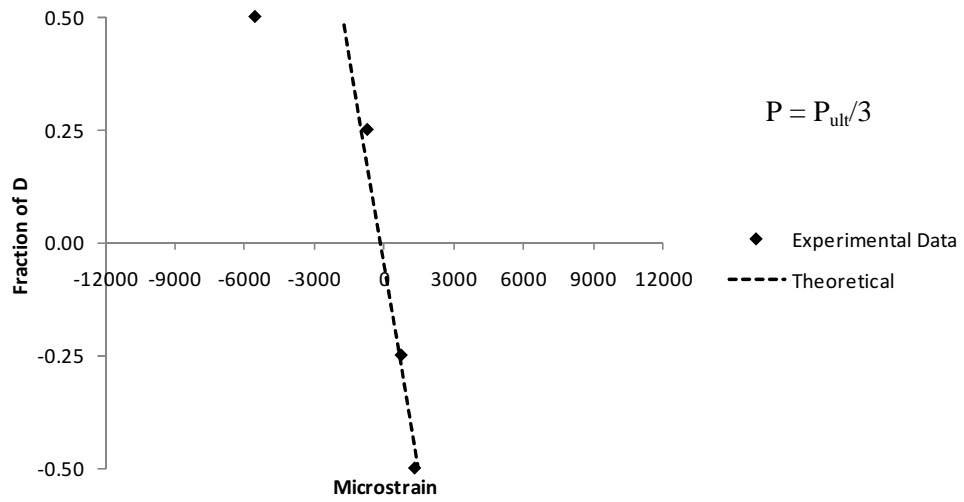
Figure 49. - Strain profile of new pole specimen with compression feeding damage (60-1-1).

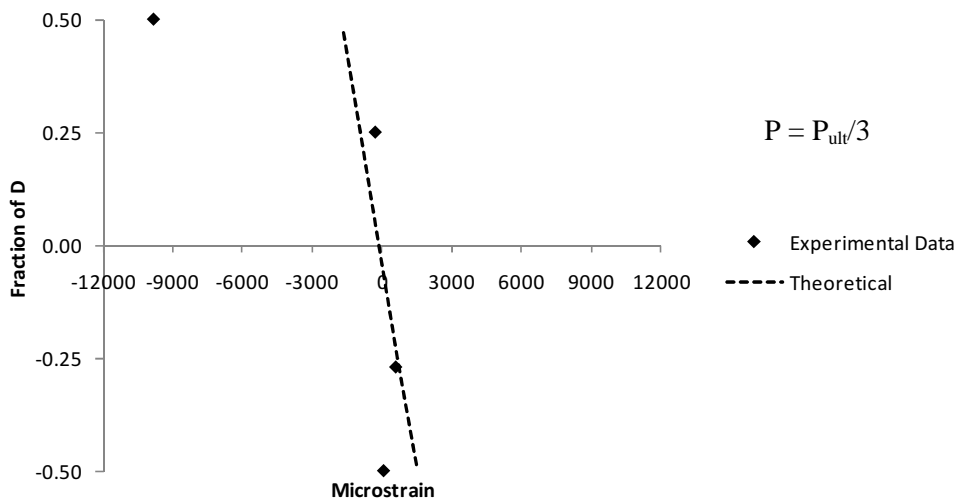
Figure 50. - Strain profile of new pole specimen with compression nesting damage (50-3-3).

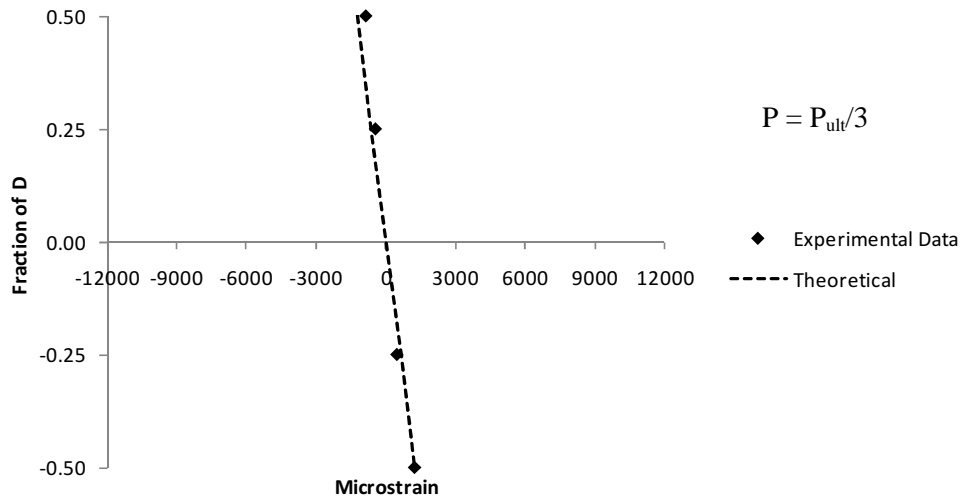
Figure 53. - Strain profile of new pole specimen with neutral axis nesting damage (55-3-1).

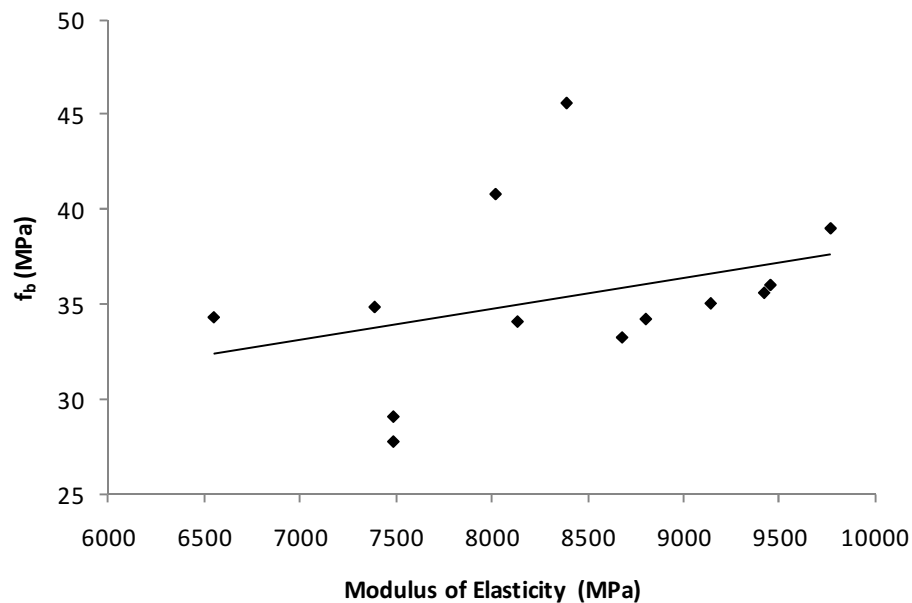
Modulus of elasticity and bending strength are graphed in Figure 54. It is evident that as the modulus of elasticity of a specimen increases, the bending strength also increases. This trend is apparent, although there is weak correlation.

Figure 54. - Bending strength vs. modulus of elasticity for new pole specimens.

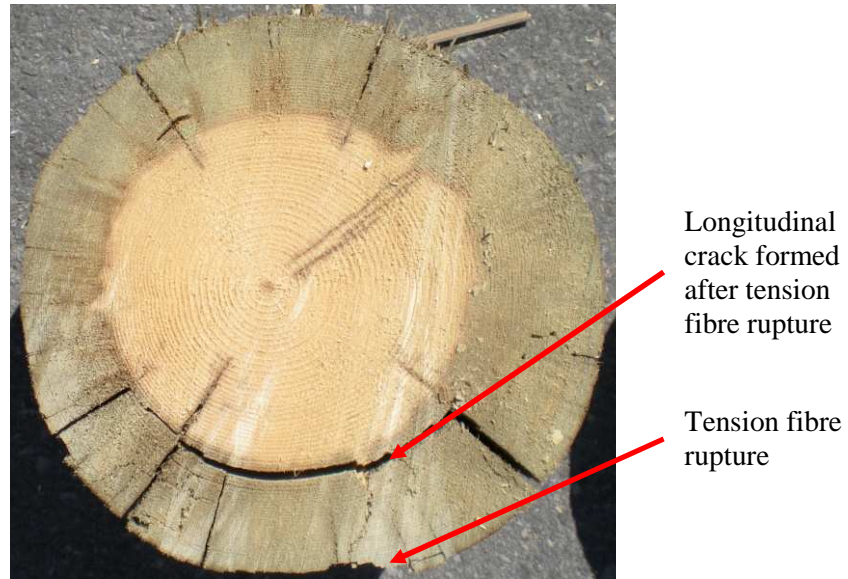
Dissection of control specimens at failure locations indicated tension fibre rupture was the primary cause of failure, as shown in Figure 55 and Figure 56.

Figure 55. - Cross-section of new control specimen (50-1-2).
