Effect of Woodpecker Damage and Wood Decay on Wood Utility Pole Strength

A thesis
presented to the University of Waterloo
in fulfillment of the
thesis requirement for the degree of
Master of Applied Science
in
Civil Engineering

Waterloo, Ontario, Canada, 2011

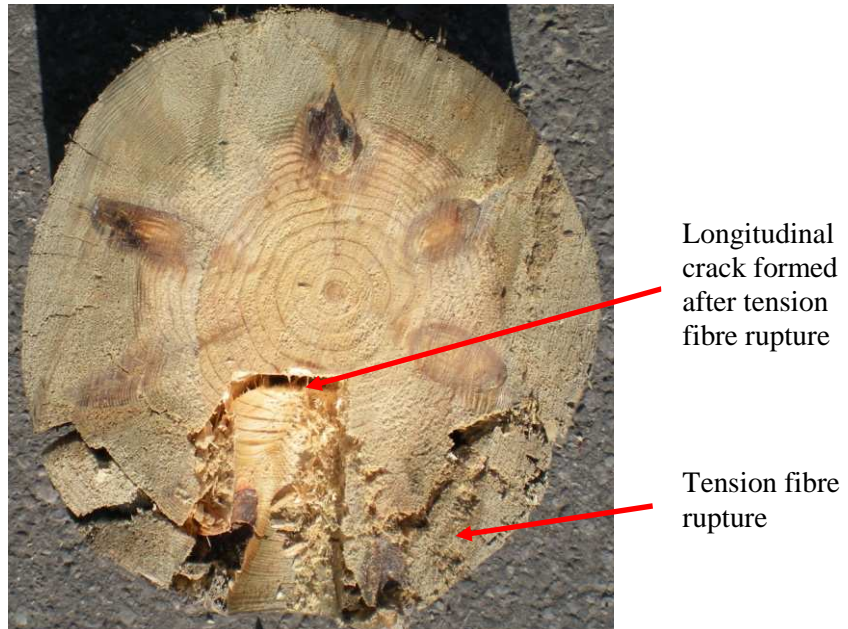
Specimens with tension oriented damage typically failed due to tension fibre rupture. Similar to the control specimens, tension fibre rupture initiated at the extreme tension fibres of specimens and caused fracture of the cross-section. Typically, prior to tension fibre rupture, longitudinal cracks would form along specimen lengths. Examples of failure cross-sections of tension specimens with varying levels of damage are shown in Figure 57 to Figure 59.

Figure 57. - Cross-section of new pole specimen with tension exploratory damage (45-2-3).

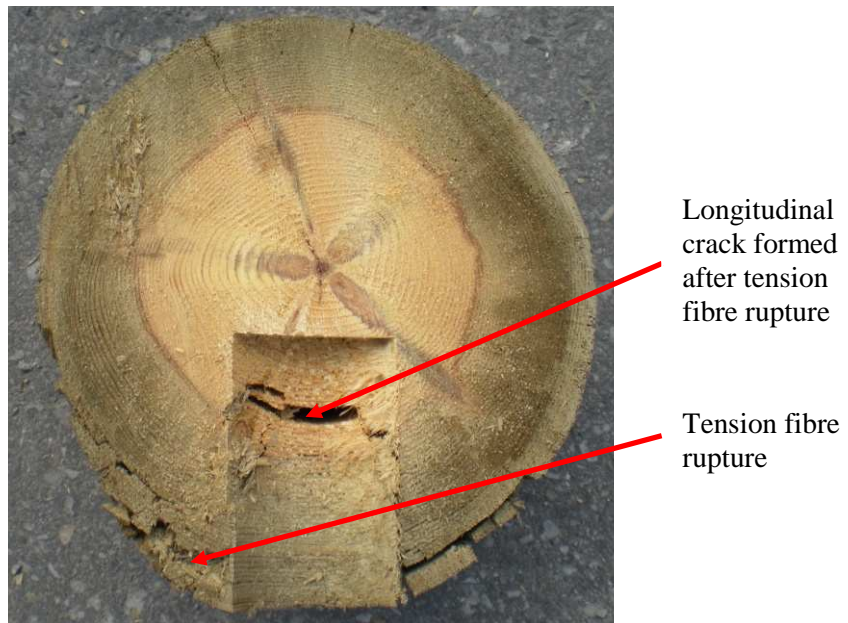
Figure 58. - Cross-section of new pole specimen with tension feeding damage (60-2-1).

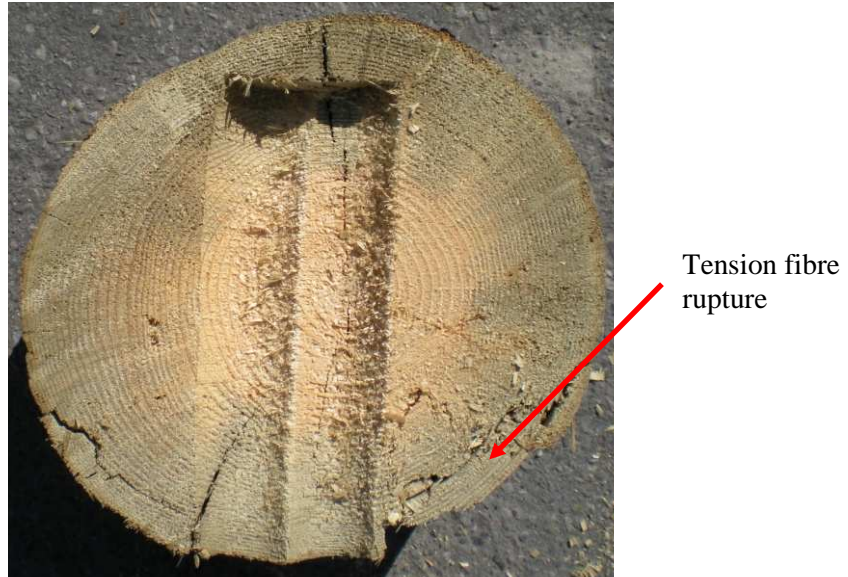
Figure 59. - Cross-section of new pole specimen with tension nesting damage (55-1-1).

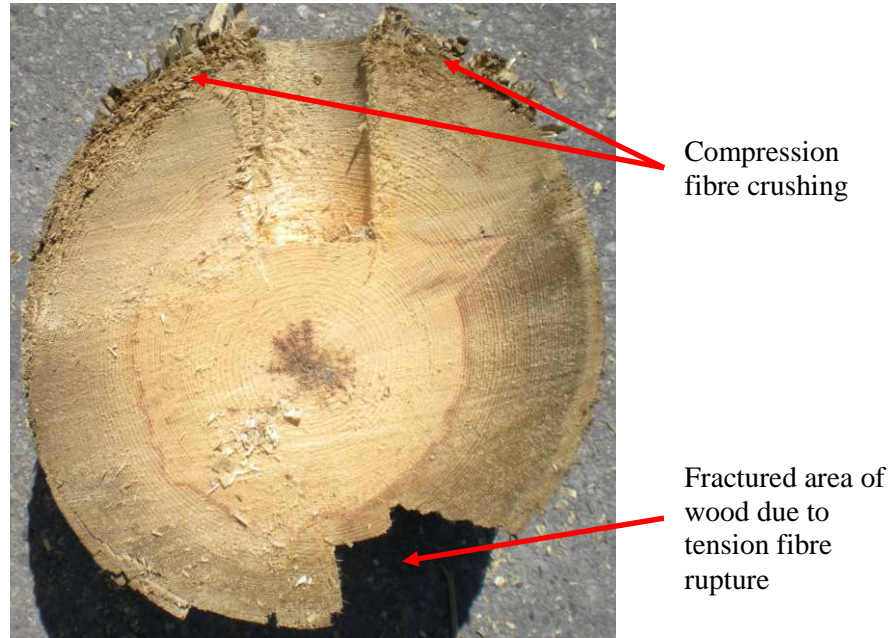
Specimens with compression oriented damage failed due to a combination of compression fibre crushing and tension fibre rupture. Typically, as loading commenced, specimens underwent compression fibre crushing at the extreme compression fibres around locations of woodpecker damage. The effect of compression fibre crushing in an extreme case can be seen in Figure 62. As loading progressed, tension fibre rupture occurred at extreme tension fibre locations as shown in Figure 60 to Figure 63.

Figure 60. - Cross-section of new pole specimen with compression exploratory damage (60-2-3).

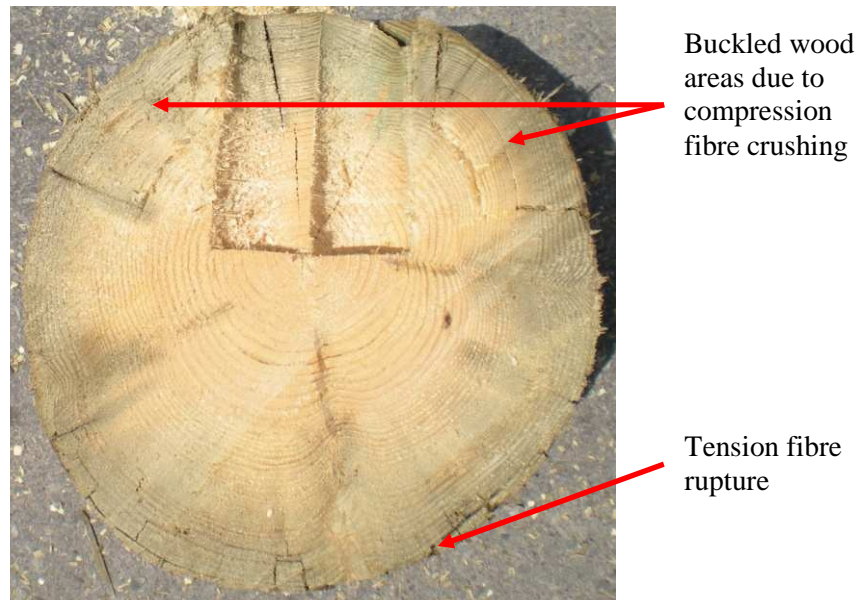
Figure 62. - Cross-section of new pole specimen with compression feeding damage (55-1-3).

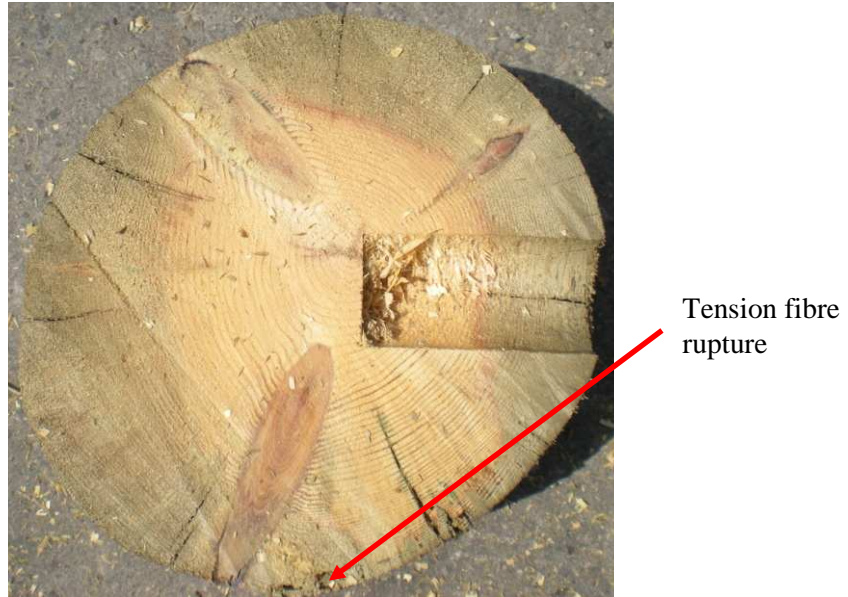
Specimens with neutral axis oriented damage were observed to fail in two different modes. Specimens with exploratory and feeding level damage (Figure 64 and Figure 65) failed due to tension fibre rupture in the same manner as the control specimens. Specimens with nesting level damage typically failed due to shear crack formation as shown in Figure 66. The shear cracks typically formed at the edges of the holes in the horizontal plane as predicted by SF analysis.

Figure 64. - Cross-section of new pole specimen with neutral axis exploratory damage (50-2-3).

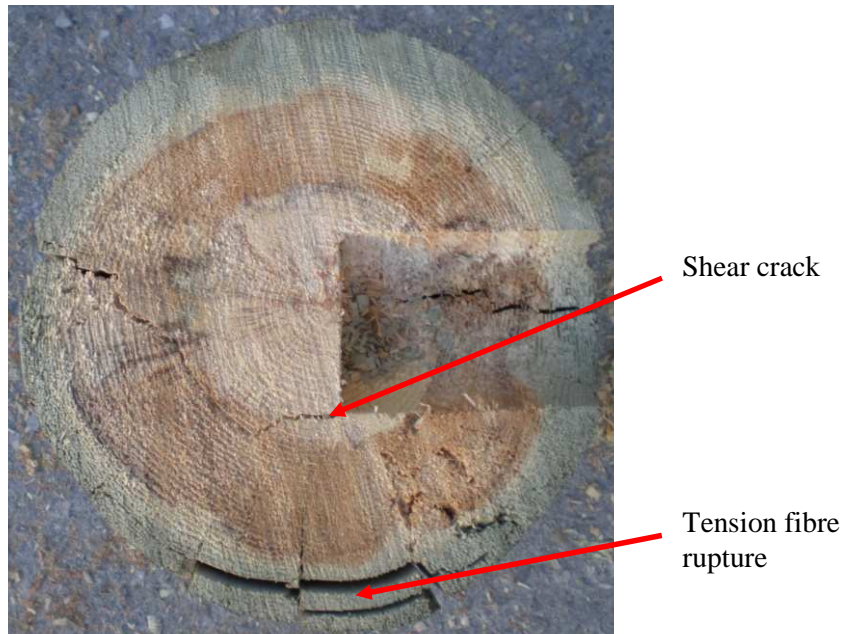
Figure 65. - Cross-section of new pole specimen with neutral axis feeding damage (60-4-1).

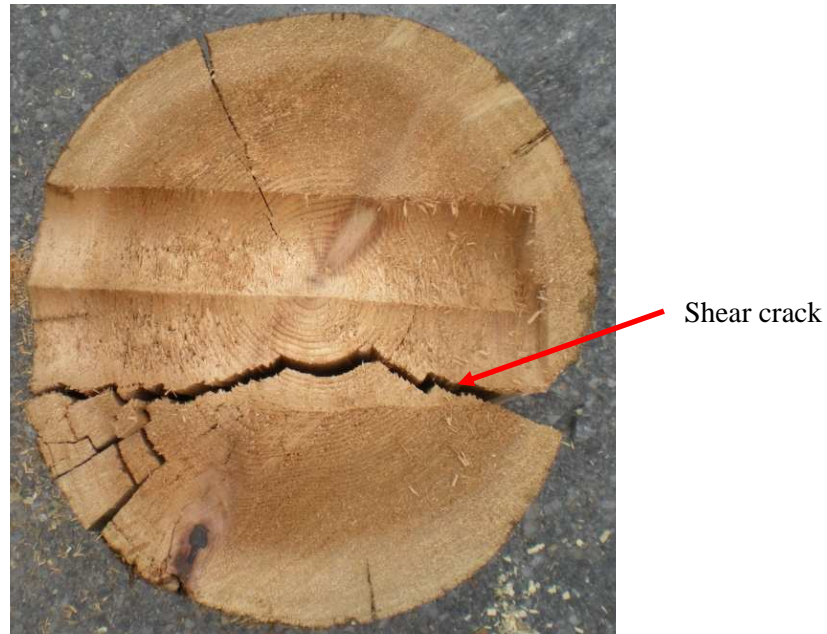
Figure 66. - Cross-section of new pole specimen with neutral axis nesting damage (55-2-3).

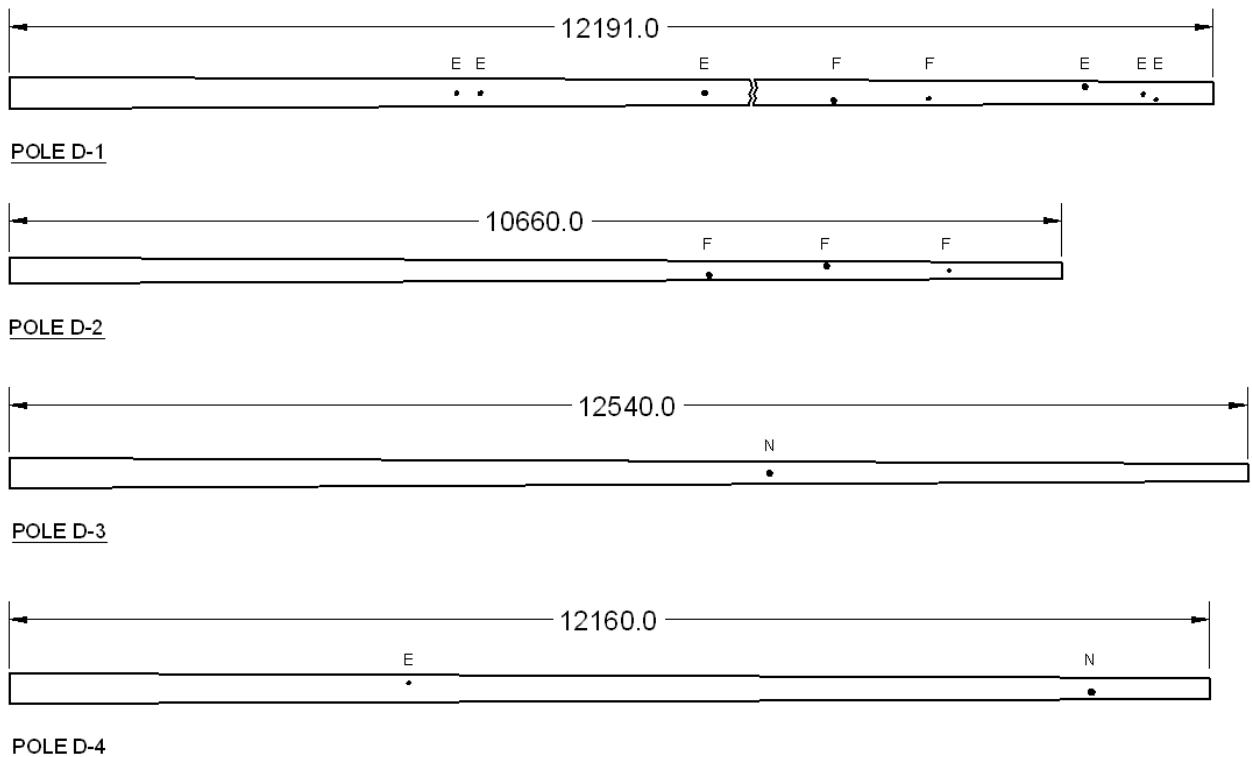
Eleven in-service utility poles were received from HONI. When received, these poles were fully documented in terms of woodpecker damage dimensions (Appendix C) and locations. It was observed that the majority of woodpecker damage occurred in the top half of poles as shown in Figure 67 to Figure 71. In these figure the symbols E, F, and N stand for exploratory, feeding, and nesting woodpecker damage, respectively. In wood pole analysis and design, the critical section for flexural failure is typically located between the groundline up to 1/3rd of a pole's height above ground (HAG). The fact that woodpecker damage was rarely observed in the critical design section is significant, since it indicates that the presence of woodpecker damage does not necessarily reduce the load carrying capacity of a pole.

Figure 67. - Group D in-service poles with woodpecker damage locations.

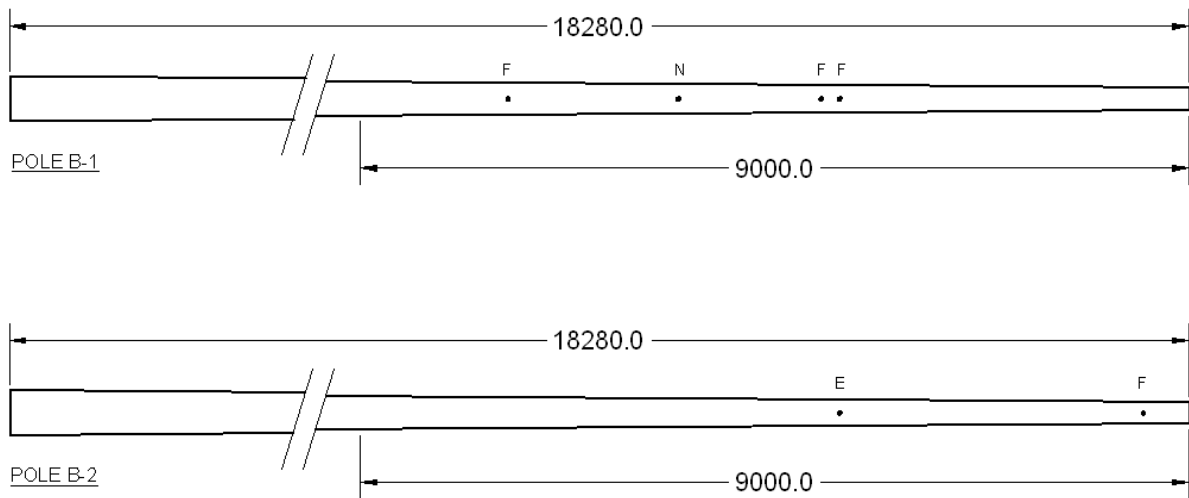
Figure 71. - Group B in-service poles with woodpecker damage locations.

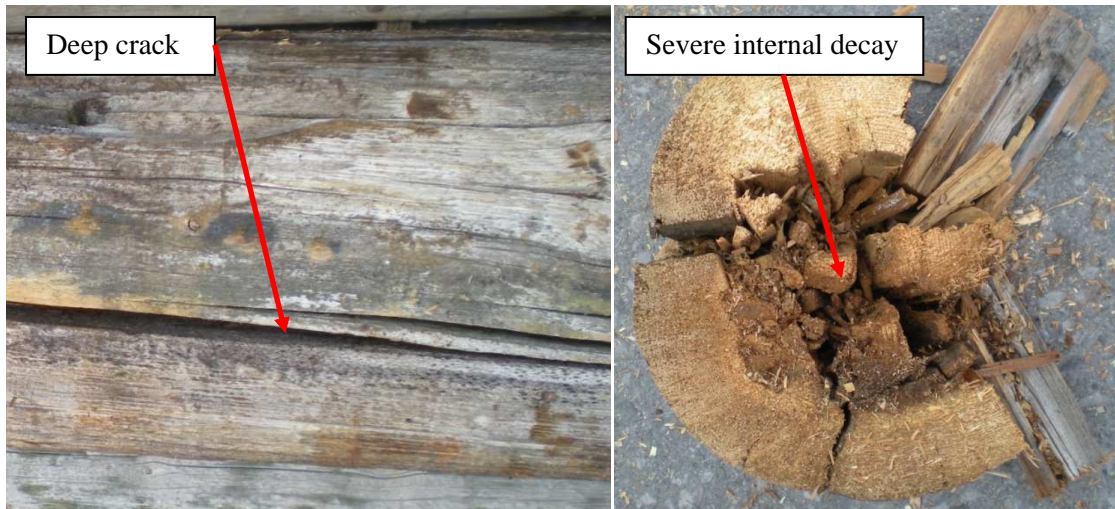
Based on previous research at the University of Waterloo (McCarthy 2005), the best external indicator of internal decay was found to be the presence of cracks and checks. Wide cracks and checks that penetrated deep into cross-sections were found to allow moisture and oxygen penetration, resulting in severe decay. This trend was evident in the received group D in-service specimens. Figure 72 shows an example of a very wide crack that penetrated into the cross-section core. The interior of this specimen at the crack location was observed to have severe decay.

Figure 72. - In-service specimen with deep crack and severe decay (D-1-1).

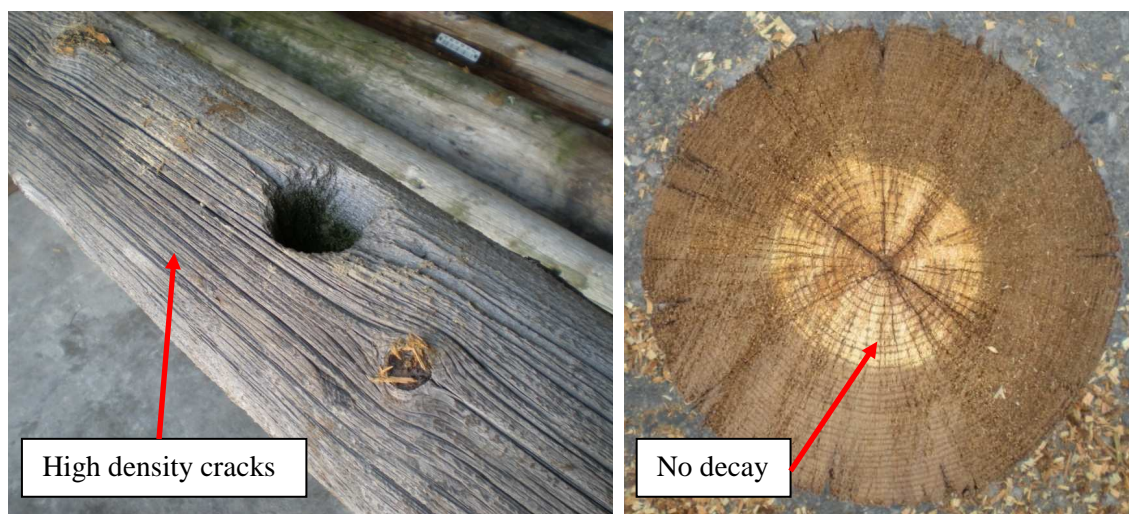
Figure 73. - In-service specimen with shallow and high density cracks with no decay (D-2-1).

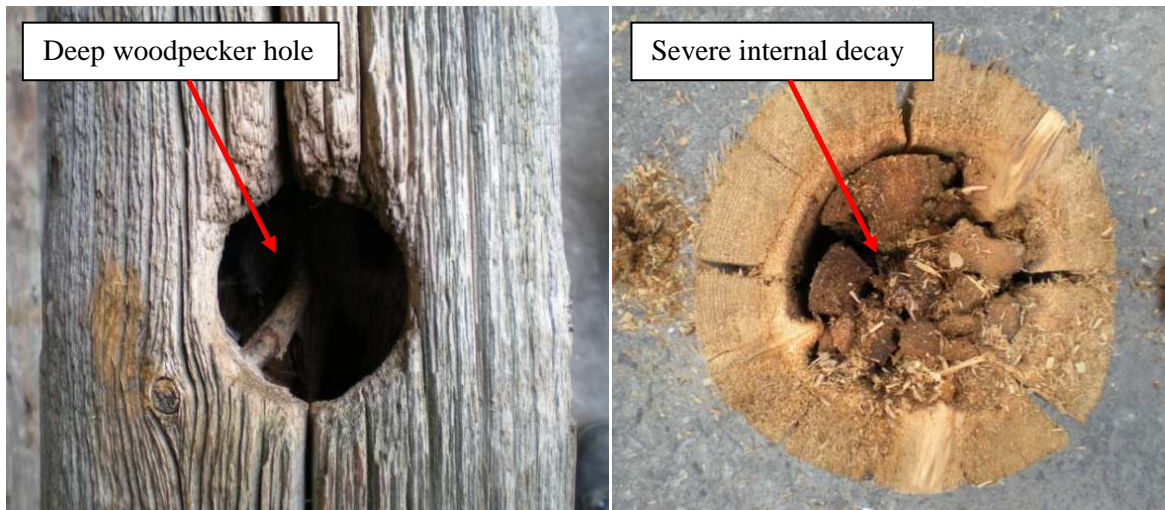
Figure 74. - In-service specimen with nesting level woodpecker damage and decay (D-4-1).

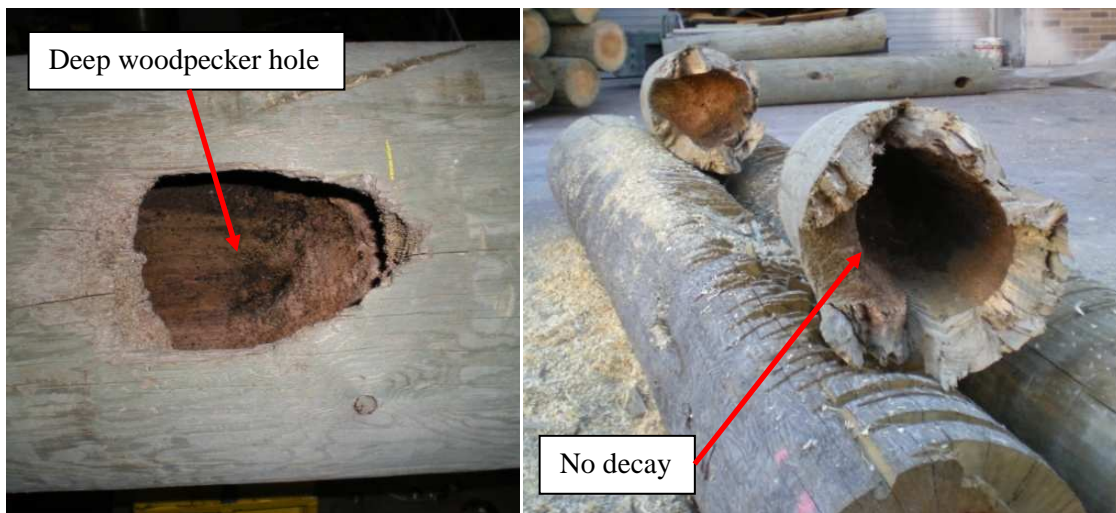
Figure 75. - In-service specimen with nesting level woodpecker damage and no decay (RP-3-1).

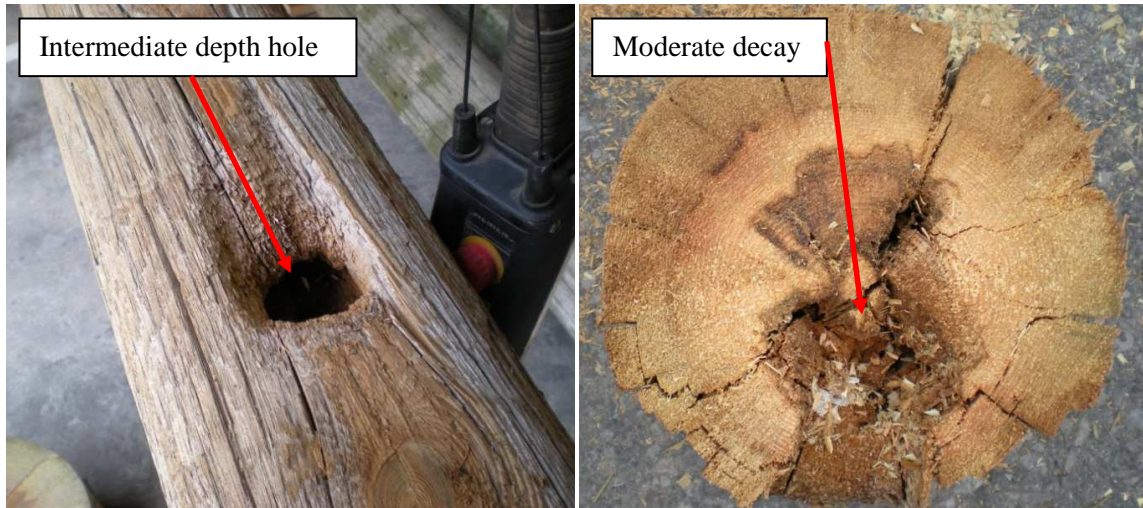
Figure 76. - In-service specimen with intermediate level woodpecker damage and decay (D-3-1).

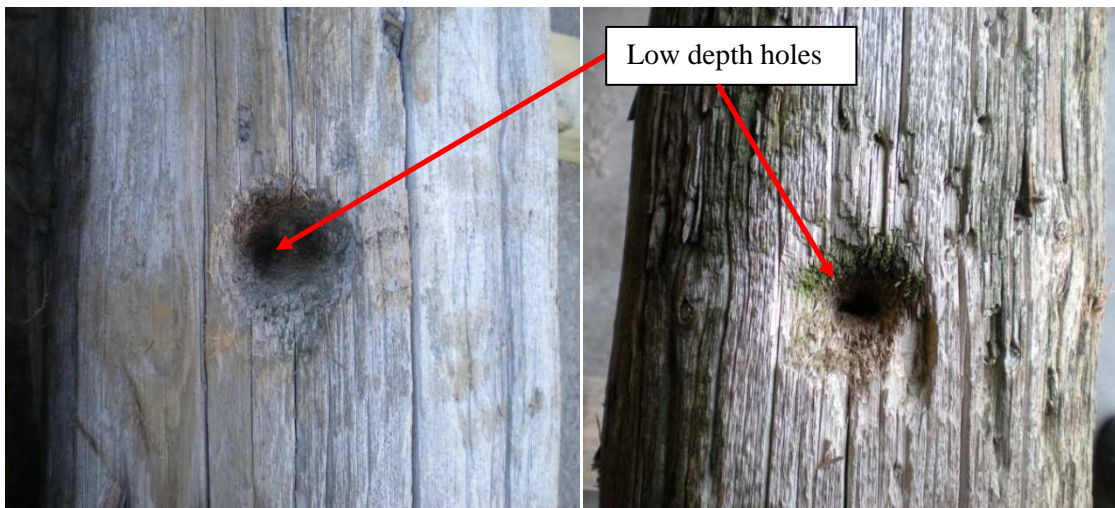
Figure 77. - In-service specimens with minor woodpecker damage and no decay (D-4-1).

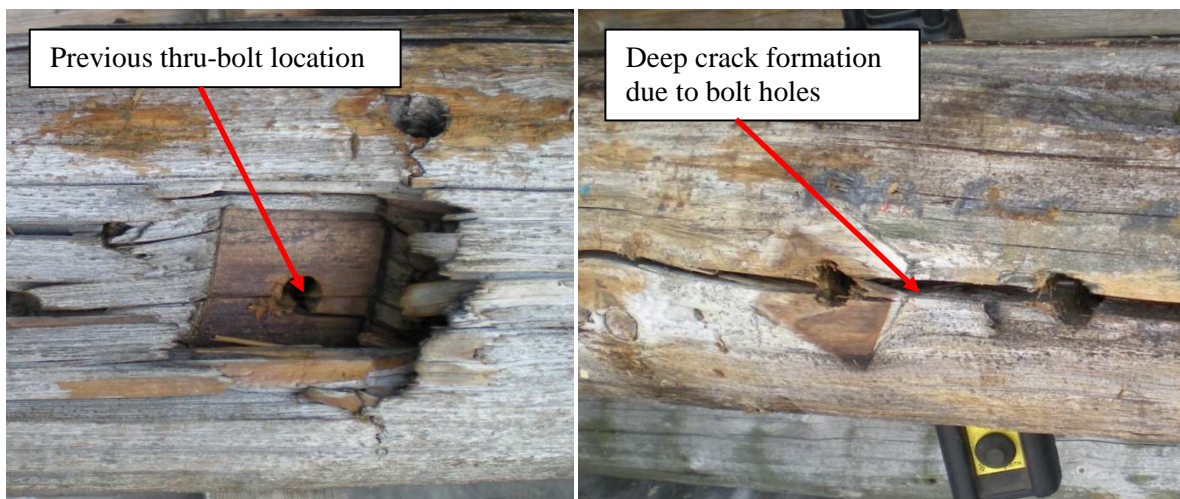
Figure 78. - In-service specimen with severe mechanical damage and decay (D-1-1).

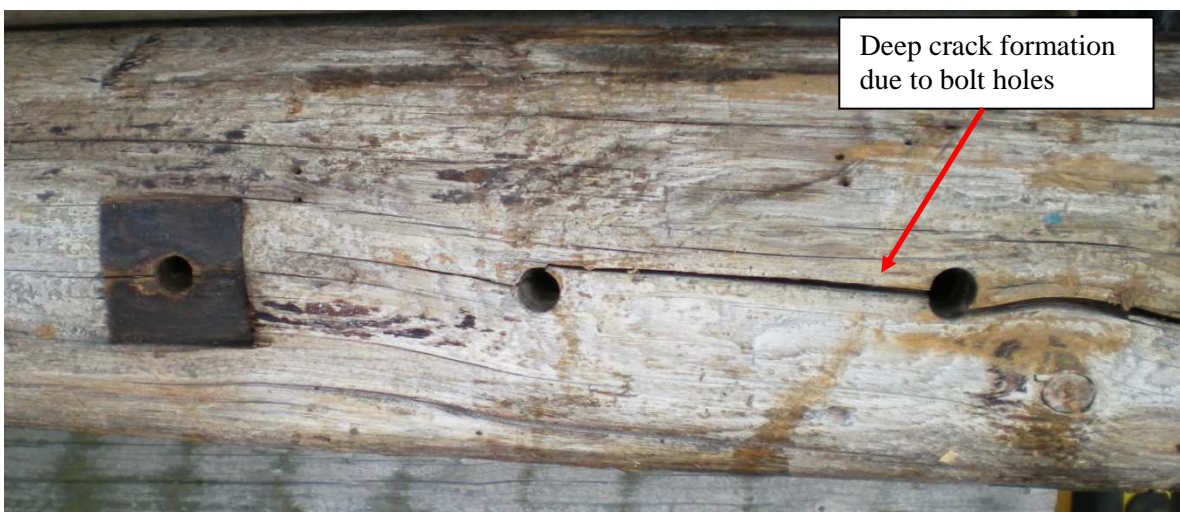
Figure 79. - In-service specimen with mechanical damage and crack formation (D-1-1).

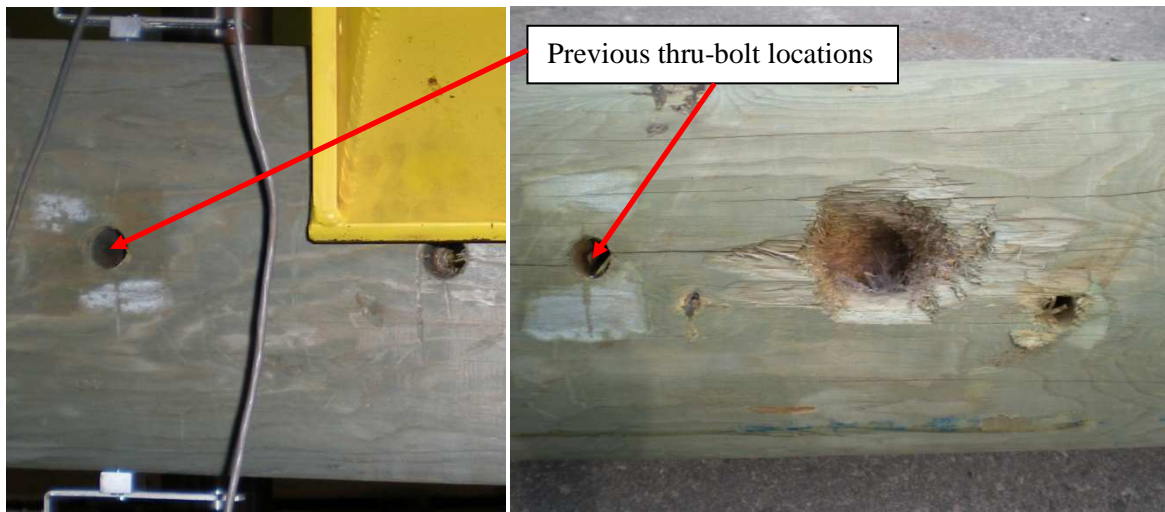
Figure 80. - In-service specimens with mechanical damage and no decay (60-4-2).

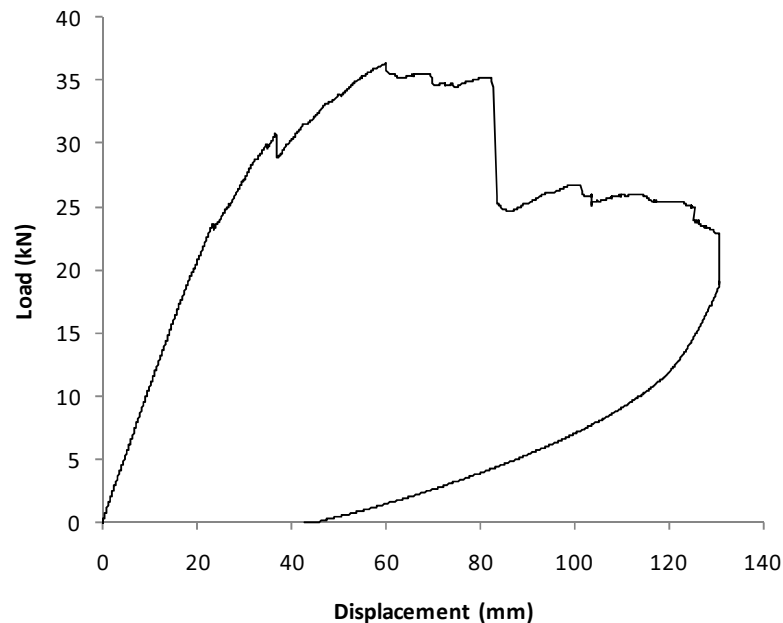
Figure 81. - Typical load-deflection curve for in-service specimen failing in bending (D-4-2).

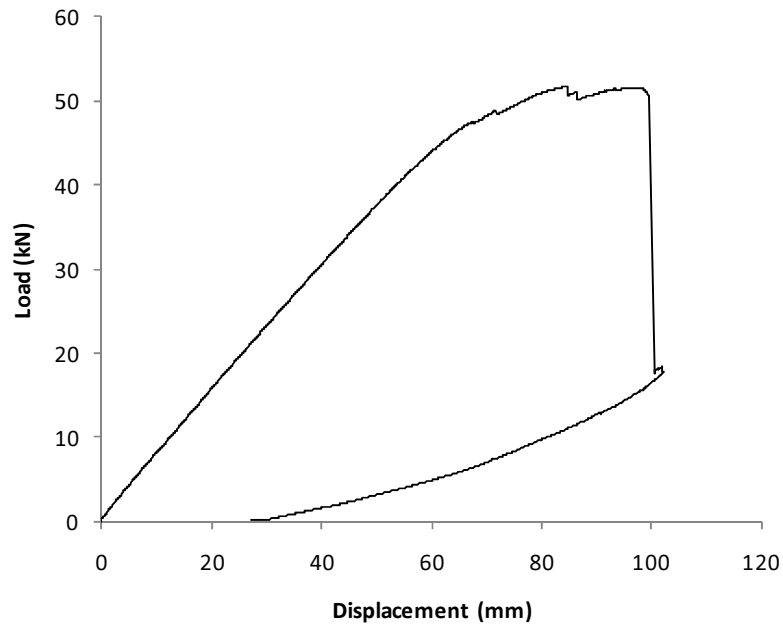
Figure 82. - Typical load-deflection curve for in-service specimen failing in shear (D-2-2).

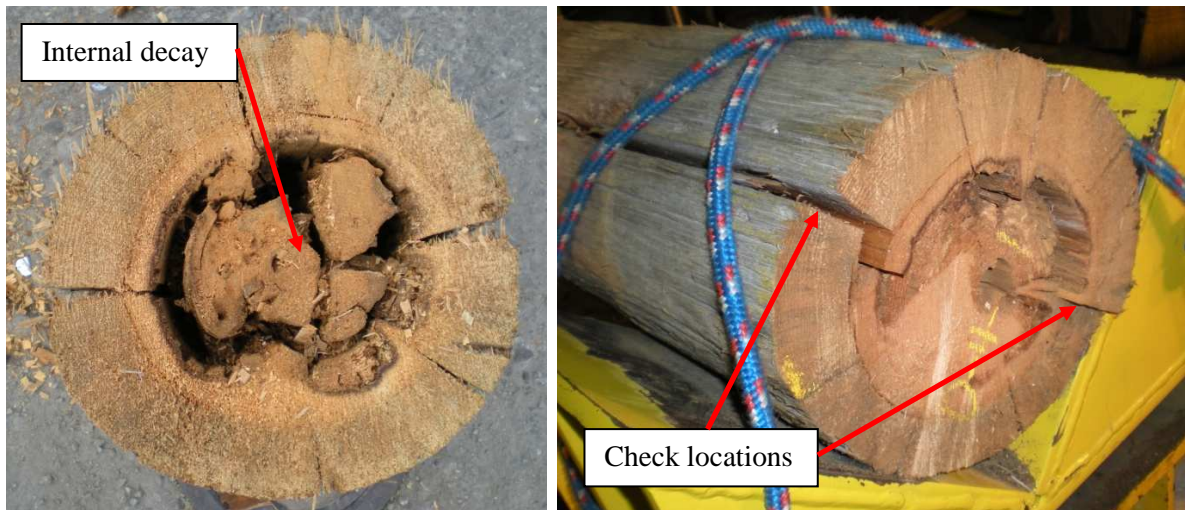
Figure 83. - Heavily decayed in-service specimen that failed in shear (D-4-1).

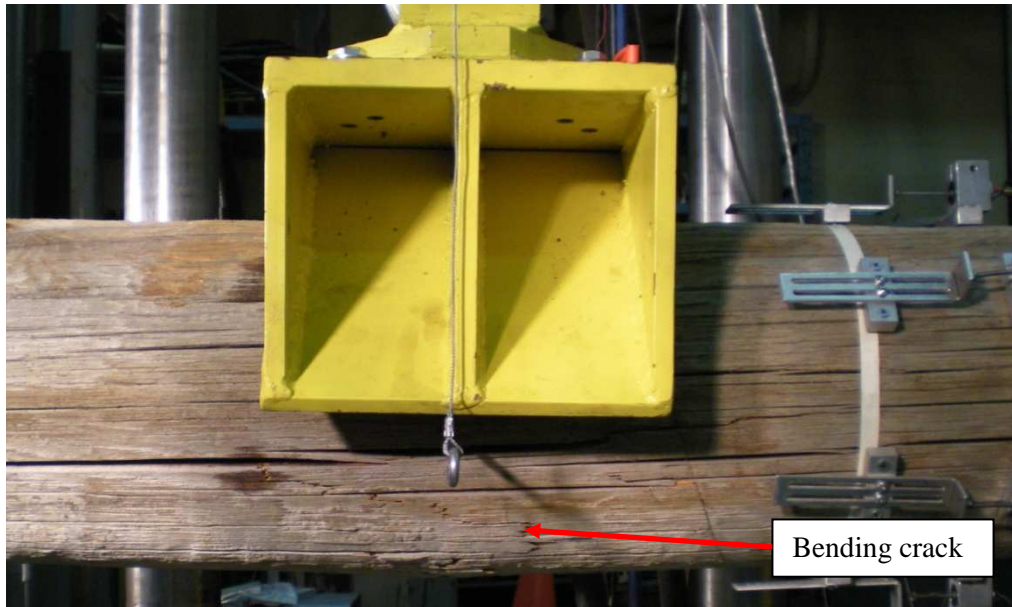
Figure 85. - In-service control specimen bending failure (D-3-2).

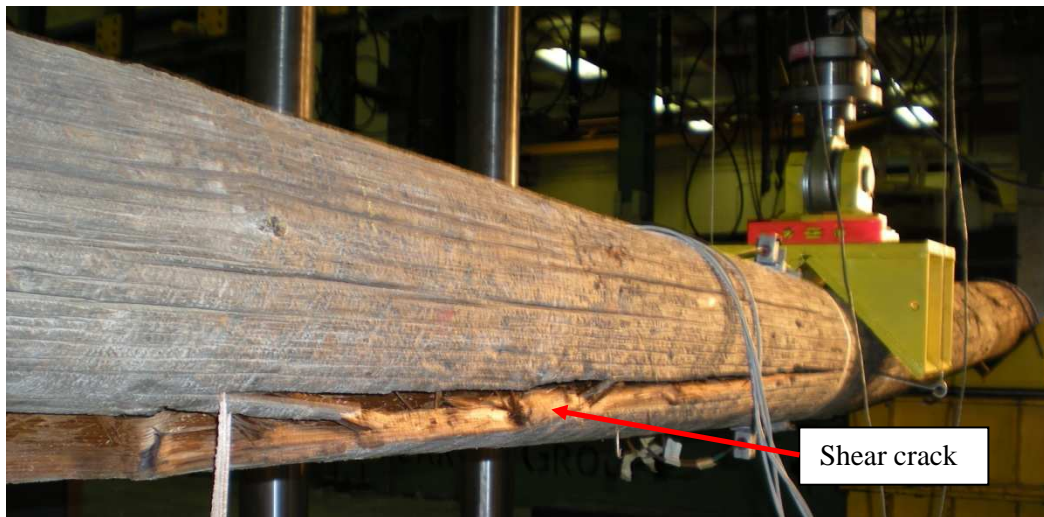
Figure 86. - In-service control specimen shear failure (D-4-1)

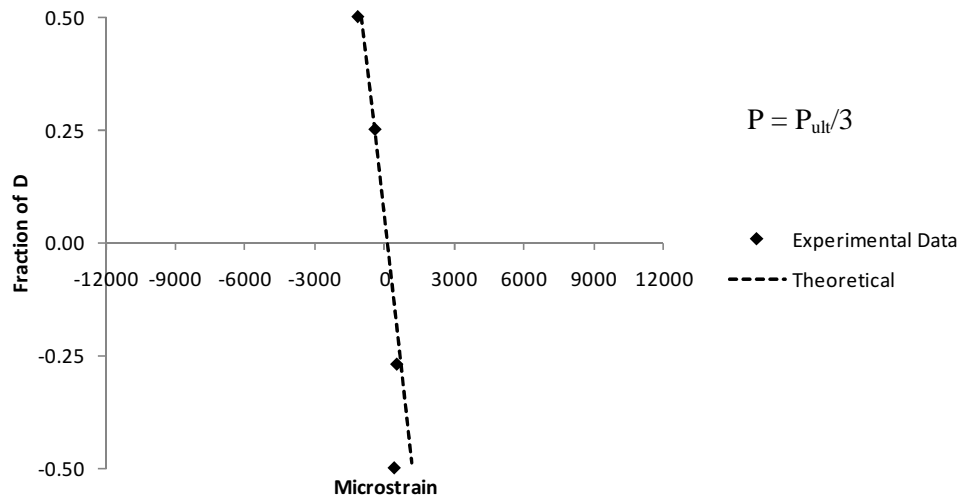
Figure 91. - Strain profile of in-service specimen with tension damage (D-3-1).

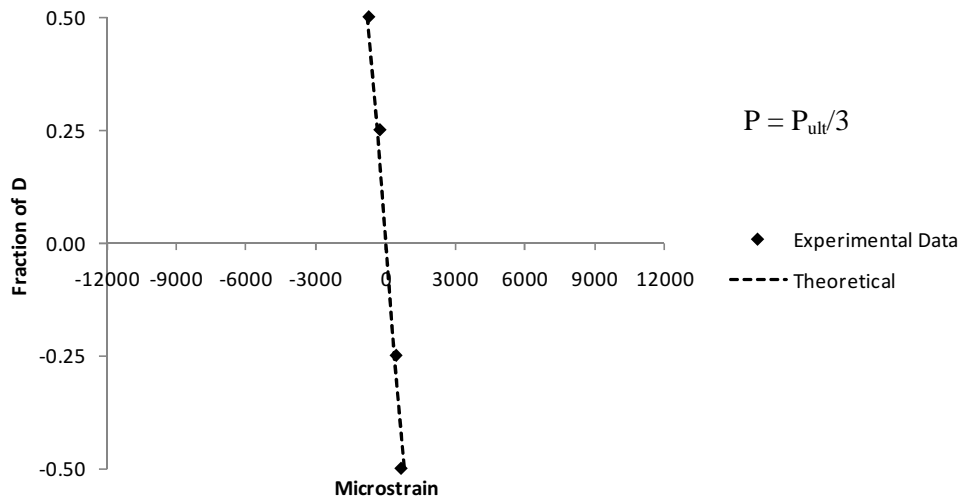
Figure 95. - Strain profile of in-service specimen with neutral axis damage (C-1-2).

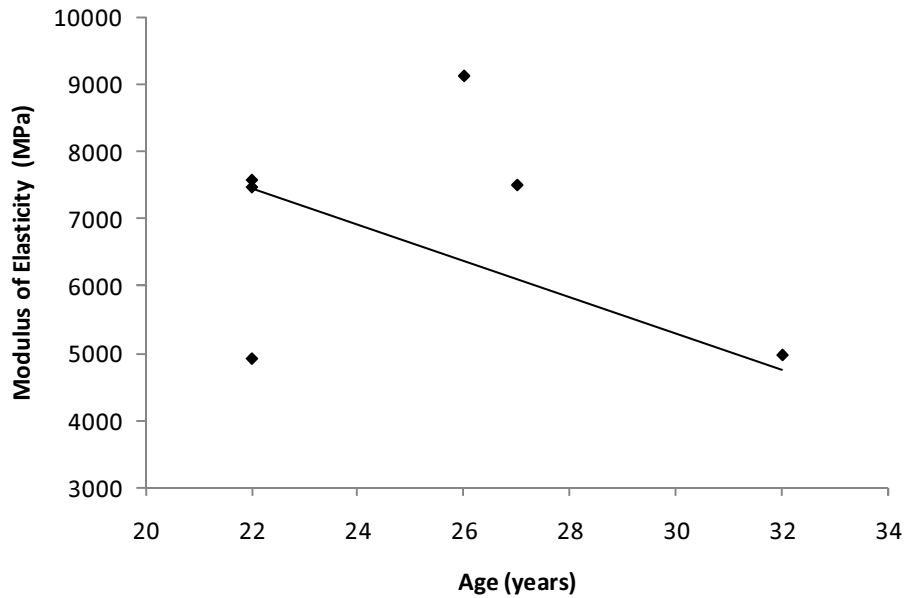
Figure 97. - Modulus of elasticity vs. age for in-service specimens.

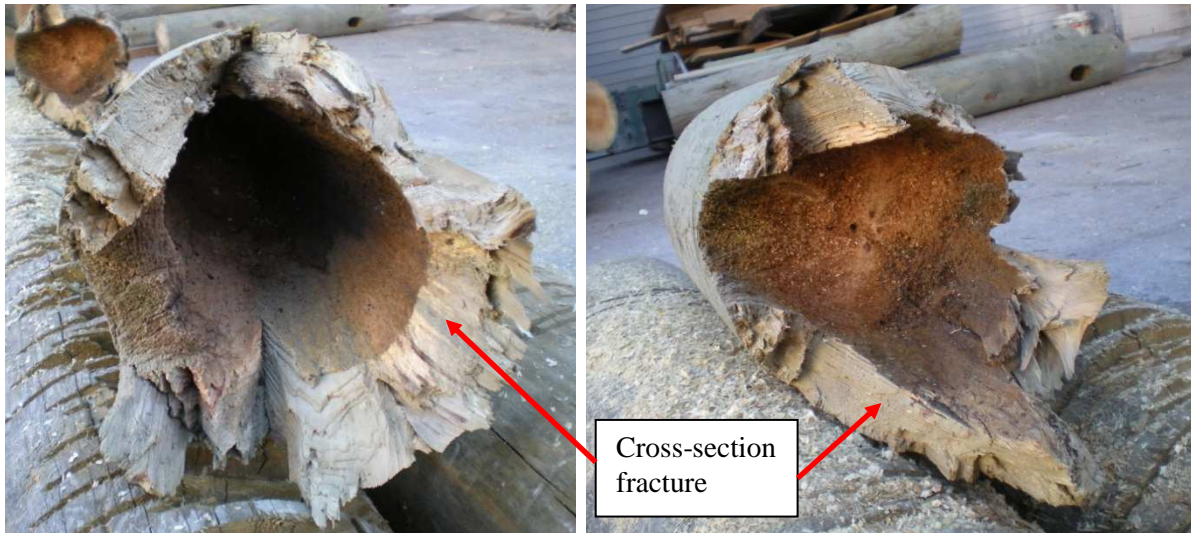
Figure 104. - Cross-section of in-service specimen with compression damage (RP-3-1).

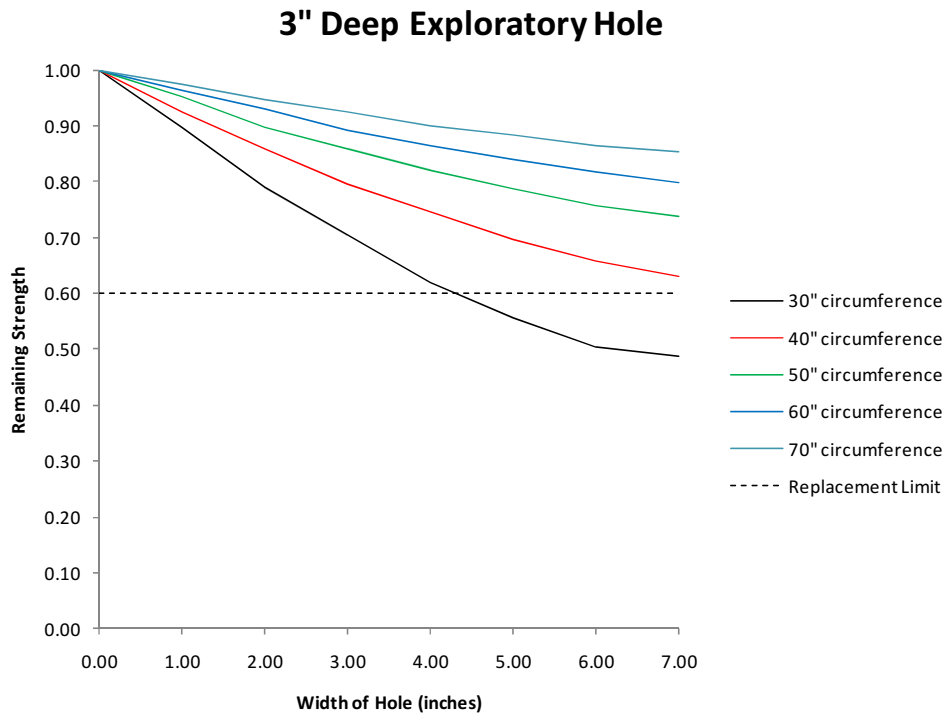
Figure 106. - Remaining strength due to exploratory level woodpecker damage.

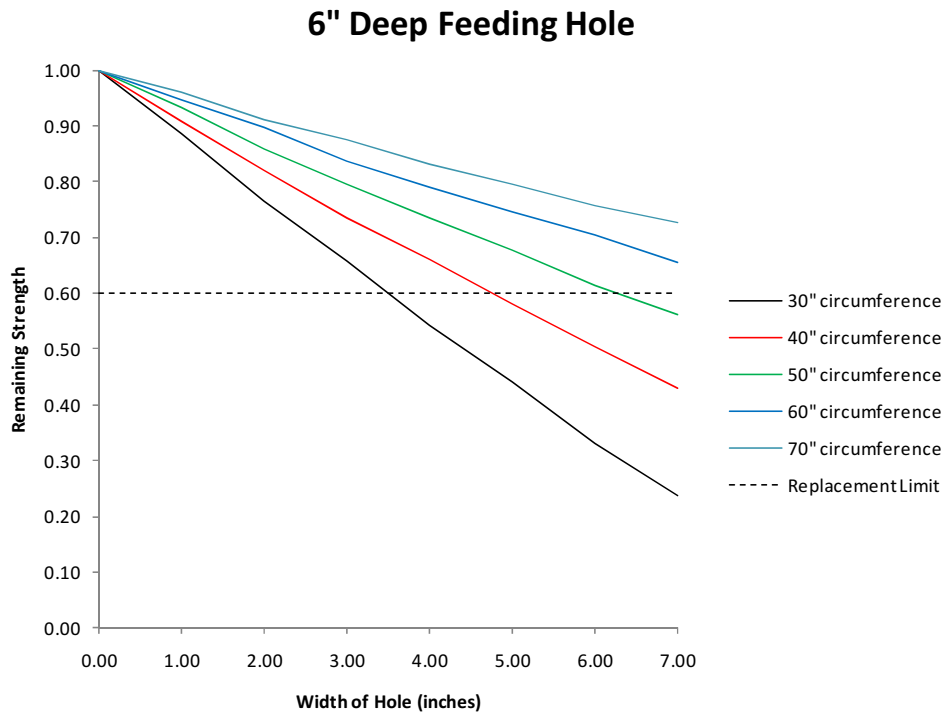
Figure 107. - Remaining strength due to feeding level woodpecker damage.

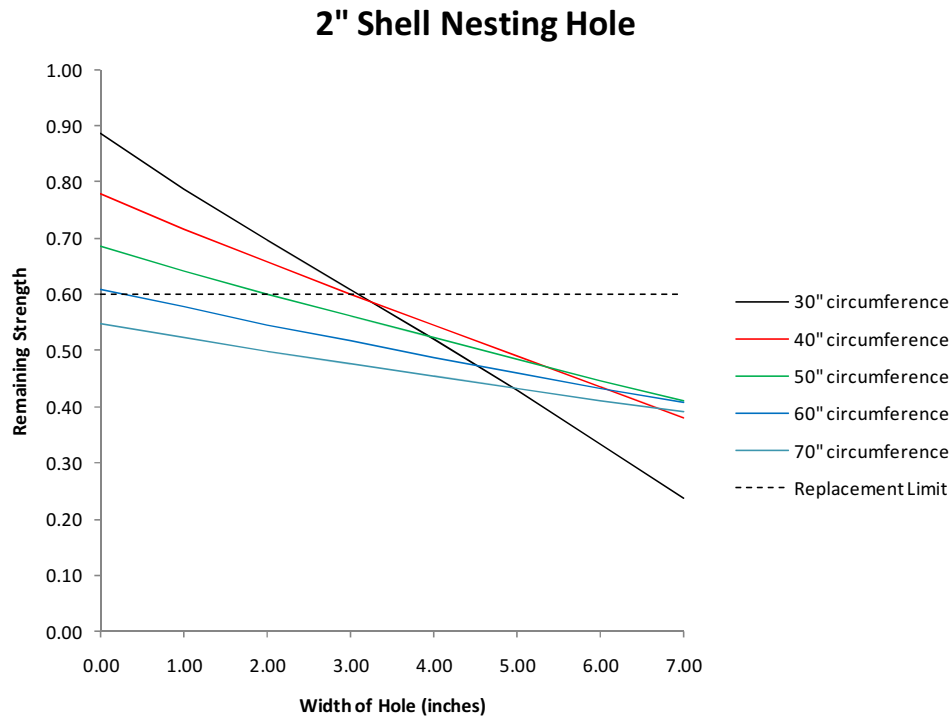
Figure 108. - Remaining strength due to nesting level woodpecker damage.

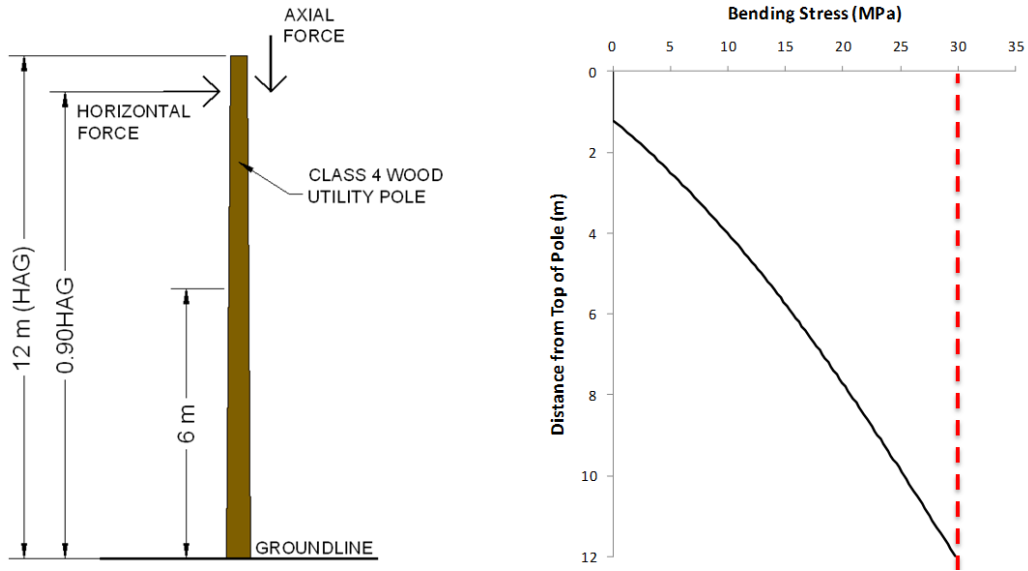
Figure 109. - New pole design.

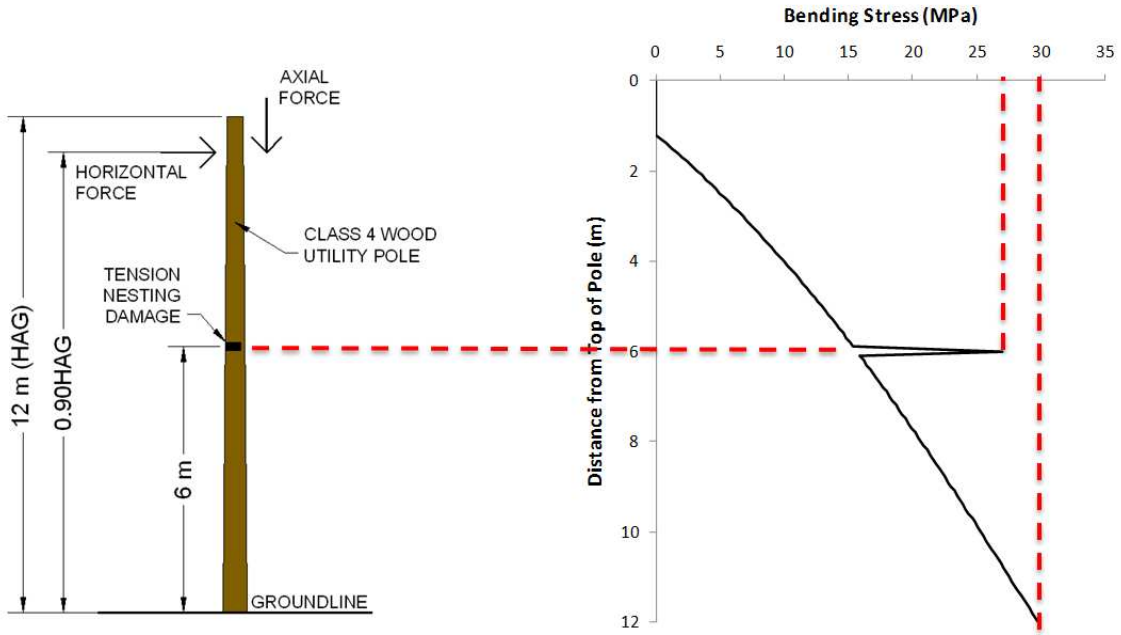
Figure 110. - Analysis of pole with woodpecker damage.
