# **A Sediment Budget of an Urban Creek in Toronto**

A thesis  
presented to the University of Waterloo  
in fulfillment of the  
thesis requirement for the degree of  
Master of Applied Science  
in  
Civil Engineering

Waterloo, Ontario, Canada 2014

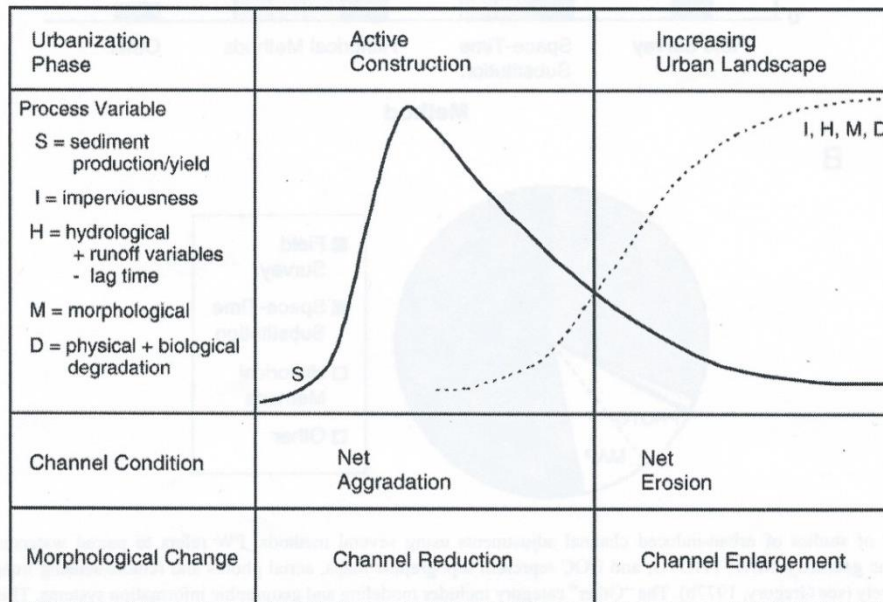
Figure 1. Phases of urbanization illustrating effect on stream channel (Chin 2006 based on Wolman 1967).

One of the first models describing the effects of urbanization on stream channels was proposed by M.G. Wolman. Prior to development, the stream channel is in a state of dynamic equilibrium. Next, the process of urbanization begins with a phase of active construction. During this period there is an increased sediment supply to rivers and streams (Wolman 1967). As the urban area expands, natural cover is replaced with roads, houses, buildings and other structures increasing

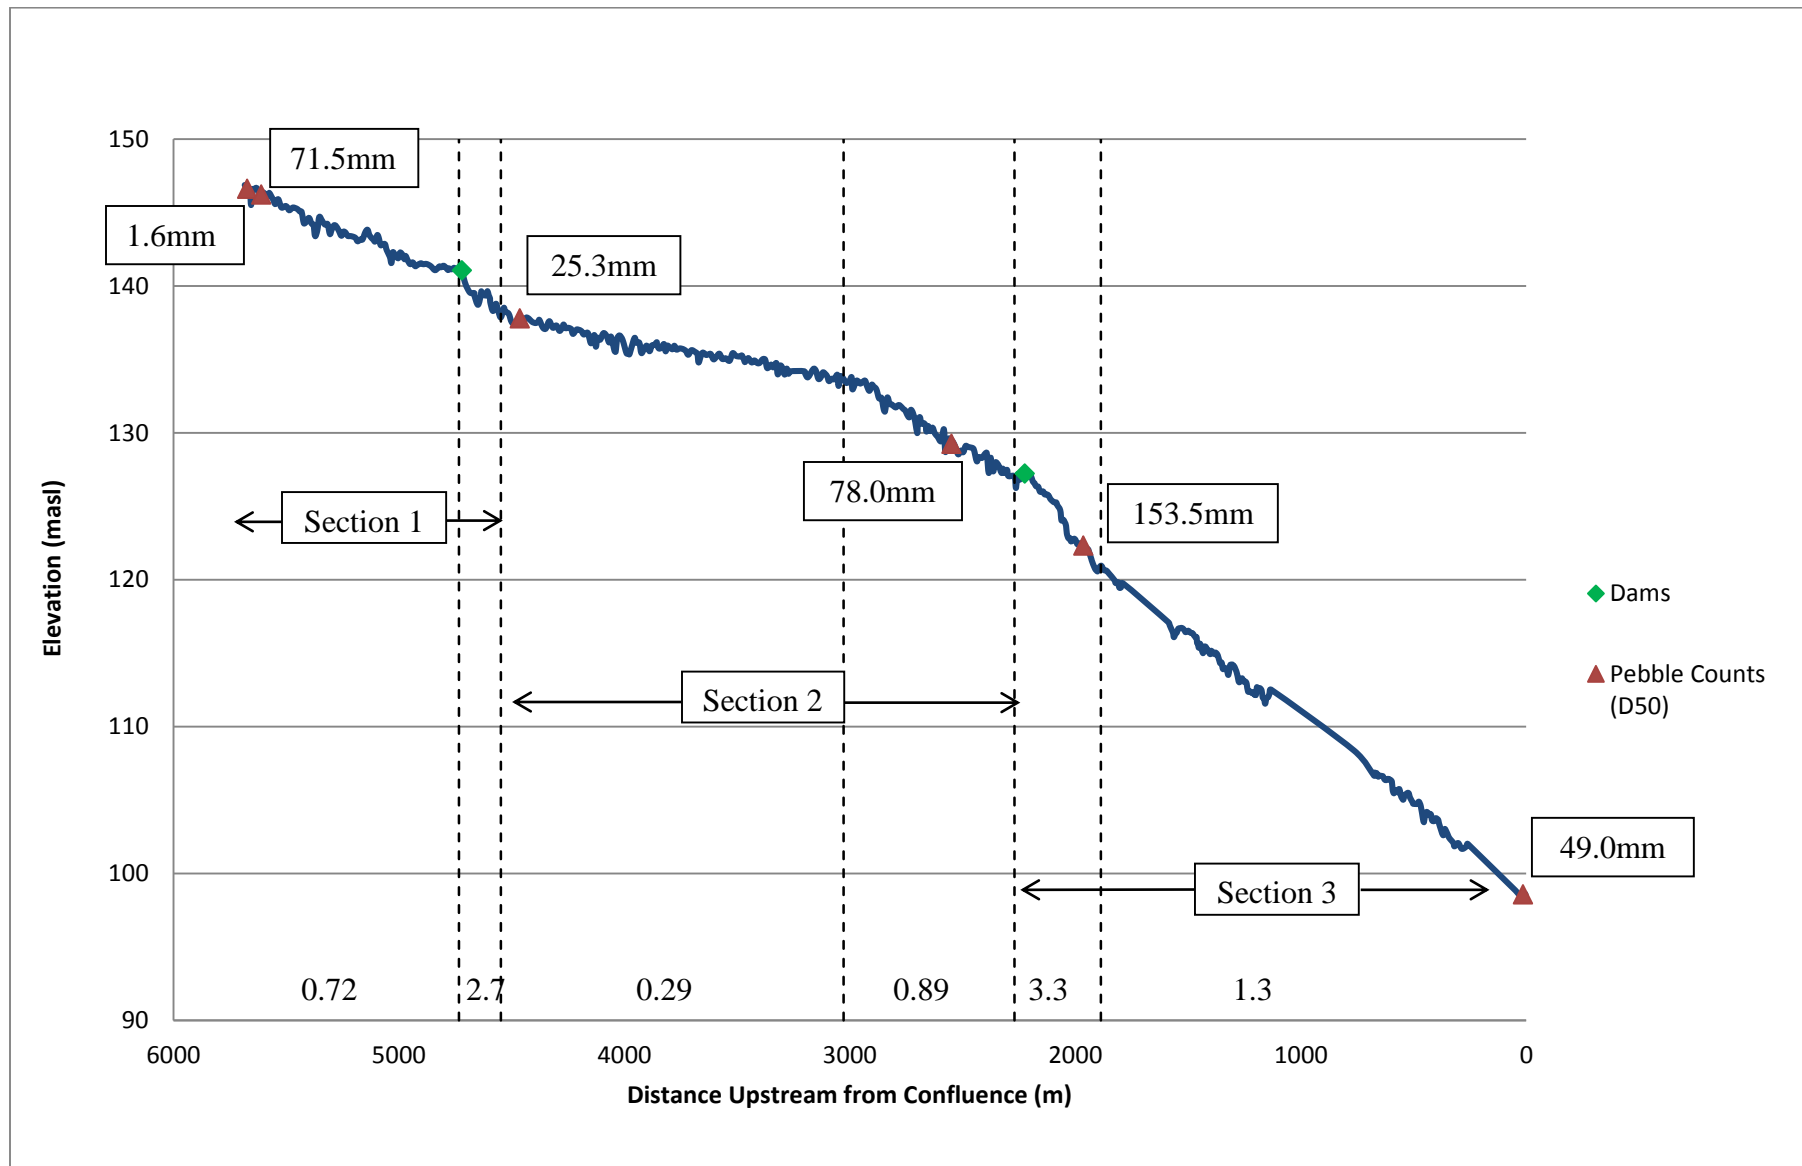
Figure 5. Longitudinal profile of Wilket Creek with location of sections, changes in slope and location of median particle size from pebble counts.

A longitudinal survey of the creek from York Mills Road to the West Don River was carried out between November of 2012 and February of 2013 (Figure 5). The survey was completed according to the guidelines in Harrelson et al (1994) using Sokkia SET530R and Trimble S6 DR3000+ total stations and a Sokkia GRX1/U Real Time Kinematic (RTK) global position system (GPS). A total of 540 points were surveyed in the thalweg. Points were surveyed as needed to capture bedforms including the top and bottom of riffles and the deepest point of pools or every two to three channel widths. No points were surveyed from 252 m to 1132 m upstream of the confluence with the West Don River. However, the results of a 2011 survey were used to provide data from 252 m to 675 m upstream of the confluence.

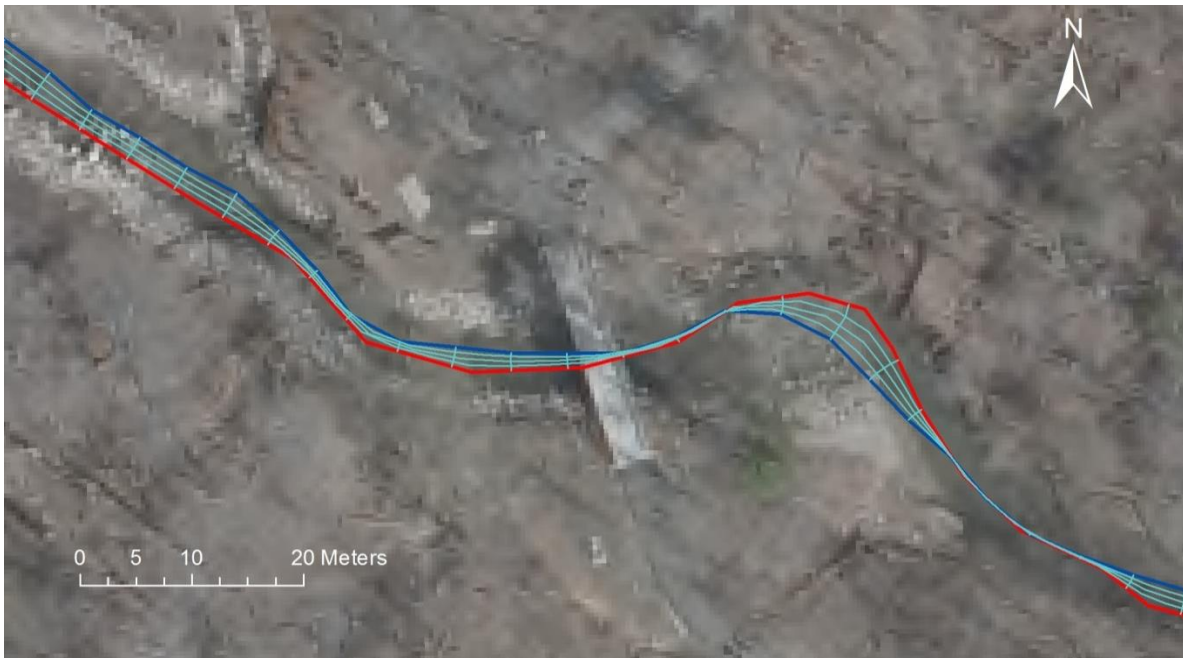
Figure 7. Channel Planform Statistics Tool output showing lateral movement from the blue reference line (2009) to the red line (2012). Lateral measurements to the right of the reference line are positive and negative to the left.

CPS was employed to measure the lateral change of the stream centerlines (Figure 7). Using the nodes interpolated during creation of the channel centerline, the CPS tool compares the lateral and normal distance between the two centerlines. The tool prompts the user for a reference centerline and then for a line to which distances will be measured. If the line to which the distance is measured is to the right of the reference centerline, the lateral displacement is positive. If it is to the left, the lateral displacement is negative (Lauer 2012).

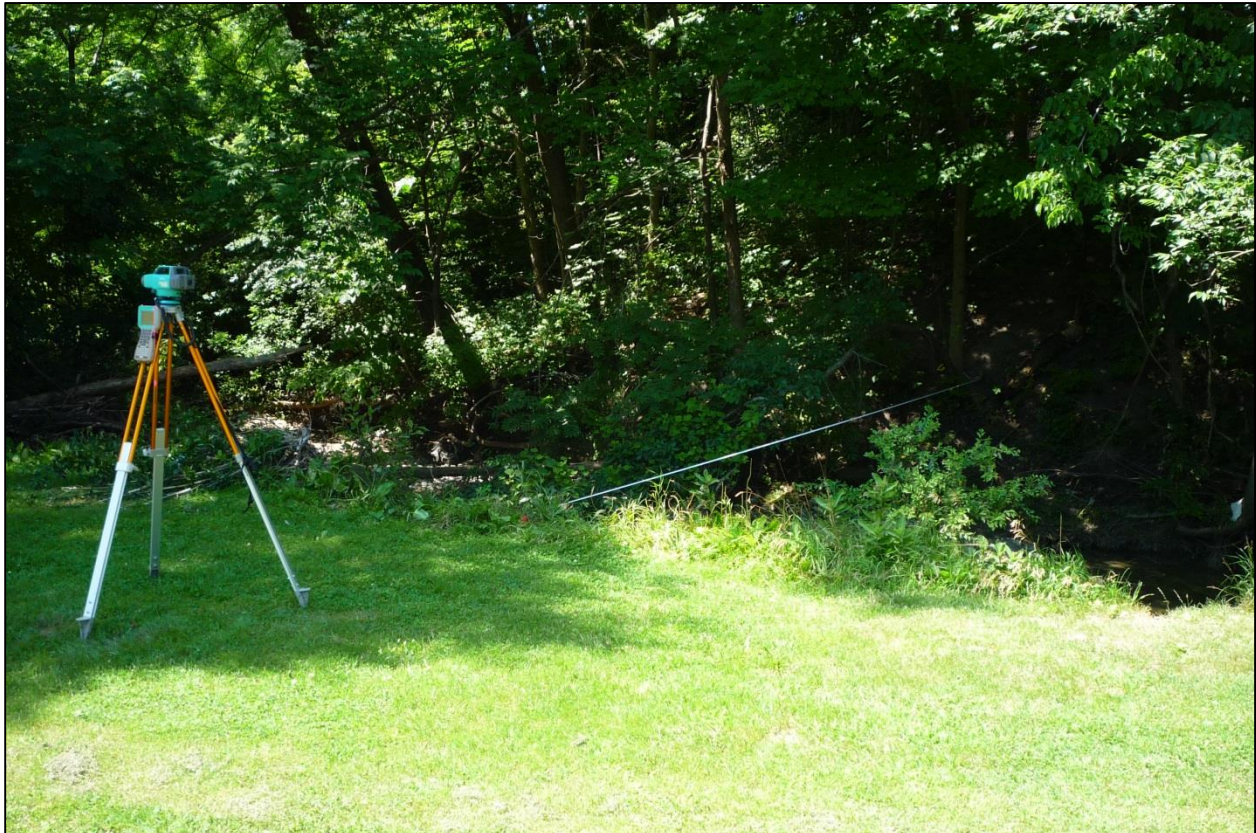
Figure 8. Auto level configuration for surveying cross sections.

the topography (Figure 8). Other measurements taken during the survey included water depth and bankfull width. After establishing the cross sections and conducting an initial survey, subsequent measurements were made between the 16<sup>th</sup> and 18<sup>th</sup> of July and the 20<sup>th</sup> and 25<sup>th</sup> of November, 2013.

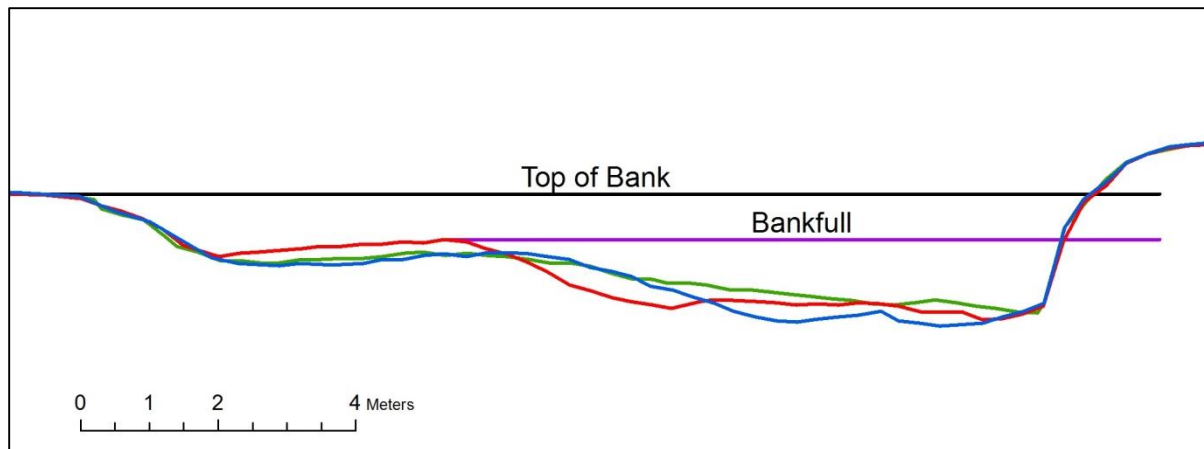
Figure 9. Cross section of Transect 13 showing bankfull and top of bank delineations.

As bankfull width can be problematic to identify in the field, metrics for the top of bank were calculated in a similar manner to the methods described above. In the case where the tops of the left and right banks were of markedly different elevations, the lower bank was used to identify the “top of bank” (Figure 9).

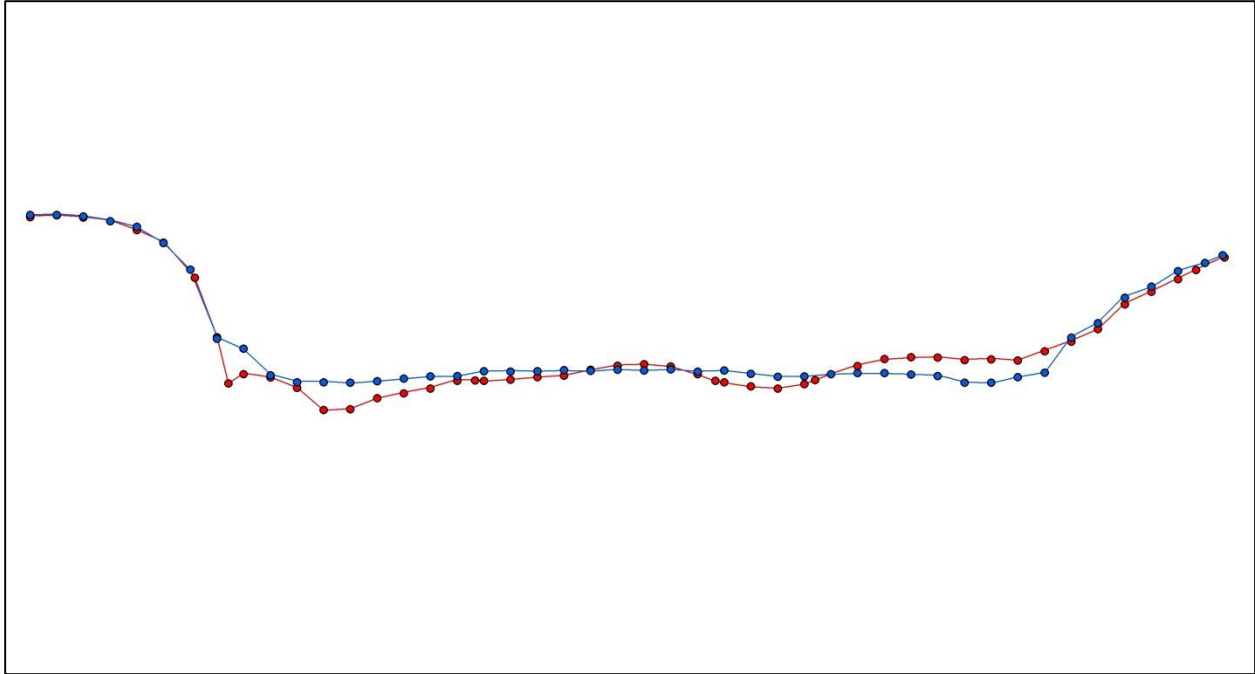
Figure 10. Transect 9 survey points and ArcGIS 10.1 shapefile polylines from 11 June 2013 (Blue) and 21 November 2013 (Red).

Although erosion and deposition at a single cross section could have been calculated using AutoCAD, ArcGIS 10.1 was used as it allows more precise evaluation of individual locations of erosion and deposition. In particular, it more fully captures bank erosion, especially in the case where the top of bank on one side is much lower than the other. Additionally, the visualization is superior and the areas of erosion and deposition at a cross section can easily be exported into Excel for further processing. Survey data from Excel were imported into ArcGIS 10.1 as an event layer. To display the data in a cross section as opposed to the typical ArcGIS planform view, the distance along the cross section was used for the x coordinate and the elevation served as the y coordinate. Due to this, it was not possible to convert the cross section event layer into a permanent shapefile. Instead, polyline shapefiles with a spatial reference of NAD 1983 Zone 17 N were created for each cross sectional survey by tracing the measured points (Figure 10).

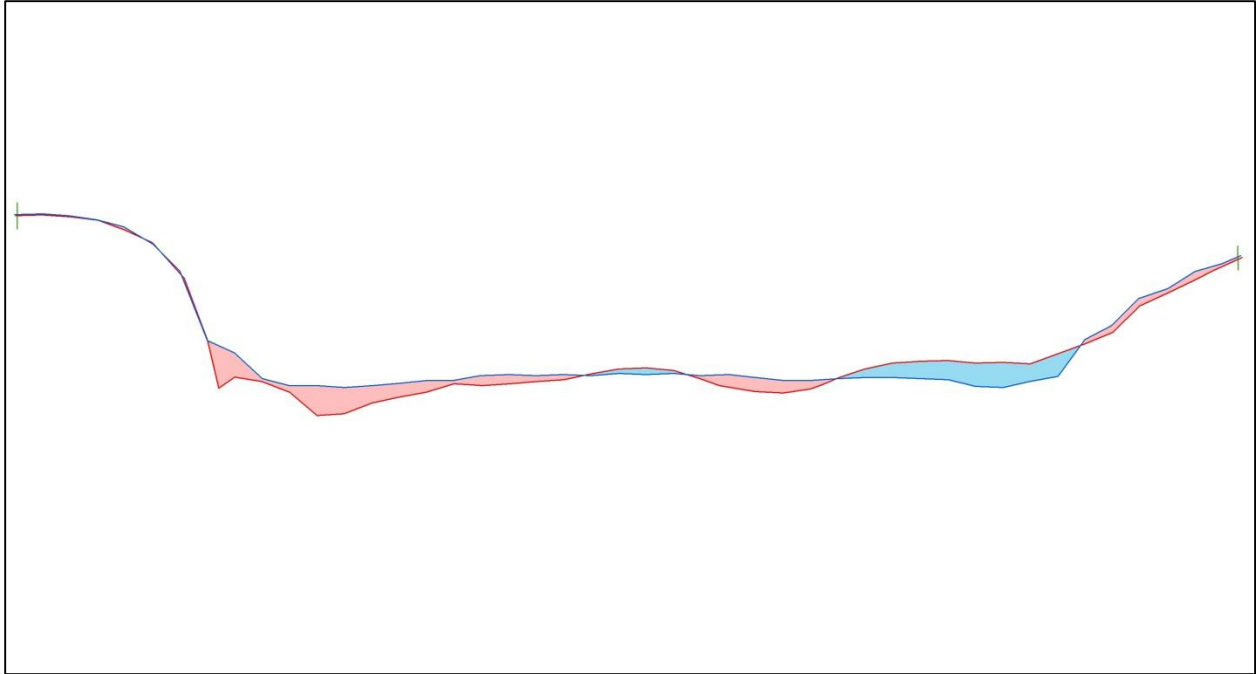
Figure 11. Polygons showing areas of deposition (Blue) and erosion (Red) at Transect 9.

The next step was to determine net areas of erosion and deposition. This was done by converting the polylines to polygons whose area can be automatically calculated using the “Calculate Geometry” tool. Afterwards, individual polygons within the shapefile were denoted as areas of erosion or deposition (Figure 11).

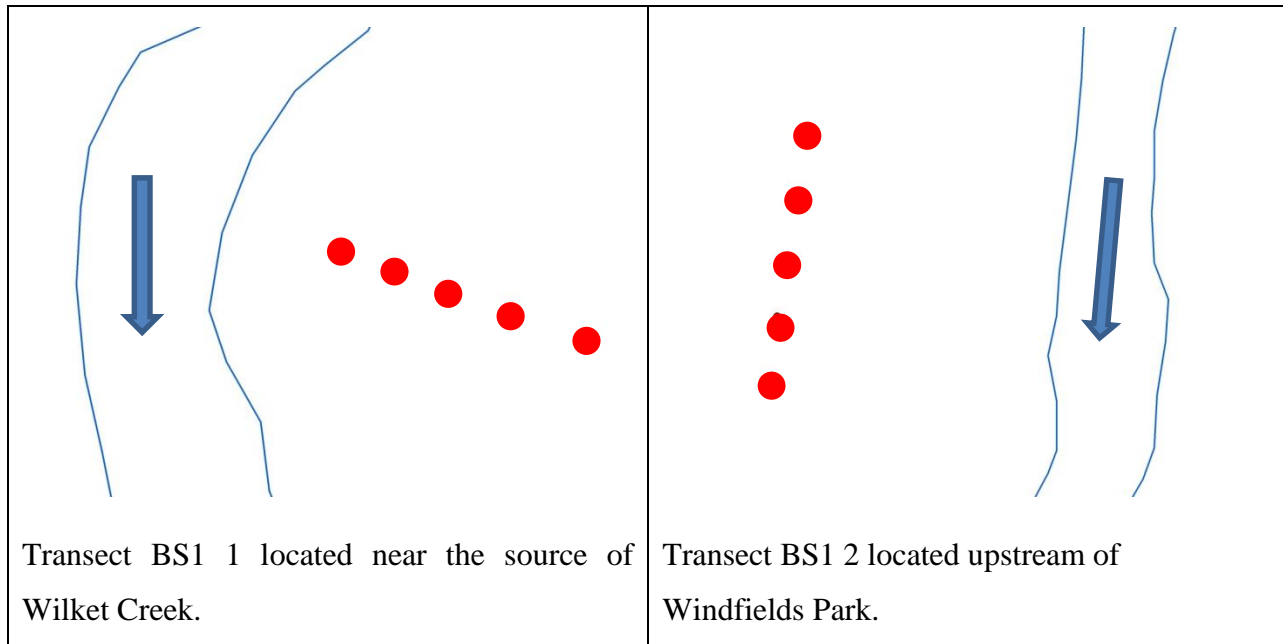
Figure 14. Bank storage pins in Section 1 of Wilket Creek.

Subsequent pins are located 2.5, 5, 7, and 11 m inland from the initial pin. The uneven spacing was due to obstructions in the ground surface such as rocks, concrete blocks and tree roots (Figure 14). The second transect (BS1 2) is located 390 m downstream of the initial transect and consists of five pins located parallel to the channel with a spacing of 2 m between pins (Figure 14).

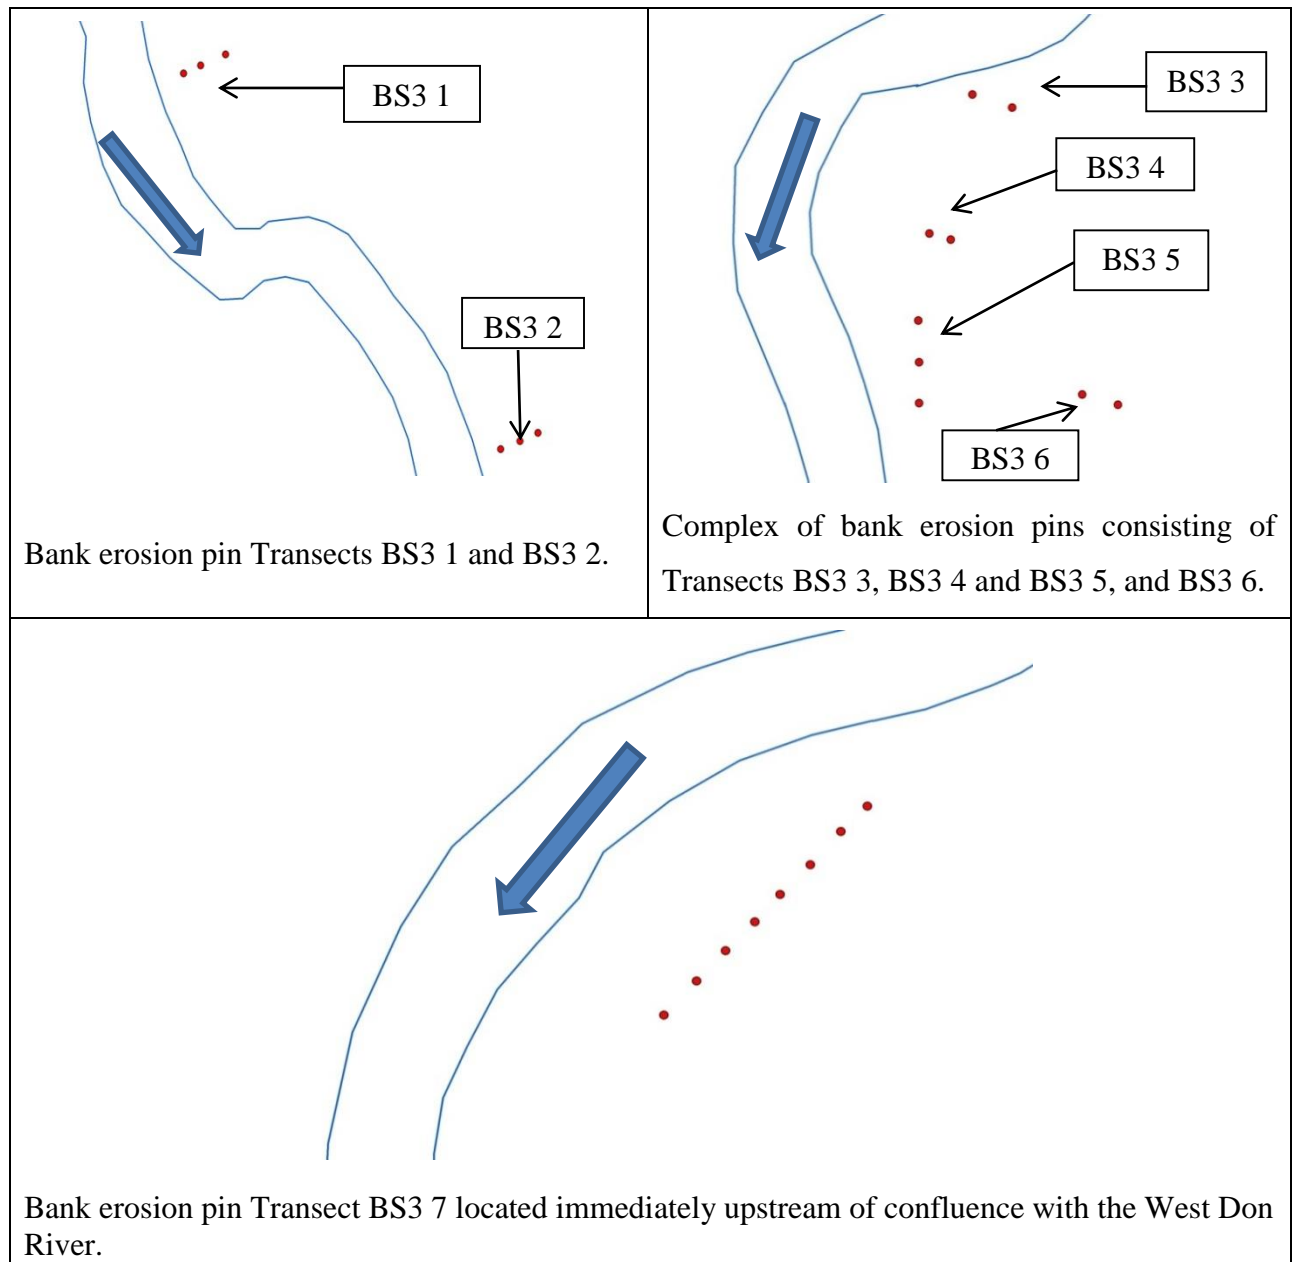
Figure 16. Bank erosion pins in Section 3 of Wilket Creek.

Section 3 has two transects, a complex of four transects and a final transect near the confluence with the West Don River. The first two transects (BS3 1 and BS3 2) are located just downstream of the 2012 restoration. This is an area of extensive bank erosion and deposition within the active channel. Both transects consist of three pins (Figure 16) and are located within the active channel as this is where deposition is occurring. At the location of Transect BS3 1, vegetation is starting to become established and this area may start to act as a bank or terrace in the future. The complex of bank erosion pins is located approximately 5430 m downstream of the source of Wilket Creek. The complex is made of four transects (BS3 3 through BS3 6). Beginning upstream, there are two transects of two pins each (BS3 3 and BS3 4). The two pins in transect BS3 3 are separated by two meters while the two pins in transect BS3 4 are separated by a meter. Transects BS3 5 and BS3 6 occur in a relic channel where extensive deposition occurs at high flows. Transect BS3 5 contains three pins each separated by two meters. The final transect (BS3 6) is made up of two pins with a spacing of two and a half meters (Figure 16). The final transect (BS3 7) is located about 80 m upstream of the confluence with the West Don River. The transect is oriented roughly parallel with the creek and consists of eight pins with a one meter spacing between pins (Figure 16).

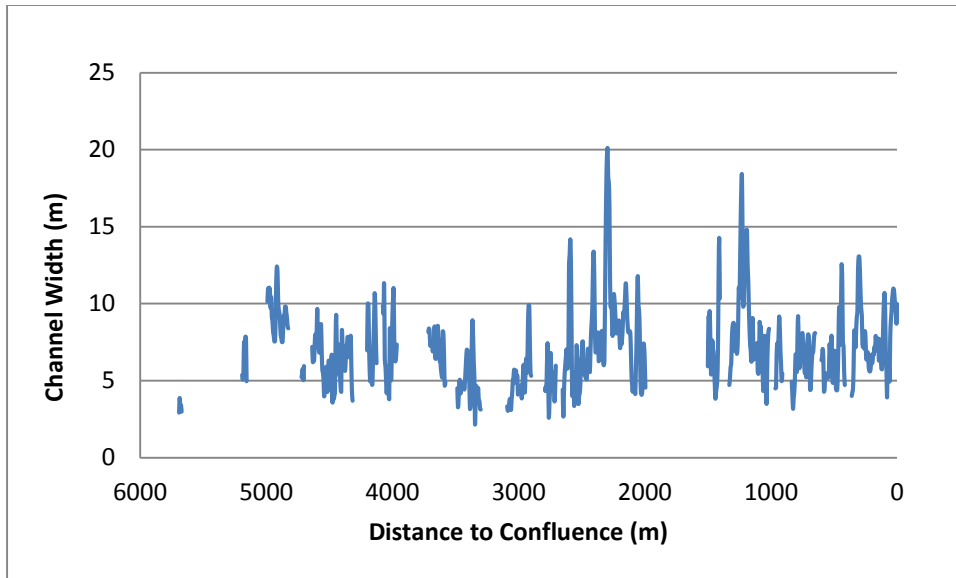
Figure 19. Channel width versus distance to confluence for 2003.

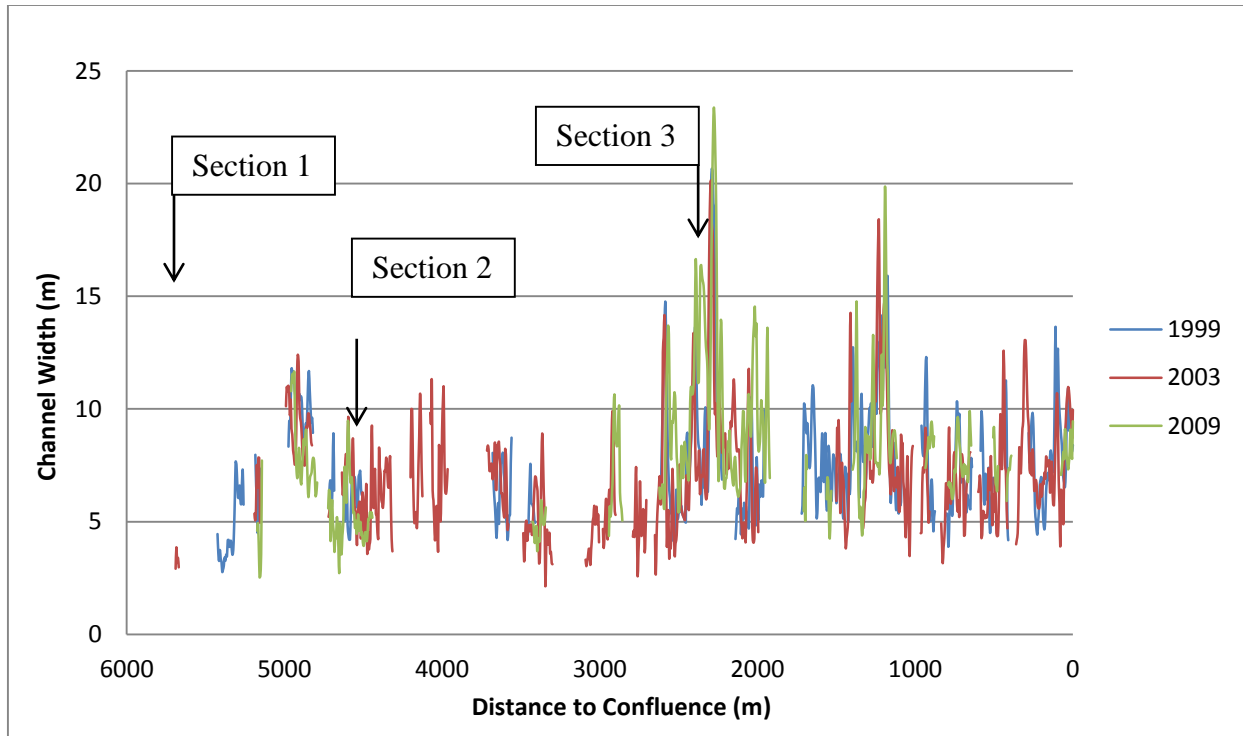
Figure 21. Channel width versus distance to confluence for 1999, 2003 and 2009.

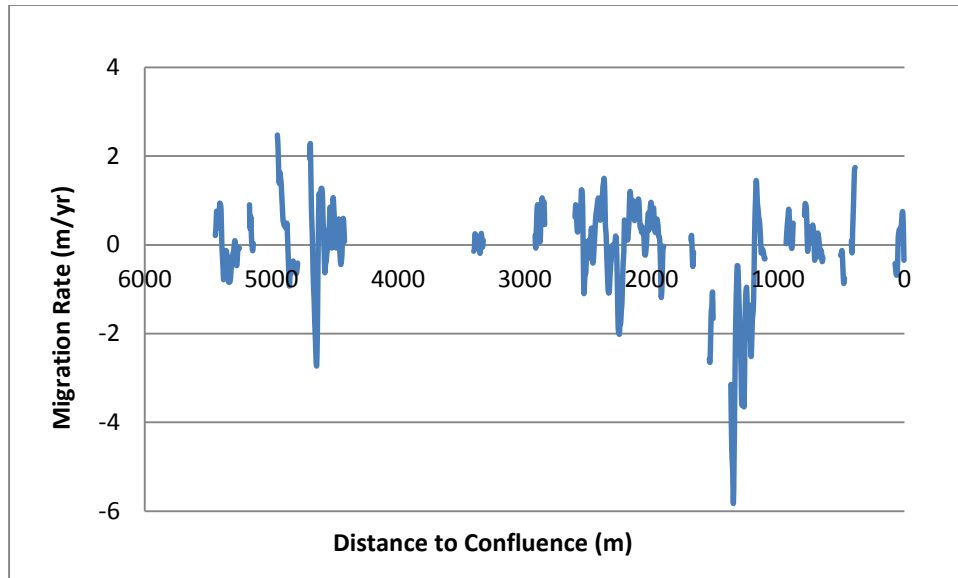
Figure 24. Channel lateral migration rate versus distance to confluence for the years 2009-2012.

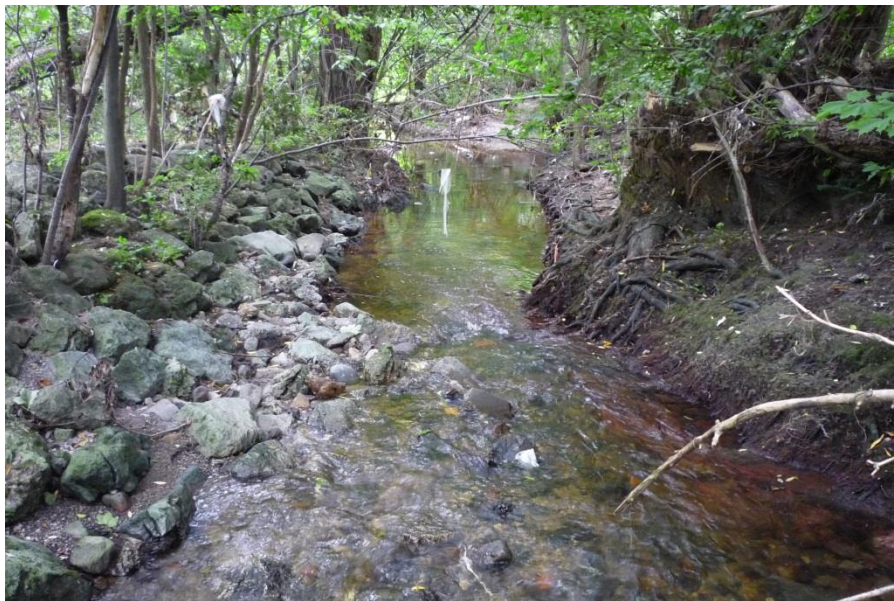
Figure 28. Site conditions at S1 A illustrating rip rap on the left bank which has migrated into the channel.

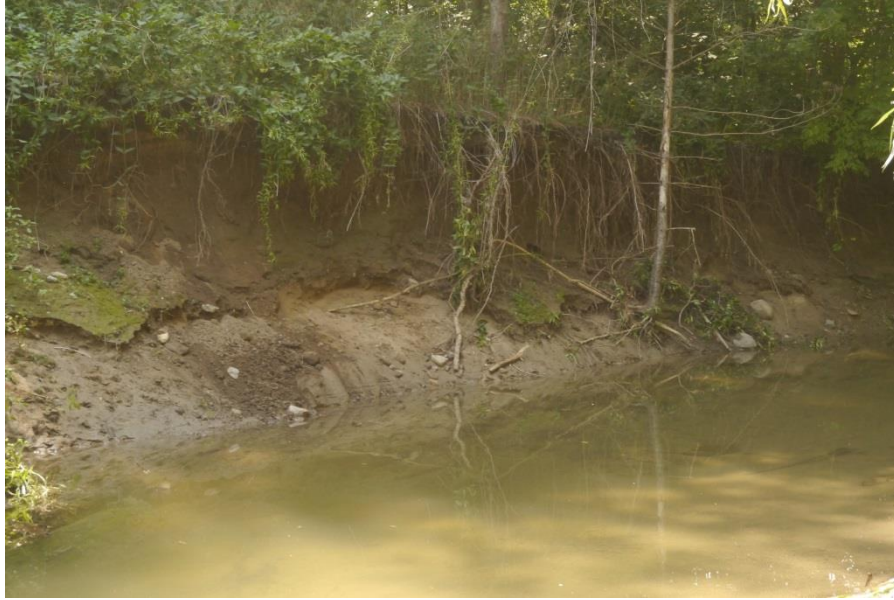
Figure 29. Right bank in area of S2 A composed of fine sediment that is actively eroding into the channel.

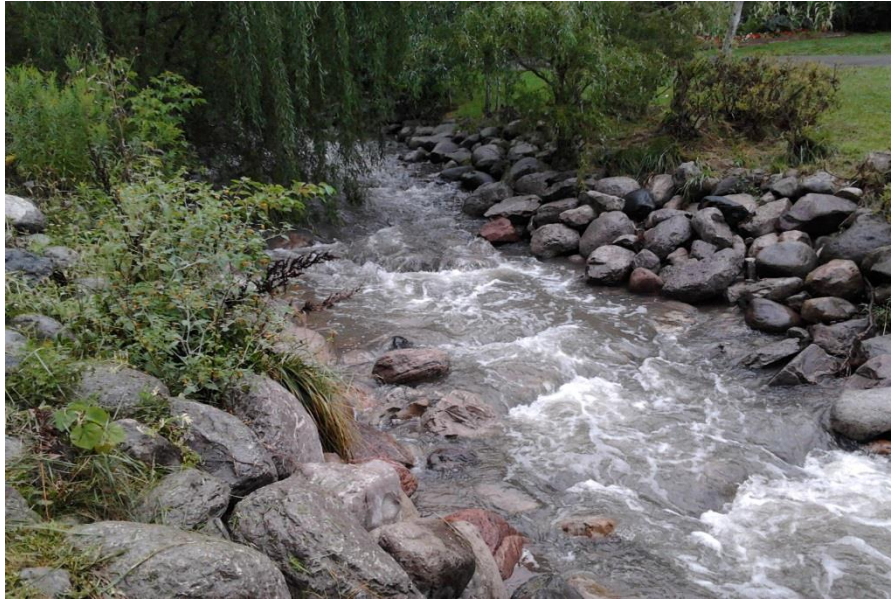
Figure 31. Wilket Creek near pebble count Site S3 A showing engineered banks with large particles sizes.

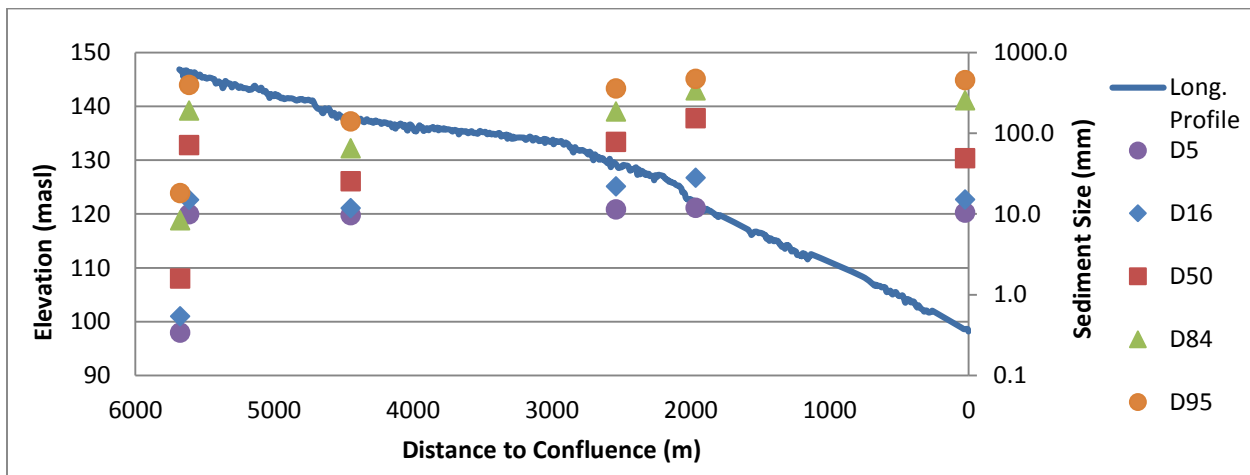
Figure 32. Size of D<sub>5</sub>, D<sub>16</sub>, D<sub>50</sub>, D<sub>84</sub> and D<sub>95</sub> particle size classes with distance along stream.

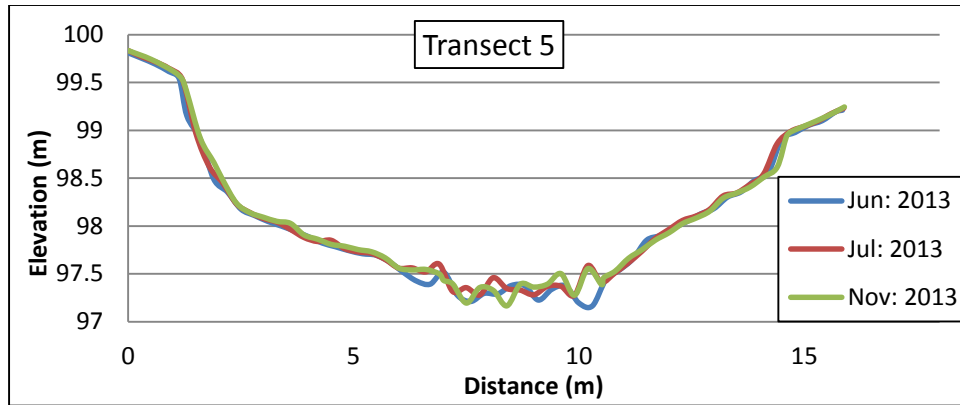
Figure 34. Cross sectional surveys of Transect 5 in Sub-Section 1b conducted between June and November 2013.

Surveyed data from the cross sections were plotted on graphs to illustrate the change in cross section area and width over time (Figure 33 to Figure 40).

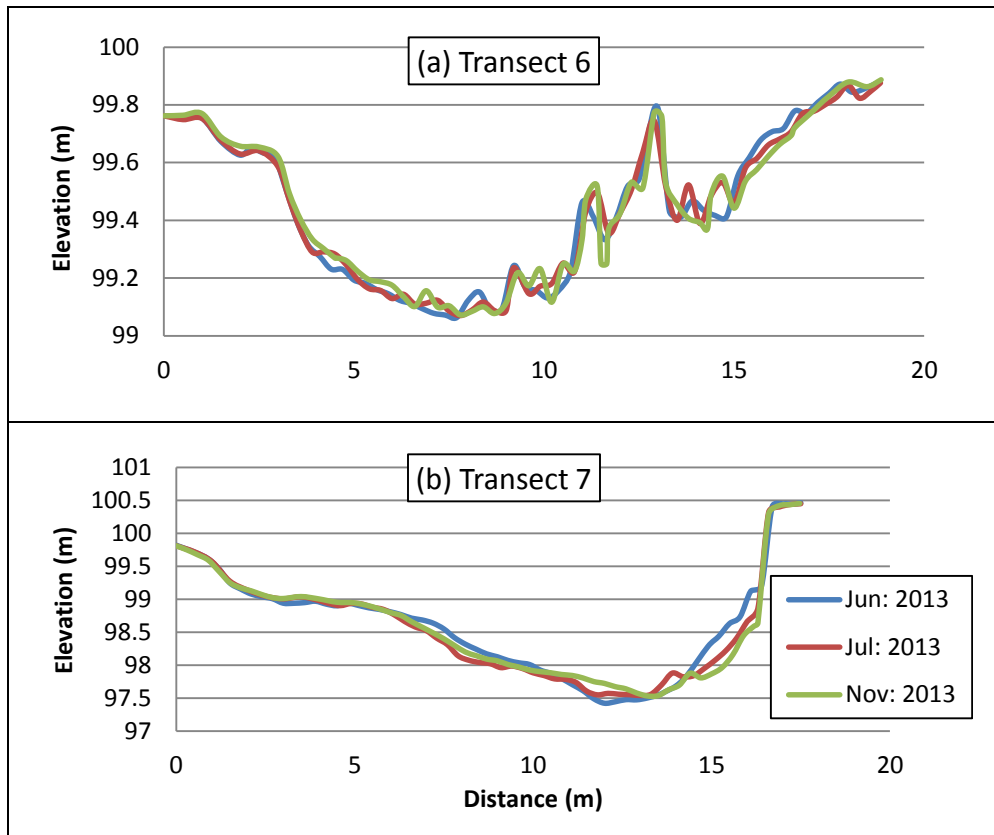
Figure 35. Cross sectional surveys of transects located in Section 2a between June and November 2013.

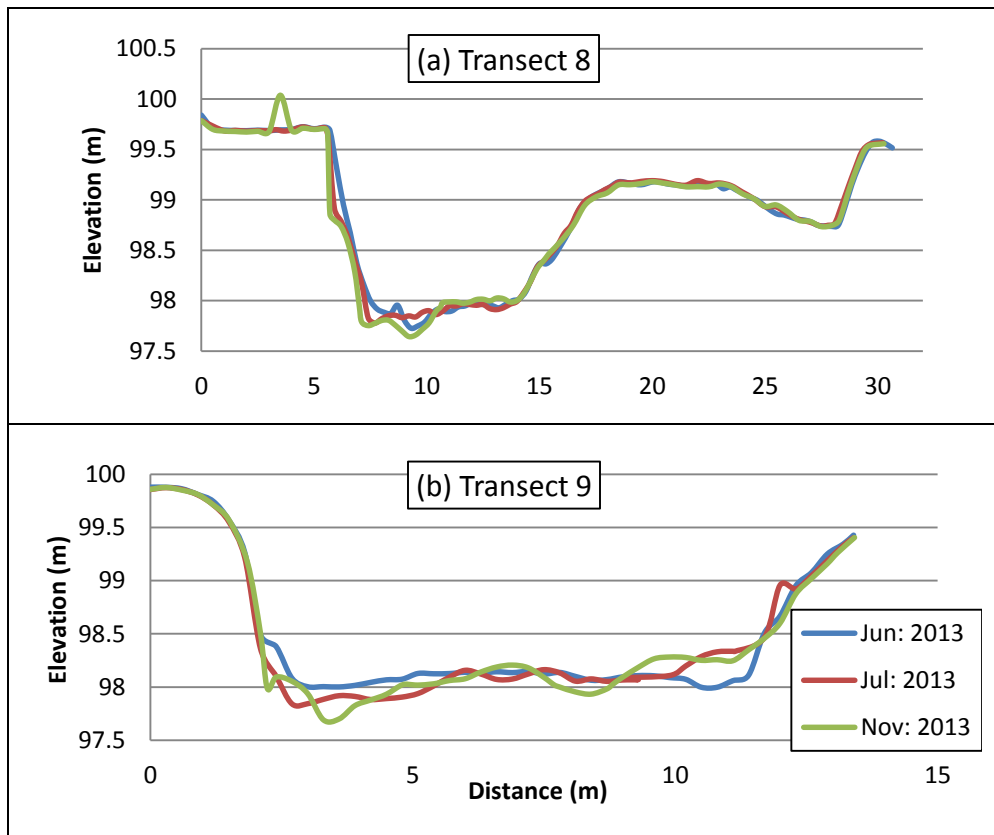
Figure 36. Cross sectional surveys of transects located in Section 2b between June and November 2013.

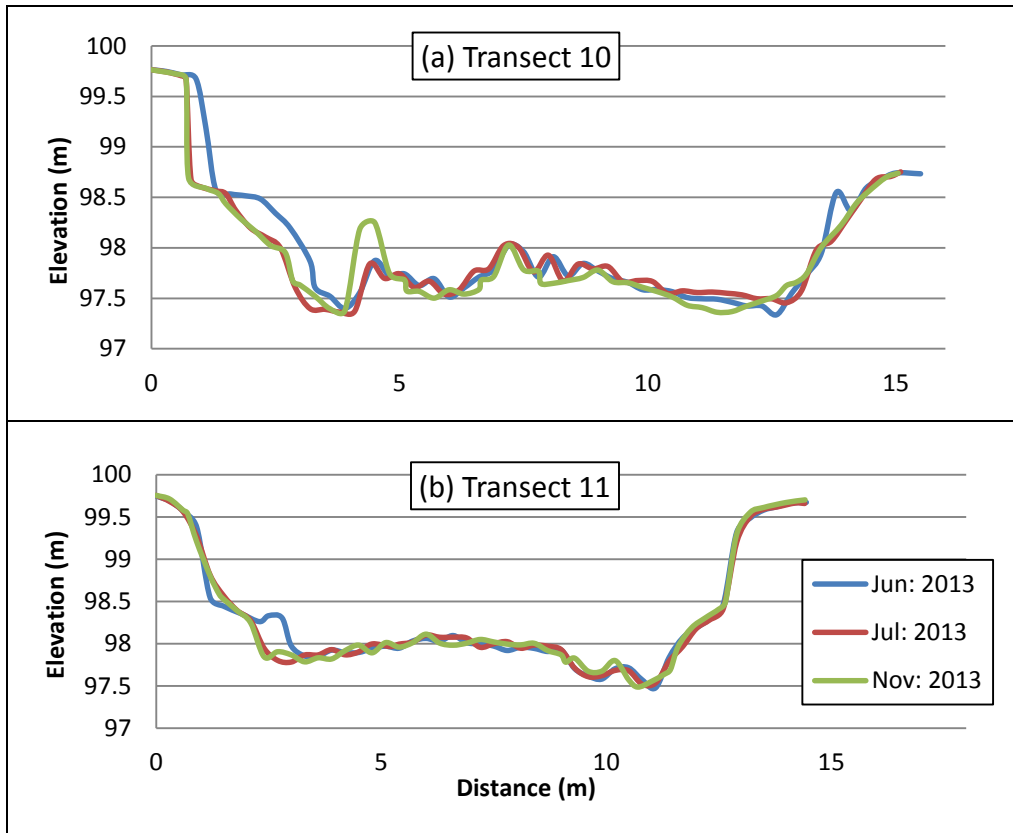
Figure 37. Cross sectional surveys of transects located in Section 2c between June and November 2013.

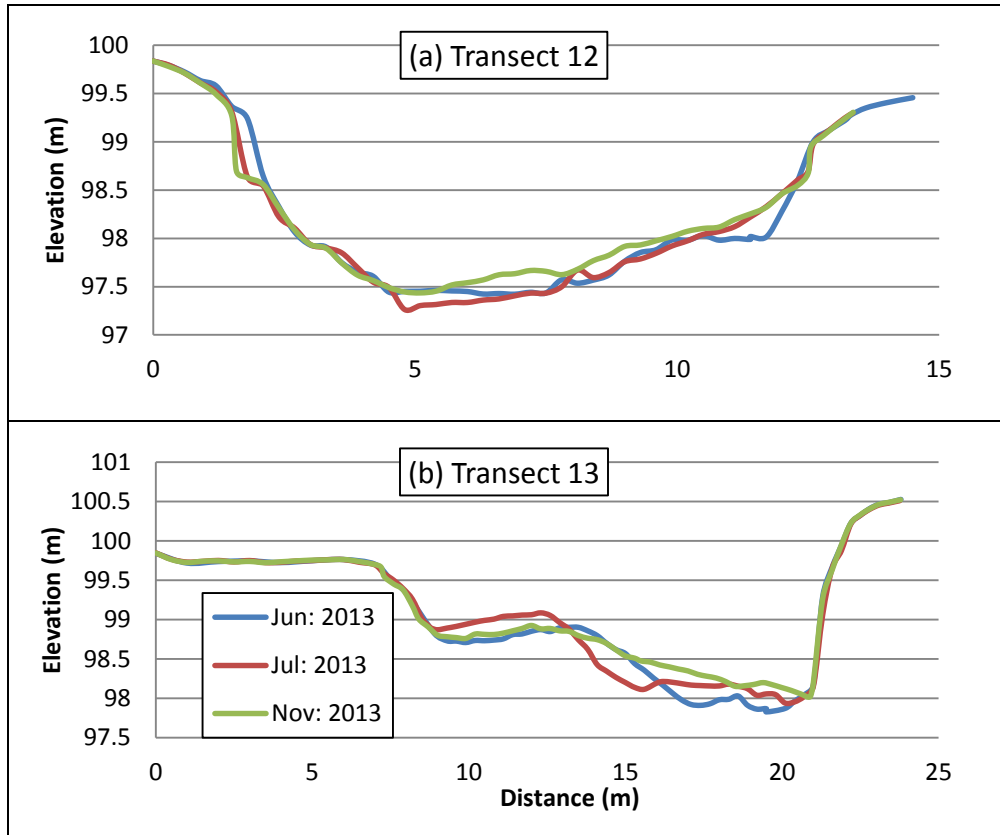
Figure 39. Cross sectional surveys of transects located in Section 3b between June and November 2013.

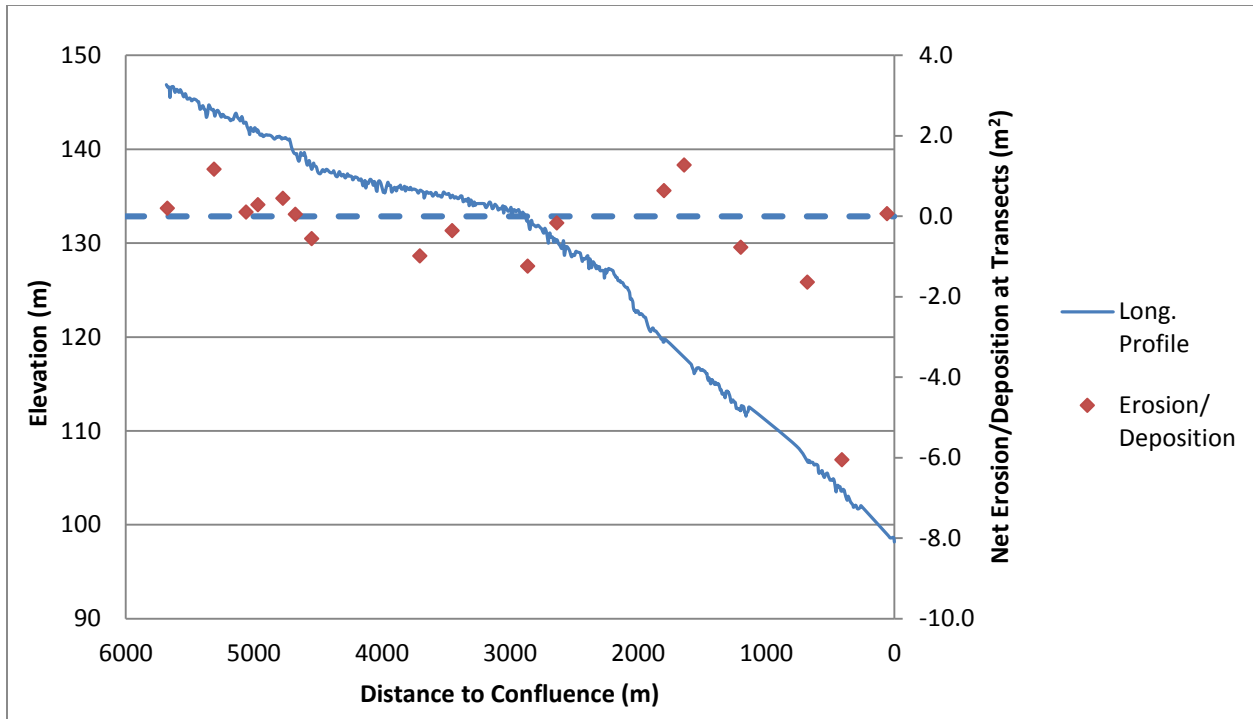
Figure 43. Net erosion/deposition and longitudinal profile of Wilket Creek between June and November 2013.

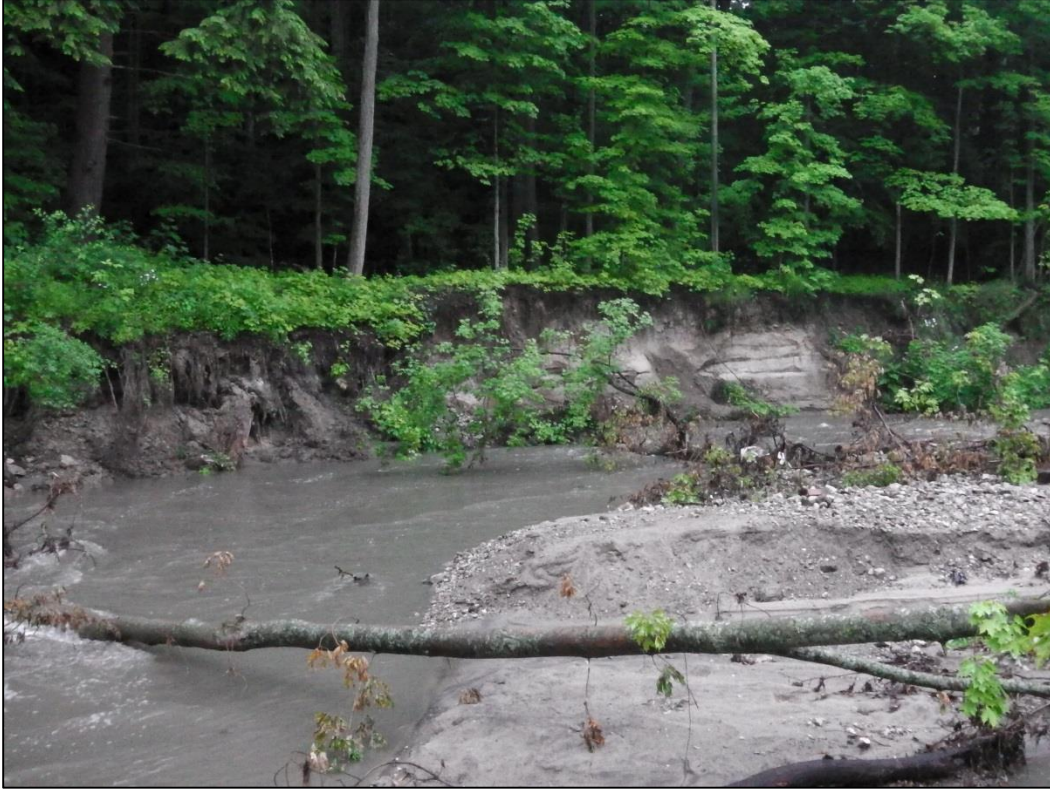
Figure 44. Conditions at Bank 3 located immediately downstream of the 2012 restoration in Section 3.

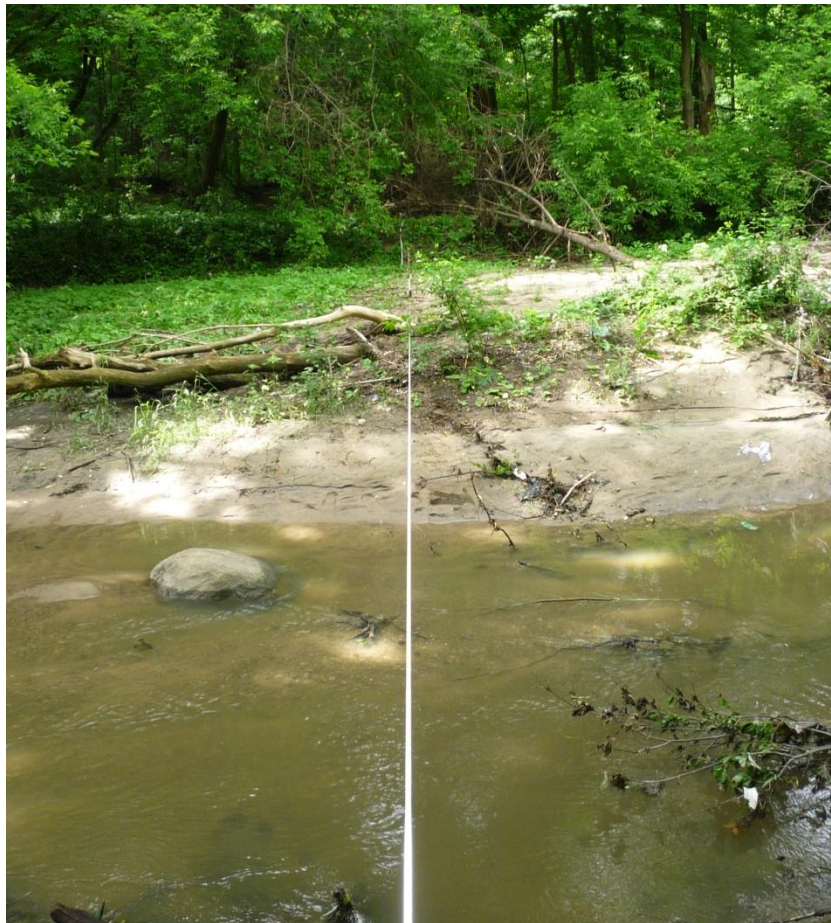
Figure 57. Transect 8 in Section 2 of Wilket Creek with large sand bar on right bank.
