# **A Sediment Budget of an Urban Creek in Toronto**

A thesis  
presented to the University of Waterloo  
in fulfillment of the  
thesis requirement for the degree of  
Master of Applied Science  
in  
Civil Engineering

Waterloo, Ontario, Canada 2014

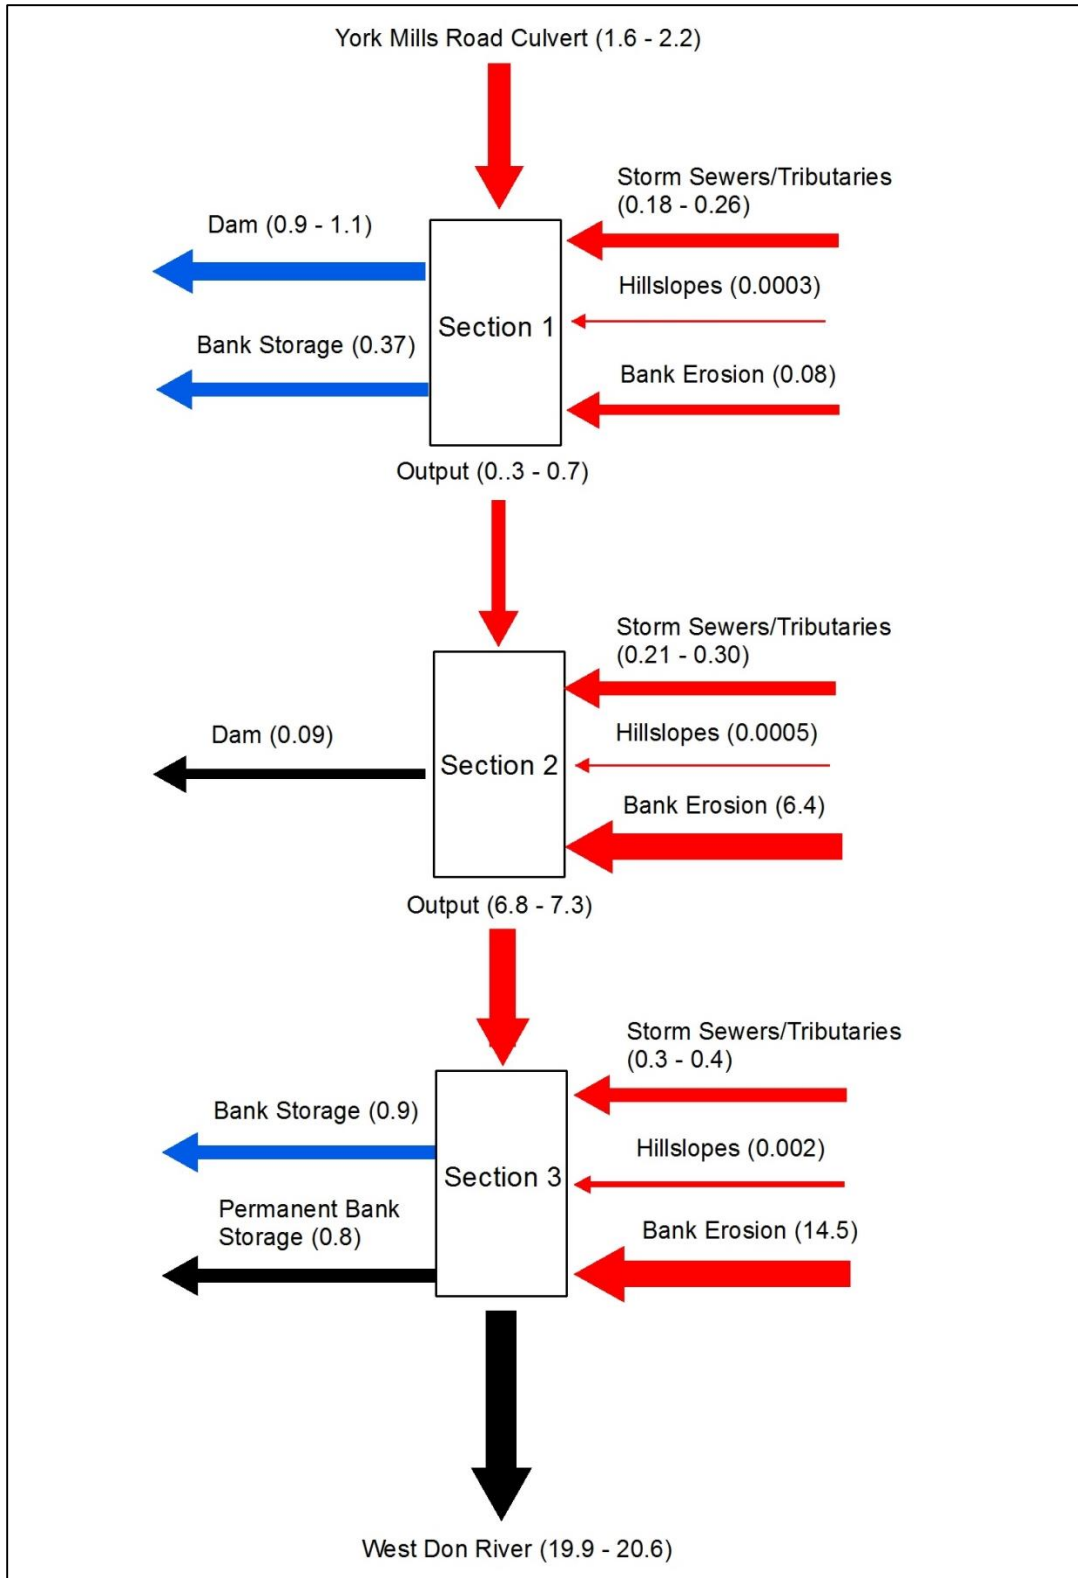
Figure 65. Flow chart of the comprehensive sediment budget for the entire exposed section of Wilket Creek with red, blue and black representing input, storage and output terms respectively. Values given in parenthesis are m<sup>3</sup>/day.

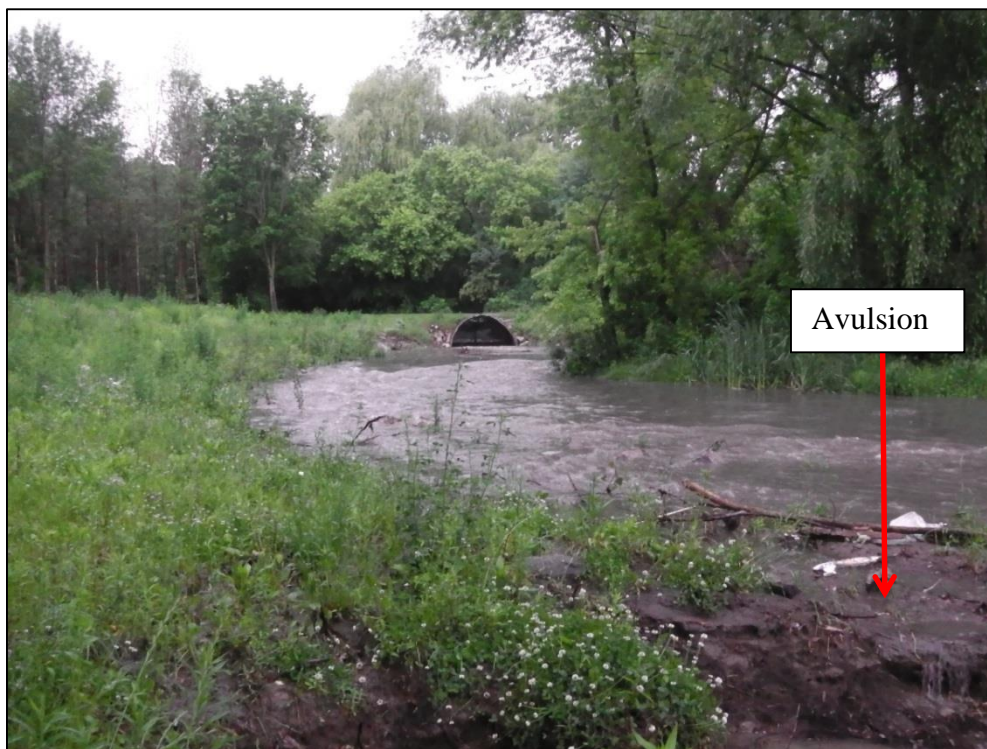
Figure 67. Failing restoration in upper reach of Section 2.

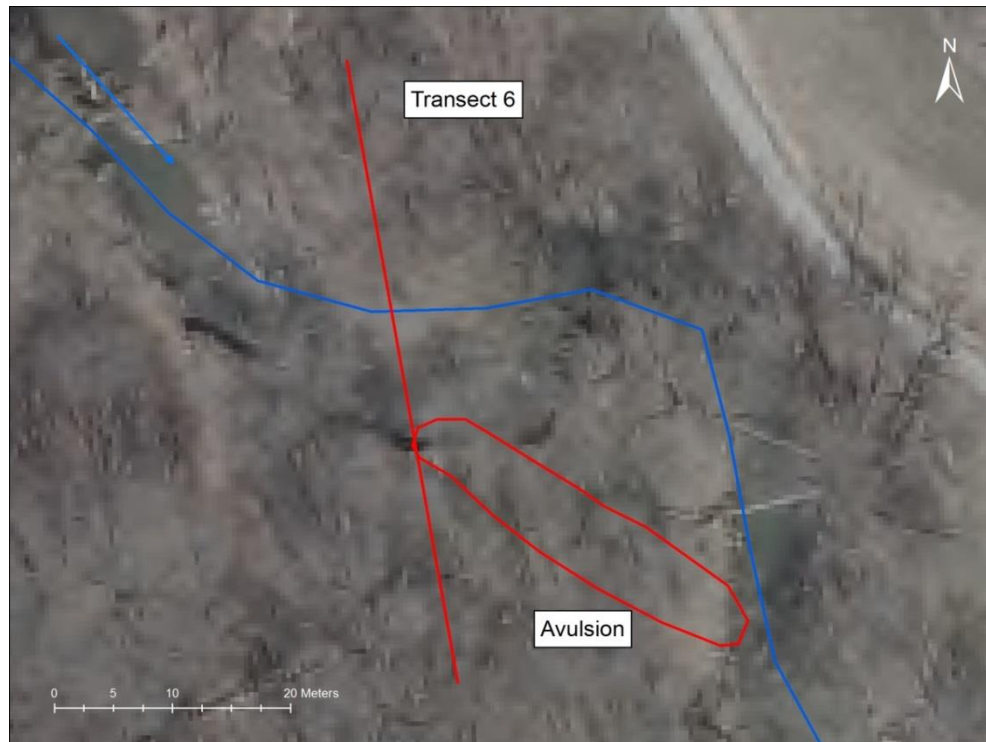
Figure 68. Active avulsion located near Transect 6 in Section 2 with headcut propagating upstream.
