The Effect of Aluminum Cold Spray Coating
on Corrosion Protection and Corrosion Fatigue
Life Enhancement of Magnesium Alloy,
AZ31B

A thesis
presented to the University of Waterloo
in fulfillment of the
thesis requirement for the degree of
Master of Applied Science
in
Mechanical Engineering

Waterloo, Ontario, Canada, 2015

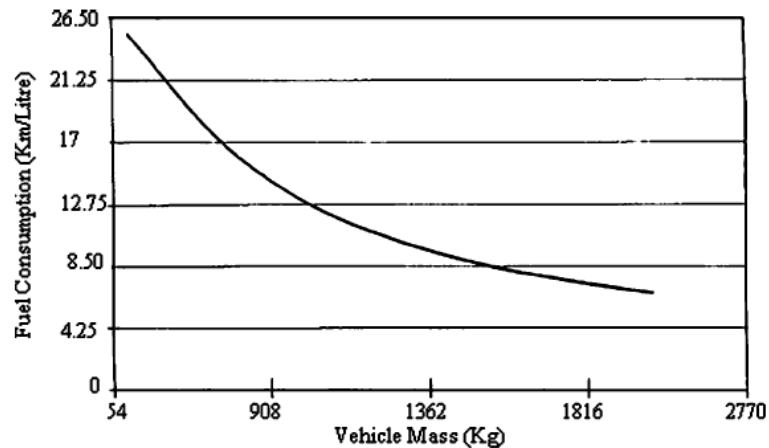
Figure 2.2: Relation between fuel consumption and vehicle mass [18]

In the past, Steel, Aluminium and plastic are known to be the most used materials in the auto industry. But in recent years and with global trends that left the automotive industry with no choice but to produce a new and safe light material that is more environmentally friendly. The reason behind this trend is that reducing the weight will saves energy and also reduces gas emissions since the CO₂ emission has a direct relation to fuel consumption and it is known that by reducing the automotive weights by a certain amount, similar percentage of improvement in fuel economy is resulted as seen in Figure 2.2 below.

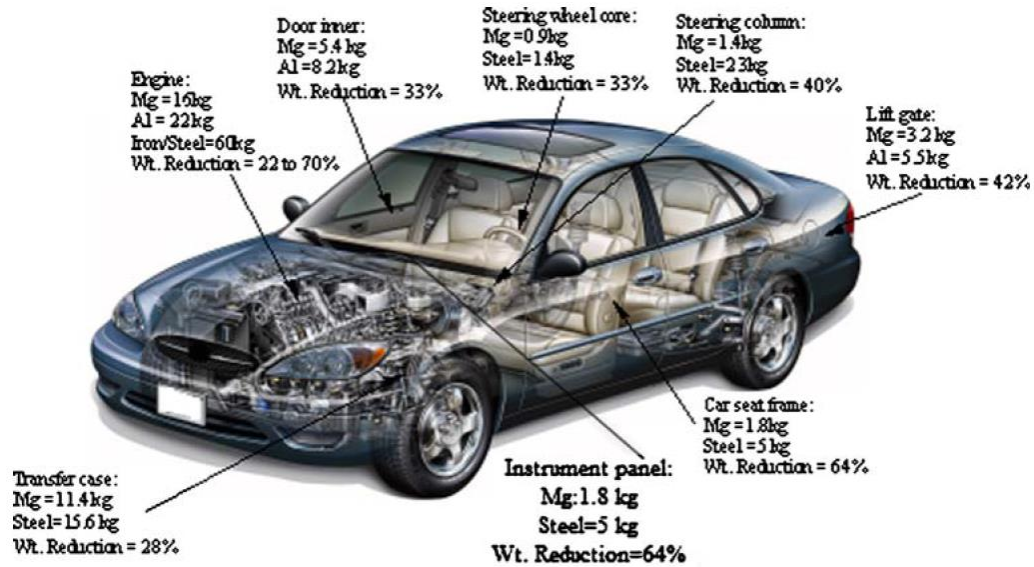
Figure 2.3: Weight reduction resulted from replacing some automotive components by Mg alloy [18]

Figure 2.3 below gives an idea for some parts in a vehicle with the potential replacement of Steel and Aluminum by Mg alloys and their impact on the weight reduction. It was reported that by replacing

some steel and aluminum parts with Mg alloys mainly from three major areas like body, power train and chassis components, the weight reduction will be 20-70% [18].

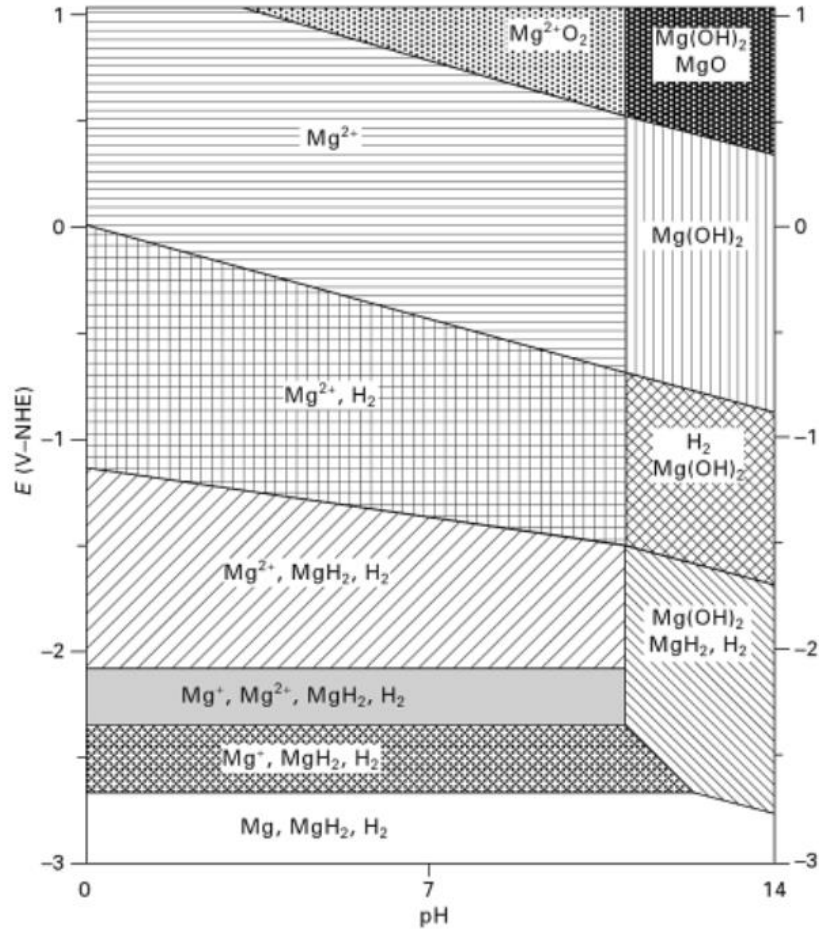
Figure 2.4: Potential-pH (Pourbaix) diagram for a magnesium-water system at room temperature [32]

The negative standard Gibbs free energy change (ΔG°) of Mg oxidation reactions given above indicates that Mg has a strong tendency to transform into its oxidized states (i.e., corrosion products) [32]. In pure water, Mg is considered unstable and various reactions may occur. Several different pourbaix diagrams (E -pH) have been reported, the E -pH diagram shown in Figure 2.4 below is an integration of the previously reported pourbaix diagrams [32].

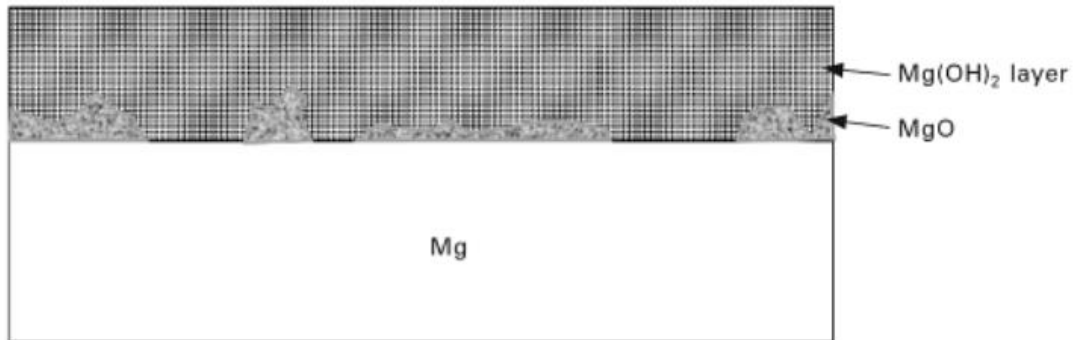
Figure 2.5: Schematic diagram of magnesium surface film [32]

corrode. An oxide MgO or hydroxide Mg(OH)_2 surface film usually forms on Mg substrate. The Mg(OH)_2 surface film is more stable than the MgO film in aqueous solutions [32]. The latter film is known to be porous and does not provide the required protection for the Mg from corrosion attack [25]. MgO is usually formed on the Mg substrate surface when it is exposed to the air, but after exposure to an aqueous solution, most of this MgO will be replaced by Mg(OH)_2 as seen in Figure 2.5.

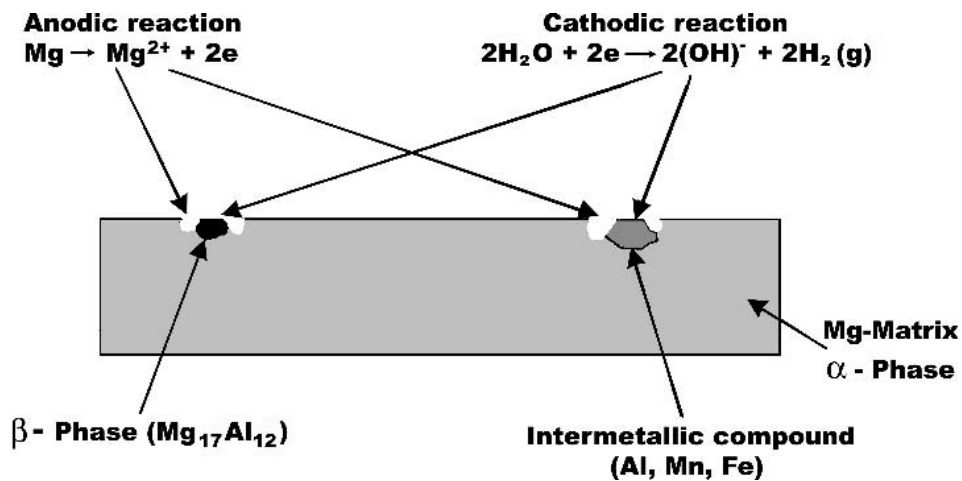
Figure 2.6: Schematic presentation of typical micro-galvanic corrosion of Mg-Al alloys [16]

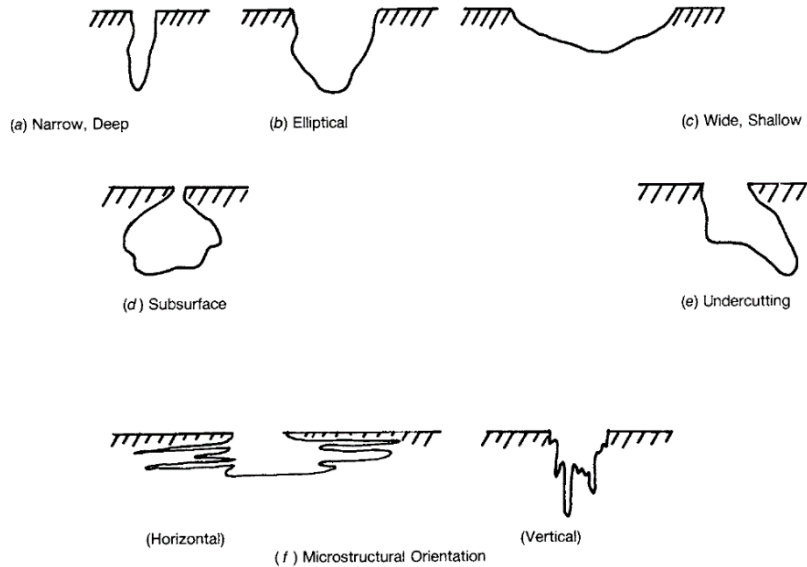
Figure 2.8: Different forms of pits [38]

of failure that is very difficult to detect, predict or design against and pits can initiate, propagate and perforate without obvious signs because the corrosion products often cover the pits. The pits can take a variety of different shapes as shown in Figure 2.8.

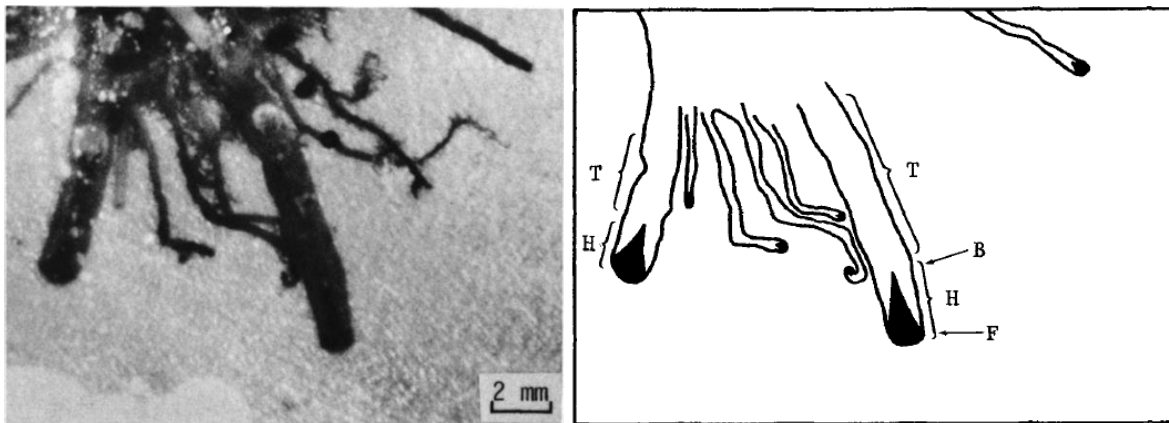
Figure 2.11: Typical filiform corrosion tracks on steel under a polyurethane coating [39]

Filiform corrosion is a type of localized corrosion that usually occurs under a coating of steel, Al or Mg. It does not occur on bare and pure Mg. The corrosion products result from bulging in the coating and the attack, which usually looks like filaments (Figure 2.11), proceeds from the points that no longer have coating [31],[39].

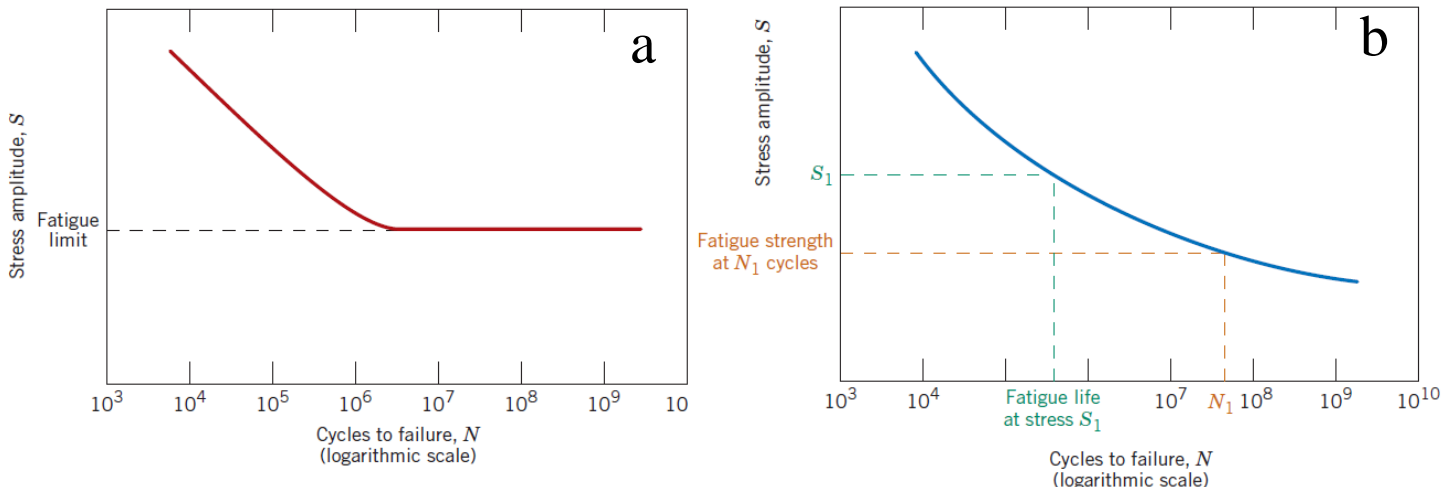
Figure 2.13: Schematic of the S-N curves of (a) a material that has an endurance limit and (b) a material that does not have an endurance limit [24]

The resulting number of cycles to failure for a specific material under a specific amount of stress will be shown on the counter and is used to plot the S-N curve. "S-N" means stress versus cycles to failure, and is displayed with the stress amplitude on the vertical axis and the logarithm of the number of cycles to failure on the horizontal axis. There are two types of S-N curves based on the behavior of the material: ferrous materials (iron based) usually reach a level of stress above which that material will not fail (the endurance limit) and the S-N curve proceeds as a horizontal line (Figure 2.13a), nonferrous material such as Al, Cu and Mg do not have an endurance limit and the fatigue will be represented by fatigue strength where the material will fail at some point and the S-N curve trend will continue downward (Figure 2.13b).

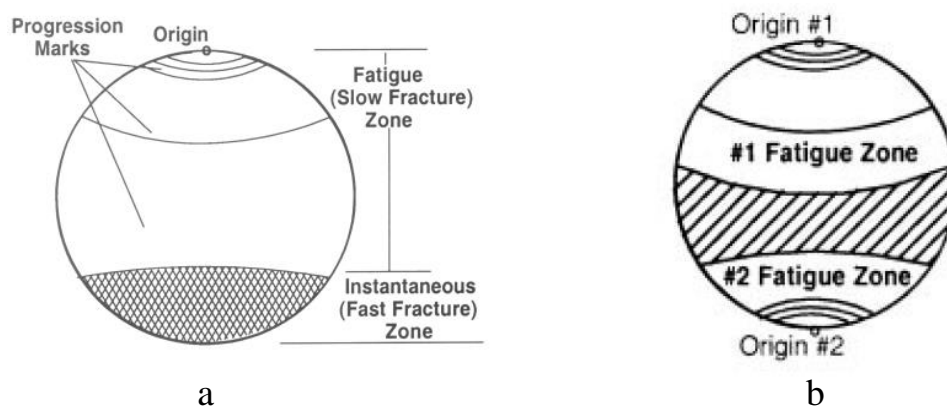
Figure 2.14: Schematic macroscopic surface features, (a) single origin and (b) two origins [43]

Failure origin or fracture initiation sites are usually located near or at the surface edges. The origin of the failure can be viewed in macro-scale, and it could be a single origin point indicating that the failure had occurred with low overstress, or multiple reversed origins (two ways) which could result from high stress or high stress concentration (Figure 2.14). Micro-scale initiation sites usually include small cleavage cracks, some porosity and other imperfection that can initiate the crack such as nicks, machining marks or corrosion pits that work as stress risers [40],[43].

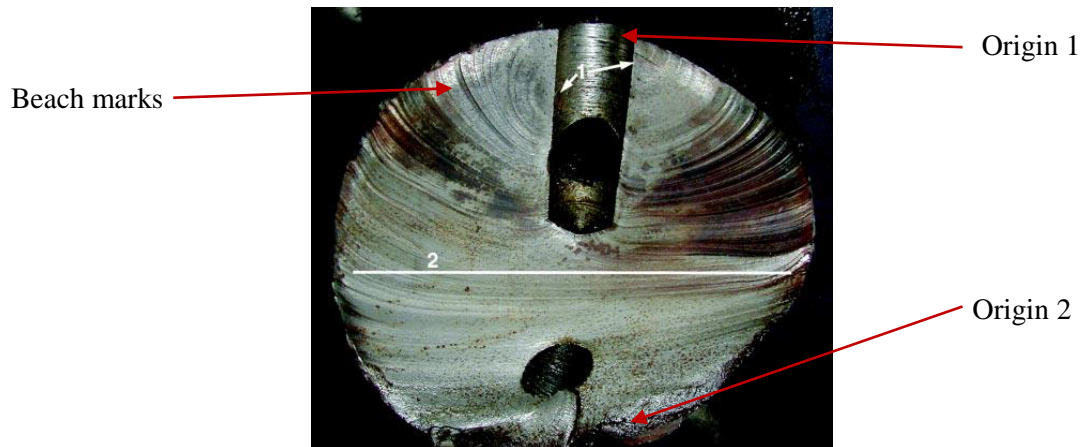
Figure 2.15: Fatigue fracture surface showing two origins with progression beach marks [43]

- **Progression marks** are usually recognized in macro-scale and give a lot of information about crack growth. These marks only exist in fractures with variations in the applied stress. The common name for these marks is ‘beach marks’; the name capturing their similar appearance to lines in the sand on a beach (Figure 2.15). Progression marks are usually generated in one of two ways, by a change in the loading or frequency, or by a change in stress amplitude (e.g., start-up and shutdown forces) [40],[43].

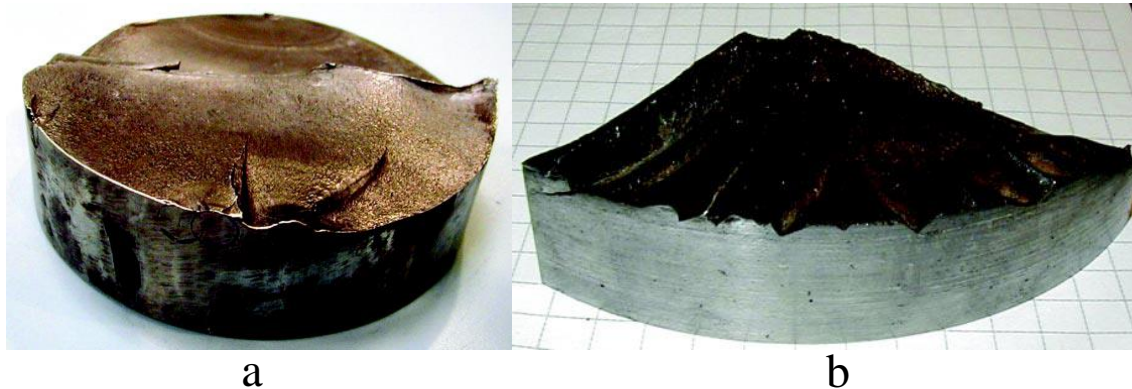
Figure 2.17: Fatigue fracture surface showing (a) two ratchet marks and multiple origins that result from bending force, and (b) ratchet marks resulting from torsion force [43]

information can be generated simply by studying the ratchet marks and the size of the fracture zone [43]. For example, it would be easy determine the major cause of the fracture, whether it was the load or the stress concentration. If there were many ratchet marks and a small overload zone, this would indicate failure under a light load and a high stress concentration.

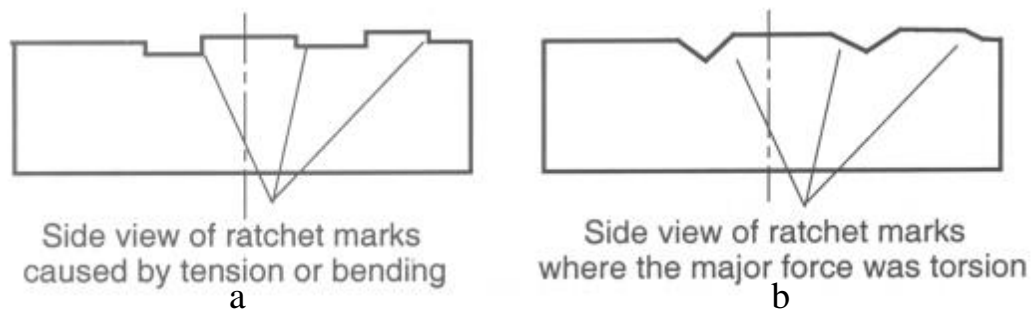
Figure 2.18: Schematic showing two different angles for ratchet marks caused by (a) tension or bending (b) torsion [43]

The ratchet mark edges indicate whether torsional forces were involved with the failure. Figure 2.18 shows two examples, one of which shows ratchet marks perpendicular to the fracture face indicating that bending or tension caused the failure, and one with tapering ratchet marks indicating that the primary load causing the failure was torsional.

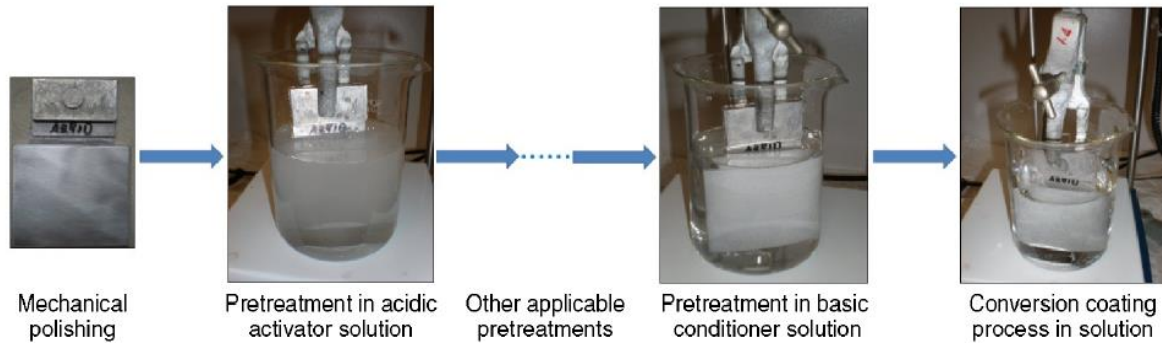
Figure 2.20: Steps in the conventional conversion coating process using AZ91D Mg alloy [8]

However, these conversion coatings are pre-treatments in effect as the surfaces coated by these processes usually have unsatisfactory corrosion protection for many applications. They do offer a good adhesion surface for paints though.

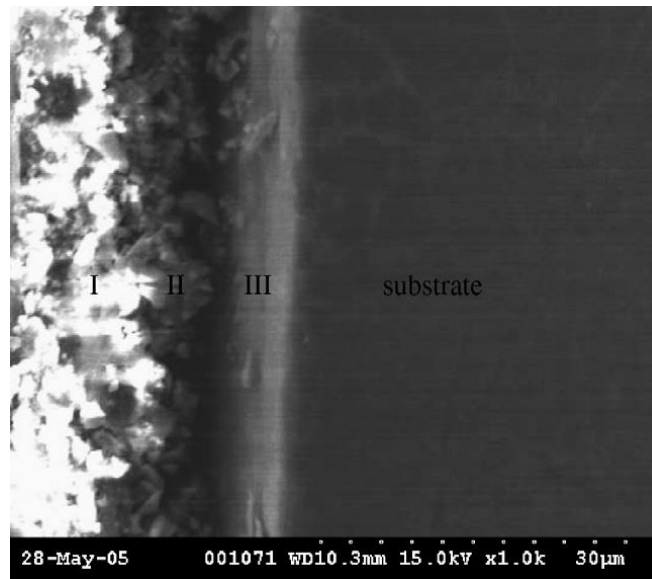
Figure 2.22: Microstructure of plasma electrolytic oxidation ceramic coating with three layers as (I) loose layer, (II) compact layer and (III) contact layer [10]

Plasma Electrolytic Oxidation (PEO) Process, also known as micro-arc oxidation and spark anodizing, is an environmentally friendly coating technique. PEO is one of the most popular coating methods in recent years for Mg alloys in the industrialized world. This method passes high voltages (usually from 100 to 500V) through the surface to be coated in an electrolytic bath containing chemicals such as phosphates, silicates, hydroxides, fluorides etc. The resultant oxide coating is considered to be thick, hard, a very good adherent for ceramic coatings, and provide good corrosion resistance to the substrate. The coating that is formed usually consists of three layers with distinct levels of porosity; the upper layer being the most porous and loose layer [53],[54]. Figure 2.22 shows a cross section of PEO ceramic coating that was applied on AZ31 Mg alloy at 300 V/3 A/40 min. The oxidized ceramic coating consists of a loose layer (I), compact layer (II) and contact layer (III), and the total thickness is about 20 μm [10].

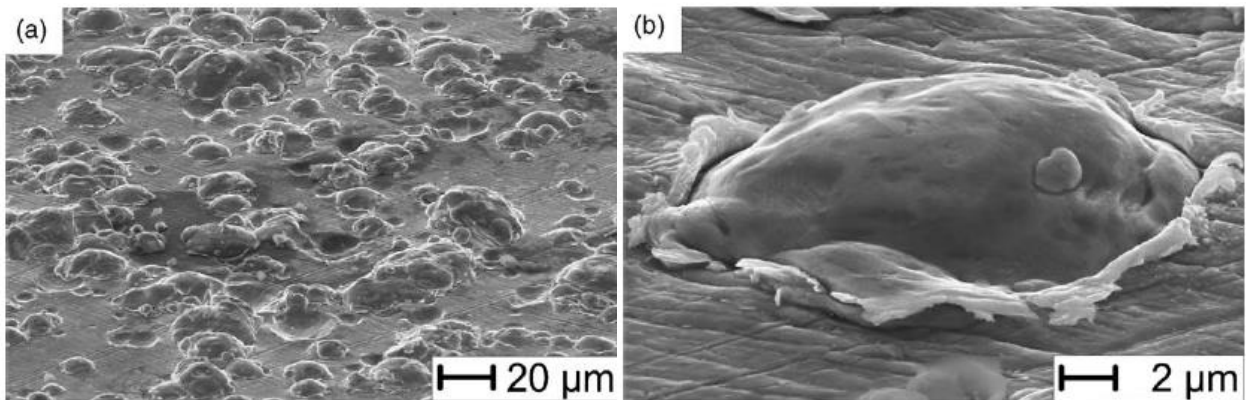
Figure 2.24: Scanning electron micrographs of cold sprayed copper particles on a copper substrate (a) an overview and (b) a close-up image [61]

itself, for example, if using particles with a size of less than $45\mu\text{m}$, device nozzle clogging may occur. The plastic behavior of the substrate and particles is also relevant to the deposition efficiency; it has been reported that using particles which are more plastic than the substrate will result in a better deposition of the coating. Materials with an FCC structure have the highest plasticity, followed by materials with hexagonal structures, while materials with a BCC structure have the lowest plasticity [58]. Figure 2.24 shows scanning electron micrographs of Cu particles that have been cold sprayed on a Cu substrate.

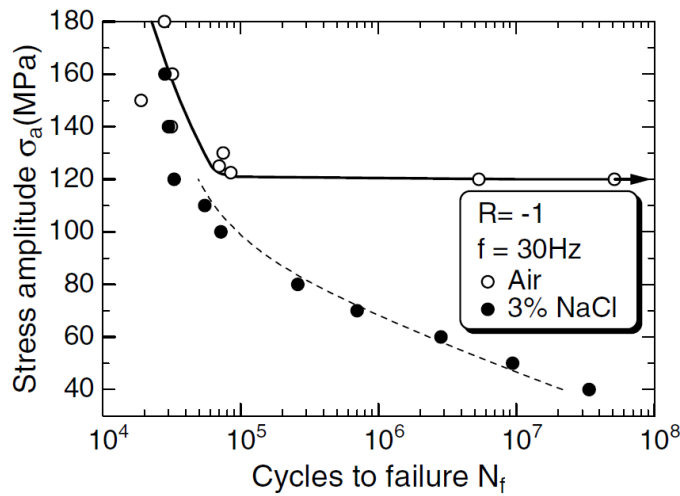
Figure 2.25: S-N curve for extruded AZ31 alloy in air and 3.5% NaCl [79]

- In 2008, Nan [79] performed corrosion fatigue testing of extruded alloy AZ31 using a 3% NaCl environment that was dripped on the smooth specimen under test at a flow rate of 140 ml/min and circulated back to the NaCl solution tank. The NaCl solution was exchanged once each day. A rotating bending machine was used for the fatigue testing at a frequency of 30 Hz and at room temperature. In order to protect the specimens under test from crevice corrosion, specific areas were protected with silicon resin. The S-N curve (Figure 2.25) was plotted based on the test results and it was compared with the results of fatigue testing on the same alloy but in laboratory air. An endurance limit at 120 MPa can be observed from the fatigue behavior of AZ31 in air, but there is no such limit in the NaCl corrosive environment where the specimen always failed regardless of the stress level.

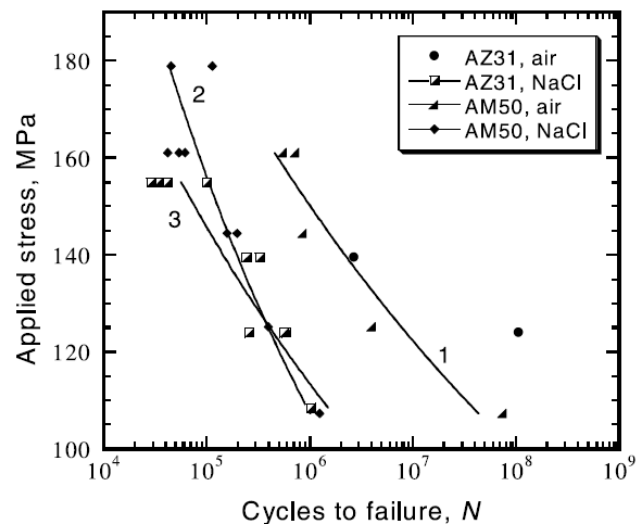
Figure 2.26: S-N curve for extruded AZ31 and AM50 alloys in air (1), AM50 in 3.5% NaCl (2), AZ31 in 3.5% NaCl (3) [11]

- In other work, Eliezer [11] performed corrosion fatigue testing of die-cast AM50 and extrusion AZ31 alloys to study the fact that an increase in the Al percentage in Mg-Al-Zn-Mn alloys will lead to an increase in the fatigue life of the alloys in both air and corrosive environments. A 3.5% NaCl (pH≈5) solution was used as a corrosive environment and was dripped on the gauge of the specimen under test. A rotating bending machine was used to induce fatigue at a frequency of 30 Hz and at room temperature. The S-N curve (Figure 2.26) was plotted based on the corrosive environment fatigue test results for the AZ31 alloy and it was compared with the same test results for AM50 and for the two alloys tested in the laboratory air environment. It was concluded that the fatigue life in air for all of the tested alloys decreased significantly when compared to testing in the 3.5 NaCl solution but this decrease was more for the extrusion alloy.

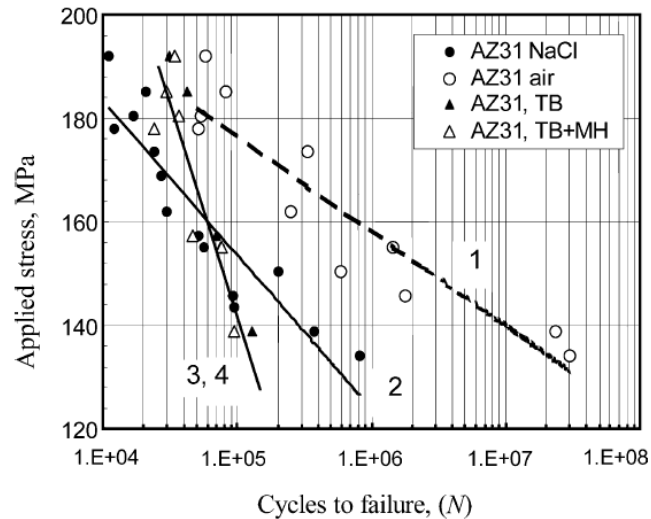
Figure 2.27: S-N curve for extruded AZ31 alloy (1) in air, (2) in 3.5% sodium chloride, (3) in 0.1N borate, and (4) 0.1N borate solution saturated with magnesium hydroxide [80]

showed very high fatigue life and corrosion fatigue properties in comparison to the other alloys. The buffer $\text{Na}_2\text{B}_4\text{O}_7$ solution reduced the fatigue life of the AZ31 alloy, while the saturation $\text{Na}_2\text{B}_4\text{O}_7$ solution with $\text{Mg}(\text{OH})_2$ had no effect on the corrosion fatigue behavior of the AZ31 alloy; however, the $\text{Mg}(\text{OH})_2$ saturated 3.5% NaCl increased the corrosion fatigue life for the AZ31 alloy as shown in the S-N curve (Figure 2.27).

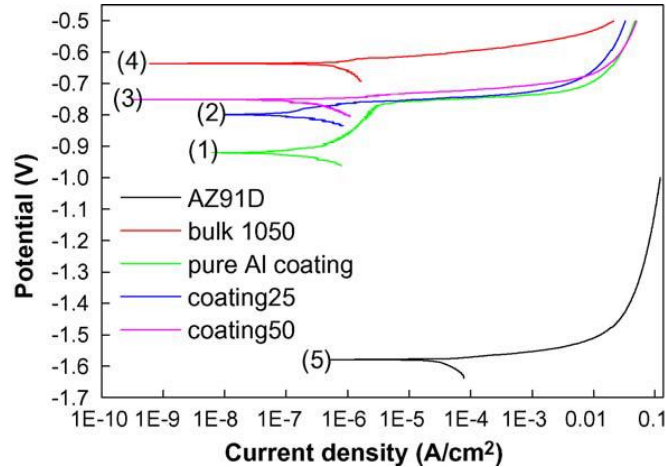
Figure 2.28: Potentiodynamic polarization curves in 3.5 wt.% NaCl solution [84]

performance than the AZ91D, as their corrosion current densities were three orders lower than that of AZ91D (Figure 2.28).

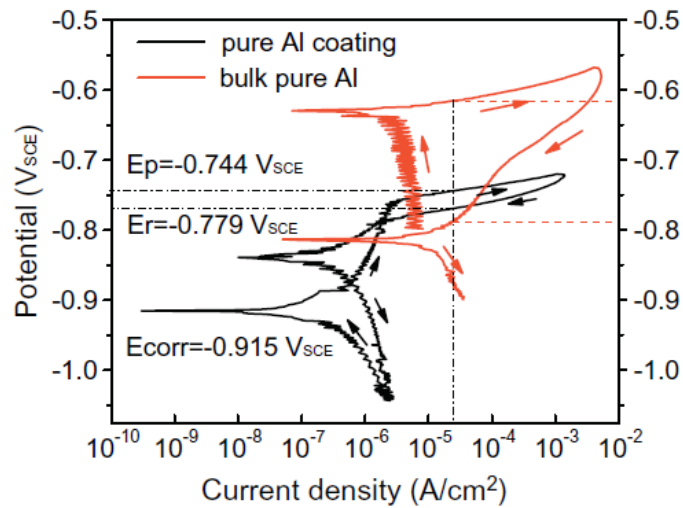
Figure 2.29: Cyclic polarization curves of cold sprayed pure Al coating and bulk pure Al after 1 h of immersion in a 3.5 wt.% NaCl solution [85]

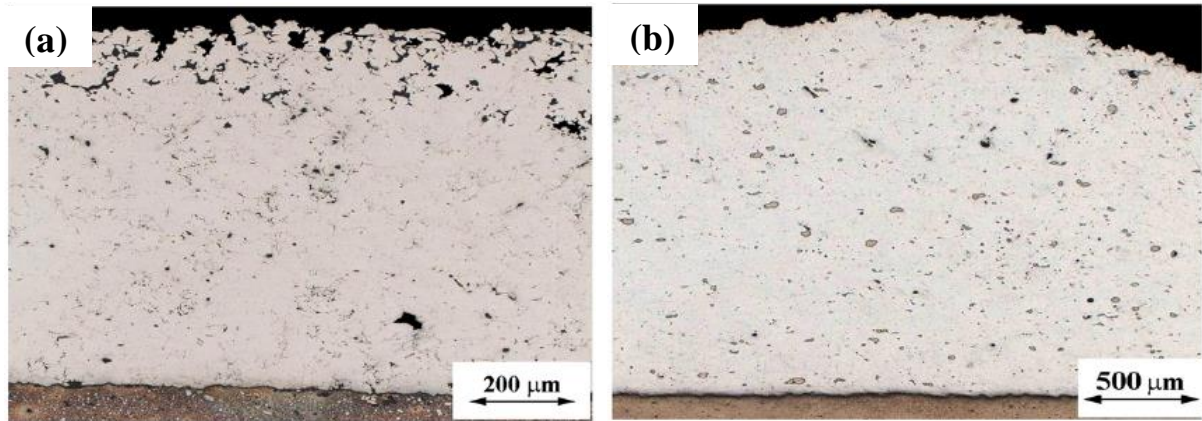
Figure 2.30: (a) Cross-section of pure aluminum coating on an AZ91D substrate, and (b) Scanning electron microscope image taken at the coating's top surface revealing the high level of porosity [86]

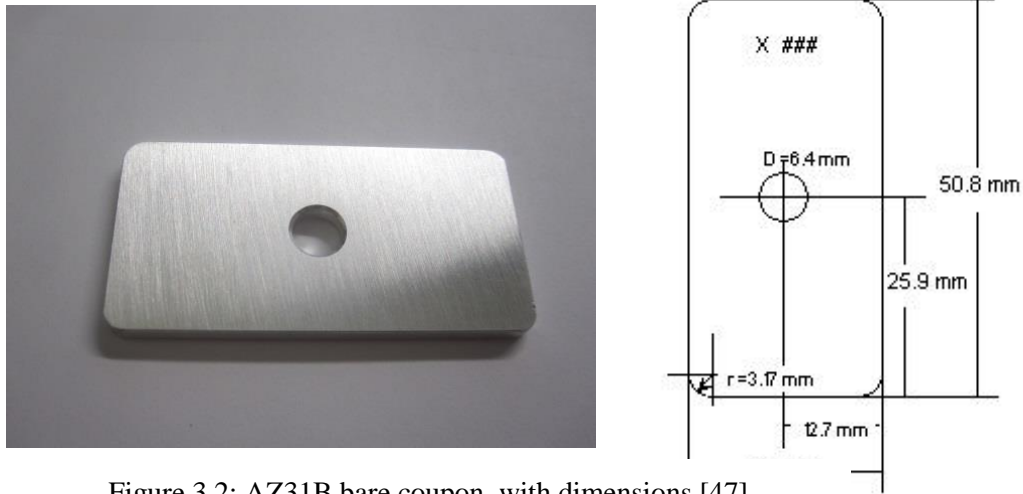
Figure 3.2: AZ31B bare coupon, with dimensions [47]

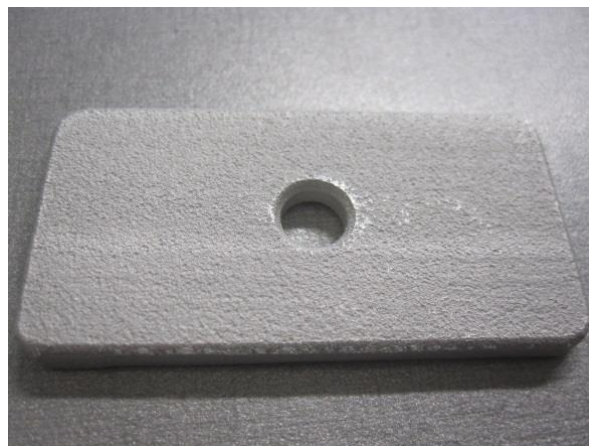
Figure 3.3: AZ31B Al cold spray coated coupon.

For the first corrosion study, 20 coupons were machined and prepared (from the extrusion piece smaller teeth shown in Figure 3.1) in the University of Waterloo machine shop as per GM standard 14872 (Figure 3.2). Each of these coupons had dimensions of 25.4 mm x 50.8 mm x 3.18 mm (width, length and thickness). Half of these coupons were sent for Al cold spray coating to CenterLine in Windsor, Ontario, Canada (Figure 3.3). Details of the cold spraying process are discussed in Section 3.1.1.

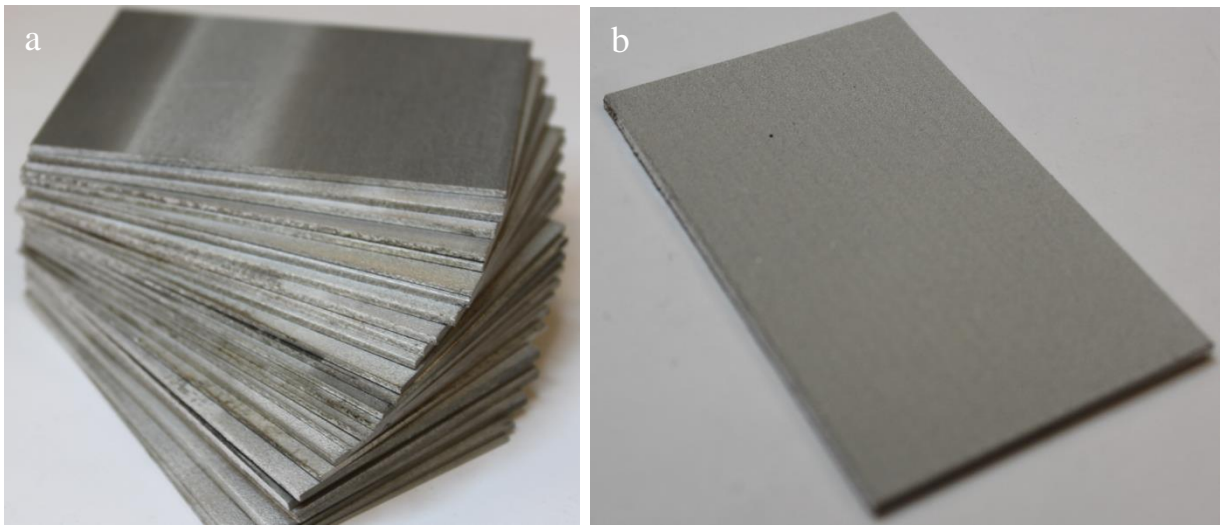
Figure 3.4: AZ31B (a) bare coupons and (b) an Al cold spray coated coupon for corrosion testing

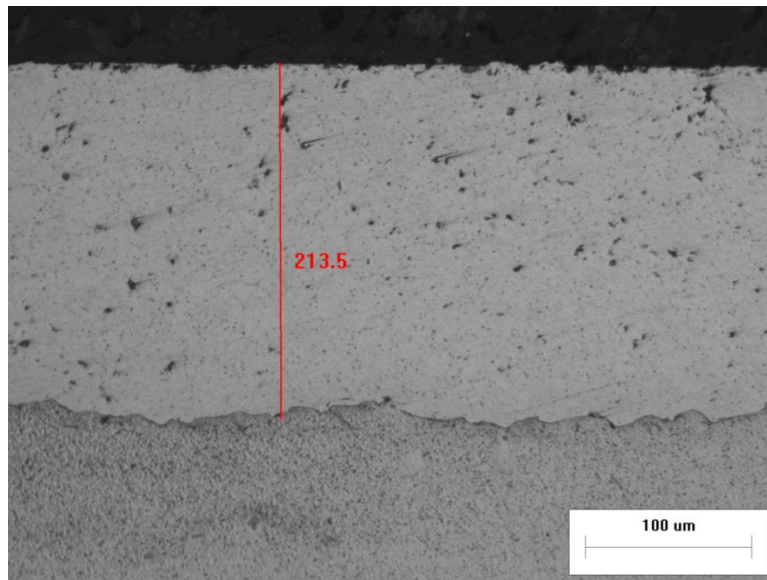
Figure 3.7: Optical microscope image showing Al coating thickness

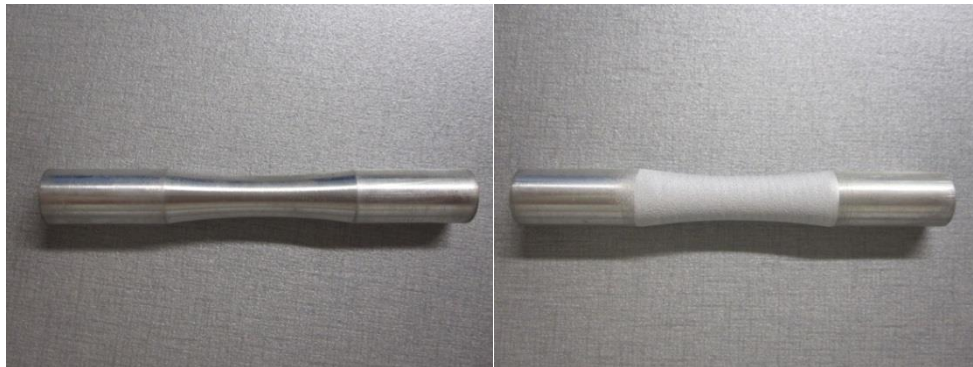
Figure 3.8: Cylindrical specimens used for corrosion fatigue testing: (a) schematic and dimensions (b) bare and (c) Al cold spray coated

For the corrosion fatigue test, 50 cylindrical specimens of AZ31B with dimensions shown in Figure 3.8 were machined and prepared from the extrusion AZ31B piece shown in Figure 3.1 at University of Waterloo machine shop in accordance with the RBM manual [89]. These specimens were then sent to Bodycote Thermal Processing, Kitchener, Ontario, Canada for stress relieve process. The procedure was done at 500 °F (260 °C) for 15 minutes, as per the ASM stress relieve process [40]. The reason for carrying out such a process is to eliminate any internal (residual) stresses that may have accumulated in the material. These stresses can cause undesired properties and behavior in the material including loss of tolerance, cracking and can contribute to some types of failures. Half of these specimens were sent after the stress relief process for Al cold spray coating to Centerline, as before.

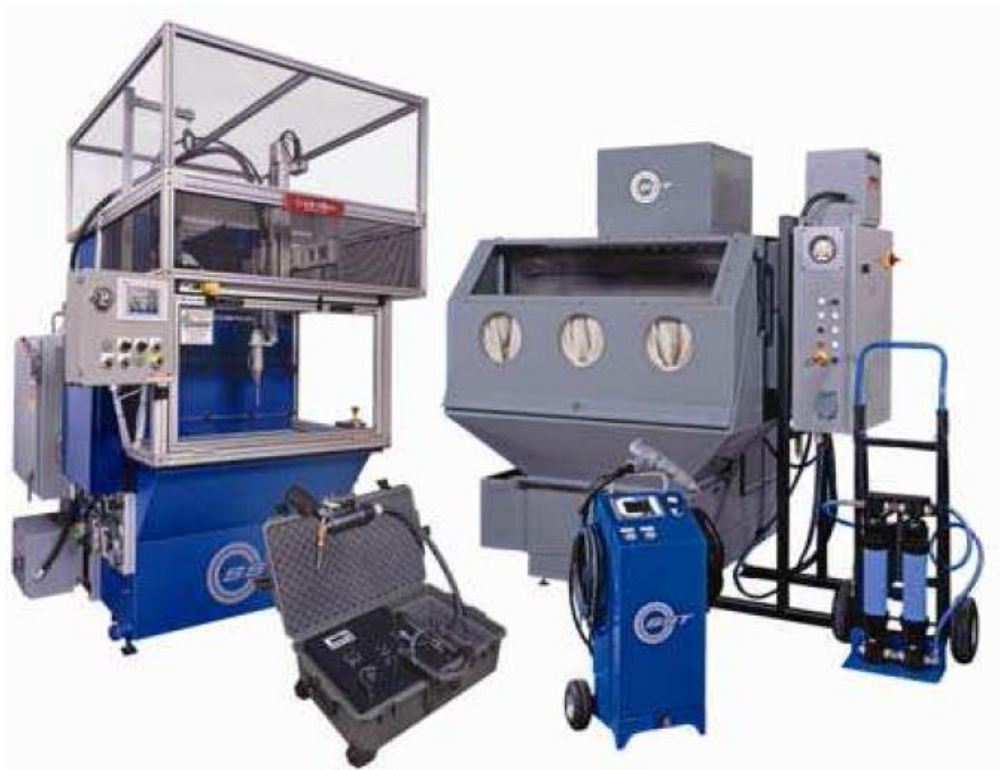
Figure 3.9: Commercial low-pressure cold spray equipment. Picture courtesy of Supersonic Spray Technologies, a division of CenterLine (Windsor) Ltd [90]

The cold spray process used on materials for this project was conducted by Supersonic Spray Technologies (SST), a division of CenterLine (Windsor) Ltd. Figure 3.9 shows typical low-pressure cold spraying equipment used by SST, however, for this research the testing coupons and cylindrical specimens were coated with a high-pressure cold spray applied inside a spray booth similar to what is illustrated in Figure 3.10.

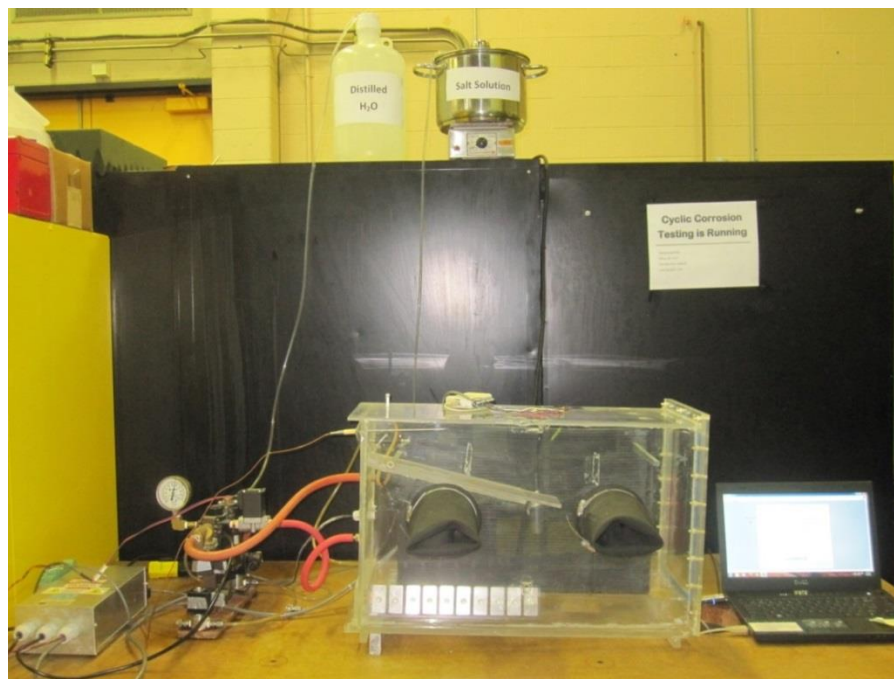
Figure 3.12: In-house corrosion testing apparatus and setup

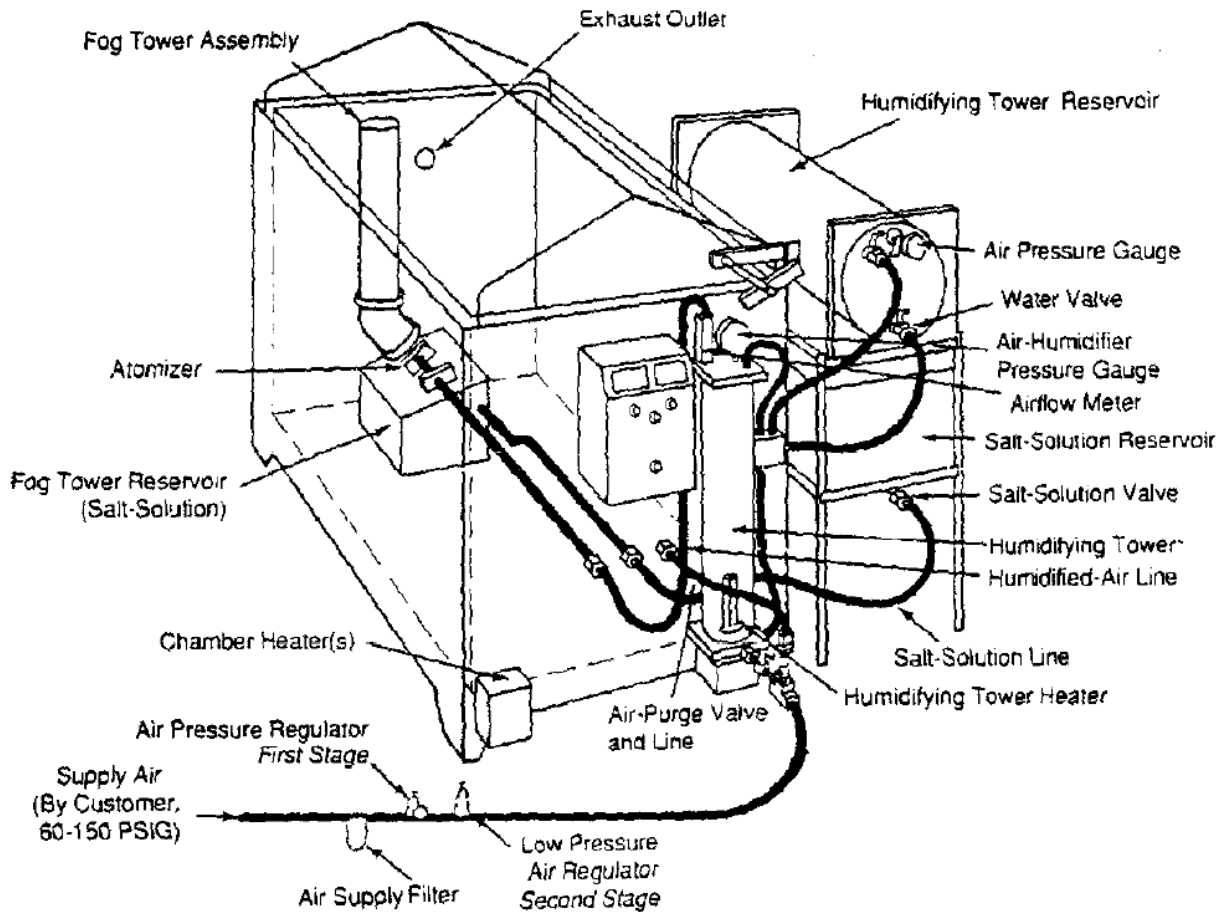
Figure 3.13: Schematic drawing of the salt fog test chamber used for corrosion testing [44]

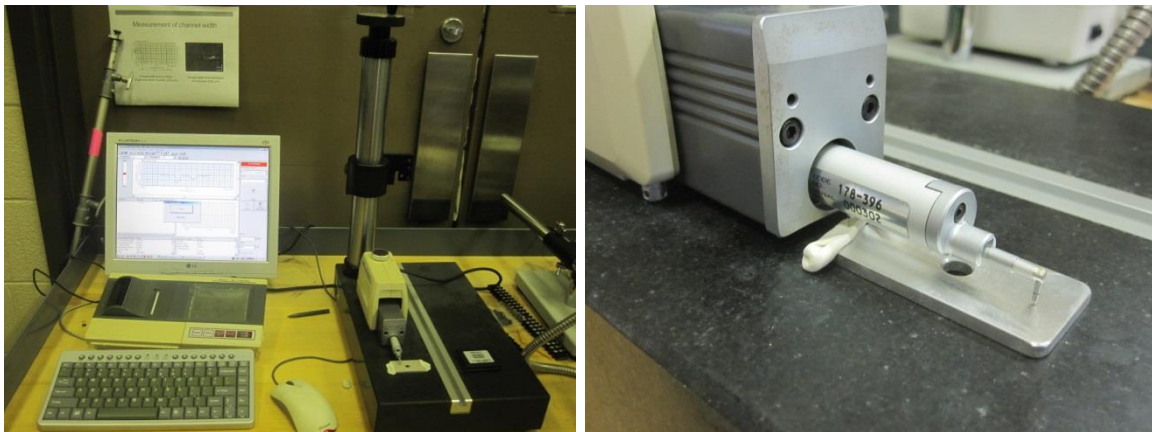
Figure 3.16: SJ-400 surface roughness tester setup

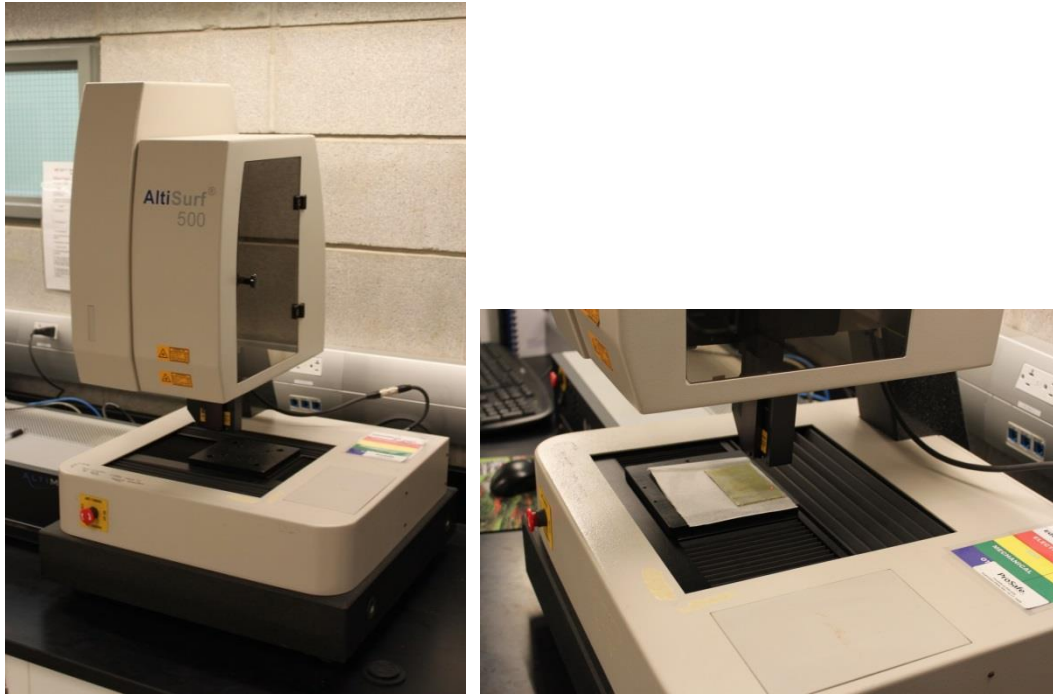
Figure 3.17: AltiSurf® 500 laser profilometer for topographic analysis of samples

In order to measure the weight of the tested coupons before and after the corrosion cycles, as well as before and after the chemical cleaning process, a four digits weighing scale was used. Plastic weighing boats and papers were also used for the weighing process. An SJ-400 surface roughness tester was utilized to measure the surface roughness of coated and uncoated coupons (Figure 3.16). Surface characterization and topographic analysis of the coupons was performed with AltiSurf® 500 laser profilometer (Figure 3.17) and Nanovea 3D Imaging (Figure 3.18), from which two dimensional (2D) and three dimensional (3D) images were generated. These images enabled surface characterization, measurement of functional parameters, pits measurements and 2D roughness analyses. An optical microscope, Scanning Electron Microscope (SEM) and Energy Dispersive X-ray (EDX) were also used in this study, particularly for the analysis of the cold spray coating bonding and analysis of microstructure and grains/grains boundaries.

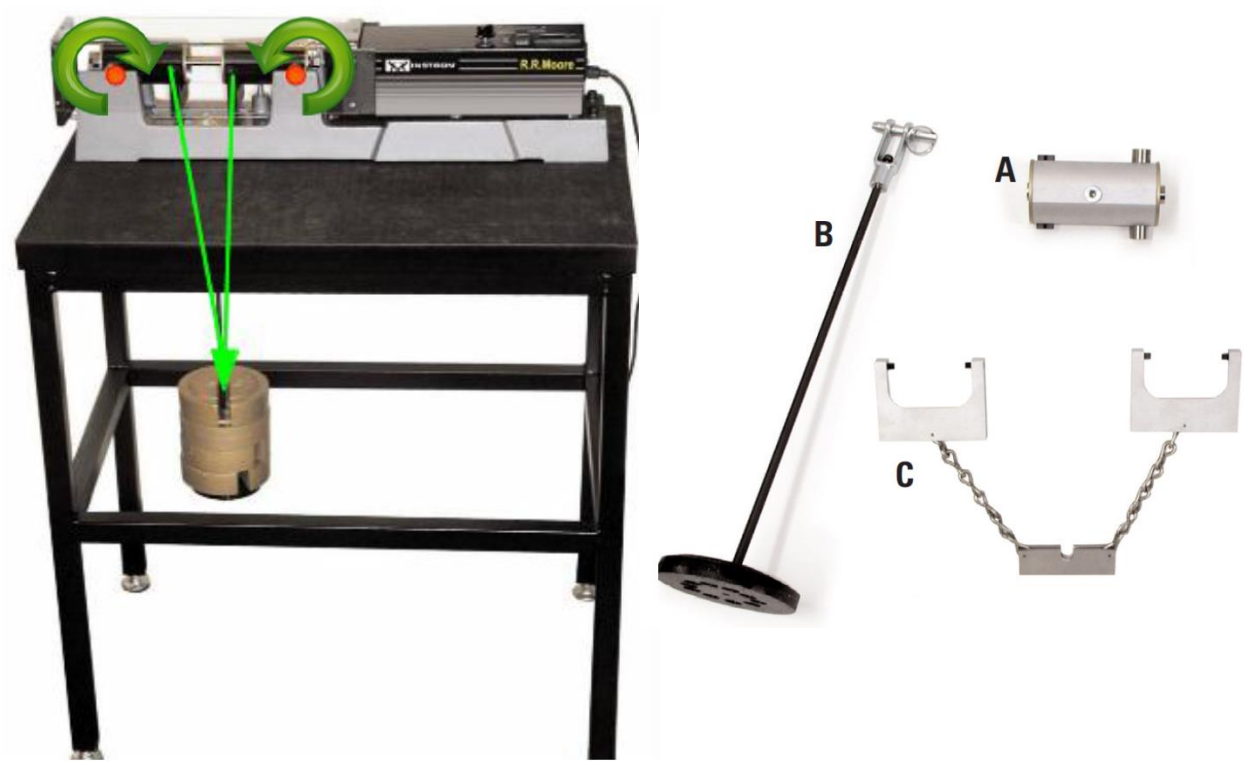
Figure 3.19: R.R. Moore Rotational Beam Fatigue Testing Machine: (a) bearing housing, (b) weight pan, and (c) loading harness [89]

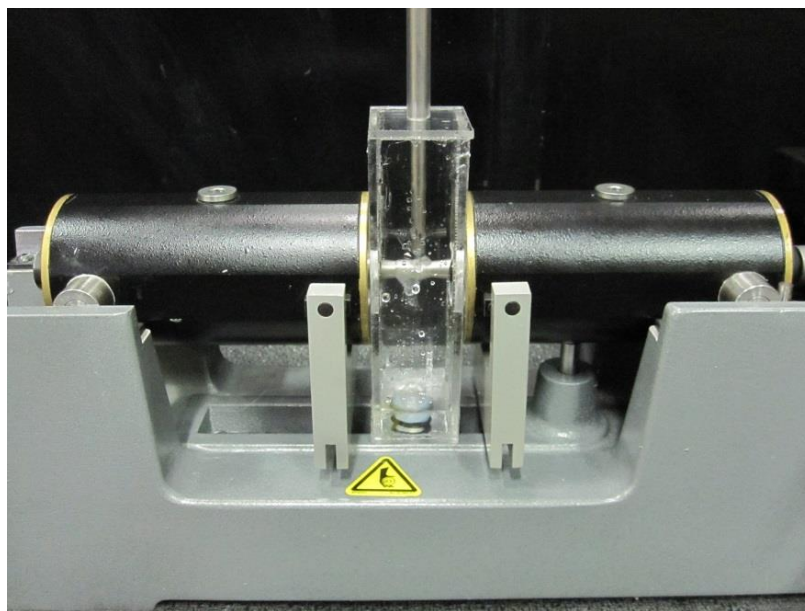
Figure 3.20: Setup for the corrosion fatigue testing

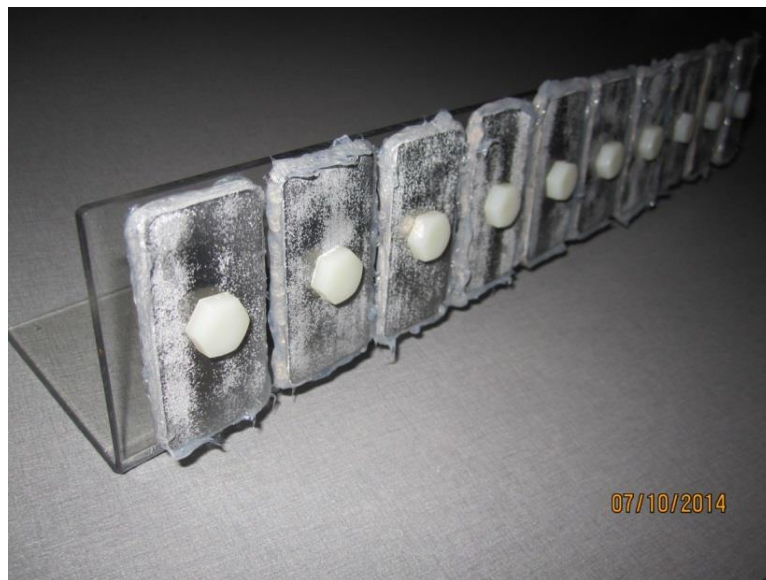
Figure 4.1: Coupons edges protected with silicon resin

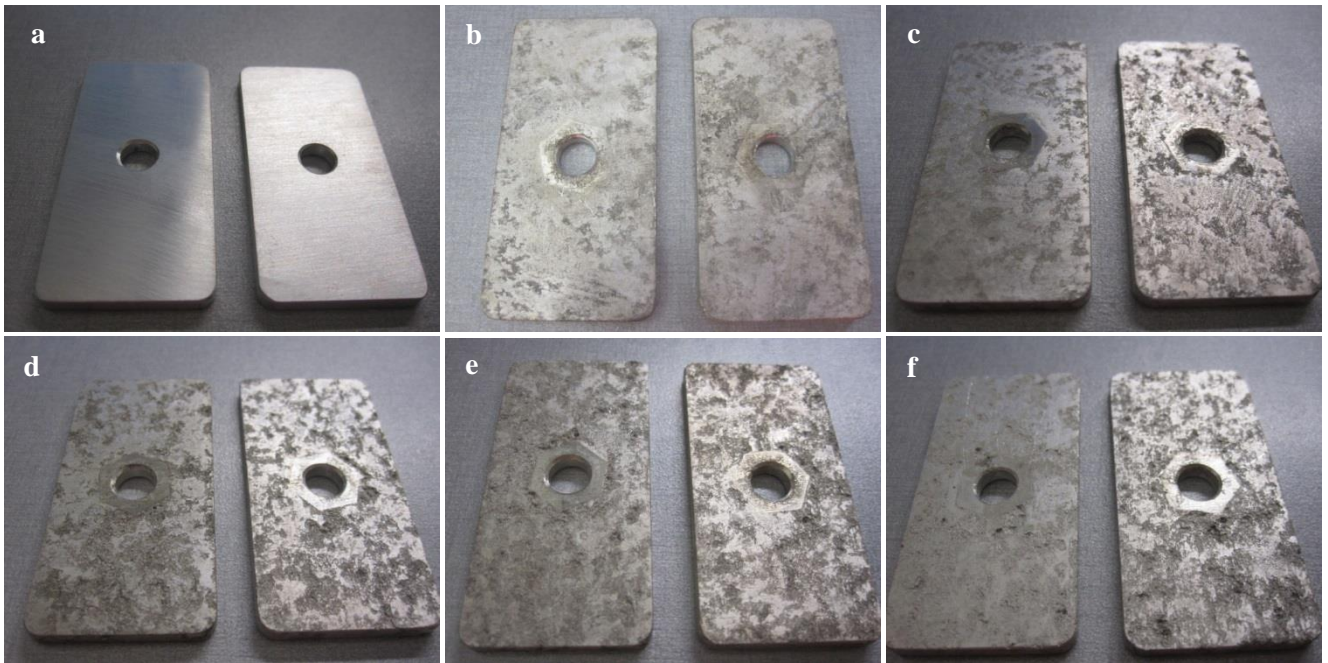
Figure 4.2: Bare AZ31B coupons before and after 15 days of salt spray exposure: (a) before testing,
