The Effect of Aluminum Cold Spray Coating
on Corrosion Protection and Corrosion Fatigue
Life Enhancement of Magnesium Alloy,
AZ31B

A thesis
presented to the University of Waterloo
in fulfillment of the
thesis requirement for the degree of
Master of Applied Science
in
Mechanical Engineering

Waterloo, Ontario, Canada, 2015

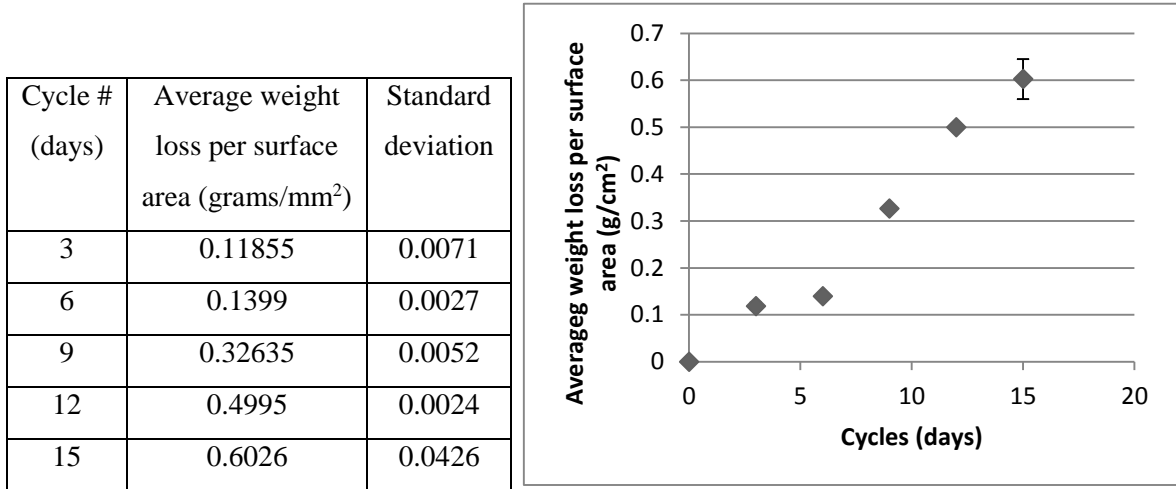
Figure 4.3: Average weight loss versus the number of tested cycles

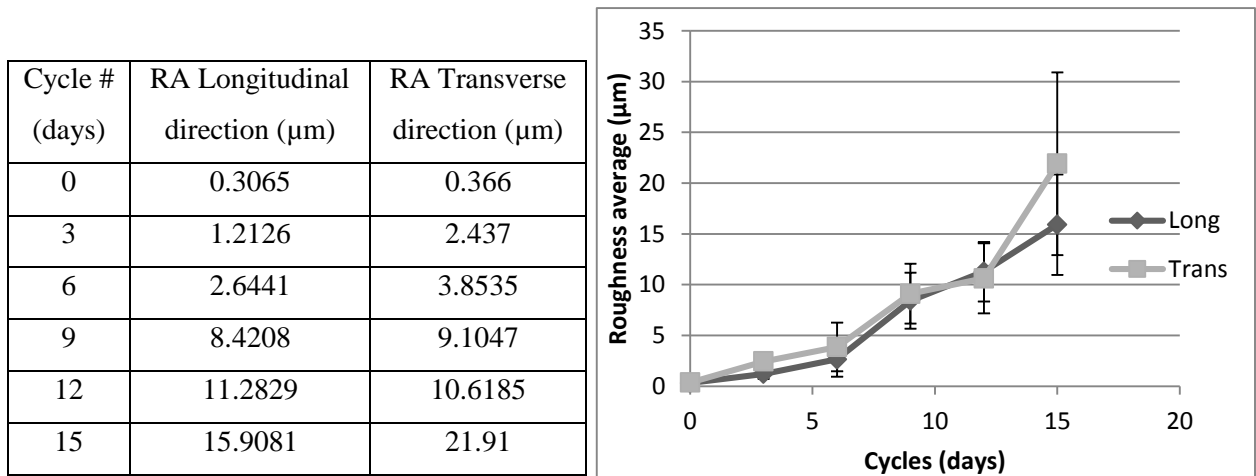
Figure 4.4: Average roughness measurements versus the number of tested cycles

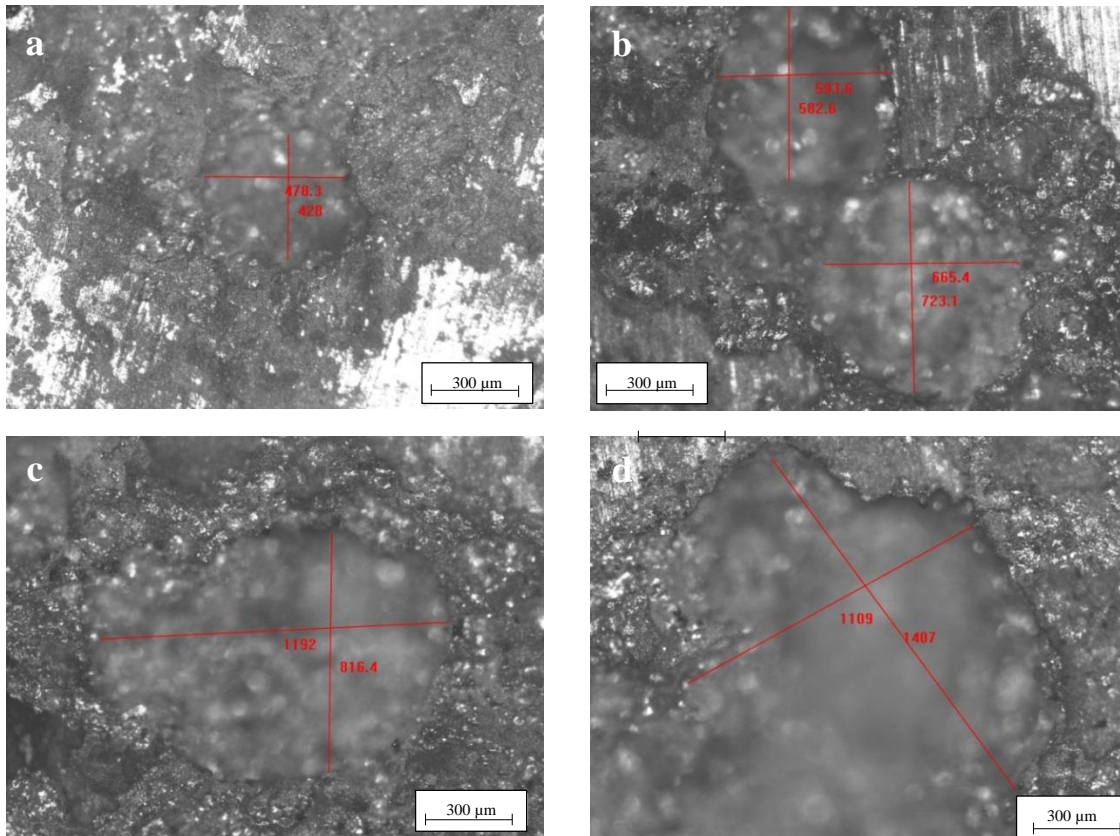
Figure 4.5: Typical sizes of the pits in bare coupons after: (a) 6 cycles, (b) 9 cycles, (c) 12 cycles, and (d) 15 cycles in bare and coated coupons

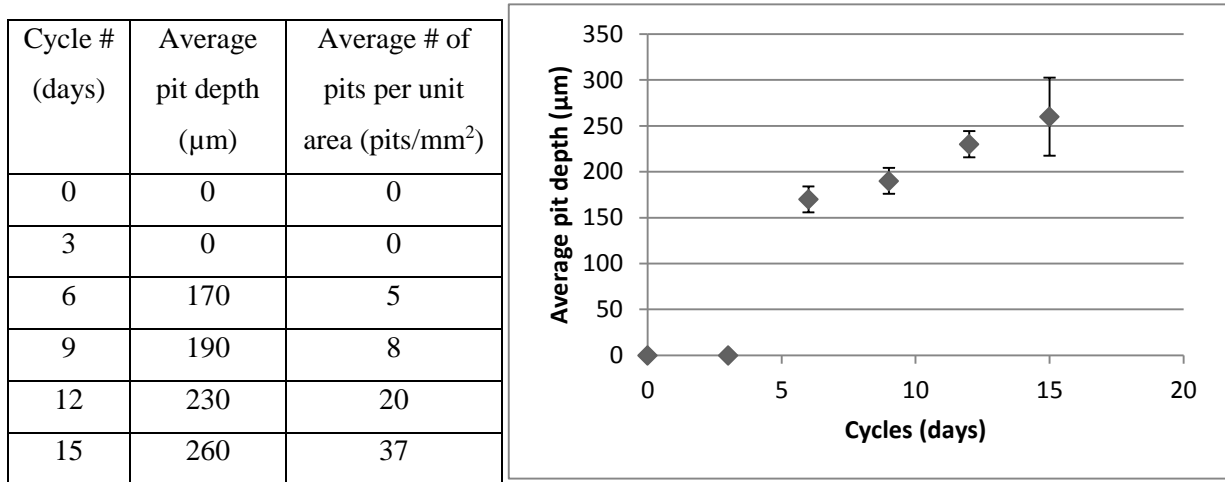
Figure 4.8: Average pit depth versus the number of tested cycles for bare and coated coupons

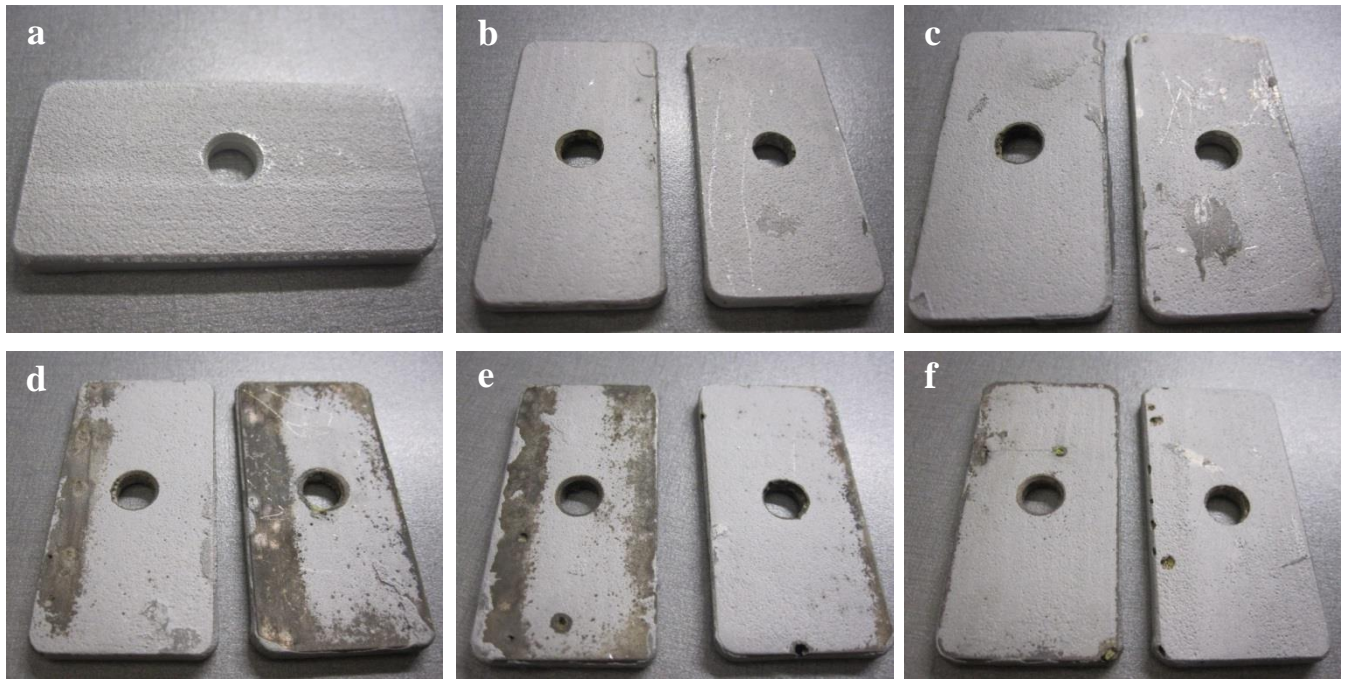
Figure 4.9 Coated coupons before and after 15 days of salt spray exposure: (a) before testing, (b) after 3 cycles, (c) after 6 cycles, (d) after 9 cycles, (e) after 12 cycles, and (f) after 15 cycles

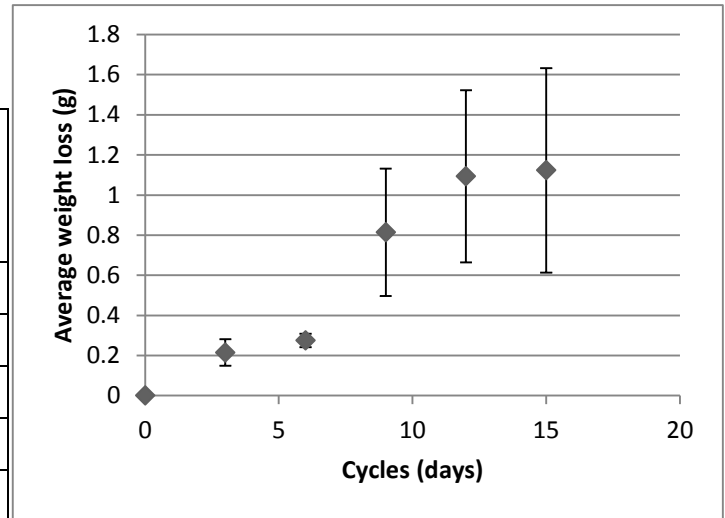
Figure 4.10: Average weight loss versus the number of tested cycles for coated coupons

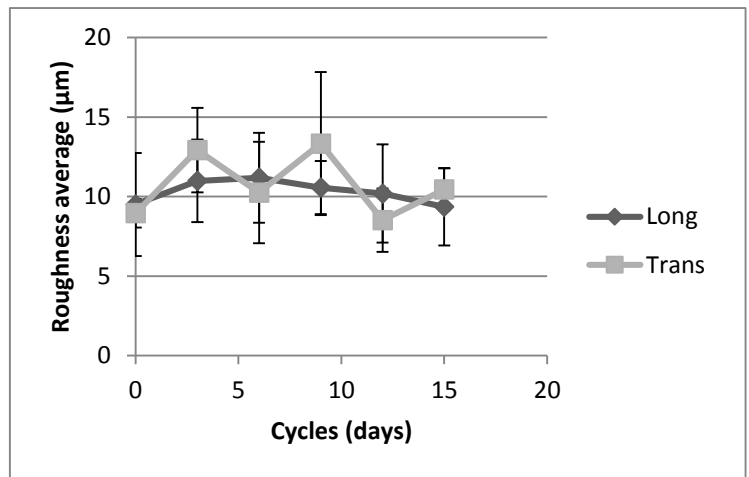
Figure 4.11: Average roughness measurements versus the number of tested cycles for coated coupons

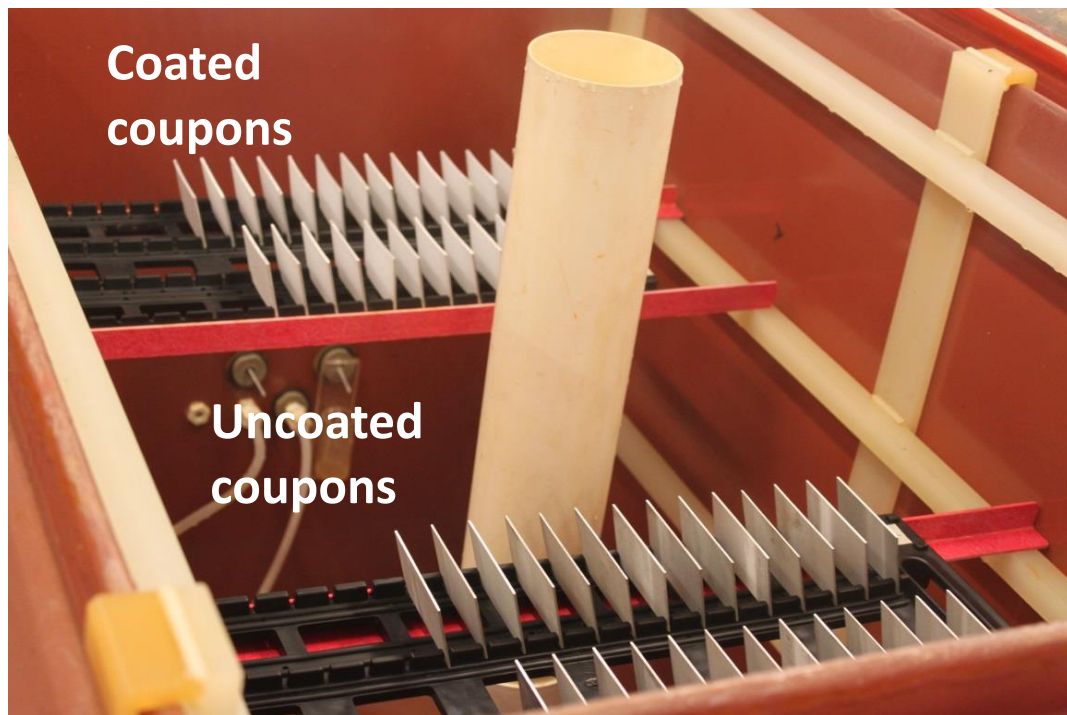
Figure 4.15: The testing coupons (coated and uncoated) distributed in the rack before testing

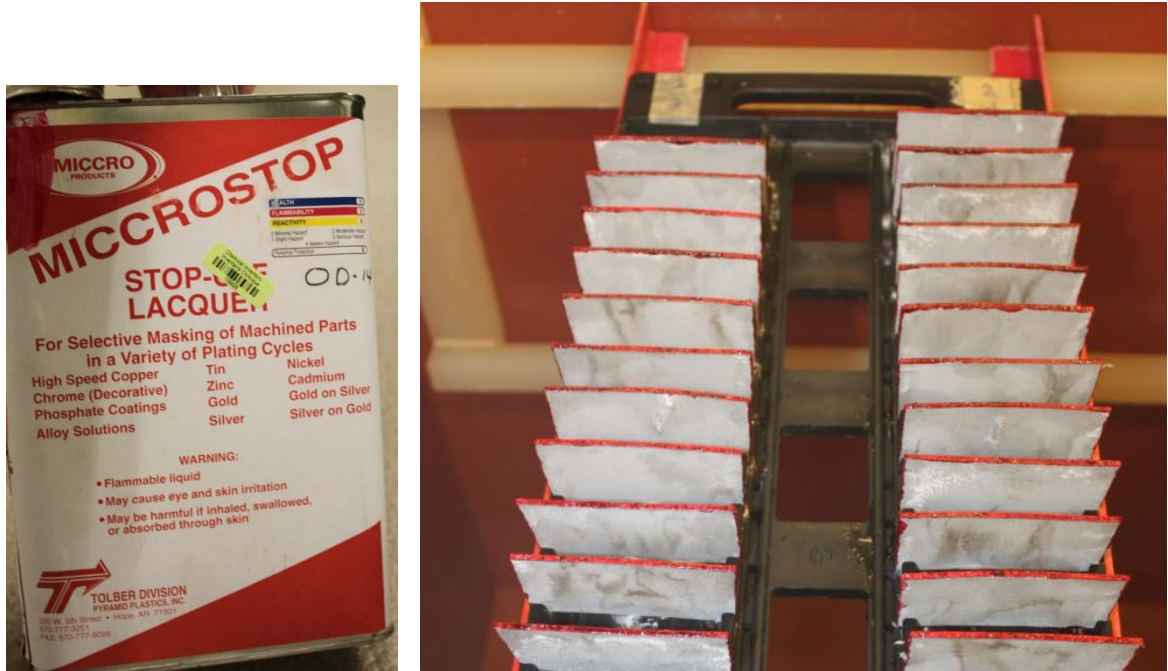
Figure 4.16: The applied mask used for protecting the edges of coated coupons

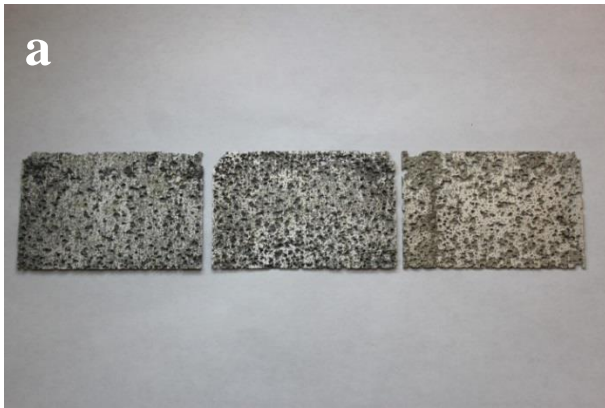
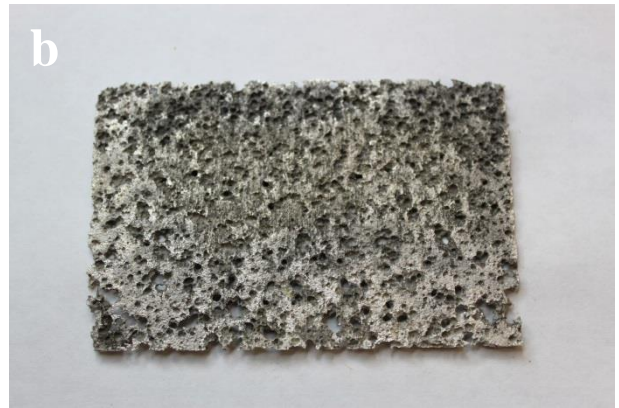
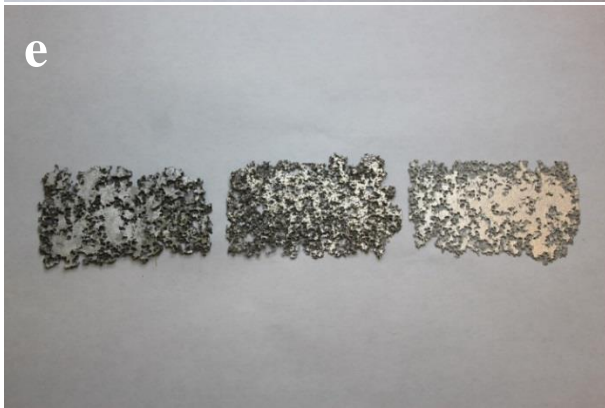
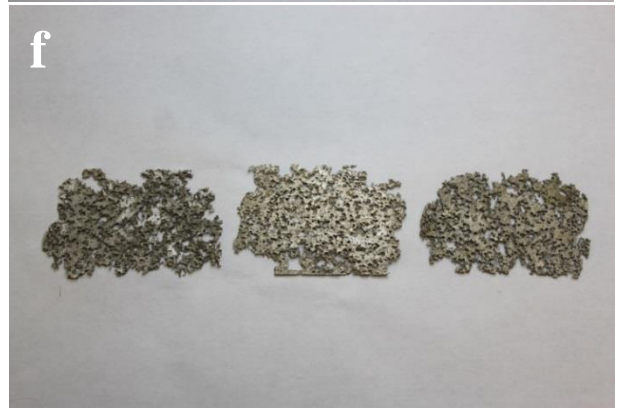
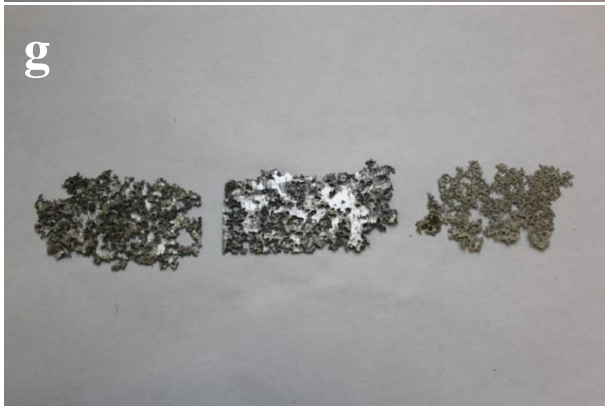
Figure 4.17: Uncoated coupons exposed to 5% salt spray after: (a) 4 cycles, (b) 6 cycles, (c) 8 cycles, (d) 11 cycles, (e) 14 cycles, (f) 17 cycles, (g) 20 cycles, (h) 23 cycles, (i) 26 cycles, and (j) 33 cycles

The general and pitting corrosion morphology and severe weight loss shown in Figure 4.2 and Figure 4.17 can be directly contributed to the oxidation/reduction reactions described in equations 4.1-4.3. However, the following factors were also playing important roles in this corrosion mechanism:

- The formed magnesium chloride salt from (Eq. 4.3) react with the naturally formed $\text{Mg}(\text{OH})_2$ film and weakens it [93]. This explains the fact that the corrosion morphology of the CanmetMATERIALS testing coupons (Figure 4.17) was more severe than those tested at UW (Figure 4.2). The reason for this is that the cyclic corrosion testing used in the UW which includes the chloride-free humidity phase, allows the formation and rebuilding of the $\text{Mg}(\text{OH})_2$ film that was damaged during the salt exposure phase and this will reduce the corrosion attack on the surface [93]. On the other hand, the CanmetMATERIALS testing coupons were exposed to a continuous salt spray with a concentration of 5% NaCl. This will not allow the Mg substrate to form the $\text{Mg}(\text{OH})_2$ film as it will be continually dissolved due to the reaction with magnesium chloride salt [93],[94].

The secondary phases and the grains boundary also act as galvanic cathodes to the α -Mg matrix; this tends to occur in Mg-Al alloys with lower amounts of Al. In our case study, AZ31B alloy is a typical example of this. Because the alloy contains less Al than AZ91, it has a small volume fraction of second phases (shown in Figure 4.22) and these second phases acted as galvanic cathodes to the α -Mg matrix and increased the corrosion rate. This fact also explains the general and pitting corrosion morphology of the tested bare AZ31B coupons in both corrosion testings Figure 4.2 and Figure 4.17.

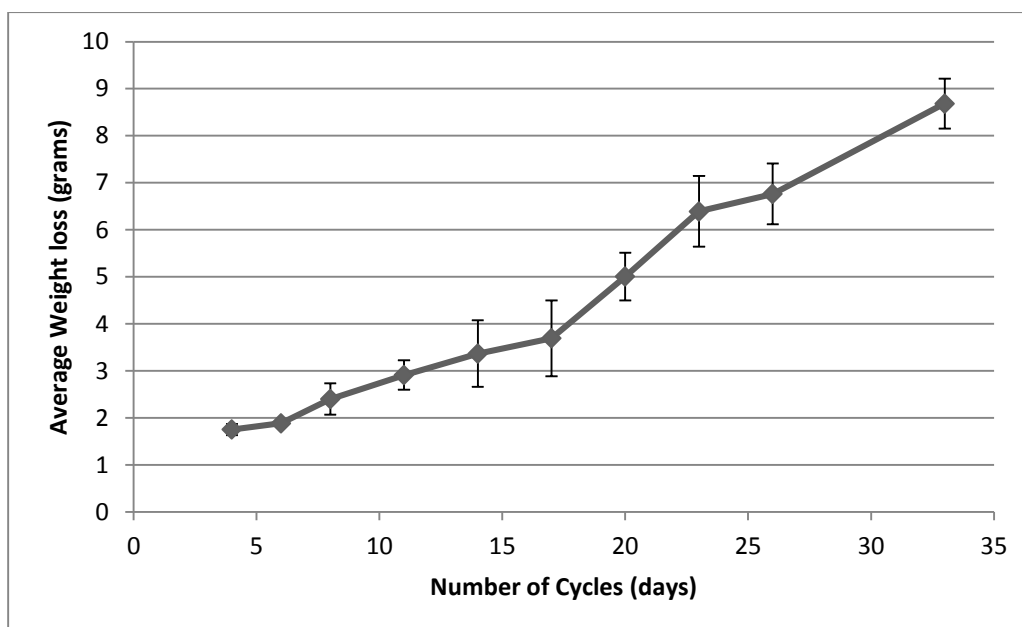
Figure 4.18: Average weight loss versus the number of tested cycles for bare AZ31B coupons

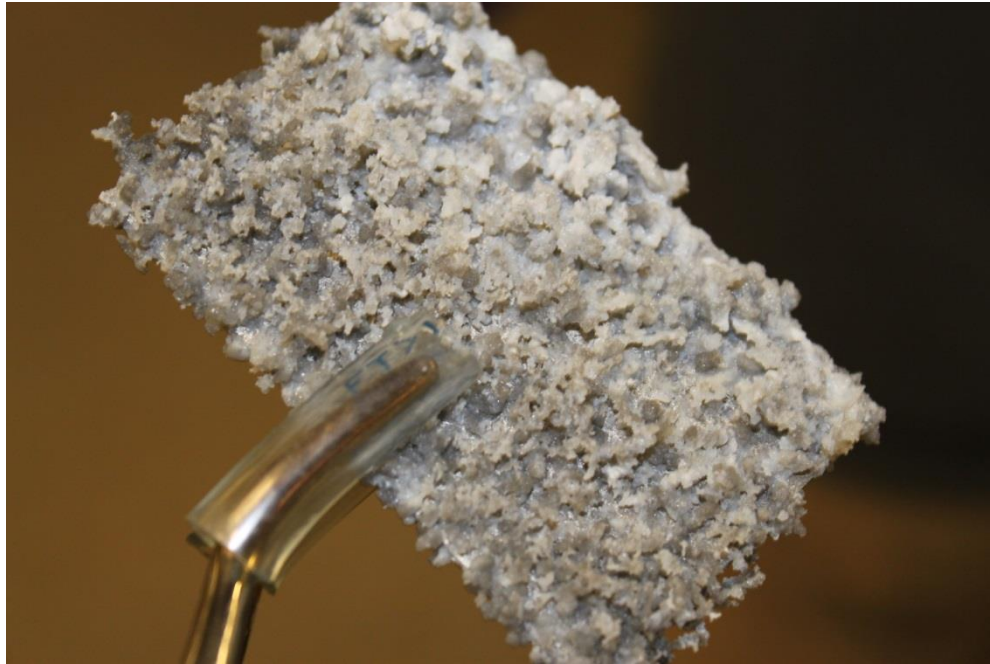
Figure 4.19: Corrosion products accumulated on a bare coupon after 6 days of testing

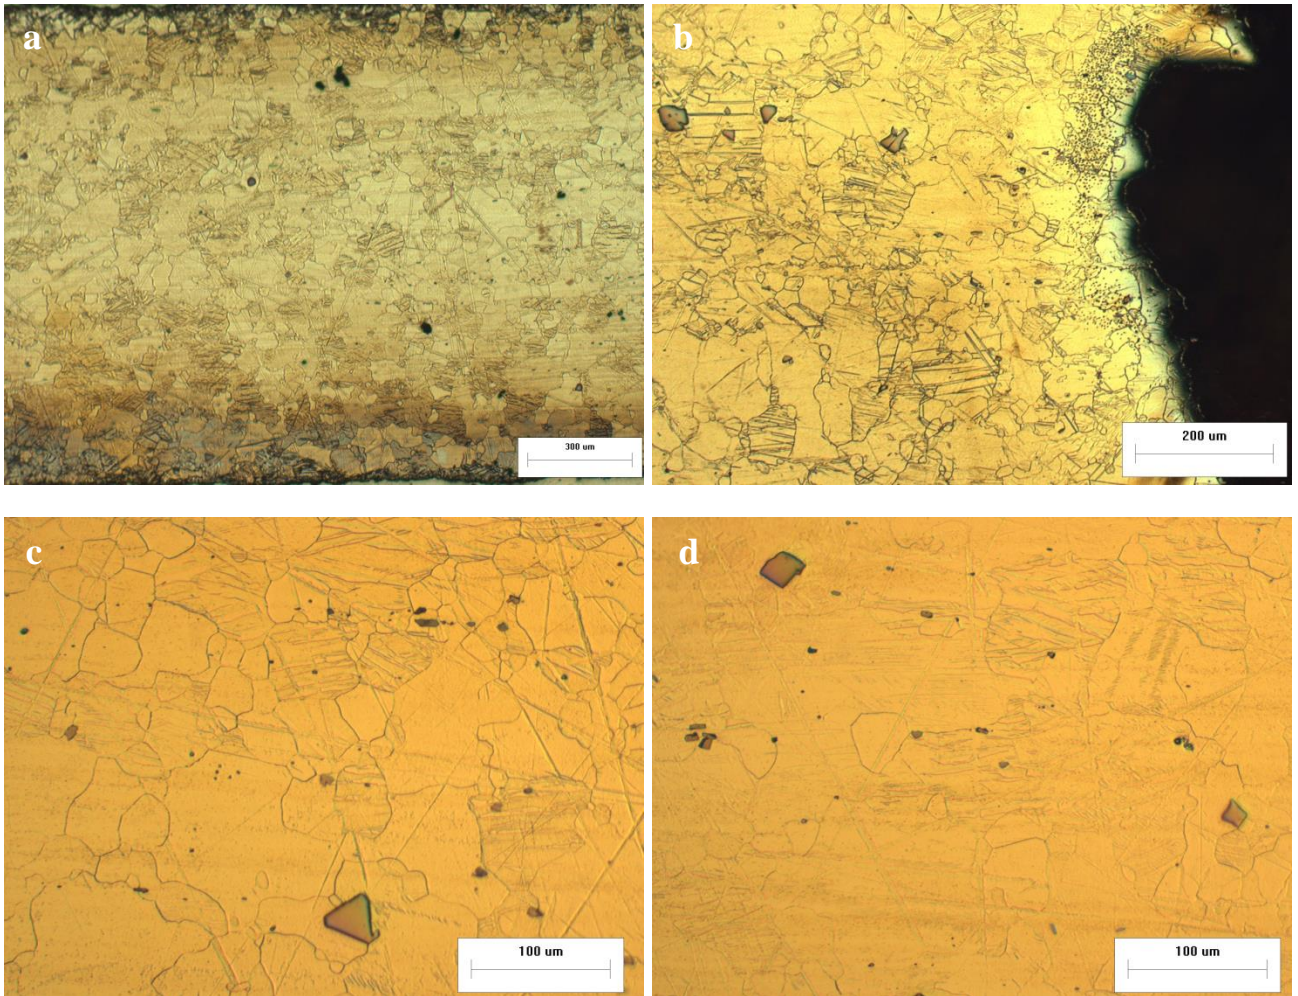
Figure 4.20: Optical cross section micrographs showing the microstructure of AZ31B as (a) coated coupon after 11 cycles of corrosion testing, (b) uncoated coupon after 8 cycles of corrosion testing, (c) coated alloy before corrosion testing, and (d) uncoated alloy

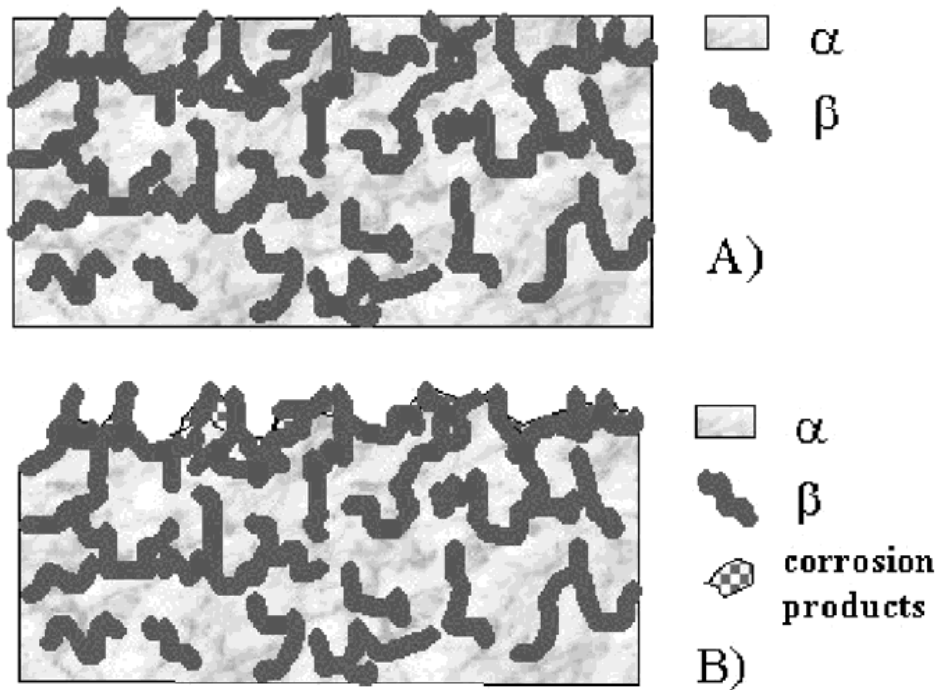
Figure 4.23: Schematic of the role of the β -phase on corrosion: (a) initial surface and (b) surface after corrosion [27]

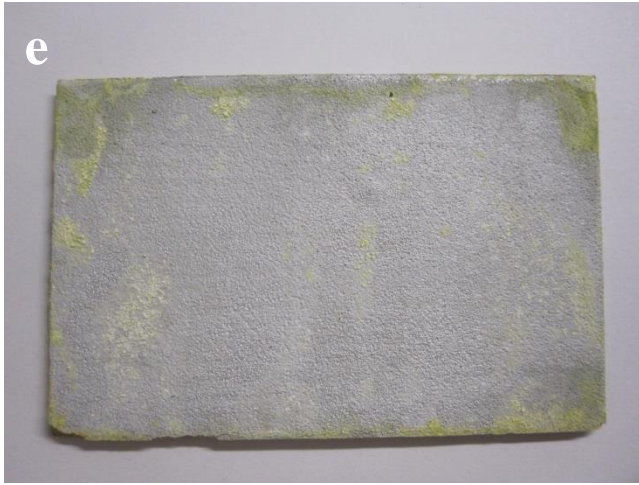
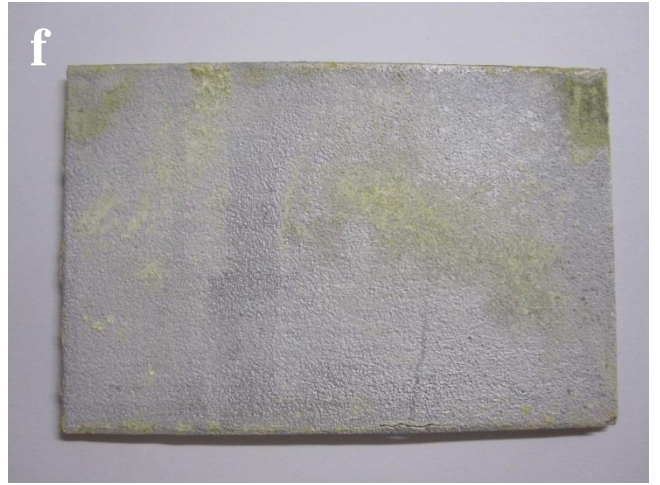
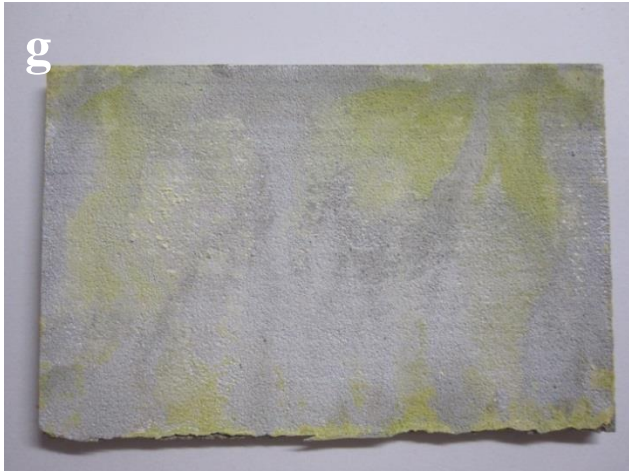
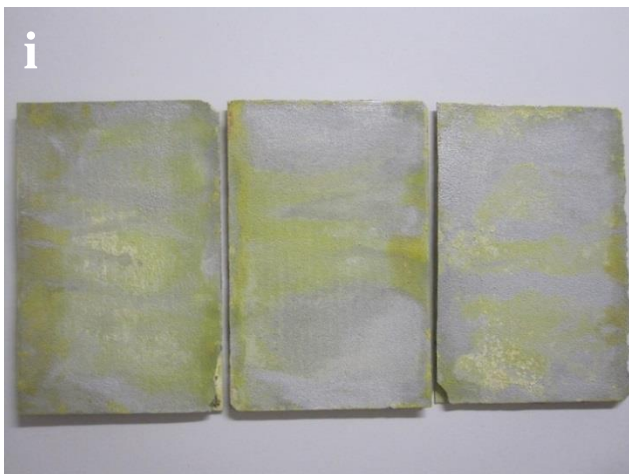
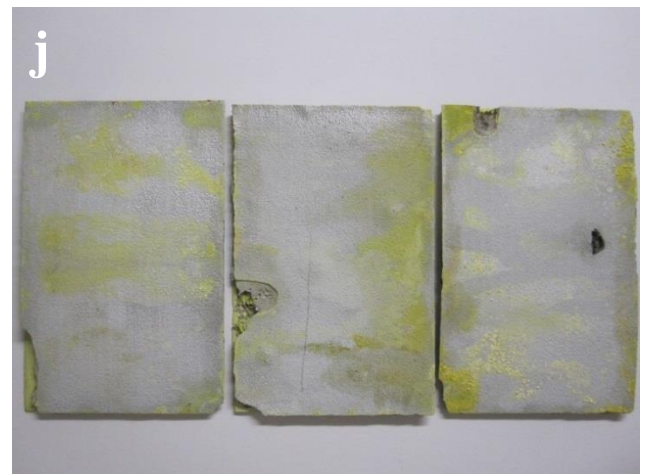
Figure 4.24: Coated coupons exposed to 5% salt spray after: (a) 4 cycles, (b) 8 cycles, (c) 11 cycles, (d) 14 cycles, (e) 17 cycles, (f) 20 cycles, (g) 23 cycles, (h) 26 cycles, (i) 33 cycles, (j) 40 cycles, (k) 60 cycles, (l) 90 cycles

A total of 20 coupons coated with cold sprayed Al powder were tested in the CanmetMATERIALS corrosion chamber under the parameters used for the bare coupons. Originally the full testing period was set to be 33 cycles (days) with the same removal frequency and analysis as the uncoated. However, at the first evaluation after 4 cycles it was observed that the coating was providing a very good corrosion protection and the Mg substrate is totally isolated except from minor areas at the edges where no Al coating could be applied. So it was decided to lower the number of coupons removed for testing and to increase the testing duration up to 90 cycles (days) in order to get a better idea about the corrosion behavior of the coated coupons and the effect of the Al cold spray coating on corrosion protection over a long exposure time. Figure 4.24 shows the macrographs of the coated coupon surfaces after 5% salt spray exposure for 90 cycles.

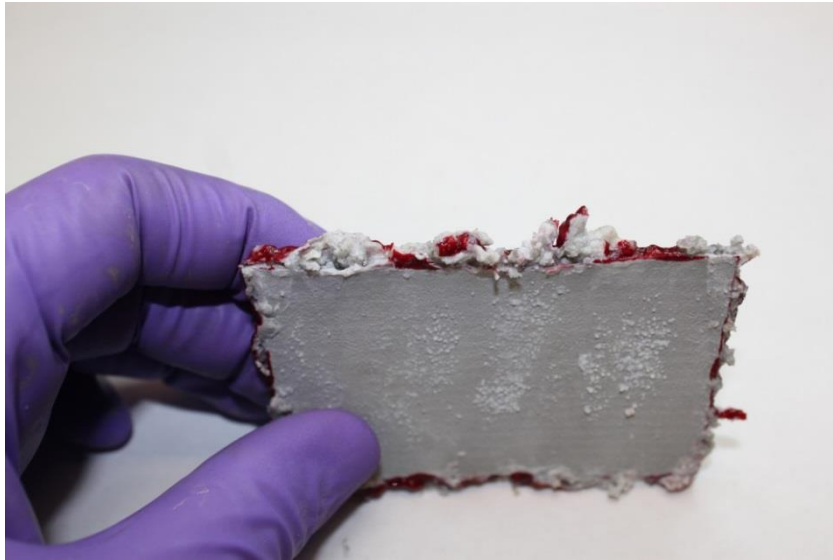
Figure 4.25: Corrosion products accumulated on a coated coupon after 8 days of testing

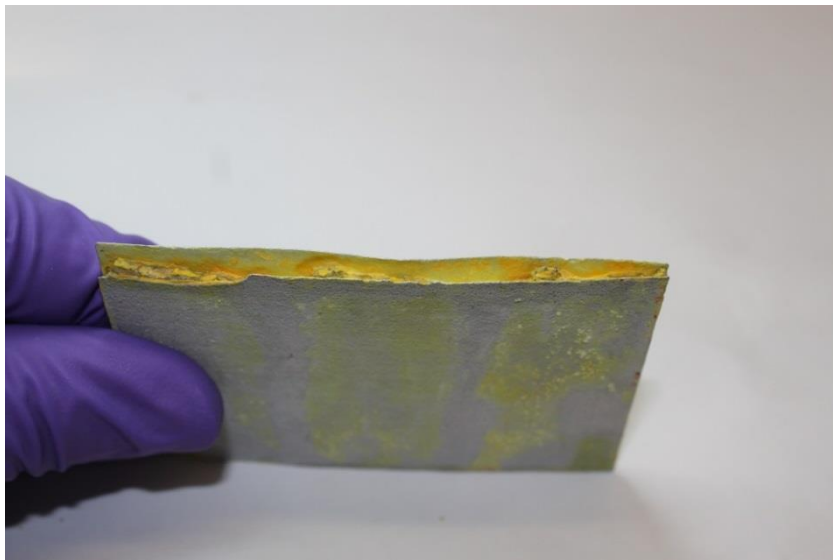
Figure 4.26: Coated coupon after cleaning/removing edges corrosion products, 40 days of testing

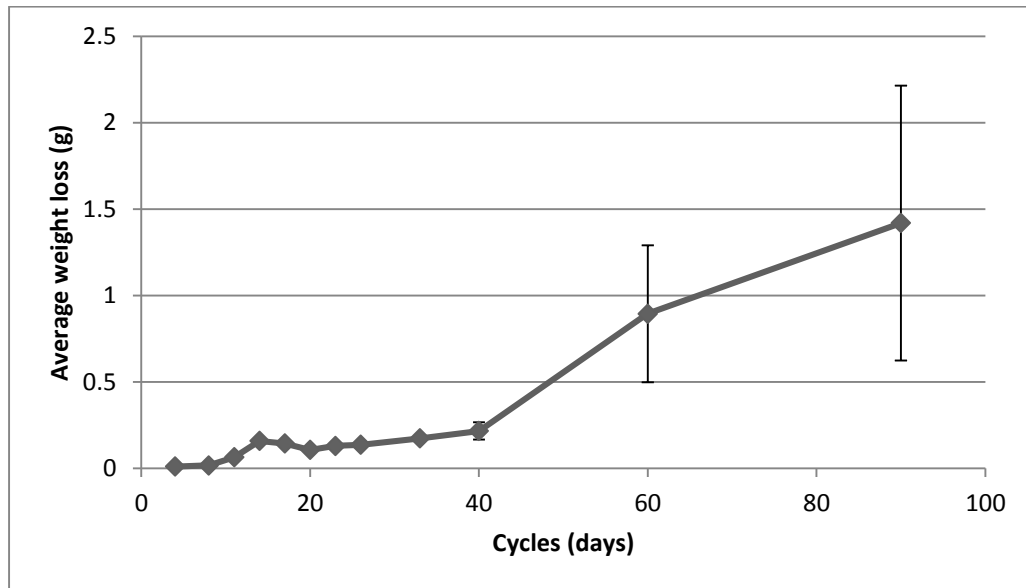
Figure 4.27: Average weight loss versus the number of tested cycles for coated coupons

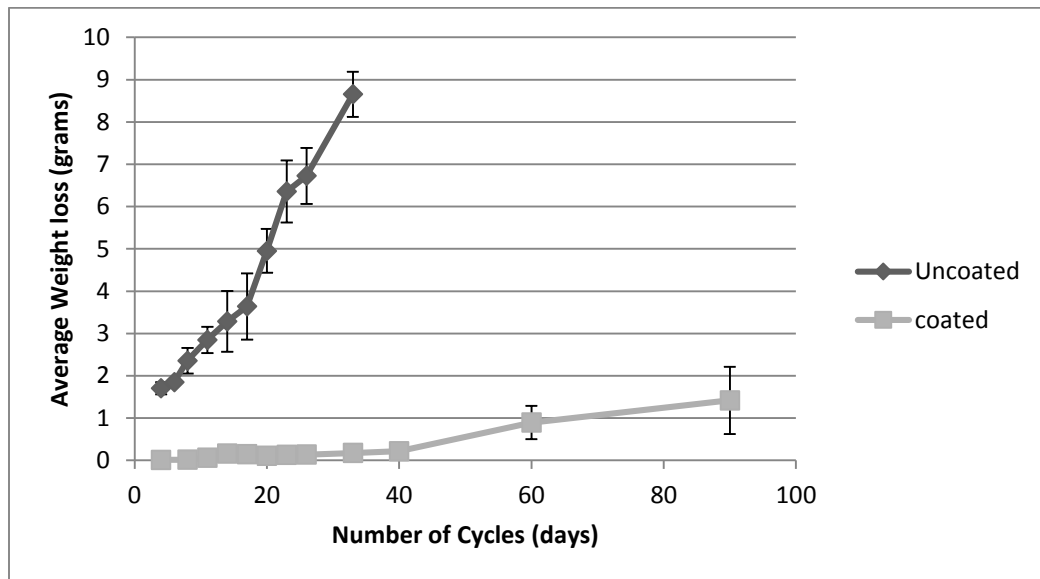
Figure 4.28: Average weight loss versus the number of tested cycles for bare and coated coupons

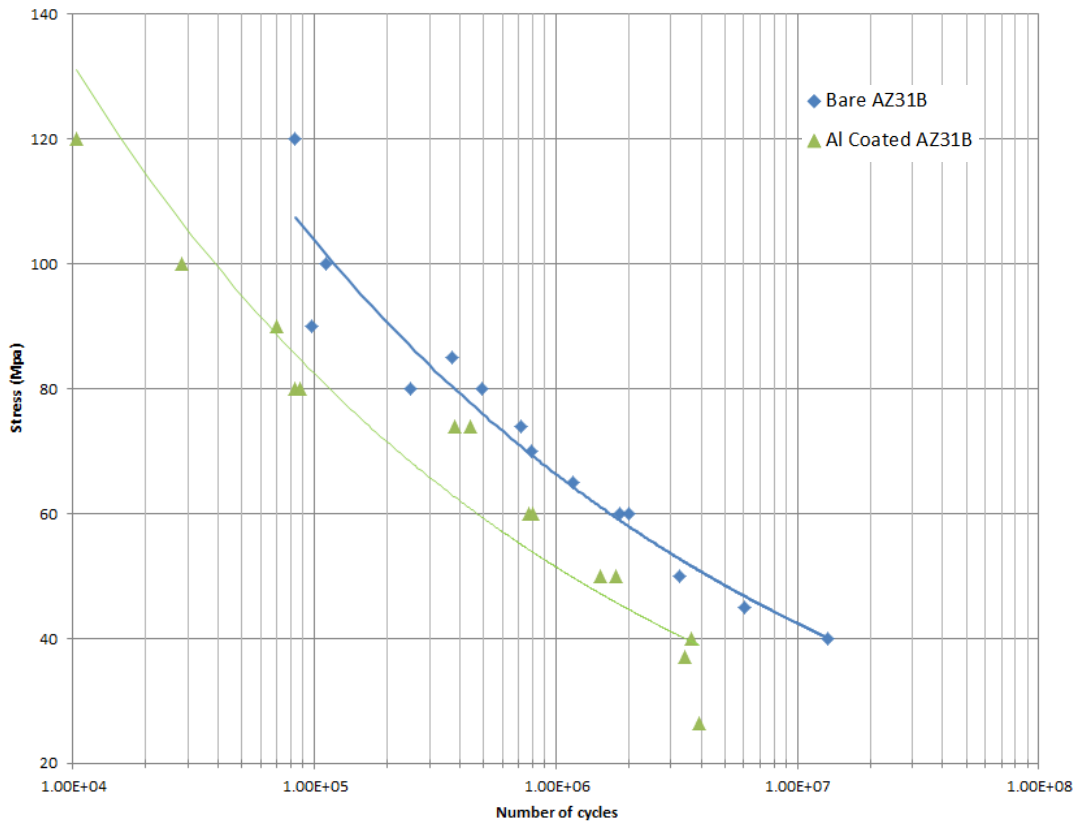
Figure 4.31: S-N curves of RBM testing for coated and uncoated specimens under NaCl environment

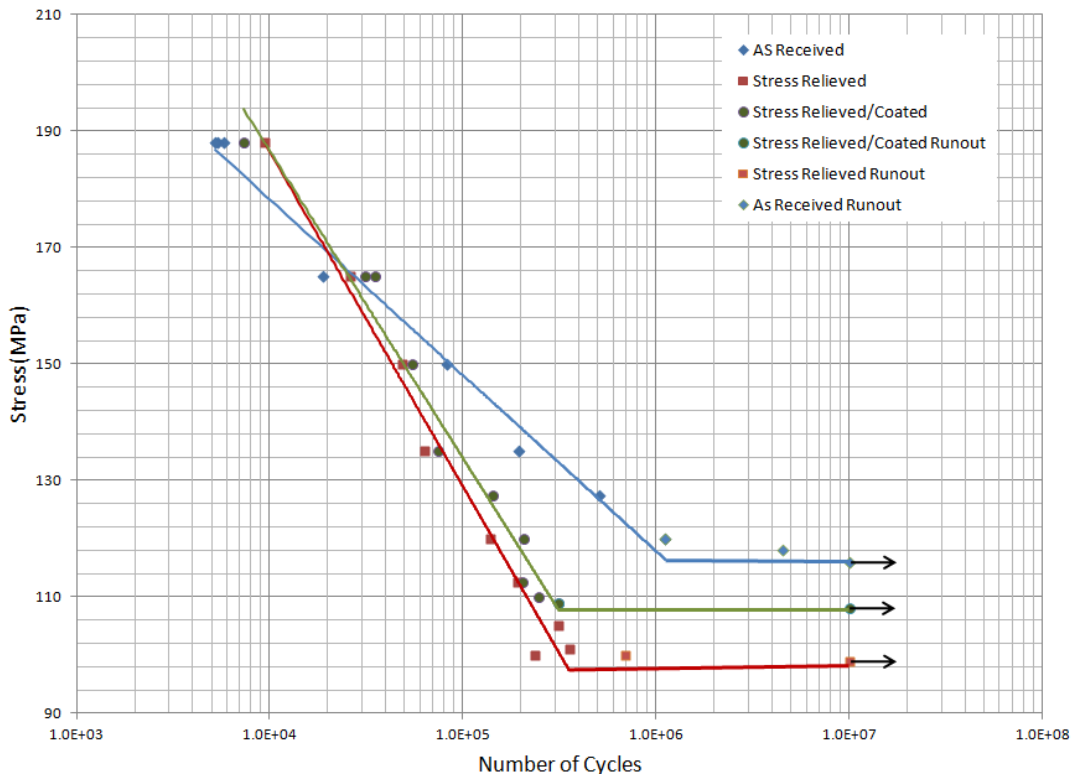
Figure 4.32: S-N curves of RBM testing for coated and uncoated specimens in air [96]

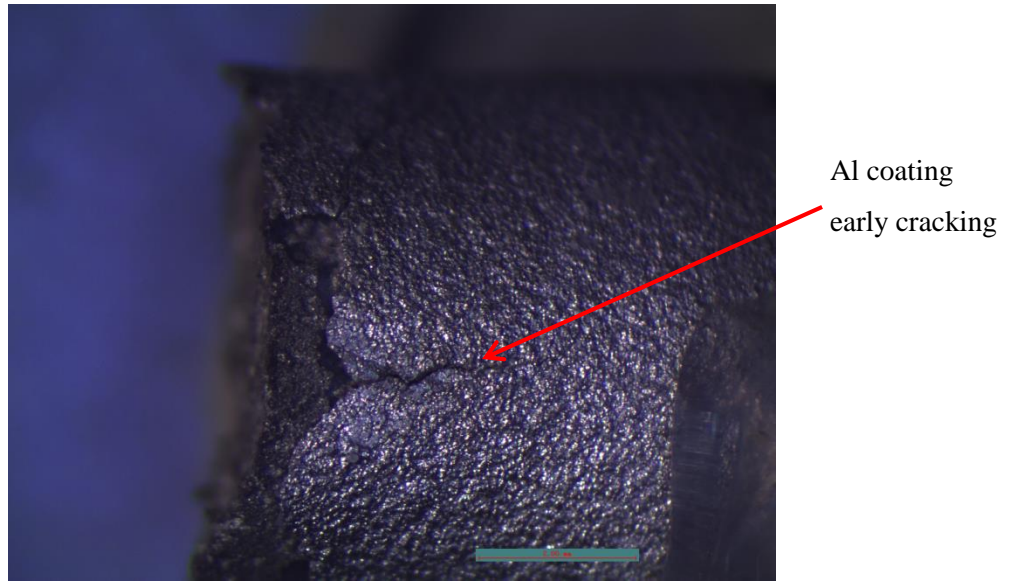
Figure 4.33: Cracking of Al cold spray coating on the surface at a stress of 60 MPa

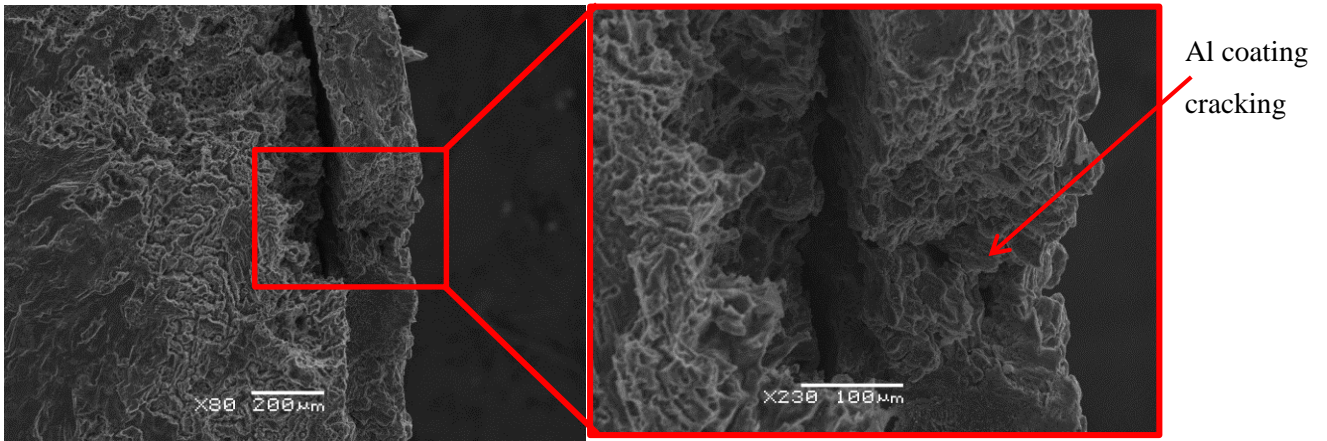
Figure 4.34: Cracking of Al cold spray coating at a stress of 80 MPa in the corrosion fatigue test

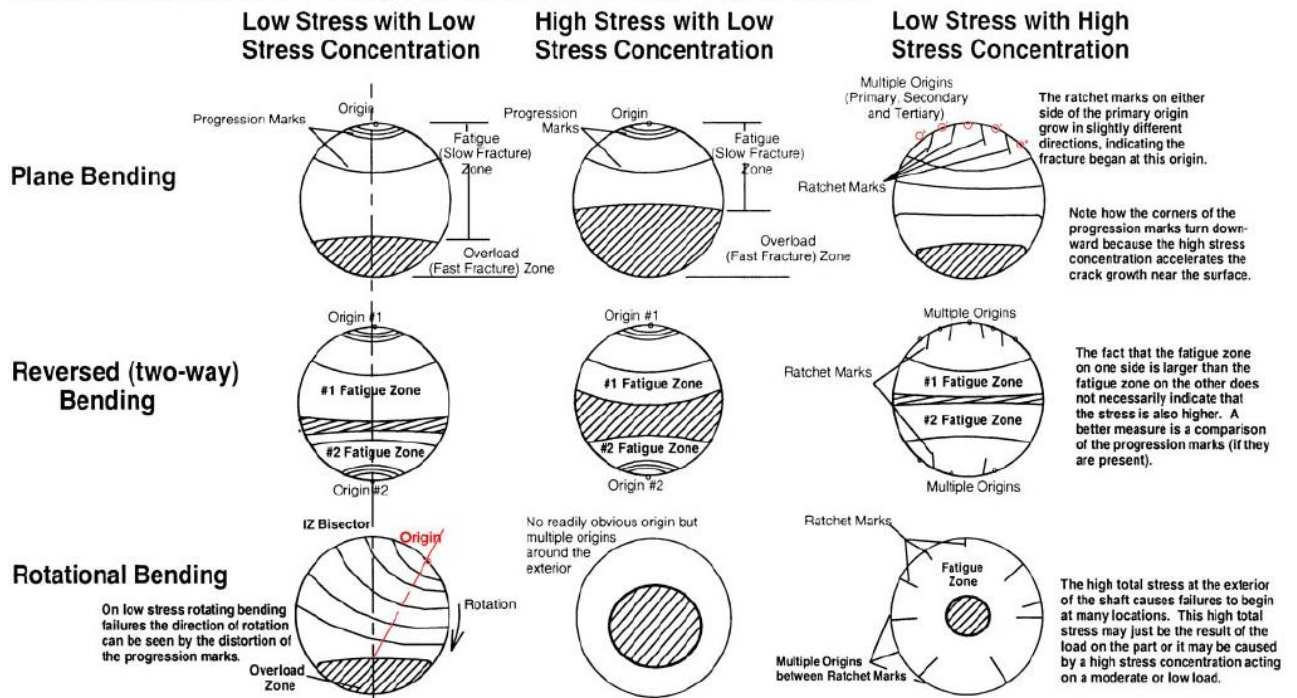
Figure 4.35: Fracture surfaces of round specimens under different types of loading [40]

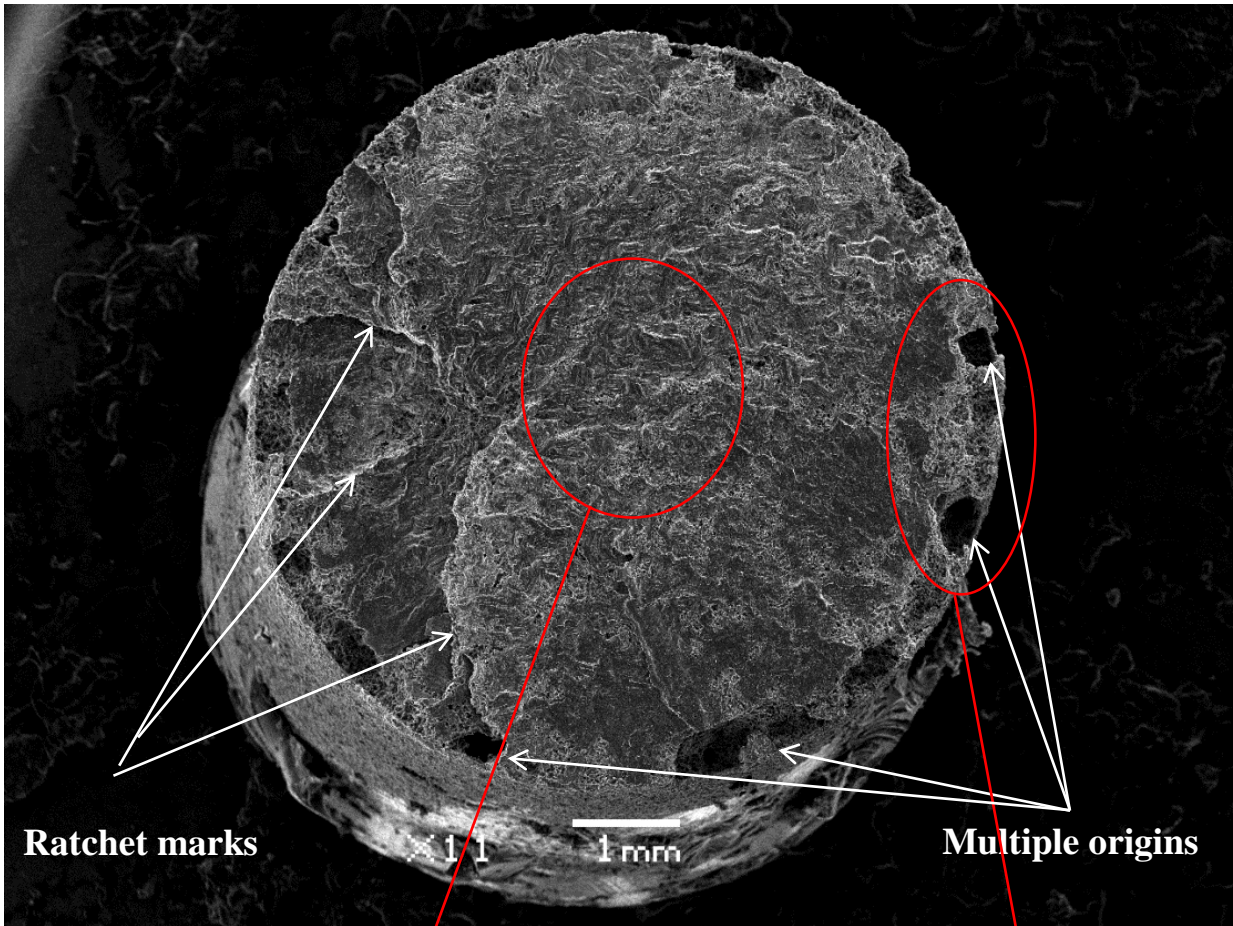
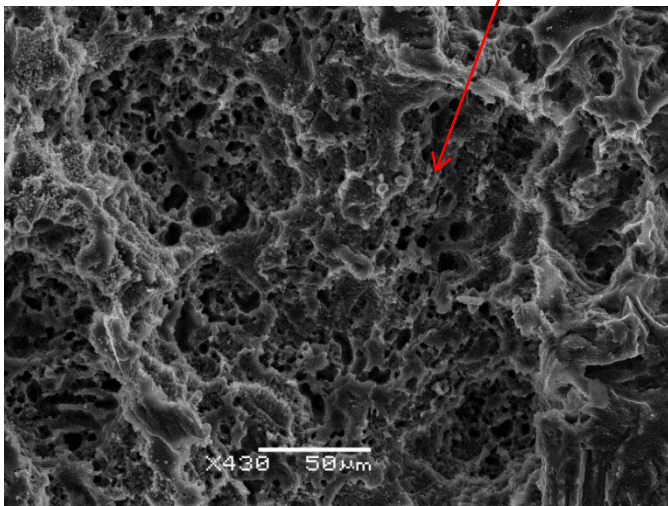
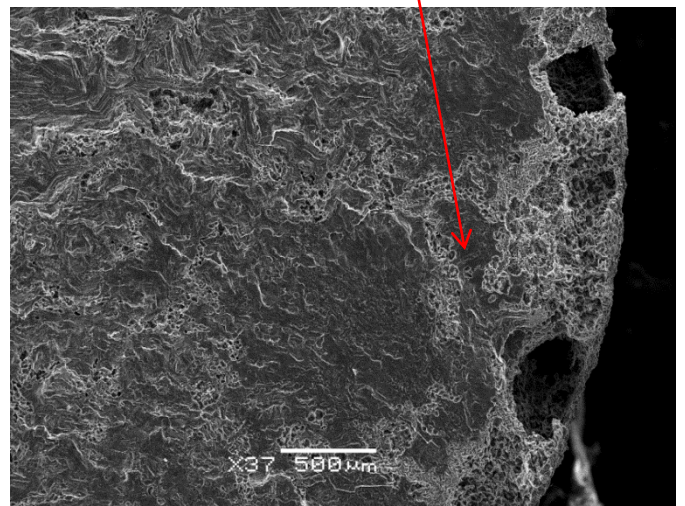
Figure 4.37: Fracture surfaces of bare sample at a stress of 40 MPa showing: (a) overall fracture surface, (b) mixed mode final fracture, and (c) initiation areas
