# RECONSTRUCTION OF THE RAILWAY LINE VINKOVCI – OSIJEK

Professional paper

After 17 years, railway line Vinkovci – Osijek has been finally restored and opened to traffic. Reconstruction of the railway line Vinkovci – Osijek is important for wider community of the two neighbouring counties. With this railway line, the Osijek – Baranja County and the Vukovar – Srijem County have got better connectivity and convenient alternative to road transport, offering the shortest and cost effective connection between the regional centres Osijek and Vinkovci. Complete replacement of the track on the line was made in a total length of 11,530 km, which includes extending from the trunk line, laying the buffer protection and geosynthetic layer. The track was made with used materials: concrete sleepers HŽ-70, rails type 49E1, rail fastening type K and new ballast bed. The line is capable of speeds of 80 km/h and traffic trains with weight of 225 kN per axle and 80 kN/m, in a total length of 33,339 m.

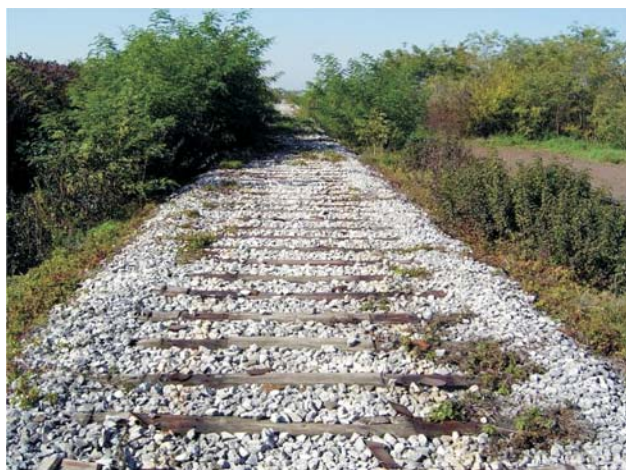
During the war the railway line suffered significant devastation. The greatest damages were at the locations of the war demarcation line, where the ballast bed and wooden sleepers were used for establishing military positions (Fig. 2). After the reintegration the demining of the line started gradually, during 2001. Subsequently, further demining of the wider belt line route was needed, which was done in 2004. During the first demining, the tour was conducted and detailed insight into the state of the line was obtained by employees of HŽ-Infrastruktura, Sekcija ZOP Osijek.

*Figure 2 Part of track between Ernestinovo and Laslovo without estranged rails and rail fastening  
Slika 2. Dio pruge između Ernestinova i Laslova bez otuđenih tračnica i kolosiječnog pribora*

It was found that the number of locations along the route of the railway was completely or partly missing over 10 km of track (rails, sleepers, rail fastening, ballast bed), while the bridge over the Bobota canal in km 22+326 was completely destroyed. All station tracks with side objects were destroyed (except in the Gaboš station), while a large number of trunk lines to establish military positions were built on the former demarcation line (between stations Brijest – Tenjski Antunovac and Vinkovci – Gaboš). After demining conditions were created for the reconstruction of the railway, for which project documentation had to be ensured. During 2005 the design was completed for the renovation project of the railway Vinkovci – Osijek, which was amended in 2007 in part related to the reconstruction of the bridge over the Bobota canal. The restoration project was drawn up by the company Granova, Zagreb.

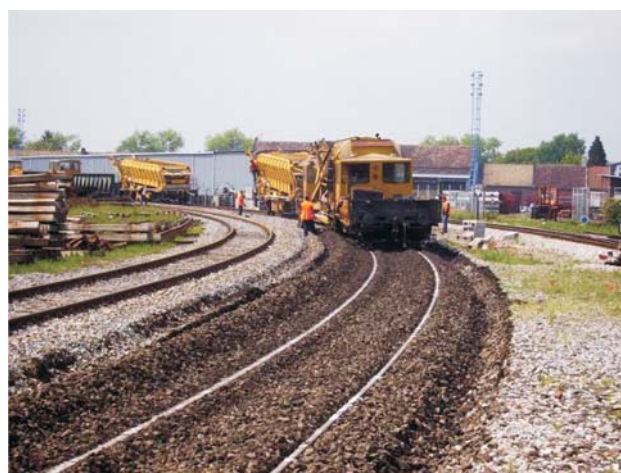
*Figure 3 Ballast bed cleaning from station Vinkovci toward Osijek  
Slika 3. Strojno rešetanje kolosijeka od kolodvora Vinkovci prema Osijeku*

In May 2007, the work on the mechanical cleaning of the ballast bed on the parts of the route where track has not been destroyed began, first on the section from the station Osijek toward the station Antunovac, then the section from the station Vinkovci to the station Gaboš (Fig. 3). In parallel with the ballast cleaning, machine works were done on levelling lining tamping, supplementing ballast material for forming appropriate ballast prism and replacing individual damaged rails, sleepers, and rail fastenings.

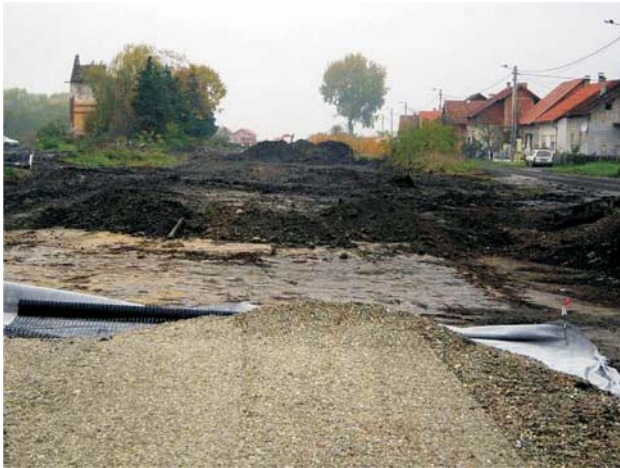
**Figure 4** The buffer laid on the subgrade at train stop Antunovac  
*Slika 4. Položeni tampon na trupu pruge kod Antunovca*

On the rolled and aligned track subgrade a layer of geotextile (with geogrids in some places) was first laid after which a protection layer of crushed stone material 30 cm thick was laid (Fig. 4). On the protection layer the used concrete sleepers with steel base plates (concrete sleeper type HZ-70) were laid at a distance of 60 cm, at which the used type 49E1 welded rails 180 m in length attached to the sleepers with type K fastening accessories were placed (Fig. 5).

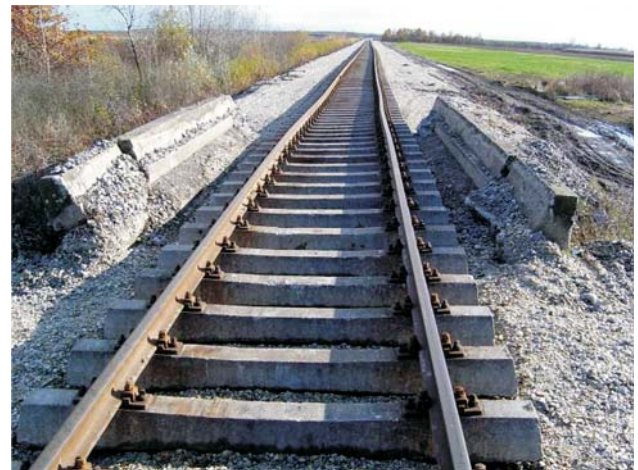
**Figure 5** Laid track made of used track materials over water culvert near the train stop Laslovo/Korođ

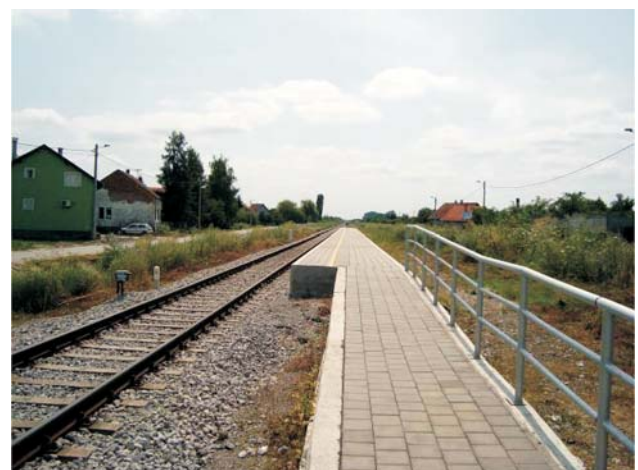
**Figure 6** Insular platform in train stop Laslovo/Korođ  
*Slika 6. Otočni peron u stajalištu Laslovo/Korođ*

At the train stops Ostrovo, Gaboš, Markušica/Antin, Ernestinovo and Antunovac new side platforms were built, with the 100 m length, 0,55 m height and 3 m width with ramps for the disabled persons' access. At the train stop Laslovo/Korođ 2,6 m wide insular platform was built (Fig. 6). All the platforms have the possibility of extending the length to 160 m. In addition, electric public lighting was built-in at all platforms. At the station Brijest the area for passengers boarding was done in 100 m length.

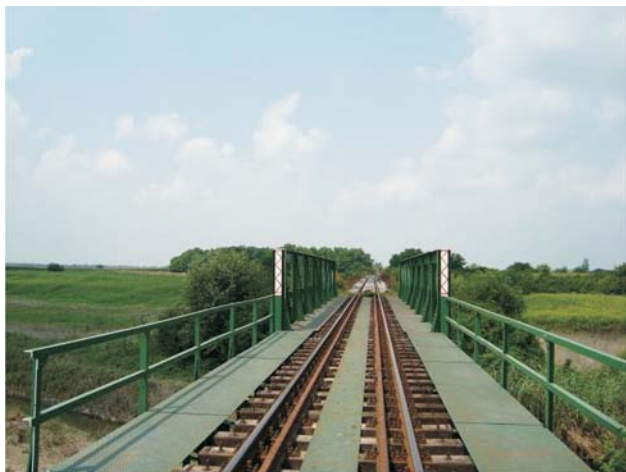
**Figure 7** The renewed steel bridge at km 9+411,9 (near train stop Gaboš)  
*Slika 7.* Obnovljeni čelični most u km 9+411,9 (kod stajališta Gaboš)

The steel bridge across the river Vuka at km 9+411,936 has a total span of 34,25 m (Fig. 7). It is composed of two structures: one structure is a beam girder with the span of 11,5 m, while the second structure is a truss girder with the span of 22,75 m. The restoration was completely done by painting the bridge and installing the new hiking surfaces and special wooden bearers.

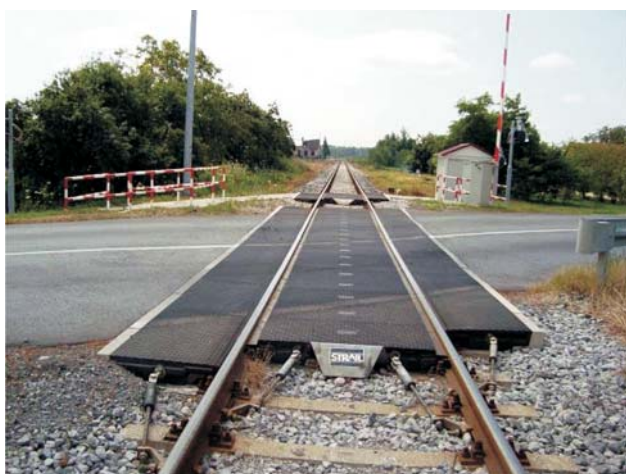
**Figure 8** Renewed level crossing at km 25+700 near train stop Antunovac  
*Slika 8.* Obnovljeni cestovni prijelaz u km 25+700 ispred stajališta Antunovac

Before the war there were 27 road level-crossings on the railway line Vinkovci – Osijek. After the renewal this number was reduced to a total of 24 level crossings, while the 3 crossings were abolished. Of the 24 crossings, 16 were paved with synthetic elements type STRAIL (Fig. 8), and 8 level-crossings were paved with wooden sleepers.

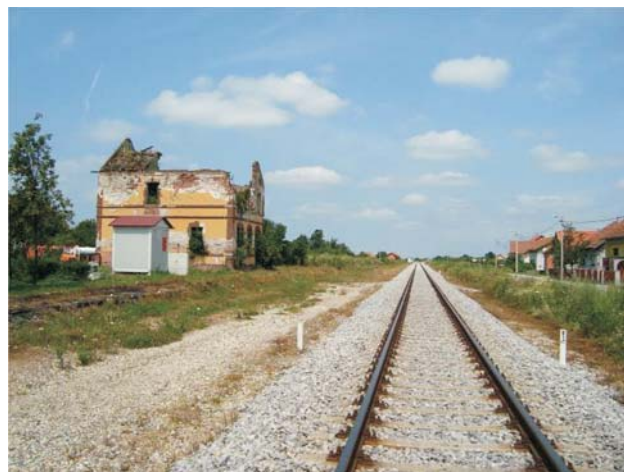
**Figure 9** Heavy damaged construction of the train stop in Laslovo/Korođ  
*Slika 9.* Teško oštećena zgrada stajališta Laslovo/Korođ

Unfortunately the restoration project of the railway line, did not provide the renovation of damaged railway buildings (ruined and dilapidated facilities at the former stations and train stops), which partially disrupts the overall impression. Hopefully, this will be resolved in the future through a demolition and removal project of dilapidated buildings (Fig. 9).
