CUTTING TOOL LIFE TESTS OF CERAMIC INSERTS FOR CAR ENGINE SLEEVES

Original scientific paper

This article is focused on the experimental determination of tool life tests for indexable ceramic cutting inserts. The set criterion of tool wear was $V/B_{\text{max}} = 0,6$ mm (in accordance with ISO 3685) or 30 pieces of machined sleeves. After at least one of the mentioned parameters was achieved, the tests were stopped and evaluated. Two types of cutting material by Saint Gobain Advanced Ceramics s.r.o. Company – ZTA 7 NI and D 250 were tested. We monitored their tool life at the same cutting parameters. The experiments were performed on machine tool – CHEMNITZ NILES N22. The machined material was the cast iron 25P mainly used for car engines. Tool wear was monitored on every fifth machined sleeve. Microgeometry was measured after tool wear test on each fifth sleeve. The aim was to determine the arithmetic tolerance of Ra profile, the greatest height of Rz profile and the external diameter D . The measurement was carried out four times; arithmetic average was performed subsequently as it is shown in the tables.

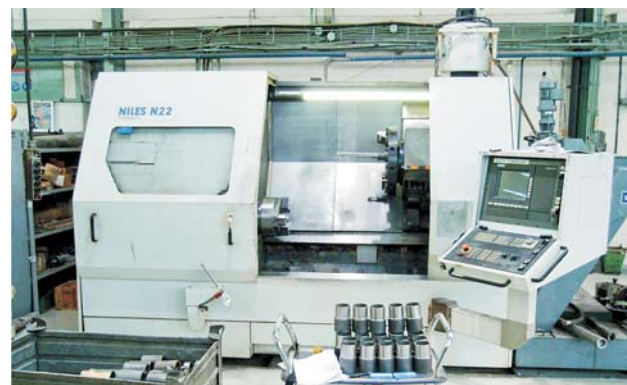
Figure 1 Machine tool CHEMNITZ NILES N22
Slika 1. Alatni stroj CHEMNITZ NILES N22

The machine tool CHEMNITZ NILES N22 (Fig. 1) was used for test sample machining. The machine tool has rigid structure and it provides a sufficient clamping condition. Jaws have recessed cone with the same apical angle as the cast iron sleeves.

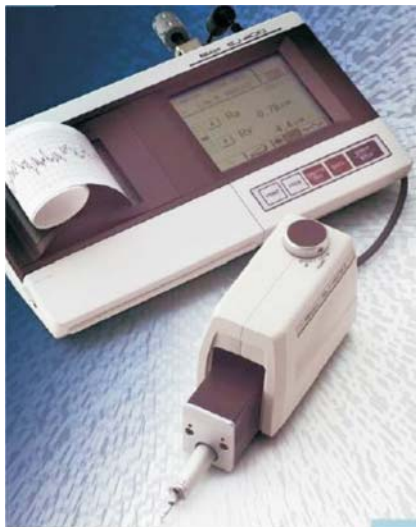
Figure 2 Portable Surface Roughness Tester Mitutoyo Surftest SJ-400 [1]

Ra and Rz values were evaluated on portable surface roughness tester - Mitutoyo SurfTest SJ-400. A wide range, high-resolution detector and an ultra-straight drive unit provide a class-leading accuracy. Cylinder surface roughness is possible to be evaluated by the skid less measurement and R-surface compensation functions.

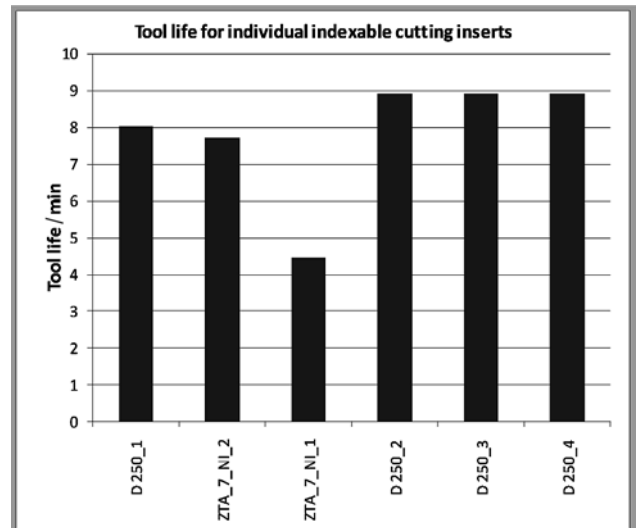
Figure 8 Tool life for individual indexable cutting inserts
Slika 8. Vijek alata za indeksirane rezne uloške

The number of machined pieces by individual ceramic cutting inserts is shown in the following graph (Fig. 7). D 250 series of cutting inserts machined the maximum number of 30 pieces except for D 250_1 insert. The D 250_1 insert probably reached this maximum as well. There was a crack of sleeve (at machining the 27th sleeve) and it resulted in cutting edge destruction. ZTA_7_NI inserts reached the criteria of tool wear at 26th, respectively at 15th machined sleeves. Fig. 8 shows the tool life of plates calculated according to formula (1) and (2) in minutes.
