DEGRADATION OF MECHANICAL PROPERTIES OF CrMo CREEP RESISTANT STEEL OPERATING UNDER CONDITIONS OF CREEP

Mechanical properties of a steam tube made of CrMo creep resistant steel are analysed in this contribution after up to $2,6 \cdot 10^5$ hours service life in creep conditions at temperature 530 °C and calculated stress level in the tube wall 46,5 MPa. During service life there were in the steel gradual micro structure changes, first pearlite spheroidization, precipitation, coagulation and precipitate coarsening. Nevertheless the strength and deformation properties of the steel (R_e , R_m , A_5 , Z), and the resistance to brittle fracture and the creep strength limit, were near to unchanged after $2,1 \cdot 10^5$ hours in service. The steam tube is now in service more than $2,6 \cdot 10^5$ h.

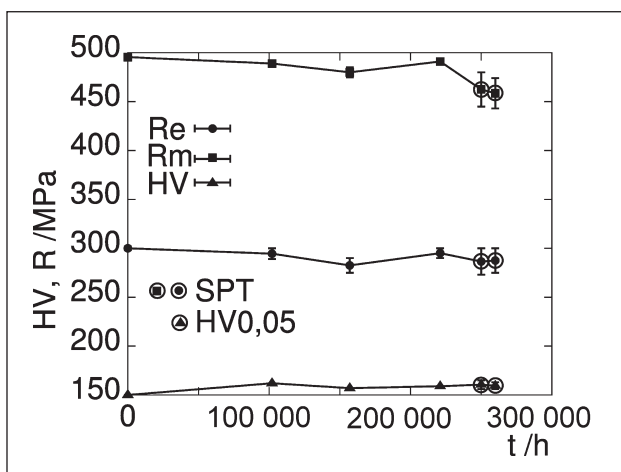
Figure 1 Influence of service life t on yield point R_e strength R_m and hardness HV. Service conditions 530 °C and stress level 46,5 MPa

As results showed after service life as long as 2,6·10⁵ h no significant degradation of mechanical properties (R_e, R_m, A₅, Z), hardness HV (HV0,05), and impact energy KCV was observed Figure 2.

A slight decrease of impact energy was observed between the initial state (KCV = 250 Jcm⁻²) and the value after service life 1,02·10⁵ h. A slight decrease of R_e and R_m about 5 % and the increase of hardness HV about 6 % after service life 1,57·10⁵ h can be explained by the small deviation in chemical composition (Table 1), or to changes in micro structure, which progress in every steel in creep conditions. The wider scatter in R_e, R_m and HV0,05 values for tests after service life times 2,5·10⁵ h and 2,6·10⁵ h, are contributed to the fact, that the values were measured by SPT in mini samples, and not by the standard test methods. The mini samples are more sensitive to the influences of micro structure heterogeneity.

Test results confirmed that the creep strength limit values did not change significantly with the service life time, and they are in good agreement with strength data from tensile tests (Figure 1).

On the other hand in our experiments as is shown in Figure 1 experimental results confirmed a less decisive decrease of the yield point mean values R_e (about 5 %) and little more of ultimate tensile stress R_m (about 8 %) after $2,2 \cdot 10^5$ h at 530 °C. It is in close correlation to the extent of coagulation and coarsening of dispersed phases. In proportion to that it was possible to suppose the decrease of the value of R_{Tm} after $2,2 \cdot 10^5$ h in service.

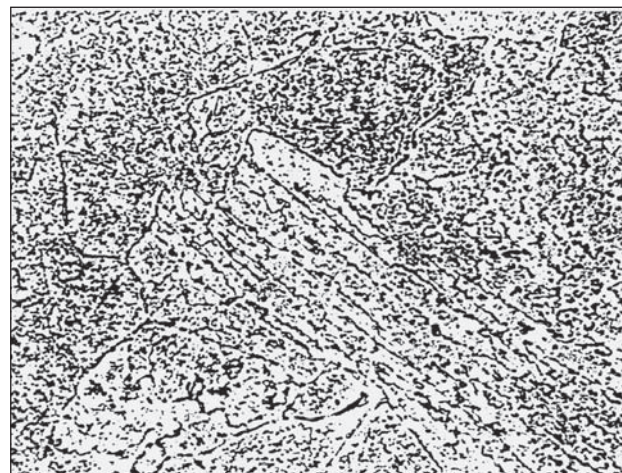
Pearlite spheroidization continued with the growth of service life time. For $1,57 \cdot 10^5$ h exposition the pearlite was completely spheroidized (Figure 5).

Figure 5 Microstructure of tested steel after $1,57 \cdot 10^5$ h in service, magn. 800x
