**Geological setting and mechanism of
Audru landslide**

M.Sc. Thesis

Tartu 2005

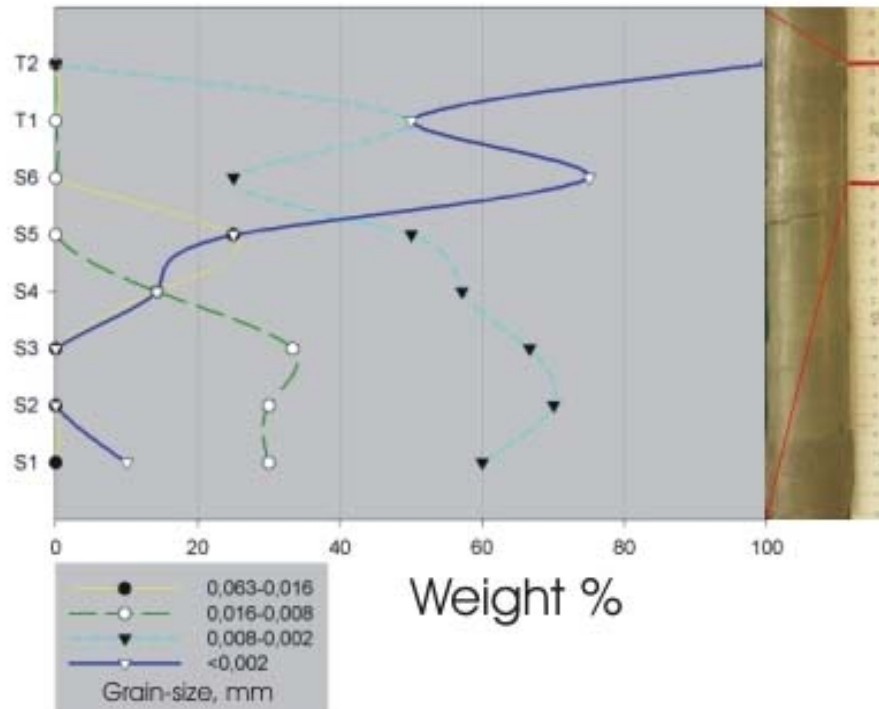
The geotechnically weakest soil type in the area is rhythmically deposited glaciolacustrine varved clay with alternating clayey winter and silty summer layers. Grain-size distribution is investigated by Reinson (2005), grain-size distribution within a single varve is displayed on Fig. 2 (Reinson, 2005).

Figure 2. Grain-size distribution within a single varve in the Audru-1 borehole, S1...T2 are sample numbers, S corresponds to summer layer and T to the winter layer (Reinson, 2005).

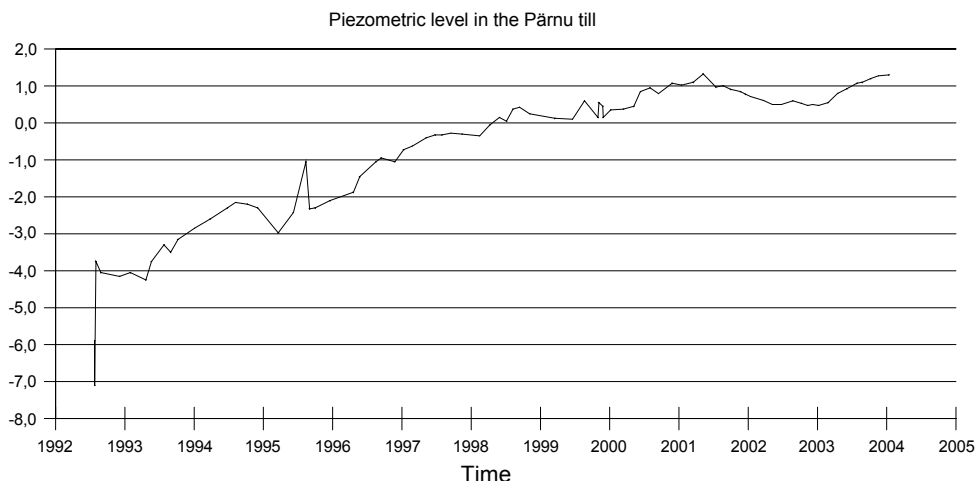
Figure 5. Piezometric levels of the groundwater related to the till in the Pärnu town (Talviste, 2004).

One can see that the piezometric level of this aquifer has been around 0...1,5 m a.s.l. over last 5 years. Although the currently investigated Audru landslide is 6 km away from the Pärnu it's relatively reasonable to assume that the groundwater levels are similar as Audru landslide and Pärnu town belong to the same geotechnical region (Vilo, 1986) and former sedimentary basin (Kattel, 1989).

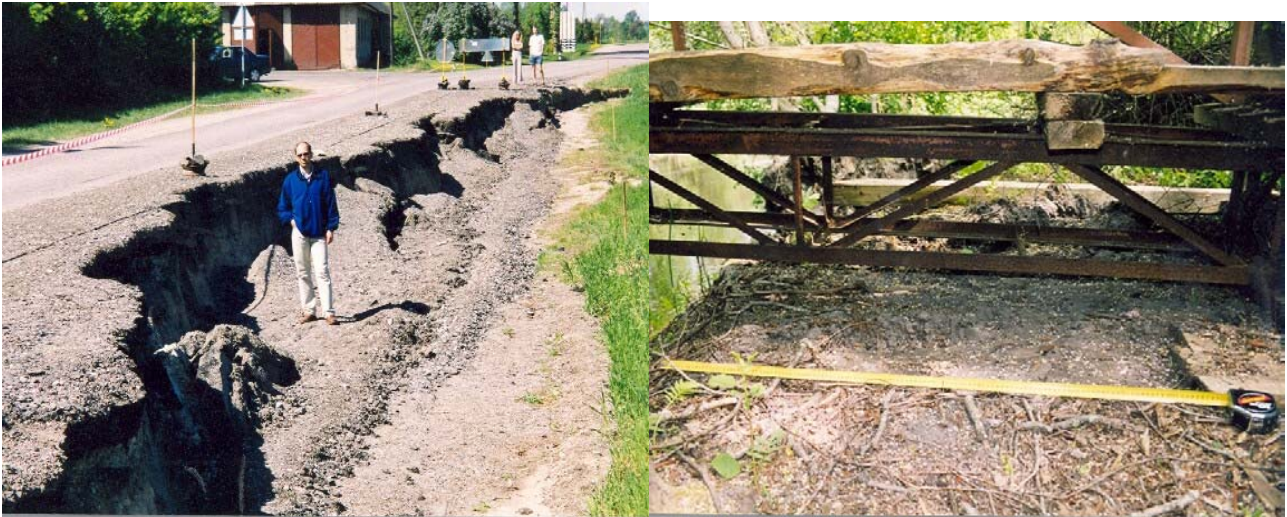
The height of the main scarp was 1,4 m and the sliding body moved 1,2 m towards the river (Photo 1).

Photo 1. Fresh scarp of the Audru landslide and skidding tail of the bridge construction. Photos by Peeter Talviste, Pille Sedman.

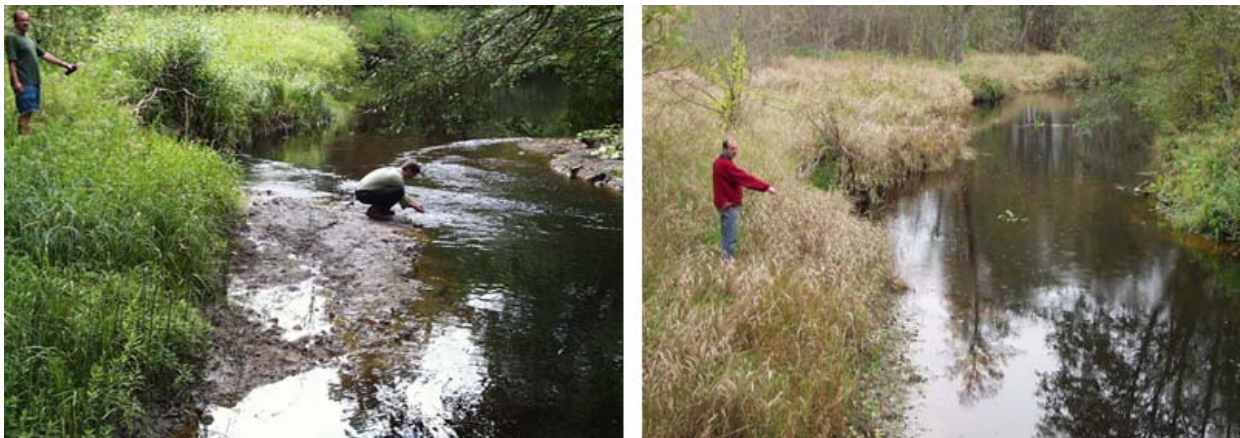
The river channel was almost totally filled with disturbed, silty clay, this fill was mostly eroded by the Audru river within a year (Photo 2).

Photo 2. The Audru landslide toe, photos are taken in 2002 and 2003 by Peeter Talviste and Volli Kalm.

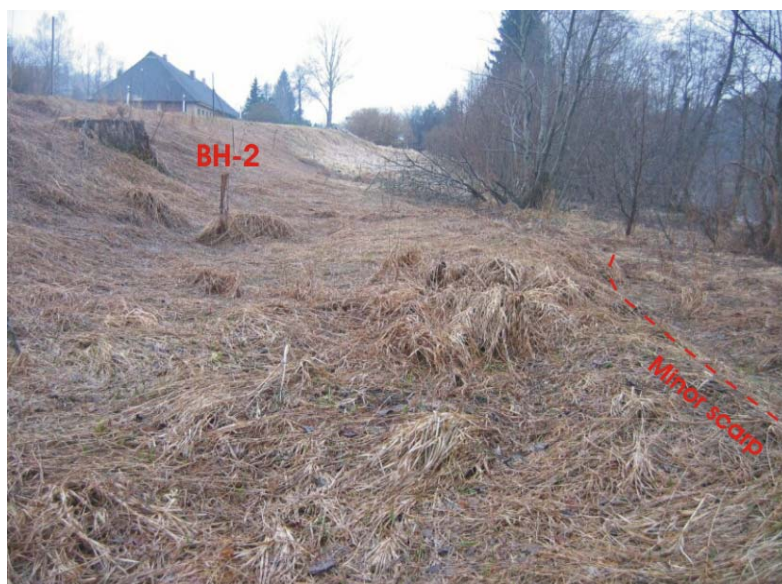
Photo 3. Questa-like morphology. Photo taken by author.

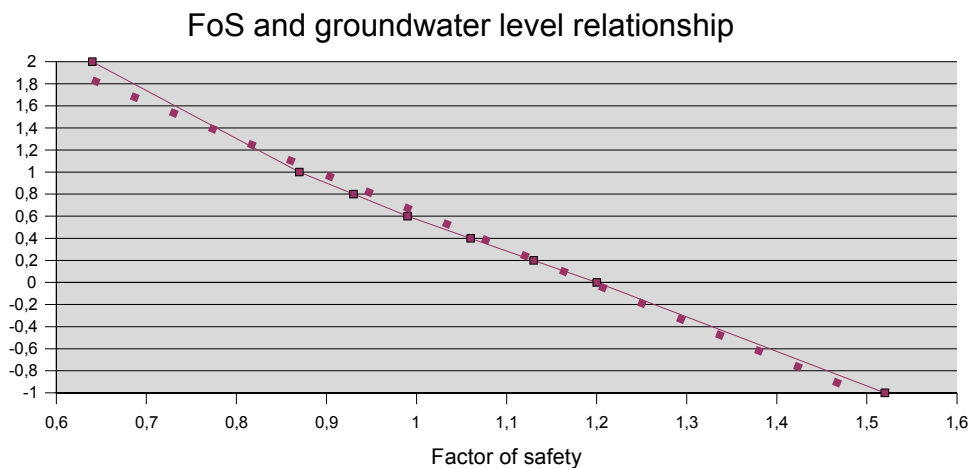
Figure 19. Influence of the piezometric level of the second groundwater layer to the initial slope stability.

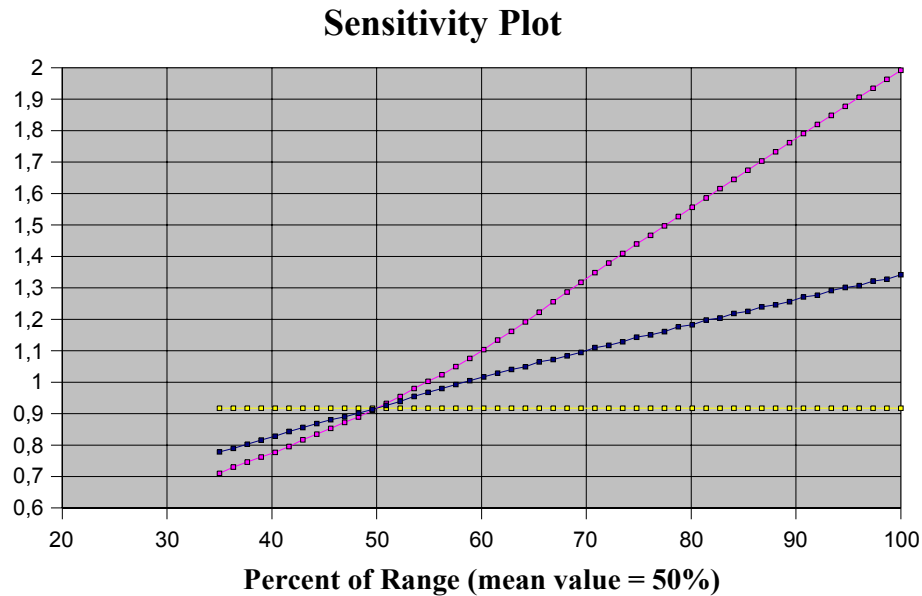
Cohesion of the middle complex has a bit smaller influence - increase by 20 %, from 7 to 8,4 kN/m² increases FoS from 0,9 to 1,1. As the first slide surface doesn't pass through the lower clay complex, cohesion of the lower complex doesn't affect the initial slope stability.

Figure 20. Relationship between cohesions and FoS of the initial slope. Mean value is the value of used cohesion (upper and middle complexes 7 kN/m² and lower complex 14 kN/m²). Magenta line represents the upper complex, blue the middle and yellow the lower complex of clay.

scale slides (Fig. 20). Therefore forestation of the riverbanks would decrease the risk of failure and it would also slow down the erosion. Opposite process is going on as small trees and bushes were cut down during this spring from the Audru landslide and nearby riverbanks. Vegetation affects only small scale slides as roots probably doesn't penetrate to the lower clay complexes that influence bigger slides (Fig. 30).

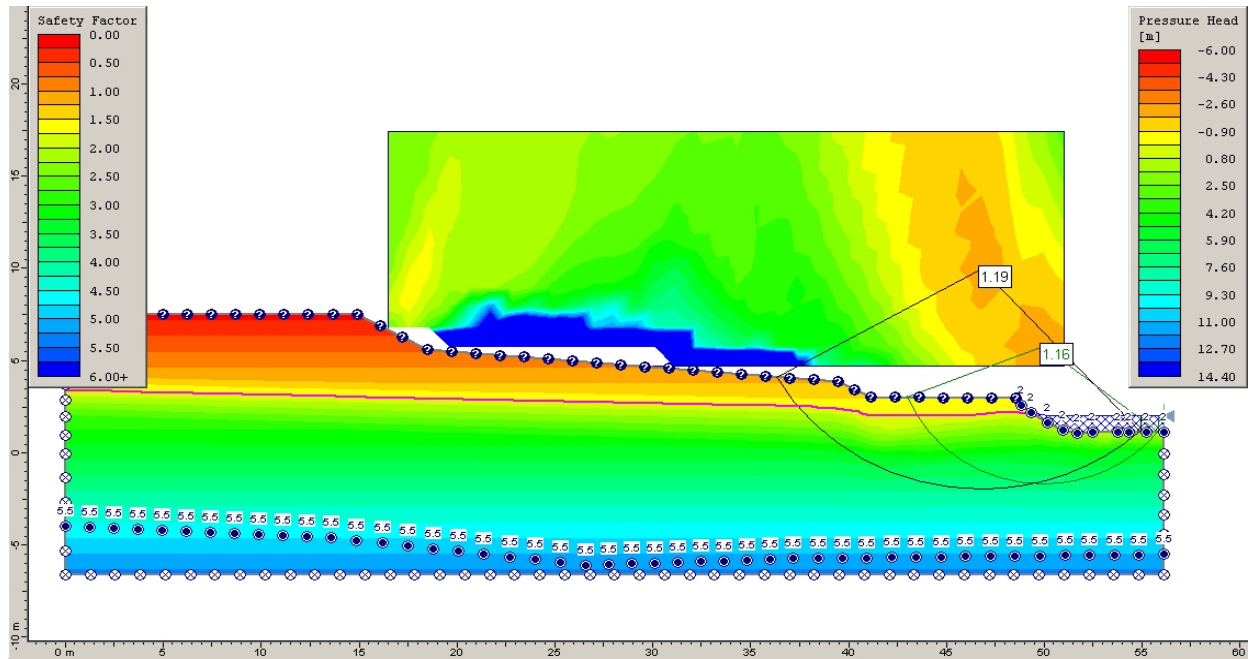
Figure 22. Second slope, piezometric level around 1 m a.s.l., water depth in the river 2 m.

According to model (Fig. 22) the second slope has two areas of instability: one is still close to the riverbank and the other is located somewhat upslope. The modelled slides near to the riverbank are strongly controlled by the water depth in the river as it was demonstrated in case of virgin slope model. Thus, in case of high water level in Audru River, the banks of the river become more stable (Fig. 23).

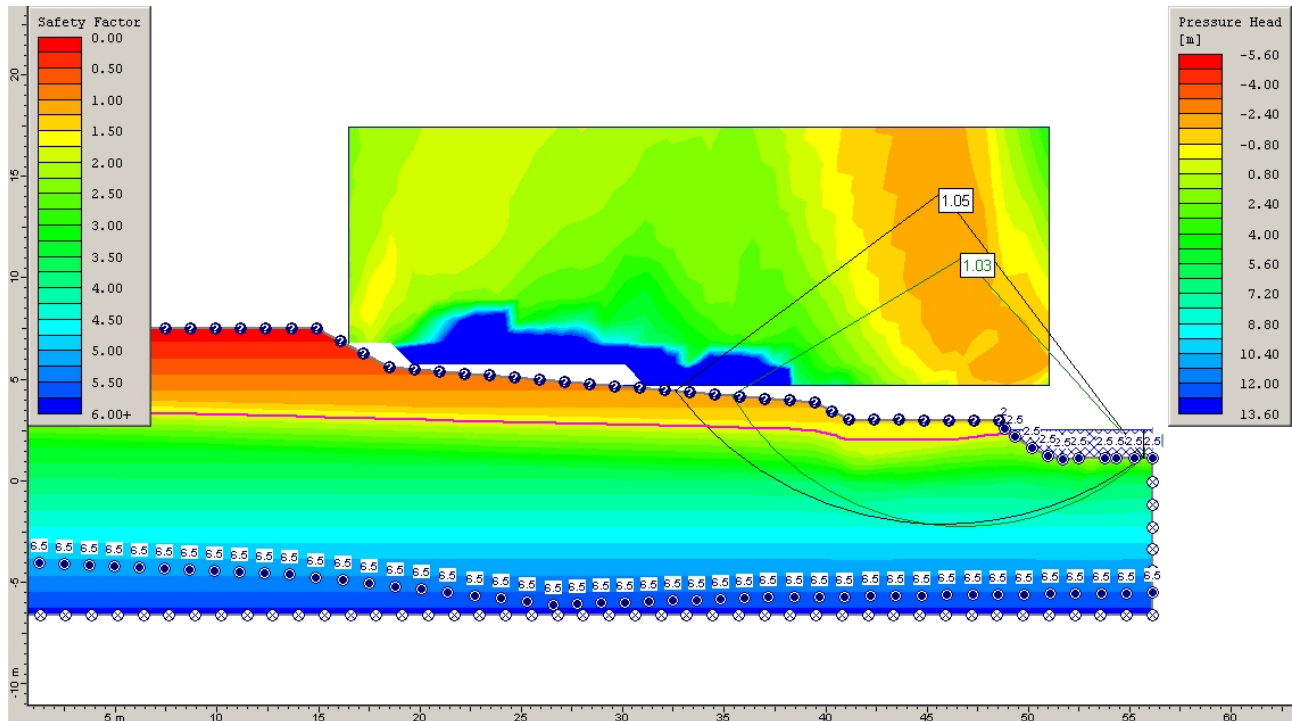
Figure 24. Second slope, piezometric level around 2 m a.s.l., water depth in the river 2,5 m.

Both water levels (second groundwater layer and water level in the river) must be high for this kind of failure. If the water level in the river is „normal“ or „low“ the slope will become unstable only close to the riverbank.

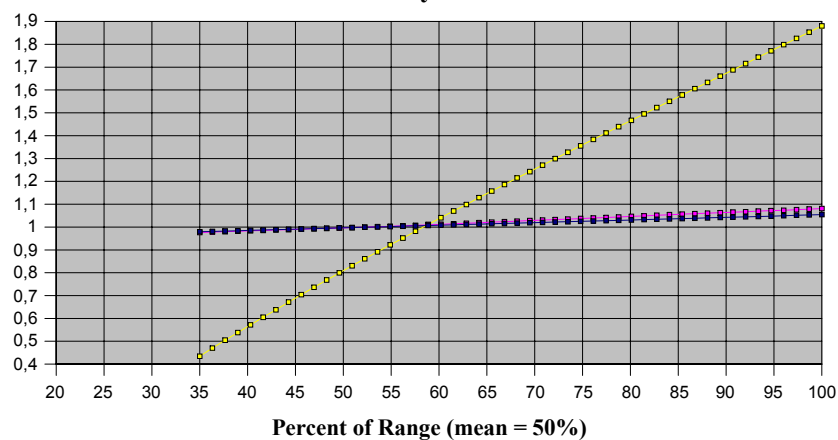
Sensitivity Plot

Figure 30. Relation between cohesion of the varved clay complexes and FoS of the third slope. Mean value is the value of used cohesion (upper and middle complex 7 kN/m² and lower complex 5
