**THE RESPONSE OF THE TWO INTERRELATED RIVER  
COMPONENTS, GEOMORPHOLOGY AND RIPARIAN  
VEGETATION, TO INTERBASIN WATER TRANSFERS  
IN THE ORANGE-FISH-SUNDAYS RIVER  
INTERBASIN TRANSFER SCHEME**

Thesis submitted in fulfilment of the requirements  
for the Degree of Master of Science  
of Rhodes University

**Anna Jacoba Elizabeth du Plessis**

January 2000

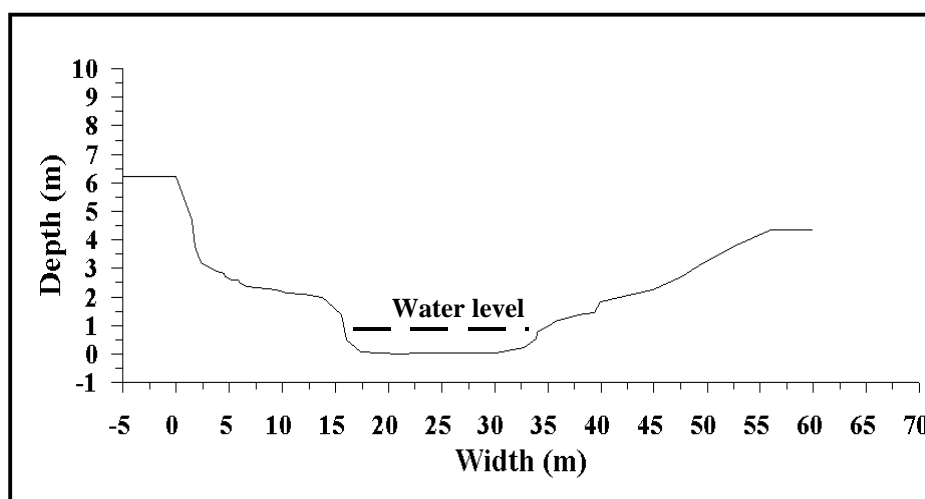
Figure 3.4: An example of a cross-section profile for the Skoenmakers River.

Cross-sectional data was downloaded directly from the total station into the computer by means of the TopComm Version 1.0 programme for Windows 95. This programme converted the data for use in the spreadsheet software package Quattro Pro. The cross-sectional profile for each transect was constructed by analysis and manipulation of this data (Figure 3.4). These cross-sections were used to calculate the average width and depth of the channel, elevations above and distances away from the channel for each vegetation type.

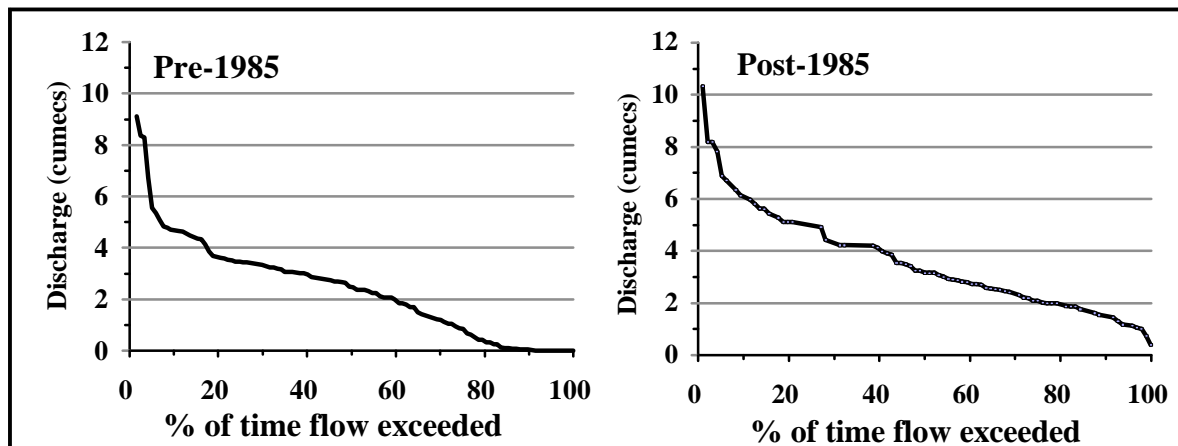
*Figure 4.2: Monthly flow duration curves for the Skoenmakers River for the period 1981 to 1997 (Source: Department of Water Affairs and Forestry: Somerset East).*

Flow duration curves (Figure 4.2) were constructed for the Skoenmakers River based on data from the gauging station below the junction of the Skoenmakers and Volkers Rivers (pre-1985) as well as releases from De Mistkraal Dam (post-1985). All discharge values were calculated from the average monthly discharge in cubic metres per second (cumeecs).

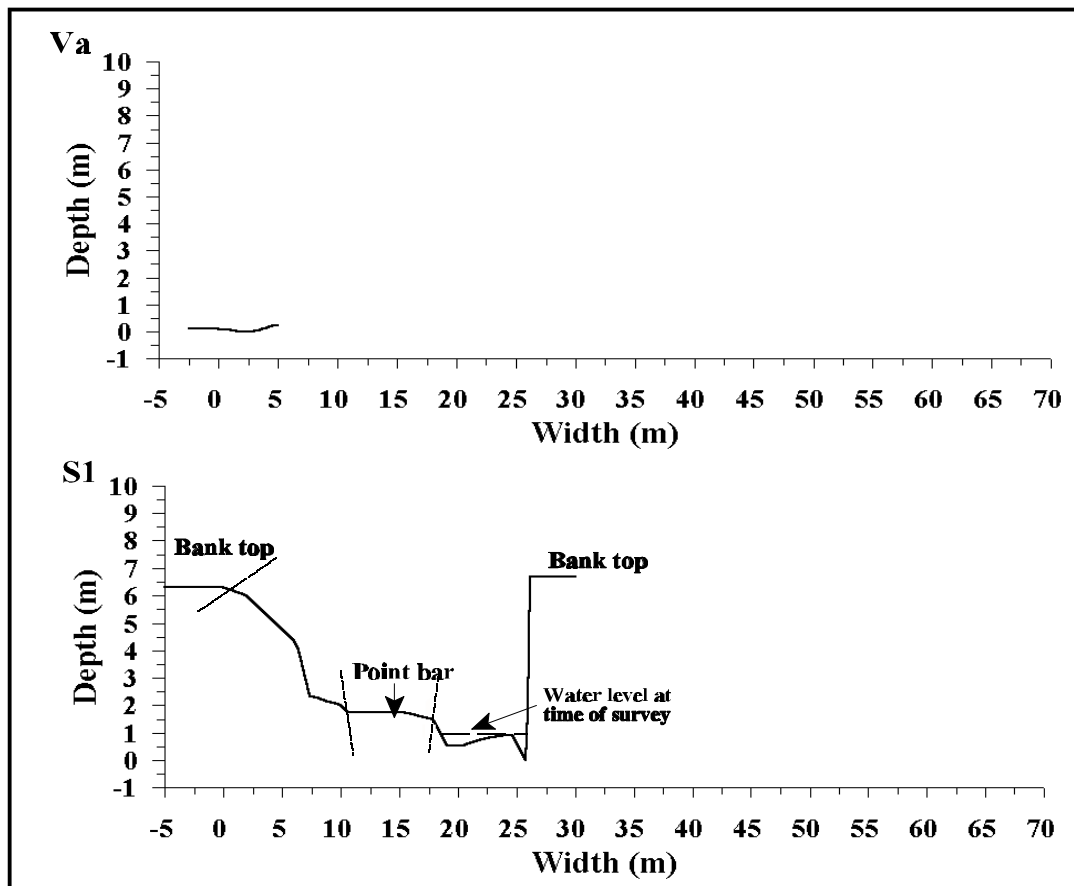
*Figure 4.4: Comparison of two cross-sectional profiles for the upper reaches of the Volkers (Va) and Skoenmakers River (S1) immediately below the point of inflow of the IBT.*

Under natural conditions, two sites at equal distances downstream for two different rivers with similar catchment conditions, like the Skoenmakers and Volkers Rivers, should have similar cross-section profiles. Such a comparison was made of two sites in the upper section of the two rivers approximately 500m below the point of IBT inflow for the Skoenmakers River and at the same distance downstream for the Volkers River (Figure 4.4).

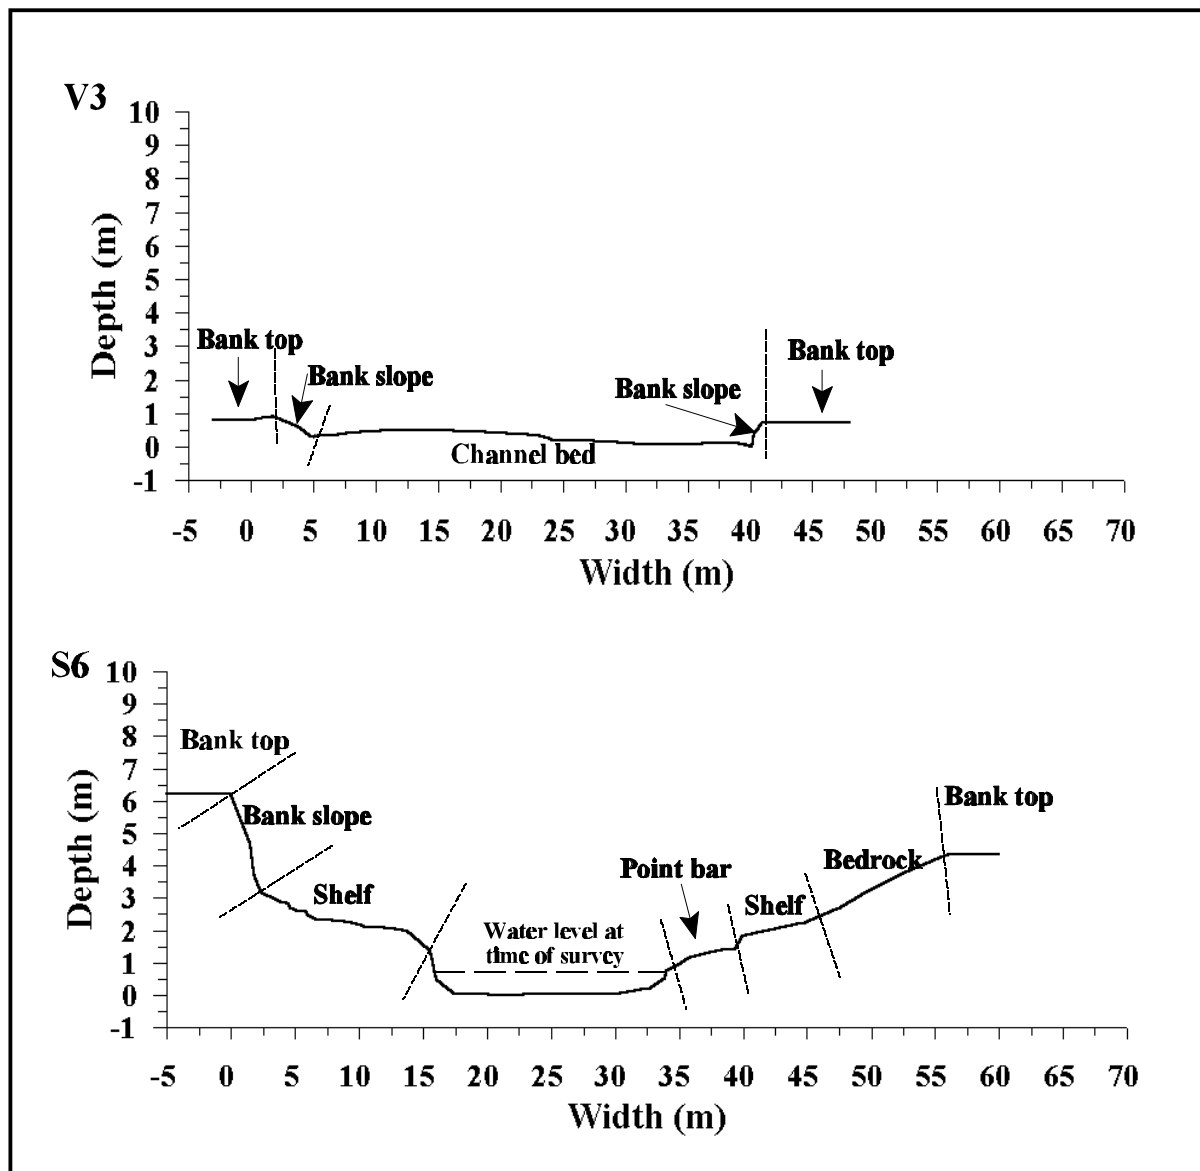
Figure 4.6: Comparison of two cross-sectional profiles for the middle reaches of the Volkers (V3) and Skoenmakers River (S6) approximately 25 km below the point of inflow of the IBT.

The cross-sectional profile of site S6 is clearly more diverse in terms of the type of morphological units present when compared to the non-regulated Volkers River (V3).

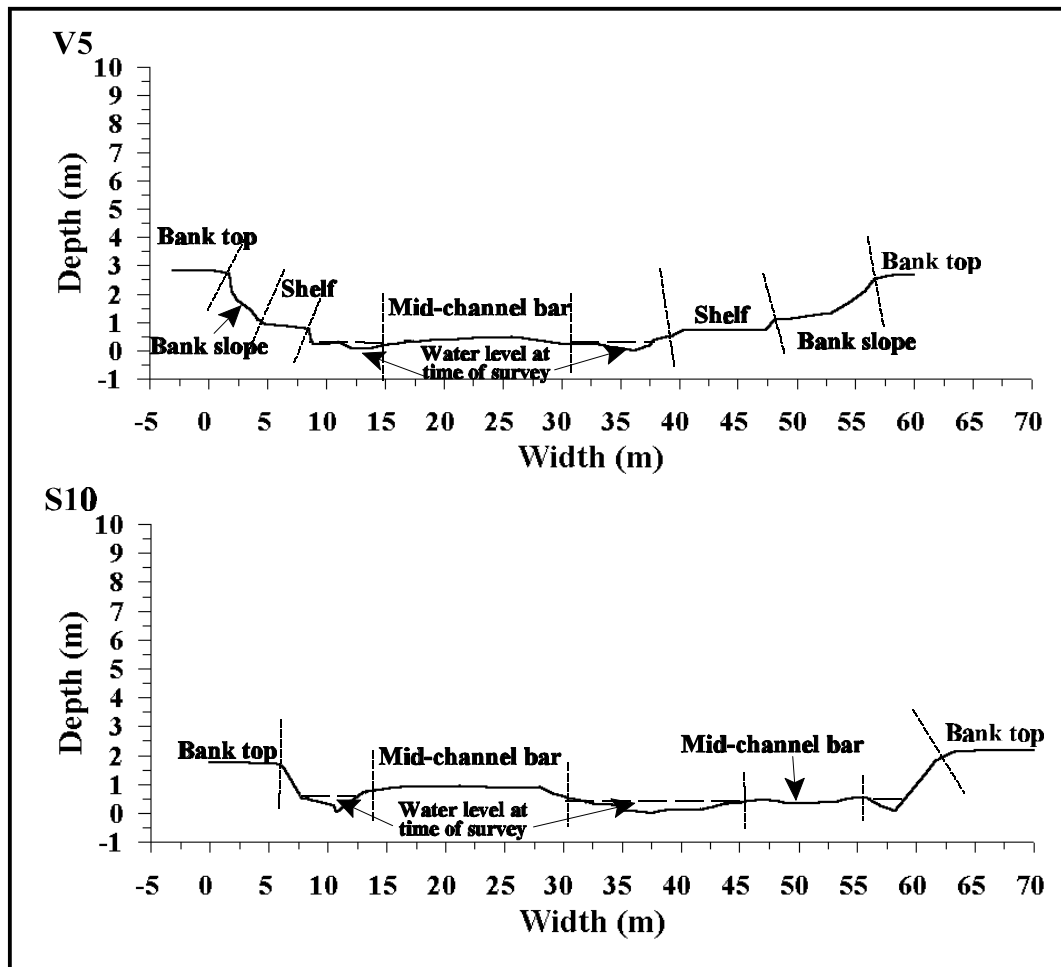
Figure 4.7 Comparison of two cross-sectional profiles for the lower reaches of the Volkers (V5) and Skoenmakers River (S10) approximately 40 km downstream for both rivers.

The similarity of the cross-sectional profiles for two sites in the lower reaches of the Skoenmakers and Volkers Rivers is evident from Figure 4.7. Similar morphological units such as mid-channel bars, etc. are evident from the cross-sectional profiles of both the regulated and non-regulated rivers. It is evident from Figure 4.7 that there is no significant difference between the width and depth of the two channels at this distance downstream.

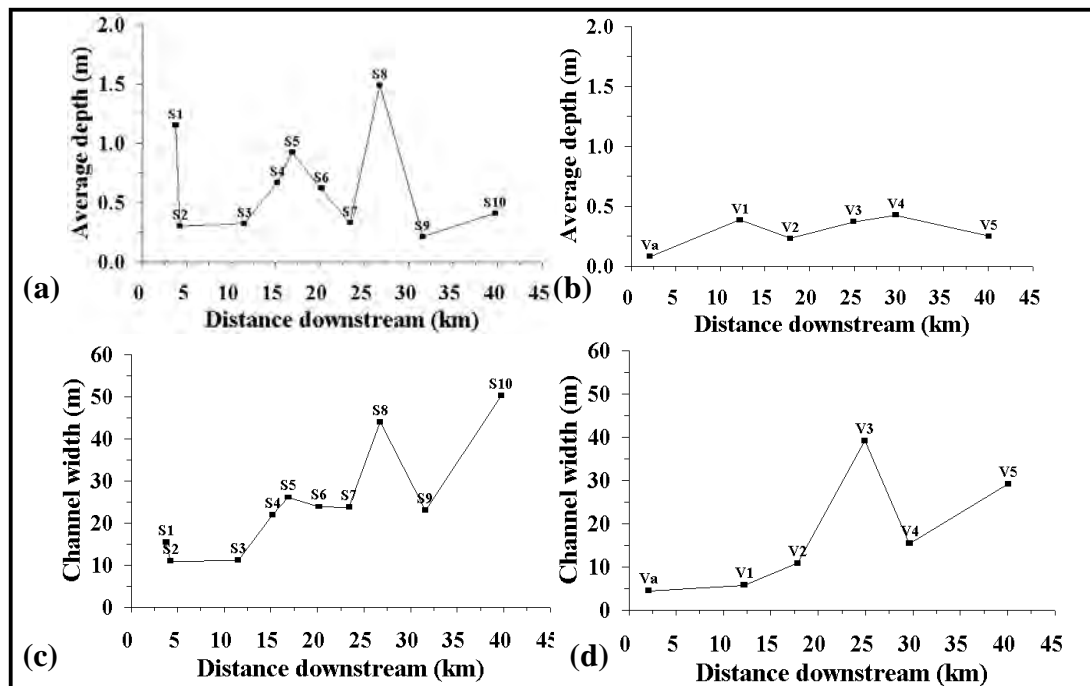
Figure 4.8: Downstream changes in the (a) depth and (c) width for the Skoenmakers River and (b) depth and (d) width for the Volkers River.

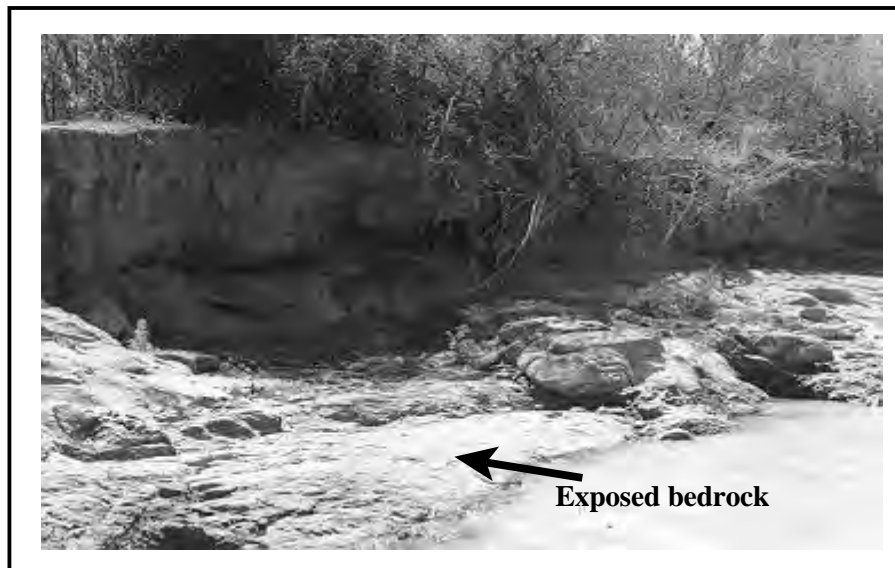
*Plate 4.1: Severe erosion and active undercutting of the right-hand bank evident for the upper reaches of the Skoenmakers River (approximately 3 km below the IBT inlet).*

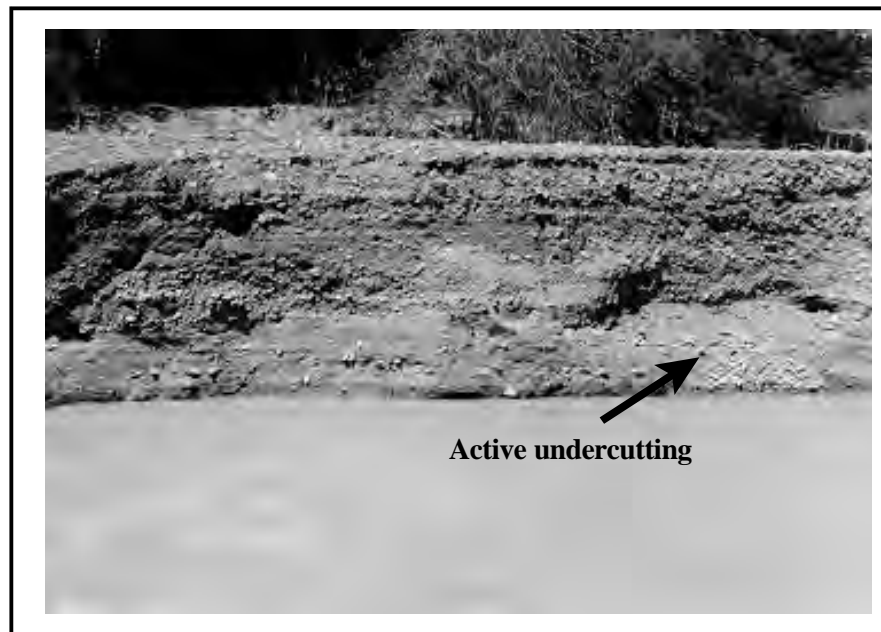
*Plate 4.2: Stratified lefthand bank for same site as Plate 4.1.*

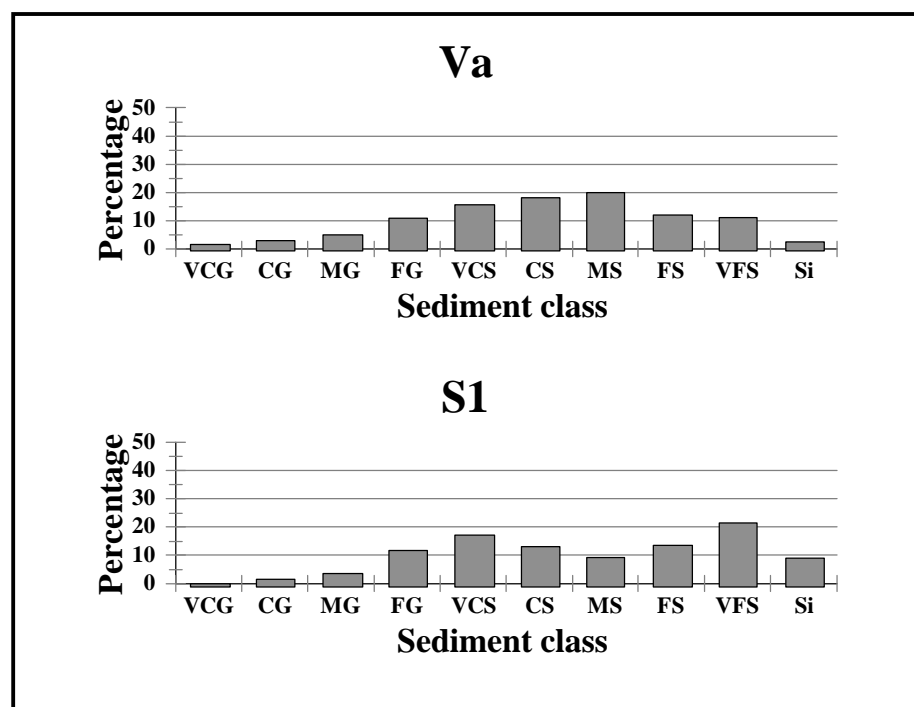
Figure 4.11: Bank sediment sample analysis for two sites at equal distances along the Volkers (Va) and Skoenmakers (S1) Rivers' upper reaches.

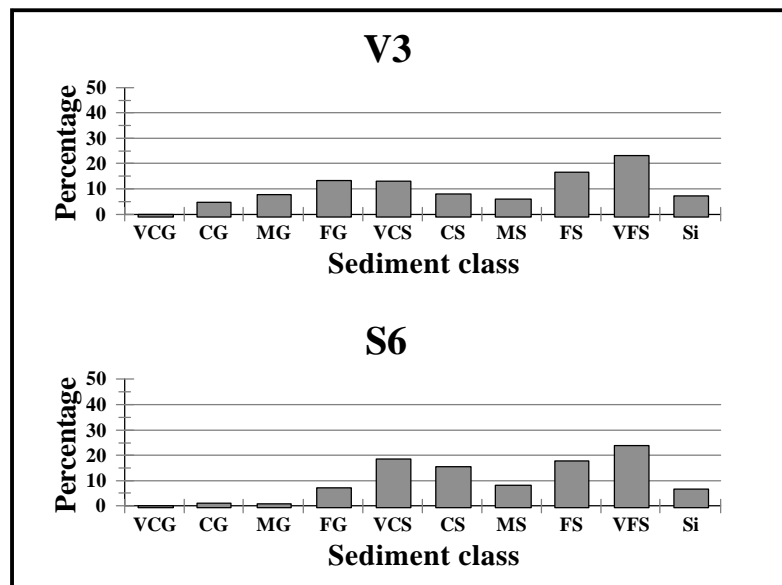
Figure 4.12: Bank sediment sample analysis for two sites at equal distances along the Volkers (V3) and Skoenmakers (S6) Rivers' middle reaches.

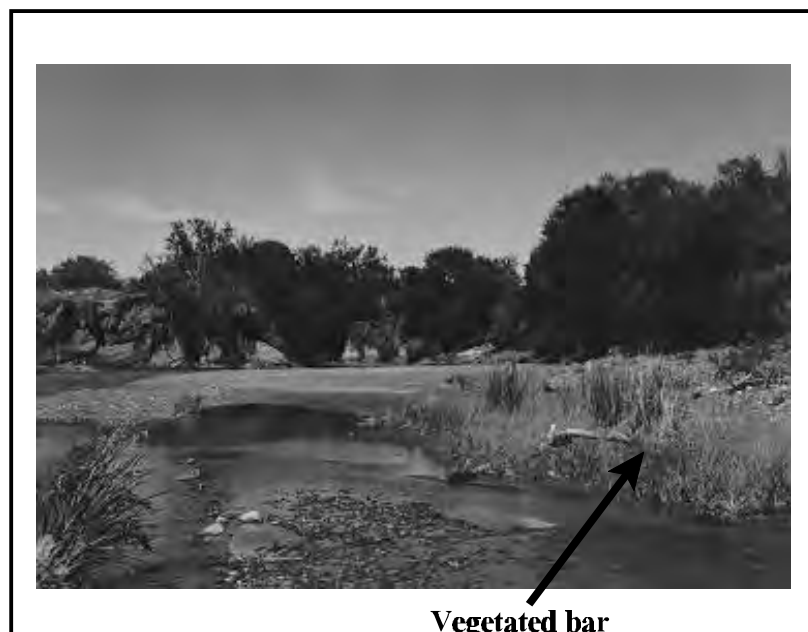
*Plate 4.4: Vegetated bar at site S4 in the middle reaches of the Skoenmakers River.*
