Retrofitting design of Kathmandu University library building after Gorkha earthquake 2015

This is a case study for Retrofitting Design of Kathmandu University Central Library Building (Block#3) after Gorkha Earthquake 2015. The building lies south to the Administrative Building of Kathmandu University, located at Dhulikhel, Kavrepalanchwok (**Fig. 1**). The strong earthquake on April 25, 2015 (7.8 M_w moment magnitude) originated at Barpak of Gorkha District and the largest aftershock with the magnitude of 7.3 M_w (United States Geological Survey) affected the building to great extent leading to the structural failure of the building. This building is an Ordinary Moment Resisting Frame (OMRF) covering an area of 888.31 sq.m.

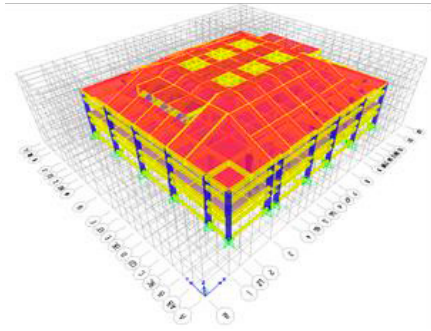
Fig. 2. 3D Model of building for analysis in SAP.

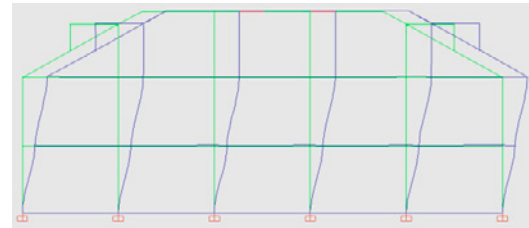
Fig. 3. Deformed shape at XZ, Y=27m, Axis G-G. Load combination: EQx. (SAP 2000 v.16).

load combinations. The deformed shape, axial force, shear force and bending moment as shown in **Figs. 3, 4, 5** and **6** respectively were then displayed under the defined load combinations.

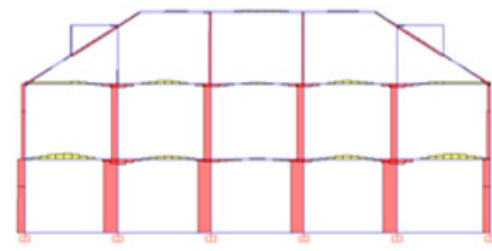
Fig. 4. Axial Force diagram at XZ, Y = 27m, Axis G-G. Load combination: 1.5D.L +1.5L.L.

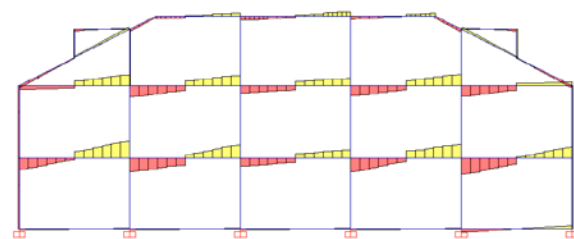
Fig. 5. Shear Force diagram at XZ, Y=27m, Axis G-G. Load combination: 1.5D.L +1.5L.L (SAP 2000 v.16).

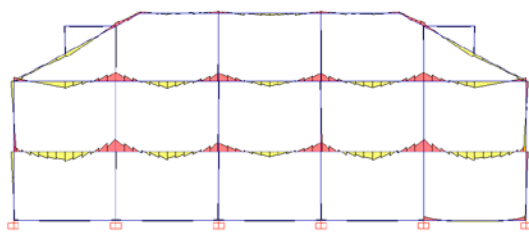
Fig. 6. Bending Moment diagram at XZ, Y=27 m, Axis G-G. Load combination: 1.5D.L +1.5L.L. (SAP 2000 v.16).

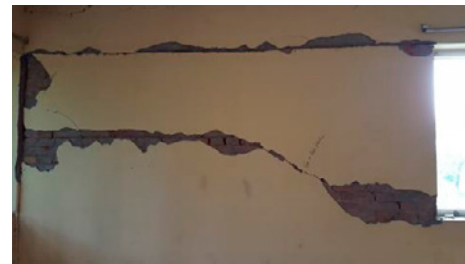
Fig. 7. Cracks seen in masonry infill wall.

During rapid visual assessment of the building, large numbers of cracks was seen in masonry infill walls and some columns had undergone structural failure as well.

Figures 7, 8 and **9** show both structural and non-structural damages as seen in the building.

During visual assessment cracks were seen in masonry infill walls. Therefore, wall repairing was carried out along with column jacketing. The walls with diagonal shear cracks were demolished as they were liable to collapse from the confining frame under the action of vertical load. Cement-sand grouting was done in parts where cracks do not span a long distance. In parts where cracks of greater depth and larger distance were detected grouting was carried out along with net plastering (**Fig. 17**).

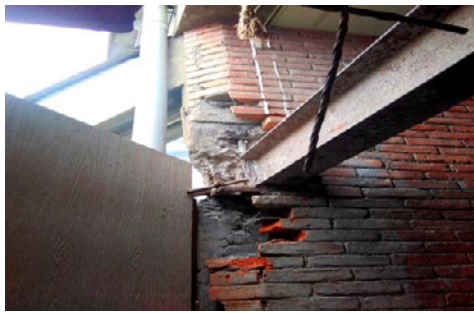
Rapid visual assessment showed structural failure of large numbers of columns; clearly evident by shear cracking, concrete spalling and exposure of longitudinal reinforcements. The building was damaged severely by frequent earthquakes and aftershocks. The main reasons adding to the structural failure of the building were soft storey effect, captive and short column effect, pounding effect, brick cladding, irregular load path and excessive load in the roof.

Fig. 8. Concrete spalling and exposure of reinforcement in column..

During SAP2000 analysis columns were identified to have failed in flexure. Reinforced Concrete Jacketing as per the guidelines provided by the code *IS 15988:2013* was, therefore, proposed for strengthening these columns.

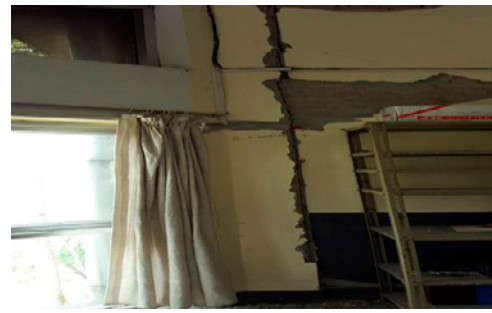
Fig. 9. Cracks in column and adjoining masonry infill wall.

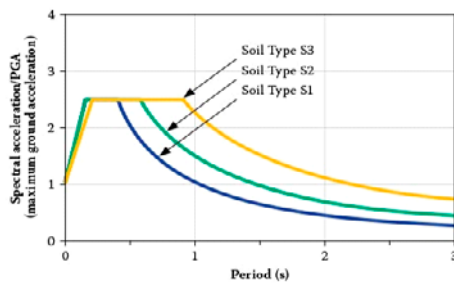
The value of S_a/g is obtained from the graph (**Fig. 10**).

The value depends on time period (T) and soil type.

Fig. 10. Response Spectra for Rock and Soil Sites for 5 % Damping.

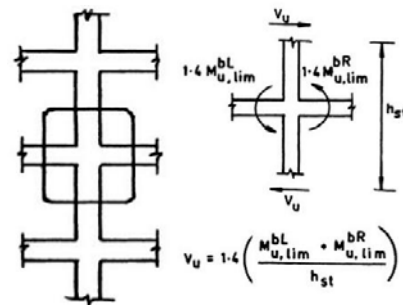
- Calculated factored shear force as per analysis
- Factored shear force given by (**Fig. 11**)

Fig. 11. Calculation of design shear force for column (Durgesh et al., 2005).

For columns where extra longitudinal reinforcement is not required, a minimum of 12φ bars in the four corners and ties of 8φ @ 100 c/c were provided with 135° bends and 10φ leg lengths (**Fig.11**).

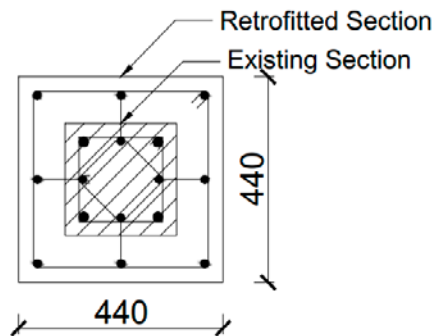
Fig. 12. Cross-section of retrofitted column.

Table 6 shows results for column size 240* 240. The cross-section of the column after retrofitting is shown in **Fig. 12**. The size, area of steel (A_s) and PMM ratio of the column before and after retrofitting were compared on the basis of analysis performed in SAP2000.

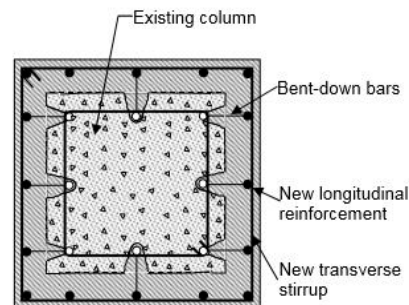
Fig. 13. Reinforcement bars and connector arrangement (IS 15988:2013).

Before carrying out jacketing the surface preparation of the existing columns was done by treating, roughening and cleaning. Bonding between old and new material and transfer of forces to new reinforcement was ensured by proper connector arrangement (**Fig. 13**). For increased flexural strength the rods for jacketing were connected in the beams by welding and drilled at least 6 inches into the foundation (**Fig. 14**).

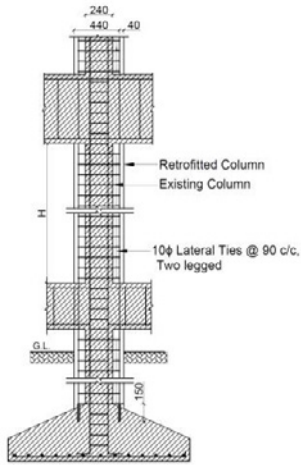
Fig. 14. Longitudinal section of Retrofitted column.

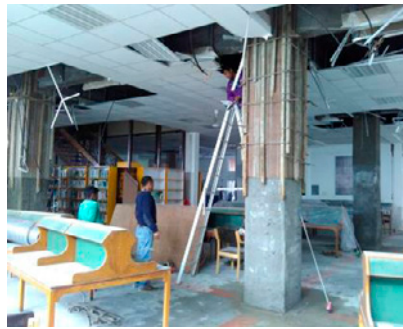
Fig. 15. Concrete jacking of Column, Kathmandu University Central Library, Dhulikhel.

All the columns of ground floor were found deficient in flexure during analysis, so all columns were retrofitted by reinforced concrete jacketing so that it was able to carry out its intended function (**Figs. 15** and **16**). For this purpose, guidelines for seismic evaluation and strengthening of existing reinforced concrete structures provided by Indian Standard Code IS 15988:2013 were followed. Similarly, the cracks in the wall were repaired by net plastering and grouting. Structural members like beams and slabs, if found failed, could also be retrofitted by considering viable retrofitting options.

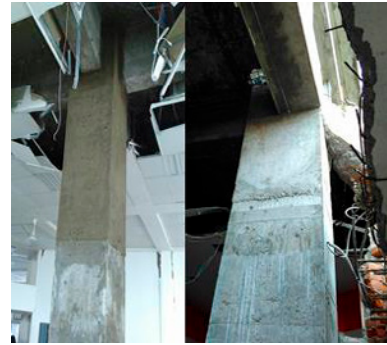
Fig. 16. Concrete jacking at Beam-Column joint, Kathmandu University Central, Dhulikhel.

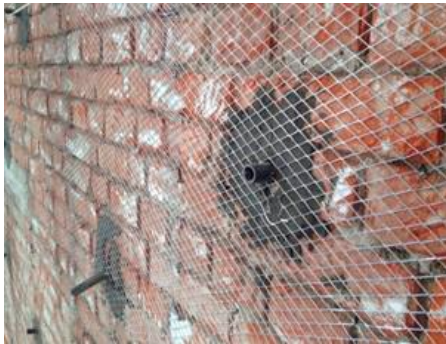
Fig. 17. Retrofitting of wall by net plastering and grouting.

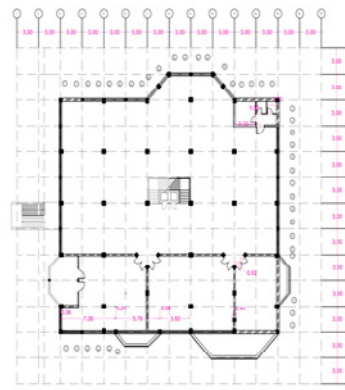
Figure 18 shows plan of first floor of Kathmandu University Central Library. All the columns were observed failed after the model analysis done in SAP2000 v.14. These columns underwent flexural failure. Therefore, reinforced concrete jacketing was proposed as a viable solution for strengthening these columns. There were four types of columns (**Fig.19**):

Fig. 18. First Floor Plan of Central Library.

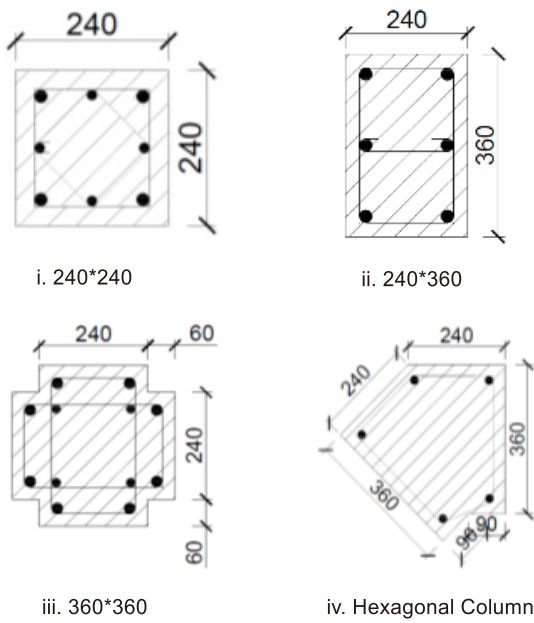
- i. 240*240
- ii. 240*360
- iii. 360*360 (central column)
- iv. Hexagonal column

Since, the analysis showed the cause of failure was due to insufficient dimension of columns, the dimension

Fig. 19. Columns before Retrofitting.

of all columns were increased by 100mm as per the code (IS 15988:2013).

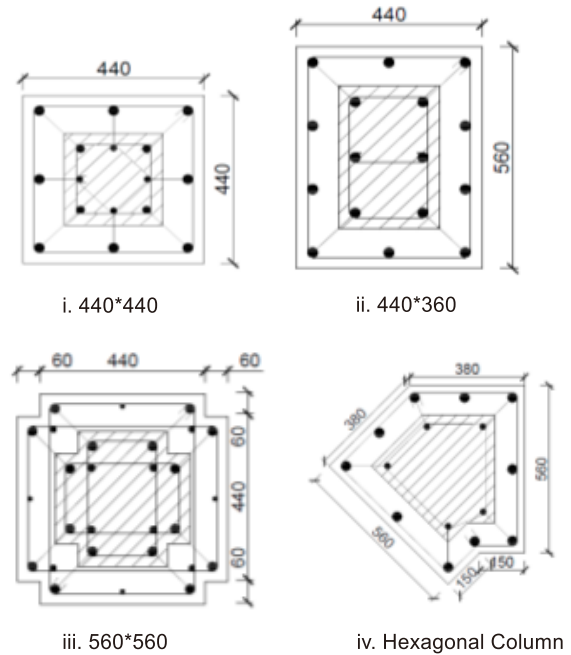
The required reinforcement was calculated as explained earlier and the arrangement of reinforcement is shown in **Fig. 20**.

Fig. 20. Columns after Retrofitting.
