Bridge maintenance to enhance corrosion resistance and performance of steel girder bridges

BRIDGE MAINTENANCE TO ENHANCE CORROSION RESISTANCE AND PERFORMANCE OF STEEL GIRDER BRIDGES

For the degree of Doctor of Philosophy

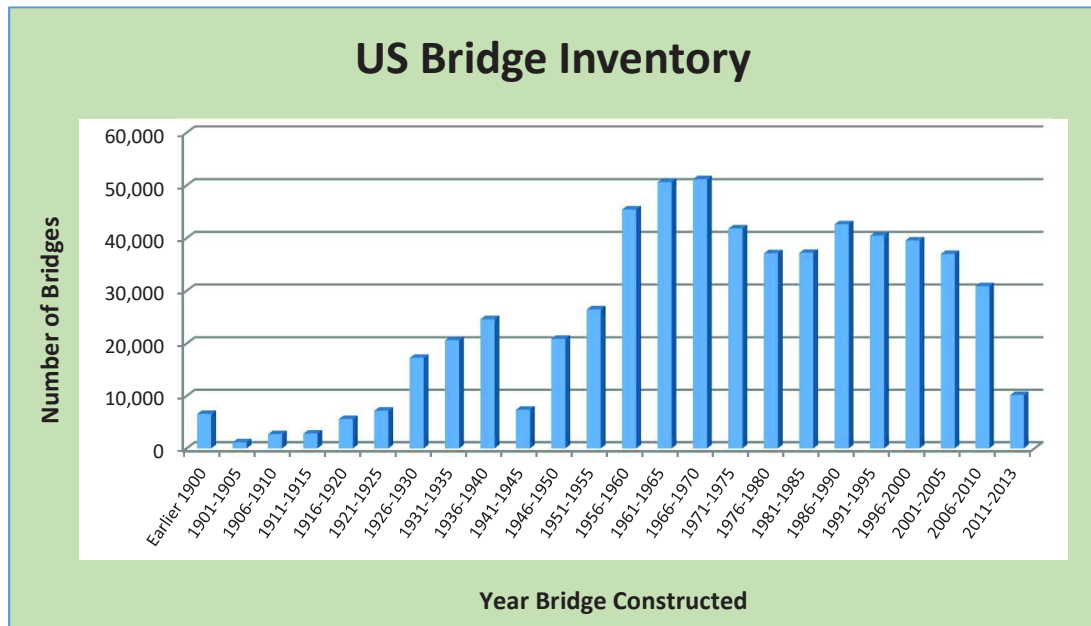
Figure 1.1: US bridge inventory by year of construction (FHWA, 2015)

1956, as seen in Figure 1.1. The National Bridge Inventory (NBI) shows that steel bridges represent more than 30% of the entire system. Steel bridges have been widely considered as an adequate alternative in the USA highway system, based on the outstanding characteristics of structural steel, such as economy, speed of construction, versatility, and aesthetics. Nevertheless, when a steel bridge is not properly designed, constructed or maintained, deterioration of the steel components became a critical issue in the bridge service life. From the steel bridges inventory, 26% are classified as structurally deficient and 19% are functionally obsolete, as shown in Figure 1.2 (Eom, 2014). The number of structurally deficient bridges will be likely to continue increasing if measures are not implemented to reduce the rate of the deterioration process.

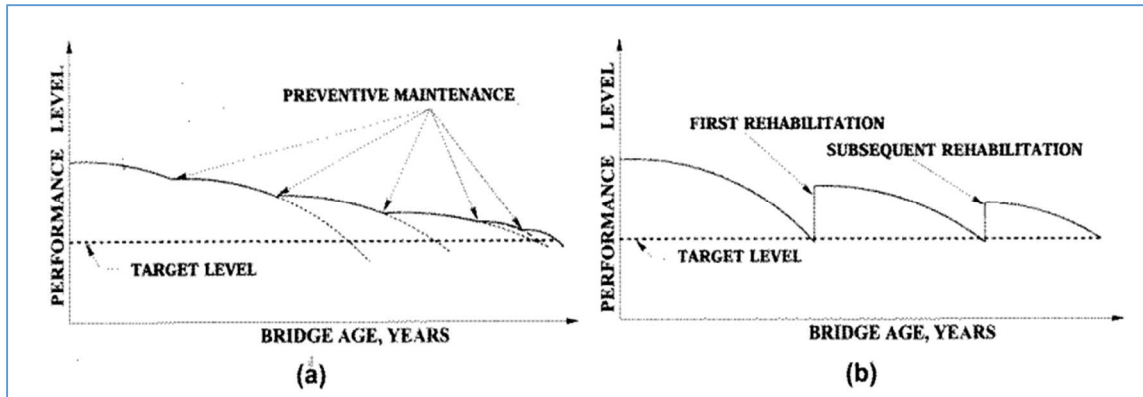
Figure 1.3: Service life extension: a) Performing simple preventive maintenance activities, b) Performing only important rehabilitation processes (NYSDOT, 2008)

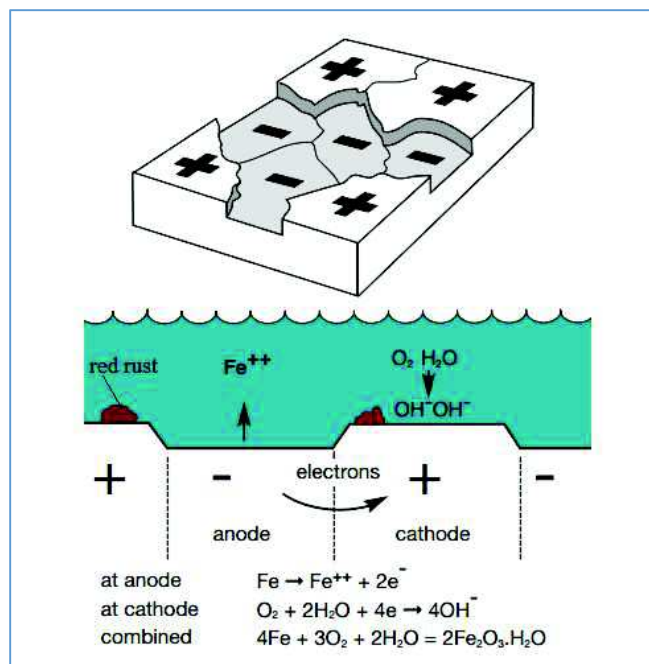
Figure 3.3: Schematic representation of the corrosion mechanism for steel (Corus, 2005)

Structural steel corrosion is an electrochemical process that requires moisture and oxygen as indicated previously. In this process the steel reacts in the aqueous environment while transferring electrons between components. This process requires that the portion of steel to be corroded will conform a corrosion cell to one area acting as an anode, and another area as a cathode, as represented in Figure 3.3.

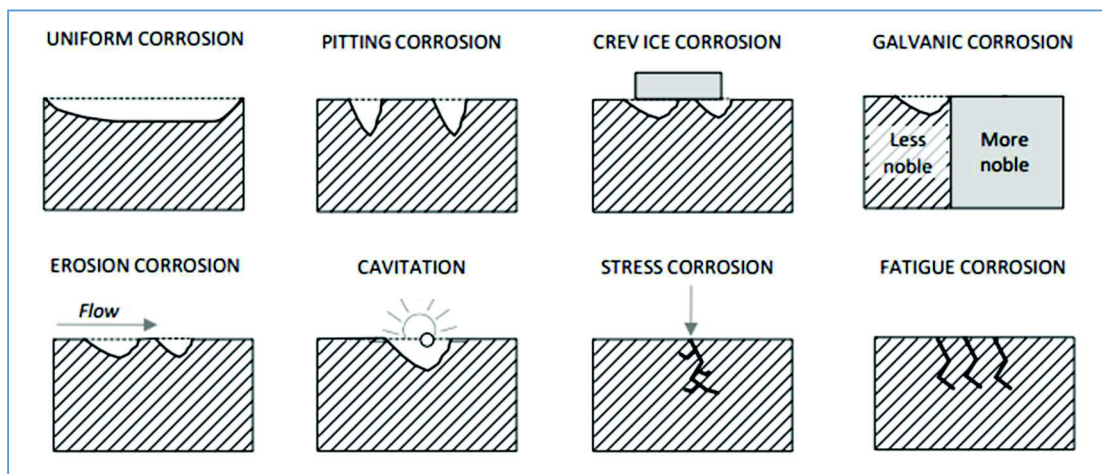
Figure 3.4: Sketches for the principal forms of steel corrosion (Landolfo, 2010)

forms of corrosion are cavitation and fatigue corrosion. Figure 3.4 presents sketches for the indicated forms of corrosion. This research focused on uniform corrosion, a diffuse corrosion penetration that is spread over the steel surface. Uniform corrosion represents the most common and severe form of corrosion in steel girder bridges.

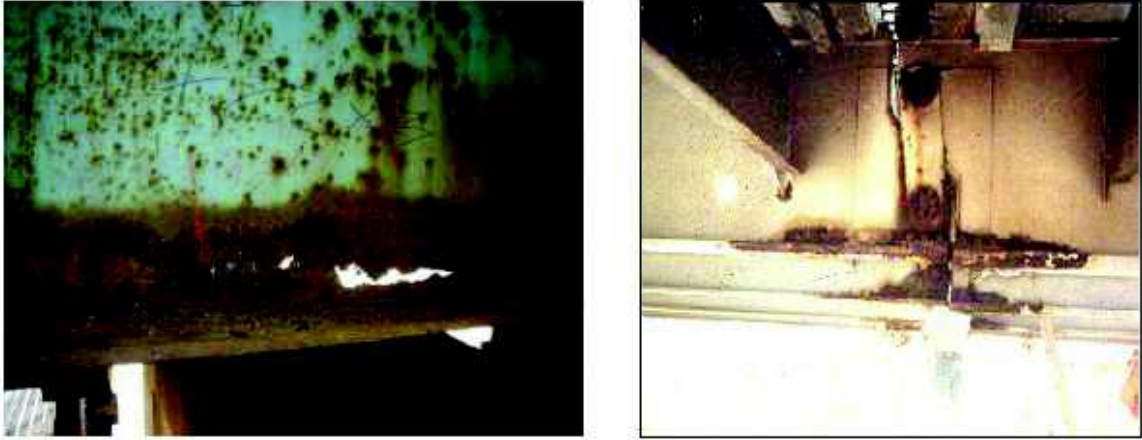
Figure 3.5: Typical corrosion process of steel girders: Left) at the web and bottom flange (Zaffetti, 2010), Right) Next to a pin and hanger connection (WisDOT, 2011)

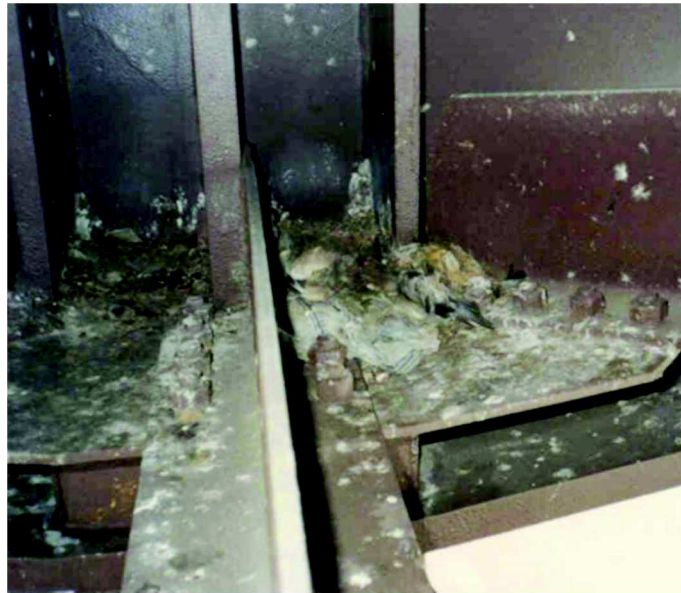
Figure 3.6: Debris accumulation at a steel superstructure connection point (Kogler, 2012)

Debris formations are another source of corrosion problems on steel girders. Debris can buildup on horizontal surfaces of steel girder and at corners formed by horizontal and vertical elements. Debris retains moisture, and keep chloride and sulfate compounds in contact with steel members for a longer period of time, increasing the rate of corrosion on those areas of contact (Albrecht and Naeemi, 1984; Kogler, 2012).

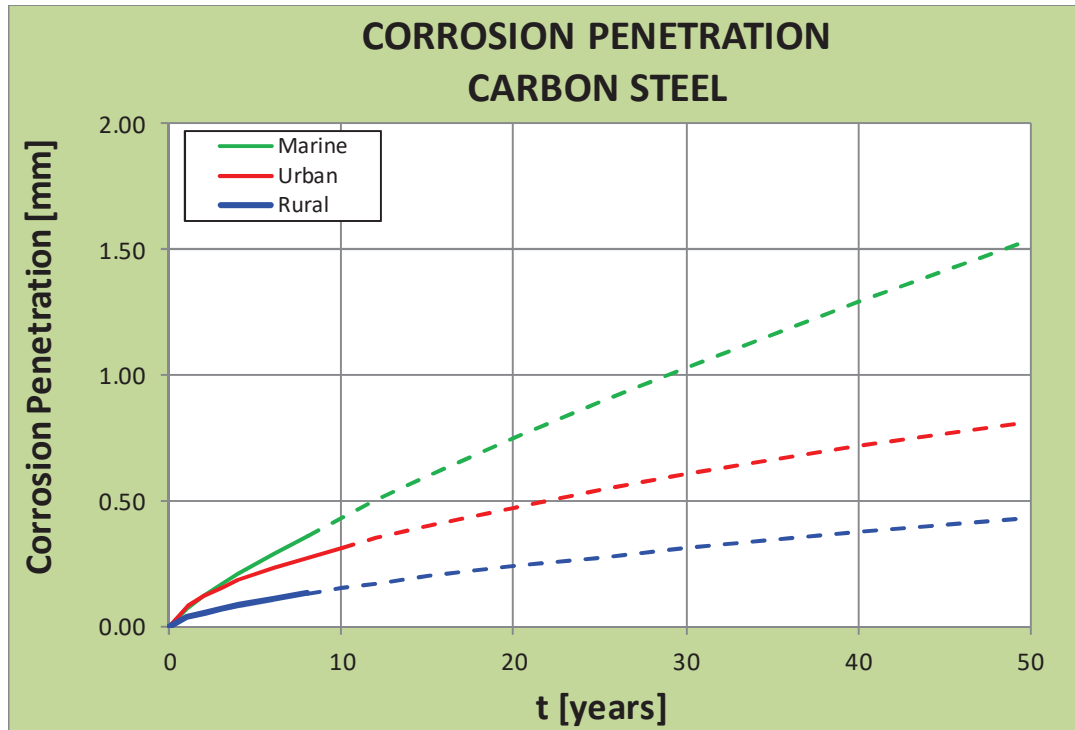
Figure 3.7: Mean of Time-Corrosion penetration curves for carbon steel (Kayser, 1988)

Kayser (1988) reported a wide range of variation for parameters A and B between environments. The same tendency was found for the coefficient of correlation between A and B . Therefore, Kayser emphasized that corrosion penetration will be approximated when the A and B are estimated without high confidence. Kayser used the mean values A and B to extrapolate, the data acquired during Albrecht and Naeemi (1984) tests to 50 years of corrosion penetration values on steel highway bridge girders for the considered environments. The curves for mean time-corrosion penetration corresponding to carbon steel when exposed to the three typical environments (Rural, Urban, and Marine) and projected to 50 years are depicted in Figure 3.7. Actual data collected by Albrecht and Naeemi (1984) are presented in Figure 3.7 in solid lines, while extrapolated values to 50 years evaluated by Kayser (1988) are presented in dotted lines. Figure 3.7 shows that the higher corrosion rates are developed at marine environments, followed by rates at urban environments, and the lower corrosion rates are presented at rural environments. Also, can be noticed that initial corrosion rates decay in time for the three considered environments. In Appendix A are presented the complete set of corrosion penetration curves for the three considered environments.

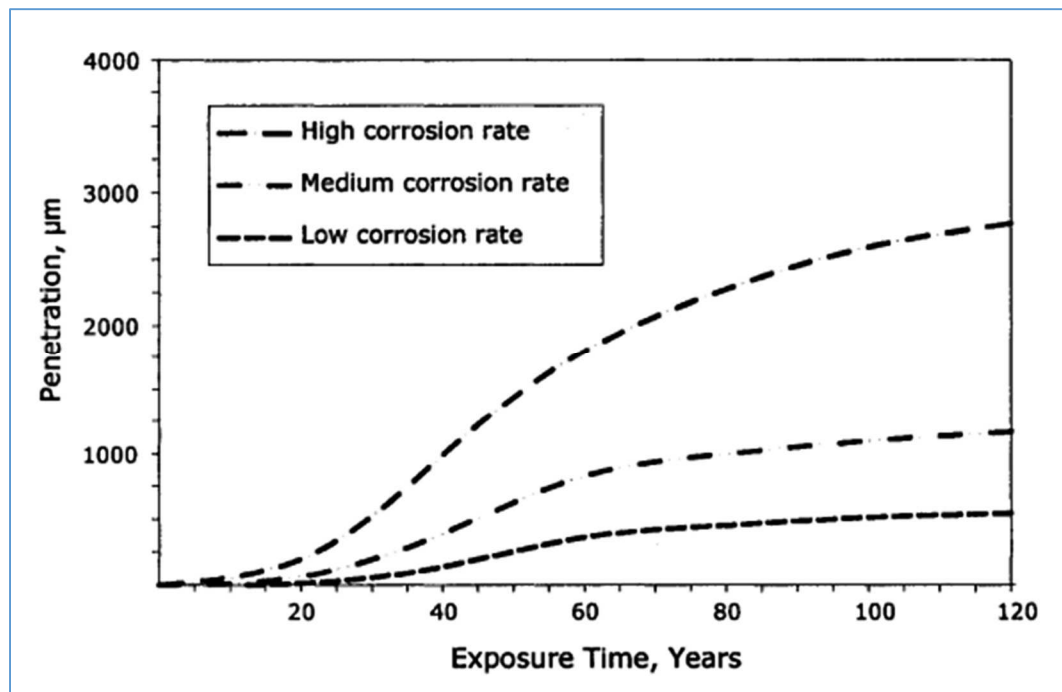
Figure 3.8: Corrosion penetration curves (Park et al., 1998)

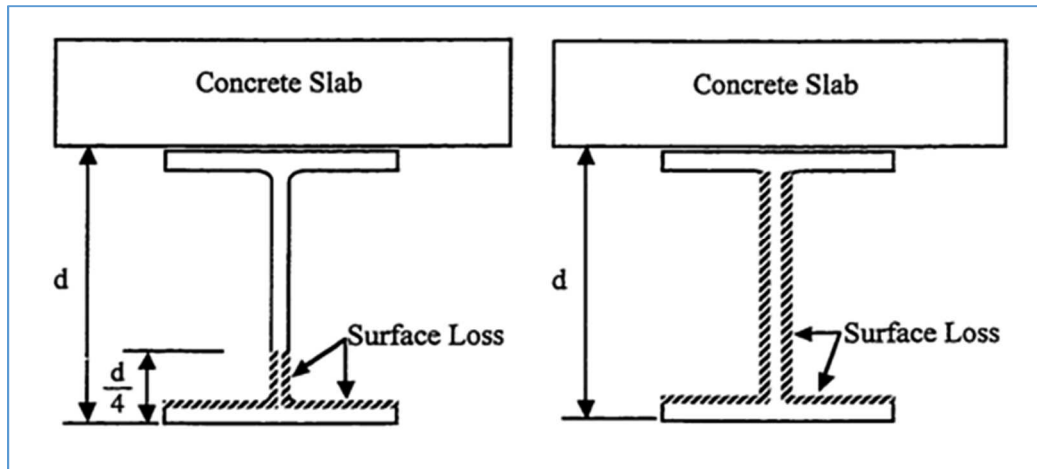
Figure 3.10: Corrosion on typical steel girder sections, at midspan (left), and at supports (right) (Park, 1999)

length of end support zones to ten percent of the span length. Figure 3.10 shows sketches for typical corrosion patterns in the cross section based on Park's research.

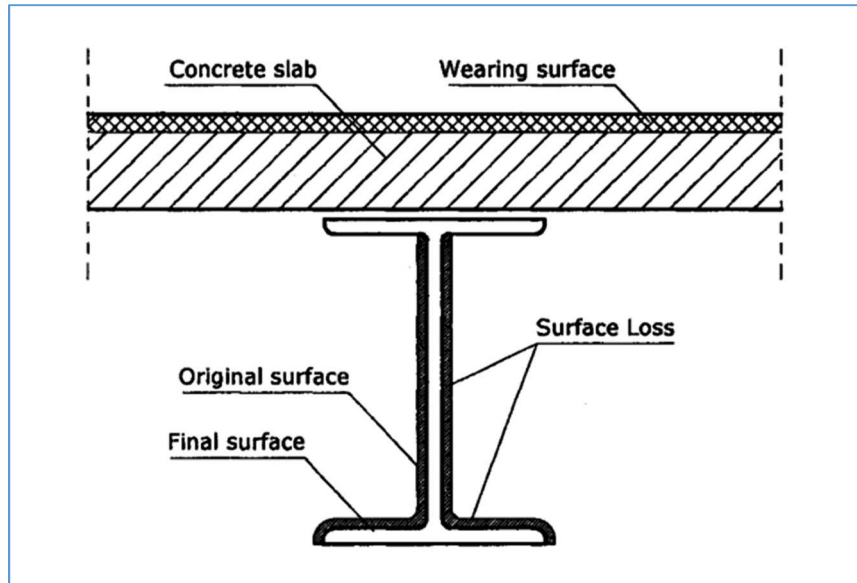
Figure 3.11: Corrosion on typical steel girder section (Czarnecki, 2006)

Czarnecki (2006) modified the model for corrosion location presented by Kayser. According to this study, there are several factors influencing the corrosion pattern as mentioned by Kayser. The complexities and uncertainties involved in determining the corrosion patterns are a significant limitation to define a very detailed corrosion model. As a consequence, the study assumed a model with corrosion located on the top surface of the bottom flange and on the entire web surfaces. The study also assumed that corrosion develops in the same pattern on all steel girders, regardless their location in the bridge. Figure 3.11 presents a sketch of a typical steel girder section with the corrosion location pattern assumed by Czarnecki (2006). The simplified model from Czarnecki (2006) was followed to model the corrosion penetration in the present research.

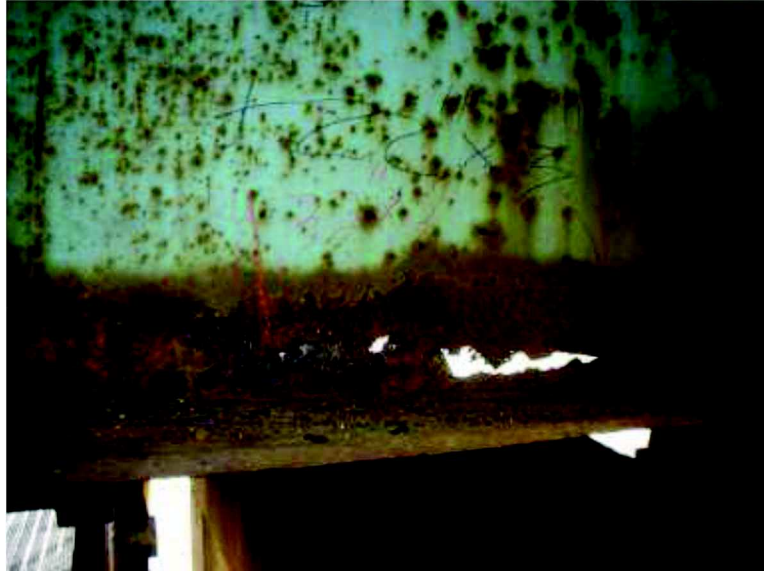
Figure 4.1: Damaged steel girder due to extended corrosion (Zaffetti, 2010)

Significant corrosion damage of a steel girder due to extended corrosion attack is shown in Figure 4.1. The loss of section for the extent of corrosion damage shown in Figure 4.1 can compromise the girder strength capability and, in some occasions, the entire bridge integrity. Consequently, corrosion control is a paramount responsibility for highway bridge owners.

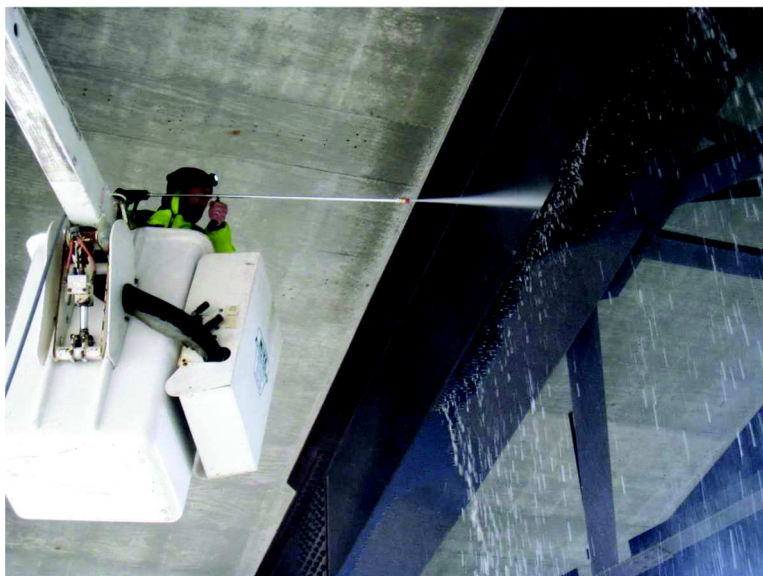
Figure 4.2: Steel bridge superstructure washing (Crampton et al., 2013)

A common method for superstructure bridge washing includes the collection and cleaning of solid materials from the superstructure, followed by the spray of pressured clean water to remove the contaminant compounds from the girder surface. Chloride compounds from deicing products are the most common and aggressive substances attacking a steel girder. Also the accumulation of dirt, debris, and dust is the source for corrosion initiation and should be cleaned from the steel girder surfaces (Berman et al., 2013). Figure 4.2 shows a maintenance crew member performing superstructure washing.

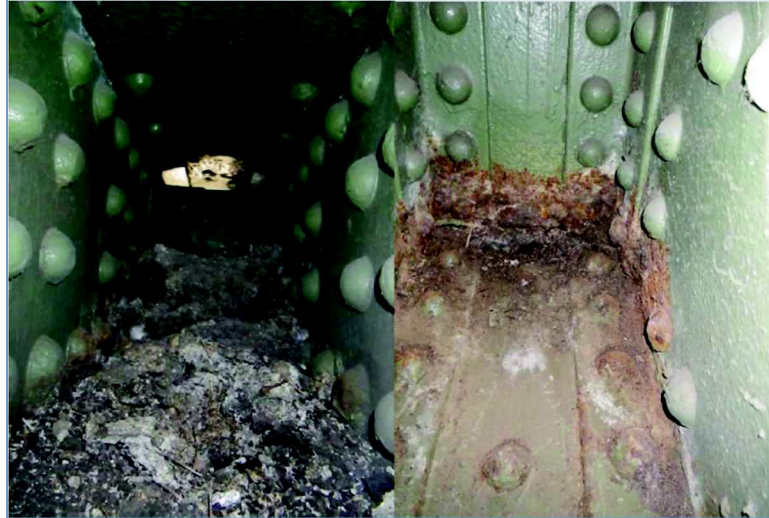
Figure 4.3: Interior of lower chord from truss. Before (left) and after (right) cleaning and washing (Berman et al., 2013)

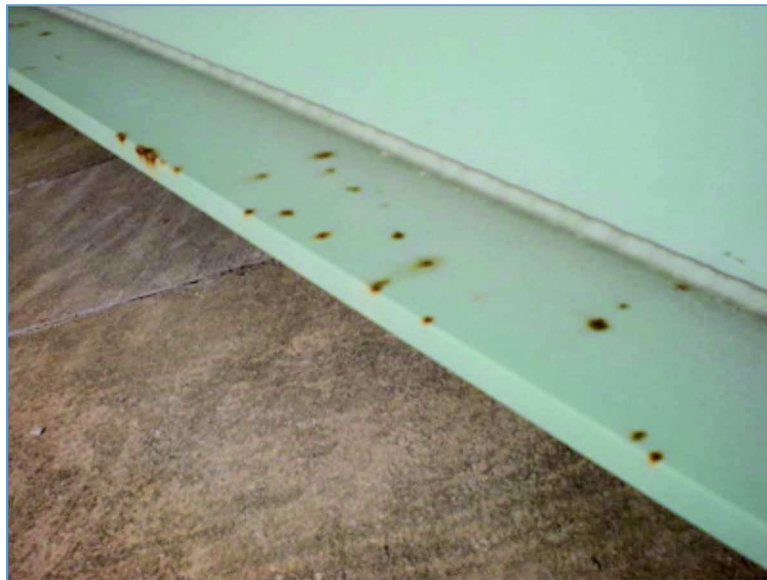
Figure 4.4: Portion of a steel girder candidate for spot painting (Myers et al., 2010)

Basically, spot painting involves these activities: 1) cleaning the damaged surface, using hand/power tools, until all corrosion material has been eliminated, 2) prepare the area to receive the new protecting coat, and 3) application of a new coating system, compatible with the original coat system, using a brush, roller or spray. Several DOT agencies include spot painting in their bridge maintenance programs, since they consider it an efficient activity to protect steel members from corrosion attack. Among those states performing spot painting routinely are New York, New Jersey, Virginia, Pennsylvania, Washington, Oregon, New Hampshire, Maine, and Minnesota. Figure 4.4 illustrates a portion of a steel girder that is a good candidate for spot painting.

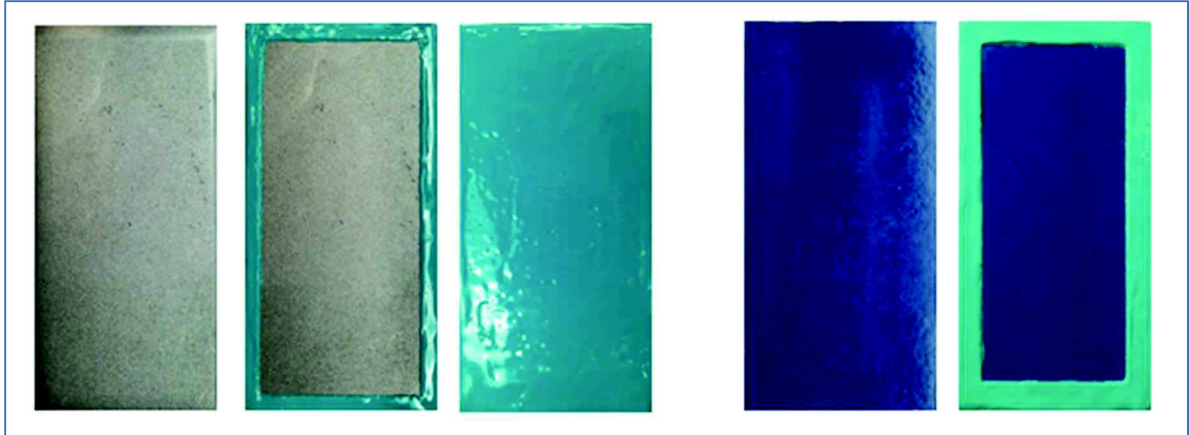
Figure 5.1: Steel coupons before and after epoxy coating application. Left: uncoated coupon, Right: coated coupon.

The steel coupons were then protected with a casing made of a thick layer of 3M Scotchkote Liquid Epoxy Coating 323, a two-part system designed to protect steel pieces from harsh corrosion. The epoxy was applied to protect completely one face of the coupon, all four edges, and the borders in the other face. Corrosion from cut edges produces more rust than rolled surfaces, therefore all cut edges were protected to avoid distortions due to this effect. The uncoated coupons presented a surface of 2 ½" x 5 ½" and the coated coupons presented a surface of 2 ¼" x 5 ¼", totally free to be exposed to corrosion attack during tests. In this manner, the steel coupons offered only one face to be exposed to corrosion while the rest of the plate was effectively protected. Figure 5.1 shows typical steel coupons before and after application of epoxy casing protection.

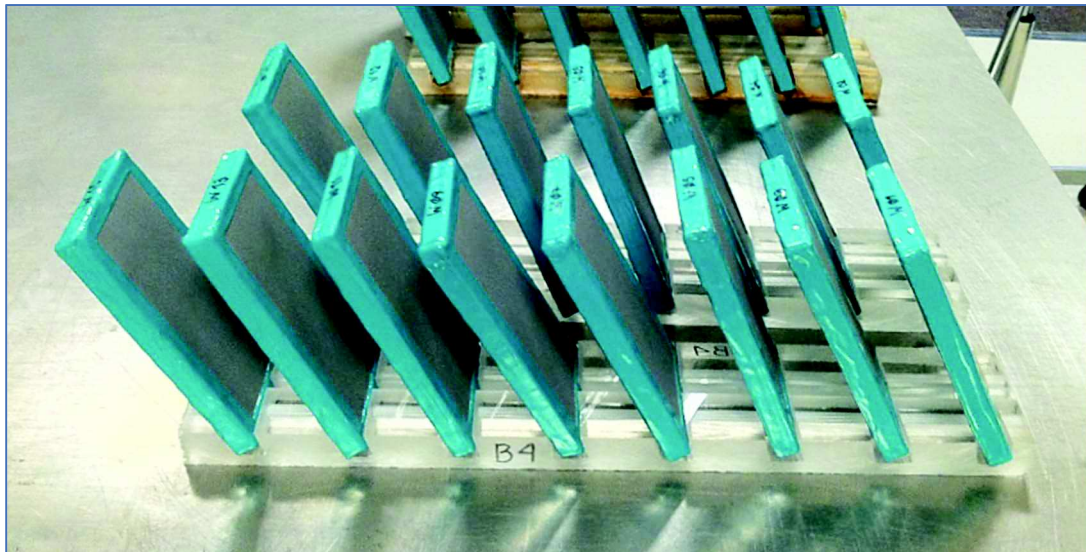
Figure 5.2: Steel coupons supported by PVC racks.

Polyvinyl chloride (PVC) racks were built to hold the steel coupons in a steady position during tests. The material was chosen to prevent galvanic couples when in contact with the metal pieces. Grooves were drilled with a tilt angle of 15° from the vertical and enough separation between them to avoid overlap of the plates. Figure 5.2 shows a group of racks holding steel coupons.

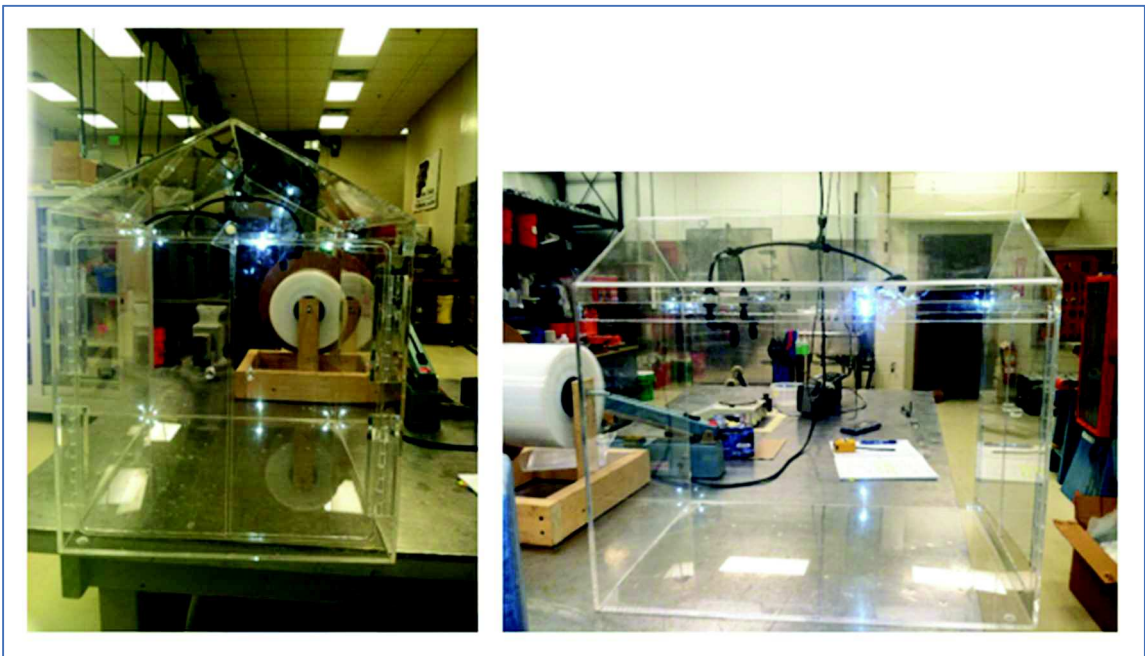
Figure 5.3: Front and lateral view of acrylic box

Acrylic boxes (25" high, 20" wide, and 27" deep) were built to contain the steel coupons inside the chamber under controlled temperature and relative humidity, as required by ASTM B117. The boxes had space to contain 40 coupons supported by racks. Each box had attachments to affix the misting system and keep 4 nozzles in a vertical position over the coupons. The ceiling had a marked inclination, such that any drop of solution accumulated in the upper inner surface would be directed to the sides. Figure 5.3 shows an acrylic box with tubing connections to conduct the pumped salt solution to the nozzles.

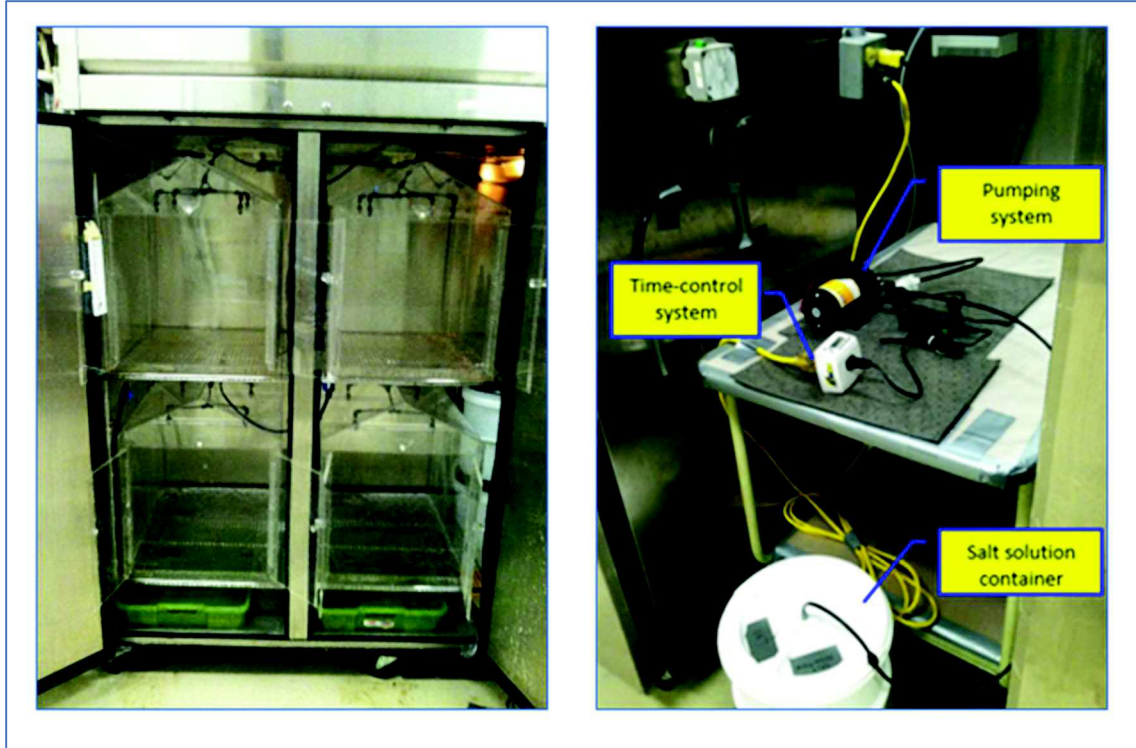
Figure 5.4 shows the interior of the weather chamber with the four acrylic boxes in position and the misting system installed.

Figure 5.4: Interior view of weather chamber with acrylic boxes (left). Misting system installed (right)

A misting system from MistKing was connected to the weather chamber to spray the salt solution periodically under a controlled regime. A 125 psi (0.86 MPa) misting pump was installed to inject the salt solution to the weather chamber. PVC tubing ¼ in. diameter was used to link a plastic bucket containing the salt solution to the misting pump, and from the misting pump to each one of the four ¼ in. nozzles located on each acrylic box. The nozzles atomized the salt solution to spray it as a fine mist over the steel coupons. A ZipDrip valve was installed to eliminate falling drops from nozzles immediately after stopping each pumping cycle. A digital time-control device with 8 programmable events was used to modulate the misting system. The time-control device controlled the run/stop pumping cycle of the salt solution according to an established schedule for the entire day. Various accessories such as T and Y unions, manifolds, and valves, were installed to fit the misting system to the acrylic boxes.

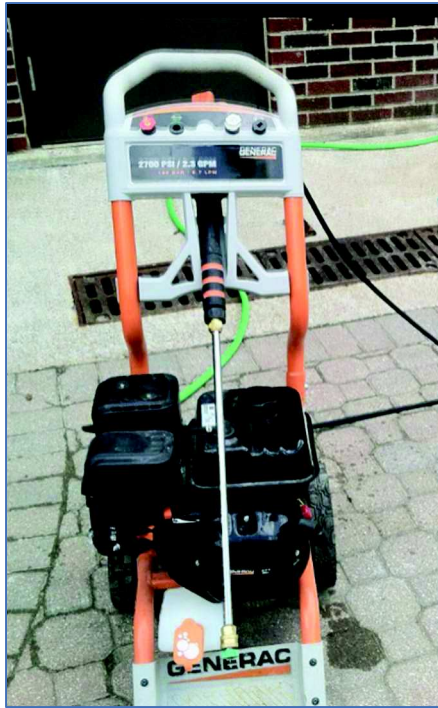
Figure 5.5: Power washer

Corroded steel coupons were treated by washing them to analyze its effect on the corrosion process. A 2500 - 3100 psi (17.24 - 21.37 MPa) Power Washer from Generac was utilized to wash the corroded steel plates at high pressure. This equipment takes water from a water source and ejects it at a high pressure; it is commonly used to clean and wash surfaces such as floors and walls. A strip pressure nozzle was recommended to produce medium rinsing, with higher pressure and medium flow. This type of nozzle was ideal for removing stains and rust without damage to the work surface. Figure 5.5 shows the power washer equipment.

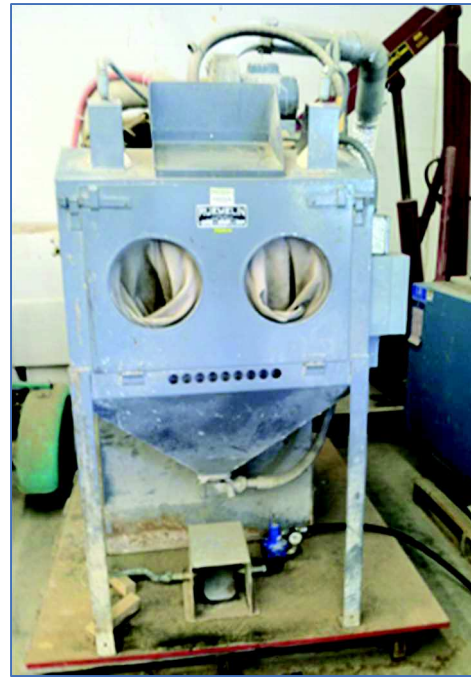
Figure 5.6: Abrasive blast cabinet

An abrasive blast cabinet from Ruemelin Manufacturing Co. from the Bowen Laboratory for Large-Scale Civil Engineering Research at Purdue University was used to clean

selected corroded steel coupons. The cabinet propells fine grains of abrasive material at high velocity by an air compressor. Exposing a corroded steel plate to the sandblast eliminates all the rust from the surface, producing a white metal blast surface. Figure 5.6 shows the Ruemelin blast cabinet.

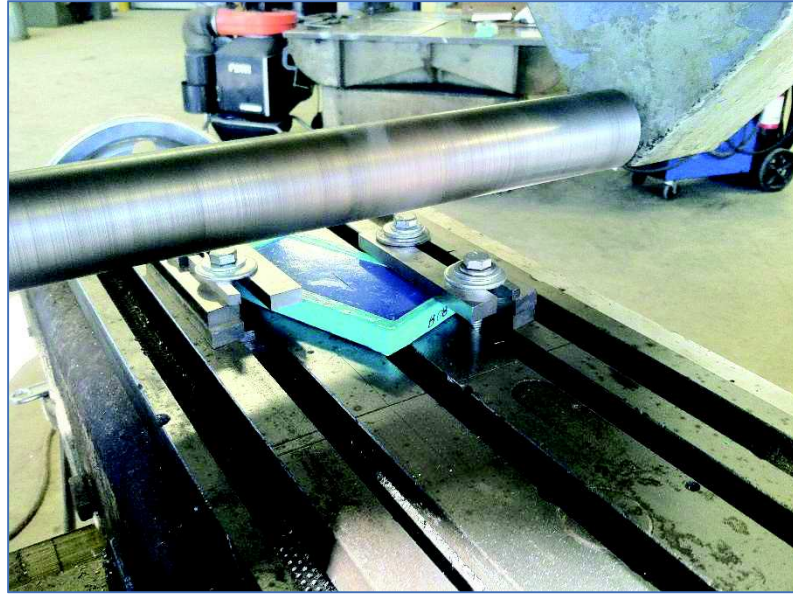
Figure 5.7: Milling machine scribing a steel plate

Steel coated coupons were scribed by a 2ML milling machine from The Cincinnati Milling Machine Co. at the Bowen Laboratory at Purdue University. The mill produced a controlled and artificial damage on coated steel samples in order to simulate damage in the field. A hard nail attached to a rotating axis produces an homogeneous cut in the sample. Figure 5.7 shows the milling machine used to scribe the steel coupons.

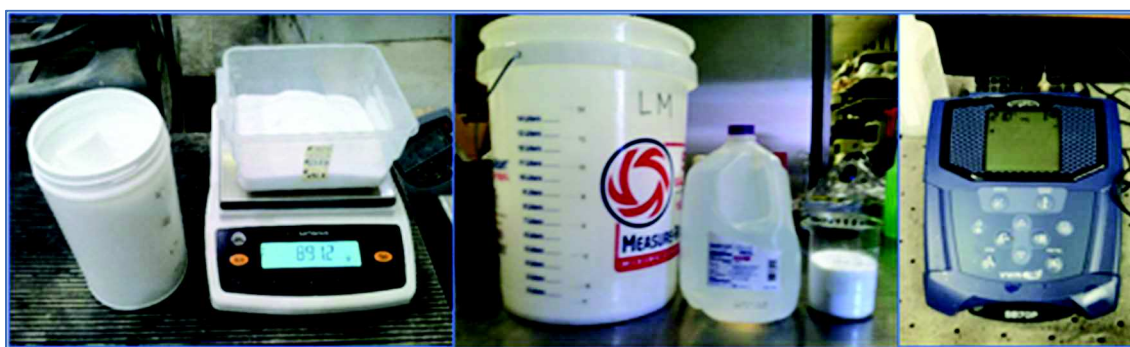
Figure 5.8: Components for salt solution preparation: Sodium chloride and scale (left), distilled water and graduated plastic bucket (center), and pH-meter (right)

The salt solution was prepared mixing 10 L of distilled water with 530.0 gr. of Culinox 999 Food Grade Sodium Chloride from Morton Salt Inc., to obtain a saltwater solution at 5% in weight. The water used in the mix was distilled water acquired at Walmart stores. The sodium chloride composition was in accordance with the ASTM-B117 requirements. A copy of the Certificate of Analysis from the sodium chloride presented by the provider is shown in Appendix B. The prepared mix was stored in a plastic bucket and injected to the chamber by the pump for 1.25 minutes each 2.5 hours. The steel coupons were

sprayed eight times each day at the following times: 00:30am., 7:00am., 9:30am., 12:00m., 2:30pm., 5:00pm., 7:30pm., 10:00pm. The total spray cycle per day resulted in an average rate of 1.55mL/h collected in an horizontal area of 12.4 in². The pH level in the mix was controlled for each load using a Symphony DB70P pH-meter, keeping the pH level at an average value of 7. Figure 5.8 shows the elements employed to prepare the salt solution in accordance to ASTM B117. Every three days the residual solution collected was eliminated from the chamber.

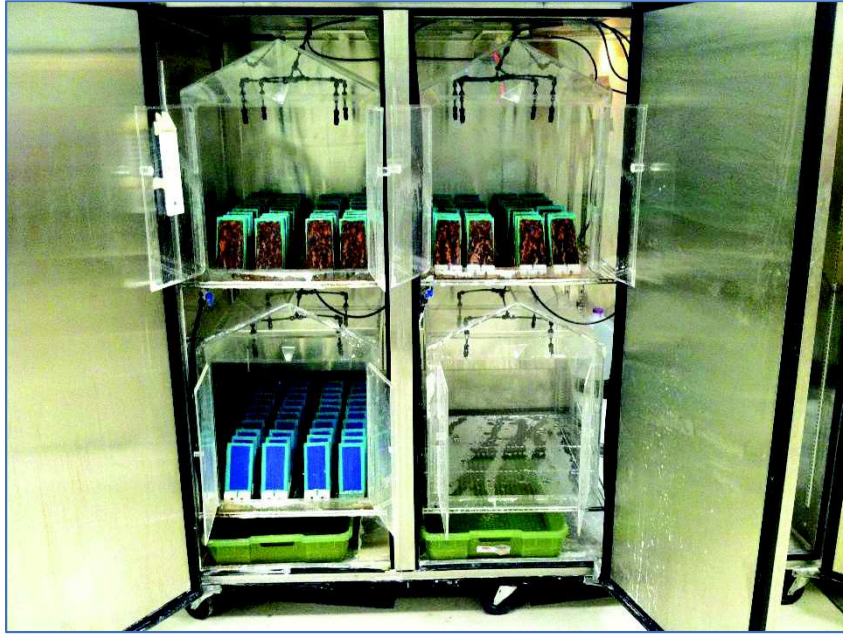
Figure 5.11: Weather chamber with steel coupons under ACT regime.

The 120 steel coupons from Groups A, B, and C, were supported on the PVC racks and placed inside the acrylic boxes. Each group of steel coupons was placed in one acrylic box, forming four lines of racks, and containing ten coupons in each line. After the spray process was initiated, the ACT continued every day for twenty four weeks, following the indicated program of eight spray cycles per day. The salt solution bucket was loaded with the 5% by weight of sodium chloride (NaCl) mix each three days to ensure a continuing fog spray of the coupons inside the boxes. The spray system was controlled in a way that never ran out of salt solution. Figure 5.11 shows the weather chamber with the acrylic boxes containing the steel coupons during the ACT regime.

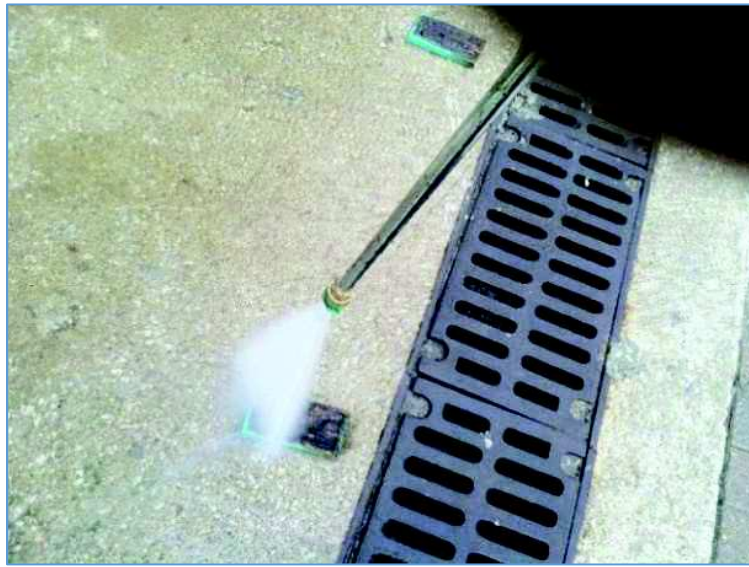
Figure 5.12: Power washing steel coupons

ejecting potable water at approximately 2500 psi (17.24 MPa), from a distance of one foot (0.30 m). The pressured water was applied during two seconds to remove the salt compounds from the coupon surface. The time of washing was estimated following the recommendations from the study by Crampton et al. (2013). This activity was performed only to coupons belonging to Groups 01 to 09, since coupons from Group 10 were never washed. Figure 5.12 shows a series of steel coupons under pressure washing.

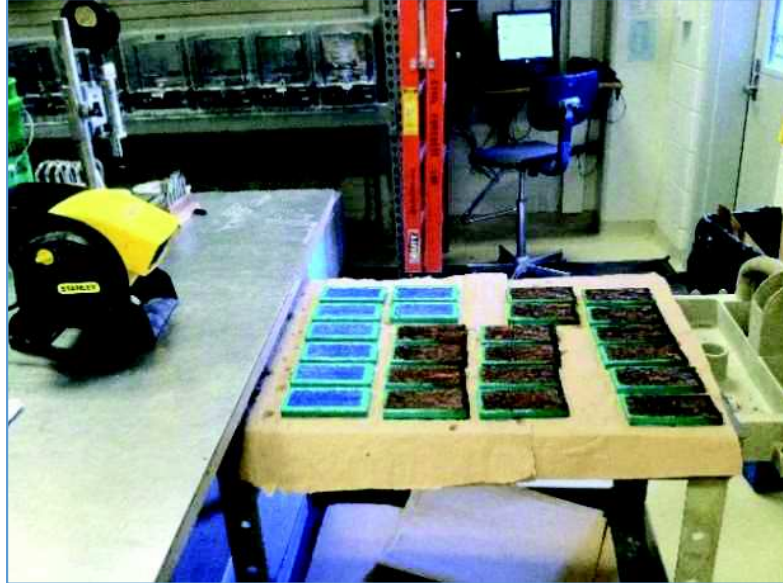
Figure 5.13: Drying wet coupons after washing

After finishing power washing, the steel coupons were dried using a portable fan. Inside the laboratory, the washed coupons were placed over a table and air-dried during 15 minutes. Figure 5.13 shows steel coupons that are being air-dried with a portable fan.

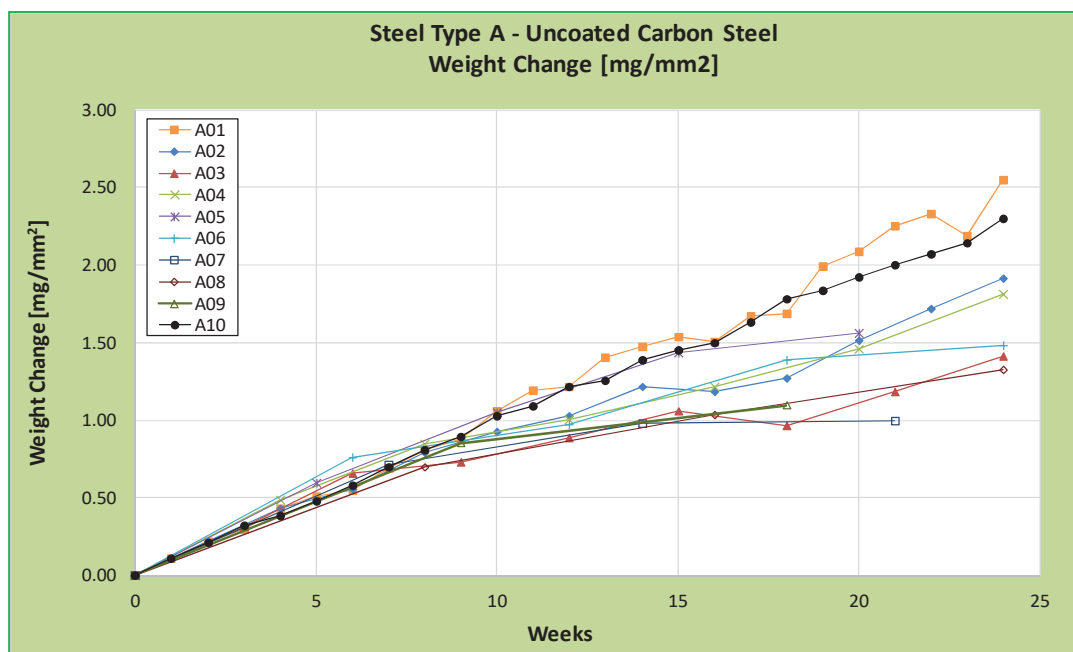
Figure 5.15: Weight change versus time for steel Type A groups

A summary of data corresponding to weight change from steel Type A coupons is presented in Figure 5.15. Figure 5.15 shows the weight change variation in time for the mean values of the four coupons conforming each group (Groups A01 to A10).

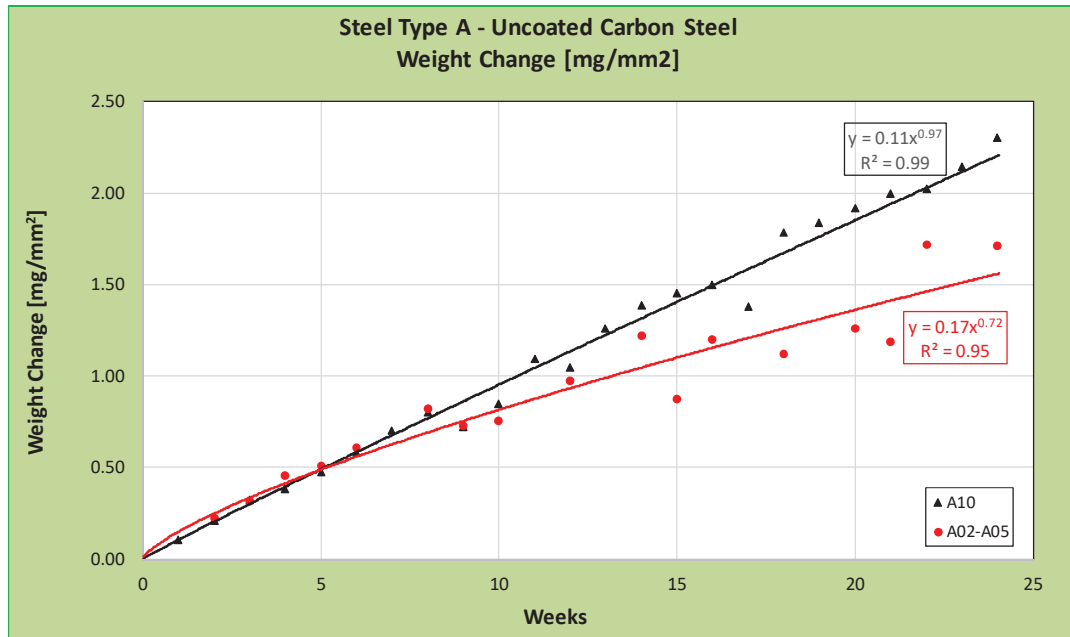
Figure 5.16: Weight change versus time for mean values from Groups A02-A05 and Group A10

After the indicated considerations, data from Groups A02, A03, A04 and A05 were combined, averaged, and plotted along with data corresponding to Group A10. Figure 5.16 presents the data for the mean of weight change values from combined Groups A02-A05 and data from Group A10. In Figure 5.16 can be observed that the average of weight change values for combined Groups A02-A05 is quite similar to values from Group A10 at the beginning of the test. After the first seven weeks the values start a marked difference, with a reduction on the increment of weight for the average values from combined Groups A02-A05.

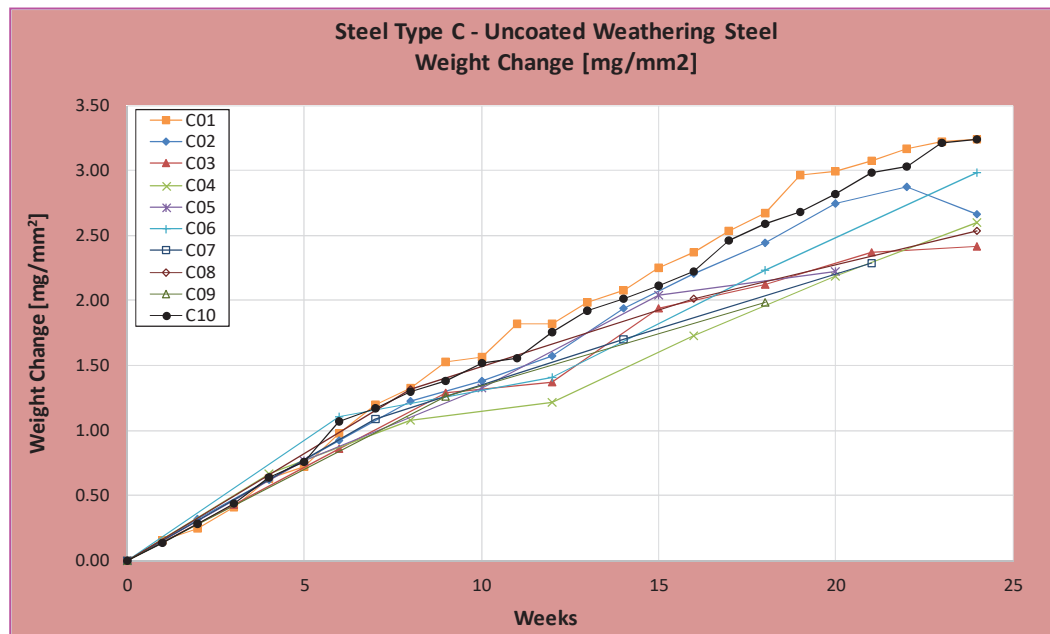
Figure 5.17: Weight change versus time for steel Type C groups

The same analysis and considerations applied to steel Type A coupons were applied to the analysis for steel Type C coupons. Figure 5.17 shows the data corresponding to the mean values of weight change variation in time for each group of coupons corresponding to steel Type C (Groups C01 to C10). Figure 5.18 shows the data for the mean of weight change values from combined Groups C02-C05 and data from Group C10. Again, it is observed that there is less weight increment, and hence lower corrosion rates, from steel washing alternatives (Groups C02-C05) versus the no washing alternative (Group C10). Data points from the two plots were fitted using the least-squares function from MS Excel to determine a representative curve for each group. Equations 5.3 and 5.4 show the power functions representing the weight change for Groups C02-A05 and Group C10 respectively. In both cases the type of function was selected based on a relatively high correlation parameter R^2 .

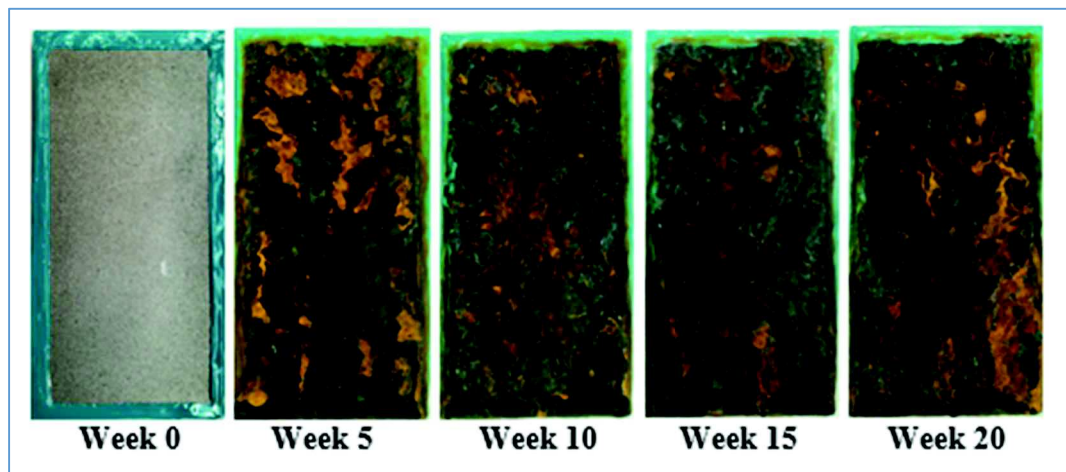
Figure 5.27: Rust formation over uncoated steel coupon (coupon A01-a)

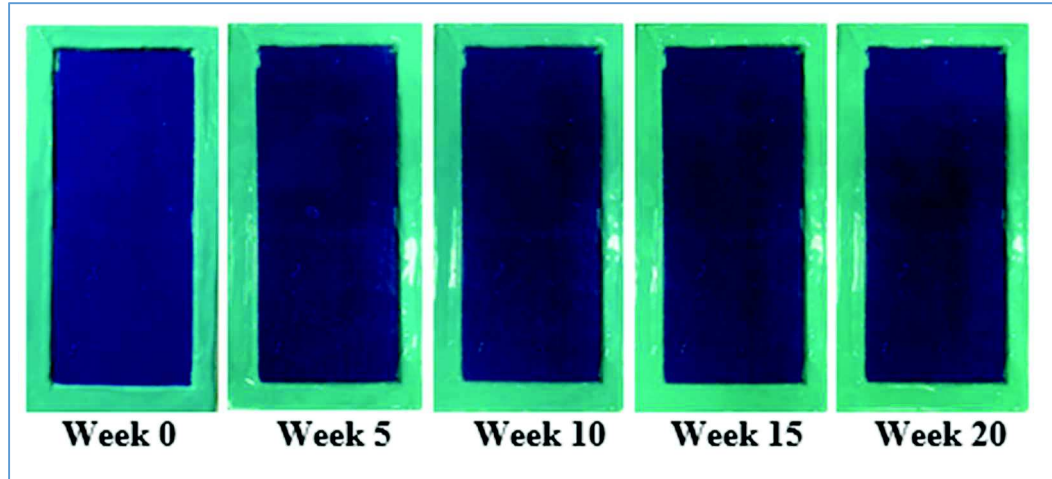
Figure 5.28: Lack of rust formation over coated steel coupon (coupon B05-a)

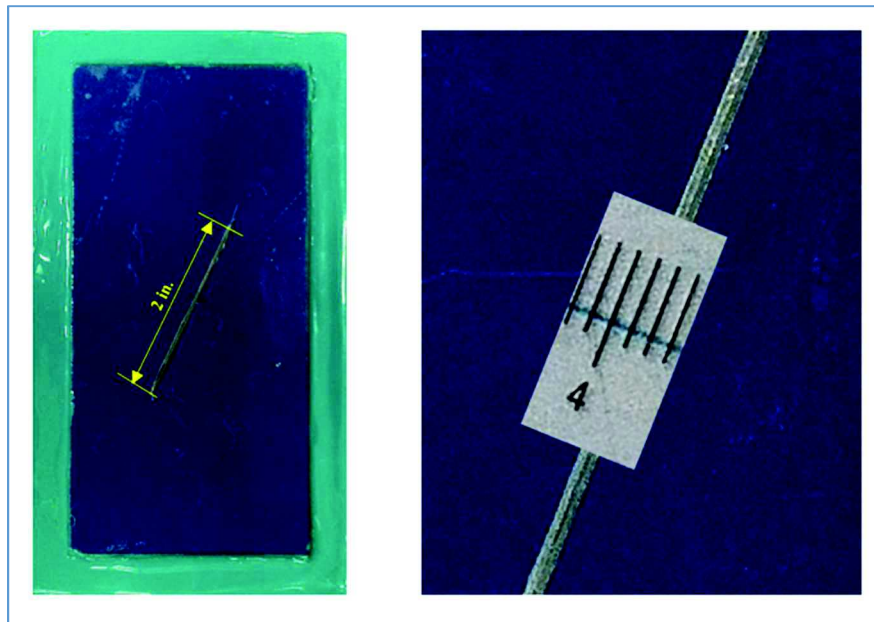
Figure 5.29: Left: Scribed steel coupon (D01-a). Right: Scribe mark magnified with scale (mm).

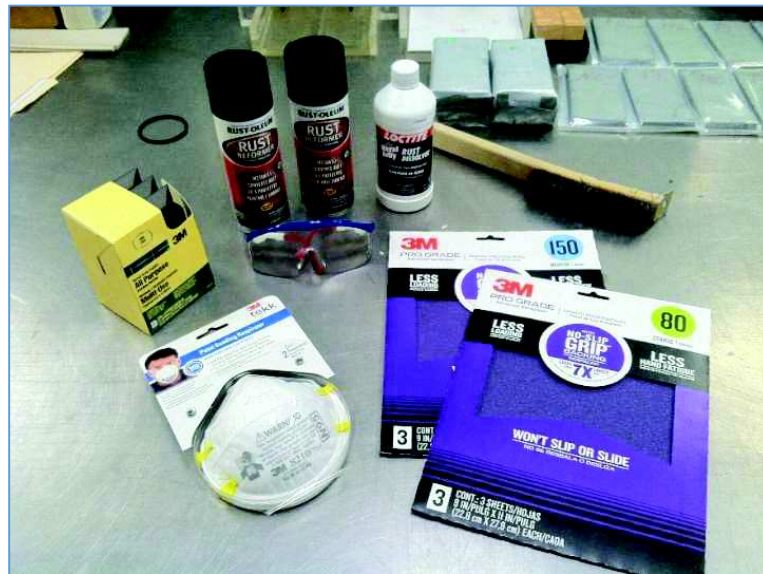
Figure 5.31: Tools and products used to eliminate the rust and protect the scribe.

At the sixth week of the ACT to evaluate spot painting, coupons from Groups D05 and D07 were treated with a protective coat to cover their scribe mark. First, the rust creepage from scribe was cleaned using sandpaper and a small steel nail. Next, the rust remaining in the scribe was removed applying a Loctite - Rust Dissolver, a treatment formula that eliminates rust from metal surfaces. When the scribe mark was completely cleaned from rust, a protective paint was sprayed onto the surface to cover the scribe mark. Scribe from coupons of Group D05 were covered with one application of Rust Reformer from Rust-Oleum, while coupons from Group D07 received two applications of Rust Reformer. Figure 5.31 shows the different tools and products used to eliminate the rust from a scribe and to protect it against future corrosion. Figure 5.32 presents the process followed to apply Rust-Oleum® products to clean and protect the scribe.

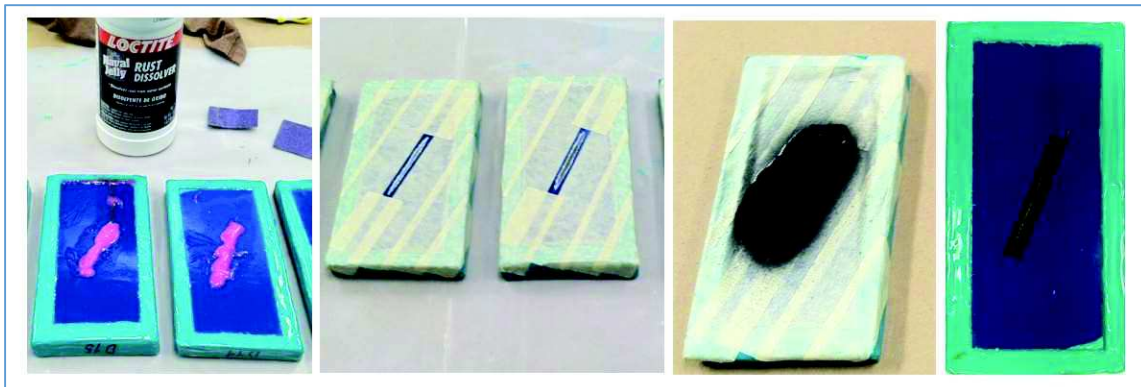
Figure 5.32: Process to clean and protect the scribe. From left to right: Clean the scribe with sandpaper and rust dissolver application; cover all coupon face but scribe mark; spray paint; coupon with covered scribe.
