Bridge maintenance to enhance corrosion resistance and performance of steel girder bridges

BRIDGE MAINTENANCE TO ENHANCE CORROSION RESISTANCE AND PERFORMANCE OF STEEL GIRDER BRIDGES

For the degree of Doctor of Philosophy

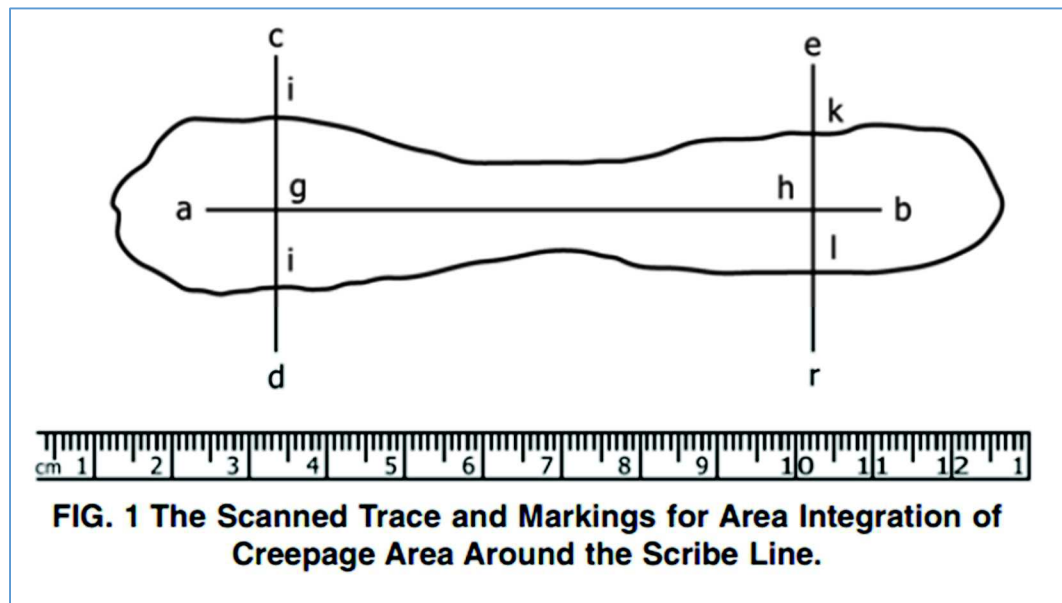
Figure 5.35: Creepage area measurement (ASTM Standard D7087-05a)

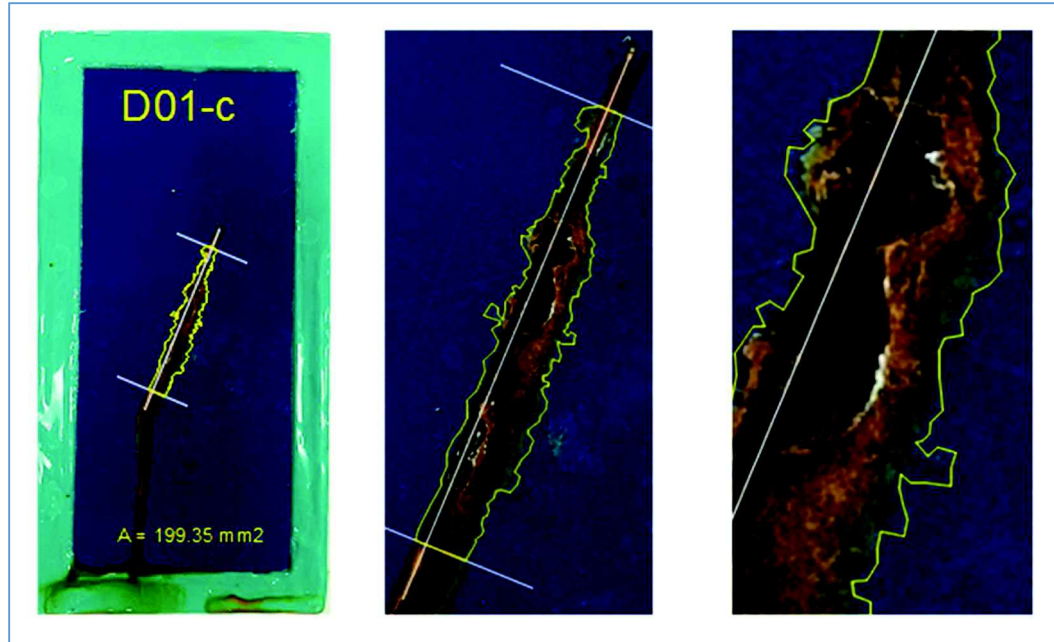
Figure 5.36: Trace of rust creepage area. Complete scribed coupon image and two magnifications after six weeks of ACT.

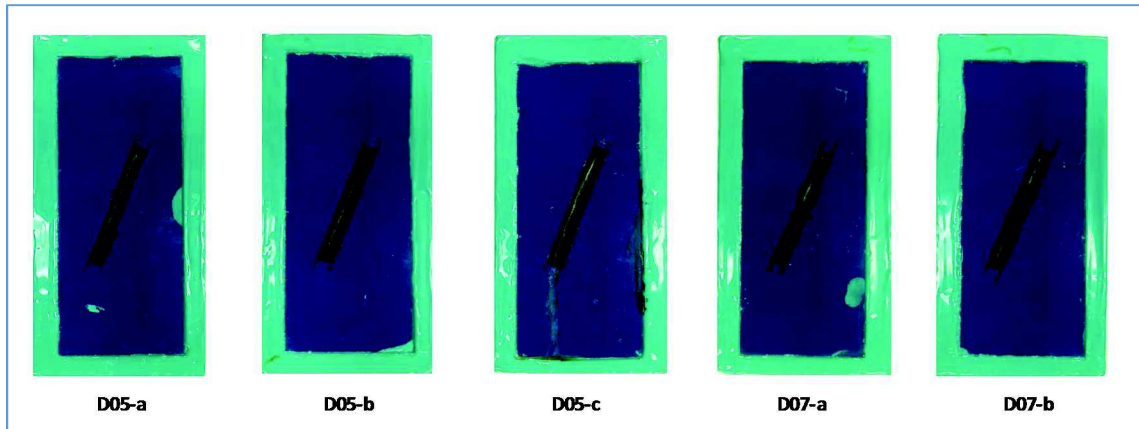
Figure 5.39: Coupons from Groups D05 and D07 after the ACT ended

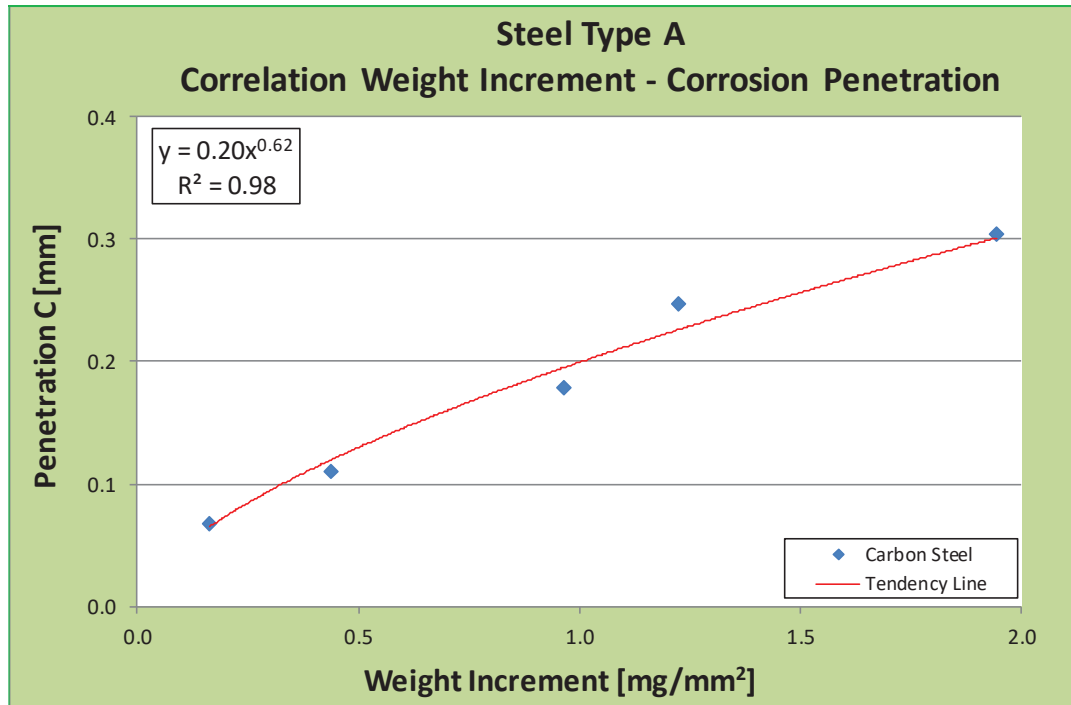
Figure 6.2: Correlation weight increment-corrosion penetration for steel Type A

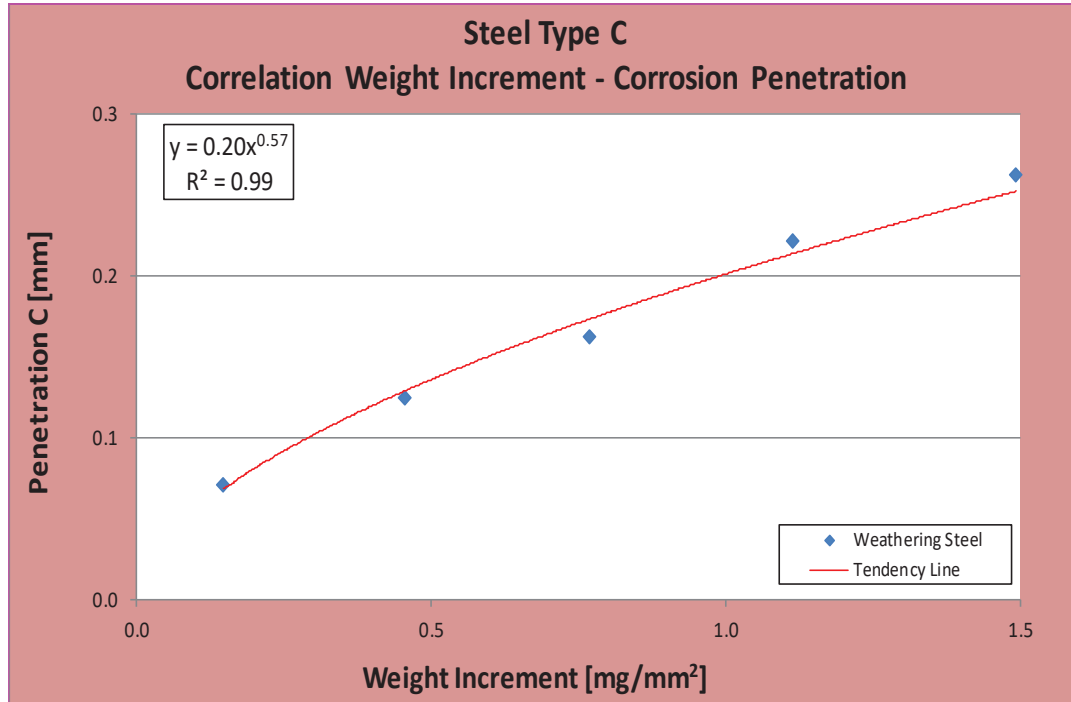
Figure 6.3: Correlating weight increment-corrosion penetration for steel Type C

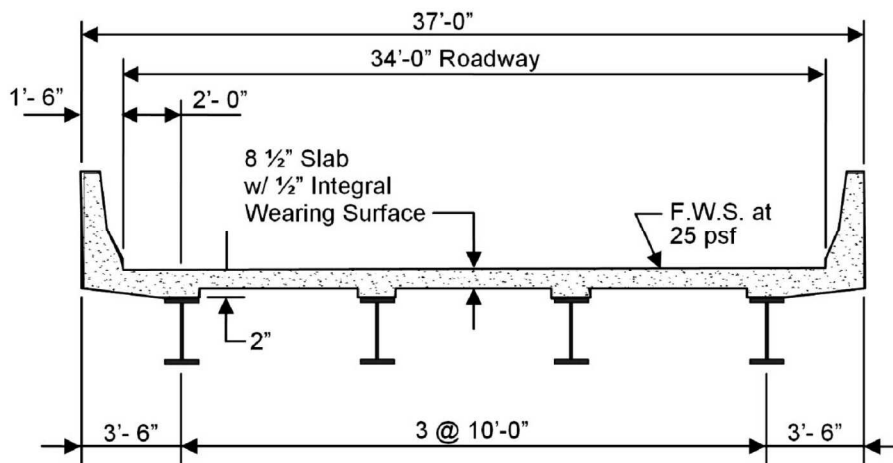
Figure 7.2: Typical bridge cross section (Barth, 2012)

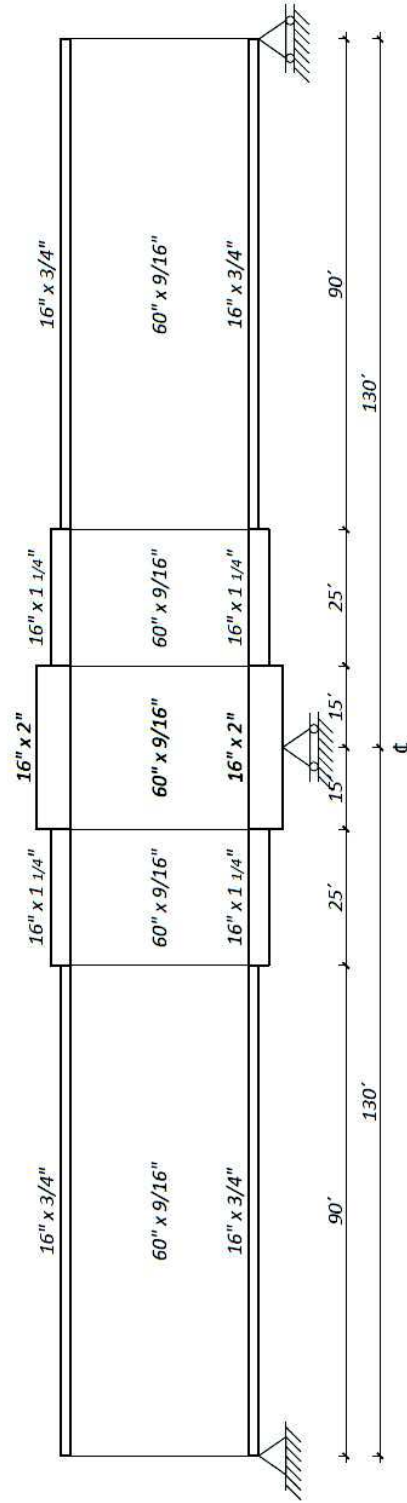
Figure 7.12: Sketch of the typical 130'-130' two-span composite steel I-girder bridge

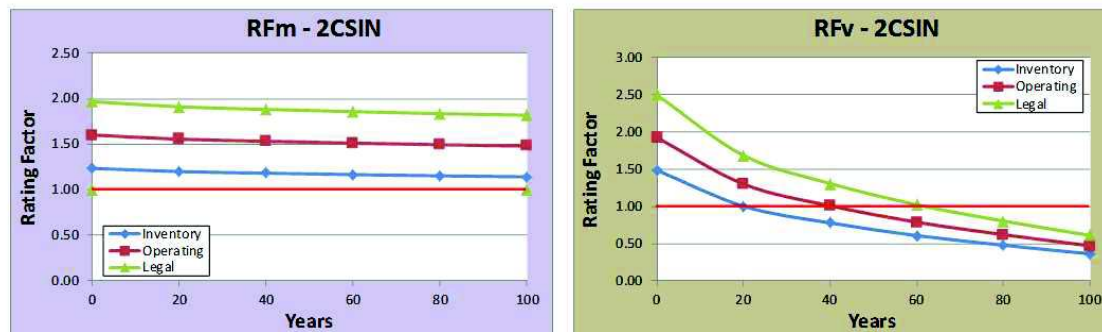
Figure 7.17: RFm and RFv versus time for bridge case 2CSIN
